**REPORT ON
GEOTECHNICAL INVESTIGATION
PROPOSED WATERMAIN CROSSING UNDER HIGHWAY 403
SOUTH OF DUNDAS STREET, OAKVILLE, ONTARIO
REGIONAL MUNICIPALITY OF HALTON**

**Prepared for:
DOWNUNDER GEOTECHNICAL LIMITED**

**By:
SPL CONSULTANTS LIMITED**

**Project: 1549-110
November 6, 2013**

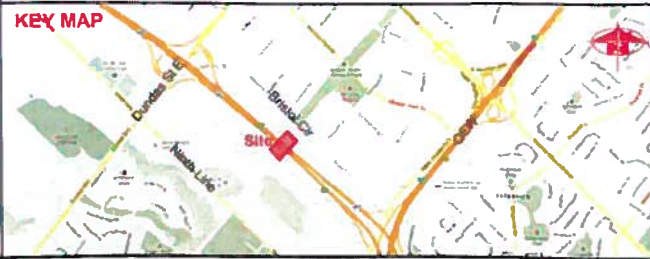
Borehole Location Plan and Geological Sections	Drawing No. 1
--	---------------

We understand that two (2) shafts, one at each end of the crossing, will be constructed for the trenchless crossing. The subsurface conditions encountered in the boreholes at or near these shafts are shown in **Drawing No. 1**, and are briefly summarized in Table 5.2.2.

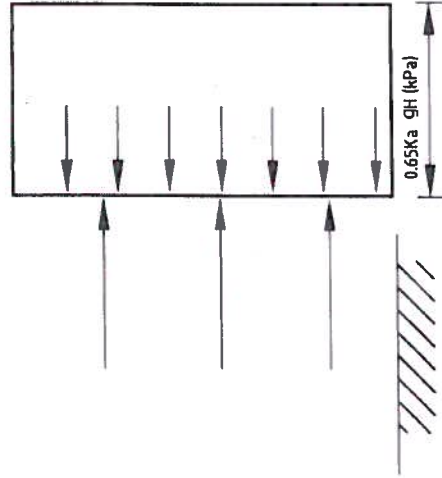
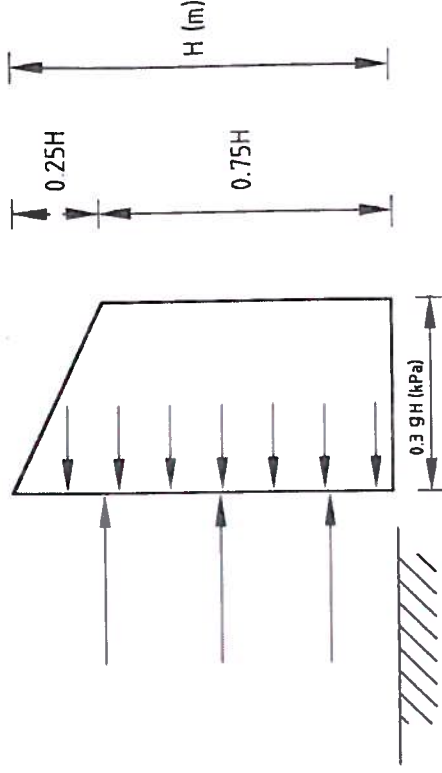
Earth Pressure Distribution	Drawing No. 2
-----------------------------	---------------

g = unit weight of soil = 21.0 kN/m³

g' = submerged unit weight of soil (i.e. below ground water level) = 11.2 kN/m³

g = unit weight of soil = 21.5 kN/m³

g' = submerged unit weight of soil (i.e. below ground water level) = 11.7 kN/m³

The earth pressure distribution on shafts can be taken as hydrostatic, i.e. which is increasing uniformly with depth according to the formula:

Provided that rock squeeze is allowed to dissipate by delaying construction of permanent concrete walls or by applying a compressible void former, the lateral earth pressures acting on this bedrock for concrete cast against rock with no backfill can be assumed to be a uniform pressure equal to the maximum overburden lateral earth pressure calculated at the overburden to rock interface, plus the hydrostatic forces.

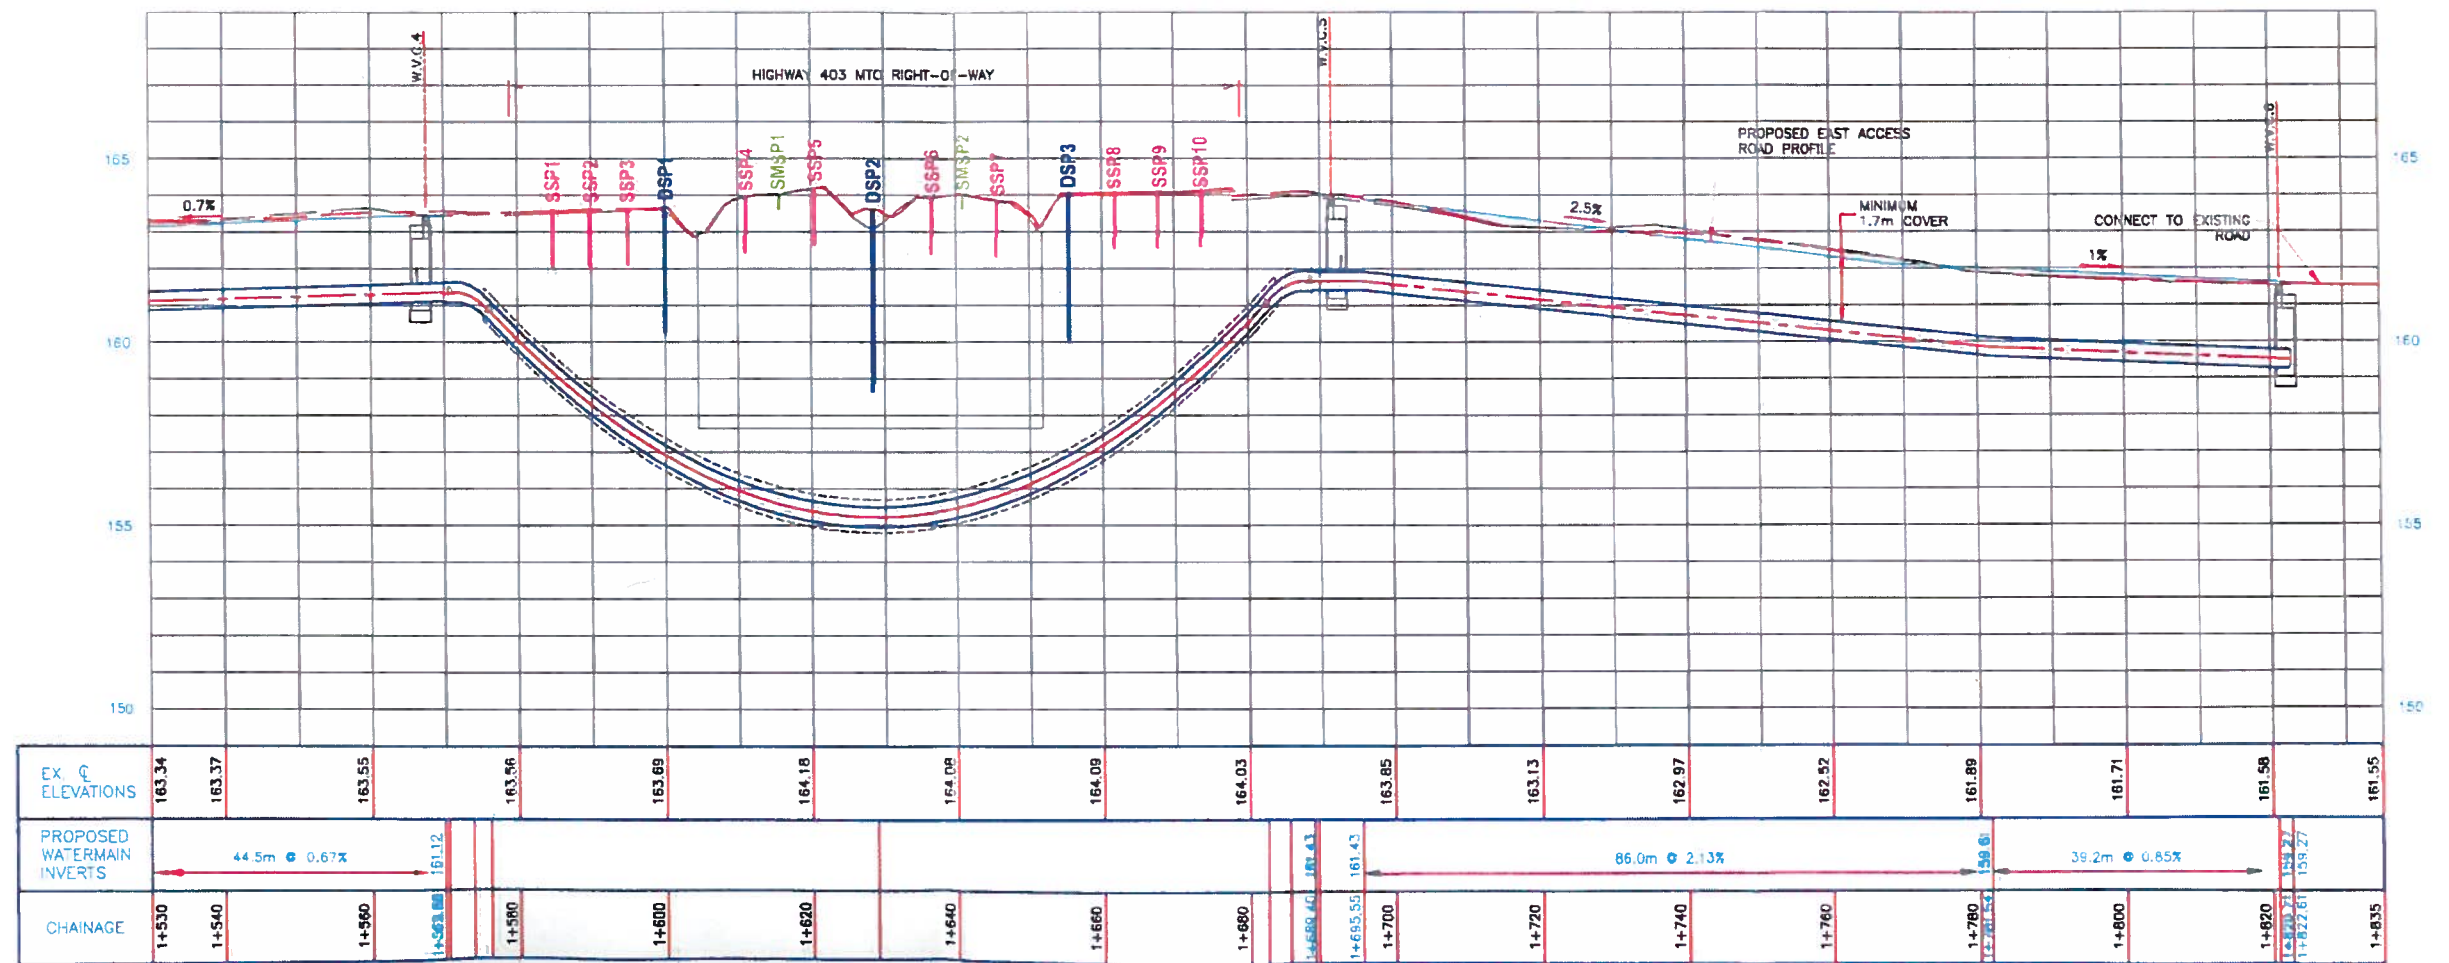
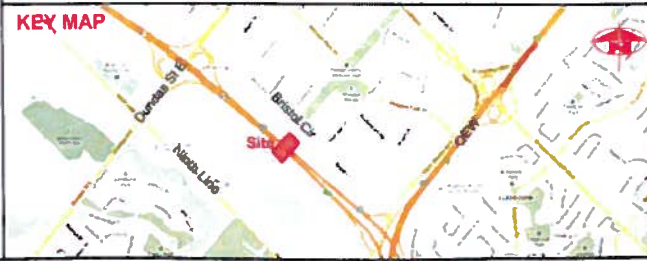
Preliminary Layout of Ground Monitoring Arrays	Drawing No. 3
--	---------------

- DBM - Deep Benchmark
- SSP - Shallow Settlement Point
- SMSP - Surface Mounted Settlement Point
- DSP - Deep Settlement Point

Monitoring of settlements at some distance above the tunnel invert is recommended underneath the pavement of Highway 403. The settlement monitoring system should consist of deep/shallow settlement points installed at different depths into the rock/soil and surface settlement points installed

A settlement monitoring program for any trenchless crossing alternative underpassing Highway 403 is required as per MTO's Guidelines for Foundation Engineering – Tunnelling Speciality for Corridor Encroachment Permit Application. The settlement monitoring system should consist of deep/shallow and surface settlement points installed at different depths into the rock/soil in the road, shoulder and near utilities. These should be installed along the tunnel alignment but care must be taken so as to stay a safe distance above the obvert to minimize the hydrofracturing potential into an instrument hole.

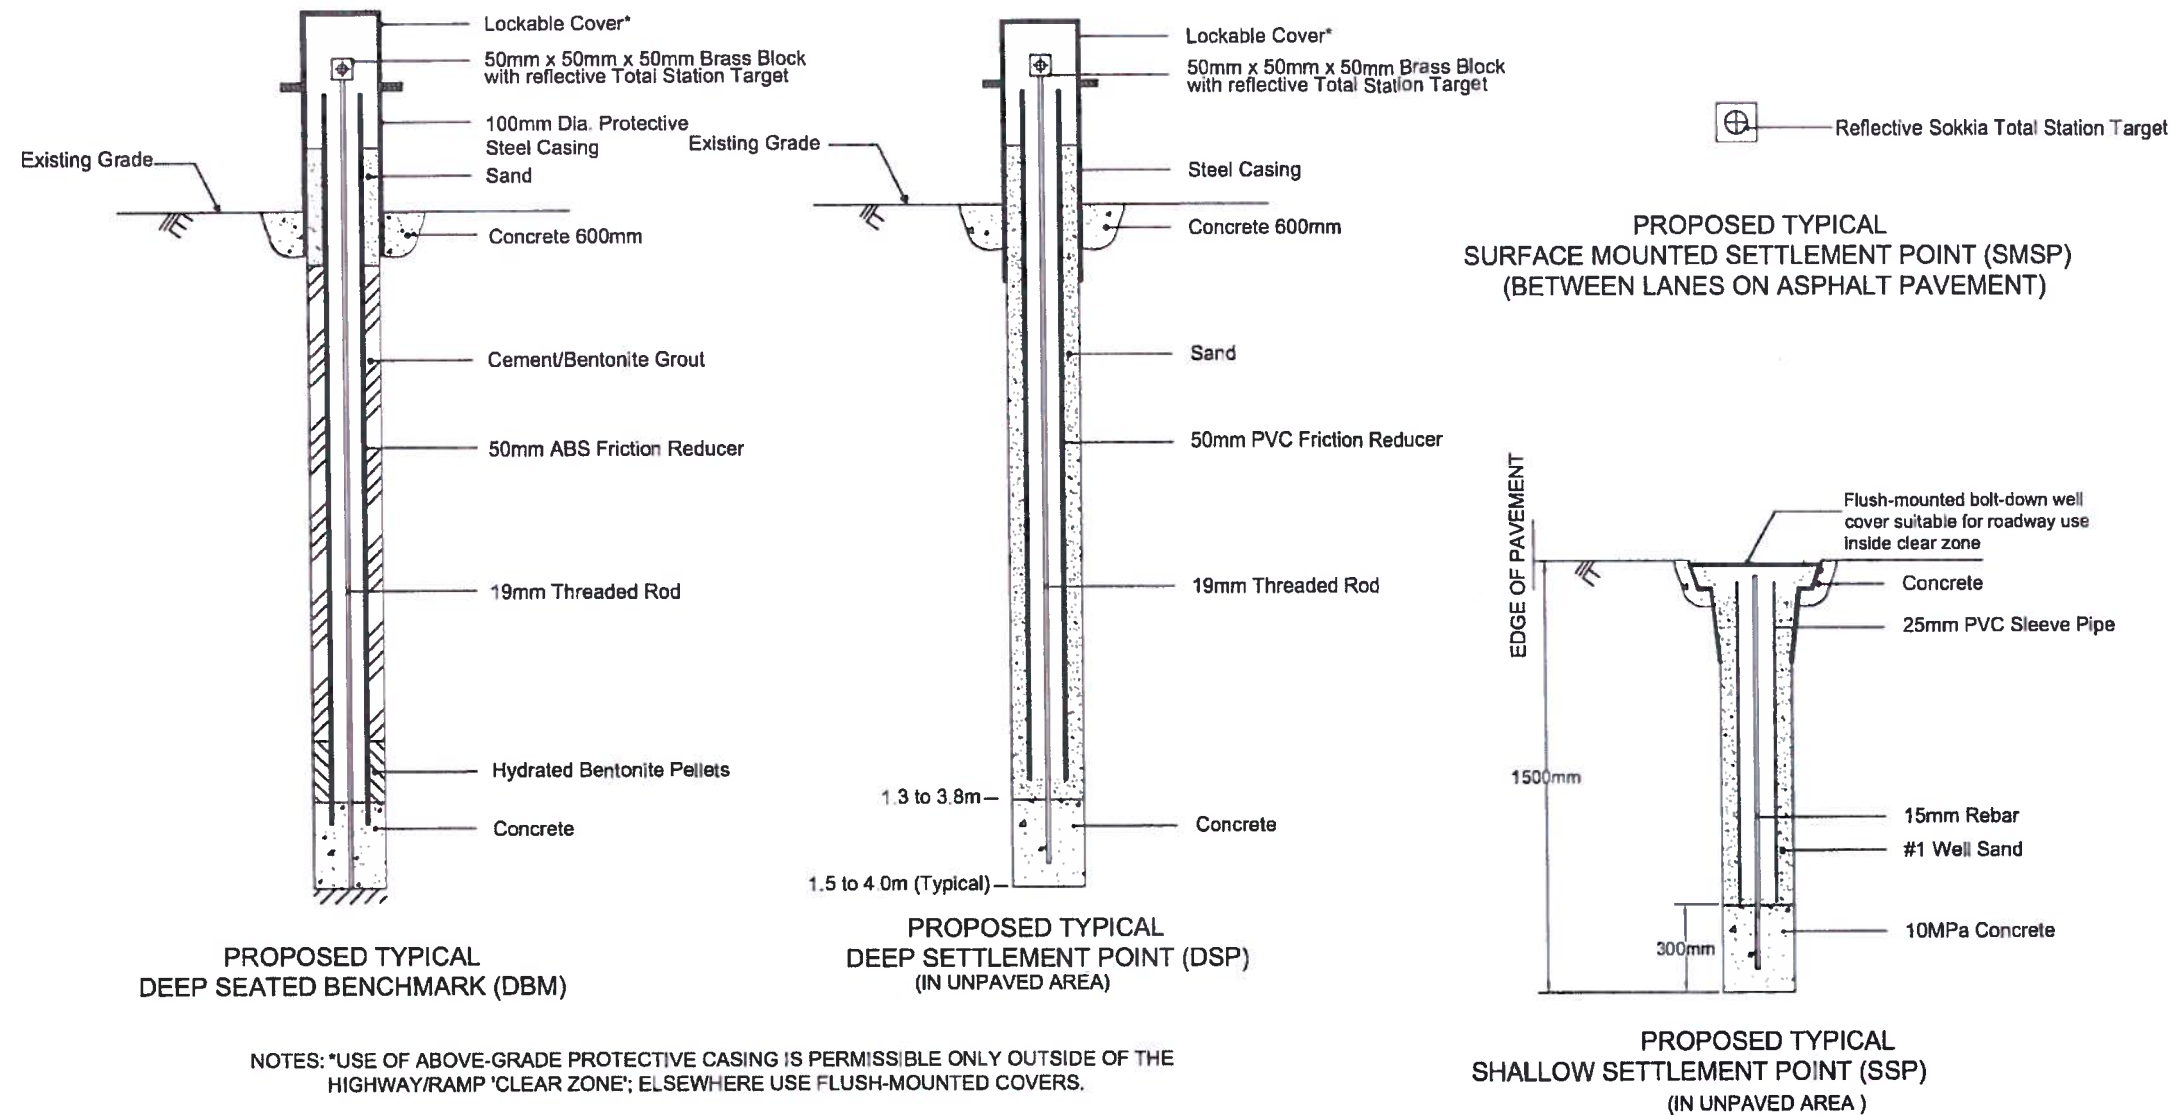
TYPICAL INSTALLATION DETAILS

Installation Details of Ground Monitoring Arrays	Drawing No. 4
--	---------------

1) Deep settlement points are to be founded into the bedrock; but no closer than 3m above the crown of the tunnel.

3) Deep Seated Benchmarks are to be founded a minimum of 0.3m into the bedrock and located at least 20m away from the tunnel alignment; Confirmed by grinding auger and split spoon refusal on the shale bedrock.

4) Shallow Settlement Points are to be flush with or recessed below the surrounding paved shoulder to protect settlement points and passing traffic from potential damage.

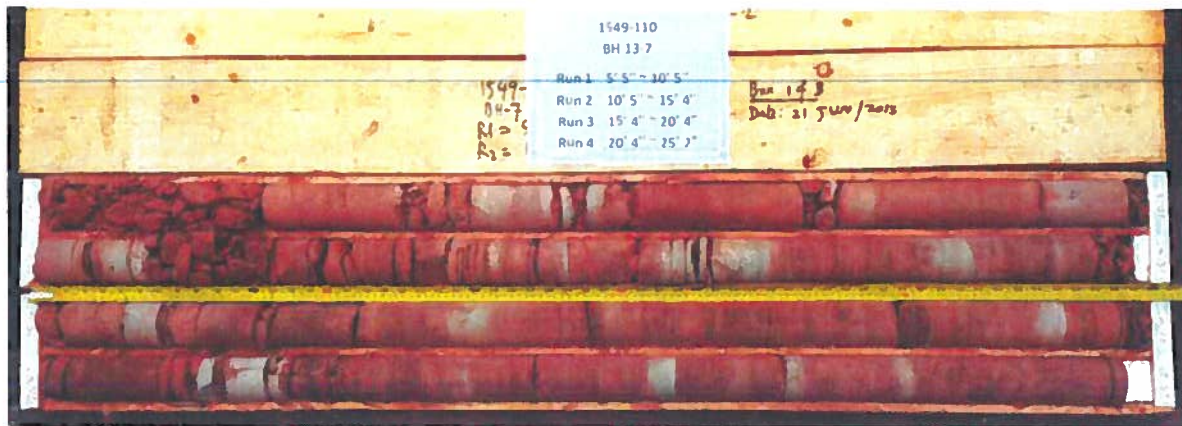
Rock Core Photo: Run 1, Run 2, Run 3 and Run 4

Run 1: 5' 5" – 10' 5" (1.65m – 3.18m) Run 2: 10' 5" – 15' 4" (3.18m – 4.68m)

Run 3: 15' 4" – 20' 4" (4.68m – 6.20m) Run 4: 20' 4" – 25' 2" (6.20m – 7.67m)

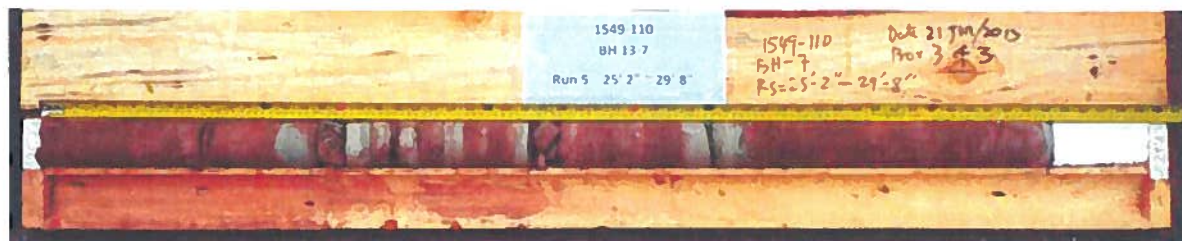
Rock Core Photo: Run 5

Run 5: 25' 2" – 29' 8" (7.67m – 9.04m)

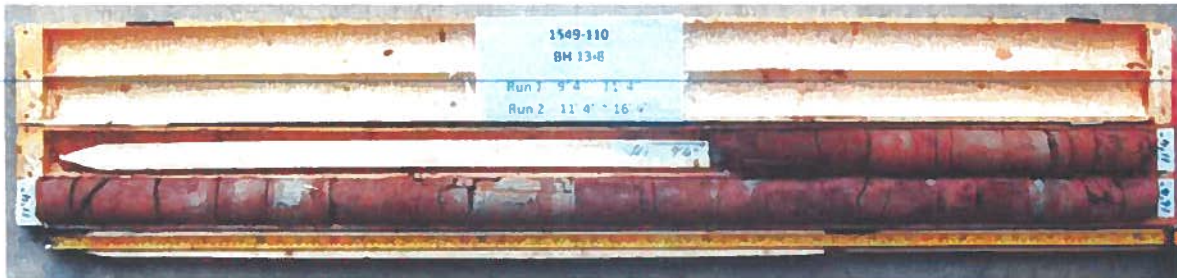
Rock Core Photo: Run 1 and Run 2

Run 1: 9' 4" – 11' 4" (2.84m – 3.45m) Run 2: 11' 4" – 16' 4" (3.45m – 4.98m)

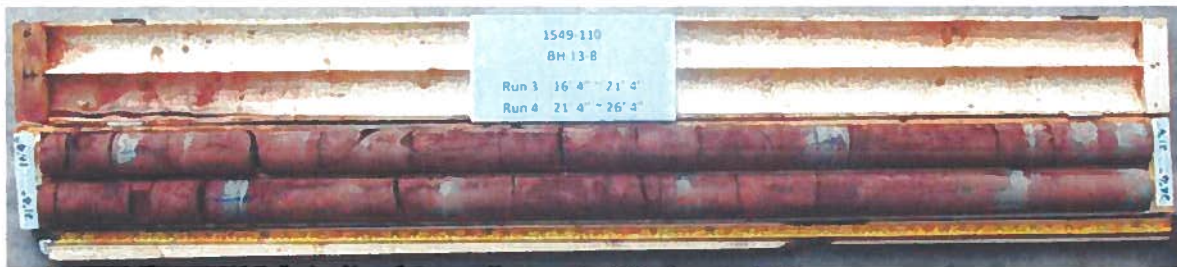
Rock Core Photo: Run 3 and Run 4

Run 3: 16' 4" – 21' 4" (4.98m – 6.50m) Run 4: 21' 4" – 26' 4" (6.50m – 8.03m)

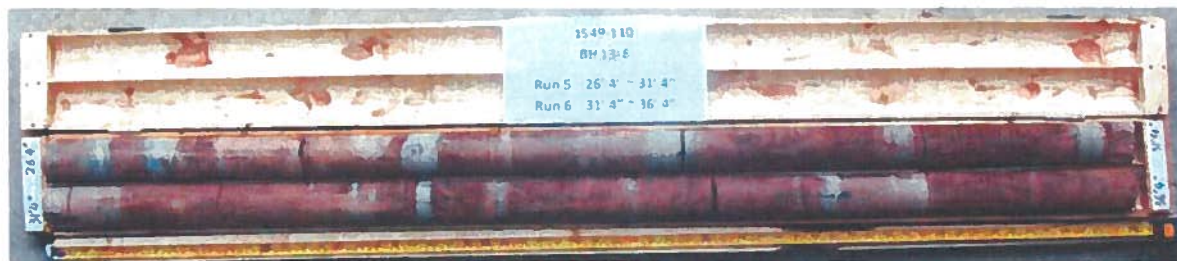
Rock Core Photo: Run 5 and Run 6

Run 5: 26' 4" – 31' 4" (8.03m – 9.55m) Run 6: 31' 4" – 36' 4" (9.55m – 11.07m)

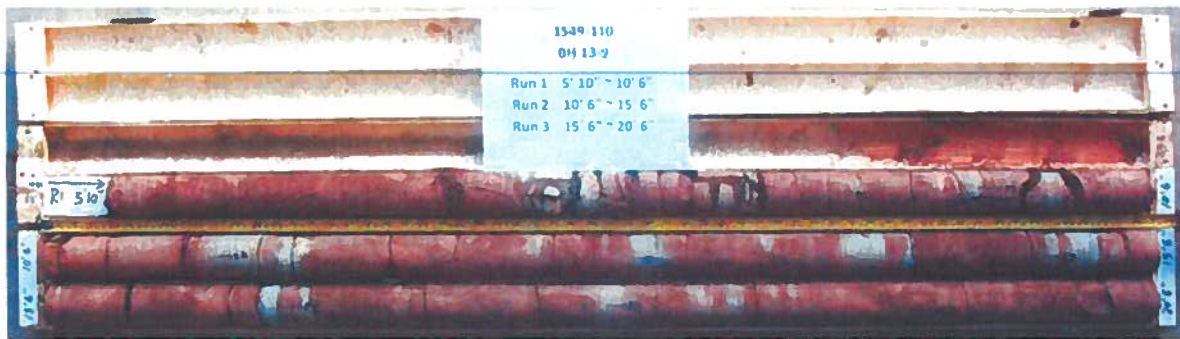
Rock Core Photo: Run 1, Run 2 and Run 3

Run 1: 5' 10" – 10' 6" (1.78m – 3.20m) Run 2: 10' 6" – 15' 6" (3.20m – 4.72m)

Run 3: 15' 6" – 20' 6" (4.72m – 6.25m)

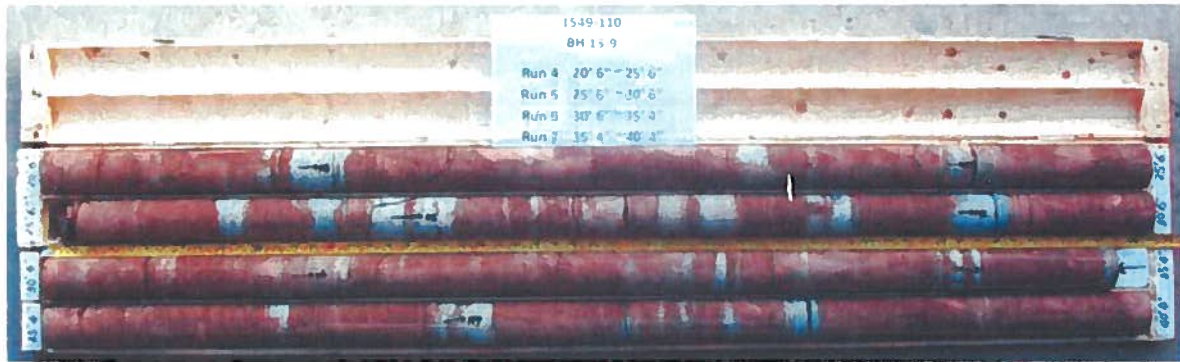
Rock Core Photo: Run 4, Run 5, Run6 and Run 7

Run 4: 20' 6" – 25' 6" (6.25m – 7.77m) Run 5: 25' 6" – 30' 6" (7.77m – 9.30m)

Run 6: 30' 6" – 35' 4" (9.30m – 10.77m) Run 7: 35' 4" – 40' 4" (10.77m – 12.29m)

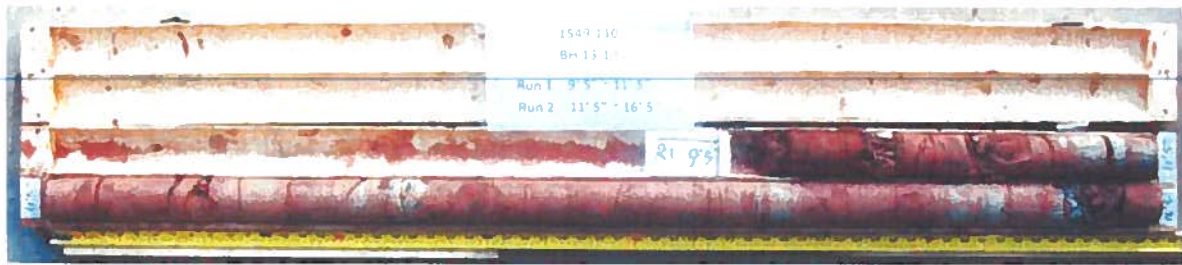
Rock Core Photo: Run 1 and Run 2

Run 1: 9' 5" - 11' 5" (2.87m - 3.48m) Run 2: 11' 5" - 16' 5" (3.48m - 5.00m)

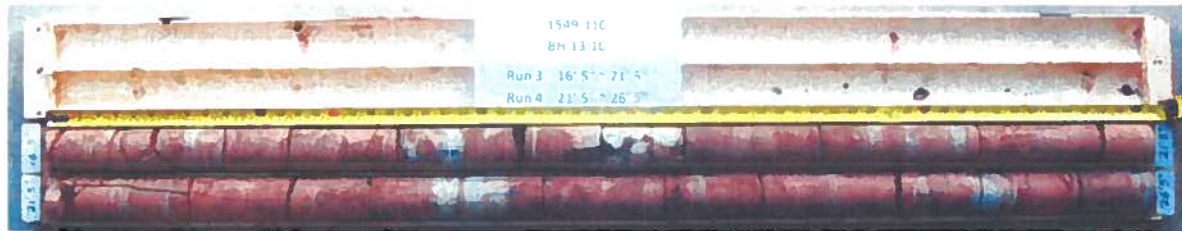
Rock Core Photo: Run 3 and Run 4

Run 3: 16' 5" - 21' 5" (5.00m - 6.53m) Run 4: 21' 5" - 26' 5" (6.53m - 8.05m)

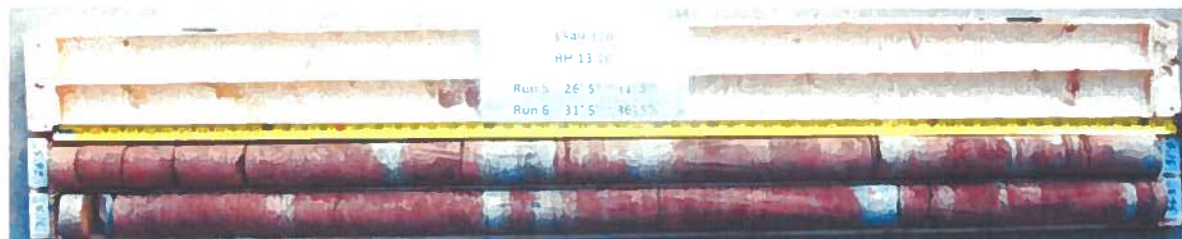
Rock Core Photo: Run 5 and Run 6

Run 5: 26' 5" - 31' 5" (8.05m - 9.58m) Run 6: 31' 5" - 36' 5" (9.58m - 11.10m)

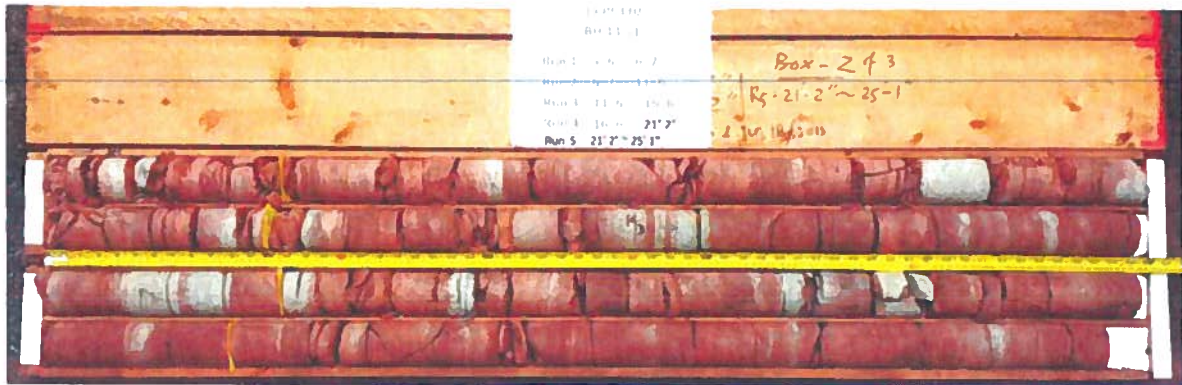
Rock Core Photo: Run 1, Run 2, Run 3, Run 4 and Run 5

Run 1: 5' 6" – 6' 7" (1.68m – 2.01m) Run 2: 6' 7" – 11' 6" (2.01m – 3.51m)

Run 3: 11' 6" – 16' 6" (3.51m – 5.03m) Run 4: 16' 6" – 21' 2" (5.03m – 6.45m)

Run 5: 21' 2" – 25' 1" (6.45m – 7.65m)

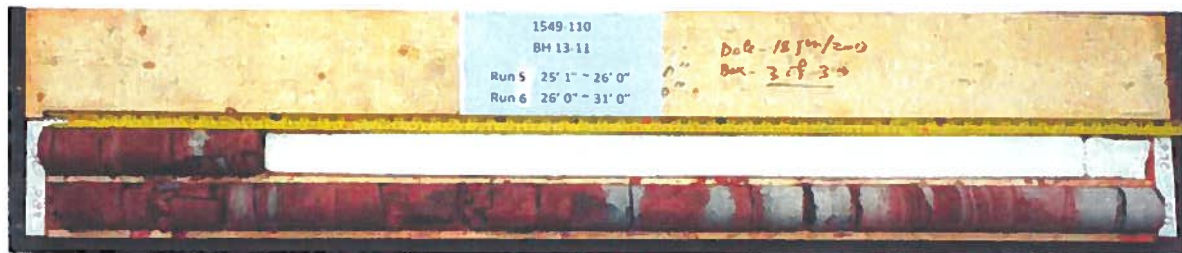
Rock Core Photo: Run 5 and Run 6

Run 5: 25' 1" – 26' 0" (7.65m – 7.92m) Run 6: 26' 0" – 31' 0" (7.92m – 9.45m)

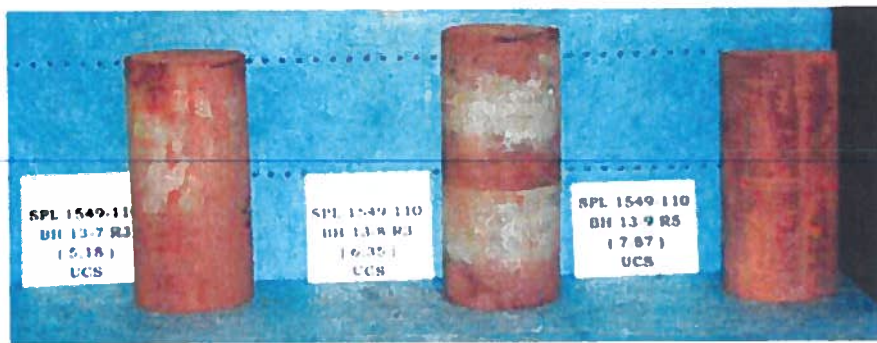
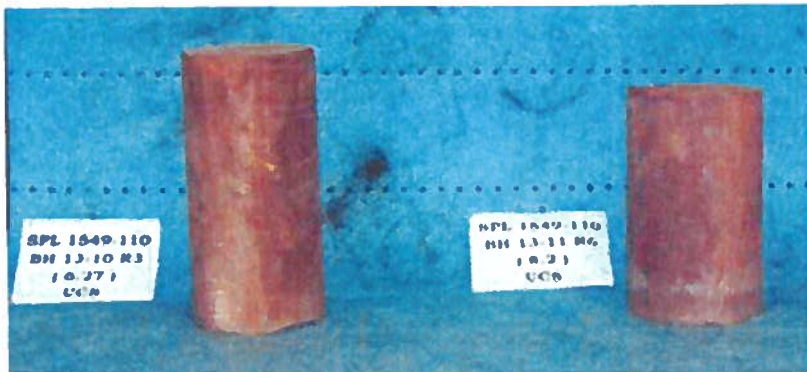
Pre-Test Samples

Table D-1 : Unconfined Compression Failure Test Results
(by Rock Mechanics Laboratory of Queen's University)

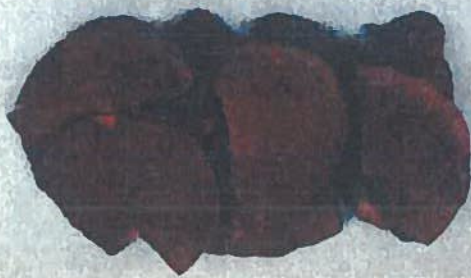
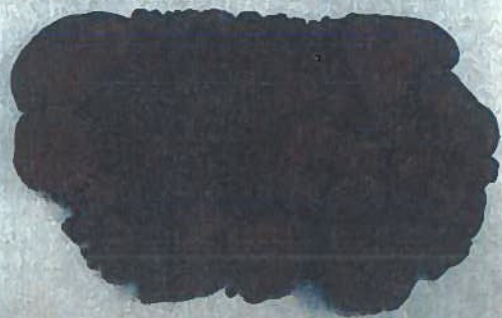
Slake Durability Test Sample (before test and after test): SL-1

Before Test

After 2nd Cycle

Slake durability tests were carried out to determine the rock slaking degradation potential. The test is a means of measuring the resistance of shale or other weak rocks to repeated cycles of wetting and drying with abrasion. The test follows ASTM test method D4644-87. There are two cycles of wetting and drying. The test sample is obtained from the rock core which is broken into approximately 10 intact, equi-dimensional rock pieces, each about 40 to 60 grams in weight. The test sample is oven-dried overnight and is then placed in a drum made from 2.0mm square mesh stainless steel wire cloth. The drum is 50% submerged in a water bath at room temperature and is rotated for 10 minutes during which time small fragments of shale or dissolved rock material pass through the openings in the mesh into the water bath. Following the 10 minute first cycle, the test specimen is oven-dried overnight and the immersion and drum rotation process is repeated (2nd cycle). The sample is again oven-dried overnight. At the end of each cycle, the oven dried sample is weighed to determine the mass of sample retained. The slake durability Index [Id(2)] reported is a measurement of the ratio of the retained mass of rock fragments after two cycles of wetting and drying over the initial mass of oven-dried rock material, before the first cycle. Samples with Id(2) near 100% have very high resistance to slaking. Samples with lower Id(2) have less resistance to slaking and are therefore prone to degradation in the field when exposed to the elements over extended periods of time. Three (3) slake durability tests on selected core samples were performed in SPL's laboratory. The samples were tested in a Gilson Slake Durability Test apparatus with twin drums. The test results, along with photographs of the core samples before and after the tests, are provided in **Appendix D**.

The data suggests that the shaly mudstone and red-brown shale material is quite slake-prone. The green-grey interbeds of more limy material, though not tested, are less prone to slaking degradation.

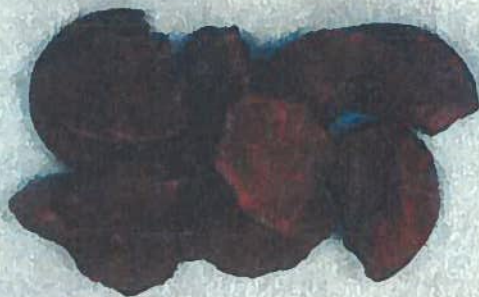
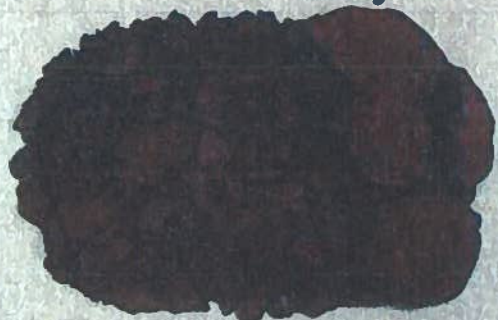
Slake Durability Test Sample (before test and after test): SL-2

Before Test

After 2nd Cycle

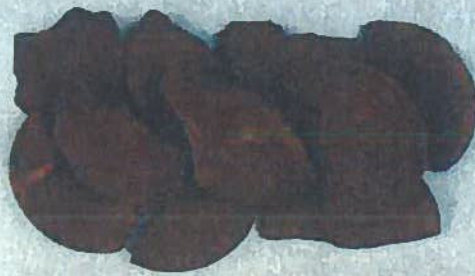
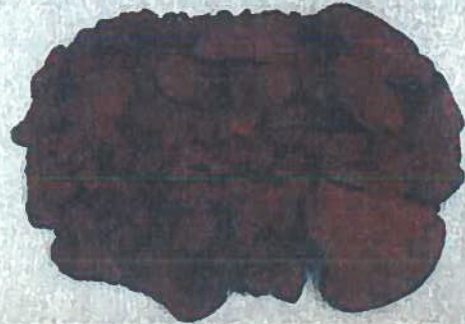
Slake Durability Test Sample (before test and after test): SL-3

Before Test

After 2nd Cycle
