**SUPPLEMENTAL GEOTECHNICAL INVESTIGATION
AND IN-SITU SOIL TESTING
LEAMINGTON FERRY DOCK
LEAMINGTON, ONTARIO**

MTO CONTRACT NO. 2007-3410

Report to

May 14, 2009
File: 17-454-92

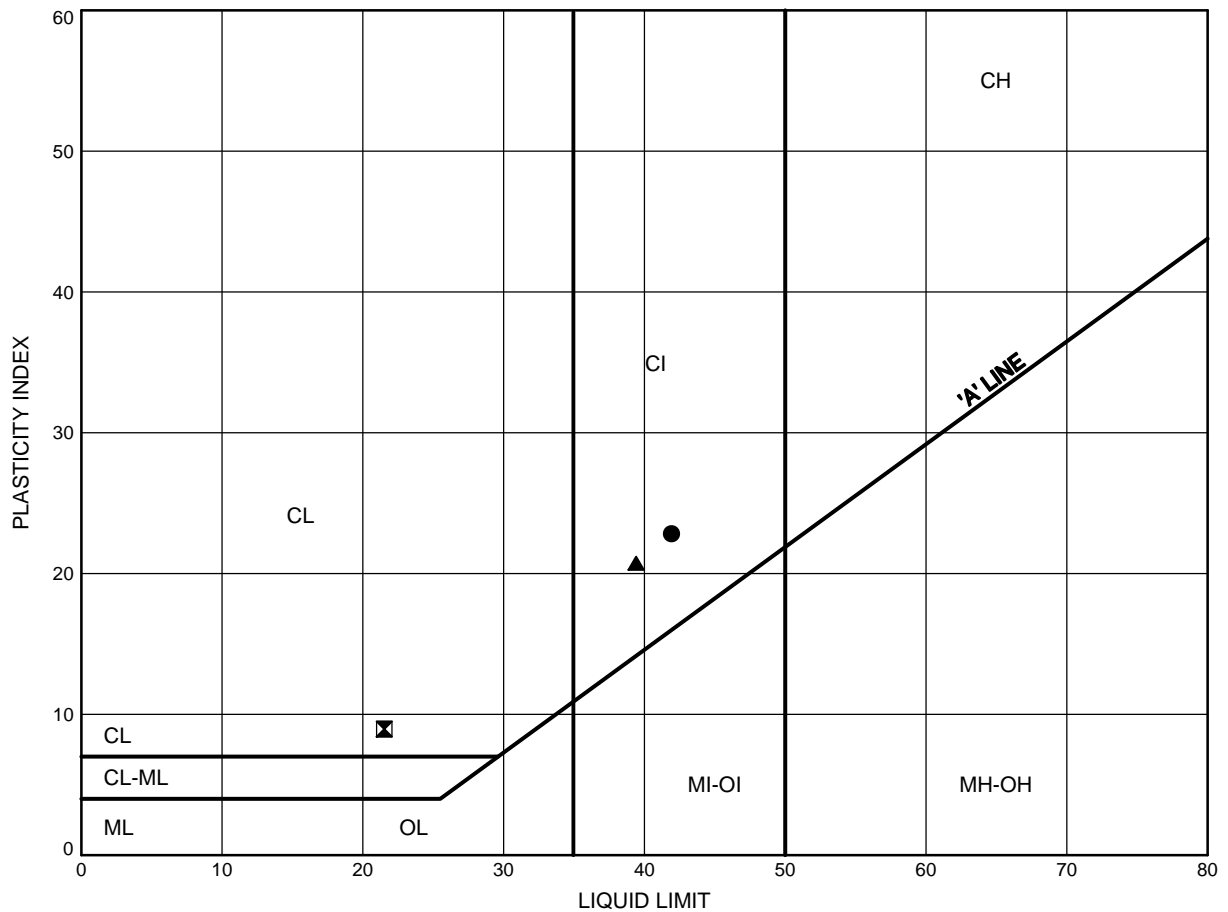
FIGURE B7

SYMBOL	BH	DEPTH (m)	ELEV. (m)
●	09-01N	10.97	165.03
⊠	09-01N	13.26	162.74
▲	09-03S	12.50	163.75

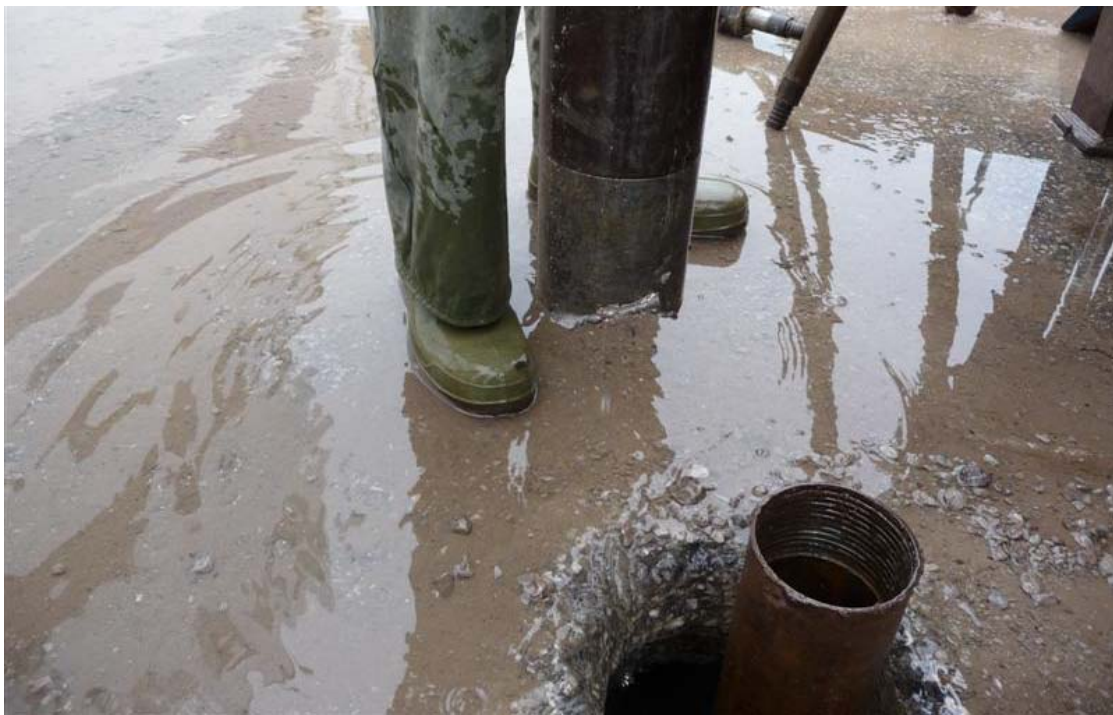
Figure 11 – Downhole insertion of the SBMP (09-02S)

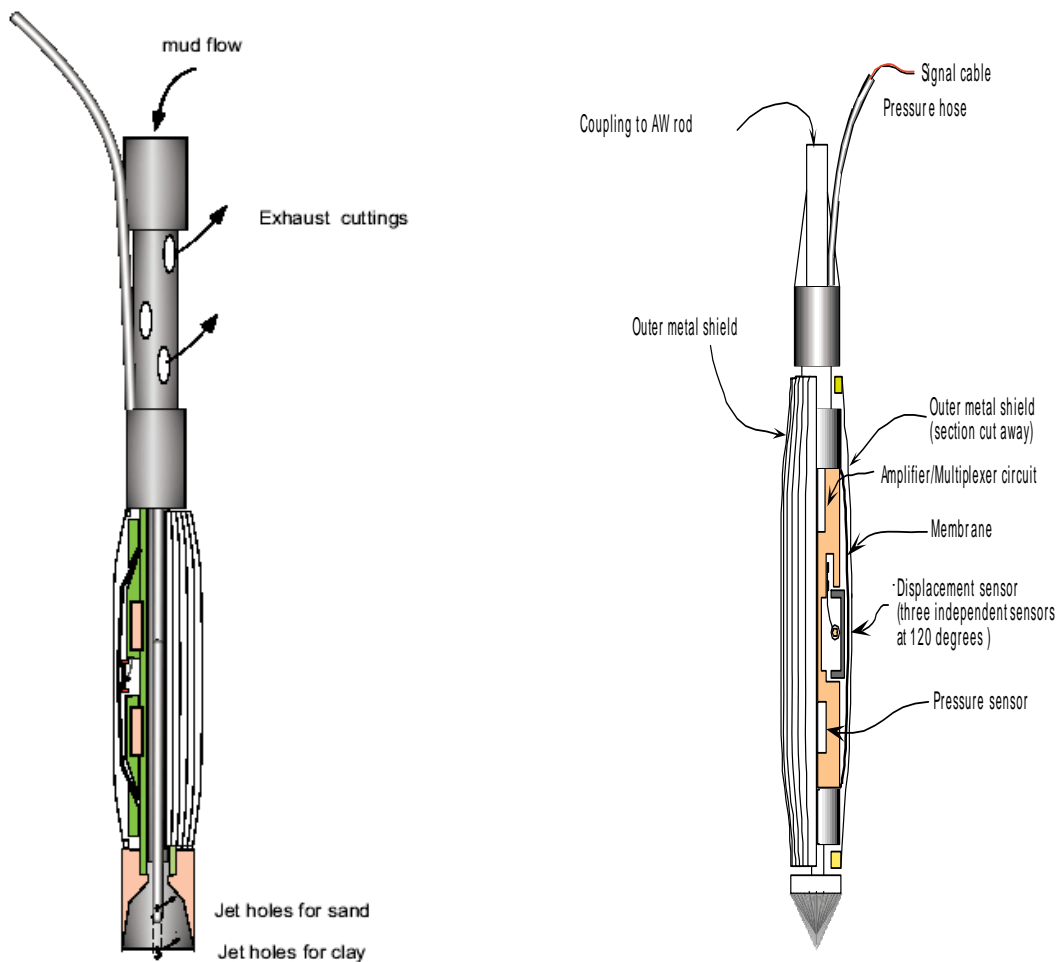
Fig.2. Below presents the essential details of both the self-boring and pre-bored pressuremeters.

**Fig.2. Schematic Details of the Pressuremeter
Self-boring (left), Pre-bored (right)**

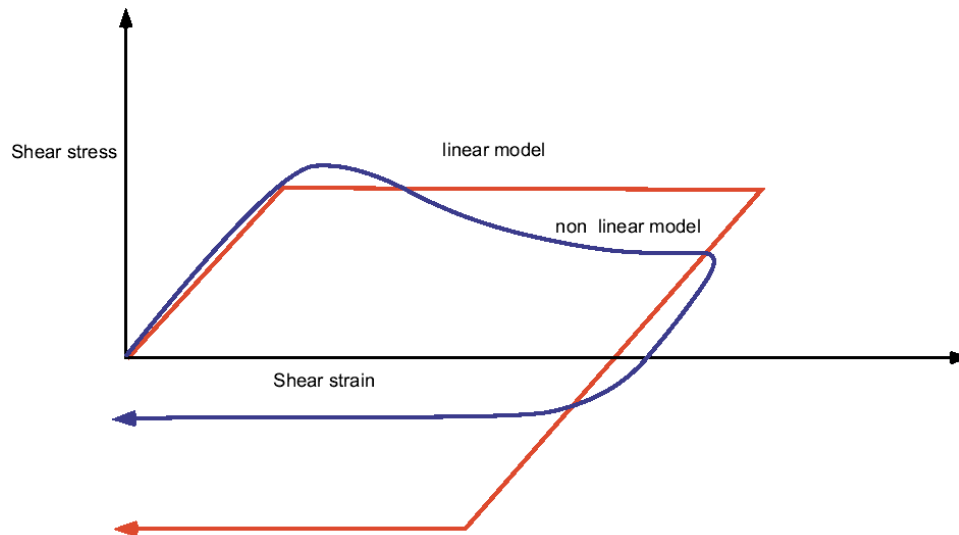
Fig.8. The ideal stress strain curves followed in loading and unloading

Therefore the final unloading curve can be analyzed to determine the shear strength by assuming that the loading shear strength is one half of the unloading shear strength. As a simplification the unloading curve can be analyzed assuming that the material behaves in a linear manner. For convenience with the existing computer programs, the final unloading curve is inverted with the maximum strain and pressure placed at the origin as shown in Fig. 9.

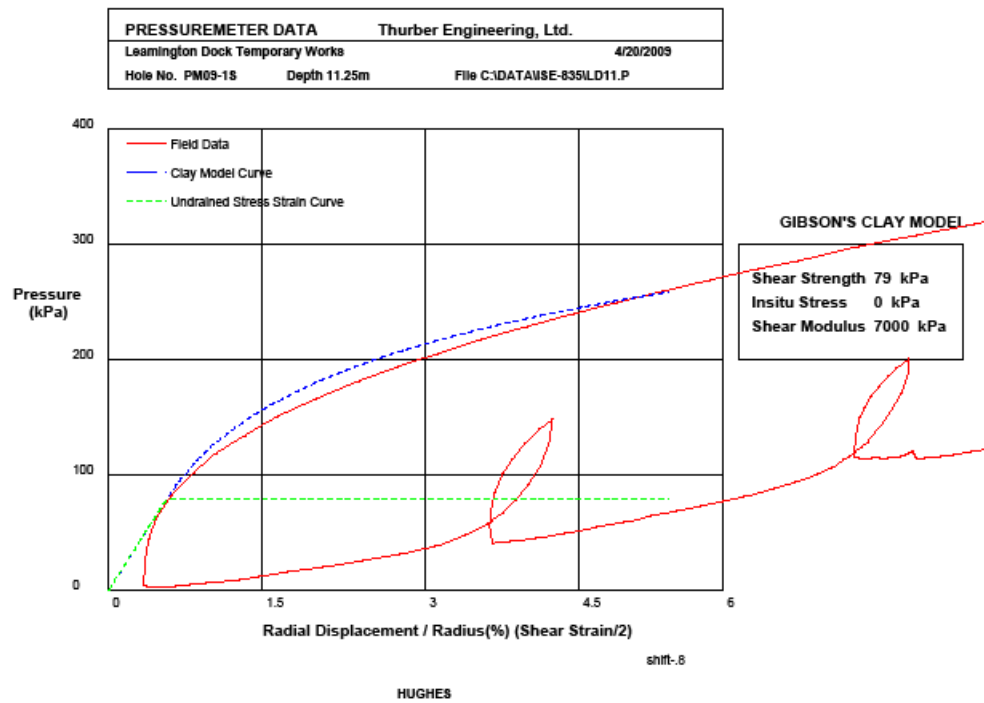
To use the available computer programs the final unloading curve is inverted, with the peak stress placed at the origin as shown in Fig. 9. The shear strength determined from the unloading curve is 79 kPa. Hence the loading shear strength, derived from the unloading curve, is 39.5 kPa. In view of the likely degradation of shear stress during the reversing of the shear direction, on unloading, the shear strength derived from the unloading curve is likely to be a conservative estimate.

Fig.9. Final unloading curve shear strength analysis.

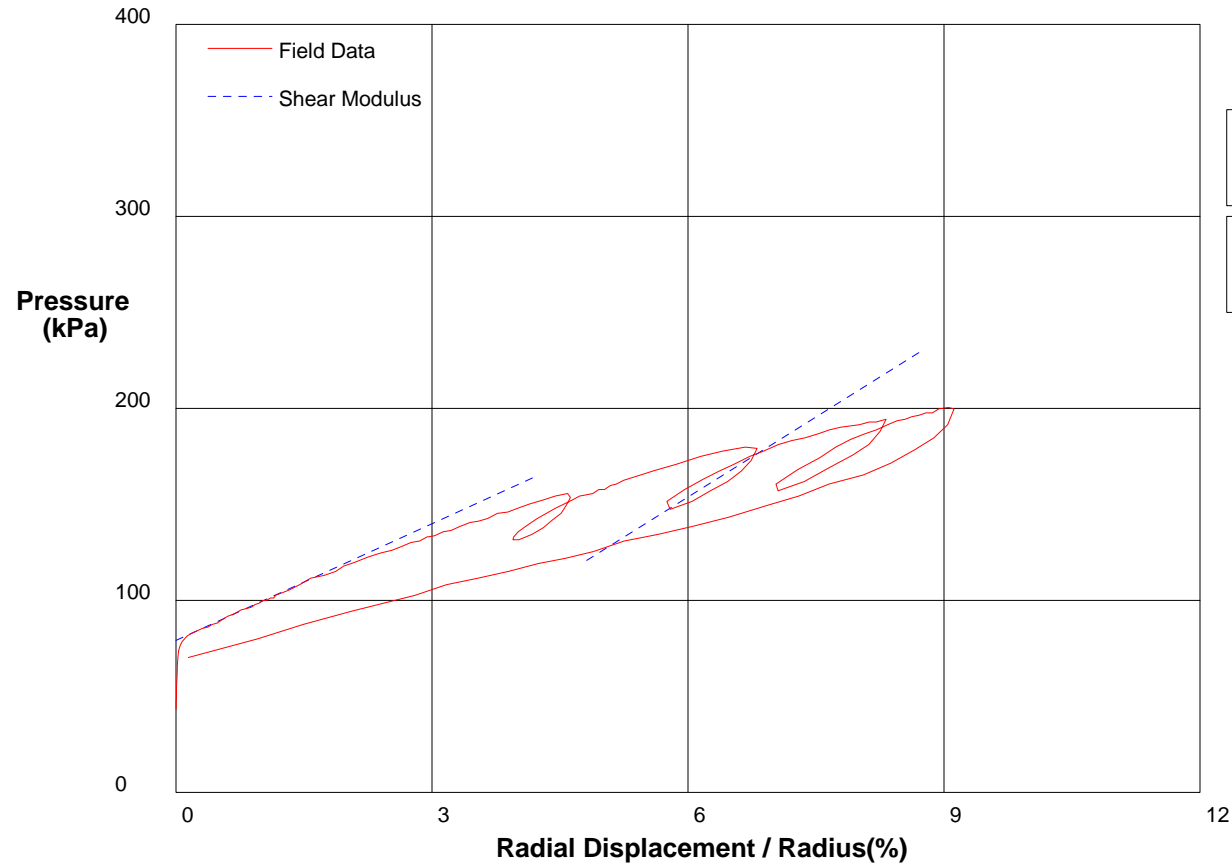
PRESSUREMETER DATA		Thurber Engineering, Ltd.
Leamington Dock Temporary Works		4/19/2009
Hole No. PM09-2S	Depth 10.5m	File C:\DATA\ISE-835\LD01.P

Shear Modulus 1013 kPa

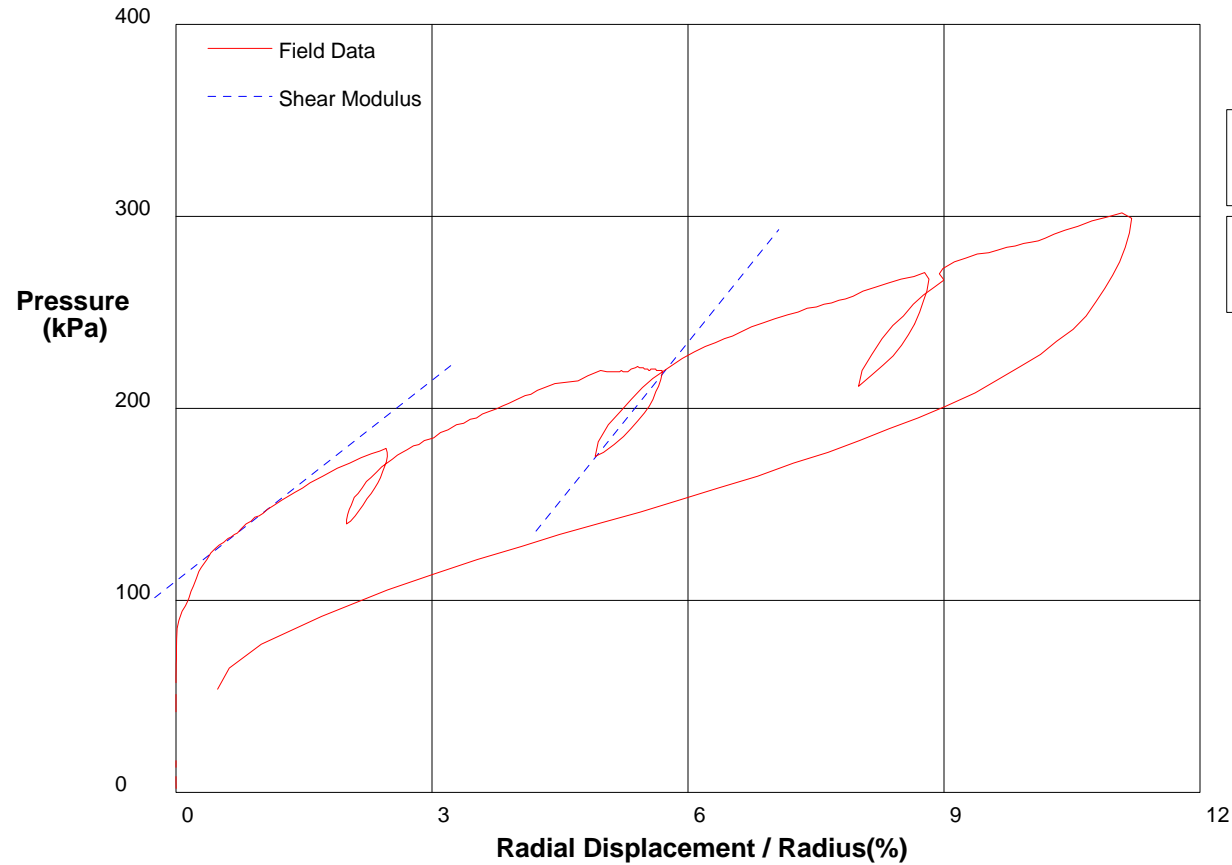
PRESSUREMETER DATA		Thurber Engineering, Ltd.
Leamington Dock Temporary Works		4/19/2009
Hole No. PM09-2S	Depth 11.25m	File C:\DATA\ISE-835\LD02.P

Shear Modulus 1741 kPa

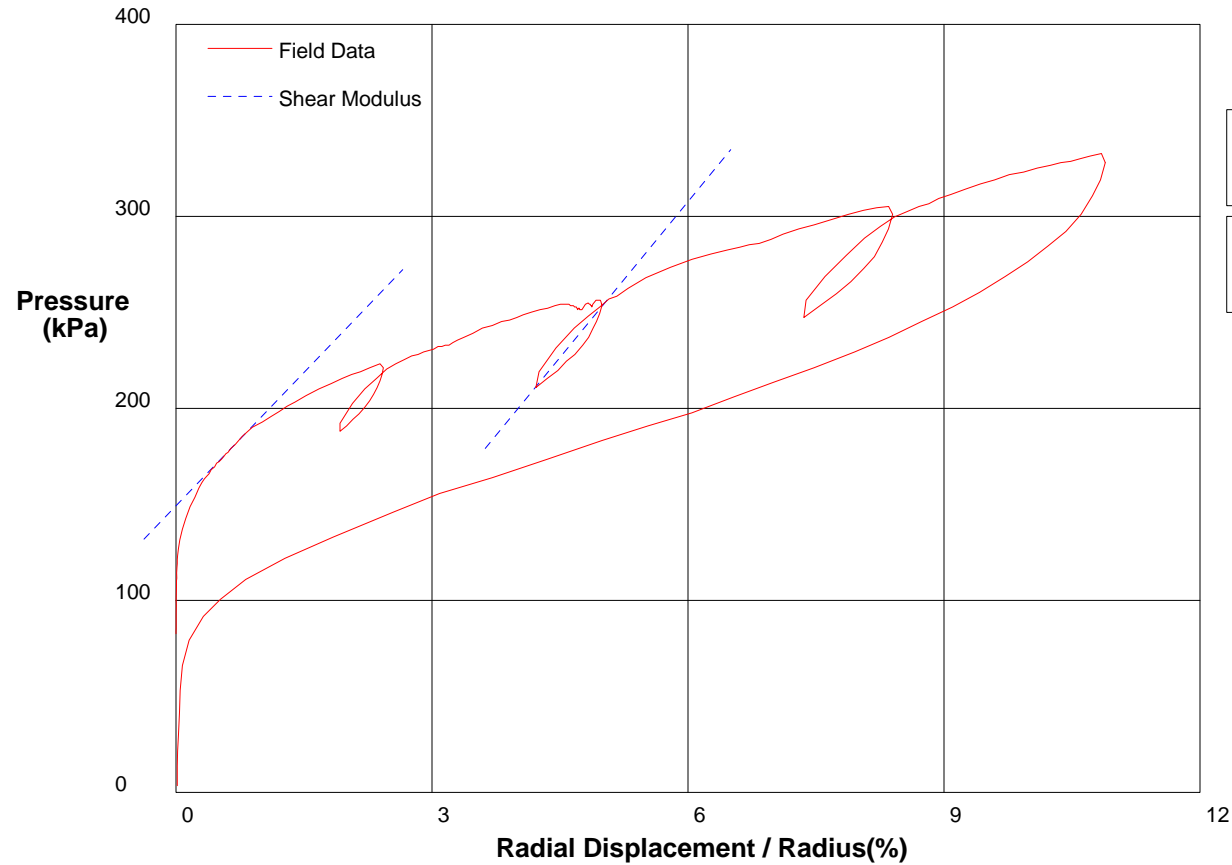
PRESSUREMETER DATA		Thurber Engineering, Ltd.
Leamington Dock Temporary Works		4/19/2009
Hole No. PM09-2S	Depth 12m	File C:\DATA\SE-835\LD03.P

Shear Modulus 2313 kPa

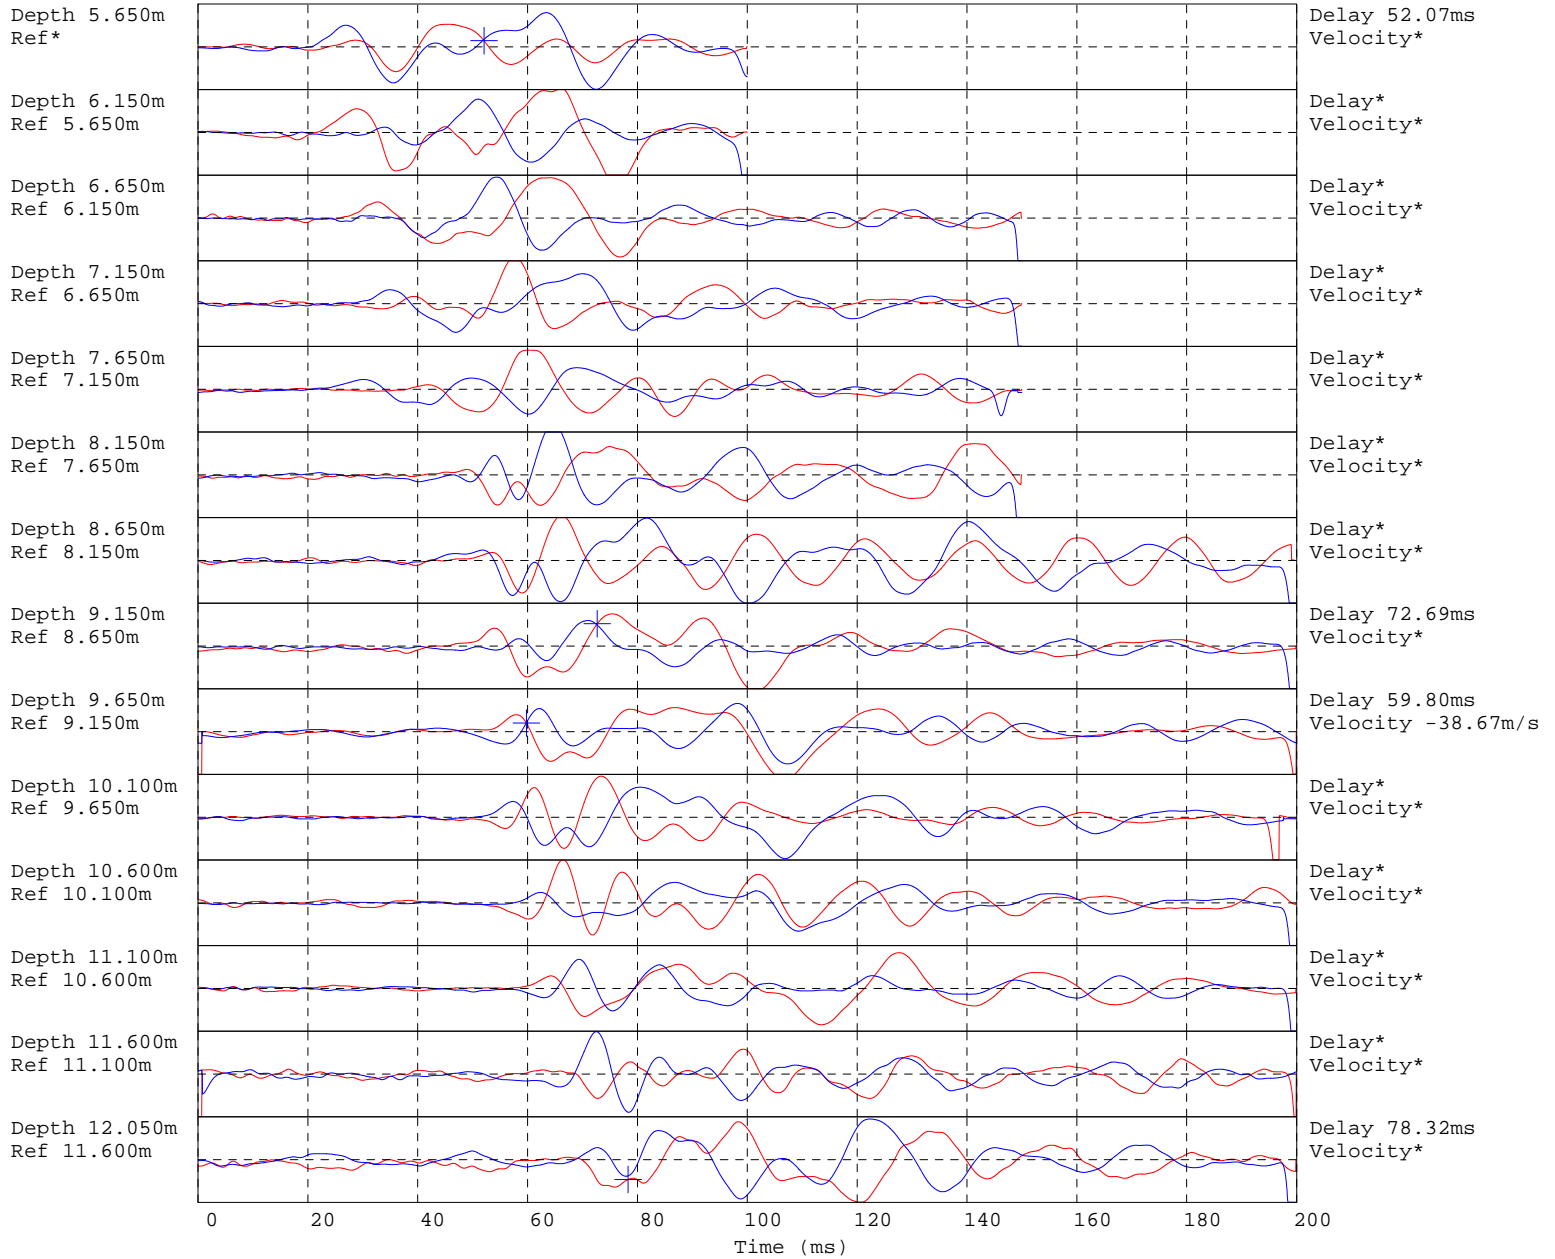
Thurber Engineering, Ltd.
Shear Wave Velocity Analysis - CPT09-1S

Hammer to Rod String Distance 0.73 (m)

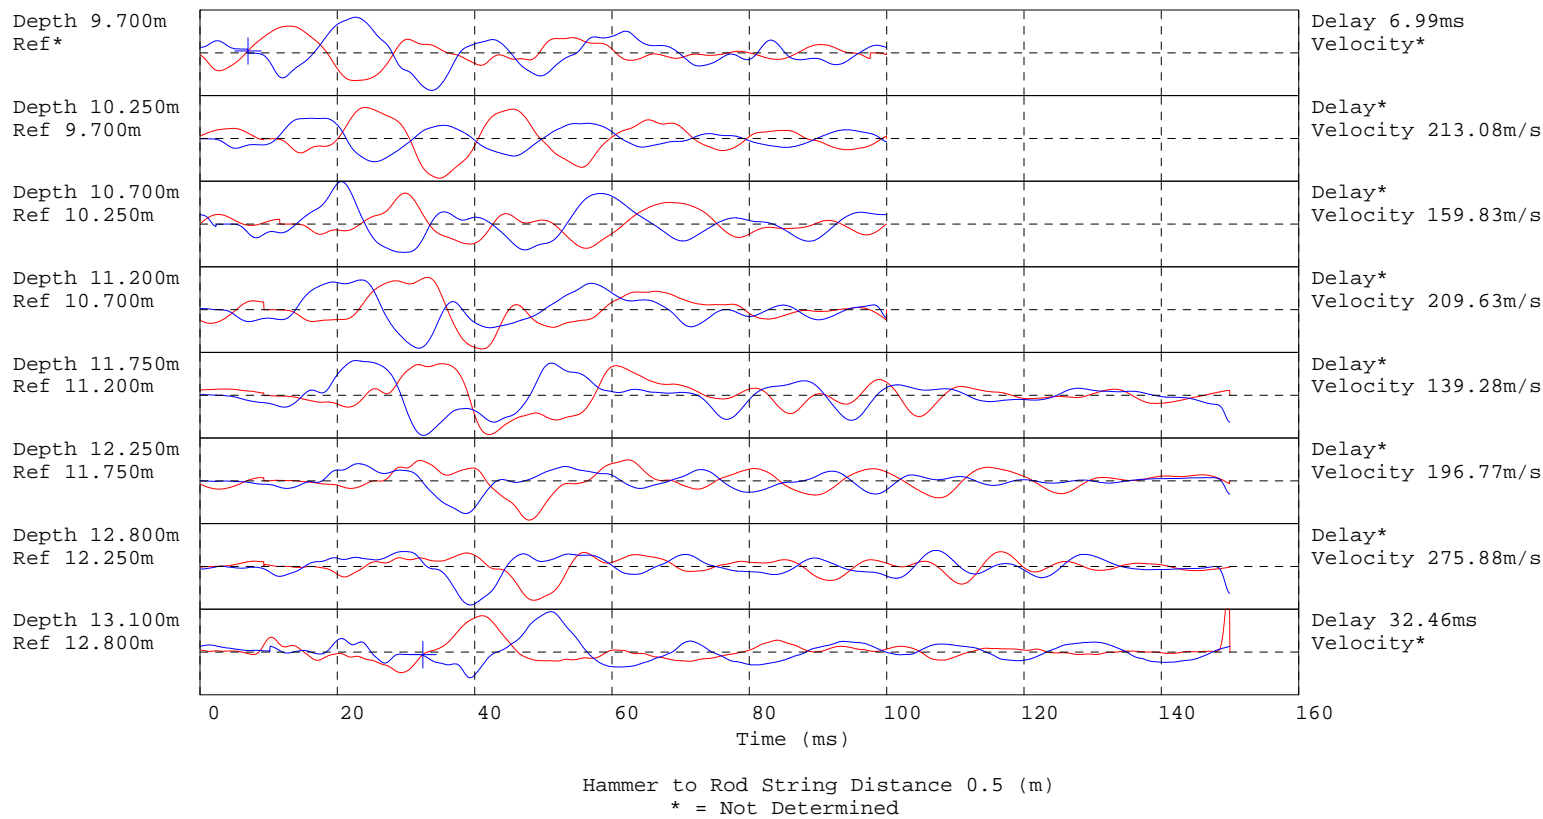
Thurber Engineering, Ltd.
Shear Wave Velocity Analysis - CPT09-2S

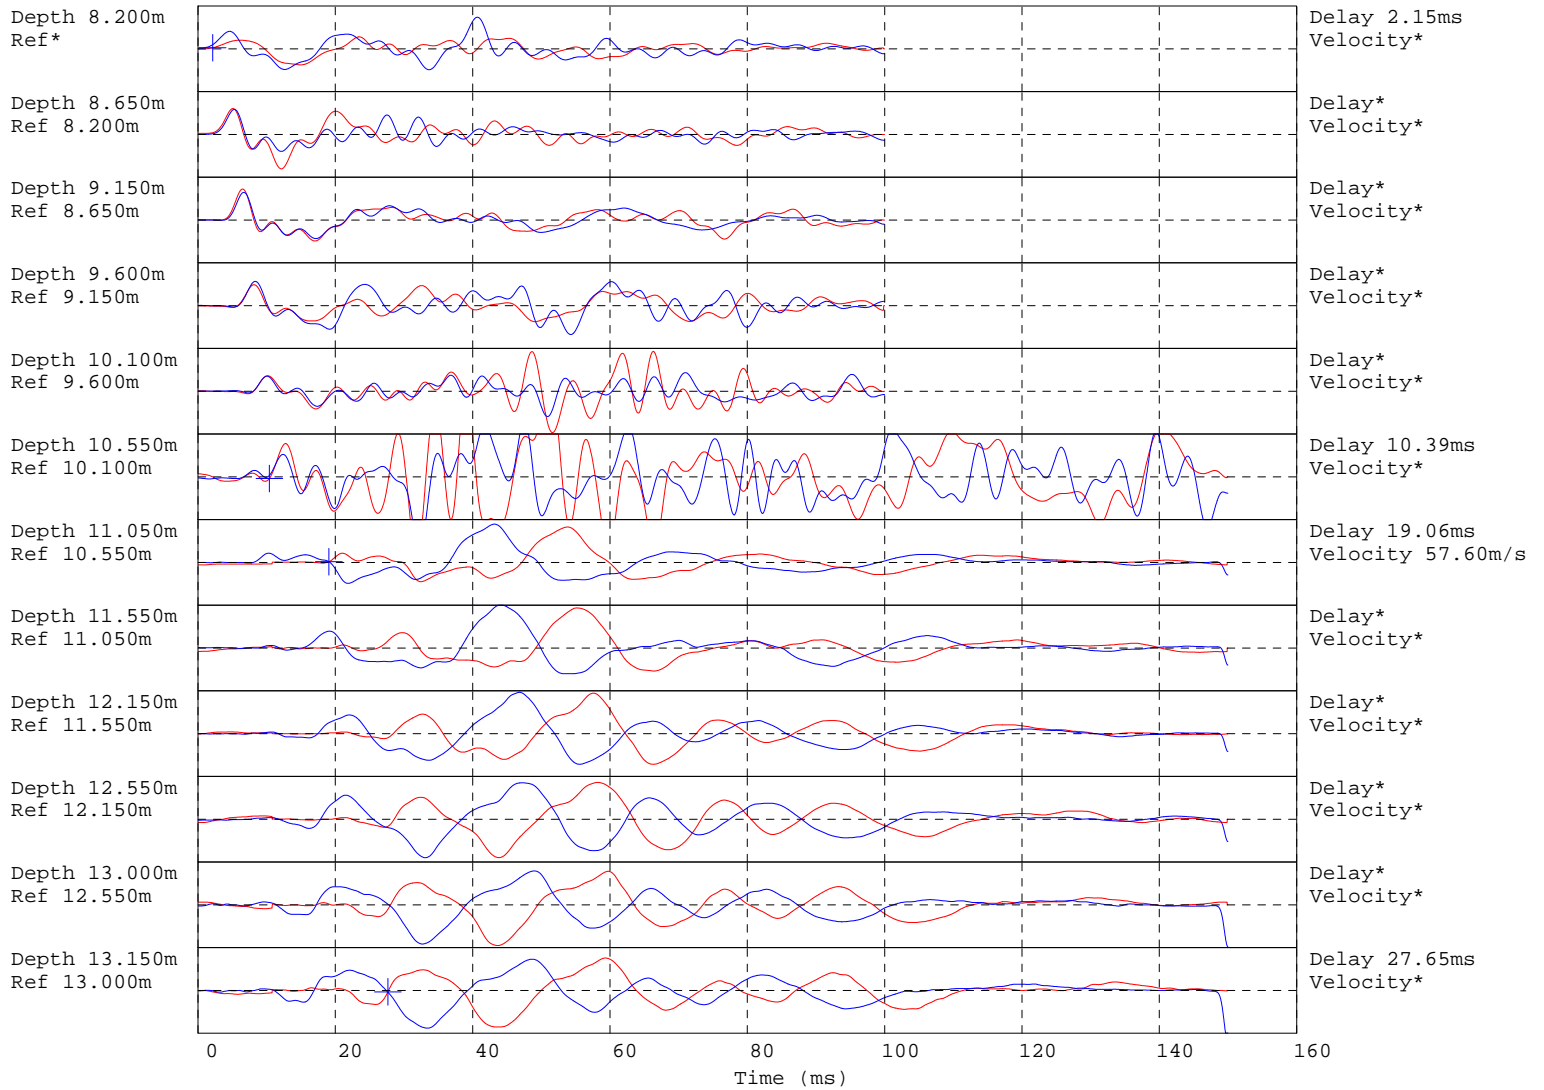
Thurber Engineering Ltd.
Shear Wave Velocity Analysis - CPT09-03S

Hammer to Rod String Distance 0.5 (m)
