**FOUNDATION INVESTIGATION AND DESIGN REPORT  
KASABONIKA LAKE MODULAR BRIDGE  
DISTRICT OF KENORA, KASABONIKA LAKE FIRST NATION, ONTARIO  
LATITUDE: 53.5263°, LONGITUDE: -88.6213°  
W.P. 6579-16-00, SITE No. 41N-0244/BO**

**GEOCRES Number: 53H-01**

Date: November 13, 2019  
File: 25489

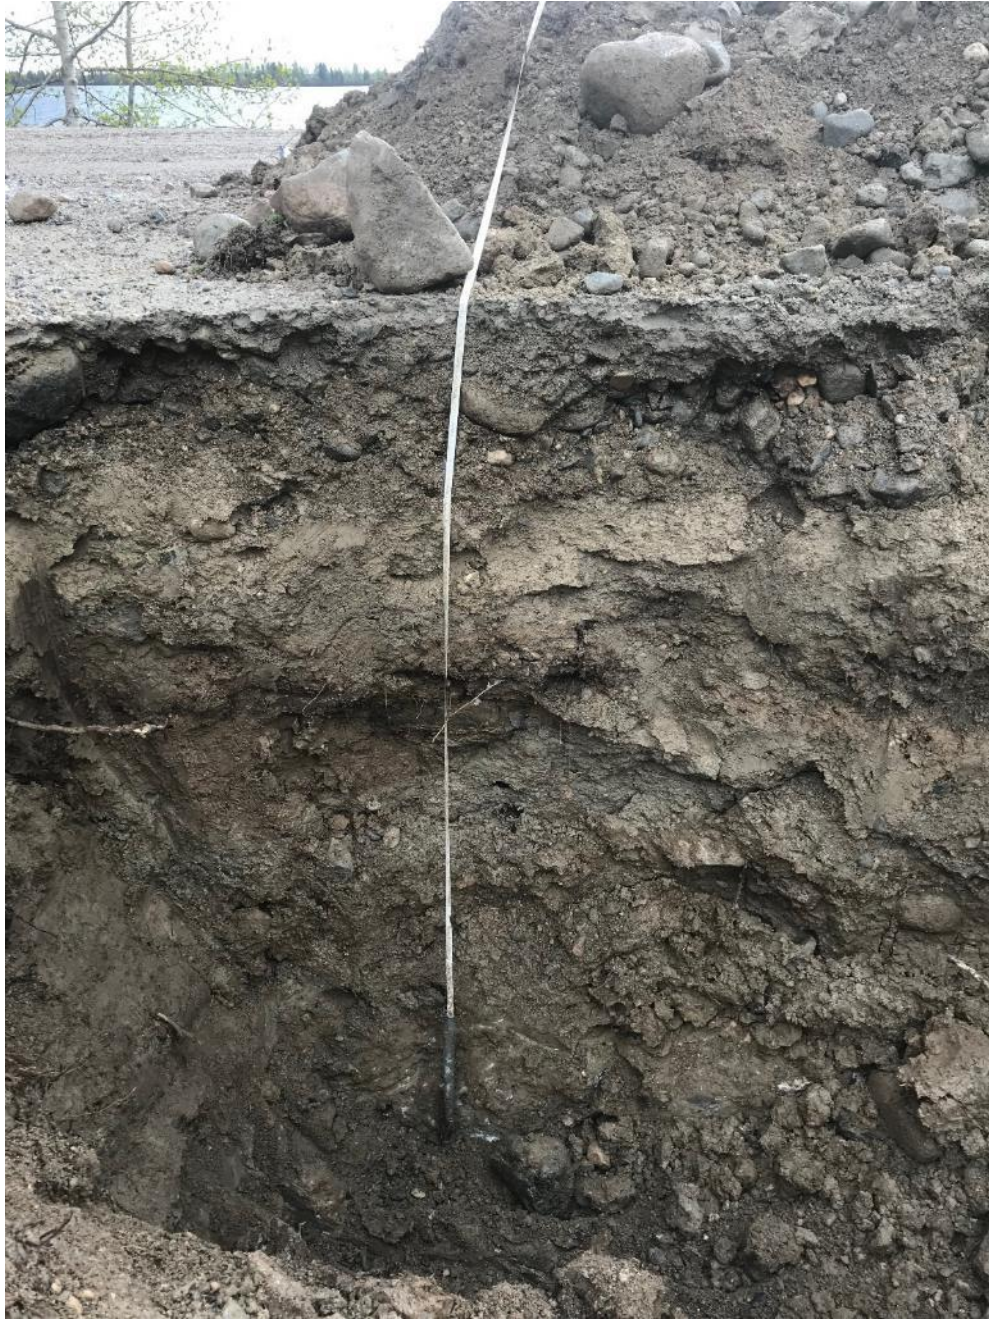
**Photo A1: Test Pit TP-01 (Date taken: June 8, 2019).**

In addition to the boreholes, three test pits were also excavated and are labelled TP-01 to TP-03. The test pits were all terminated at a depth of 2.1 m (Elevation 184.9 m to 183.9 m). TP-01 was excavated on the west approach while TP-02 and TP-03 were excavated along the east approach. Ten hand probes (HP1 to HP10) were also conducted near the base of the causeway embankments.

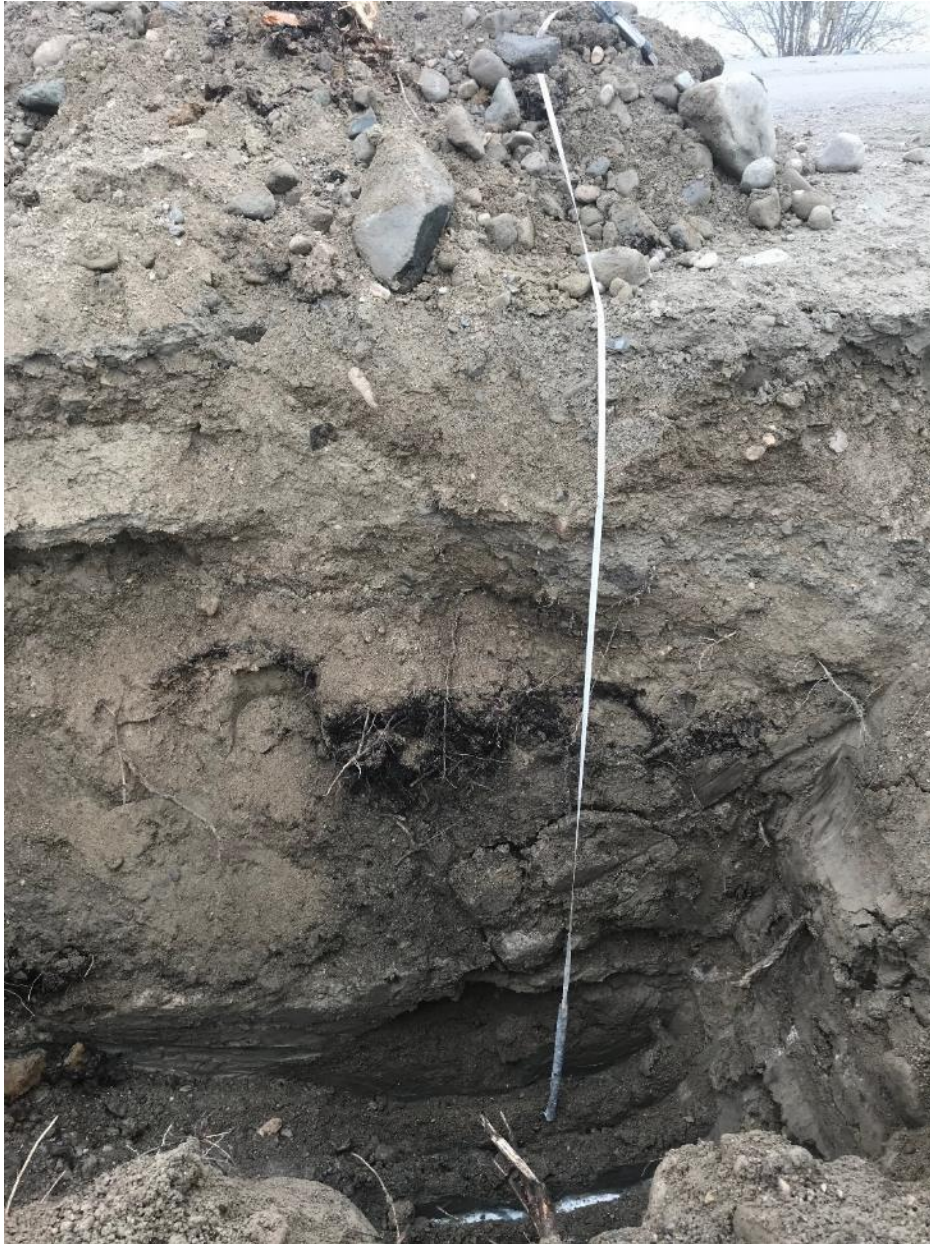
**Photo A2: Test Pit TP-02 (Date taken: June 8, 2019).**

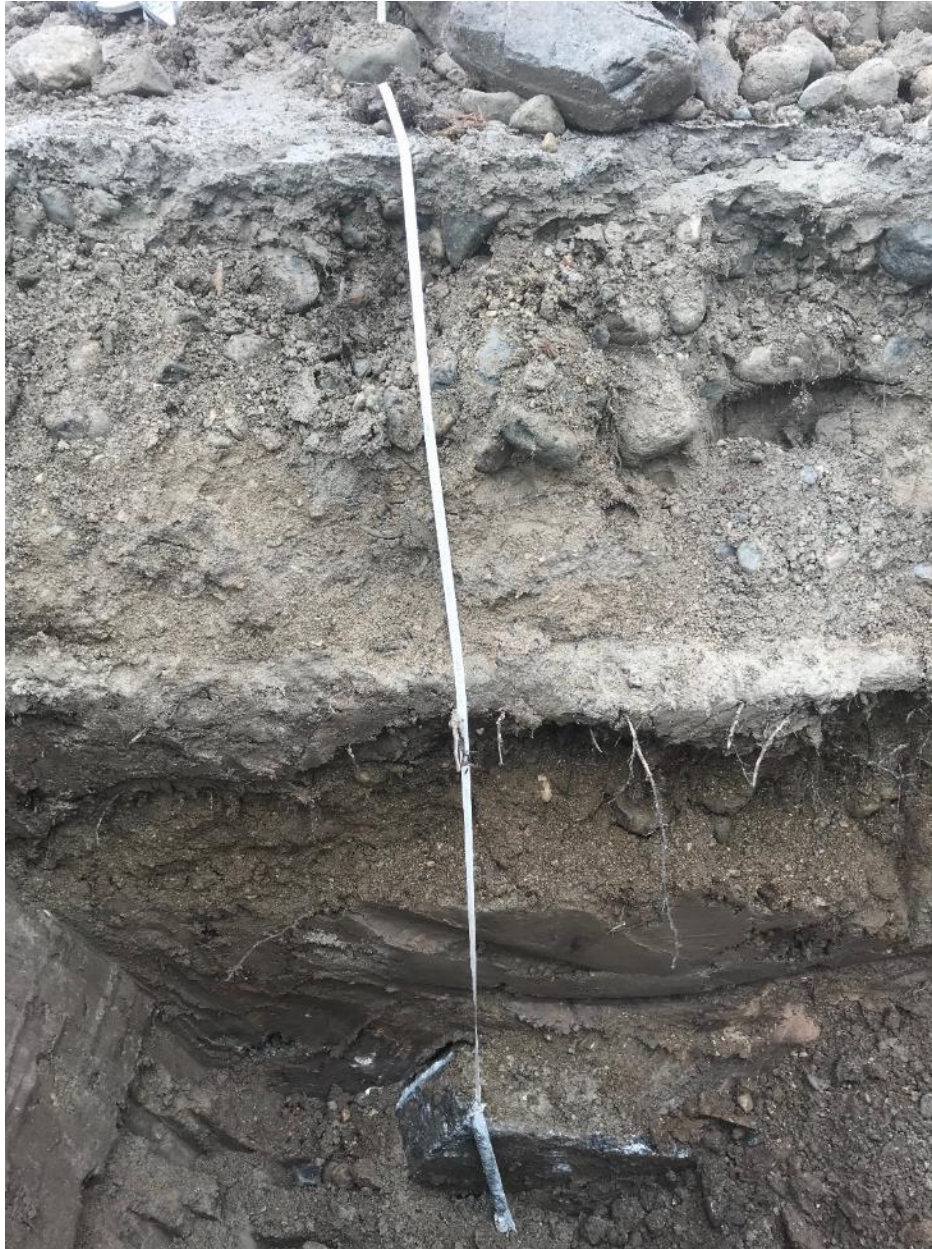
**Photo A3: Test Pit TP-03 (Date taken: June 8, 2019).**

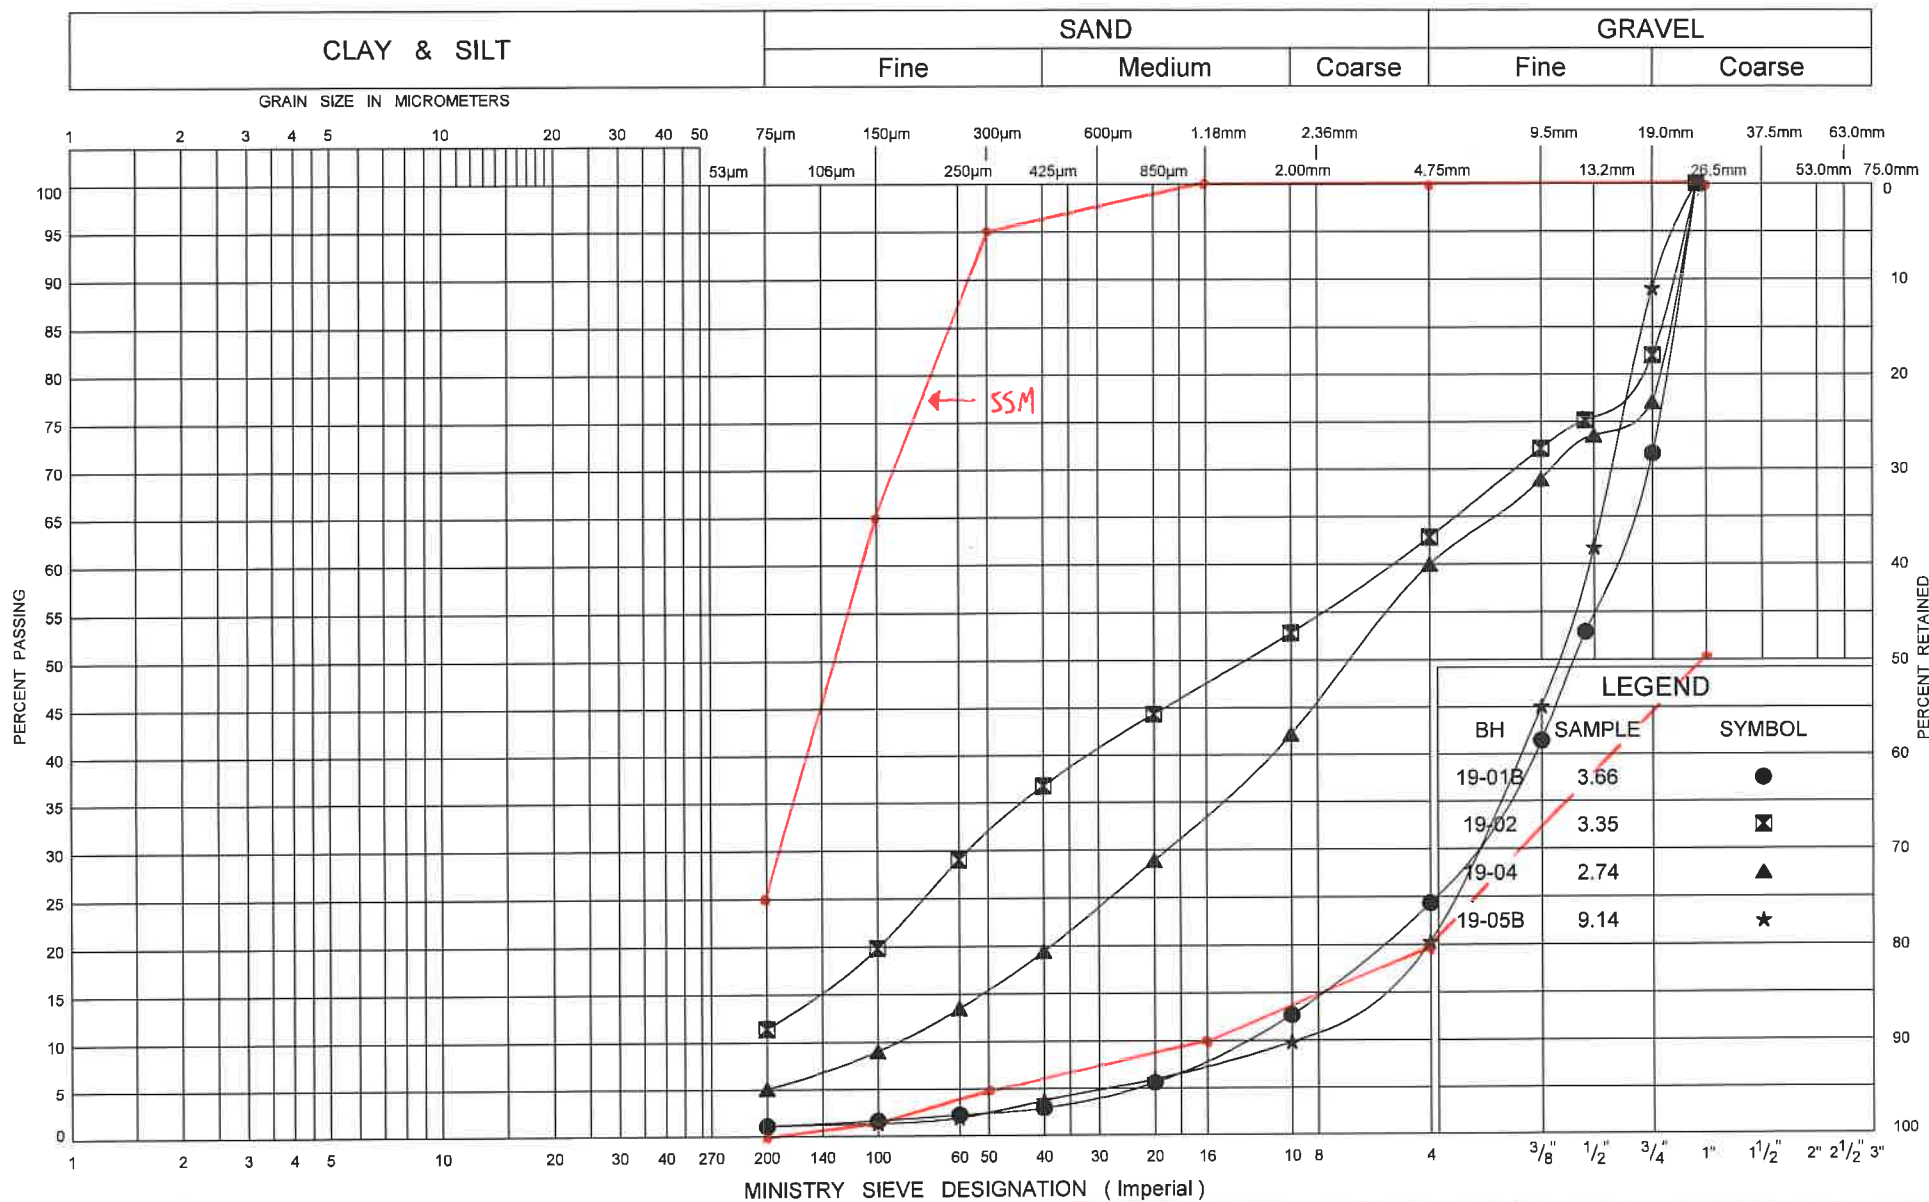
FIG No B5 (B)

**GRAIN SIZE DISTRIBUTION**  
SAND AND GRAVEL to GRAVEL

SPT 'N' values measured in the sand and gravel to gravel layer ranged from 23 to greater than 100 blows per 0.3 m of penetration indicating a compact to very dense consistency. Values of 100 blows or greater may represent the presence of cobbles or boulders. The moisture content within the deposit ranged from 3 to 18 percent.

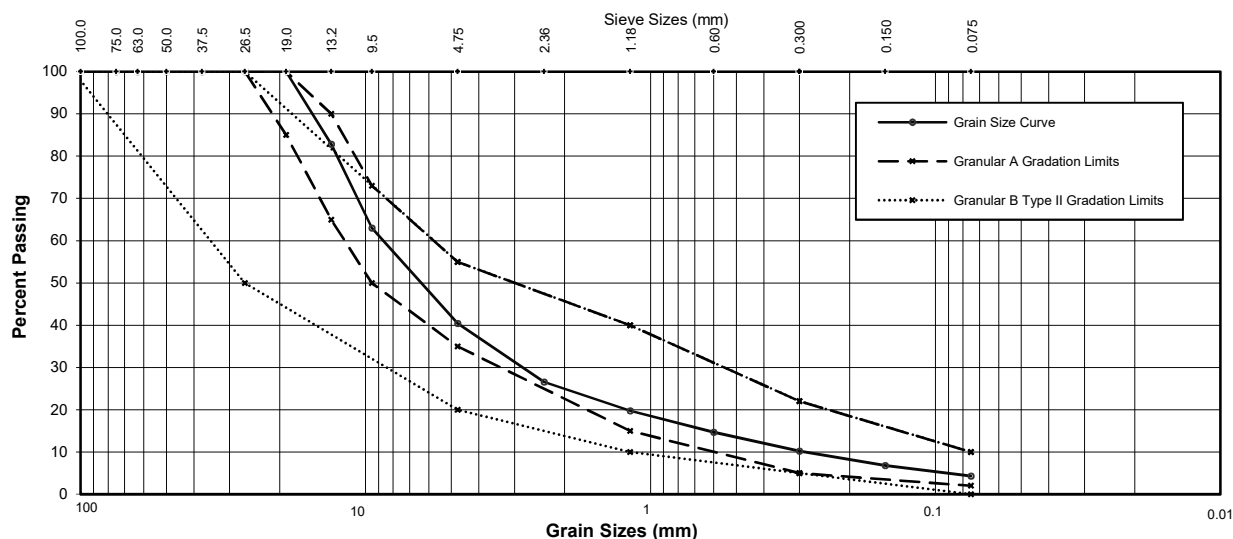
**Sample Source:** Stockpile at Kasabonika Airport  
**Material Type:** Granular A or Granular B Type II  
**Specification:** OPSS 1010  
**Sample Description:** 19 mm Crusher Run Rock - Sample #1

GRAVEL				
Sieve No.	Opening (mm)	Percent Passing	Gradation Limits	
			Max	min
	150	100.0		
	100	100.0		
	75	100.0		
	63	100.0		
	50	100.0		
	37.5	100.0		
	26.5	100.0		
	19	100.0		
	13.2	82.8		
	9.5	63.0		
	4.75	40.5

SAND & FINES				
Sieve No.	Opening (mm)	Percent Passing	Gradation Limits	
			Max	min
	2.36	26.6		
	1.18	19.7		
	0.6	14.7		
	0.3	10.2		
	0.15	6.8		
	0.075	4.3

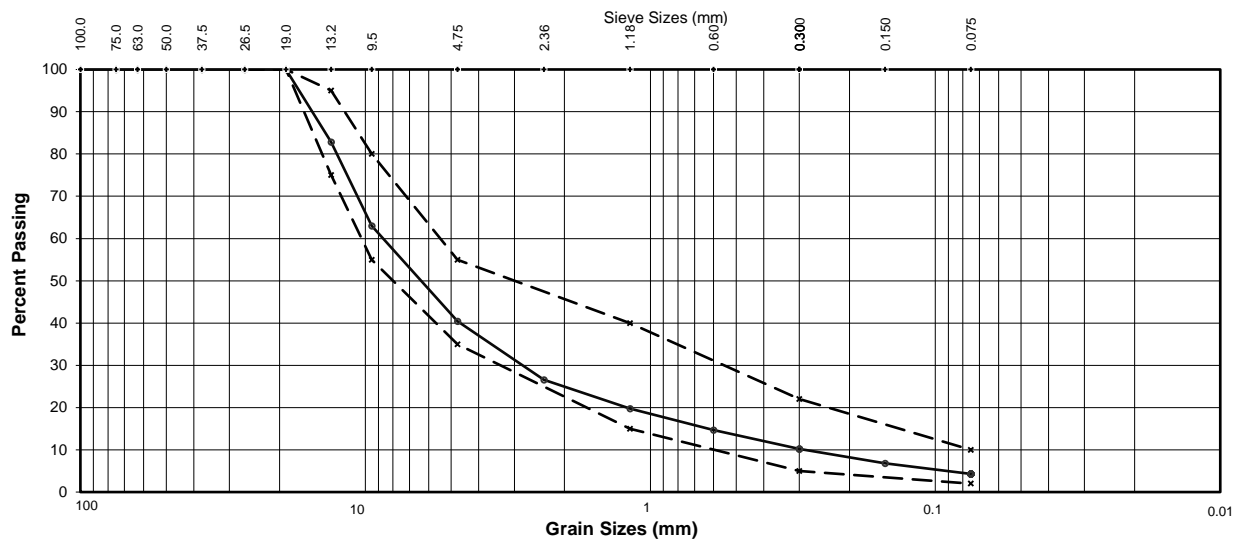
Sample Source: Stockpile at Kasabonika Airport  
 Material Type: Granular M  
 Specification: OPSS 1010  
 Sample Description: 19 mm Crusher Run Rock - Sample #1

GRAVEL				
Sieve No.	Opening (mm)	Percent Passing	Gradation Limits	
			Max	min
	150	100.0		
	100	100.0		
	75	100.0		
	63	100.0		
	50	100.0		
	37.5	100.0		
	26.5	100.0	100	100
	19	100.0	100	100
	13.2	82.8	95	75
	9.5	63.0	80	55
	4.75	40.5	55	35

Gravel: 59.5%      Deleterious  
 Sand: 36.2%      Material: -  
 Fines: 4.3%      % Crushed: -  
                       Asph. Content: -

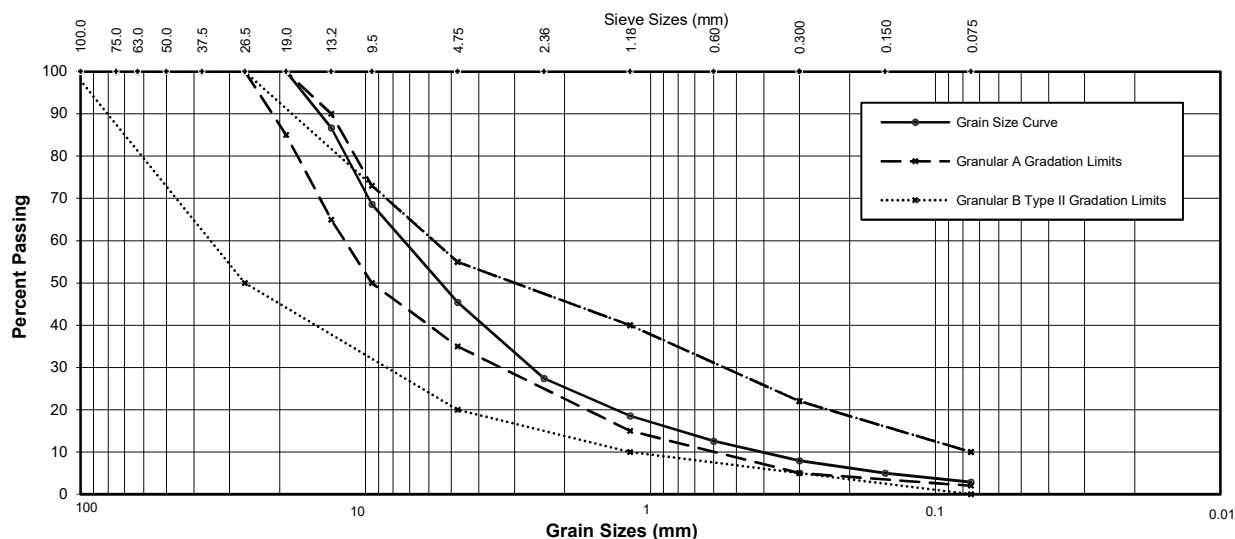
**Sample Source:** Stockpile at Kasabonika Airport  
**Material Type:** Granular A or Granular B Type II  
**Specification:** OPSS 1010  
**Sample Description:** 19 mm Crusher Run Rock - Sample #2

GRAVEL				
Sieve No.	Opening (mm)	Percent Passing	Gradation Limits	
			Max	min
	150	100.0		
	100	100.0		
	75	100.0		
	63	100.0		
	50	100.0		
	37.5	100.0		
	26.5	100.0		
	19	100.0		
	13.2	86.7		
	9.5	68.6		
	4.75	45.4

SAND & FINES				
Sieve No.	Opening (mm)	Percent Passing	Gradation Limits	
			Max	min
	2.36	27.4		
	1.18	18.5		
	0.6	12.6		
	0.3	8.0		
	0.15	5.0		
	0.075	2.9

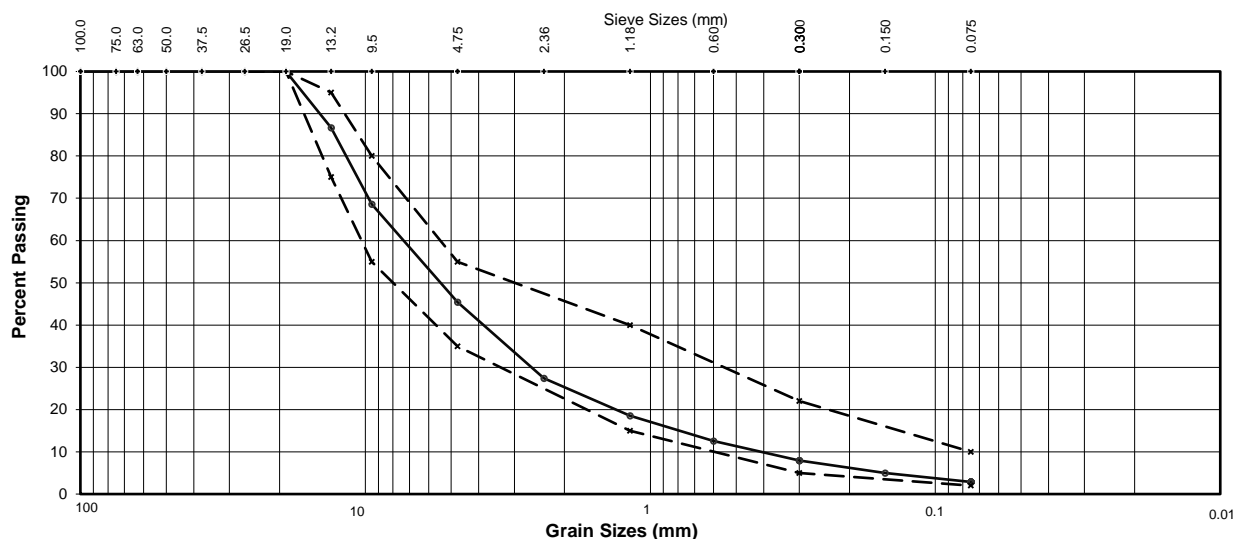
**Sample Source:** Stockpile at Kasabonika Airport  
**Material Type:** Granular M  
**Specification:** OPSS 1010  
**Sample Description:** 19 mm Crusher Run Rock - Sample #2

GRAVEL				
Sieve No.	Opening (mm)	Percent Passing	Gradation Limits	
			Max	min
	150	100.0		
	100	100.0		
	75	100.0		
	63	100.0		
	50	100.0		
	37.5	100.0		
	26.5	100.0	100	100
	19	100.0	100	100
	13.2	86.7	95	75
	9.5	68.6	80	55
	4.75	45.4	55	35

SAND & FINES				
Sieve No.	Opening (mm)	Percent Passing	Gradation Limits	
			Max	min
	2.36	27.4	40	15
	1.18	18.5		
	0.6	12.6		
	0.3	8.0	22	5
	0.15	5.0		
	0.075	2.9	10	2

**Comments:** This sample meets OPSS 1010 requirements for Granular M.

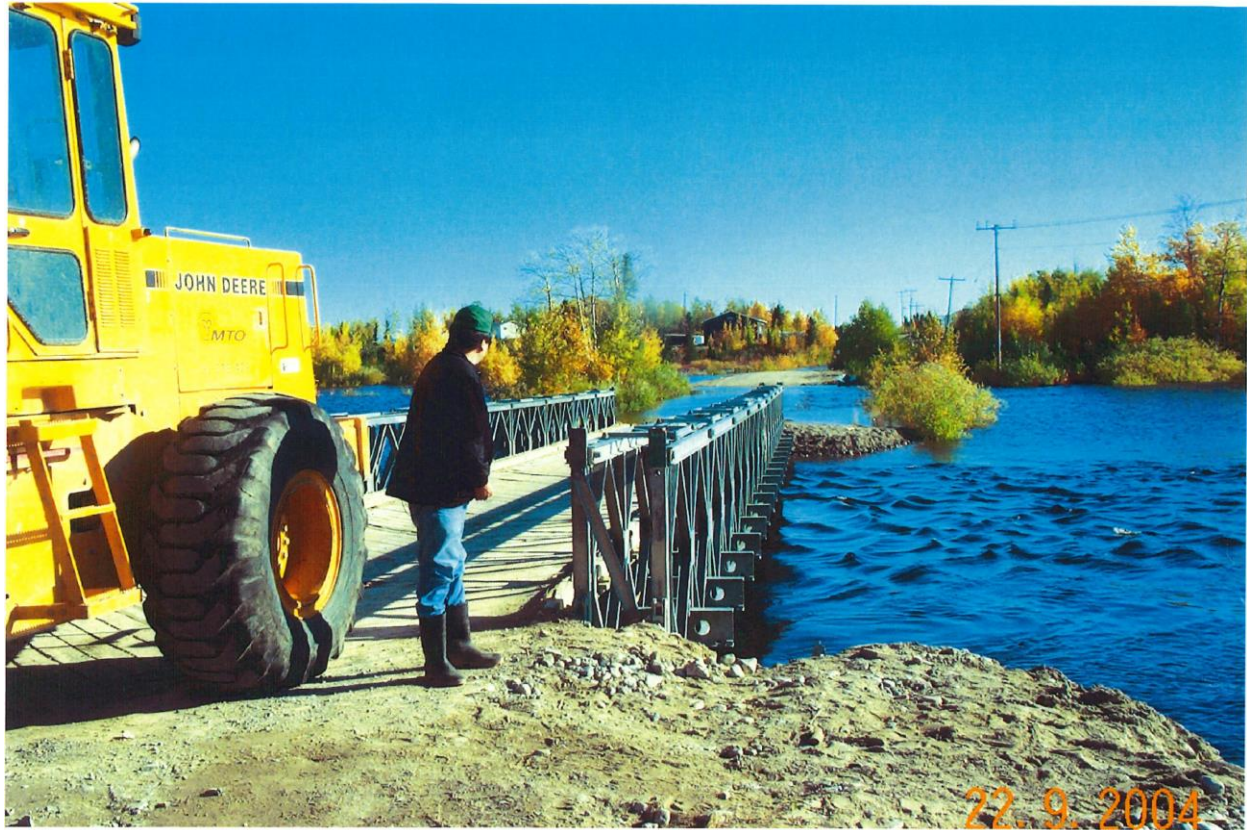
**Photo C1: Overtopping of east causeway embankment**  
(Date taken: Sept. 22, 2004; provided by MTO).

Hatch. The previous flooding that overtopped the east approach embankment in 2004 indicates that the lake water level has previously been observed at greater than approximate Elevation 186 m.

Photographs in Appendix C show that the causeway beyond the bridge has previously been overtopped by high lake water levels. Severe erosion of the approach embankments, possibly due to this flooding, has also previously occurred and exposed and undermined the timber crib bridge foundations.

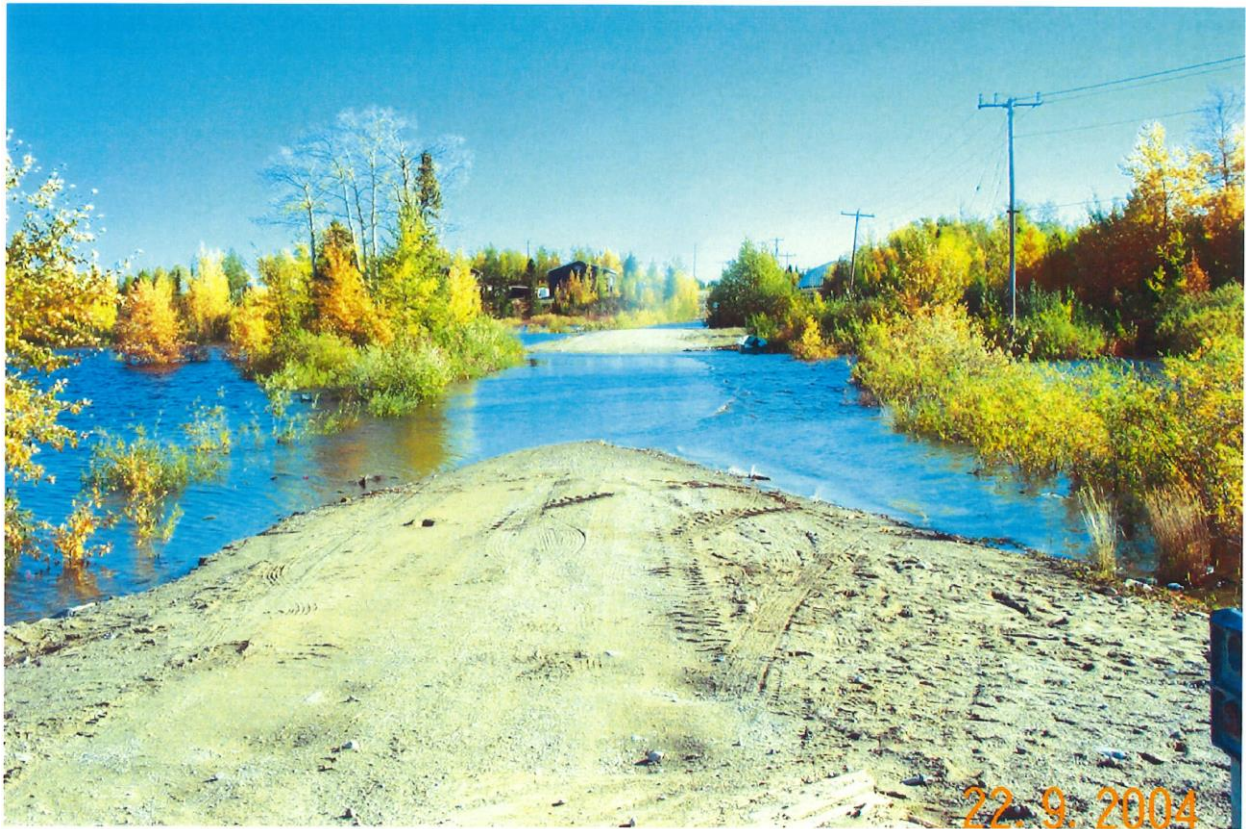
**Photo C2: Overtopping of east causeway embankment**  
(Date taken: Sept. 22, 2004; provided by MTO).

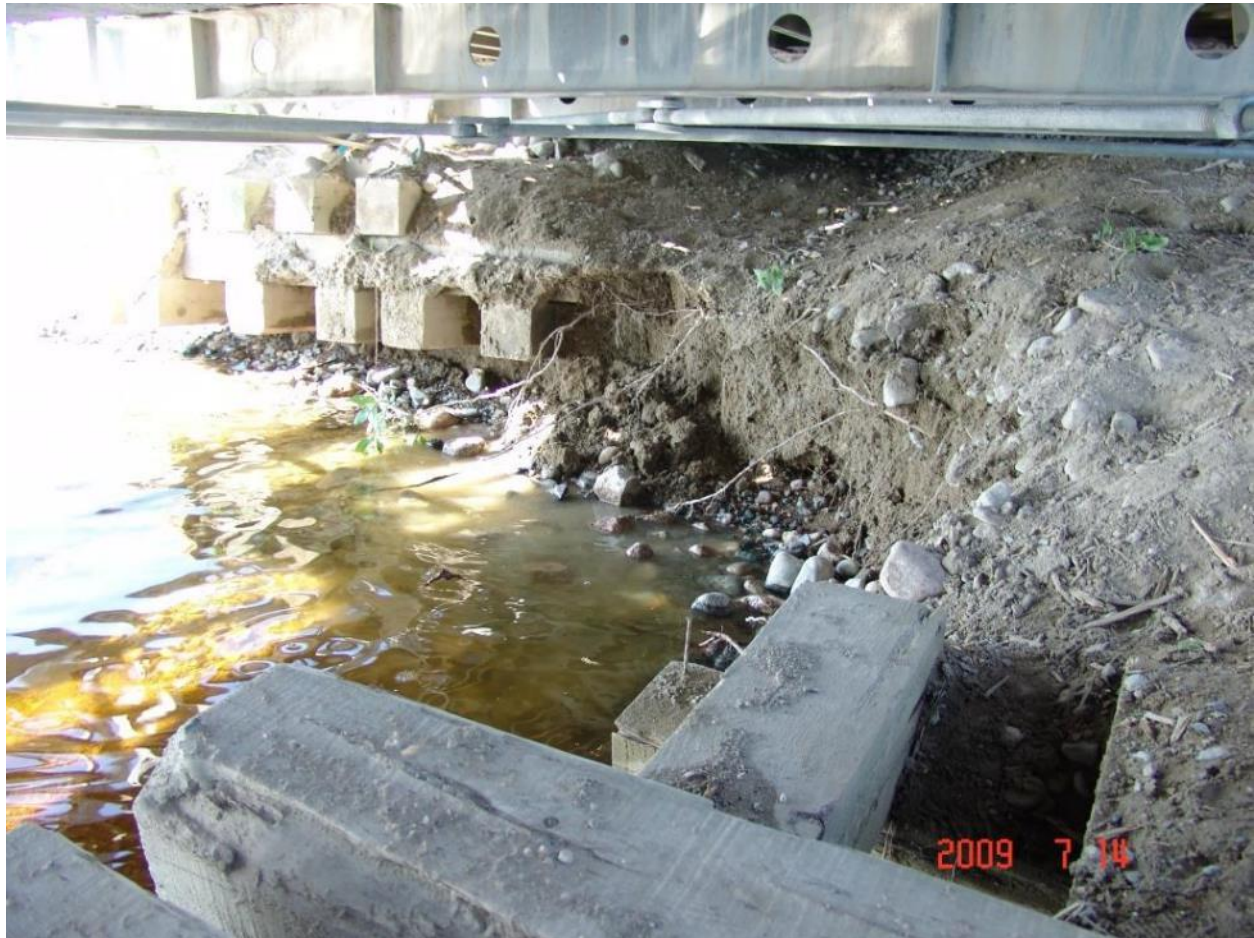
Photo C3: Erosion at west abutment foundation (Date taken: July 7, 2009; provided by MTO).

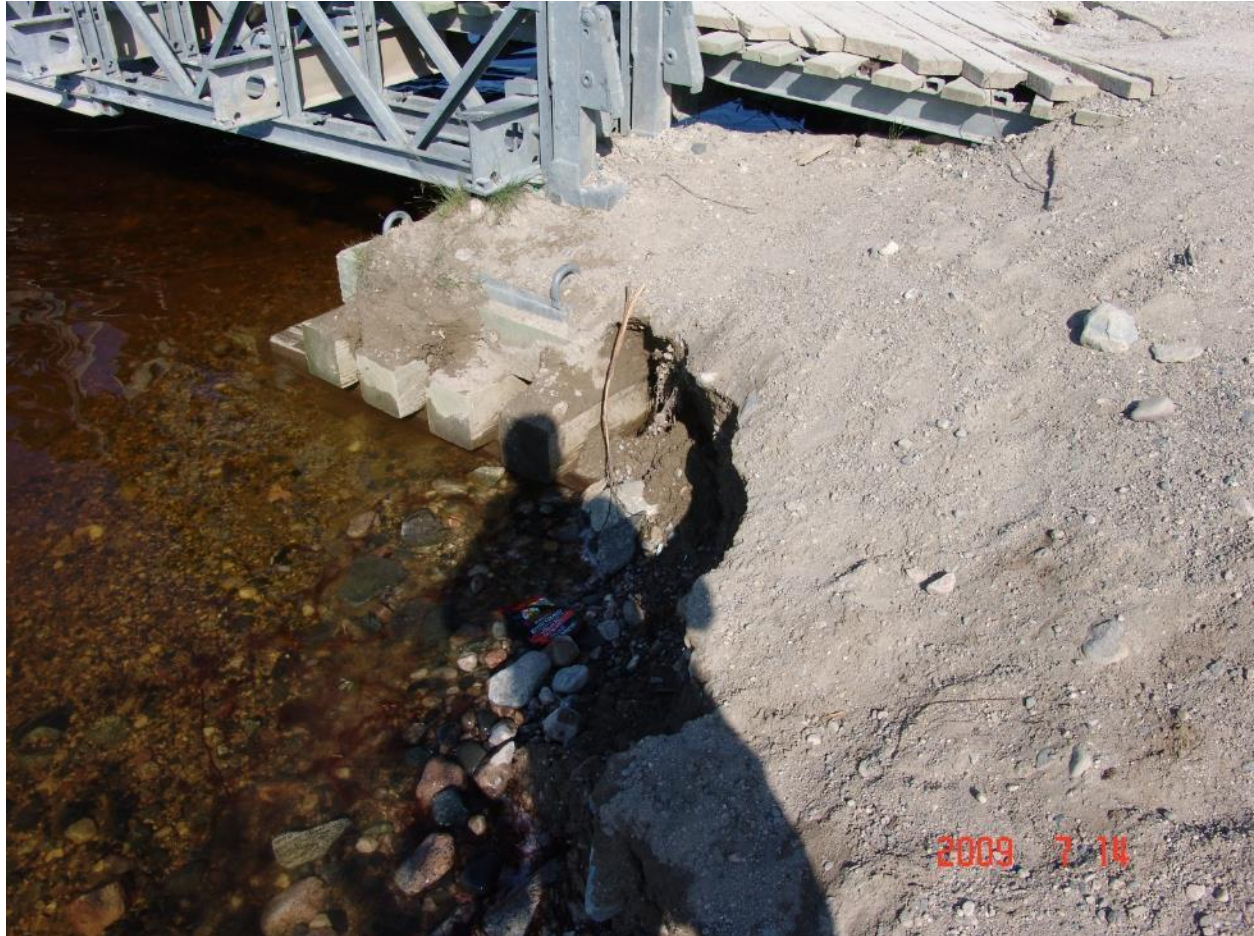
**Photo C4: Erosion at east abutment foundation (Date taken: July 7, 2009; provided by MTO).**

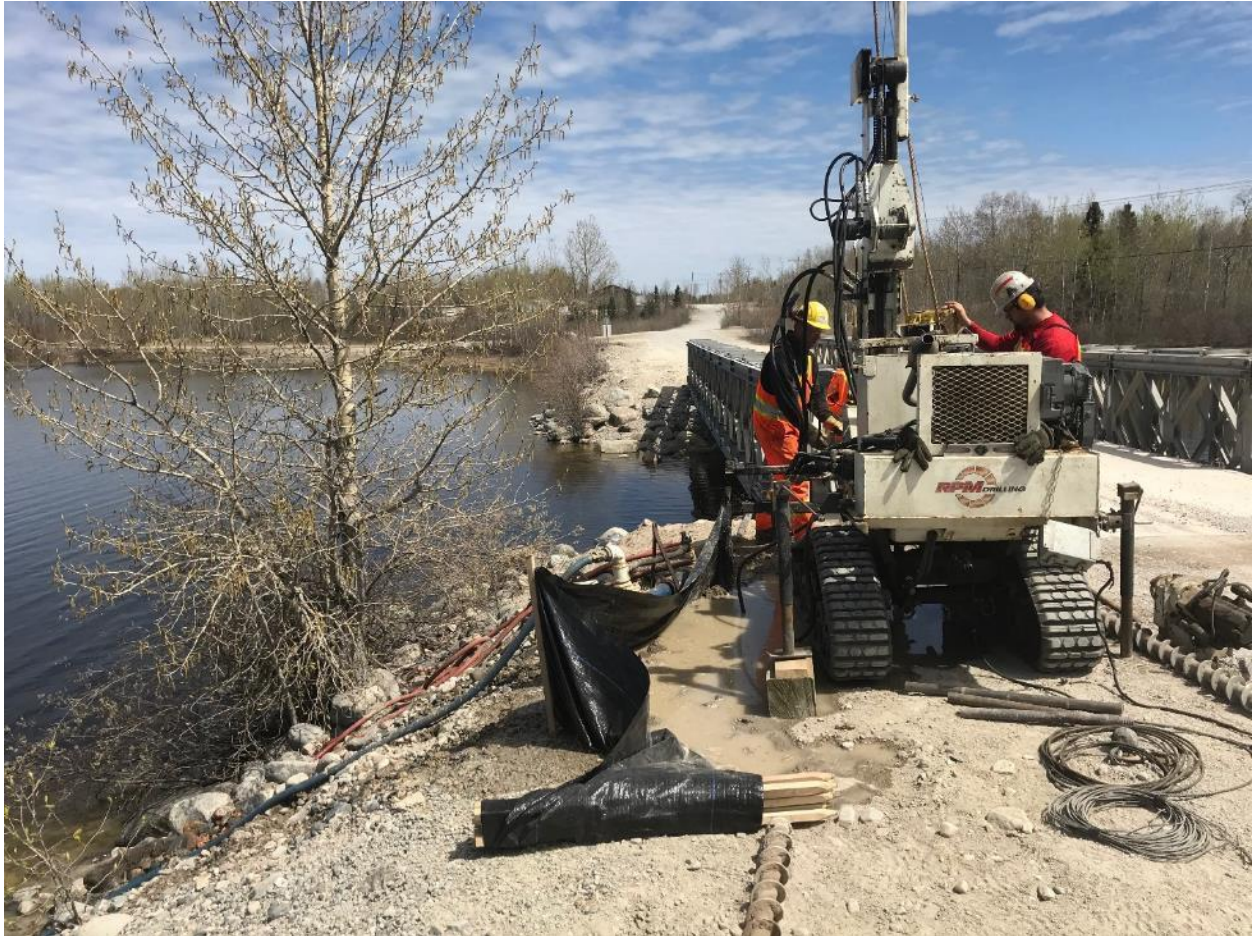
**Photo C5: Simco Drill Rig drilling at Borehole 19-01; north side of west abutment looking east  
(Date taken: June 5, 2019).**

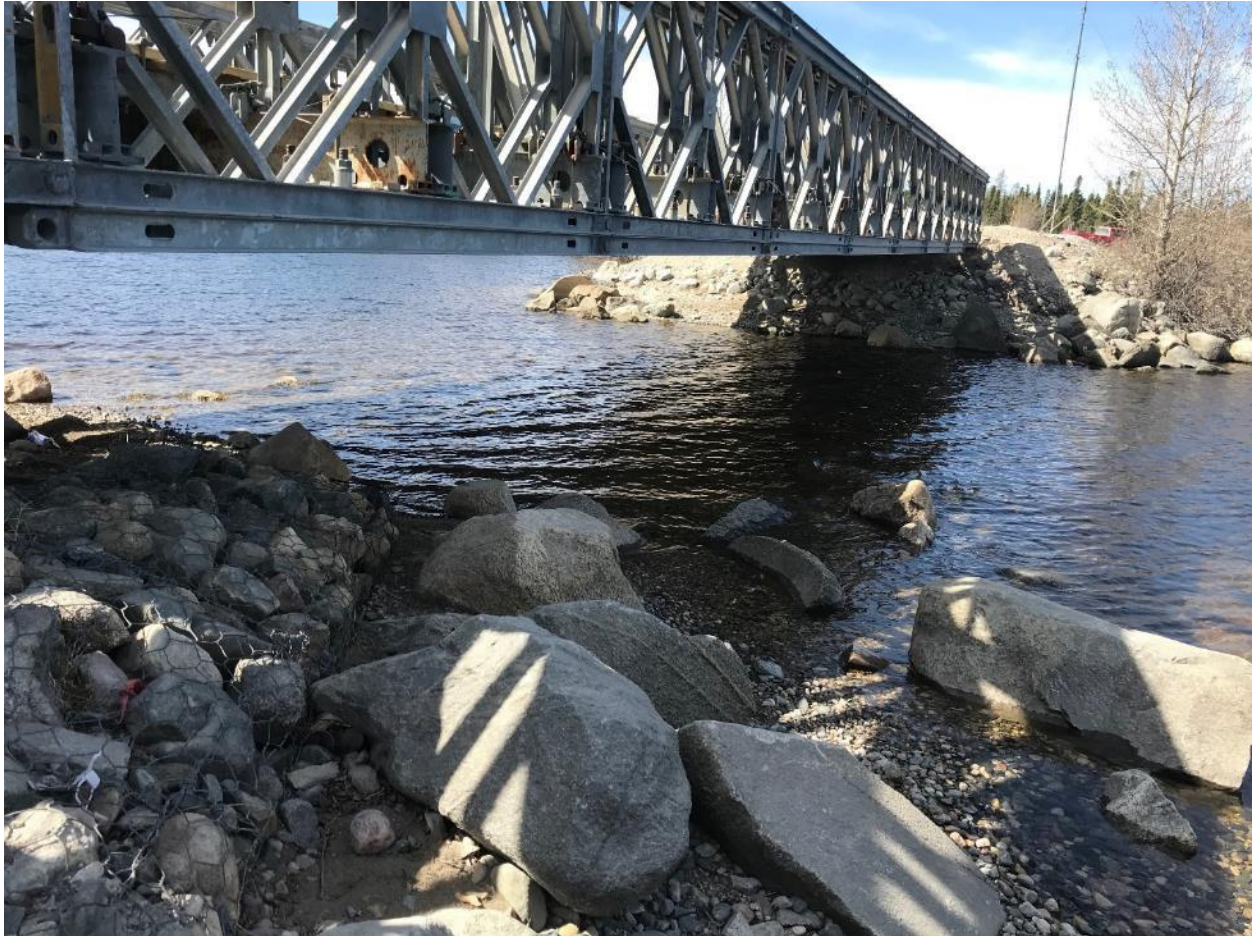
**Photo C13: North side of bridge looking west showing large boulders and gabion baskets for erosion protection (Date taken: June 4, 2019).**

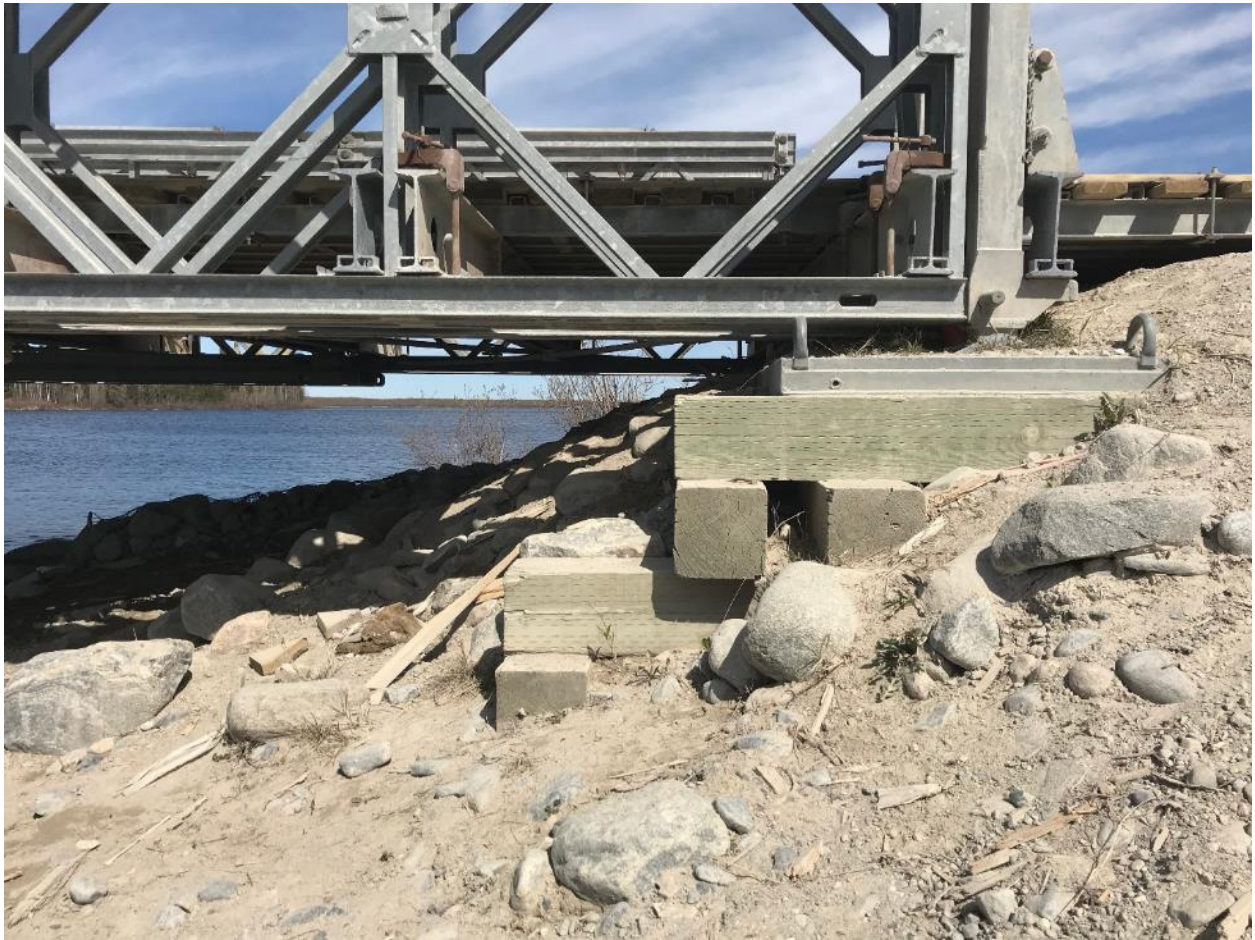
**Photo C14: East abutment footing looking north (Date taken: June 4, 2019).**

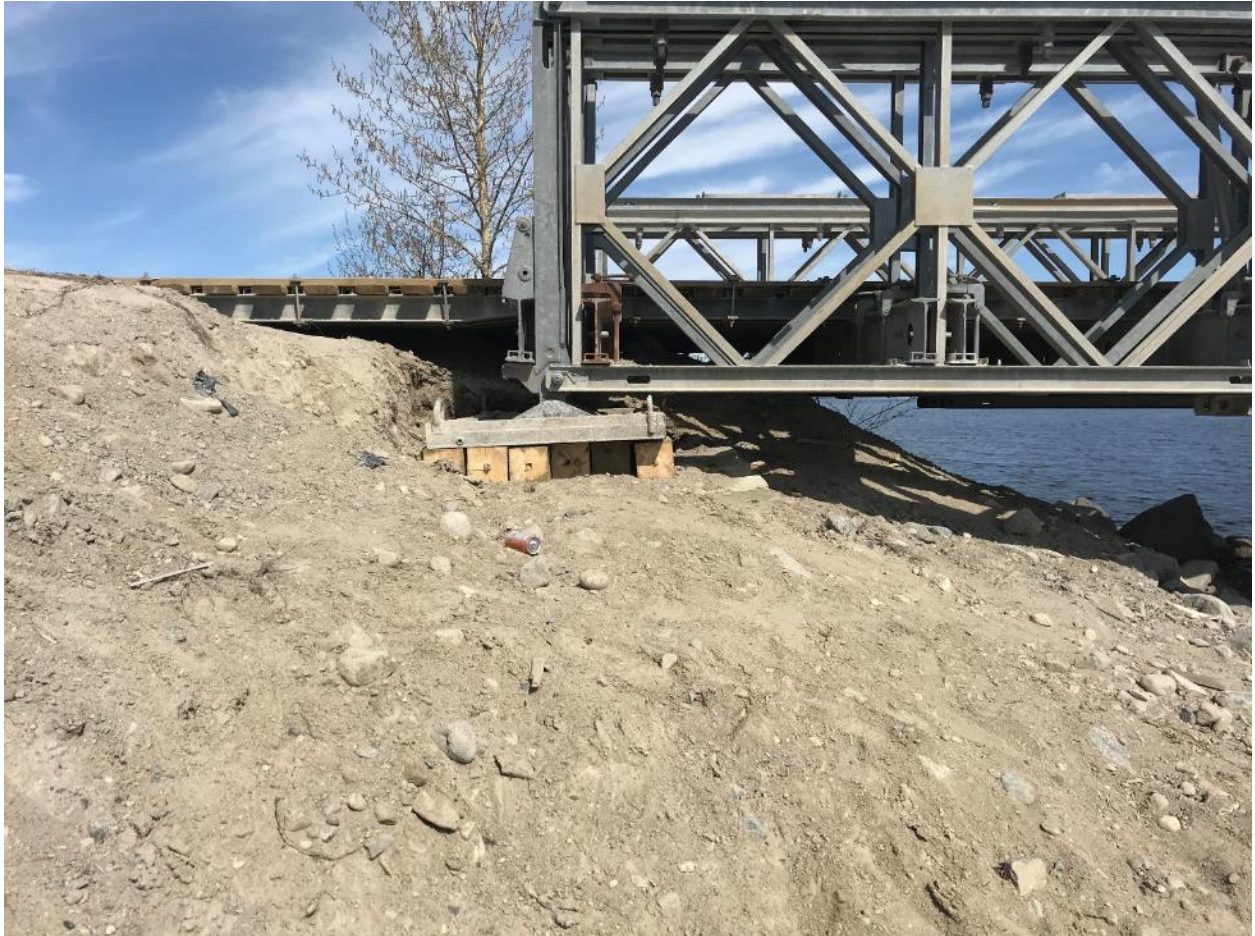
**Photo C16: West abutment footing looking north (Date taken: June 4, 2019).**
