**FOUNDATION INVESTIGATION AND DESIGN REPORT  
KASABONIKA LAKE MODULAR BRIDGE  
DISTRICT OF KENORA, KASABONIKA LAKE FIRST NATION, ONTARIO  
LATITUDE: 53.5263°, LONGITUDE: -88.6213°  
W.P. 6579-16-00, SITE No. 41N-0244/BO**

**GEOCRES Number: 53H-01**

Date: November 13, 2019  
File: 25489

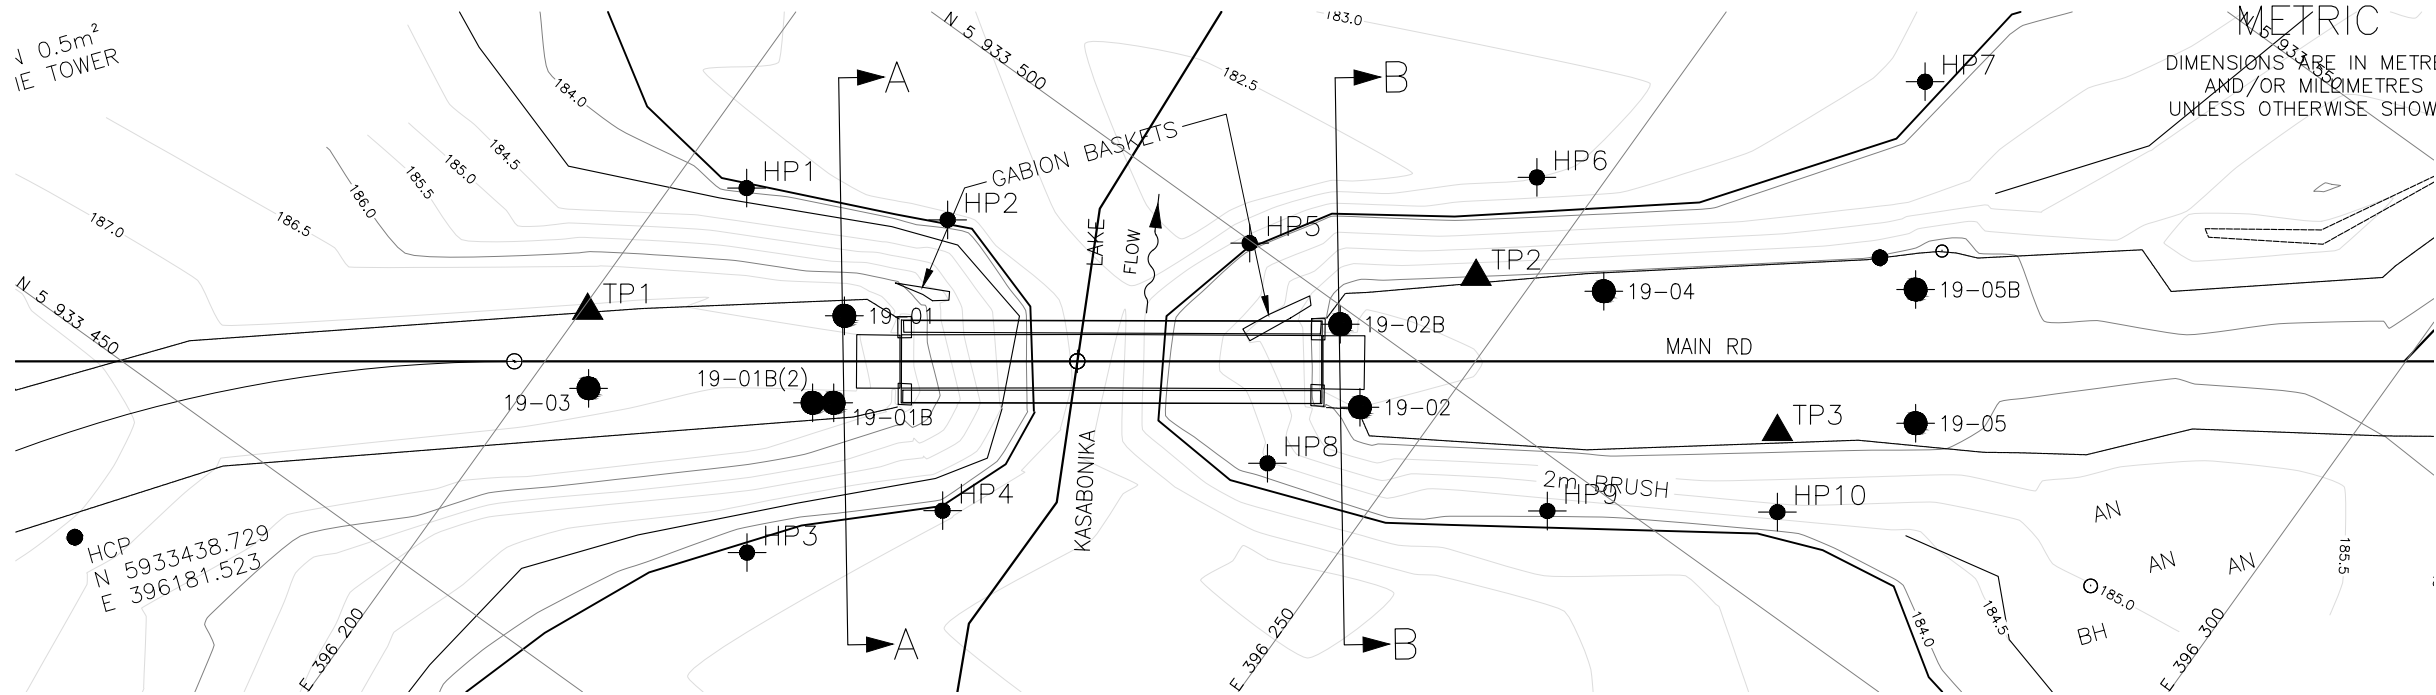
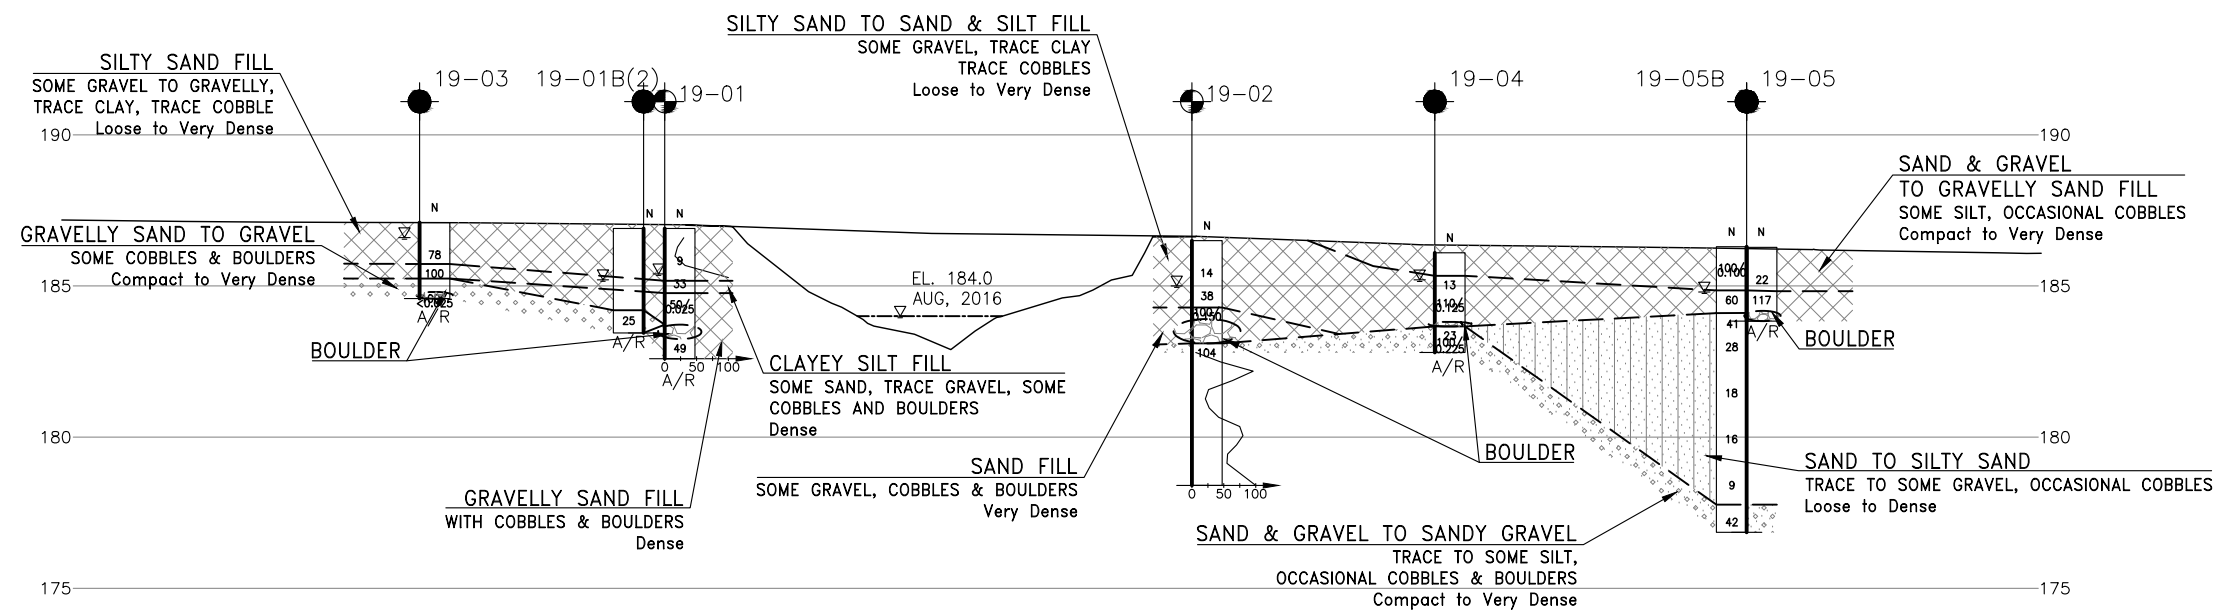
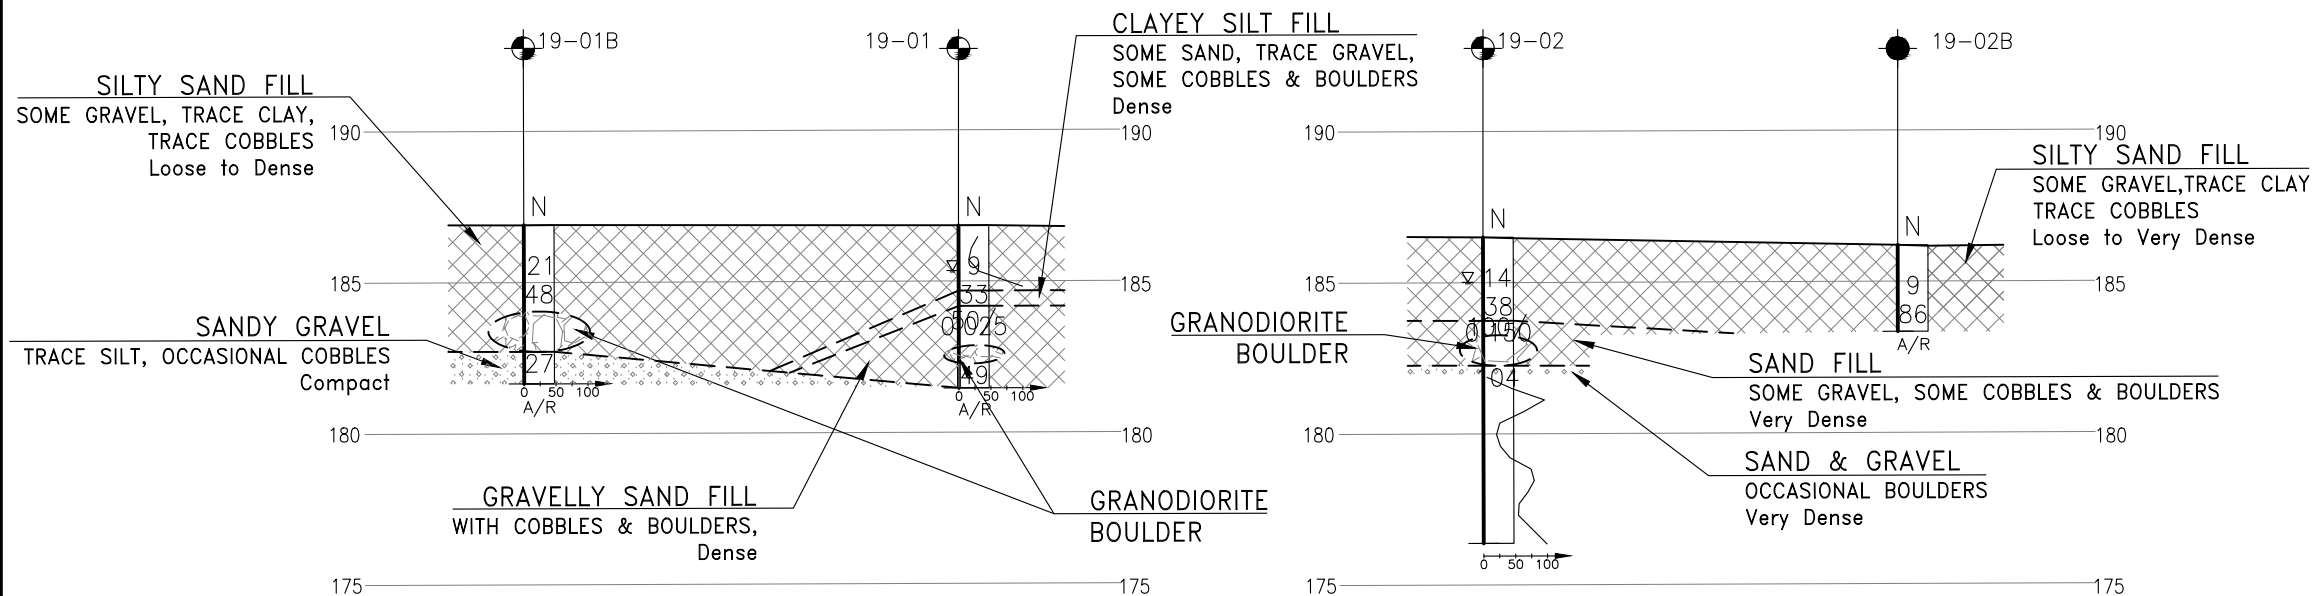
BOREHOLE LOCATIONS AND SOIL STRATA

- 1) The boundaries between soil strata have been established only at Borehole locations. Between Boreholes the boundaries are assumed from geological evidence.
- 2) This drawing is for subsurface information only. Surface details and features are for conceptual illustration.
- 3) Coordinate system is MTM NAD 83 Zone 15.

SECTION A-A

Reference is made to the Record of Borehole sheets included in Appendix A. Details of the encountered soil stratigraphy are presented on the Record of Borehole sheets and on the Borehole Locations and Soil Strata Drawing included in Appendix D. A general description of the stratigraphy, based on the conditions encountered in the boreholes, is given in the following paragraphs. However, the factual data presented on the Record of Borehole sheets takes precedence over this general description and must be used for interpretation of the site conditions. It must be recognized and expected that soil conditions may vary between and beyond the borehole locations.

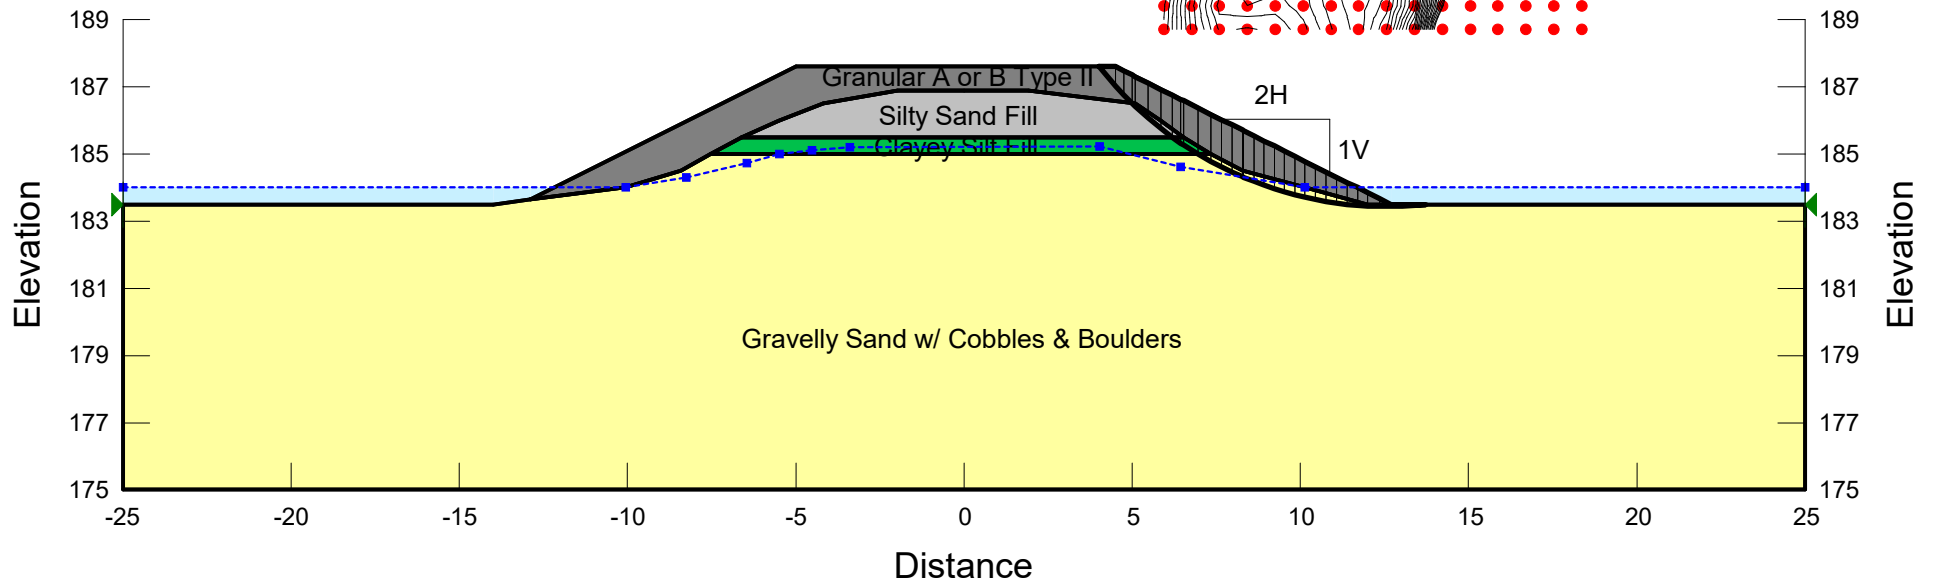
FIGURE 2

Clayey Silt Fill 21 kN/m<sup>3</sup> 0 kPa 30 °

Gravelly Sand w/ Cobbles & Boulders 22 kN/m<sup>3</sup> 0 kPa 35 °

# KASABONIKA LAKE BRIDGE SIDE SLOPE EAST ABUTMENT 2H:1V CONDITION WITH GRADE RAISE

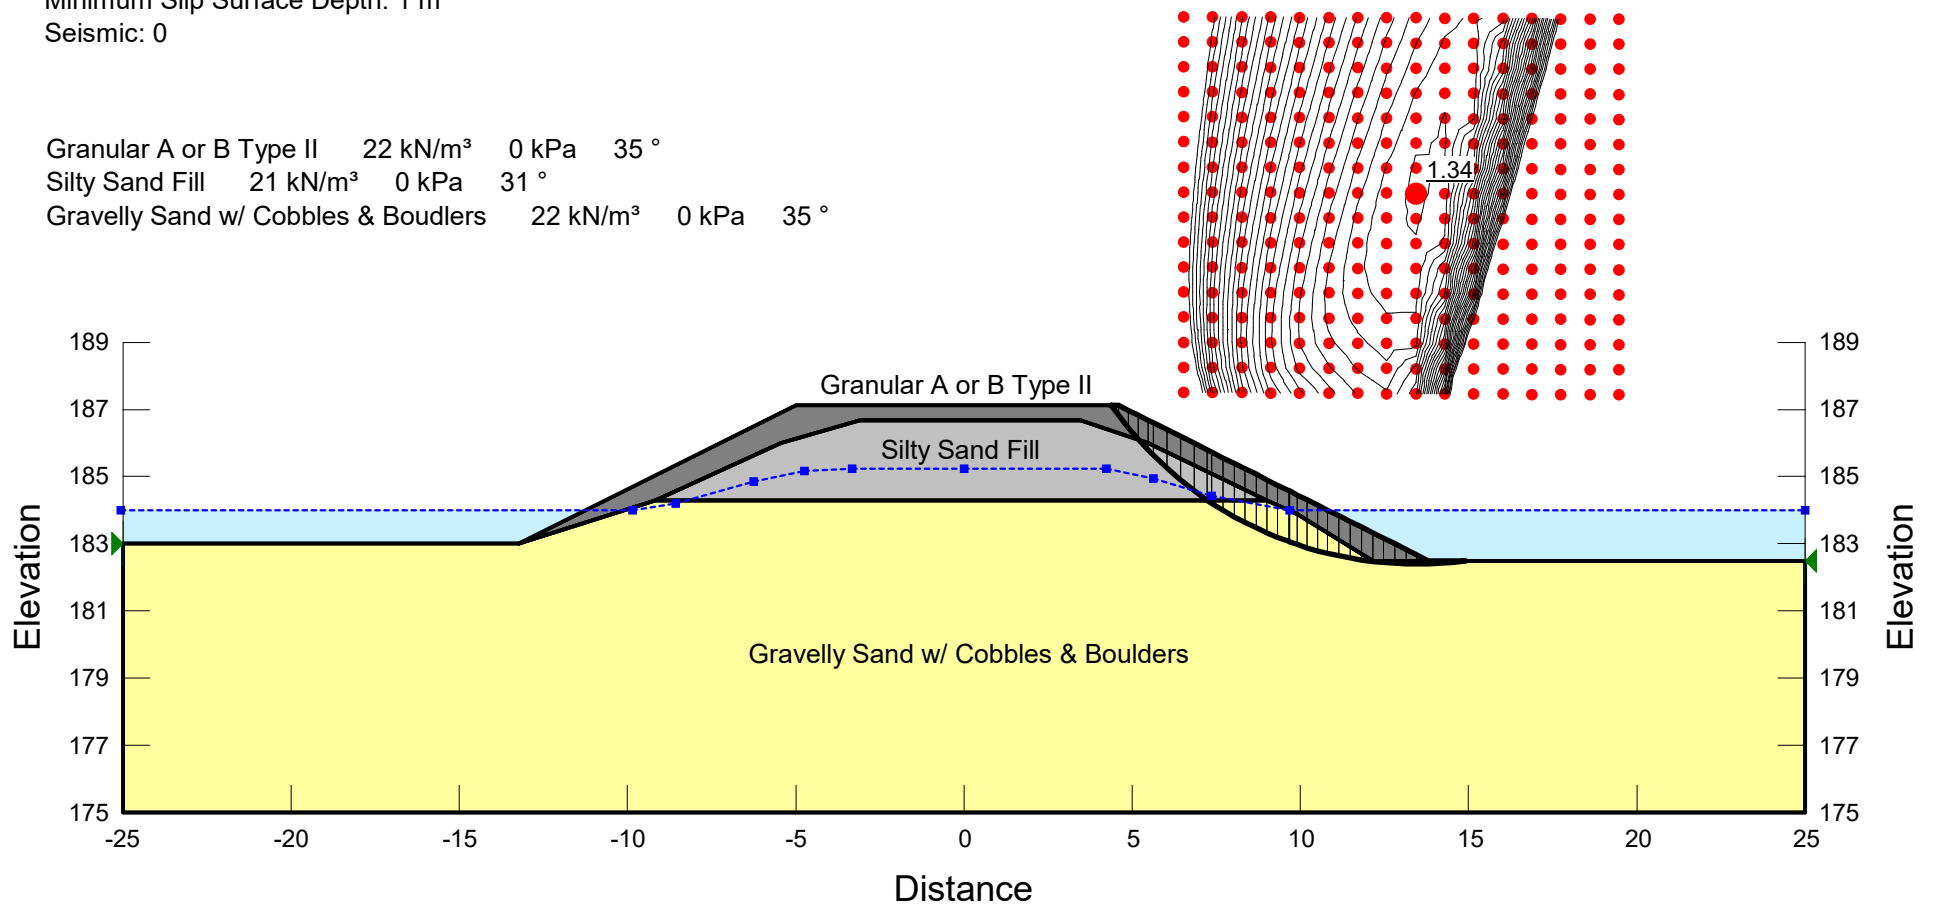
FIGURE 3

Silty Sand Fill    21 kN/m<sup>3</sup>    0 kPa    31 °

Gravelly Sand w/ Cobbles & Boulders    22 kN/m<sup>3</sup>    0 kPa    35 °

# KASABONIKA LAKE BRIDGE SIDE SLOPE WEST ABUTMENT 2H:1V CONDITION WITH GRADE RAISE

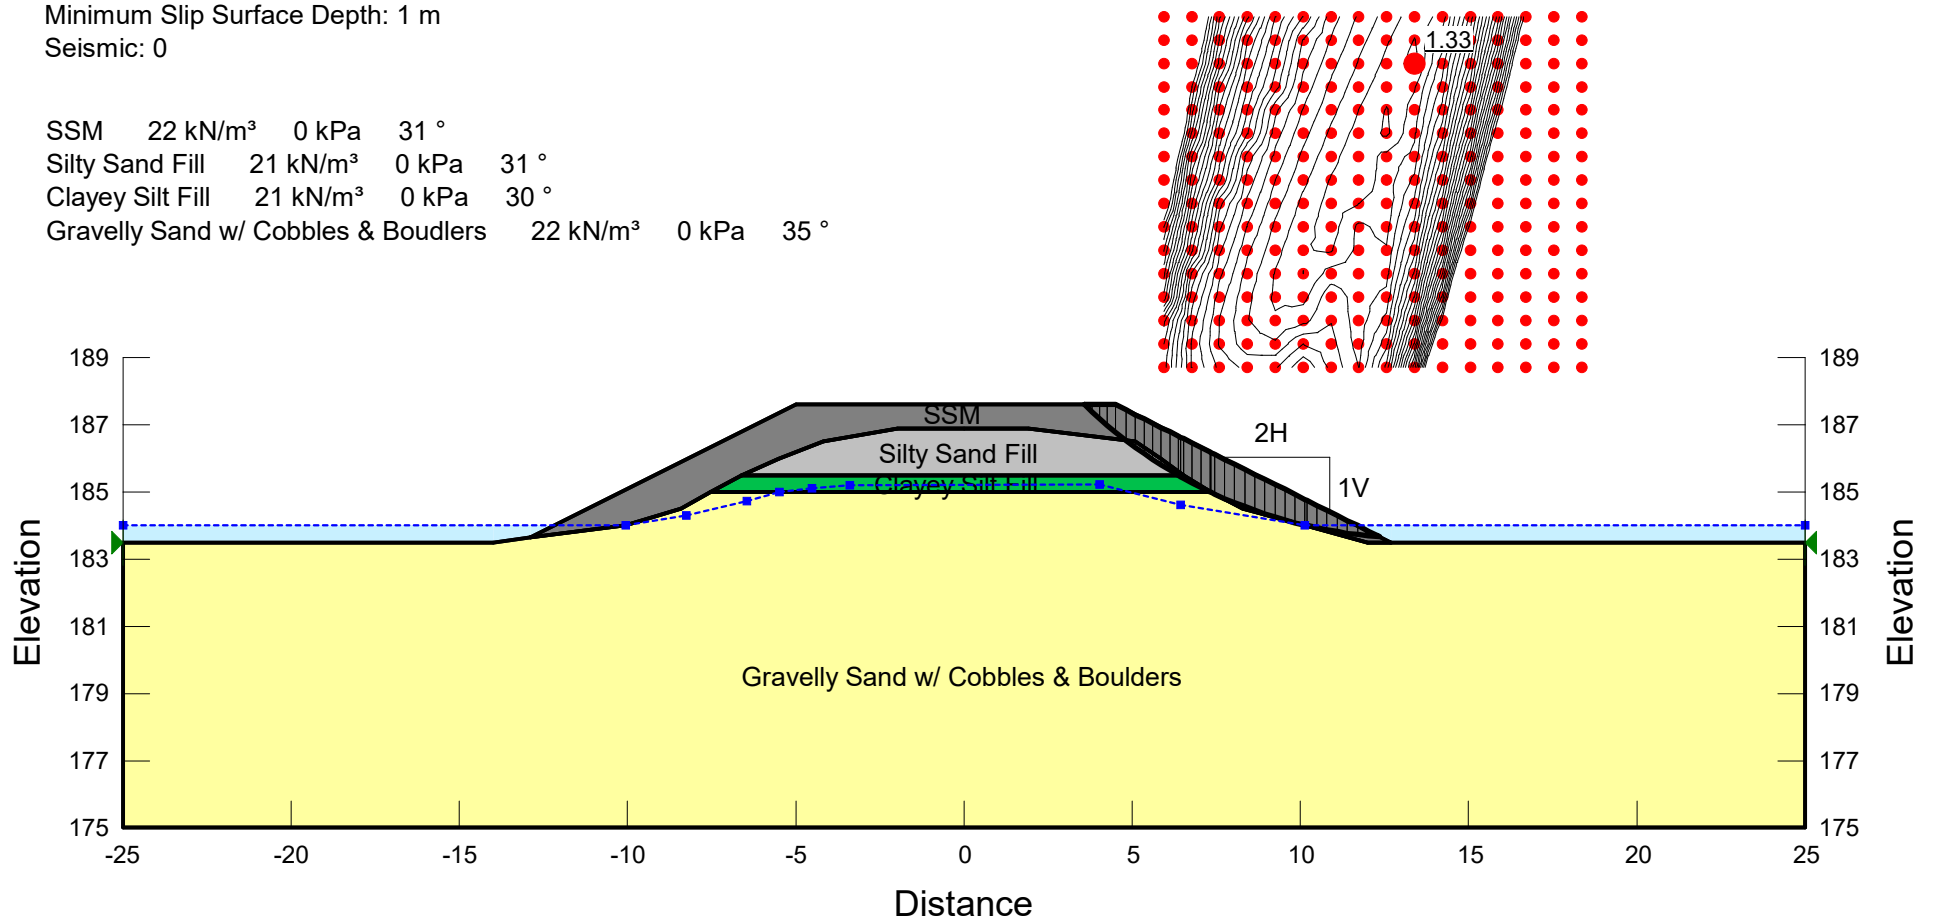
FIGURE 4

Method: Morgenstern-Price  
Minimum Slip Surface Depth: 1 m  
Seismic: 0

SSM	22 kN/m <sup>3</sup>	0 kPa	31 °
Silty Sand Fill	21 kN/m <sup>3</sup>	0 kPa	31 °
Clayey Silt Fill	21 kN/m <sup>3</sup>	0 kPa	30 °
Gravelly Sand w/ Cobbles & Boulders	22 kN/m <sup>3</sup>	0 kPa	35 °

# KASABONIKA LAKE BRIDGE SIDE SLOPE EAST ABUTMENT 2H:1V CONDITION WITH GRADE RAISE

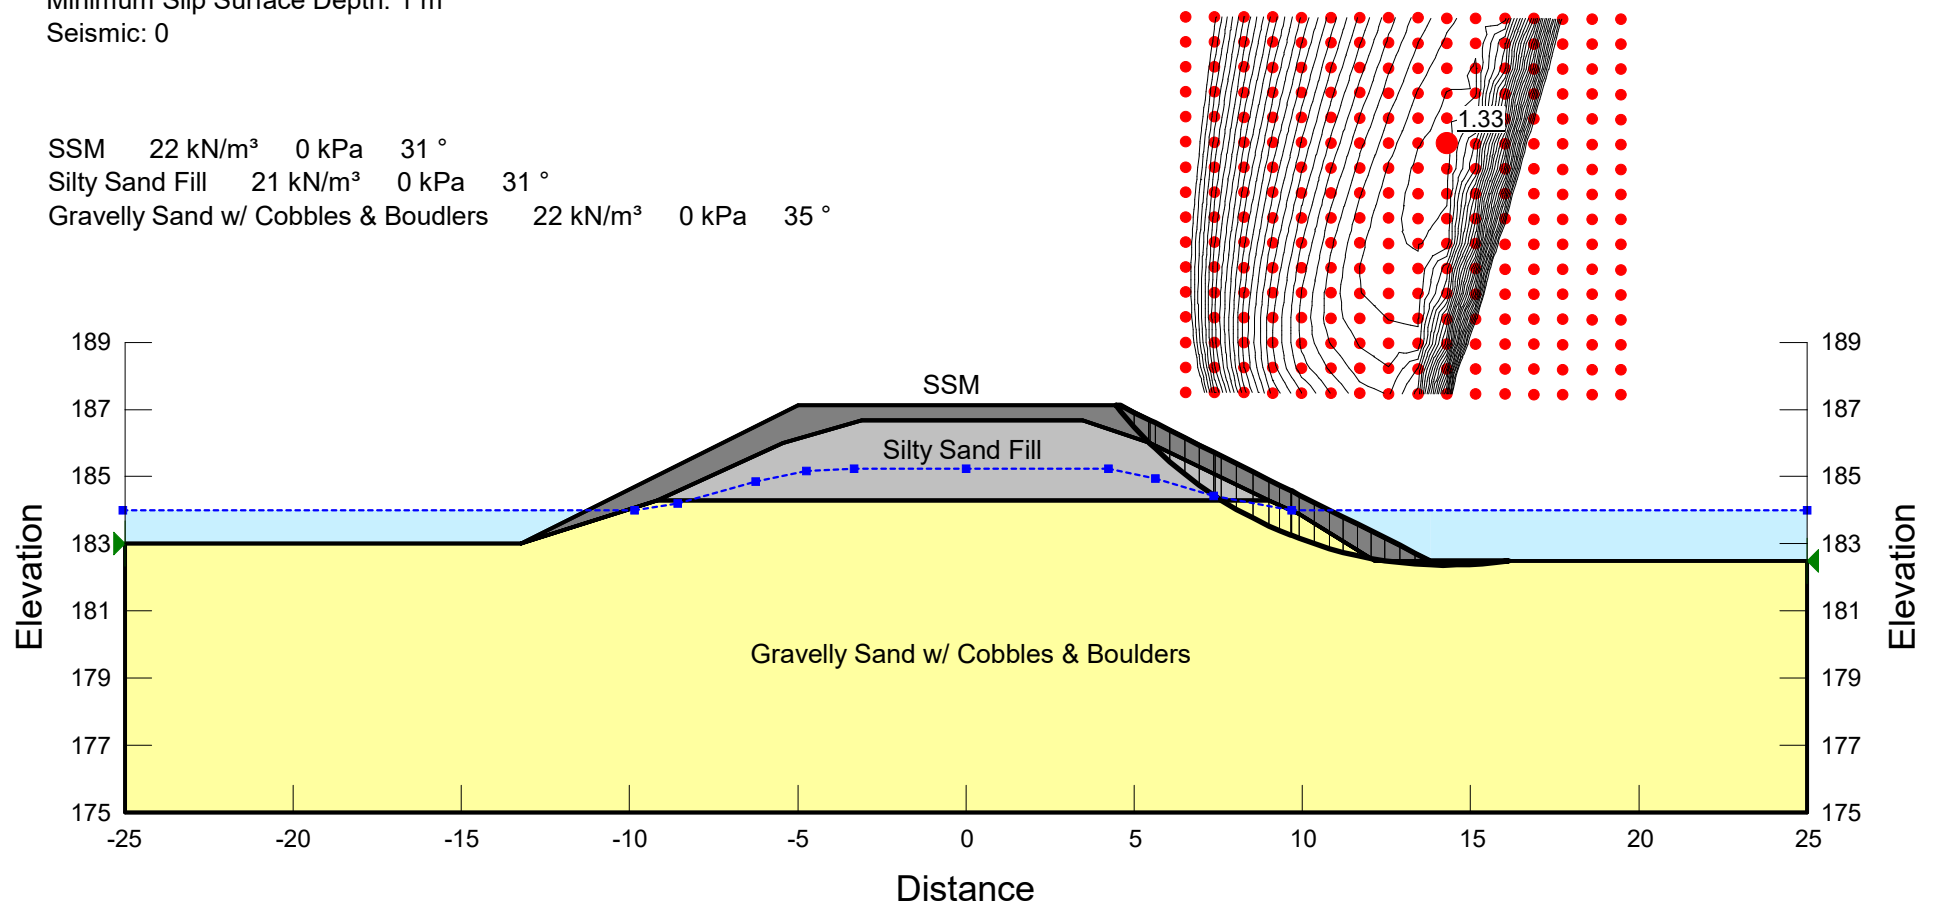
**FIGURE 5**

Silty Sand Fill 21 kN/m<sup>3</sup> 0 kPa 31 °

Gravelly Sand w/ Cobbles & Boulders 22 kN/m<sup>3</sup> 0 kPa 35 °

# KASABONIKA LAKE BRIDGE FORWARD SLOPE WEST ABUTMENT EXISTING CONDITION WITH GRADE RAISE

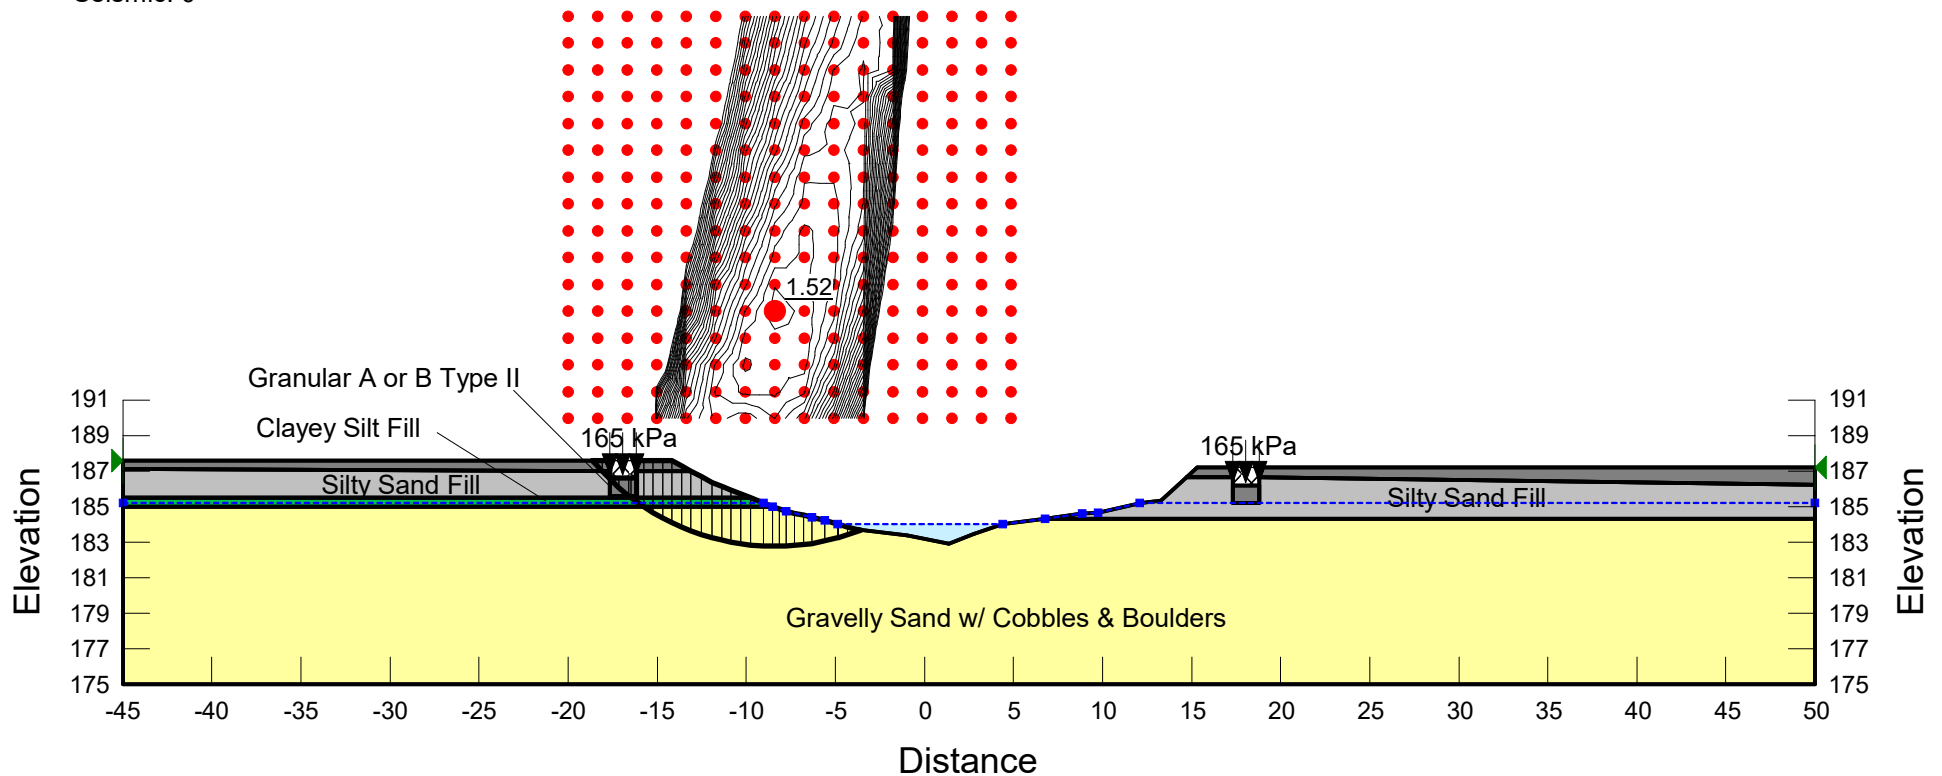
FIGURE 6

Method: Morgenstern-Price  
Minimum Slip Surface Depth: 1 m  
Seismic: 0

Granular A or B Type II	22 kN/m <sup>3</sup>	0 kPa	35 °
Silty Sand Fill	21 kN/m <sup>3</sup>	0 kPa	31 °
Clayey Silt Fill	21 kN/m <sup>3</sup>	0 kPa	30 °
Gravelly Sand w/ Cobbles & Boulders	22 kN/m <sup>3</sup>	0 kPa	35 °

# KASABONIKA LAKE BRIDGE FORWARD SLOPE WEST ABUTMENT EXISTING CONDITION WITH GRADE RAISE

If the engineered fill pads are located close to the lake channel (if the existing timber footings are not left in place), the forward slope of the foundation pads should be embedded at least 1.0 m below a 2H:1V face of the forward slope, with the edge of footing at a minimum of 2 m behind the crest of the forward slope. Since erosion at the existing abutments was a critical issue at this site, provision of properly designed erosion protection works will be critical to ensure adequate performance of the foundations/engineered fill pads and protect the surface of the forward slopes that will be in contact with the lake water.

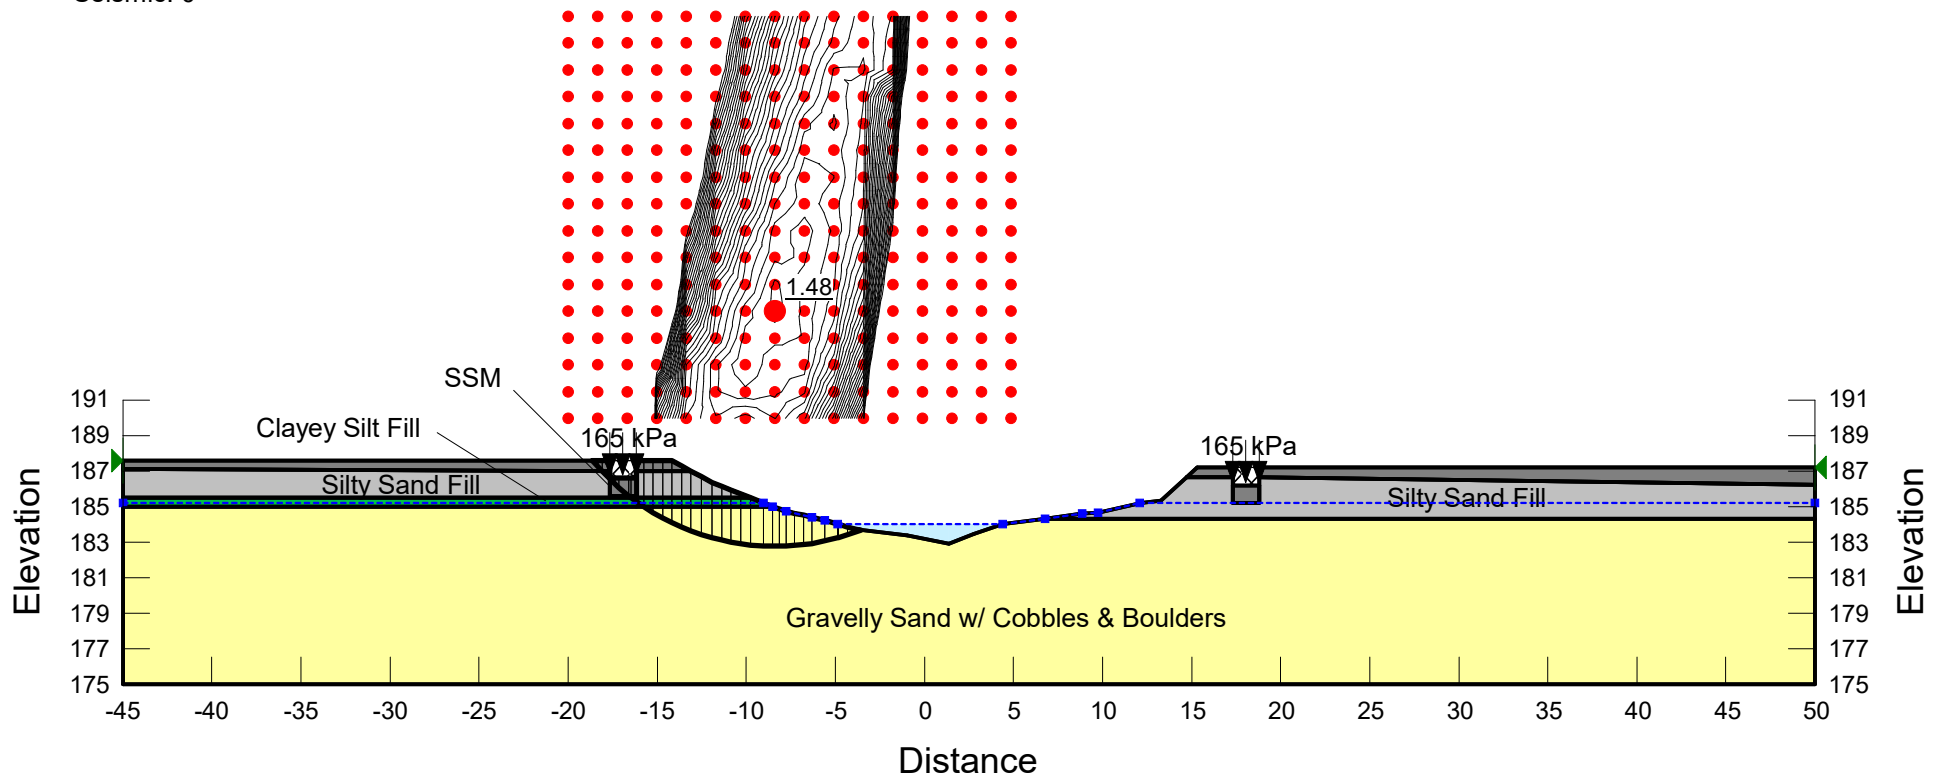
**FIGURE 7**

Method: Morgenstern-Price  
Minimum Slip Surface Depth: 1 m  
Seismic: 0

SSM	22 kN/m <sup>3</sup>	0 kPa	31 °
Silty Sand Fill	21 kN/m <sup>3</sup>	0 kPa	31 °
Clayey Silt Fill	21 kN/m <sup>3</sup>	0 kPa	30 °
Gravelly Sand w/ Cobbles & Boulders	22 kN/m <sup>3</sup>	0 kPa	35 °

# KASABONIKA LAKE BRIDGE FORWARD SLOPE EAST ABUTMENT EXISTING CONDITION (1.3H:1V) WITH GRADE RAISE

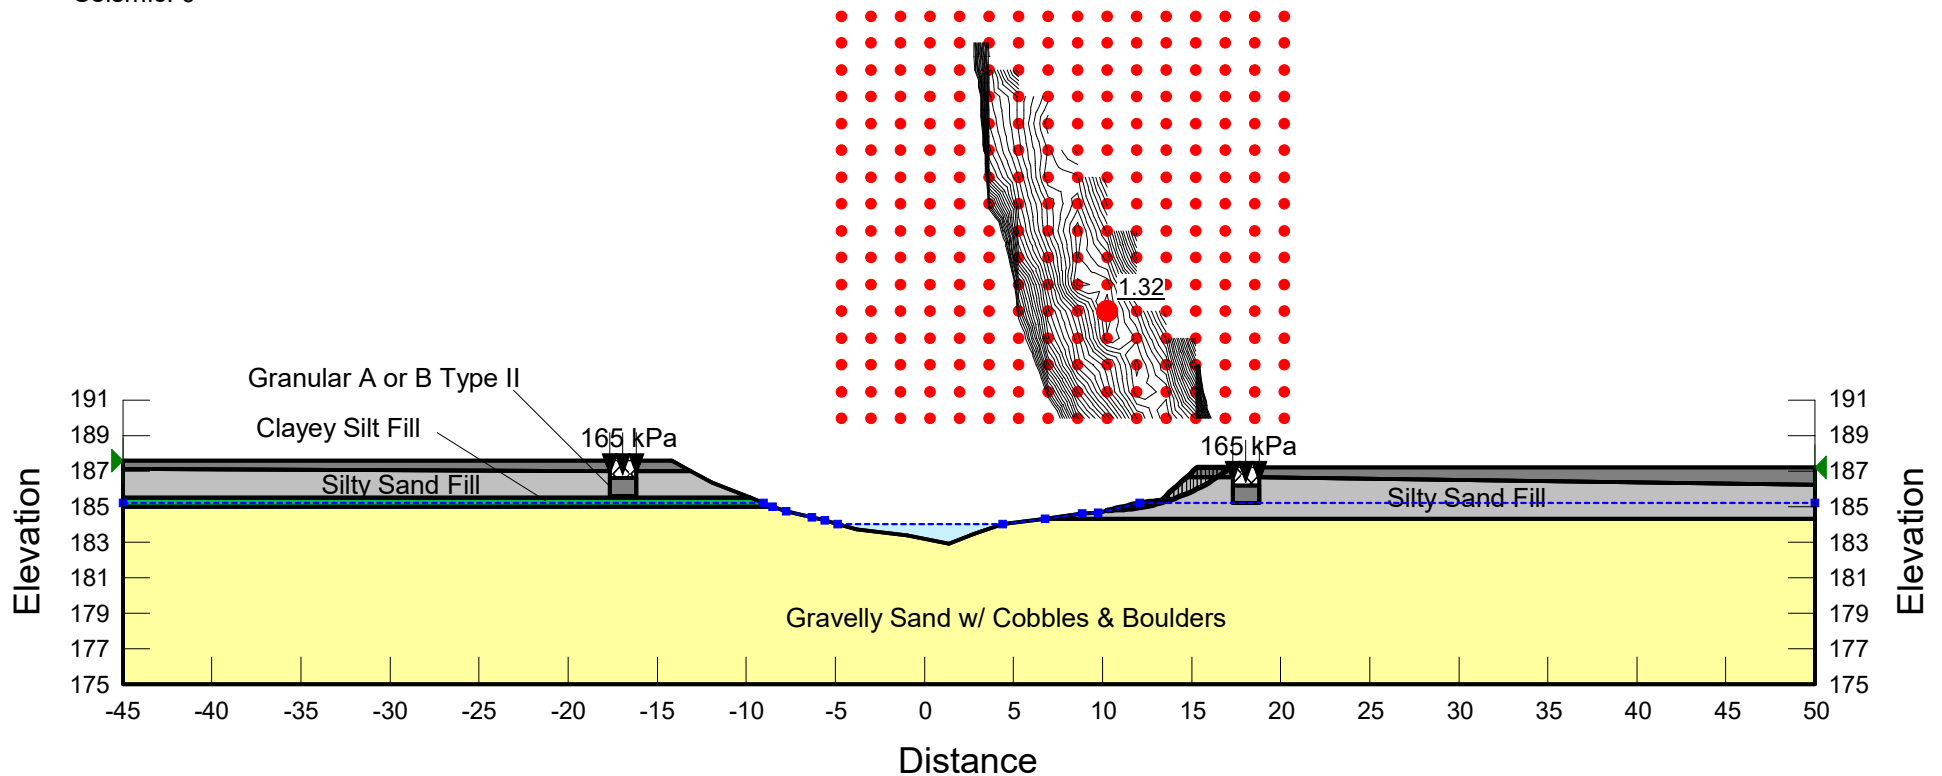
**FIGURE 8**

Method: Morgenstern-Price  
Minimum Slip Surface Depth: 1 m  
Seismic: 0

Granular A or B Type II	22 kN/m <sup>3</sup>	0 kPa	35 °
Silty Sand Fill	21 kN/m <sup>3</sup>	0 kPa	31 °
Clayey Silt Fill	21 kN/m <sup>3</sup>	0 kPa	30 °
Gravelly Sand w/ Cobbles & Boulders	22 kN/m <sup>3</sup>	0 kPa	35 °

# KASABONIKA LAKE BRIDGE FORWARD SLOPE EAST ABUTMENT EXISTING CONDITION (1.3H:1V) WITH GRADE RAISE

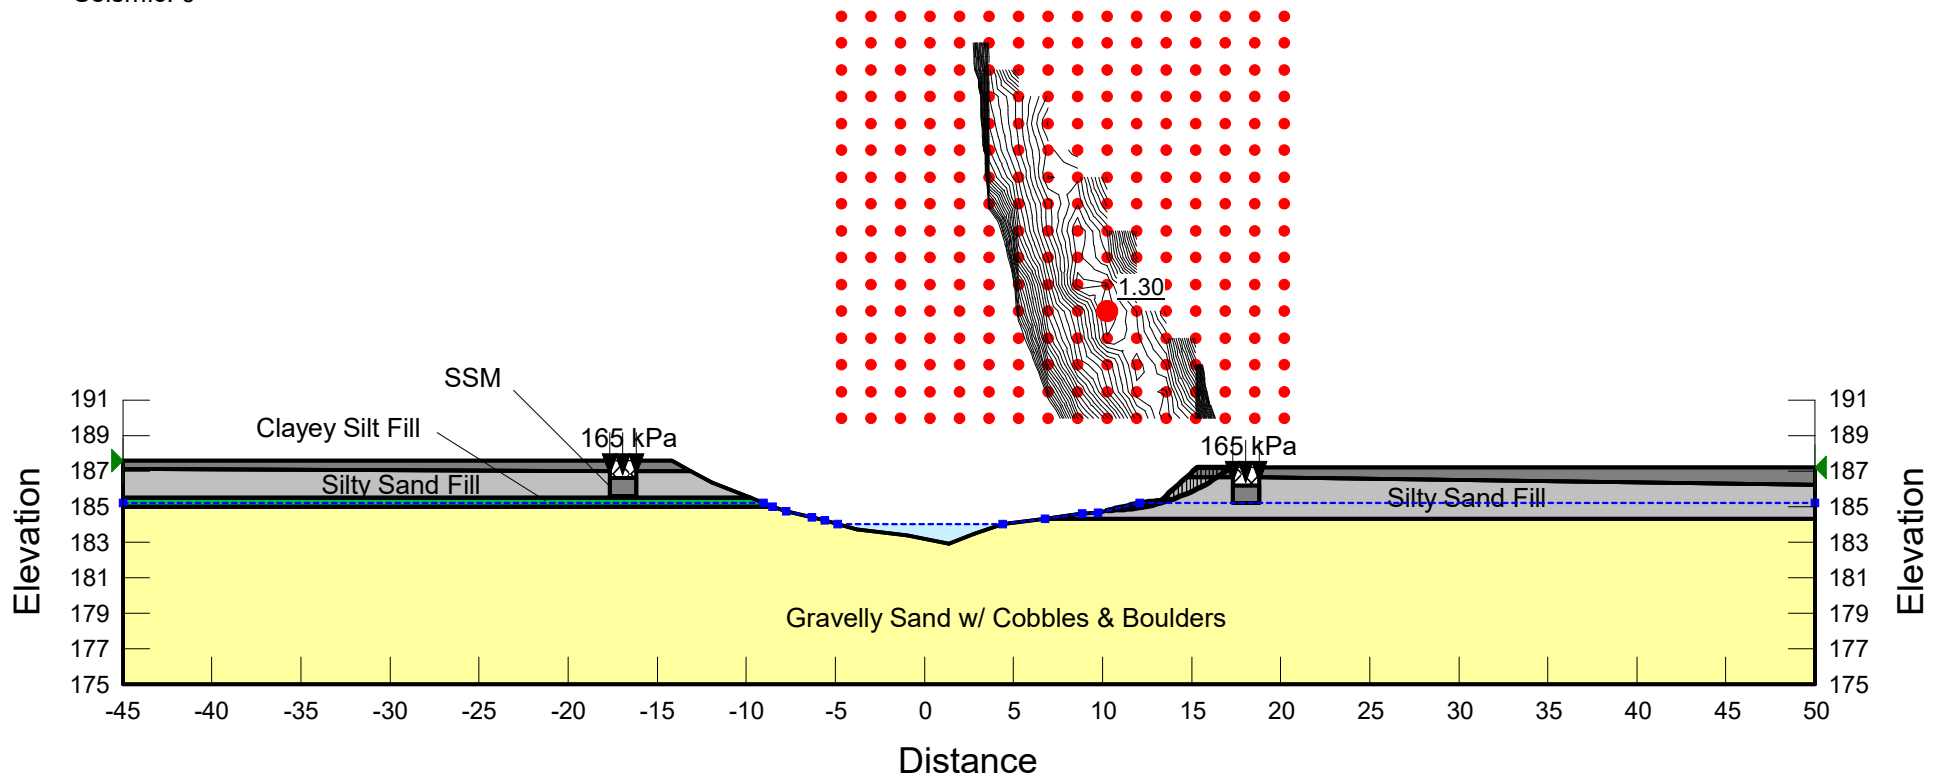
**FIGURE 9**

Method: Morgenstern-Price  
Minimum Slip Surface Depth: 1 m  
Seismic: 0

SSM	22 kN/m <sup>3</sup>	0 kPa	31 °
Silty Sand Fill	21 kN/m <sup>3</sup>	0 kPa	31 °
Clayey Silt Fill	21 kN/m <sup>3</sup>	0 kPa	30 °
Gravelly Sand w/ Cobbles & Boulders	22 kN/m <sup>3</sup>	0 kPa	35 °

# KASABONIKA LAKE BRIDGE FORWARD SLOPE EAST ABUTMENT 2H:1V CONDITION WITH GRADE RAISE

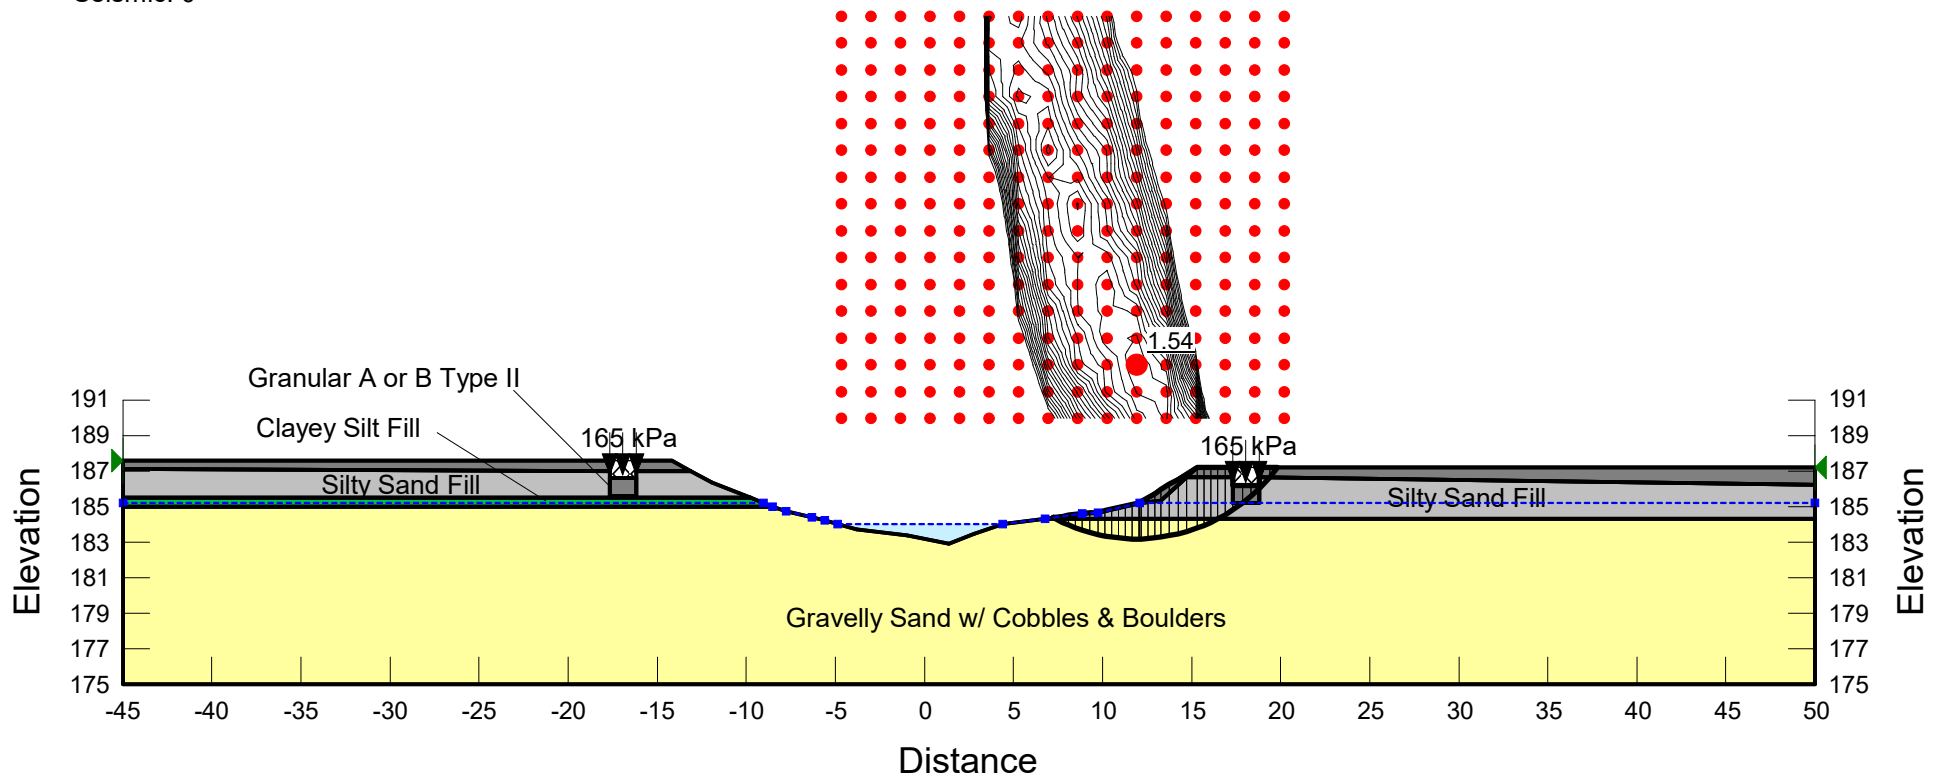
FIGURE 10

Method: Morgenstern-Price  
Minimum Slip Surface Depth: 1 m  
Seismic: 0

Granular A or B Type II	22 kN/m <sup>3</sup>	0 kPa	35 °
Silty Sand Fill	21 kN/m <sup>3</sup>	0 kPa	31 °
Clayey Silt Fill	21 kN/m <sup>3</sup>	0 kPa	30 °
Gravelly Sand w/ Cobbles & Boulders	22 kN/m <sup>3</sup>	0 kPa	35 °

# KASABONIKA LAKE BRIDGE FORWARD SLOPE EAST ABUTMENT 2H:1V CONDITION WITH GRADE RAISE

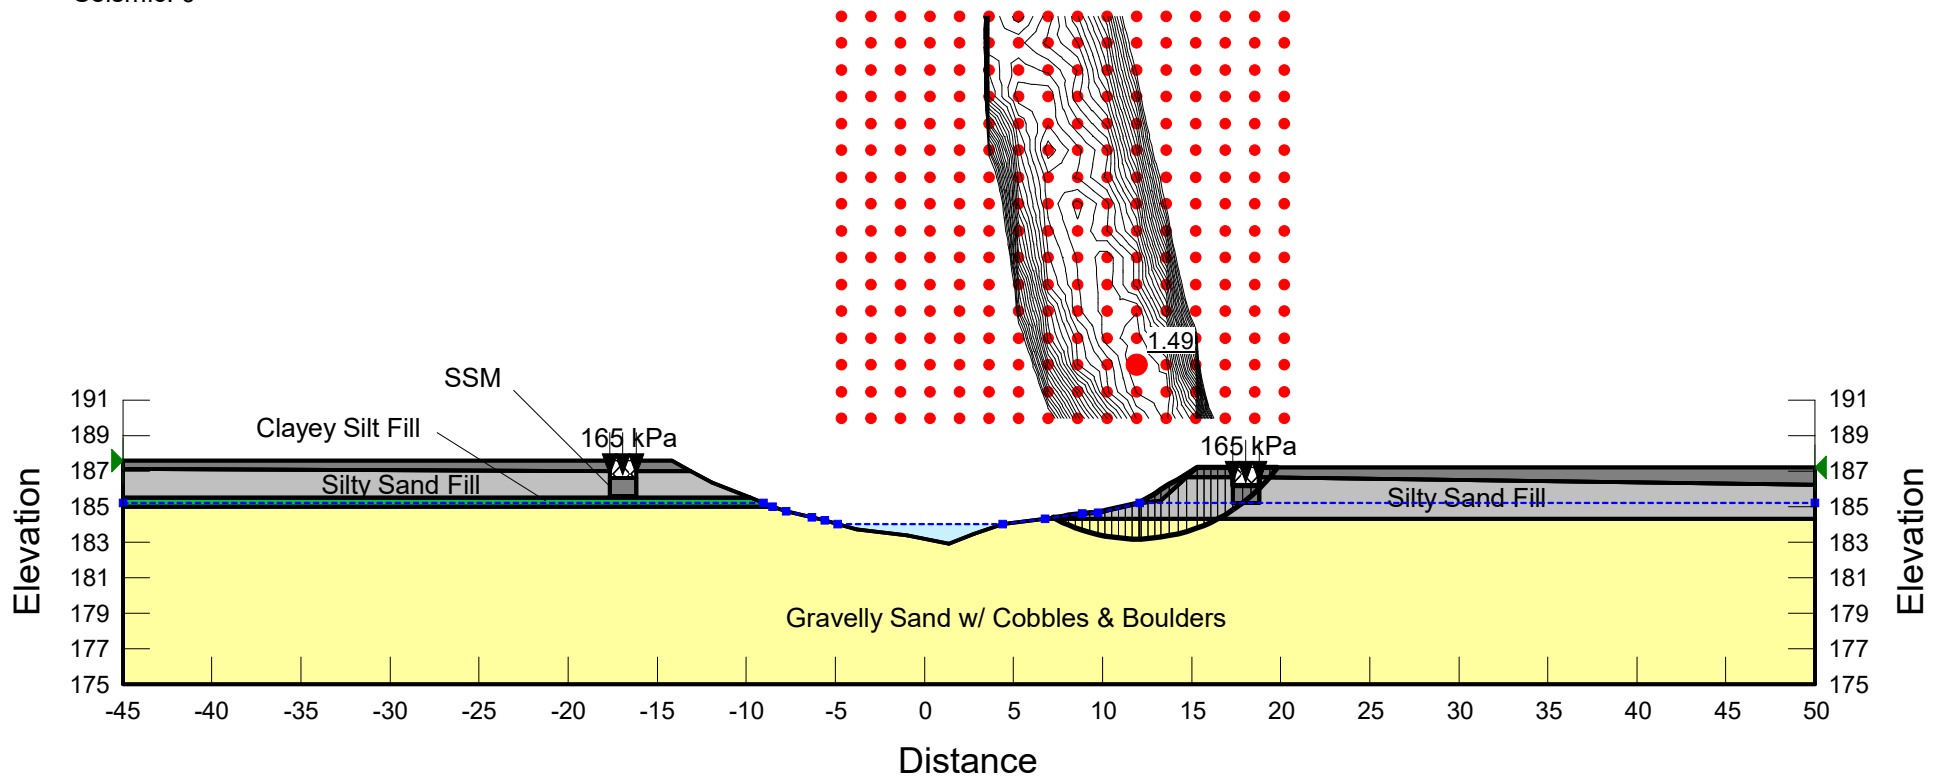
Method: Morgenstern-Price  
Minimum Slip Surface Depth: 1 m  
Seismic: 0

SSM	22 kN/m <sup>3</sup>	0 kPa	31 °
Silty Sand Fill	21 kN/m <sup>3</sup>	0 kPa	31 °
Clayey Silt Fill	21 kN/m <sup>3</sup>	0 kPa	30 °
Gravelly Sand w/ Cobbles & Boulders	22 kN/m <sup>3</sup>	0 kPa	35 °
