**FOUNDATION INVESTIGATION REPORT
KASABONIKA LAKE MODULAR BRIDGE
DISTRICT OF KENORA, KASABONIKA LAKE FIRST NATION, ONTARIO
LATITUDE: 53.5263°, LONGITUDE: -88.6213°
W.P. 6579-16-00, SITE No. 41N-0244/BO**

GEOCRES Number: 53H-01

Date: November 13, 2019
File: 25489

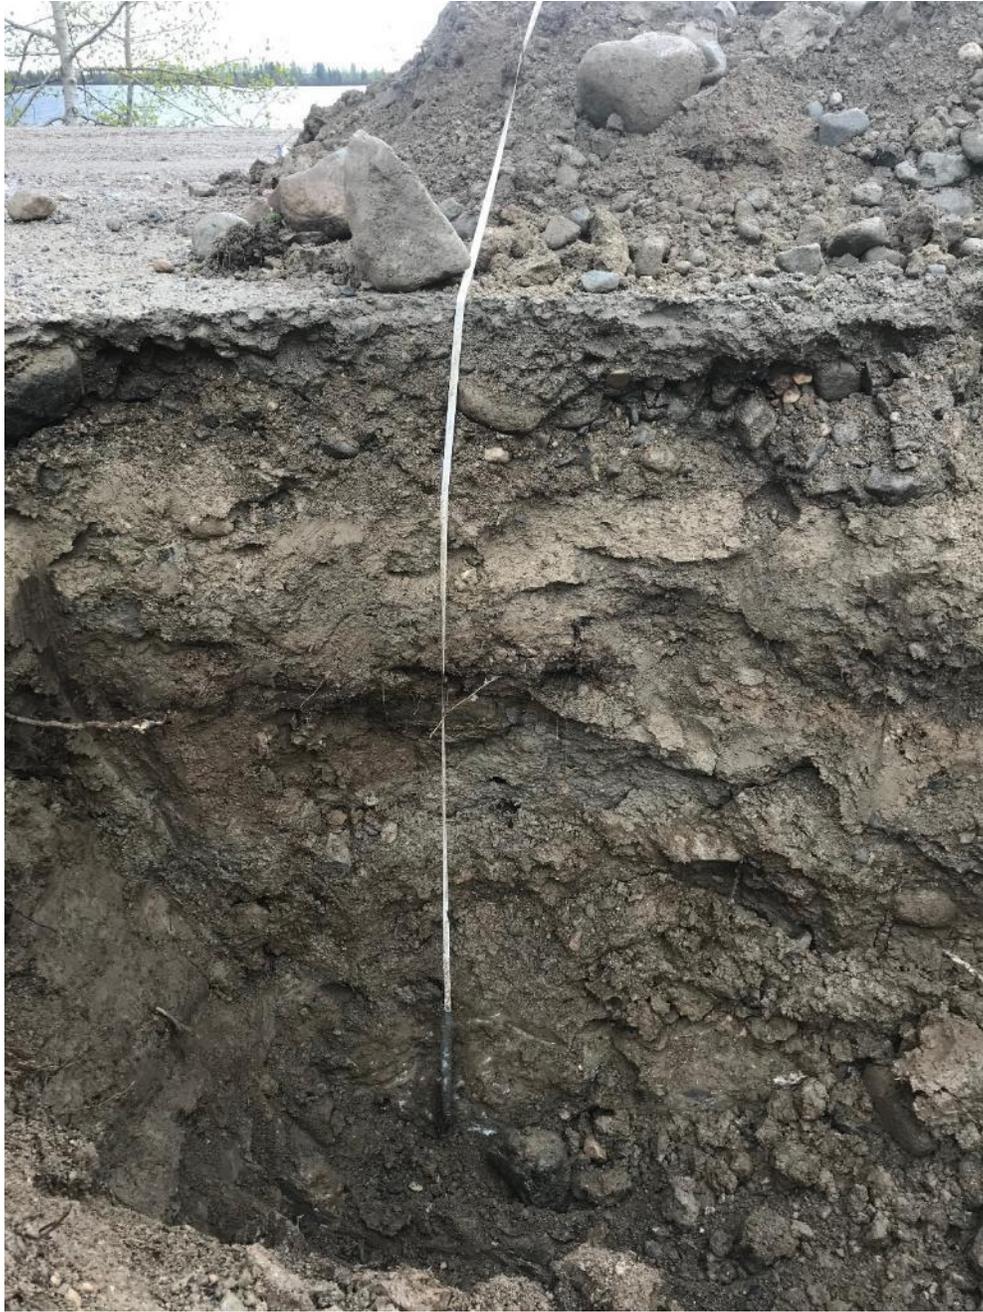
Photo A1: Test Pit TP-01 (Date taken: June 8, 2019).

In addition to the boreholes, three test pits were also excavated and are labelled TP-01 to TP-03. The test pits were all terminated at a depth of 2.1 m (Elevation 184.9 m to 183.9 m). TP-01 was excavated on the west approach while TP-02 and TP-03 were excavated along the east approach. Ten hand probes (HP1 to HP10) were also conducted near the base of the causeway embankments.

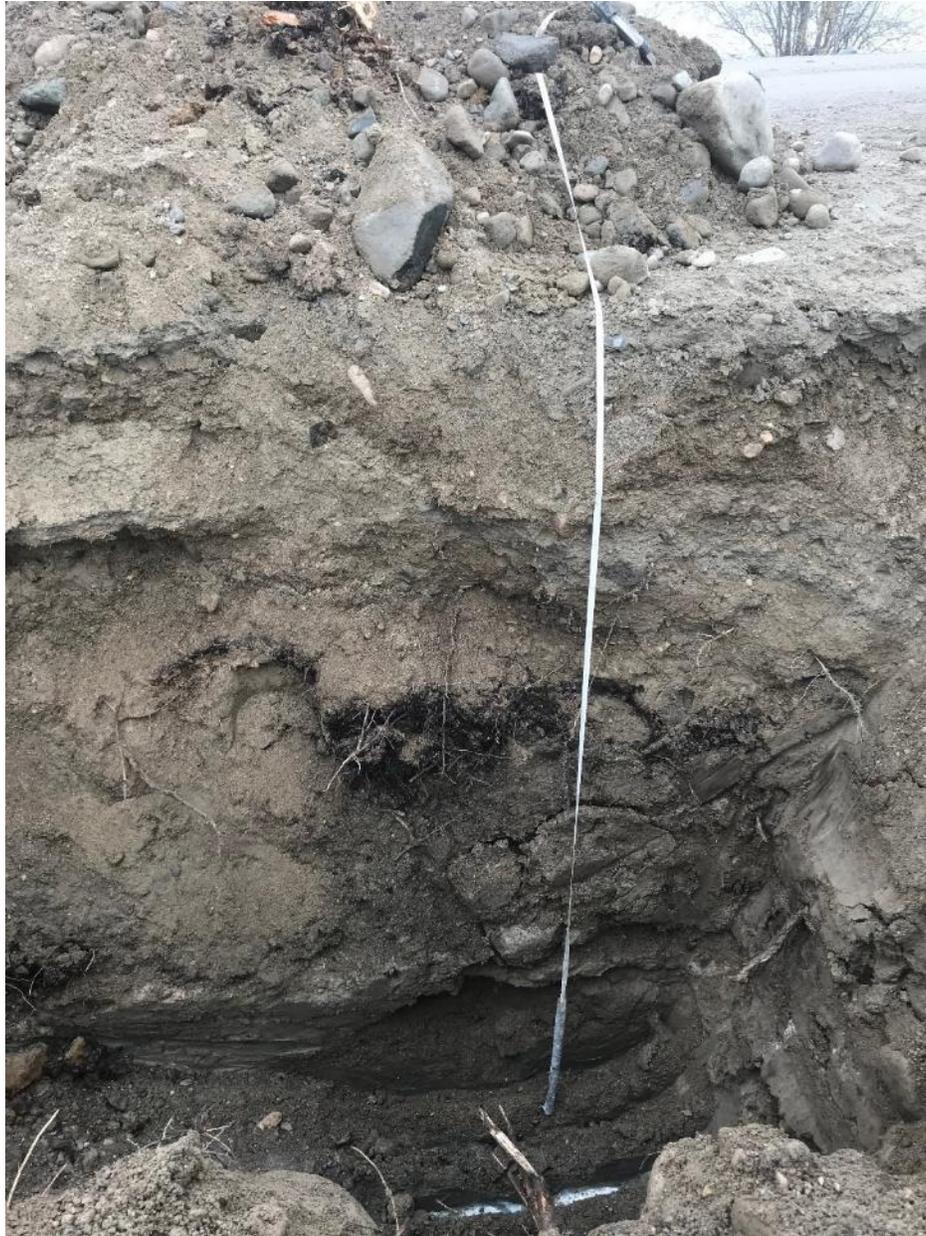
Photo A2: Test Pit TP-02 (Date taken: June 8, 2019).

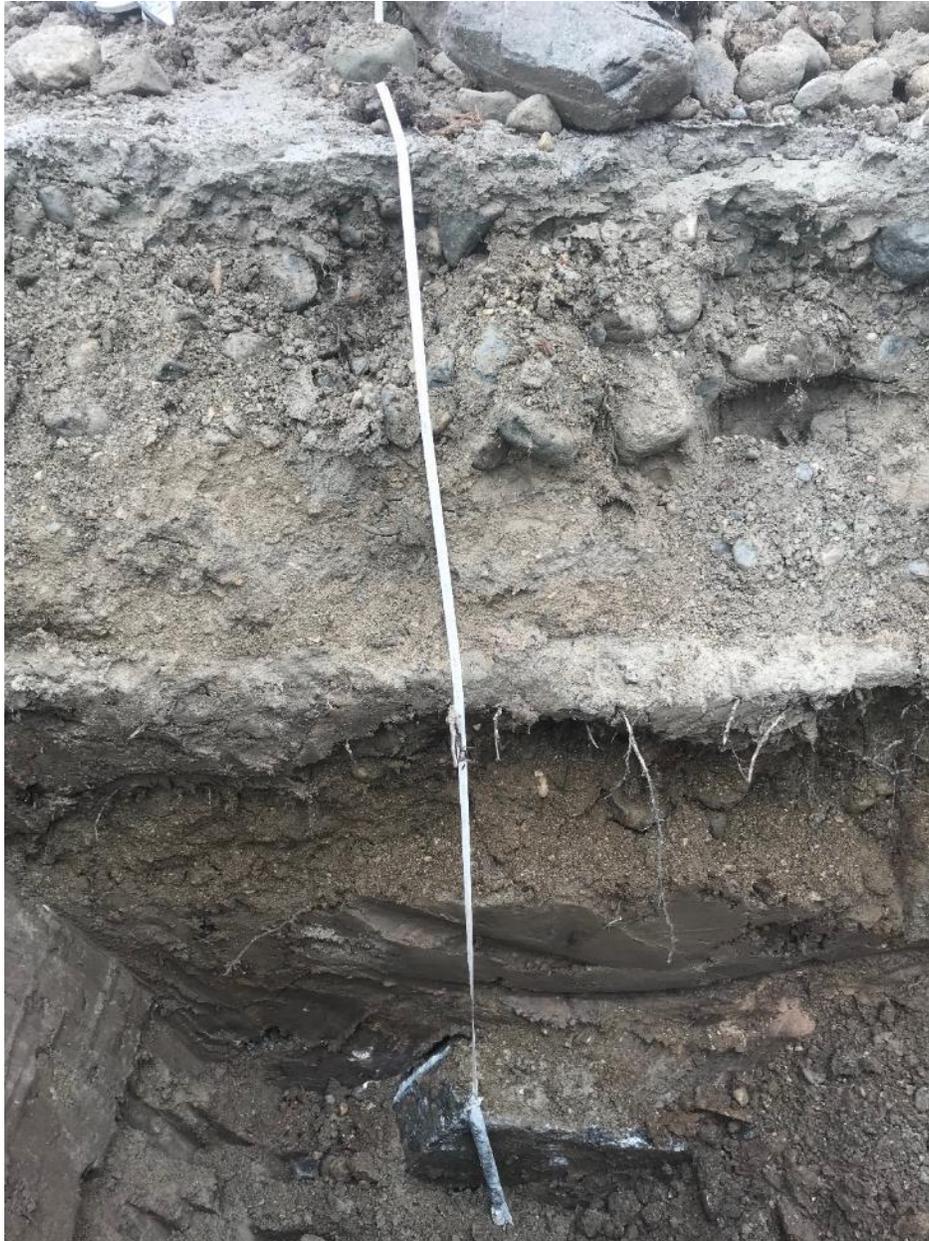
Photo A3: Test Pit TP-03 (Date taken: June 8, 2019).

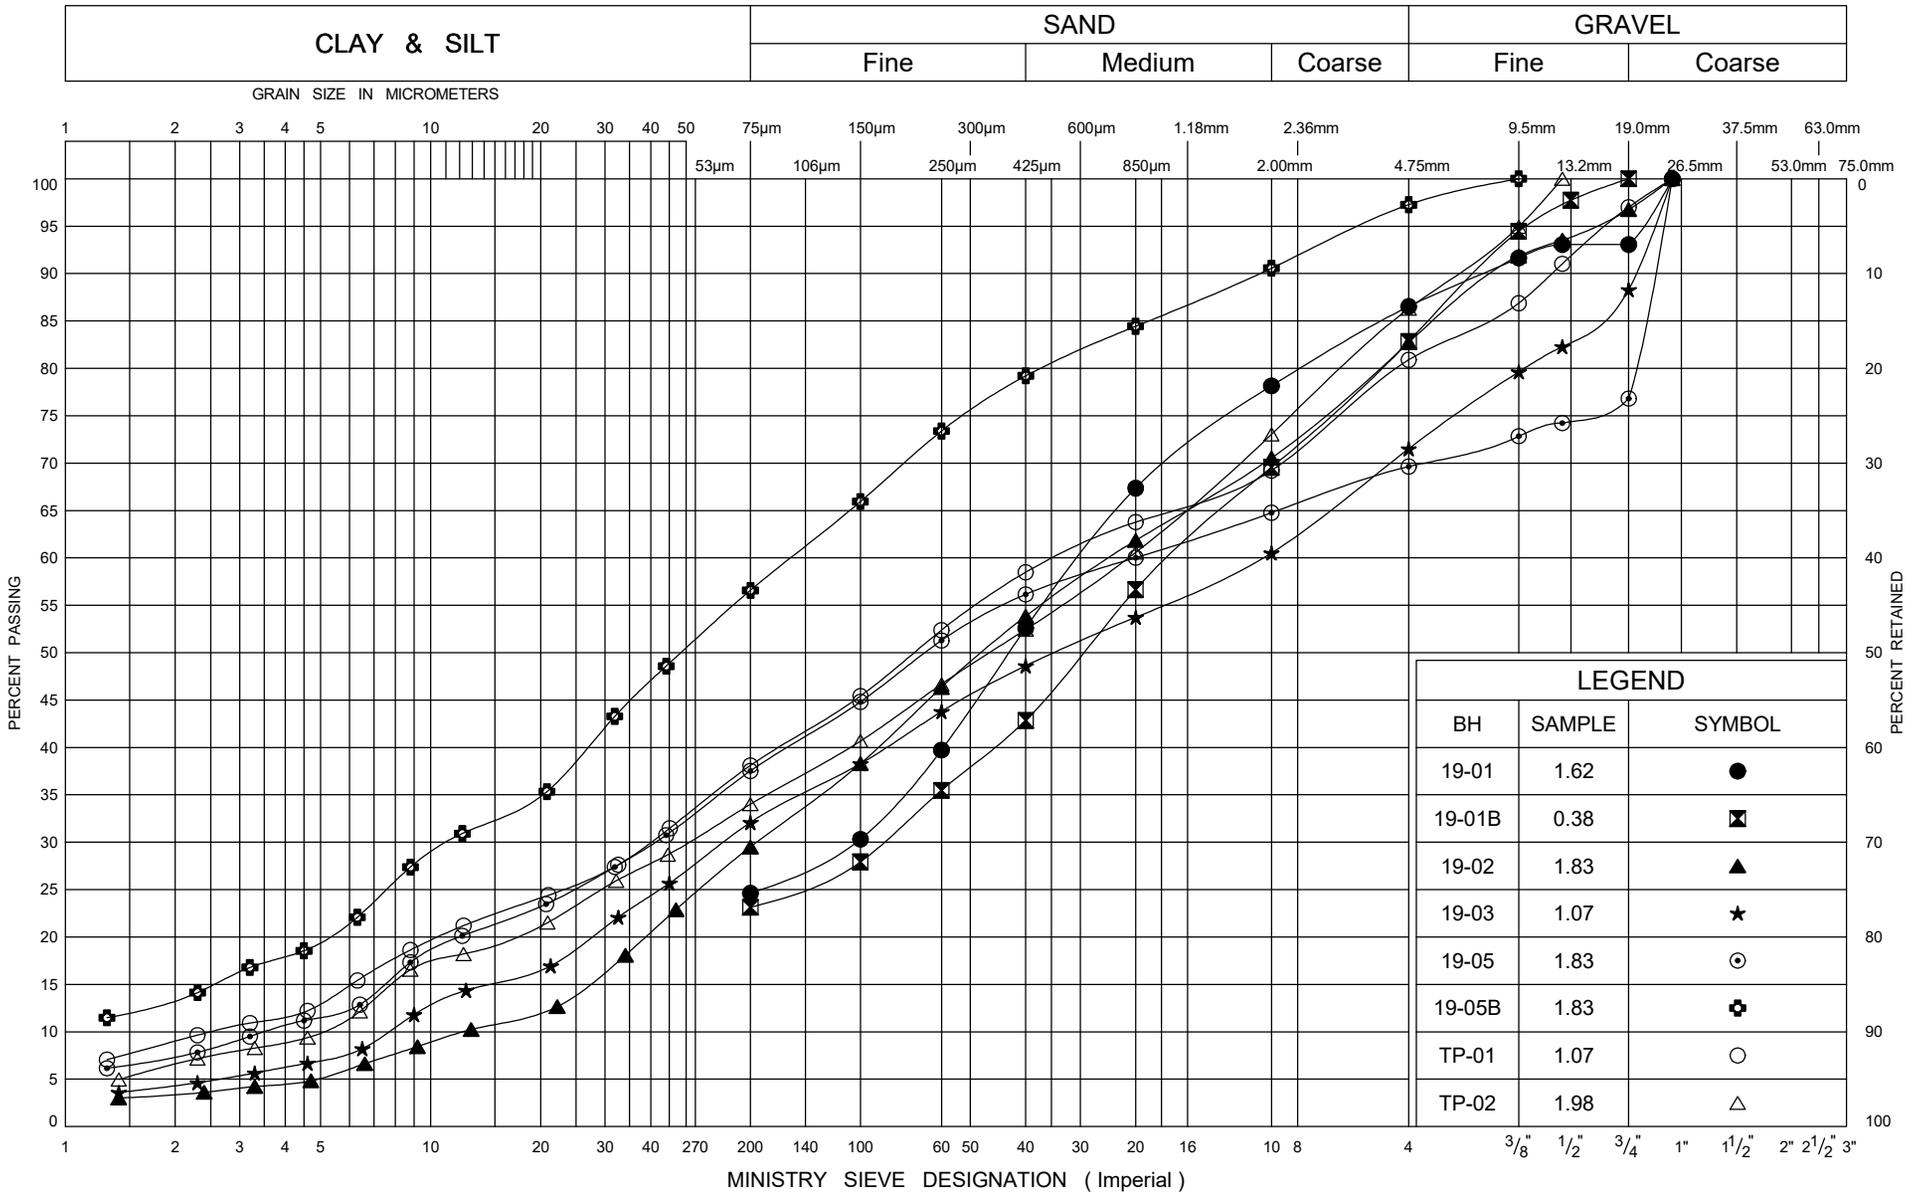
FIG No B1
W P 6579-16-00
Kasabonika Lake Modular Bridge

LEGEND		
BH	SAMPLE	SYMBOL
19-01	1.62	●
19-01B	0.38	■
19-02	1.83	▲
19-03	1.07	★
19-05	1.83	⊙
19-05B	1.83	⊕
TP-01	1.07	○
TP-02	1.98	△

Silty SAND Fill

All recovered soil samples were subjected to visual identification (VI) and to natural moisture content determination. Selected samples were also subjected to grain size distribution analyses (sieve and/or hydrometer), where appropriate. The results of this laboratory testing program are shown on the Record of Borehole sheets included in Appendix A and on the figures included in Appendix B.

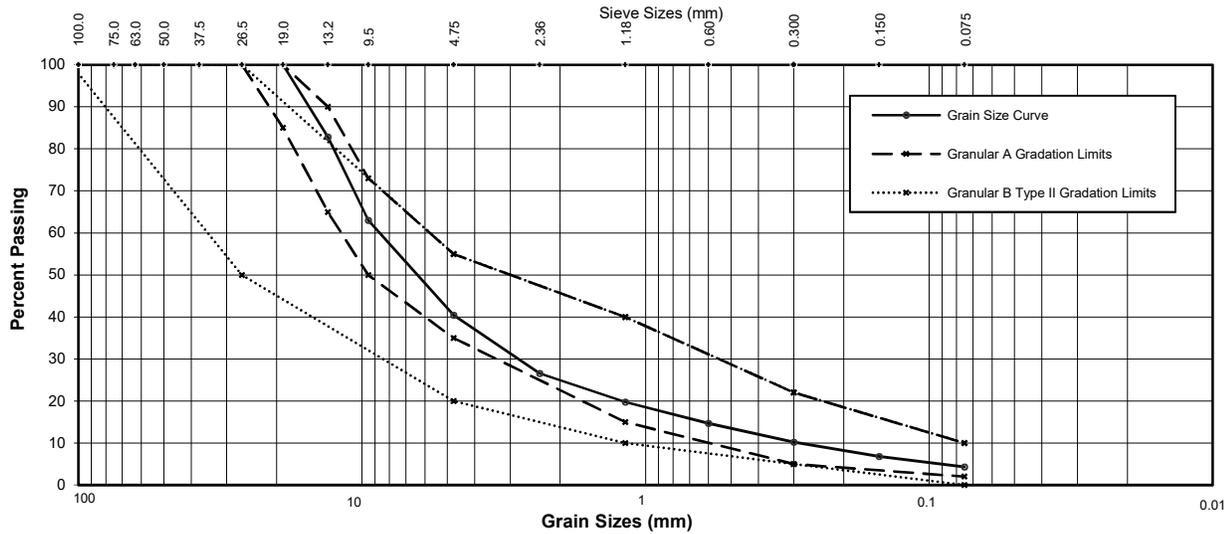
Sample Source: Stockpile at Kasabonika Airport
Material Type: Granular A or Granular B Type II
Specification: OPSS 1010
Sample Description: 19 mm Crusher Run Rock - Sample #1

GRAVEL				
Sieve No.	Opening (mm)	Percent Passing	Gradation Limits Max	Gradation Limits min
	150	100.0		
	100	100.0		
	75	100.0		
	63	100.0		
	50	100.0		
	37.5	100.0		
	26.5	100.0		
	19	100.0		
	13.2	82.8		
	9.5	63.0		
	4.75	40.5

SAND & FINES				
Sieve No.	Opening (mm)	Percent Passing	Gradation Limits Max	Gradation Limits min
	2.36	26.6		
	1.18	19.7		
	0.6	14.7		
	0.3	10.2		
	0.15	6.8		
	0.075	4.3

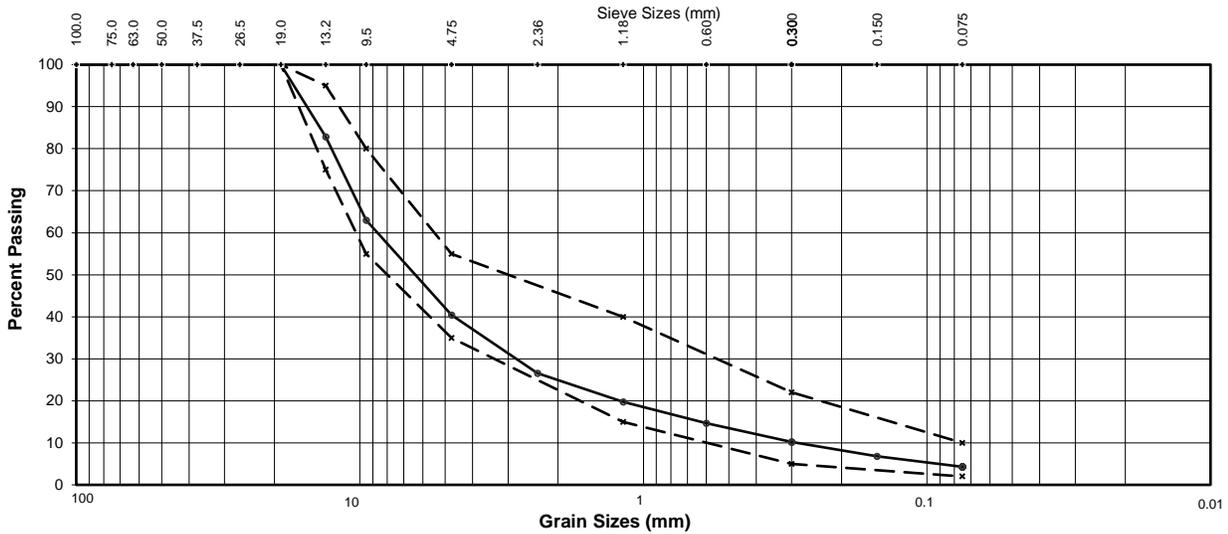
Sample Source: Stockpile at Kasabonika Airport
Material Type: Granular M
Specification: OPSS 1010
Sample Description: 19 mm Crusher Run Rock - Sample #1

GRAVEL				
Sieve No.	Opening (mm)	Percent Passing	Gradation Limits Max	Gradation Limits min
	150	100.0		
	100	100.0		
	75	100.0		
	63	100.0		
	50	100.0		
	37.5	100.0		
	26.5	100.0	100	100
	19	100.0	100	100
	13.2	82.8	95	75
	9.5	63.0	80	55
	4.75	40.5	55	35

SAND & FINES				
Sieve No.	Opening (mm)	Percent Passing	Gradation Limits Max	Gradation Limits min
	2.36	26.6		
	1.18	19.7	40	15
	0.6	14.7		
	0.3	10.2	22	5
	0.15	6.8		
	0.075	4.3	10	2

Comments: This sample meets OPSS 1010 requirements for Granular M.

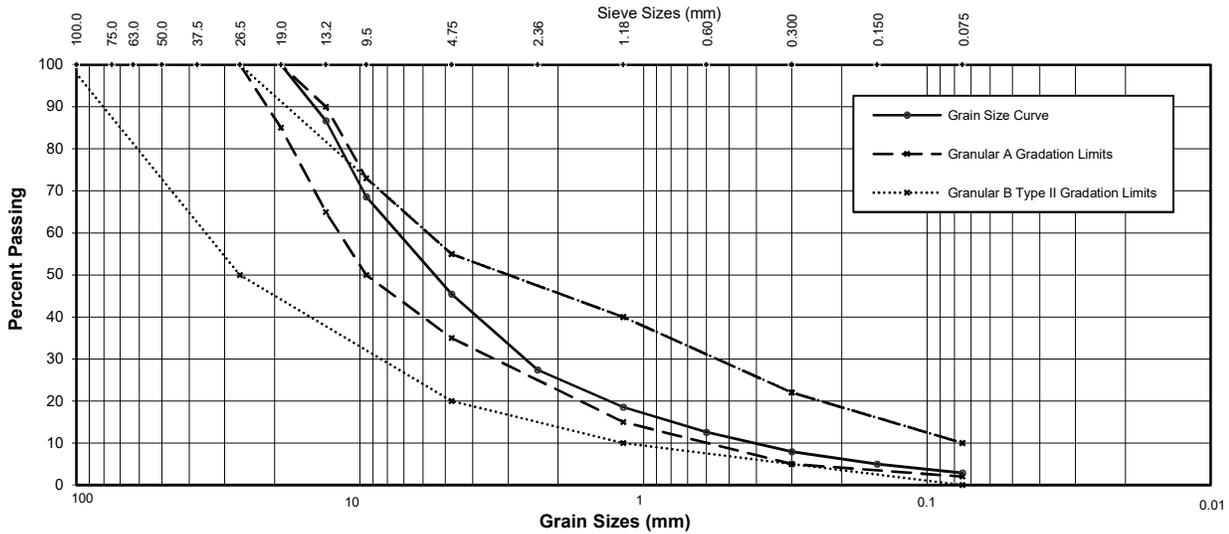
Sample Source: Stockpile at Kasabonika Airport
Material Type: Granular A or Granular B Type II
Specification: OPSS 1010
Sample Description: 19 mm Crusher Run Rock - Sample #2

GRAVEL				
Sieve No.	Opening (mm)	Percent Passing	Gradation Limits Max	Gradation Limits min
	150	100.0		
	100	100.0		
	75	100.0		
	63	100.0		
	50	100.0		
	37.5	100.0		
	26.5	100.0		
	19	100.0		
	13.2	86.7		
	9.5	68.6		
	4.75	45.4

SAND & FINES				
Sieve No.	Opening (mm)	Percent Passing	Gradation Limits Max	Gradation Limits min
	2.36	27.4		
	1.18	18.5		
	0.6	12.6		
	0.3	8.0		
	0.15	5.0		
	0.075	2.9

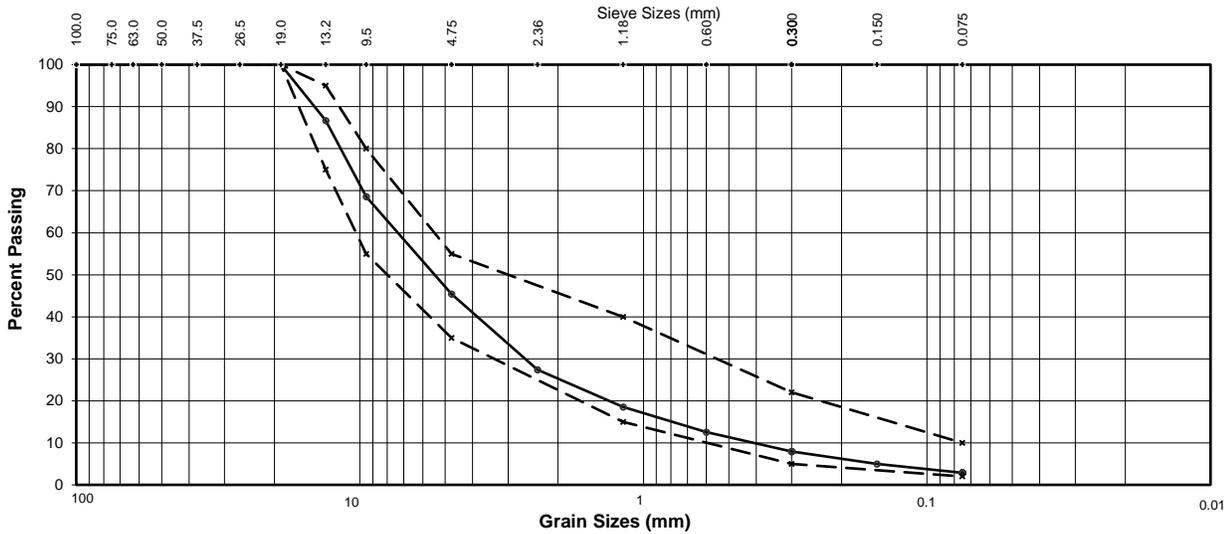
Sample Source: Stockpile at Kasabonika Airport
Material Type: Granular M
Specification: OPSS 1010
Sample Description: 19 mm Crusher Run Rock - Sample #2

GRAVEL				
Sieve No.	Opening (mm)	Percent Passing	Gradation Limits Max	Gradation Limits min
	150	100.0		
	100	100.0		
	75	100.0		
	63	100.0		
	50	100.0		
	37.5	100.0		
	26.5	100.0	100	100
	19	100.0	100	100
	13.2	86.7	95	75
	9.5	68.6	80	55
	4.75	45.4	55	35

SAND & FINES				
Sieve No.	Opening (mm)	Percent Passing	Gradation Limits Max	Gradation Limits min
	2.36	27.4		
	1.18	18.5	40	15
	0.6	12.6		
	0.3	8.0	22	5
	0.15	5.0		
	0.075	2.9	10	2

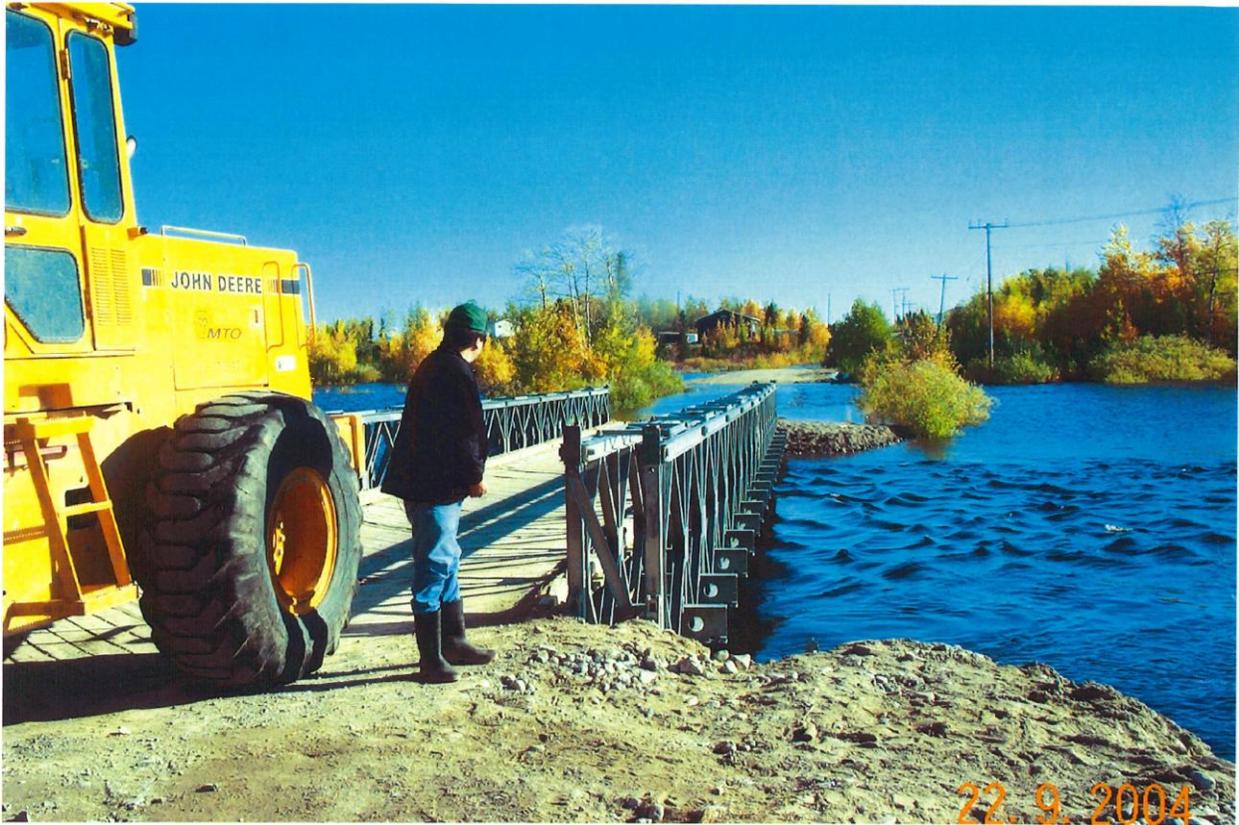
**Photo C1: Overtopping of east causeway embankment
(Date taken: Sept. 22, 2004; provided by MTO).**

Hatch. The previous flooding that overtopped the east approach embankment in 2004 indicates that the lake water level has previously been observed at greater than approximate Elevation 186 m.

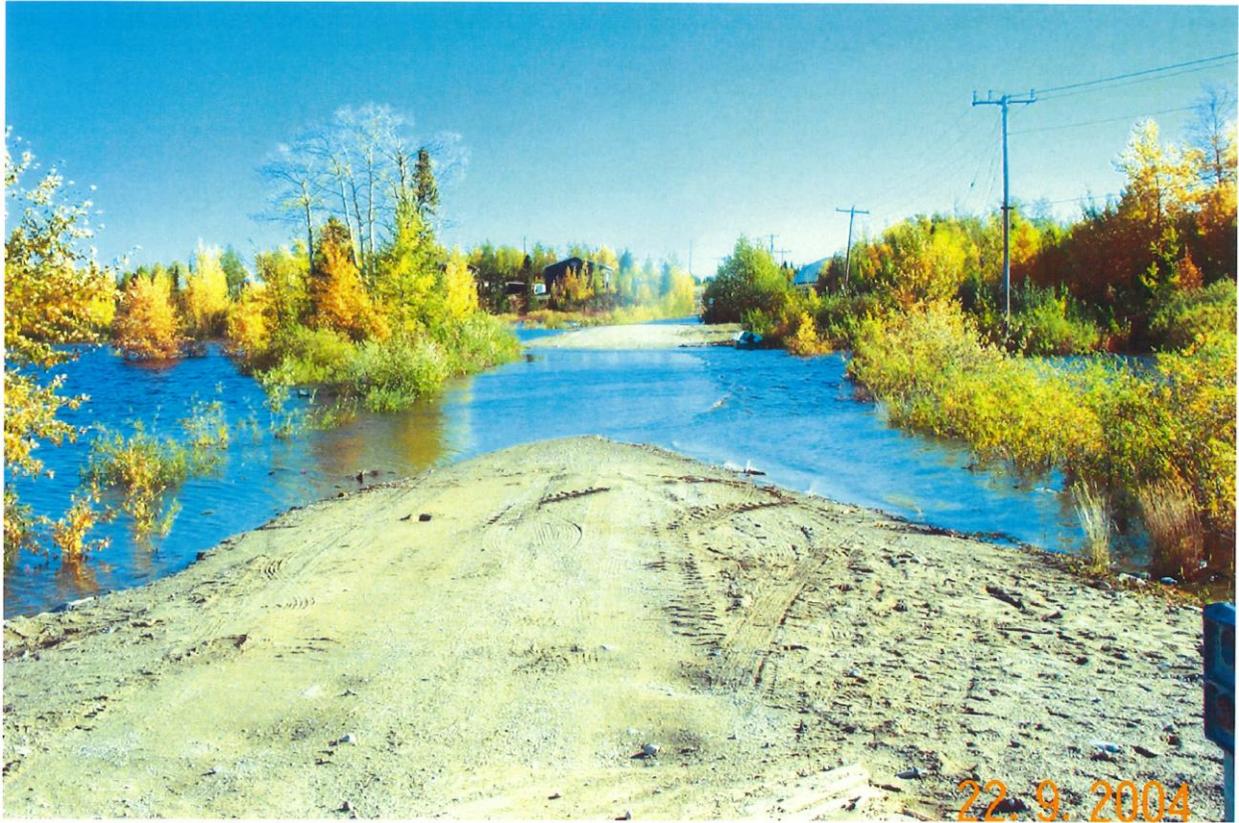
**Photo C2: Overtopping of east causeway embankment
(Date taken: Sept. 22, 2004; provided by MTO).**

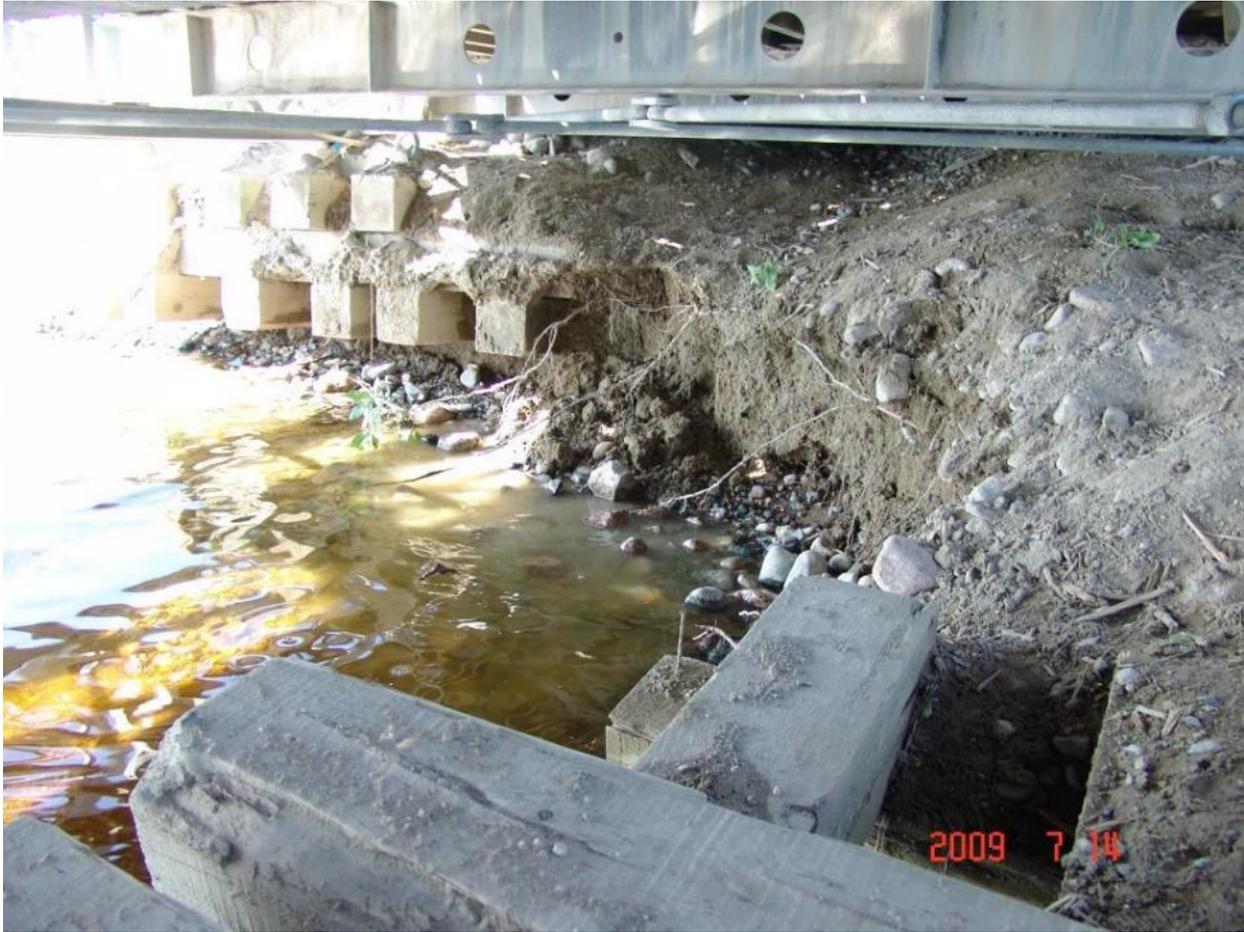
Photo C3: Erosion at west abutment foundation (Date taken: July 7, 2009; provided by MTO).

in the lake. The southwest approach embankment to the bridge is approximately 30 m long to the mainland and the fill is approximately 3.5 m high at the bridge. The northeast approach embankment is approximately 50 m long to the island and the fill is approximately 3 m high at the bridge. Photographs provided by MTO (see Photos C1 and C2 in Appendix C) show that the causeway beyond the bridge has previously been overtopped by high lake water levels. Photographs from 2009 (see Photos C3 and C4 in Appendix C) show that severe erosion of the approach embankments, possibly due to this flooding, has previously occurred at the bridge abutments, leading to exposure and undermining of the timber cribs. The embankment erosion was subsequently repaired at an unknown time.

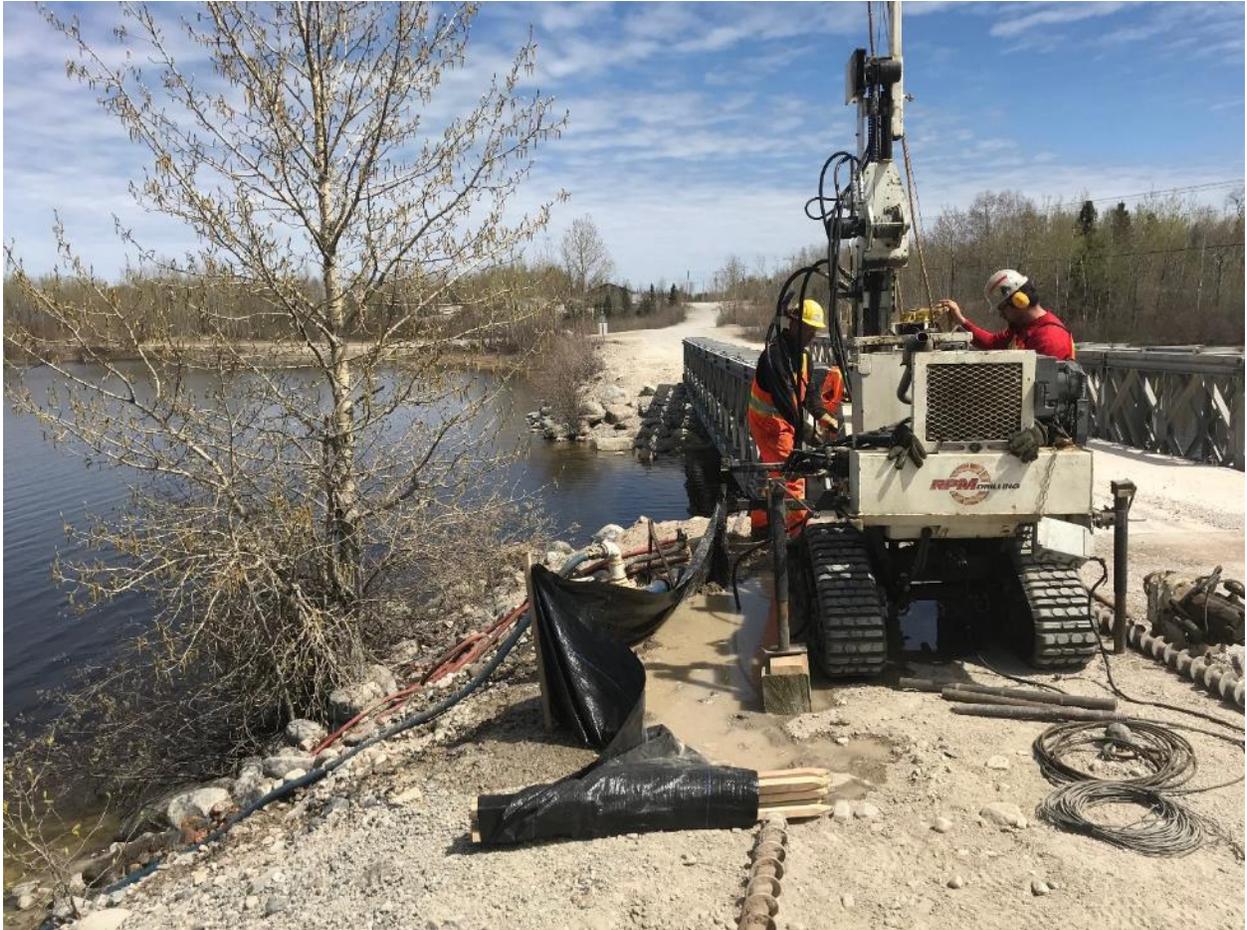
**Photo C5: Simco Drill Rig drilling at Borehole 19-01; north side of west abutment looking east
(Date taken: June 5, 2019).**

A limited access Simco drill rig (Photo C5 in Appendix C) was used to advance Boreholes 19-01 to 19-05B using solid stem augers and BW casing. The drill rig was transported to the site by plane from Pickle Lake, Ontario (Photo C6 in Appendix C). The soil samples were obtained in the boreholes at selected intervals using a split spoon sampler in conjunction with Standard Penetration Testing (SPT). At Boreholes 19-01, 19-01B, 19-02, 19-03, 19-04 and 19-05, BQ coring methods were used to advance the boreholes past large boulders. A backhoe supplied and operated by the Kasabonika Lake First Nation was used to excavate the test pits (Photo C7 in Appendix C). Grab samples of the excavated soil were obtained from the test pits. Photos of the test pits (Photos A1 to A3) are included in Appendix A following the borehole logs for Test Pits TP-01 to TP-03.

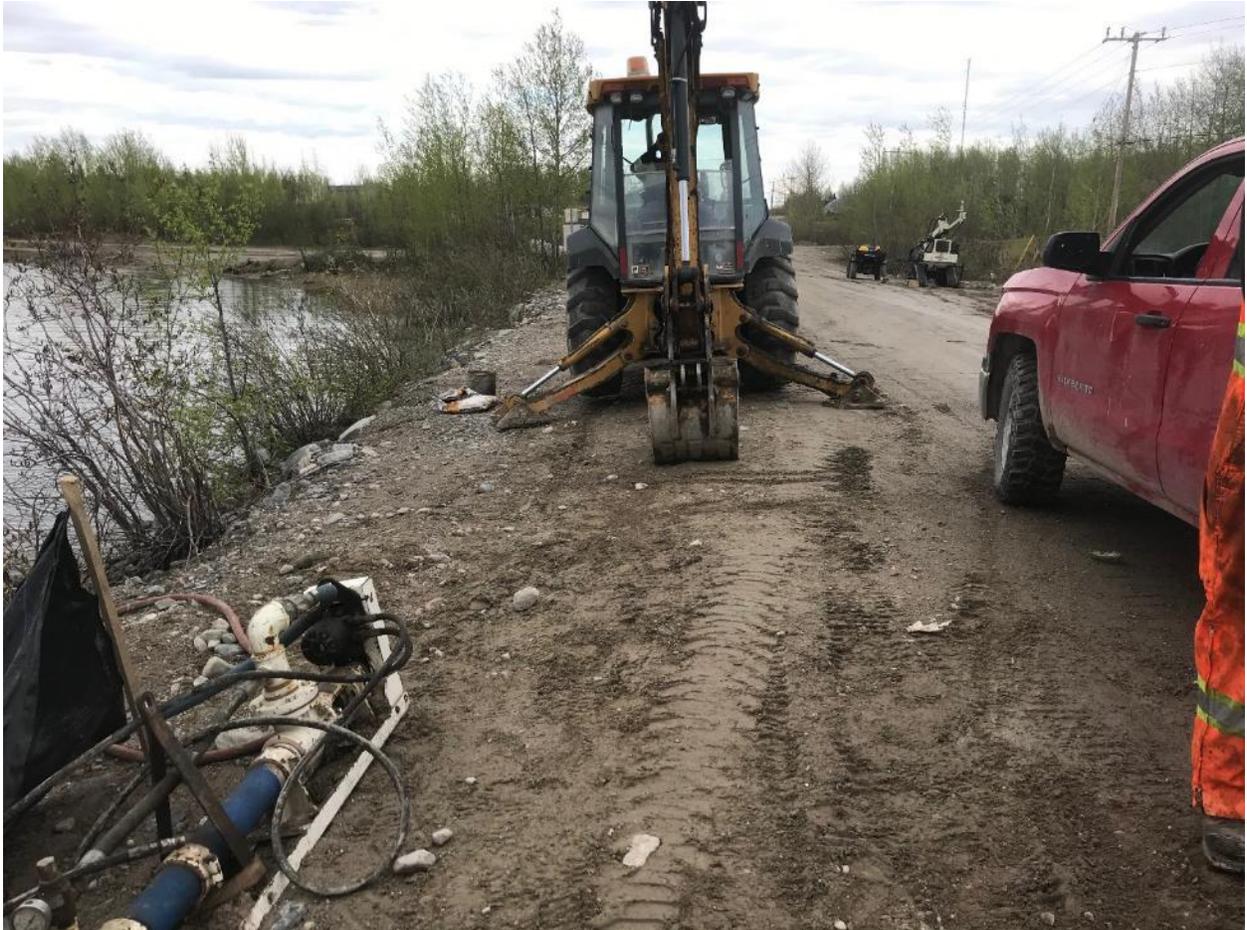
**Photo C7: Backhoe at Test Pit TP-02 on north side of east approach embankment, looking east
(Date taken: June 8, 2019).**

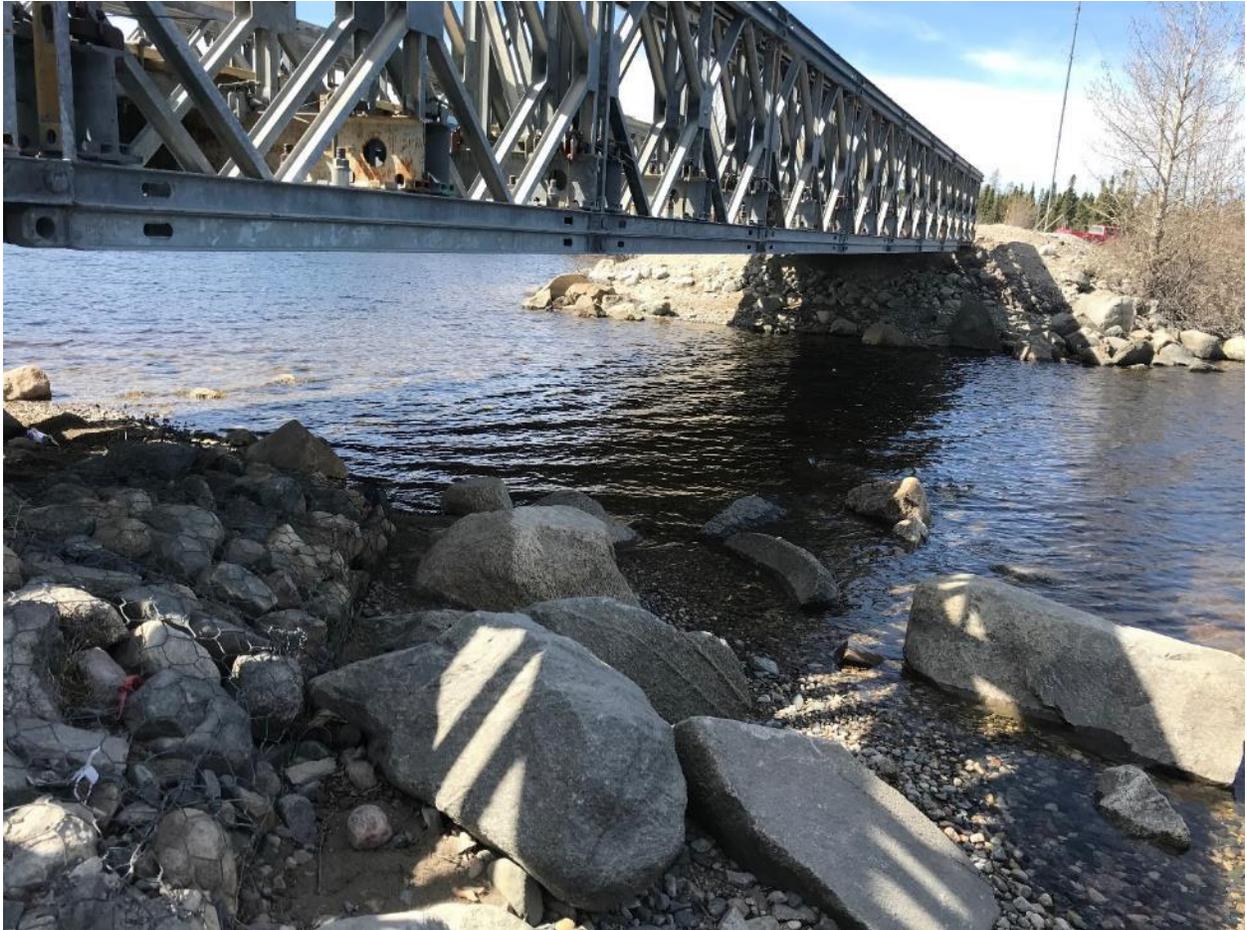
Photo C13: North side of bridge looking west showing large boulders and gabion baskets for erosion protection (Date taken: June 4, 2019).

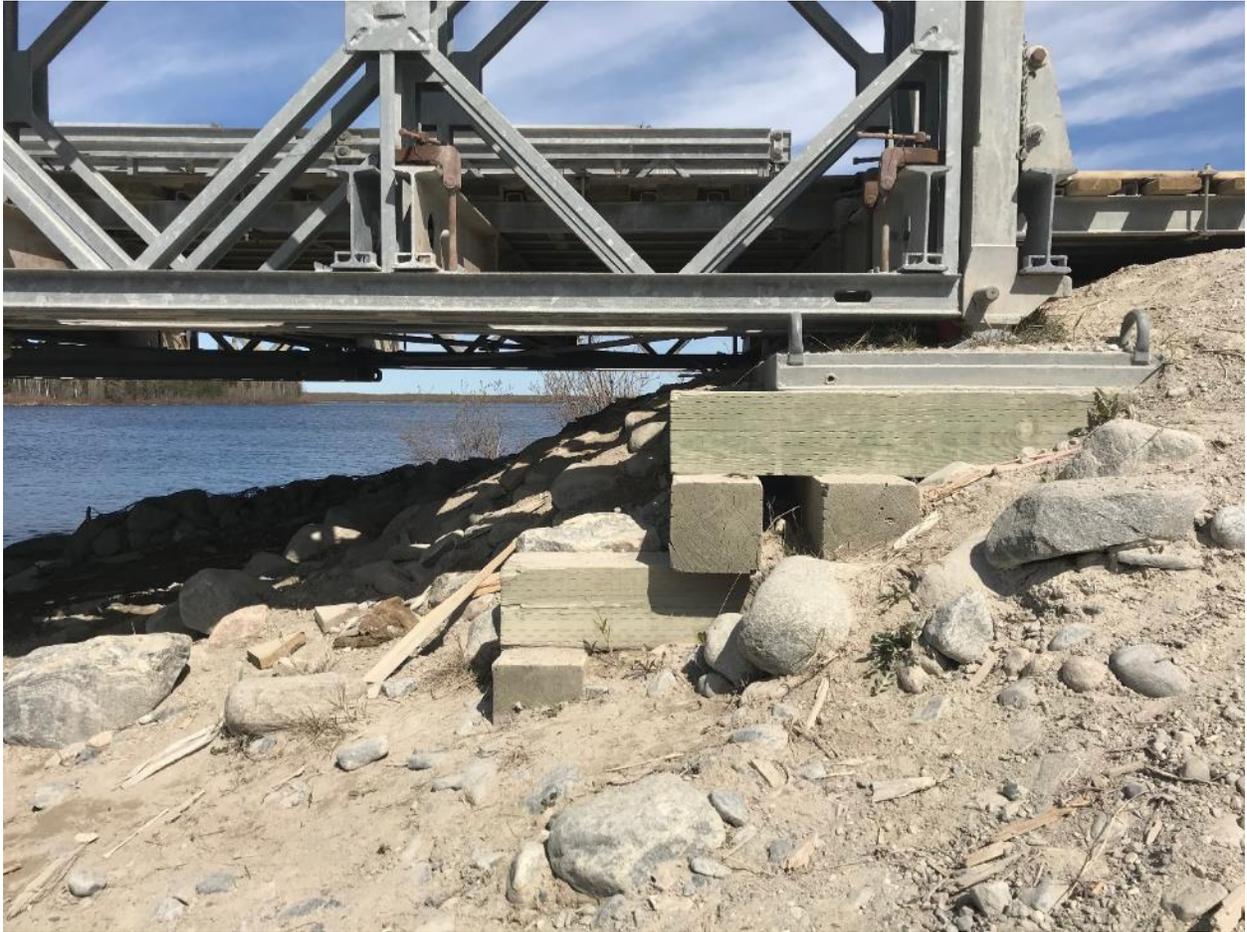
Photo C14: East abutment footing looking north (Date taken: June 4, 2019).

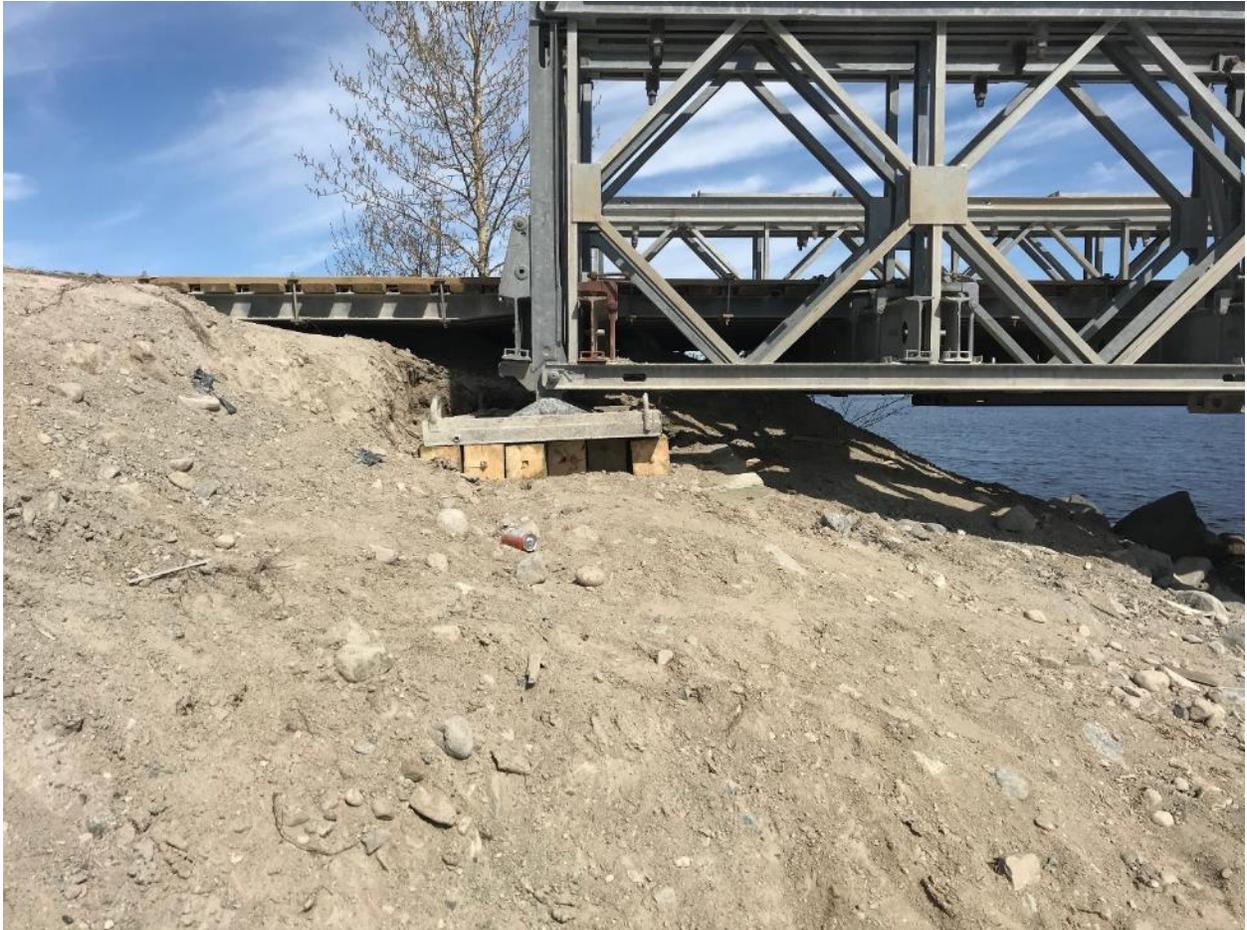
Photo C16: West abutment footing looking north (Date taken: June 4, 2019).

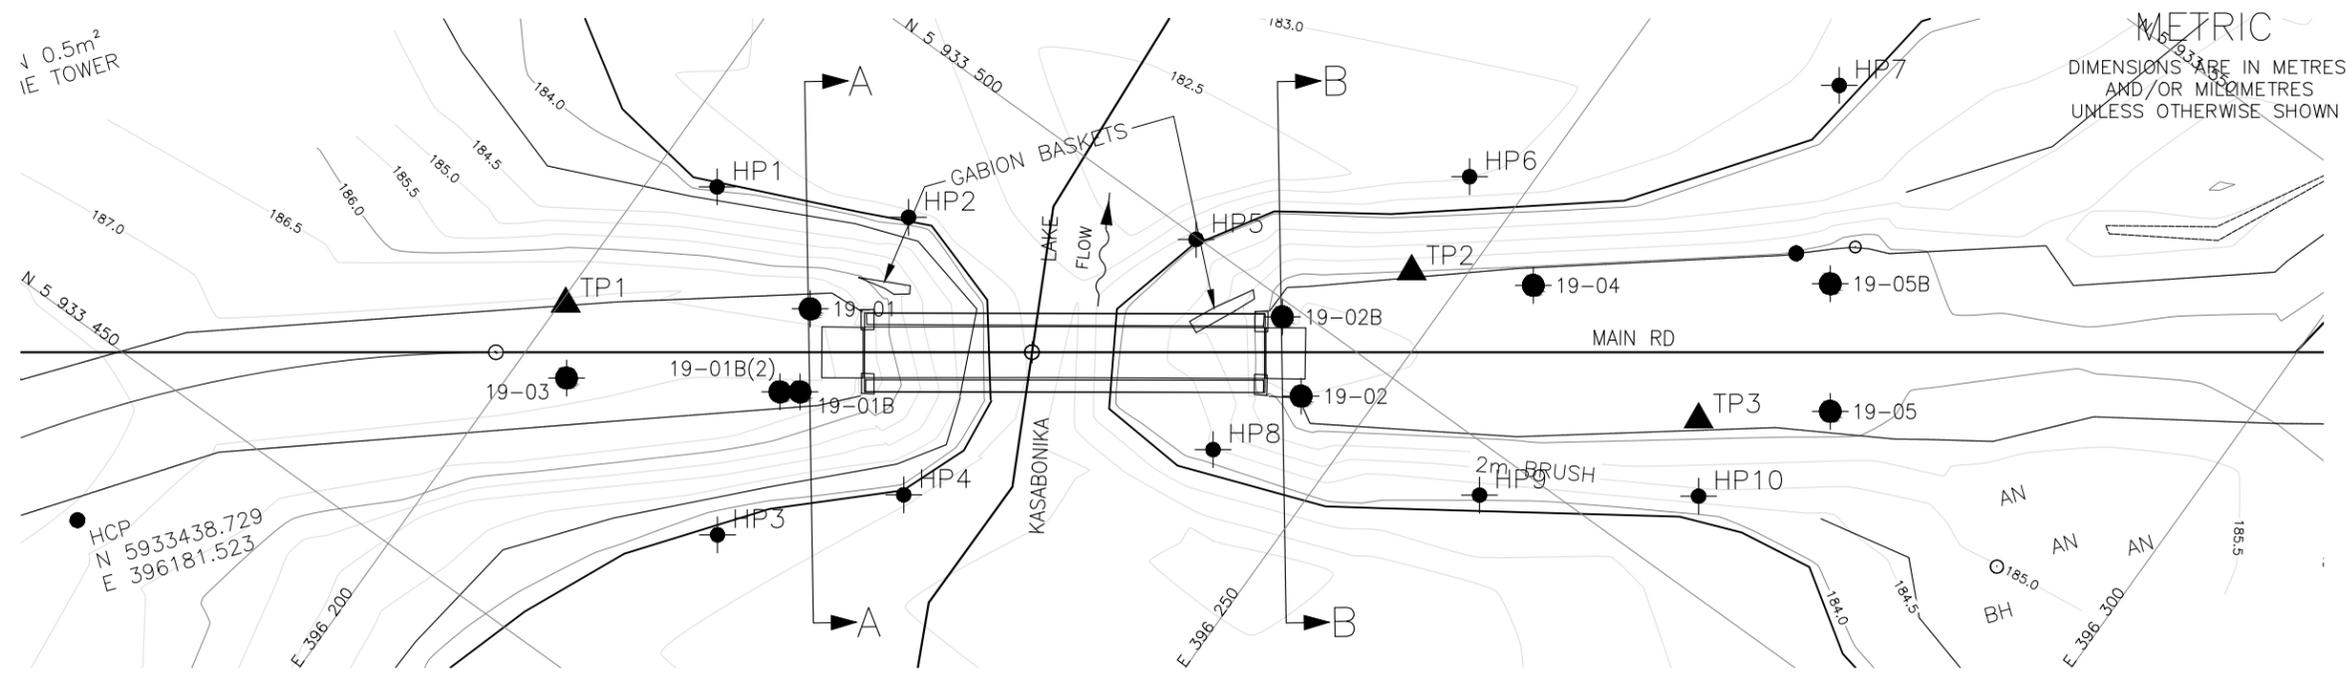
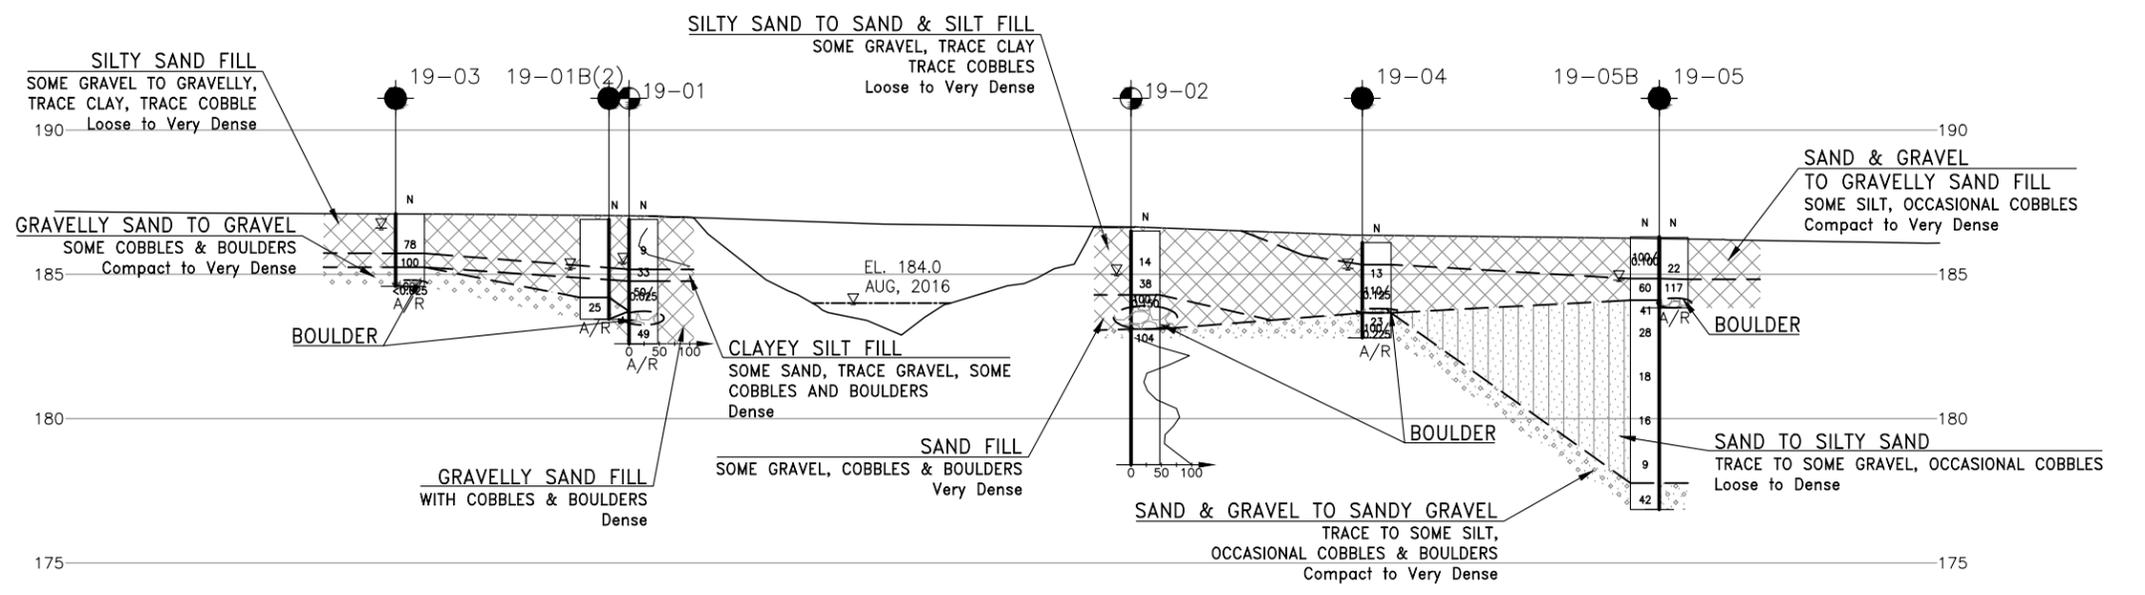
BOREHOLE LOCATIONS AND SOIL STRATA

NO	ELEVATION	NORTHING	EASTING
19-01	186.9	5 933 480.3	396 214.3
19-01B	186.9	5 933 475.2	396 217.1
19-01B(2)	186.9	5 933 474.4	396 216.0
19-02	186.5	5 933 495.3	396 245.6
19-02B	186.2	5 933 499.0	396 241.3
19-03	187.1	5 933 466.5	396 203.4
19-04	186.1	5 933 510.9	396 254.2
19-05	186.1	5 933 515.9	396 276.0
19-05B	186.2	5 933 523.0	396 270.9

- The boundaries between soil strata have been established only at Borehole locations. Between Boreholes the boundaries are assumed from geological evidence.
- This drawing is for subsurface information only. Surface details and features are for conceptual illustration.
- Coordinate system is MTM NAD 83 Zone 15.

The approximate locations of the boreholes, test pits and hand probes from the investigation are shown on the Borehole Locations and Soil Strata Drawing included in Appendix D.

Reference is made to the Record of Borehole sheets included in Appendix A. Details of the encountered soil stratigraphy are presented on the Record of Borehole sheets and on the Borehole Locations and Soil Strata Drawing included in Appendix D. A general description of the stratigraphy, based on the conditions encountered in the boreholes, is given in the following paragraphs. However, the factual data presented on the Record of Borehole sheets takes precedence over this general description and must be used for interpretation of the site conditions. It must be recognized and expected that soil conditions may vary between and beyond the borehole locations.
