Geotechnical Foundation Investigation and Design Report (FIDR)

Installation of Three Trenchless Crossings and Sanitary Servicing for Proposed Development - Hwy 26, Meaford

Golder Associates Ltd.

June 2, 2022

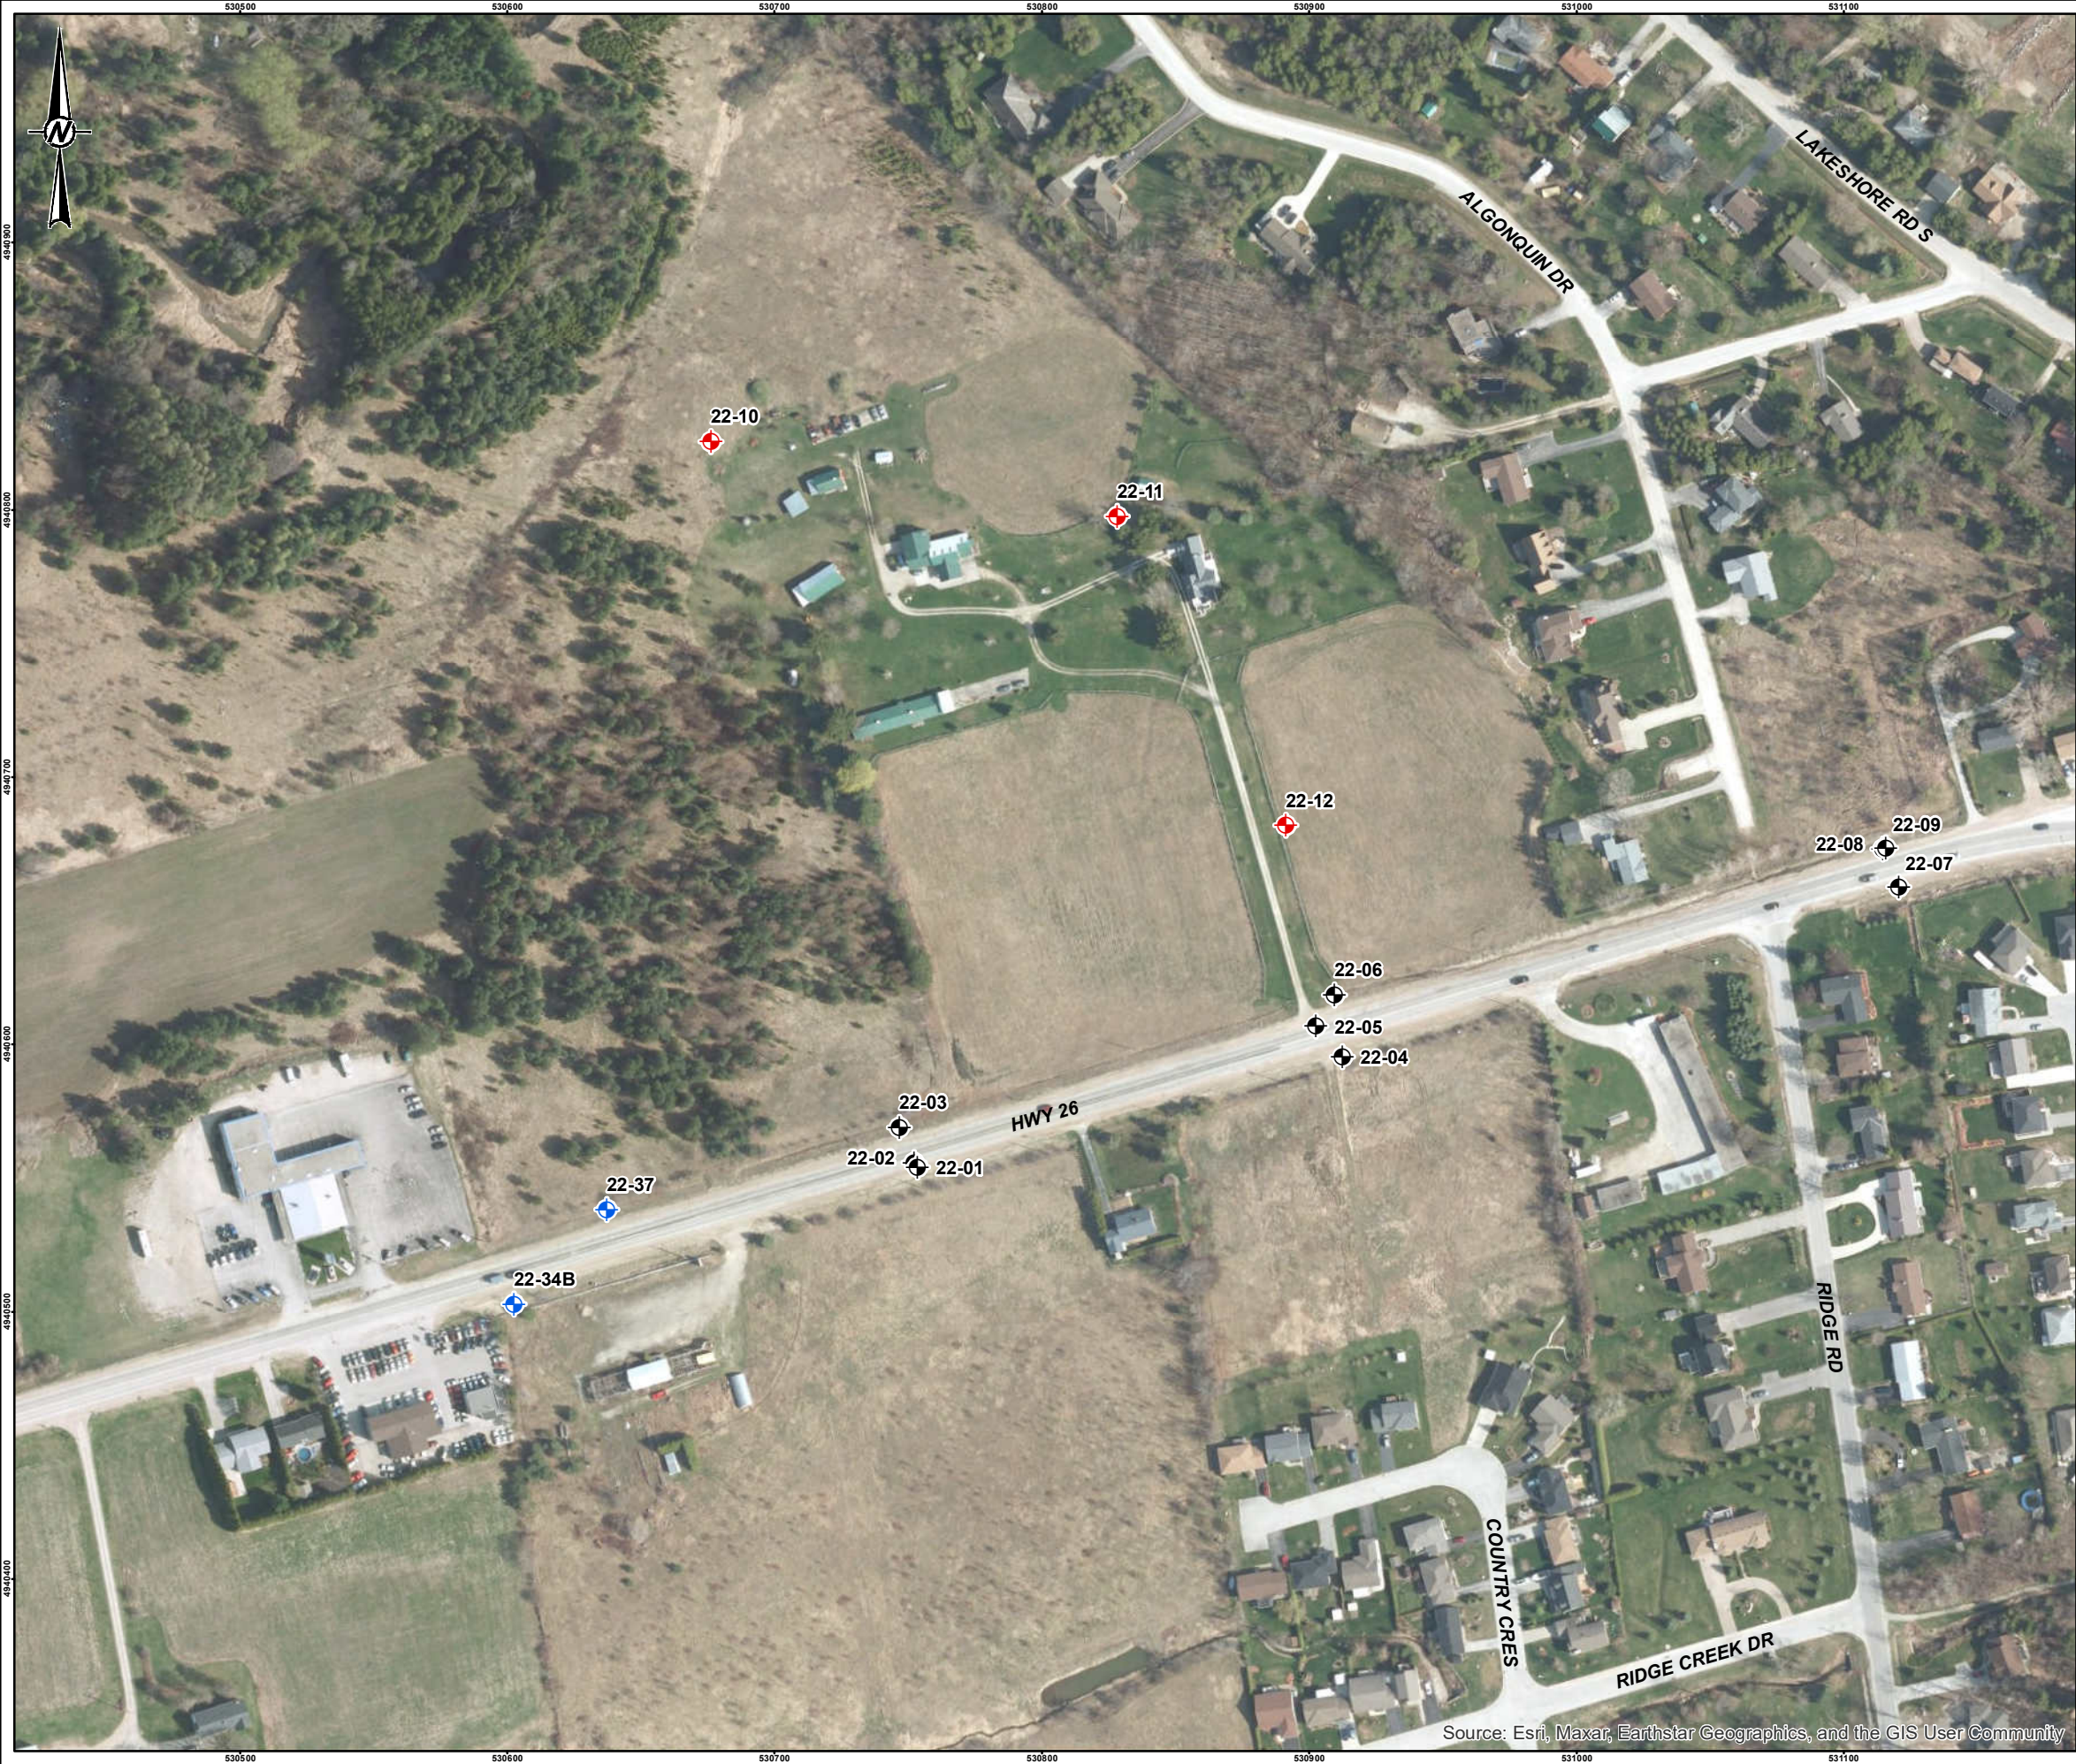
Figure 1 - Borehole Location Plan

Prior to drilling, Golder staff laid out the borehole locations as shown on the Borehole Location Plan, Figure 1 in Appendix B. The field work for this investigation was monitored by a member of our geotechnical staff, who arranged for the clearance of underground utilities, observed the drilling, sampling and in situ testing operations, logged the boreholes, and examined and took custody of the recovered soil samples. The soil samples obtained during this investigation were identified in the field, placed in appropriate containers, labelled and transported to Golder’s laboratory for further detailed visual examination by a geotechnical engineer, water content testing and selected geotechnical classification analyses.
