**FINAL  
FOUNDATION INVESTIGATION AND DESIGN REPORT  
HIGHWAY 11 UNDERPASS STRUCTURE  
MUSKOKA RD 2, DISTRICT OF MUSKOKA  
AGREEMENT NO. 5017-E-0003  
Site No.: 42-168**

**G.W.P. 5336-11-00**

Geocres No.: 31E-392

August 2019  
Thurber File: 20244

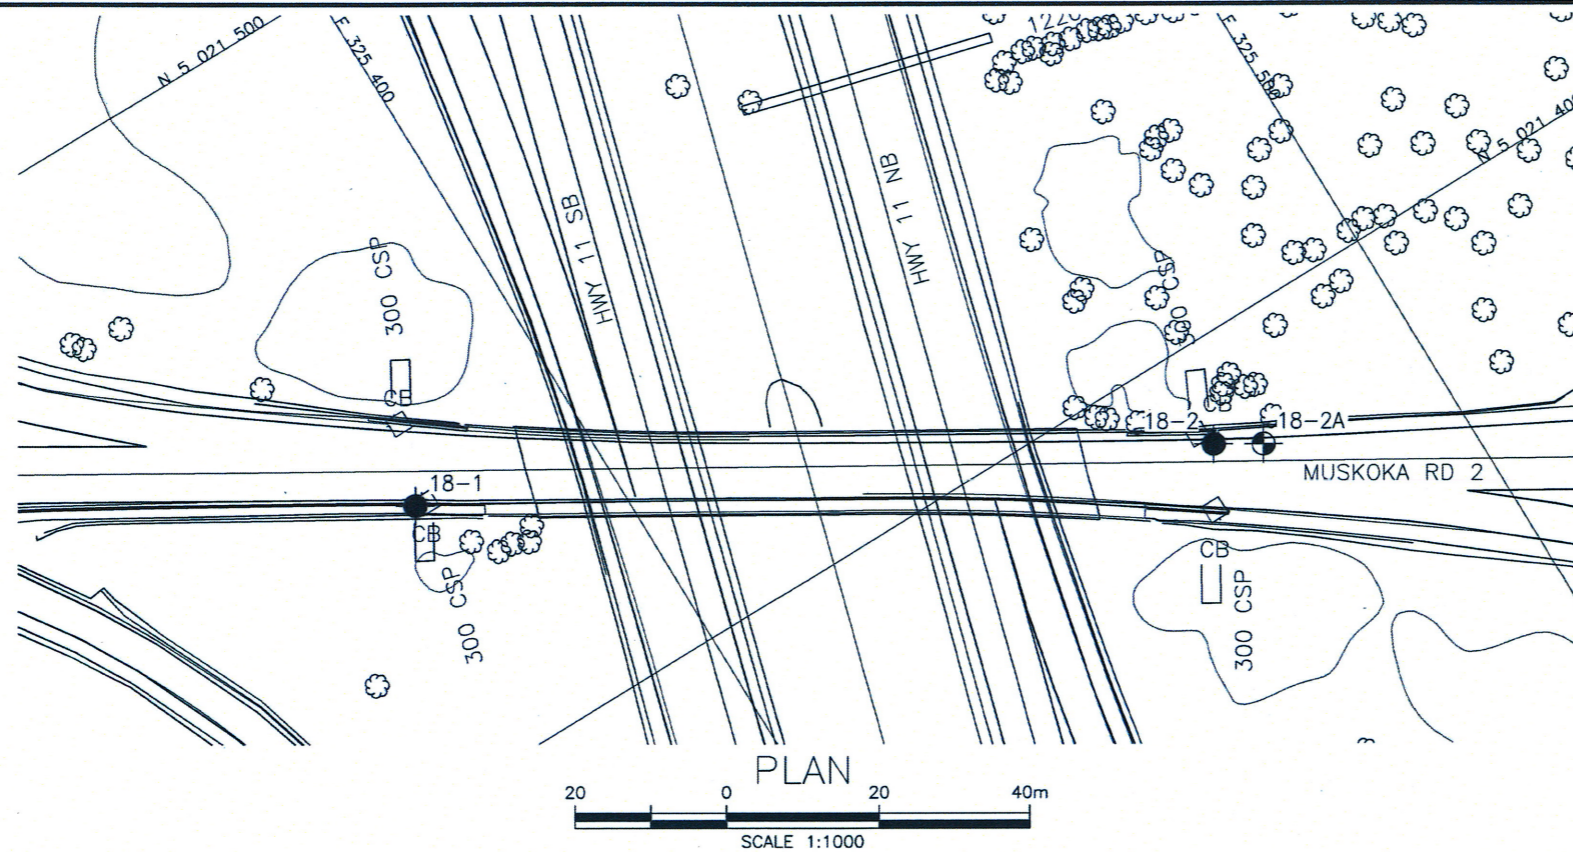
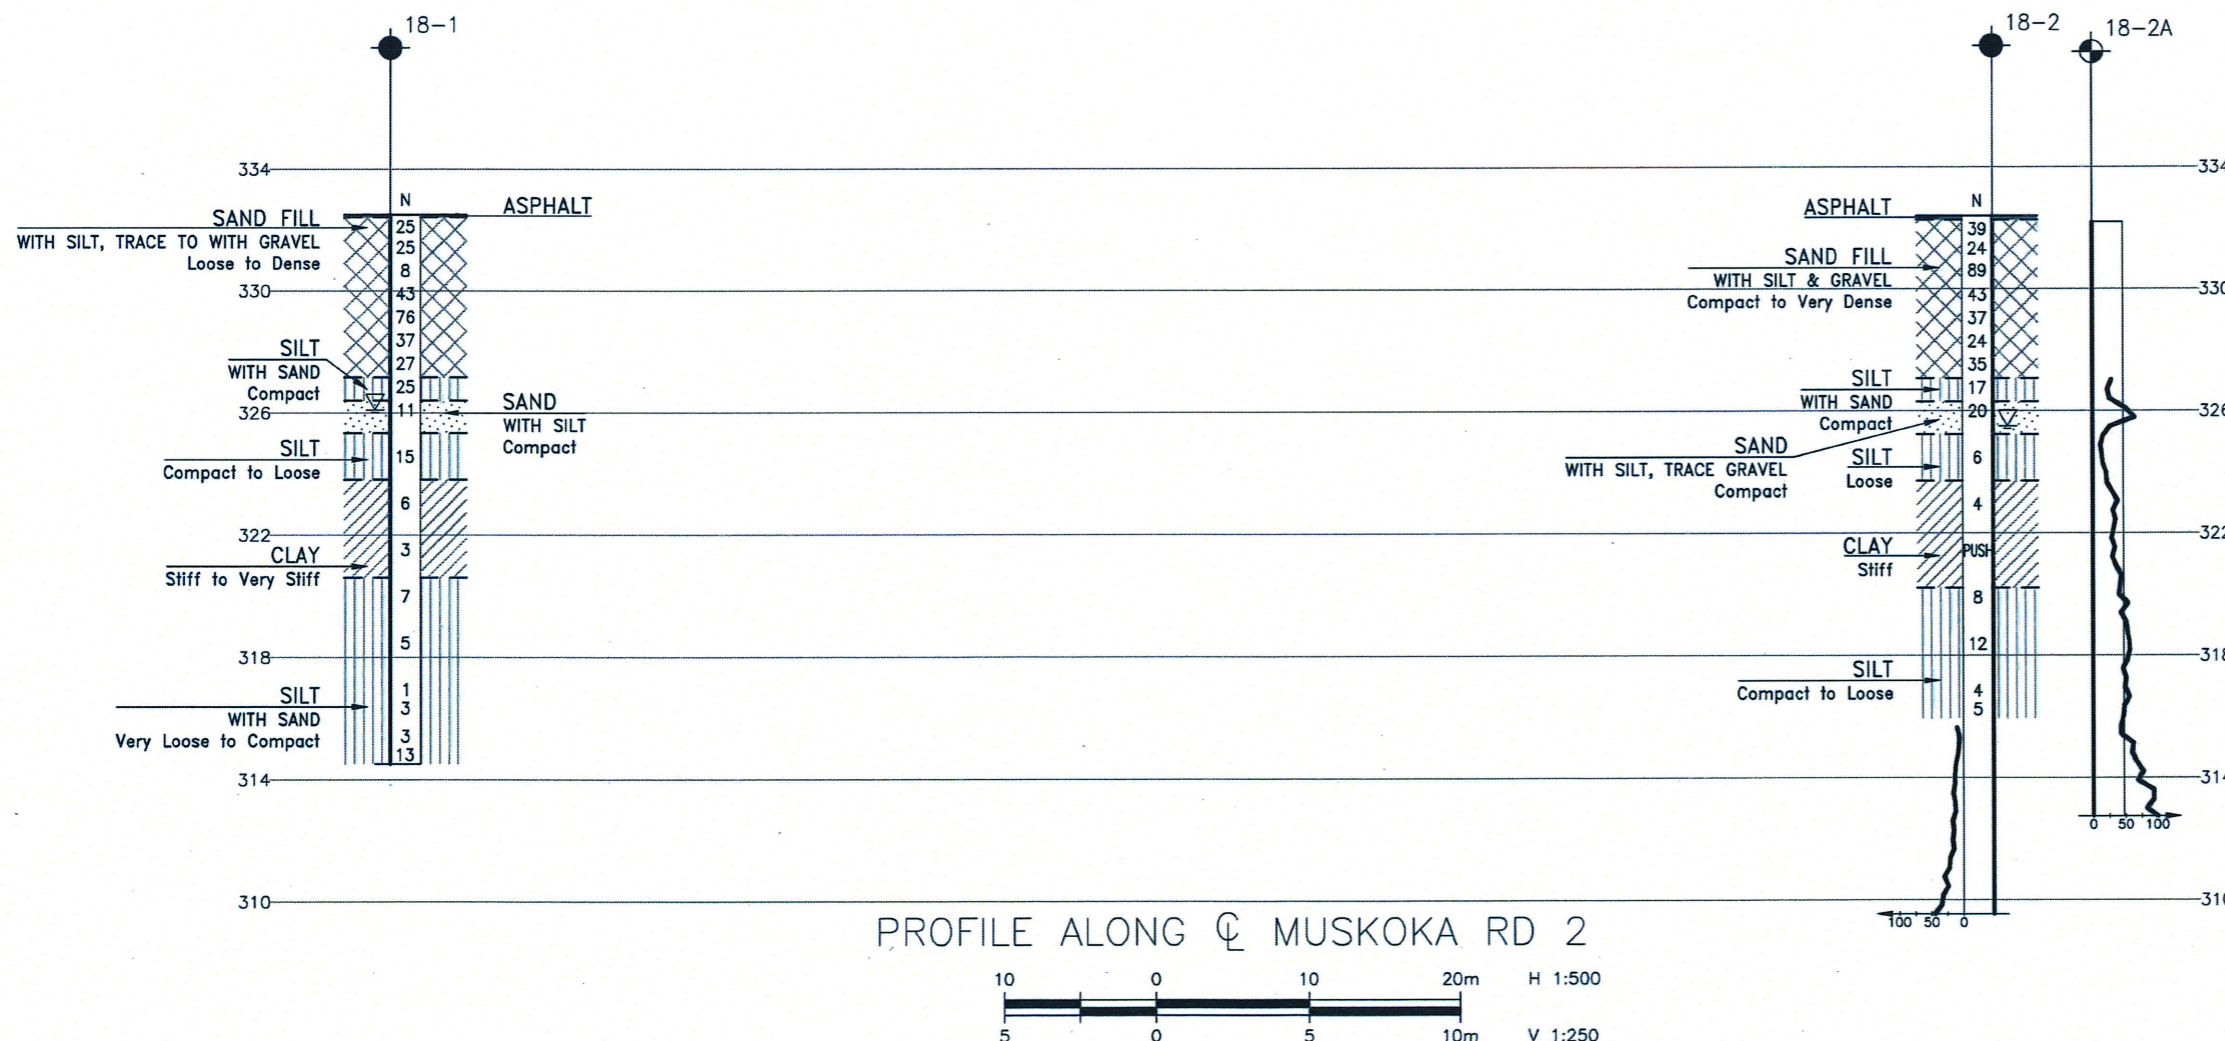
HIGHWAY 11  
MUSKOKA ROAD 2  
UNDERPASS  
BOREHOLE LOCATIONS AND SOIL STRATA

The approximate borehole locations are shown on the Borehole Locations and Soil Strata Drawing included in Appendix A. The coordinates and elevations of the boreholes from the current investigation are provided on this drawing and on the individual Record of Borehole sheets. The northing and easting (MTM zone 10), elevation, and termination depth of the boreholes are summarized below in Table 3-1. The borehole elevations were surveyed relative to benchmark HCP 113 (elev. 330.230 m), shown on Drawing B-625-11-10 dated April 20, 2017, provided by MPCE, with a Nikon-AP-8 with an accuracy of +/- 1.5 mm. Horizontal locations were measured relative to existing site features.

Details of the encountered soil stratigraphy are presented on the Record of Borehole sheets included in Appendix B and the Borehole Location and Soil Strata drawing included in Appendix A. A general description of the stratigraphy, based on the conditions encountered in the boreholes, is given in the following paragraphs. However, the factual data presented on the Record of Borehole sheets takes precedence over this general description for interpretation of the site conditions. It must be recognized that the soil and groundwater conditions may vary between and beyond borehole locations.

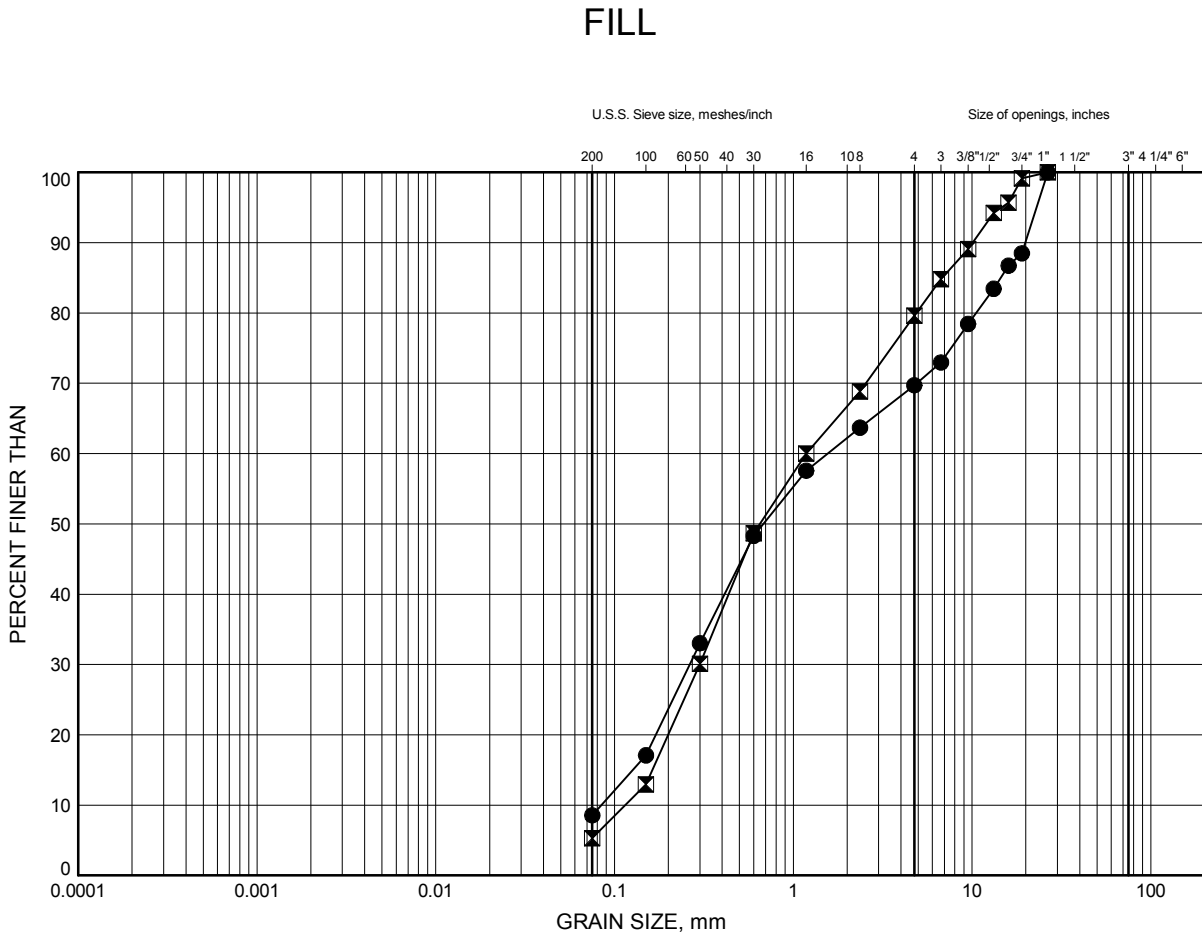
FIGURE C1

## GRAIN SIZE DISTRIBUTION

Recorded moisture contents ranged from 2 to 11%. The results of grain size analyses conducted on two samples of the sand fill are summarized below and are illustrated on Figure C1 in Appendix C.

Soil Particle	Percentage (%)
Gravel	20 – 30
Sand	61 – 74
Silt & Clay	6 – 9

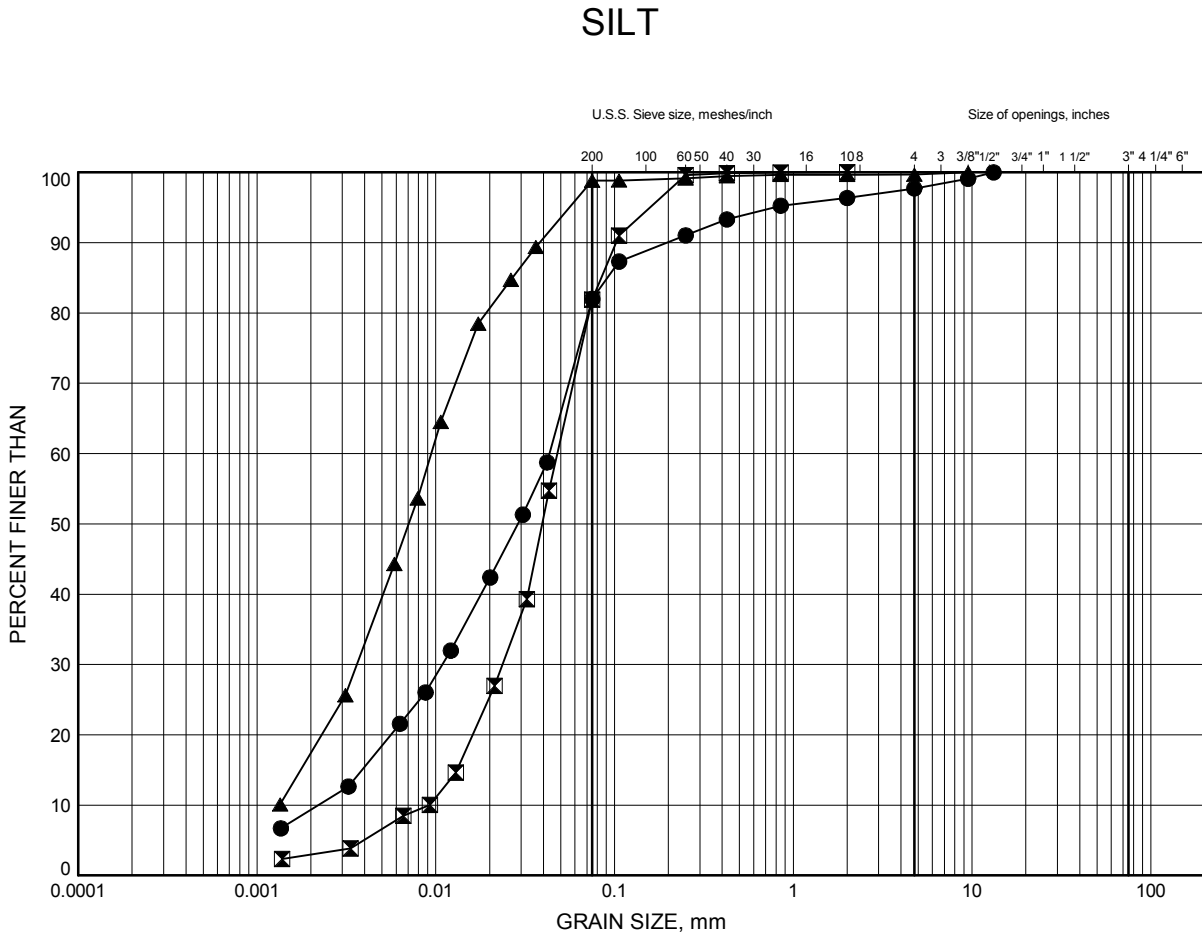
FIGURE C2

## GRAIN SIZE DISTRIBUTION

Recorded moisture contents ranged from 17 to 20%. Atterberg Limits testing on one sample indicated that this material was non-plastic. The results of a grain size analysis conducted on one sample of the silt indicated the material consisted of 2% gravel, 16% sand, 73% silt and 9% clay, and the results are illustrated on Figure C2 in Appendix C.

Recorded moisture contents ranged from 20 to 40%. Atterberg Limits testing on two samples indicated that this material was non-plastic. The results of grain size analysis conducted on two samples of the lower silt are summarized below and are illustrated on Figure C2 in Appendix C.

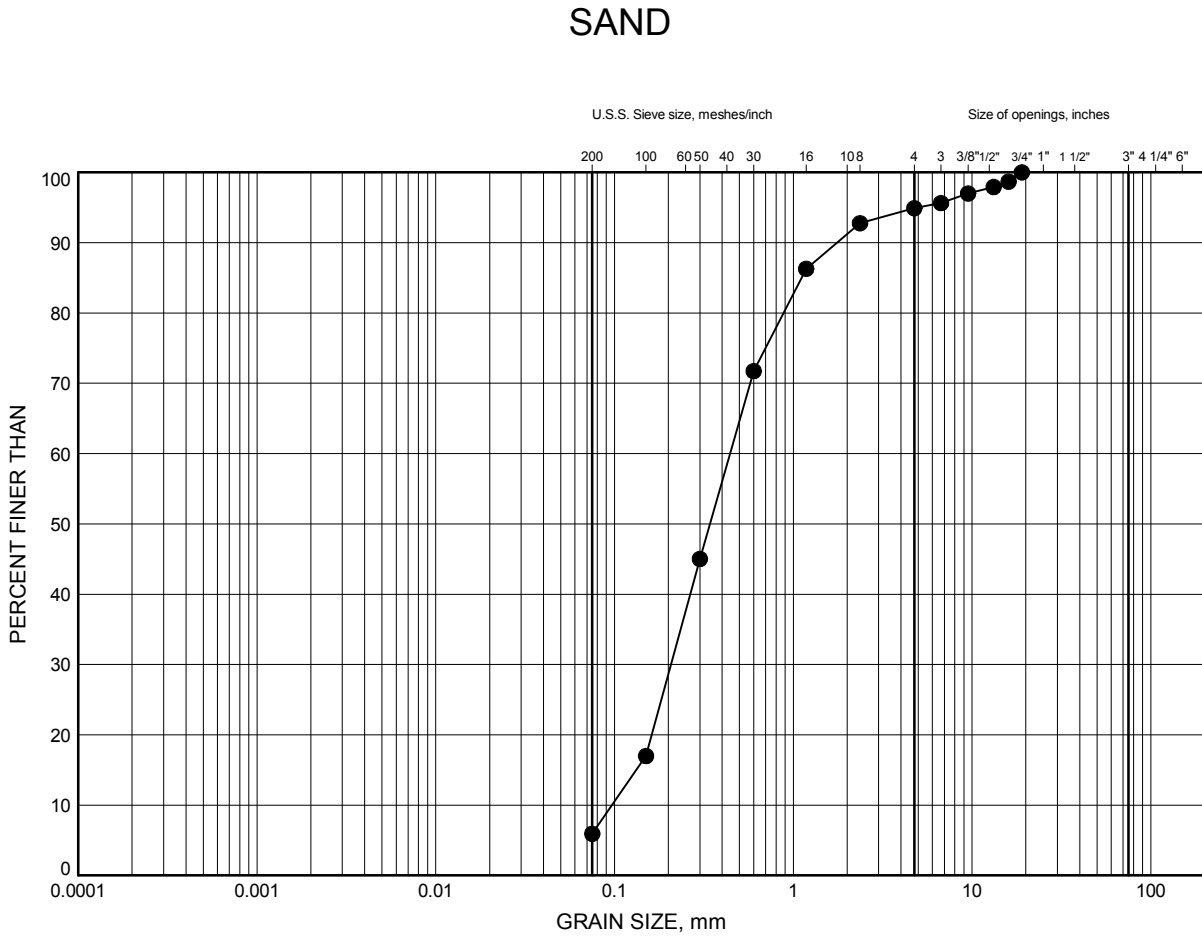
FIGURE C3

Hwy's 11 and 118 - Muskoka Road 2  
**GRAIN SIZE DISTRIBUTION**

The recorded moisture contents ranged from 8 to 13%. The results of a grain size analysis conducted on one sample of the sand deposit indicated the material consisted of 5% gravel, 89% sand and 6% fines, and the results are illustrated on Figure C3 in Appendix C.

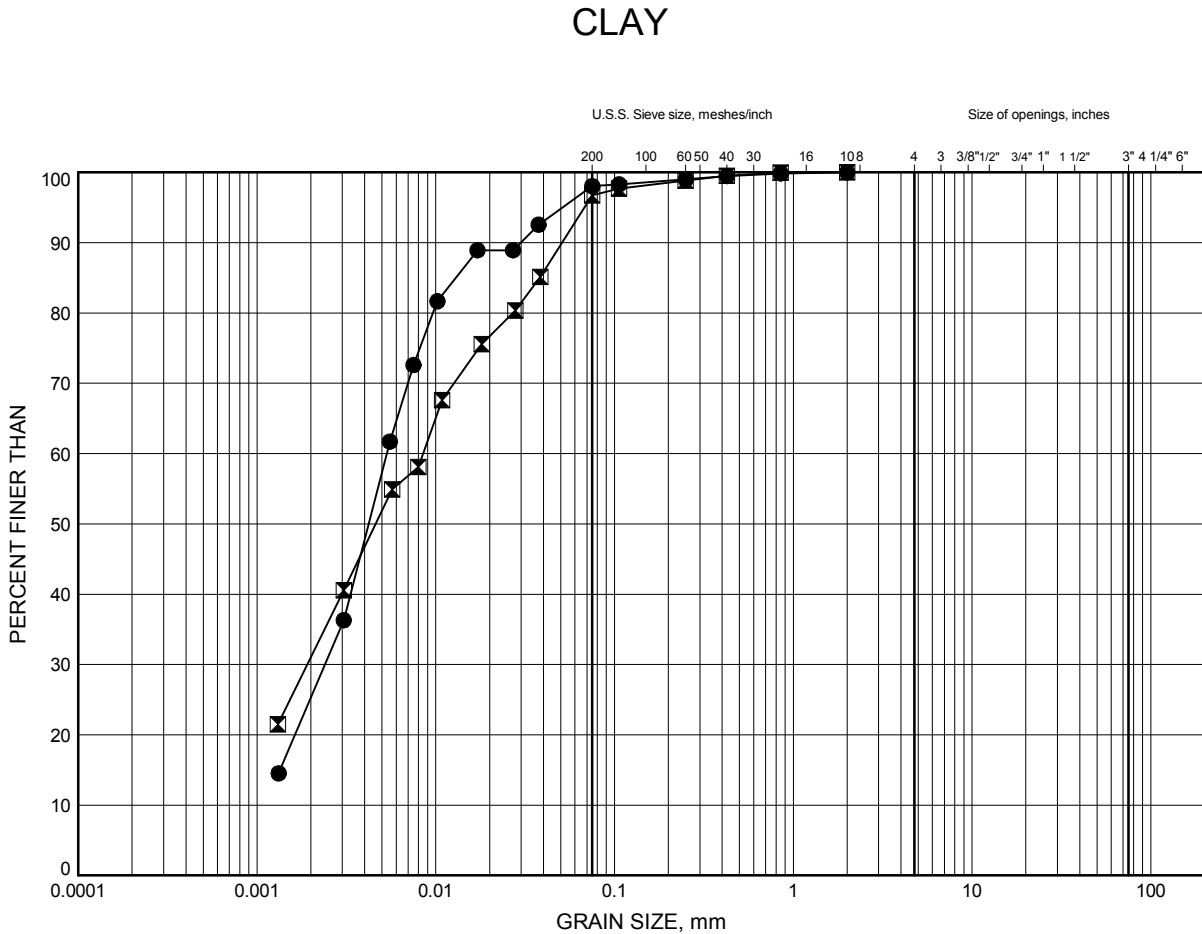
FIGURE C4

## GRAIN SIZE DISTRIBUTION

Recorded moisture contents ranged from 29 to 45%. The results of grain size analyses conducted on two samples of the clay are summarized below and illustrated on Figure C4 in Appendix C.

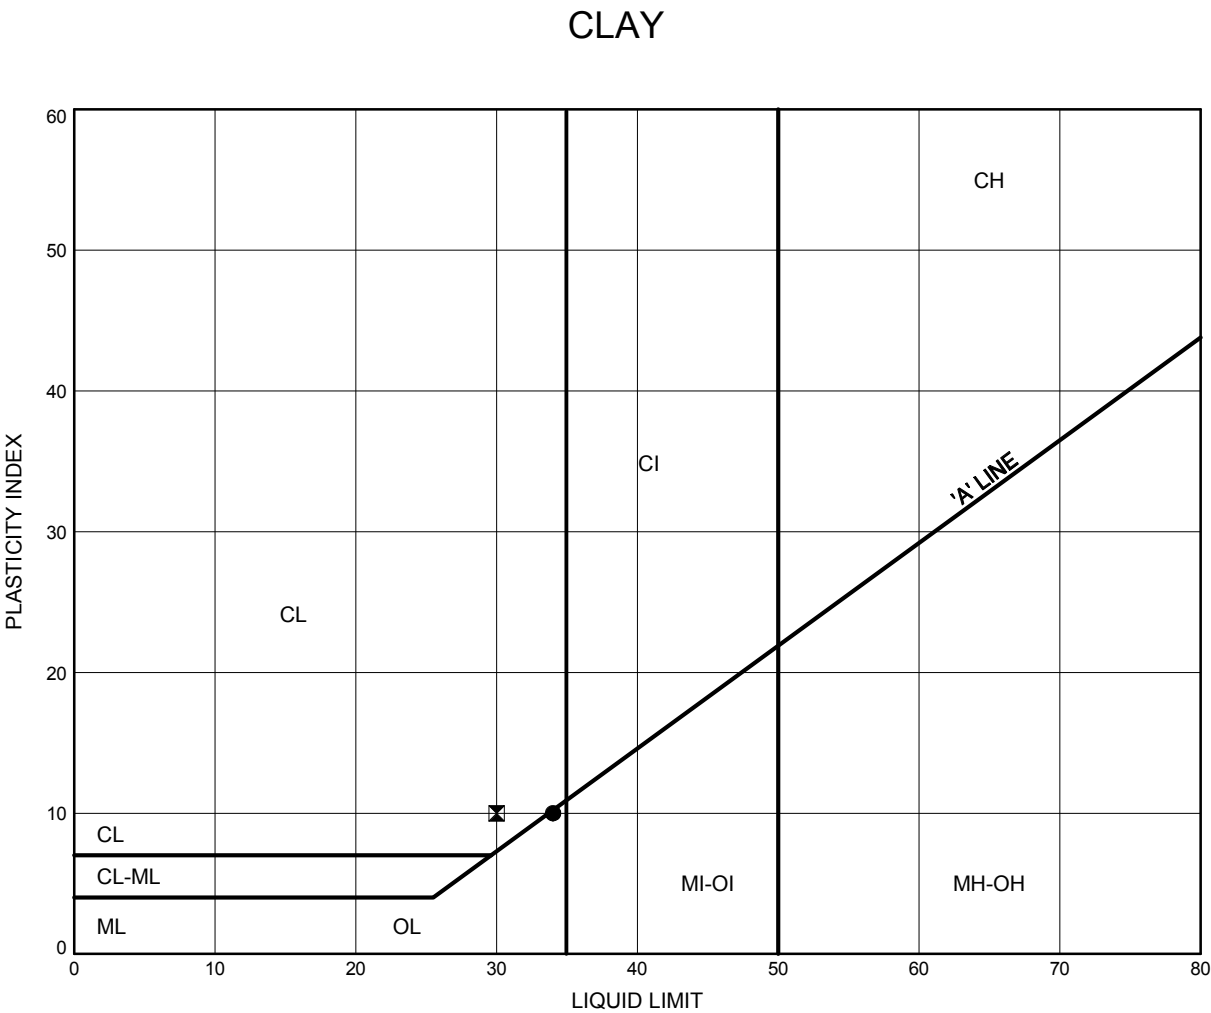
FIGURE C5

# ATTERBERG LIMITS TEST RESULTS

SYMBOL	BOREHOLE	DEPTH (m)	ELEV. (m)
●	18-1	11.0	321.5
⊠	18-2	9.4	323.0

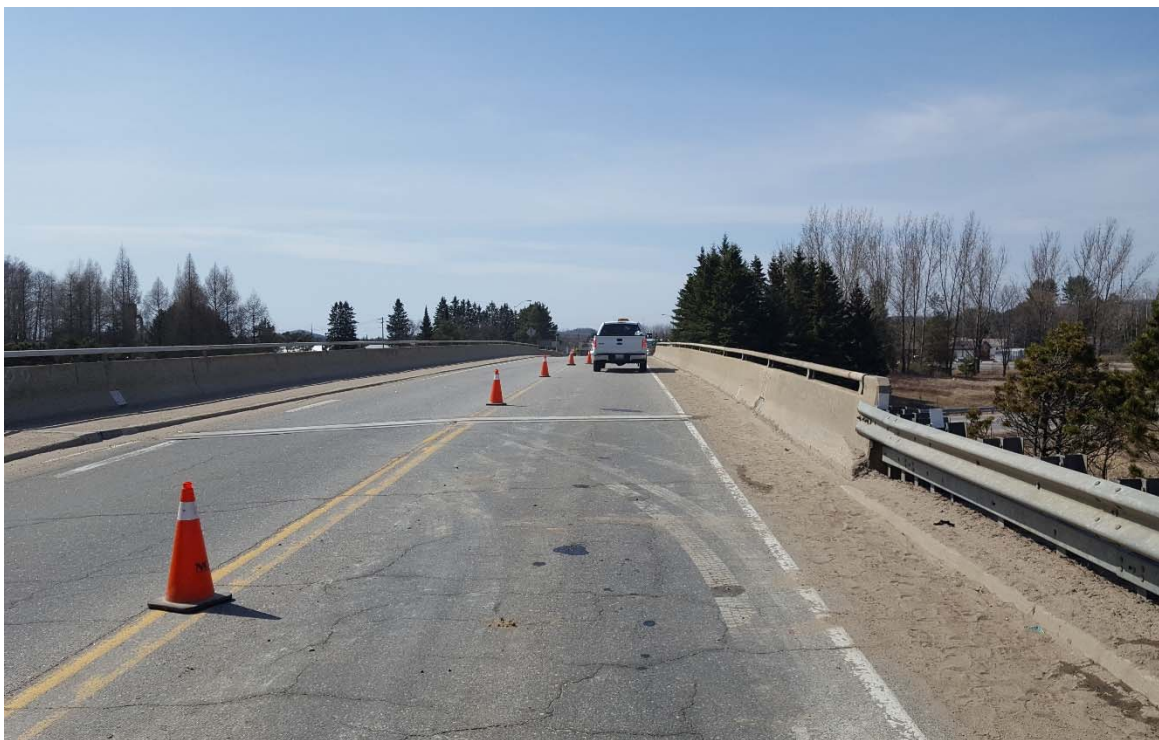
**Photo 2. Muskoka Road 2 Underpass Structure from east (May 1<sup>st</sup>, 2018)**
