**FINAL
FOUNDATION INVESTIGATION AND DESIGN REPORT
HIGHWAY 11 UNDERPASS STRUCTURE
MUSKOKA RD 3, DISTRICT OF MUSKOKA
AGREEMENT NO. 5017-E-0003
Site No.: 42-169**

G.W.P. 5336-11-00

Geocres No.: 31E-393

August 2019
Thurber File: 20244

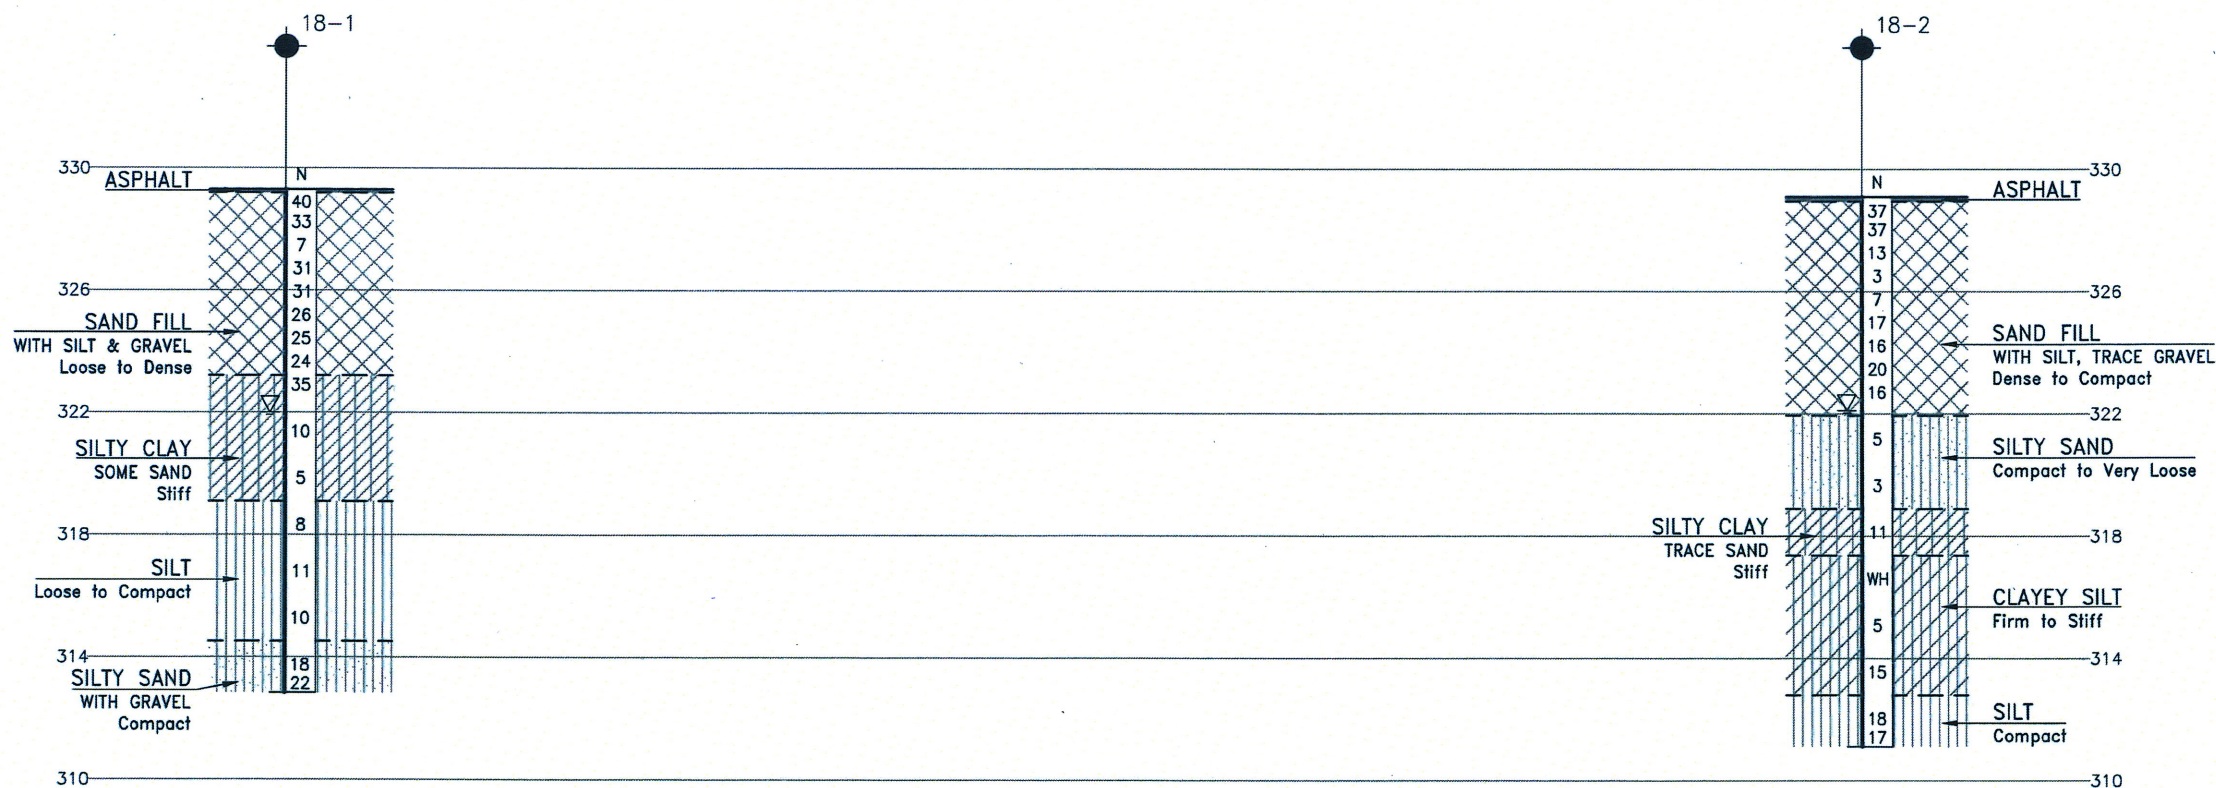
HIGHWAY 11
MUSKOKA ROAD 3
UNDERPASS
BOREHOLE LOCATIONS AND SOIL STRATA

The approximate borehole locations are shown on the Borehole Locations and Soil Strata Drawing included in Appendix A. The coordinates and elevations of the boreholes from the current investigation are provided on this drawing and on the individual Record of Borehole sheets. The northing and easting (MTM zone 10), elevation, and termination depth of the boreholes are summarized below in Table 3-1. The borehole elevations were surveyed relative to benchmark HCM 820120090 (elev. 329.535 m), shown on Drawing B-625-11-10 dated April 20, 2017, provided by MPCE, with a Nikon-AP-8 with an accuracy of +/- 1.5 mm. Horizontal locations were measured relative to existing site features.

Details of the encountered soil stratigraphy are presented on the Record of Borehole sheets included in Appendix B and the Borehole Location and Soil Strata drawing included in Appendix A. A general description of the stratigraphy, based on the conditions encountered in the boreholes, is given in the following paragraphs. However, the factual data presented on the Record of Borehole sheets takes precedence over this general description for interpretation of the site conditions. It must be recognized that the soil and groundwater conditions may vary between and beyond borehole locations.

- The boundaries between soil strata have been established only at Borehole locations. Between Boreholes the boundaries are assumed from geological evidence.
- This drawing is for subsurface information only. Surface details and features are for conceptual illustration.
- Coordinate system is MTM NAD 83 Zone 10.

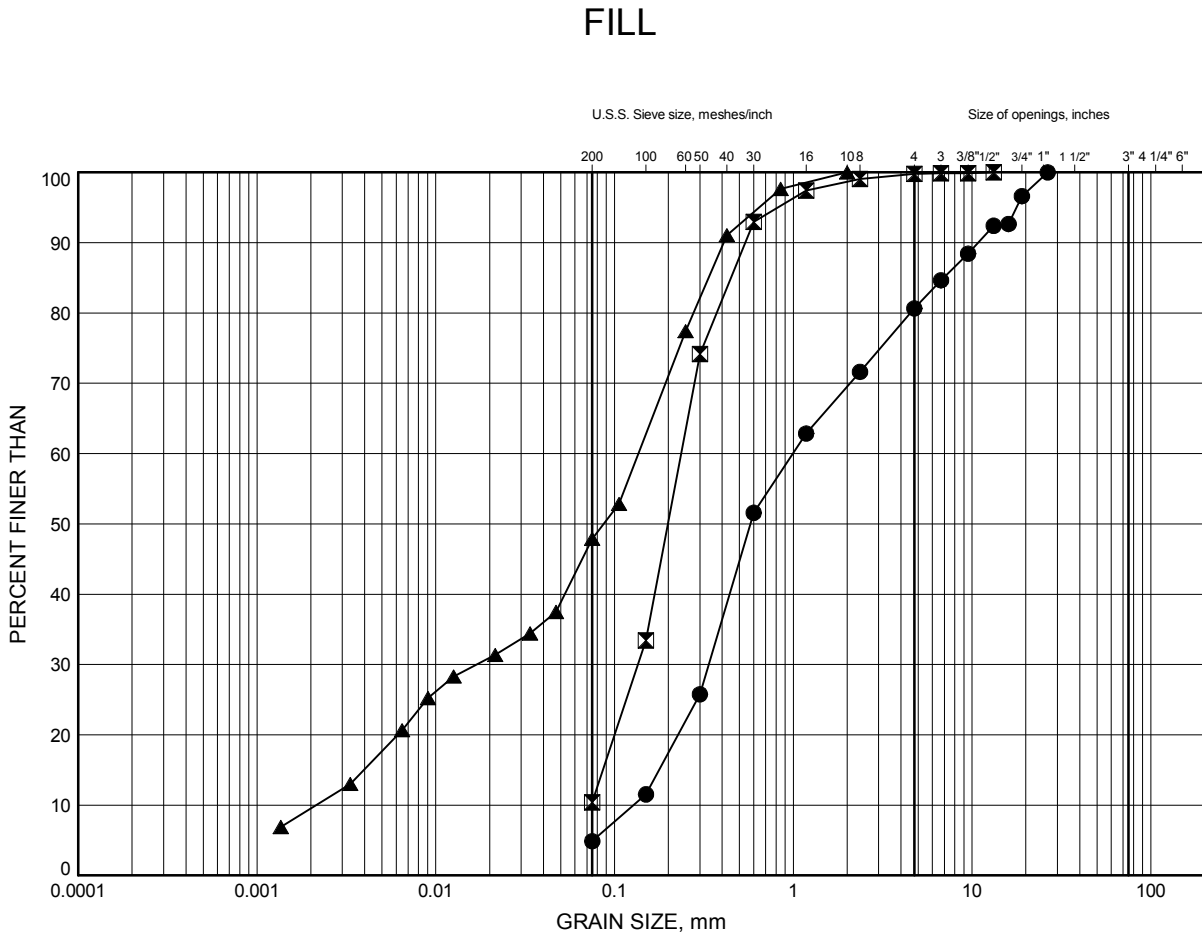
FIGURE C1

Hwy's 11 and 118 - Muskoka Road 3
GRAIN SIZE DISTRIBUTION

Recorded moisture contents ranged from 1 to 8%. The results of grain size analyses conducted on two samples of the sand fill are summarized below and are illustrated on Figure C1 in Appendix C.

The recorded moisture contents were approximately 23%. Atterberg Limits testing conducted on one sample of the silty sand indicate this material to be non-plastic. The results of a grain size analysis conducted on one sample of the silty sand indicated the material to consist of 0% gravel, 52% sand, 38% silt and 10% clay, and the results are summarized on the Record of Borehole sheet in Appendix B and are illustrated on Figure C1 in Appendix C.

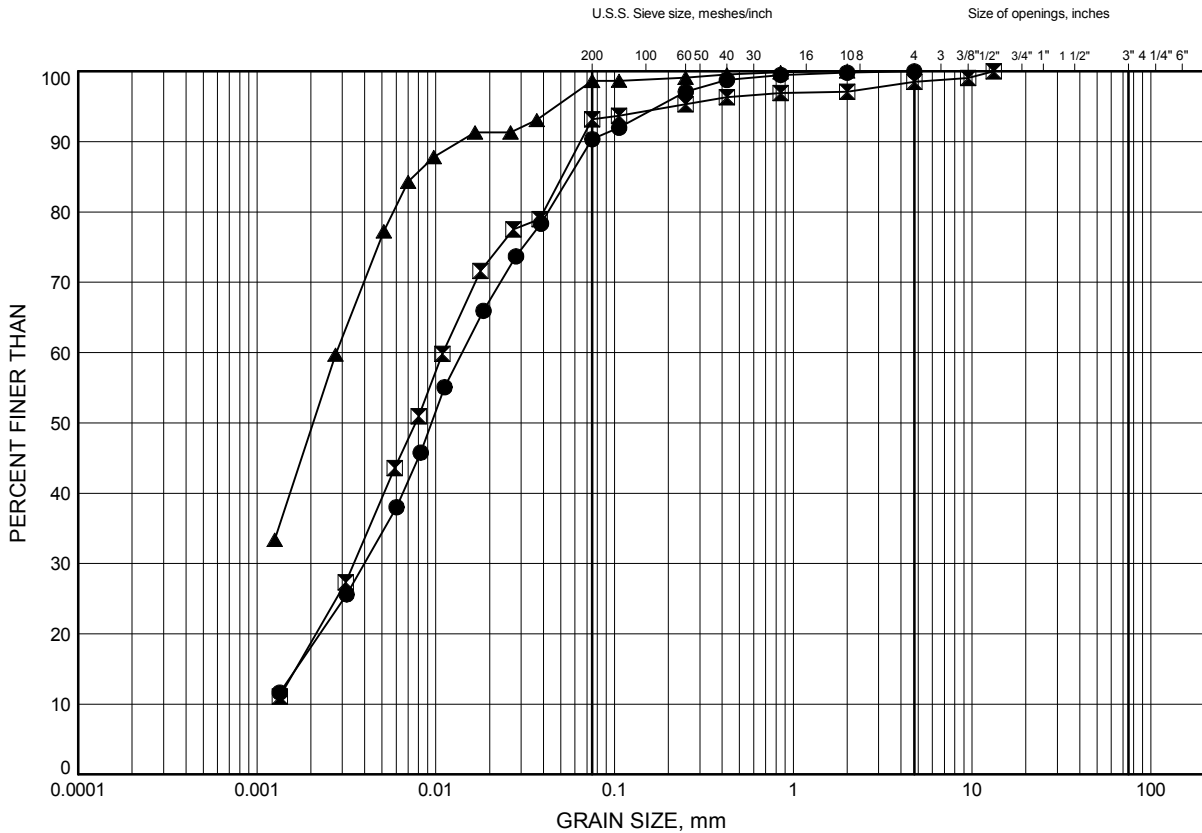
FIGURE C2

SILTY CLAY TO CLAYEY SILT

Recorded moisture contents ranged from 16 to 39%. The results of grain size analysis conducted on two samples of the silty clay are summarized below and are illustrated on Figure C2 in Appendix C.

Recorded moisture contents ranged from 34 to 44%. The results of grain size analysis conducted on one sample of the clayey silt indicated the material to consist of 0% gravel, 1% sand, 50% silt and 49% clay, and the results are summarized on the Record of Borehole sheet in Appendix B and are illustrated on Figure C2 in Appendix C.

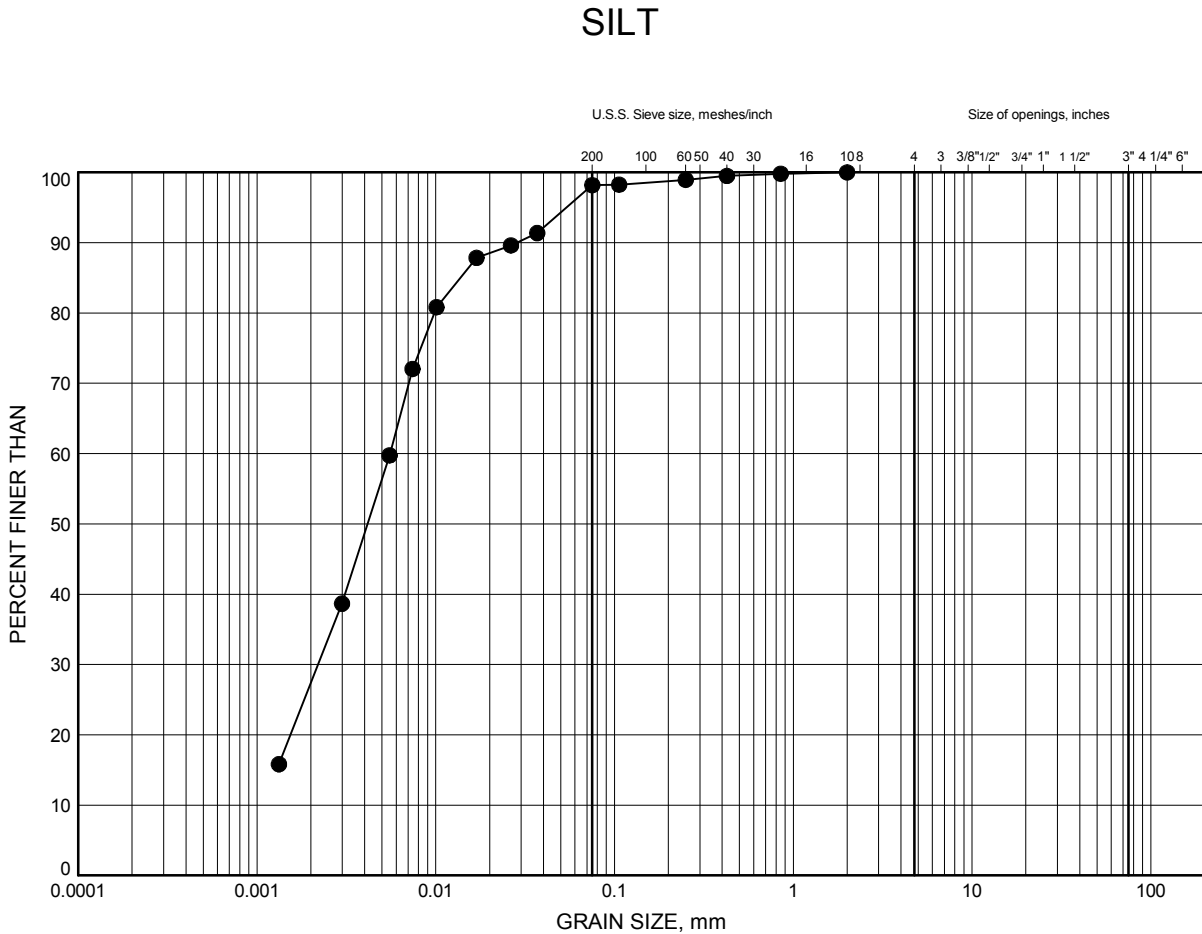
FIGURE C3

Hwy's 11 and 118 - Muskoka Road 3
GRAIN SIZE DISTRIBUTION

Recorded moisture contents ranged from 24 to 32%. Atterberg Limits testing conducted on one sample of the silt indicate this material to be non-plastic. The results of grain size analysis conducted on one sample of the silt indicated this material to consist of 0% gravel, 2% sand, 71% silt and 27% clay and the results are summarized on the Record of Borehole sheet in Appendix B and illustrated on Figure C3 in Appendix C.

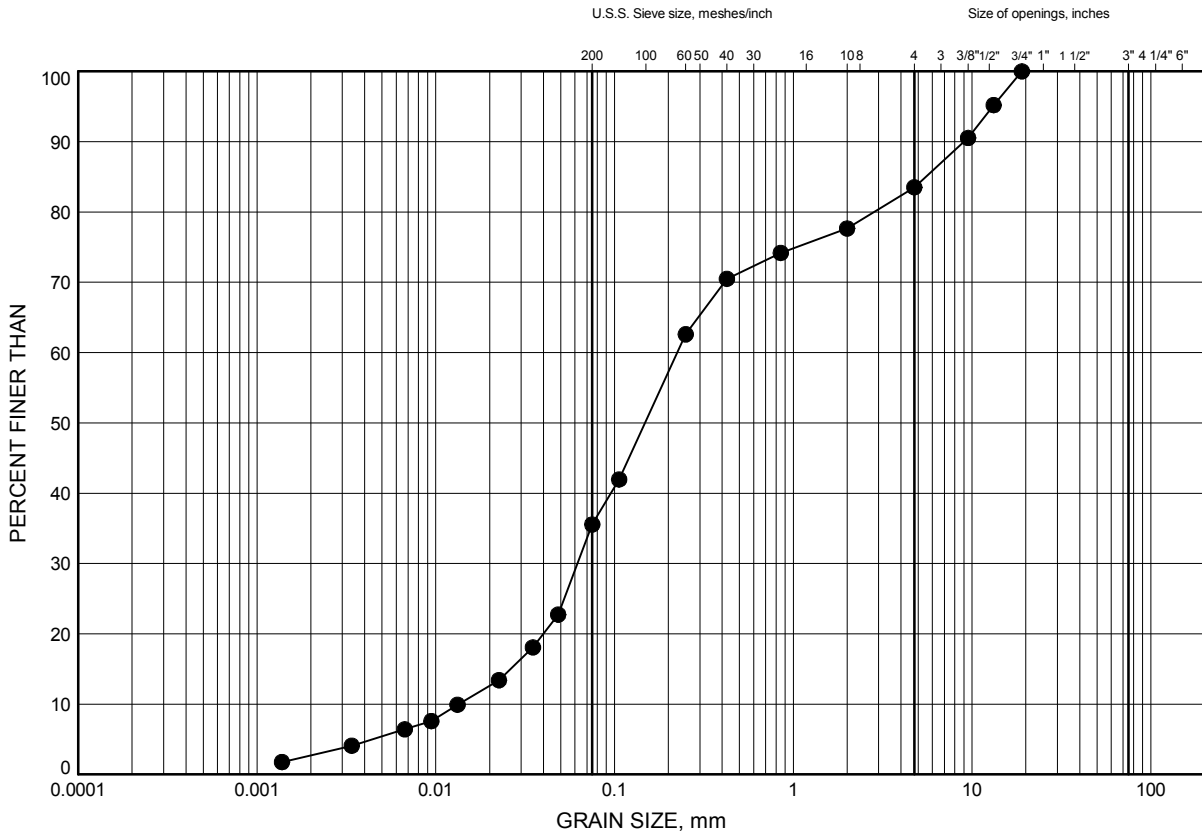
FIGURE C4

SILTY SAND with gravel

The recorded moisture contents ranged from 14 to 28%. Atterberg Limits testing conducted on one sample of the silty sand indicate this material to be non-plastic. The results of a grain size analysis conducted on one sample of the silty sand indicated the material to consist of 16% gravel, 48% sand, 33% silt and 3% clay, and the results are summarized on the Record of Borehole sheet in Appendix B and illustrated on Figure C4 in Appendix C.

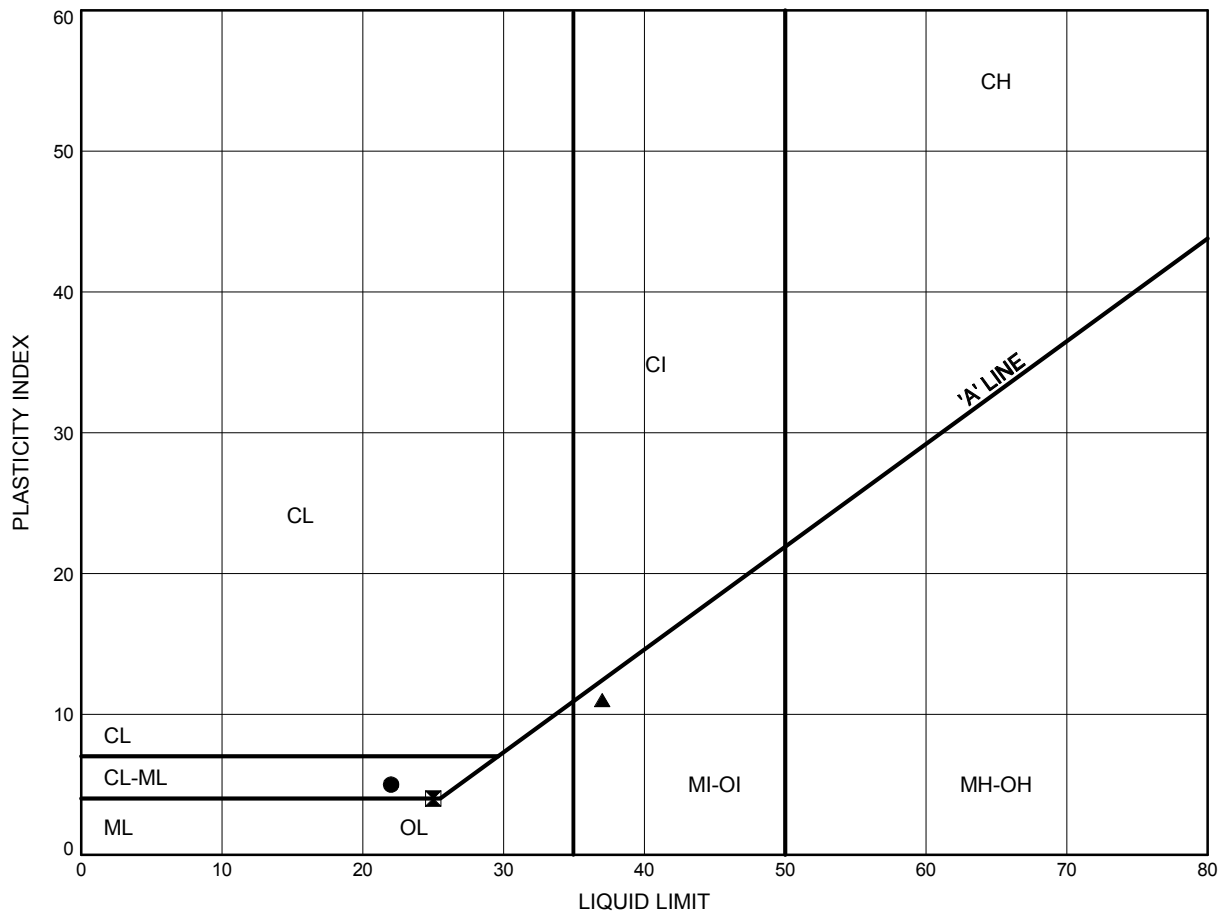
FIGURE C5

SILTY CLAY to CLAYEY SILT

SYMBOL	BOREHOLE	DEPTH (m)	ELEV. (m)
●	18-1	6.4	322.9
⊠	18-2	11.0	318.1
▲	18-2	12.5	316.6

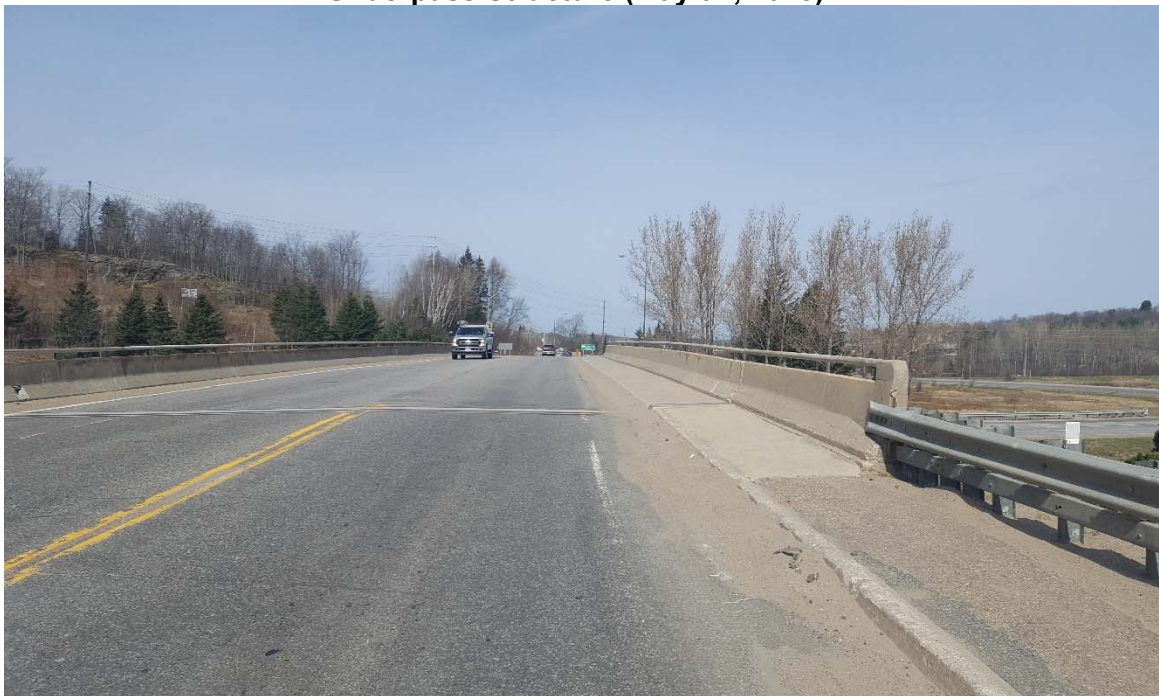
Photo 2. Muskoka Road 3 Underpass Structure from east (May 9th, 2018)

The underpass (Structure No.42-169) has two spans of 36.6 m each, an overall width varying from 11.6 to 13.1 m and a road width varying from 9.1 to 10.6 m. The clearance under the structure is approximately 4.6 m. The structure is understood to have been constructed in 1980 and rehabilitated in 2000. The foundations are documented to consist of H-piles driven to refusal.
