**FOUNDATION INVESTIGATION REPORT
REPLACEMENT OF CULVERT No. CV-0252-0400-0075
HIGHWAY 400 NORTHBOUND
TOWNSHIP OF SEVERN
G.W.P. 2041-13-00
2013-E-0053**

**September 2016
19-3405-5**

**FOUNDATION INVESTIGATION REPORT
REPLACEMENT OF CULVERT No. CV-0252-0400-0075
HIGHWAY 400 NORTHBOUND
TOWNSHIP OF SEVERN
G.W.P. 2041-13-00
ASSIGNMENT NUMBER: 2013-E-0053**

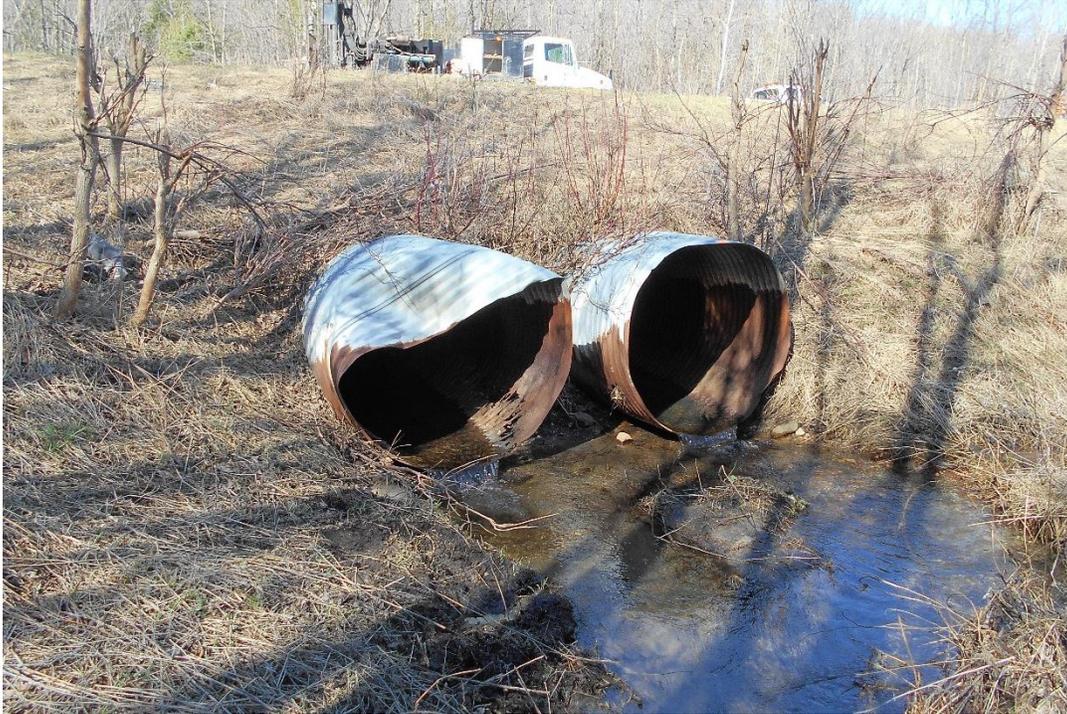
Figure 3: Existing condition of culverts and embankment at outlet

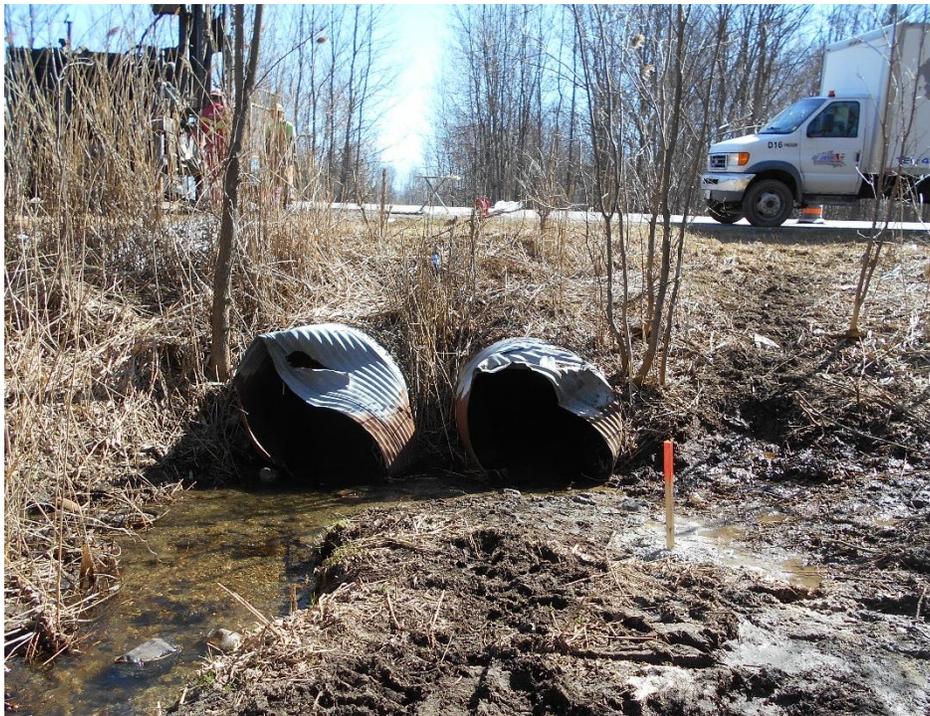
Figure 5: Existing condition of culverts and embankment at inlet
