**FOUNDATION INVESTIGATION AND DESIGN REPORT
NAMEWAMINIKAN RIVER BRIDGE REPLACEMENT
HIGHWAY 801, JELLCOE
DISTRICT OF THUNDER BAY, ONTARIO
LATITUDE: 49.7643°, LONGITUDE -87.7670°**

SITE No. 48C-0125

Date: October 23, 2020
File: 28671

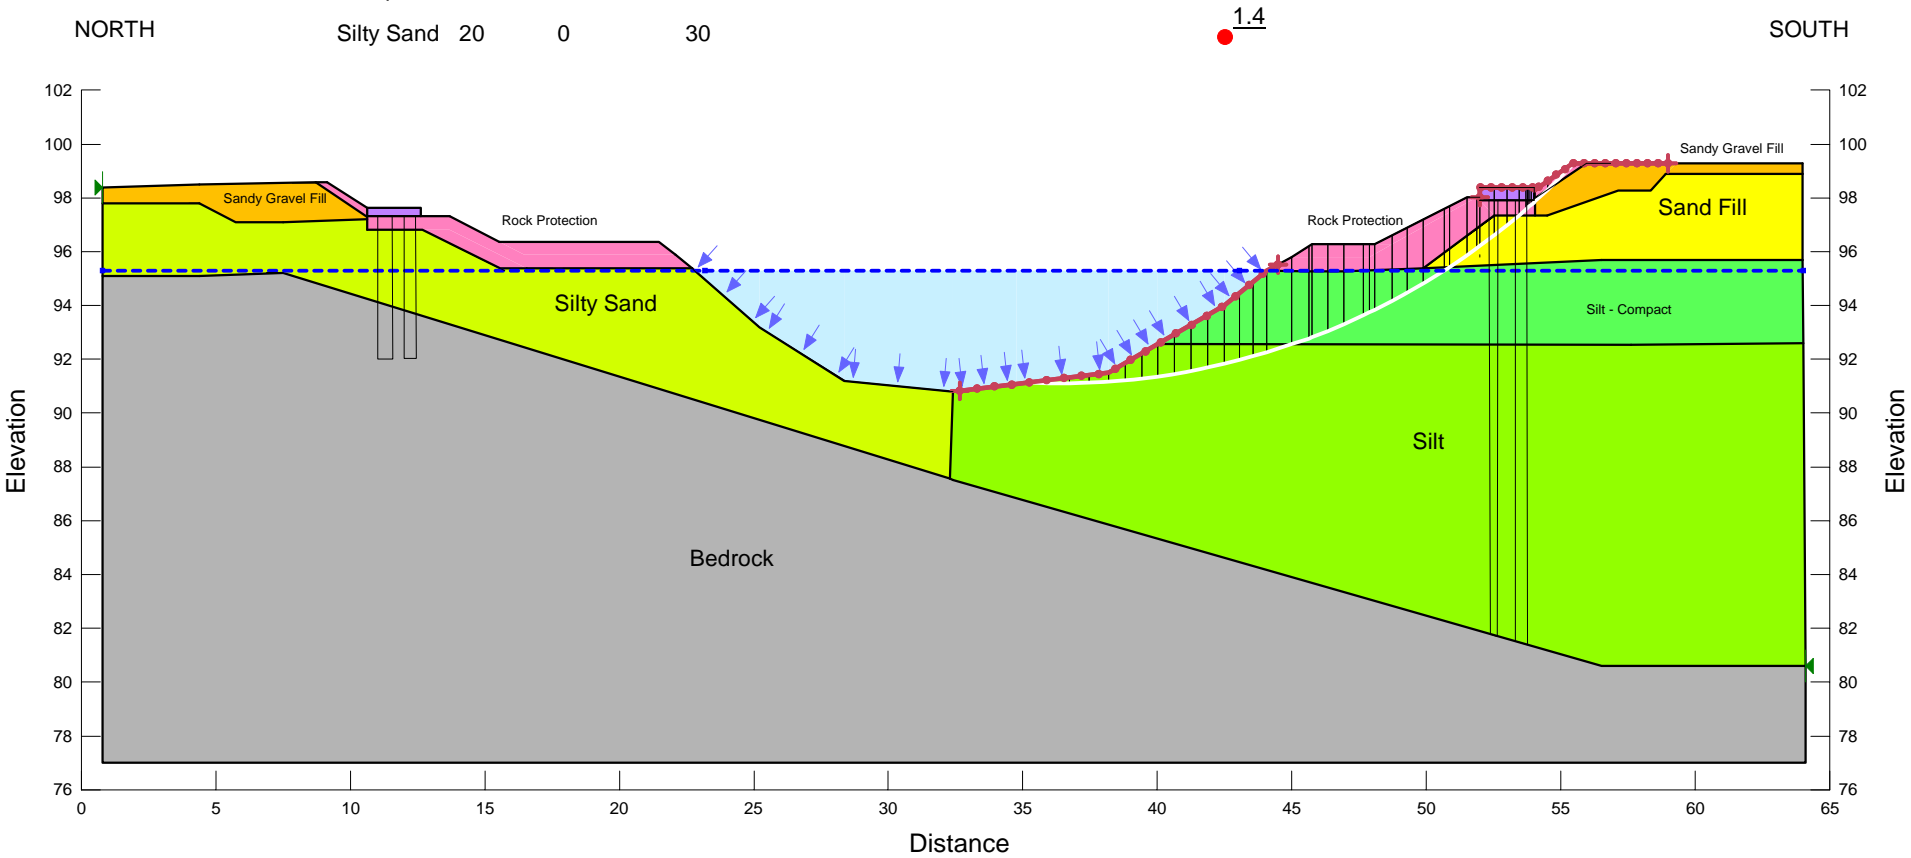
FIGURE E2
PROPOSED NORTH SLOPE H-PILE
FOUNDATION

Name	Unit Weight (kN/m ³)	Cohesion' (kPa)	Phi' (°)
Bedrock			
Footing	1	3,000	32
Rock Protection	18	0	42
Sand Fill	19	0	31
Sandy Gravel Fill	21	0	35
Silt	19	0	30
Silt - Compact	19	0	32
Silty Sand	20	0	30

Method: Morgenstern-Price
Minimum Slip Surface Depth: 1 m
PWP Conditions from: Piezometric Line
Center: (31.939756, 129.3275) m
Radius: 38.516858 m

Analyses	Factor of Safety (Drained Analysis)	Appendix E Figure Number
Existing South Slope River Valley	1.0	Figure E1
Proposed South Abutment H-Pile Foundation	1.4	Figure E2
Proposed North Abutment H-Pile Foundation	1.6	Figure E3
