**PRELIMINARY
FOUNDATION INVESTIGATION AND DESIGN REPORT
OGDEN PEDESTRIAN BRIDGE REPLACEMENT
QUEEN ELIZABETH WAY, MISSISSAUGA, ONTARIO
G.W.P. 09-20003**

GEOCRES Number: 30M11-253

July 13 2015
File: 19-1351-219

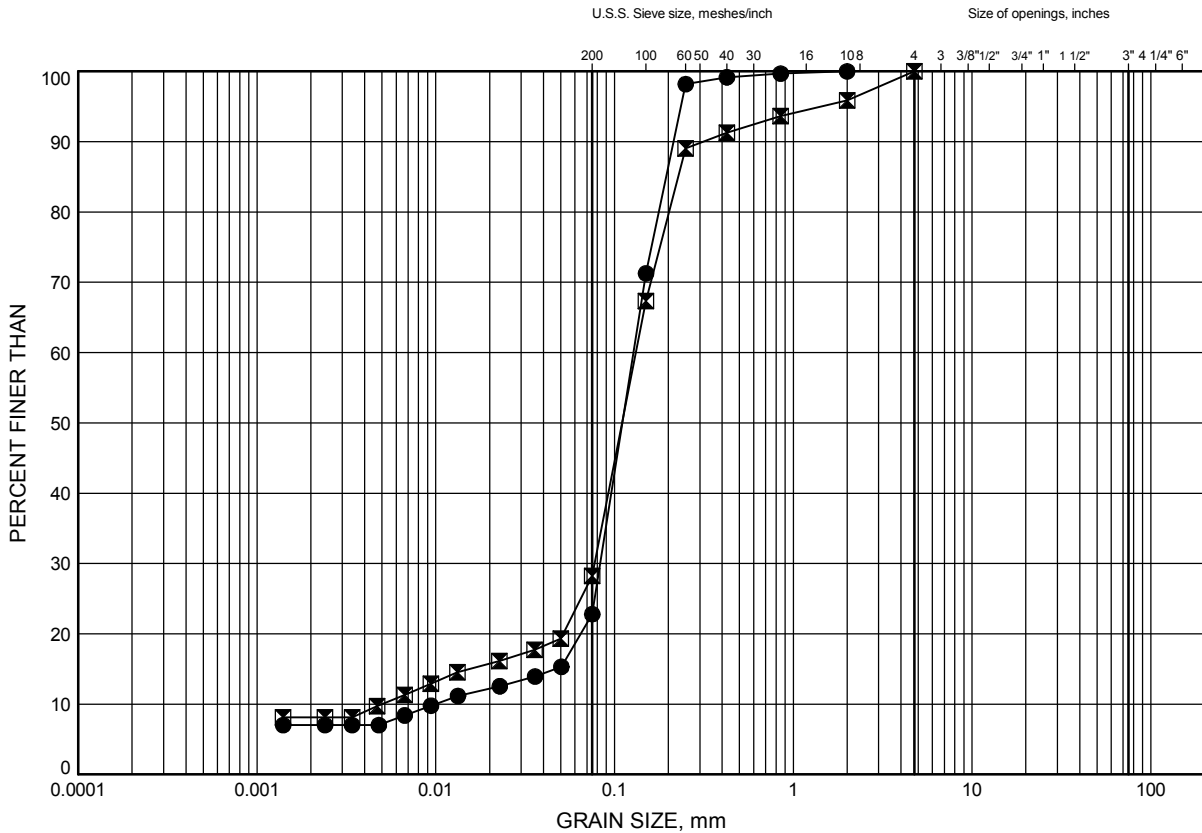
FIGURE B1

Results of grain size analyses conducted on selected samples of sand fill are presented on the Record of Borehole sheets, on Figure B1 in Appendix B, and are summarized below:

Soil Particles	Percentage (%)
Gravel	0
Sand	72 to 77
Silt	16 to 20
Clay	7 to 8

SAND FILL

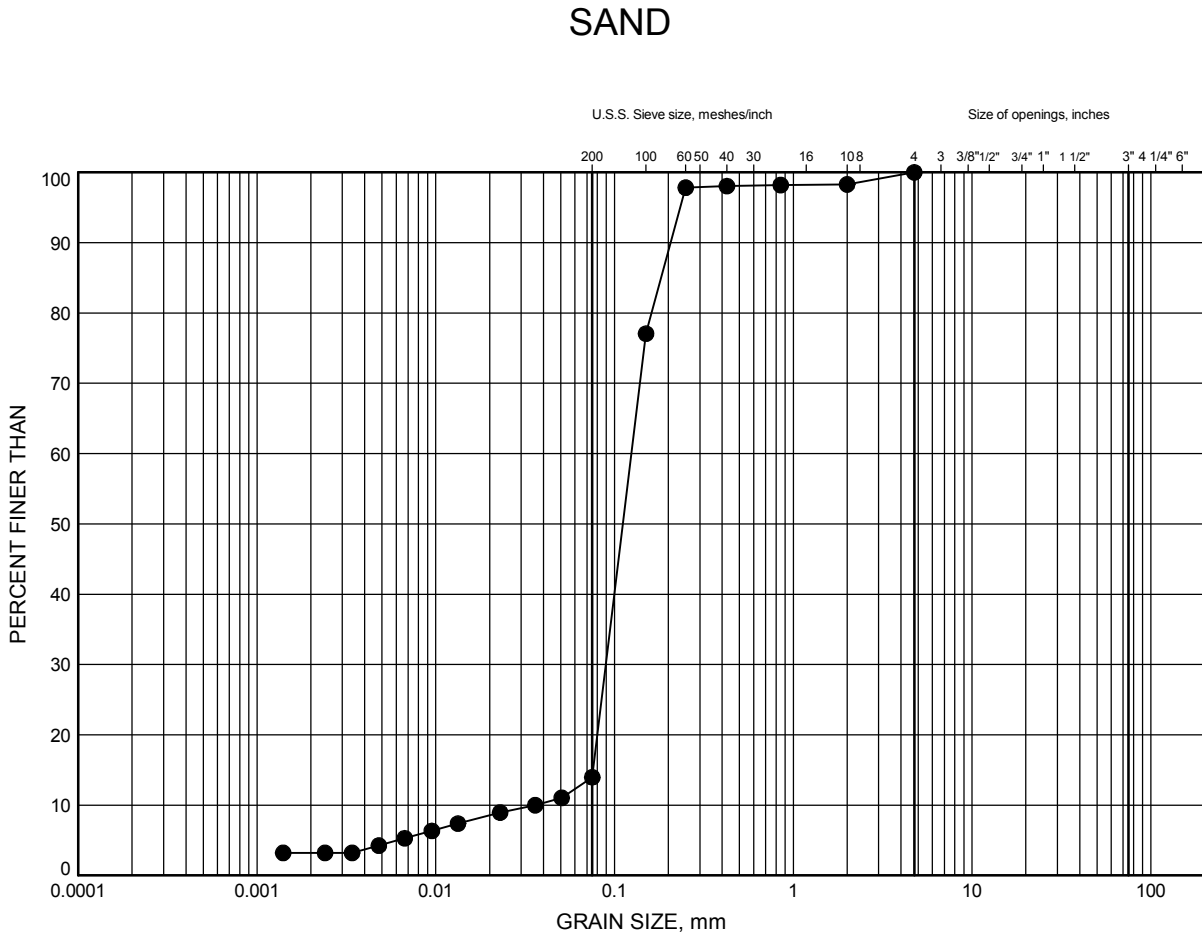
FIGURE B2

Results of grain size analyses conducted on selected samples of the sand are presented on the Record of Borehole sheets, on Figure B2 in Appendix B, and are summarized below:

Soil Particles	Percentage (%)
Gravel	0
Sand	86
Silt	11
Clay	3

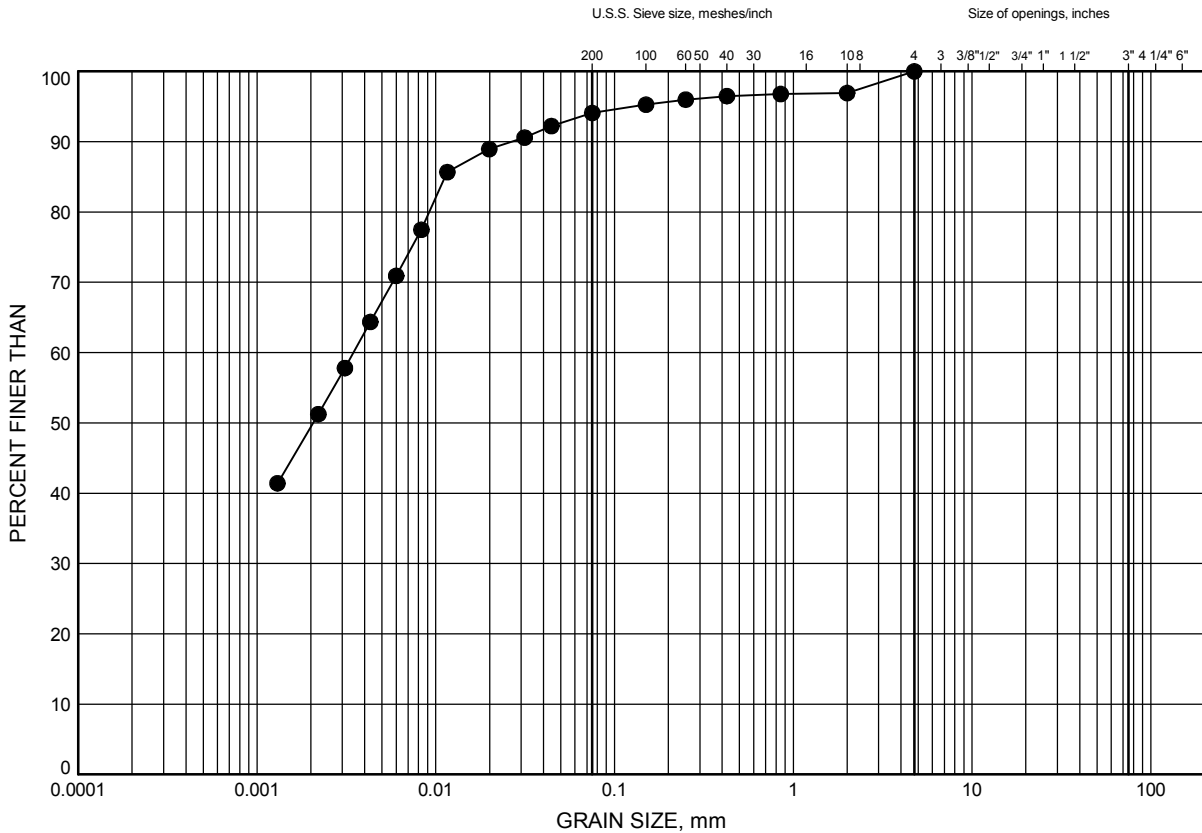
FIGURE B3

The results of grain size analyses conducted on a sample of the silty clay indicate the following fraction contents:

Soil Particles	Percentage (%)
Gravel	0
Sand	6
Silt	45
Clay	49

SILTY CLAY

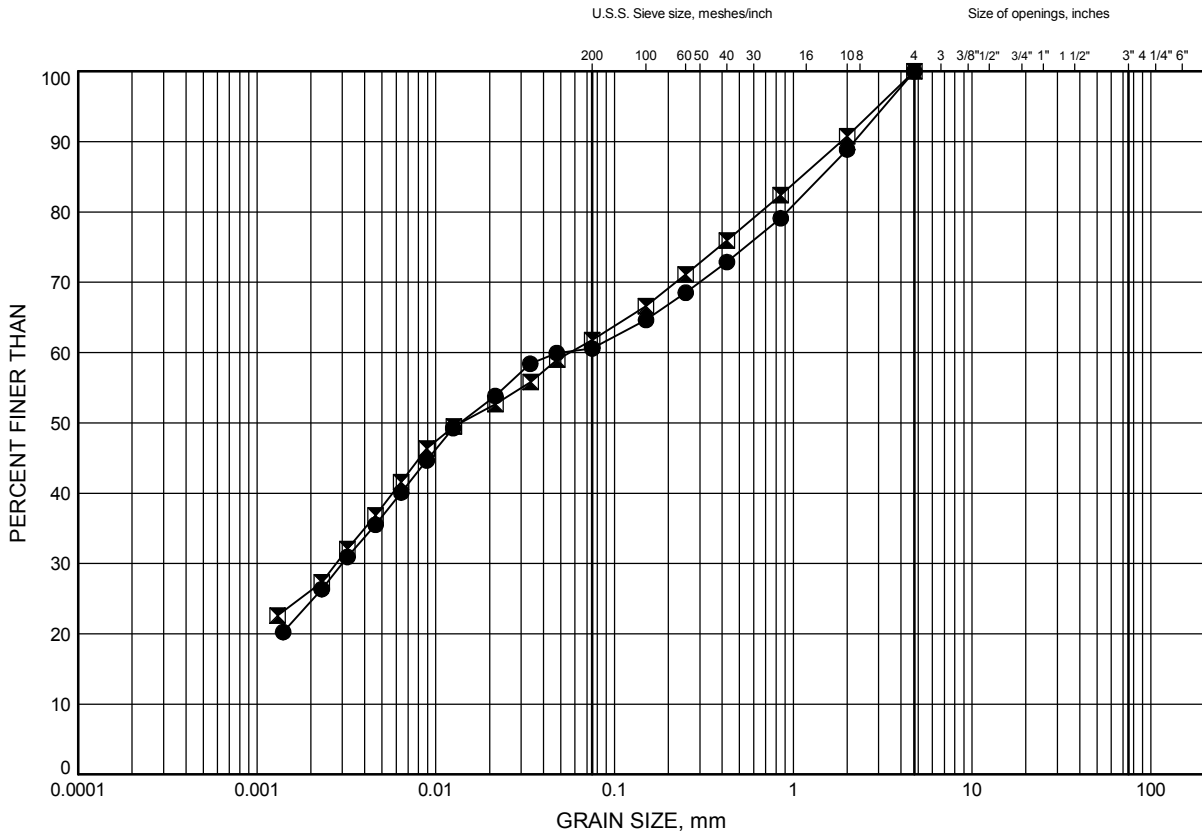
FIGURE B4

SILTY CLAY WITH SAND TILL

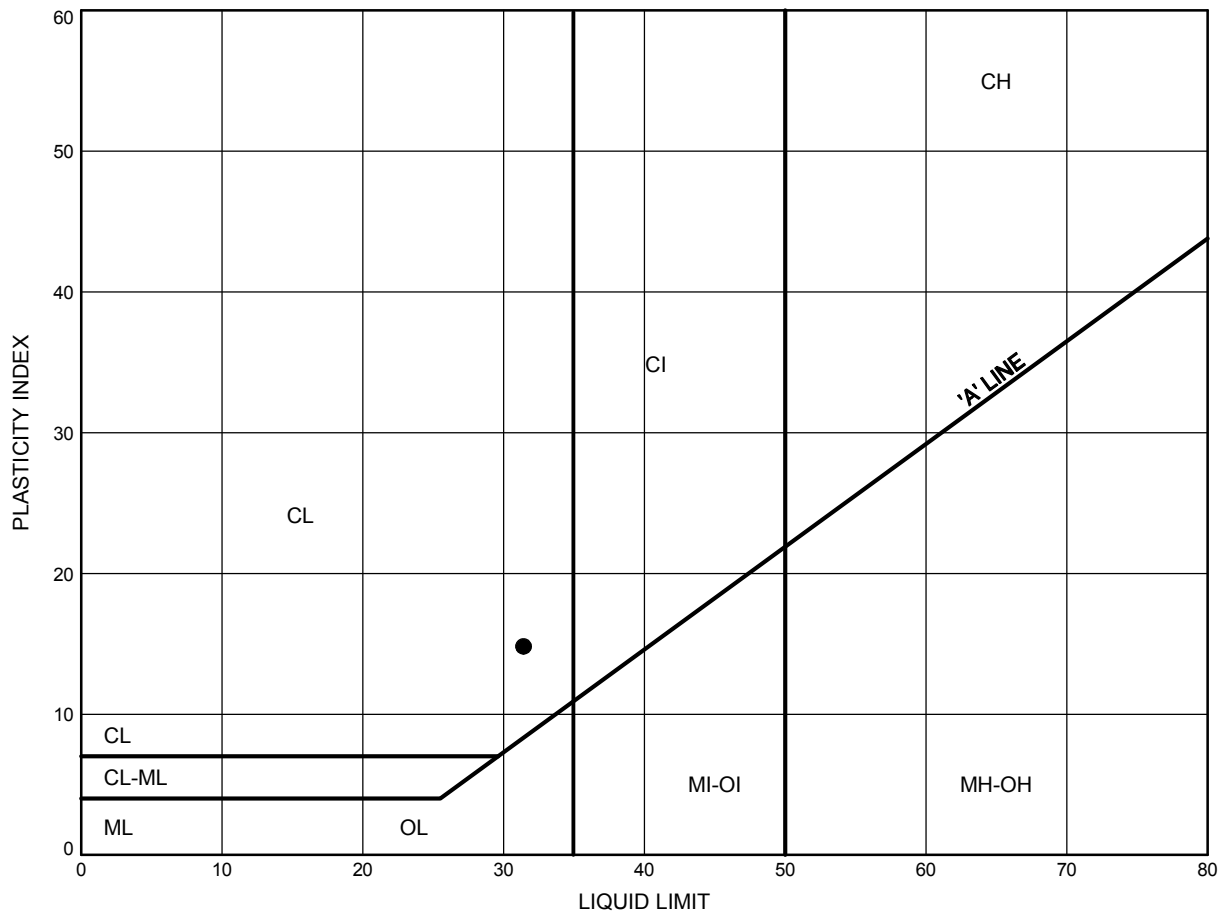
FIGURE B5

The results of Atterberg Limits test conducted on a sample of the silty clay are provided on the Record of Borehole sheet in Appendix A and are illustrated in Figure B5 of Appendix B. The results indicated that the deposit has liquid limit of 32% and plasticity index of 15%, suggesting low plasticity of the deposit. The measured natural moisture content of the clay samples were 19% and 20%.

SILTY CLAY

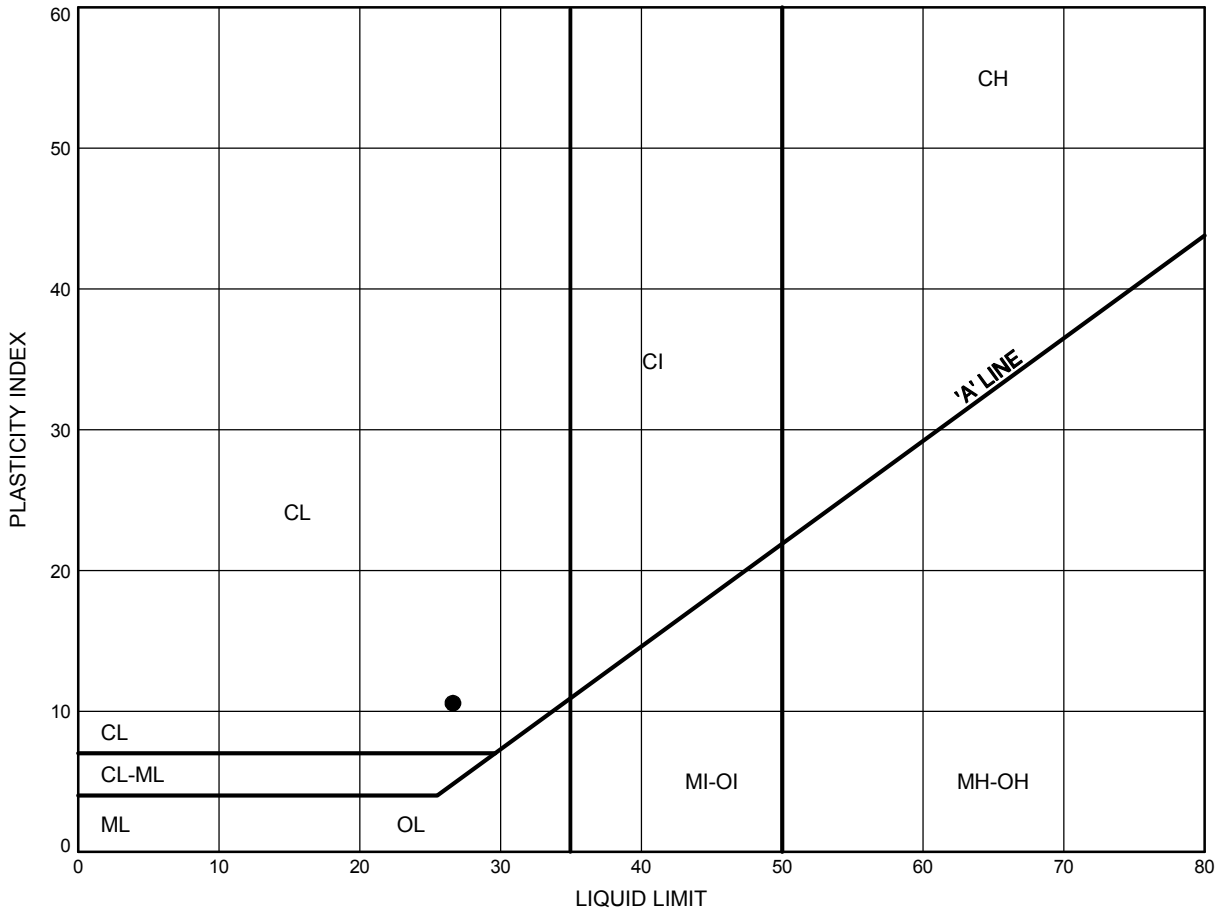
FIGURE B6

The results of Atterberg Limits test conducted on a sample of the silty clay till are provided on the Record of Borehole sheet in Appendix A and are illustrated in Figure B6 of Appendix B. The results indicated that the deposit has liquid limit of 27% and plasticity index of 16%, suggesting low plasticity of the deposit. The measured natural moisture content of the till samples ranged from 10% to 11%.

SILTY CLAY WITH SAND TILL

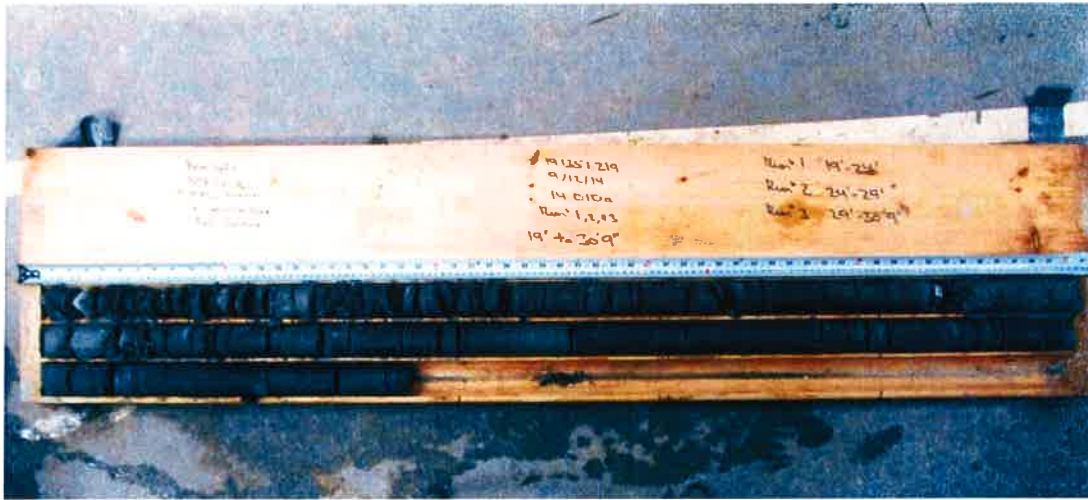
Photograph 1 – Rock Core from Drillhole 14-01a

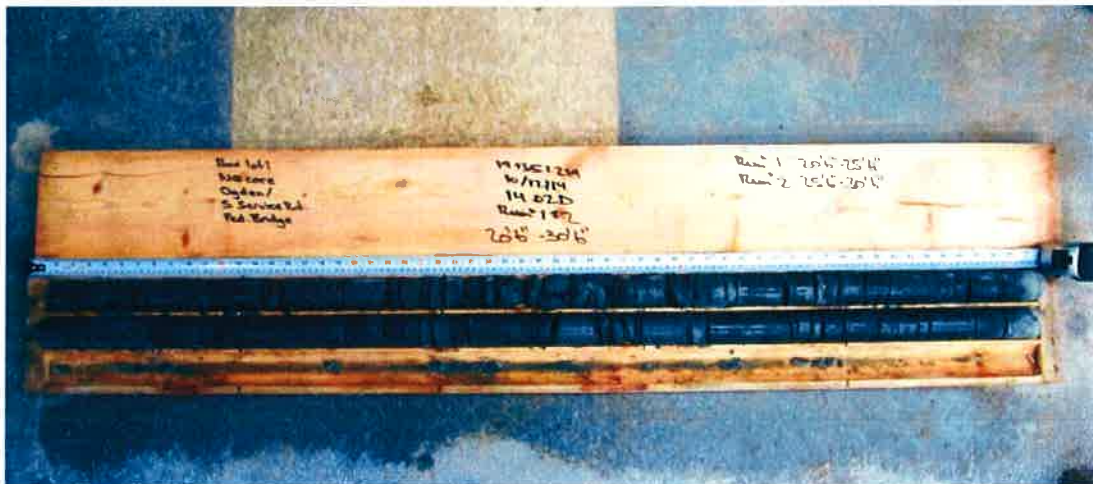
Photograph 2 – Rock Core from Drillhole 14-02

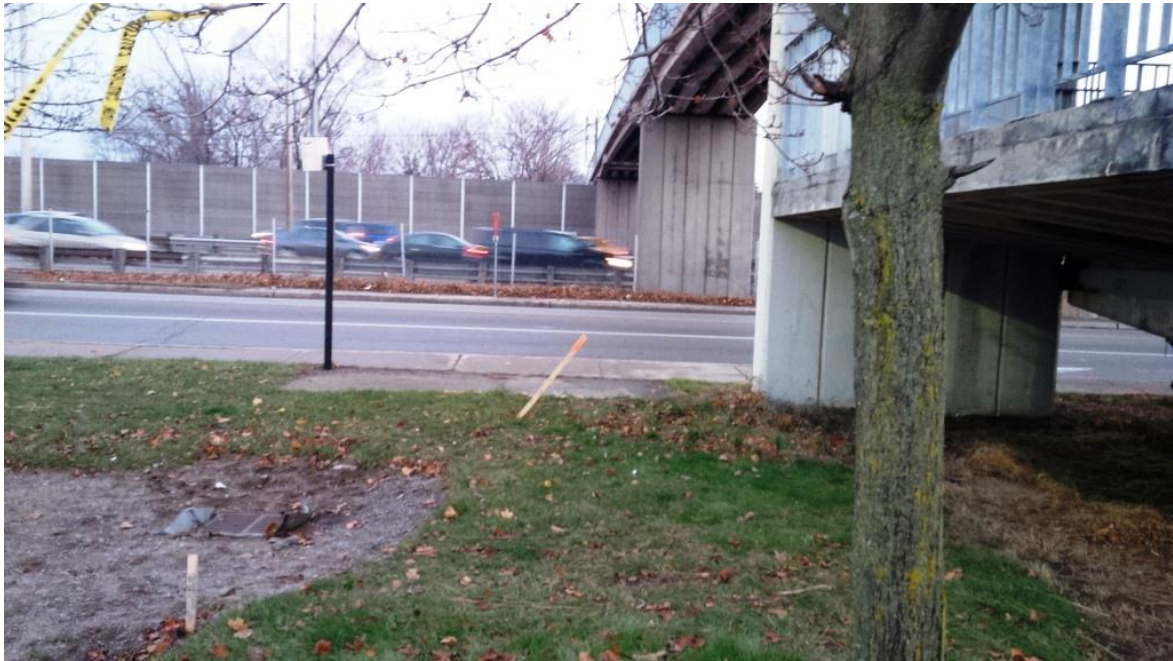
Photograph 1 – Ogden Bridge, East Elevation; looking south

Visual inspection did not reveal any evidence for performance problems in the bridge or ramp foundations.

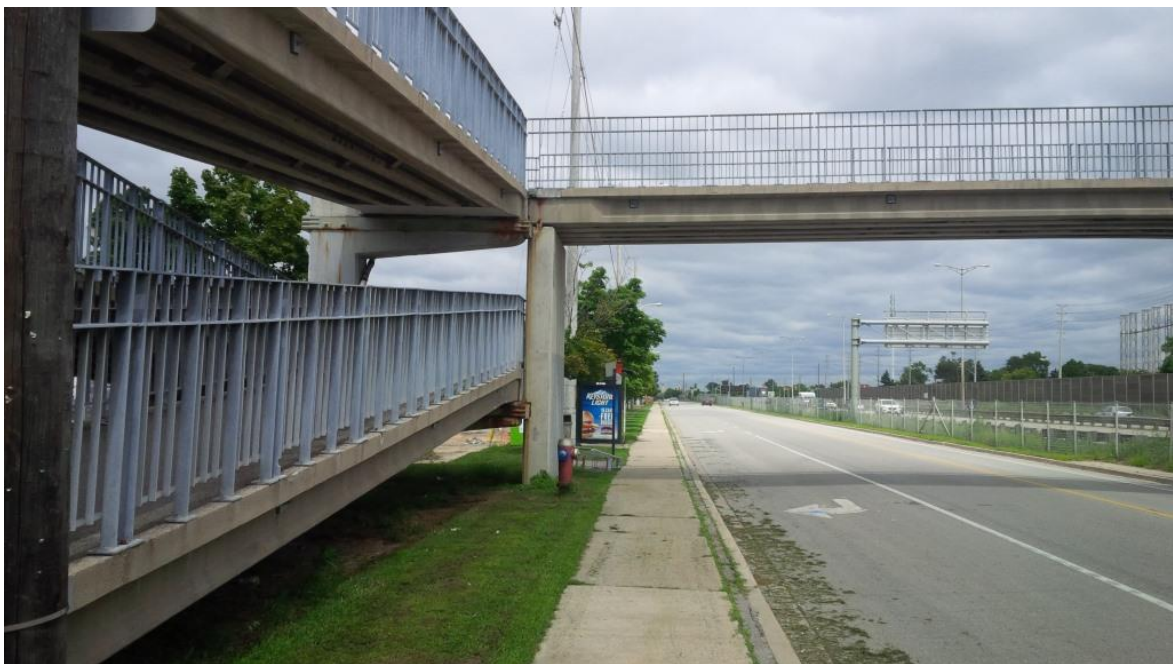
Photograph 2 – North end of Ogden Bridge and access ramps; looking east along North Service Road

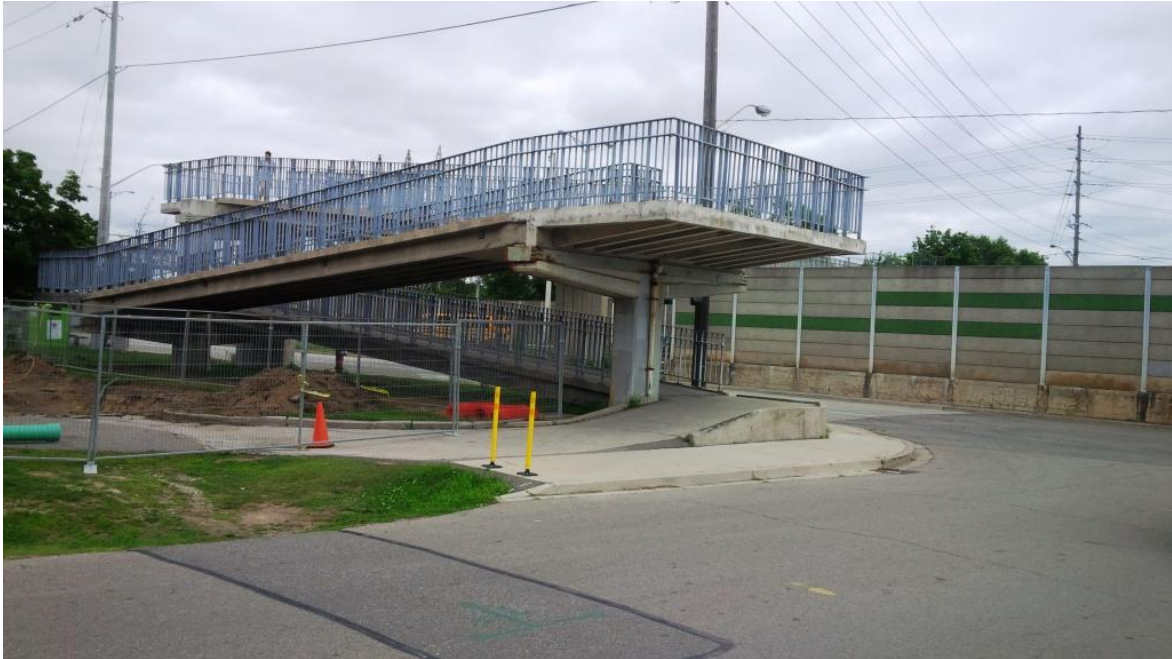
Photograph 3 – North ramps and landings; also visible overhead hydro lines - view from the west side of Insley Road

- Existing overhead hydro line will need to be considered in selection of construction equipment.
- If deep foundations are selected for this structure, the caisson installation equipment should be capable of dislodging and removing any obstructions such as cobbles, boulders and other obstructions in the fill and native soils, if encountered. Hard layers of limestone interbedded in the shale bedrock may require the use of coring or rock breaking equipment in addition to the augering equipment, as the Contractor would be required to advance holes to specified elevations.

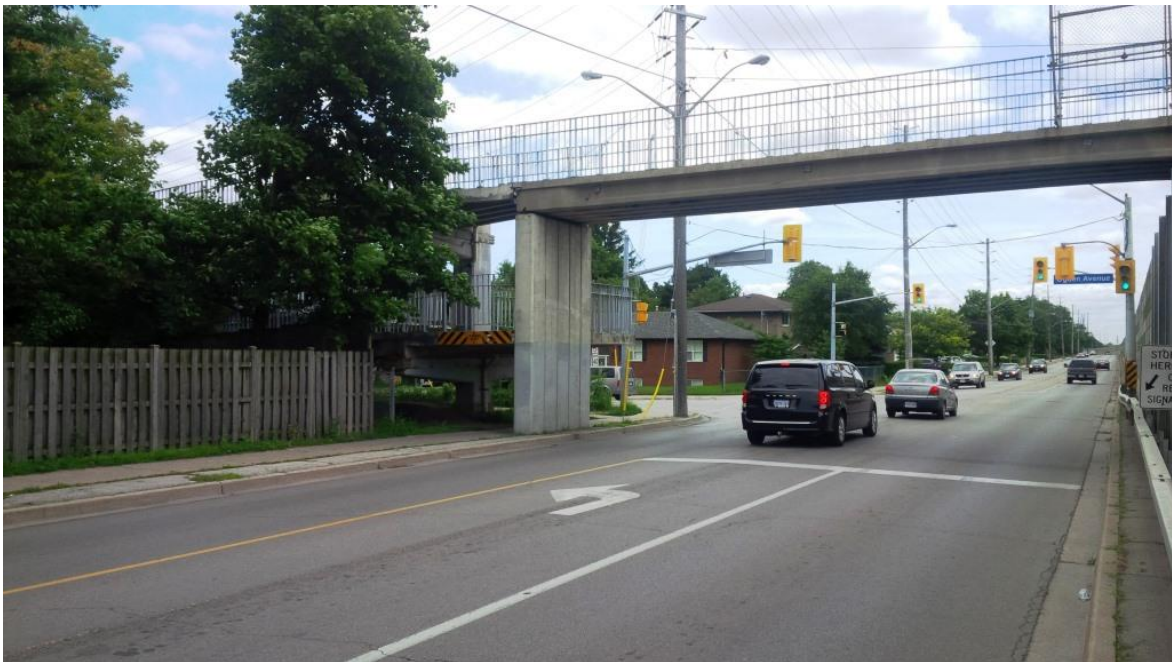
Photograph 4 – Southern section of the Ogden Bridge: looking west along South Service Road.

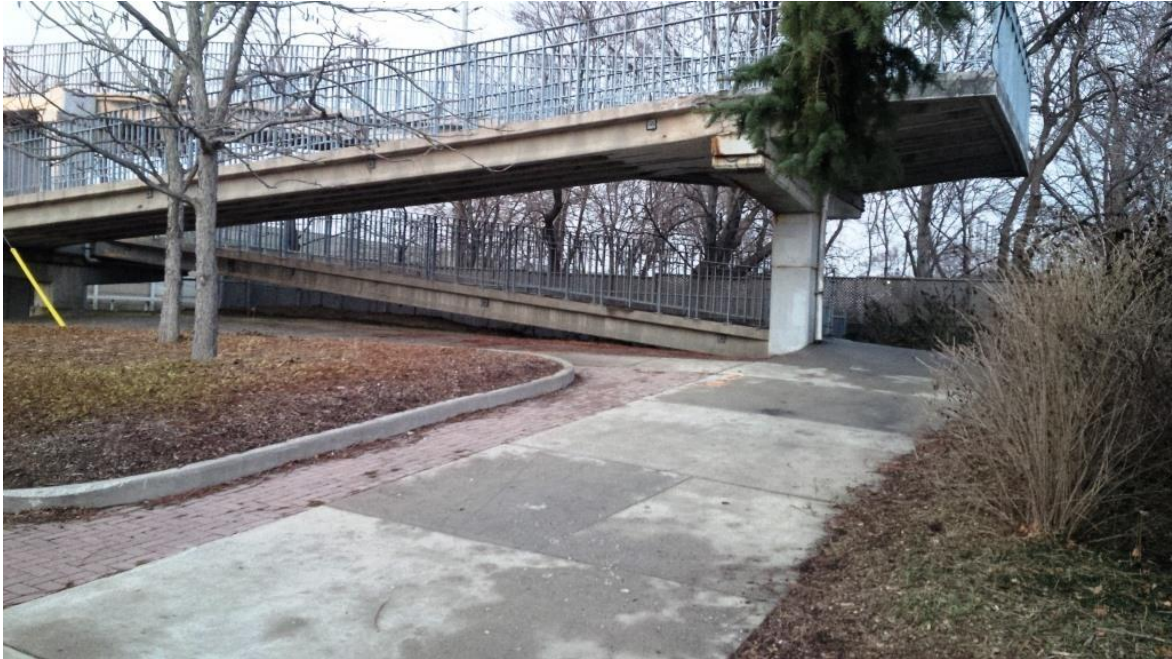
Photograph 5 – South ramps and landings; looking east from Ogden Avenue

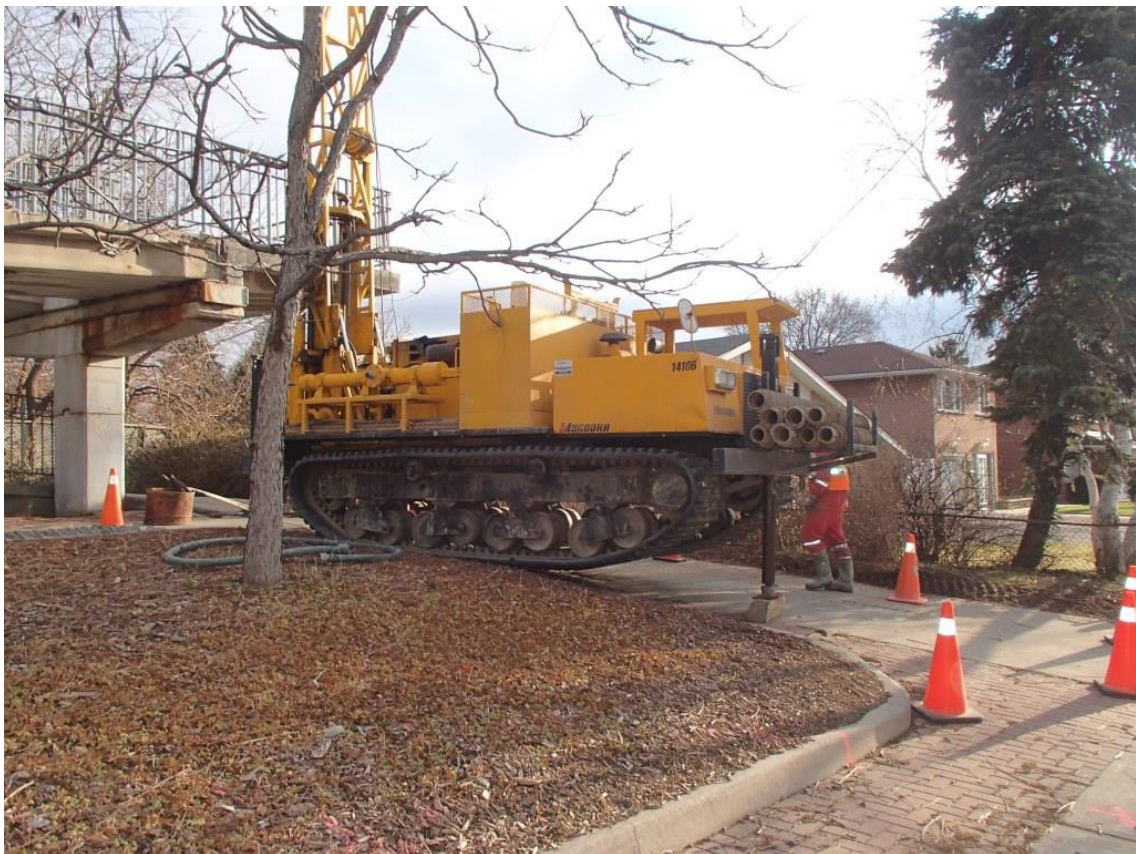
Photograph 6 – Drill rig lined up in front of south ramps at Borehole PB14-02; looking southeast from Ogden Avenue

A rubber track-mounted Acker drill rig was used in combination with continuous flight hollow stem augers to advance the boreholes through pavement structure and native soils into bedrock. Soil samples were obtained at selected intervals using a split spoon sampler in conjunction with the Standard Penetration Testing (SPT). Bedrock was proved by a minimum of 3 m coring using NQ-sized coring equipment. All rock cores were logged, and properties including Total Core Recovery (TCR), Solid Core Recovery (SCR), Rock Quality Designation (RQD) and Fracture Indices (FI) were determined, where applicable.
