**FOUNDATION INVESTIGATION AND DESIGN REPORT
REED NARROWS BRIDGE REHABILITATION
HIGHWAY 71, TOWNSHIP OF SIOUX NARROWS-NESTOR FALLS
DISTRICT OF KENORA, ONTARIO
W.P. No. 6808-14-03, SITE No. 41S-002**

LATITUDE: 49.432946°, LONGITUDE: -94.013724°

GEOCRES Number: 52E-070

Date: December 13, 2018
File: 18879

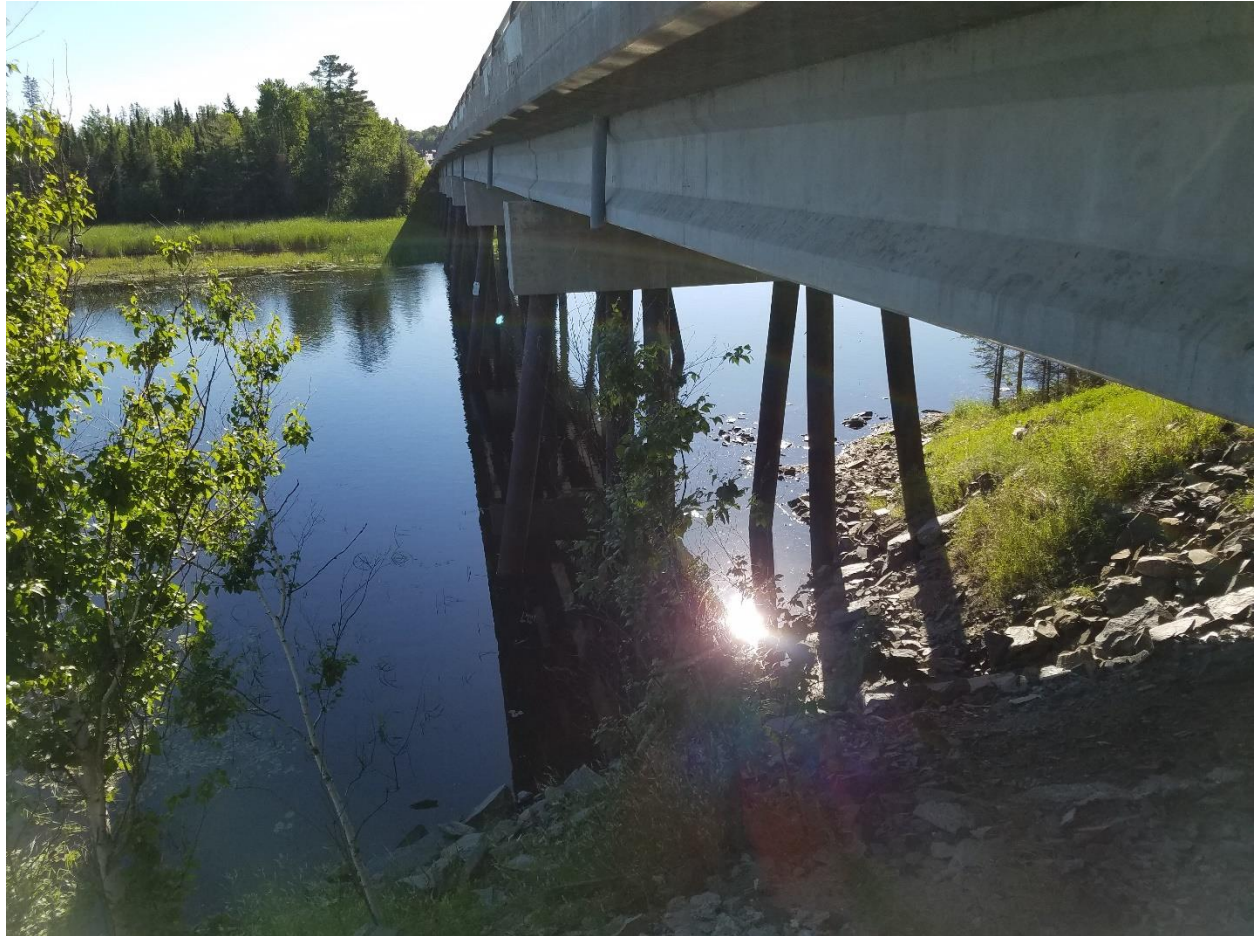
Photograph # 1 – West Side of Bridge looking north (July 2018)

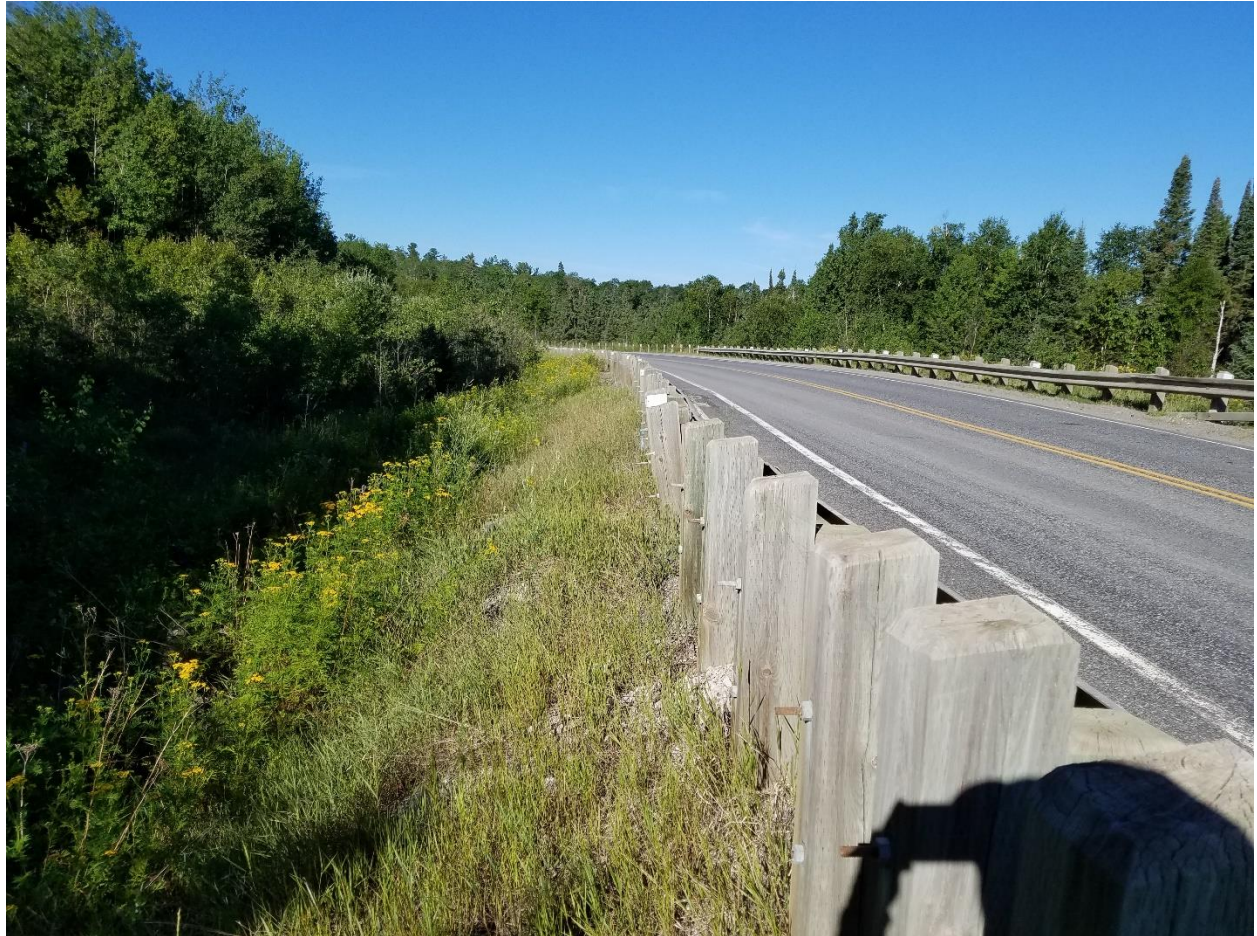
Photograph # 2 –South Approach looking south (July 2018)

Photographs of the bridge and surrounding area are presented in Appendix A. Rock fill was observed at the surface at both the north and south approaches. The existing approach embankments appear to be stable. The margins of the narrows are marshy and the adjacent lands are wooded. Bedrock outcrops are visible on the west side of the waterway. The general area of the bridge consists of rock outcrops, forests, swamps and lakes.

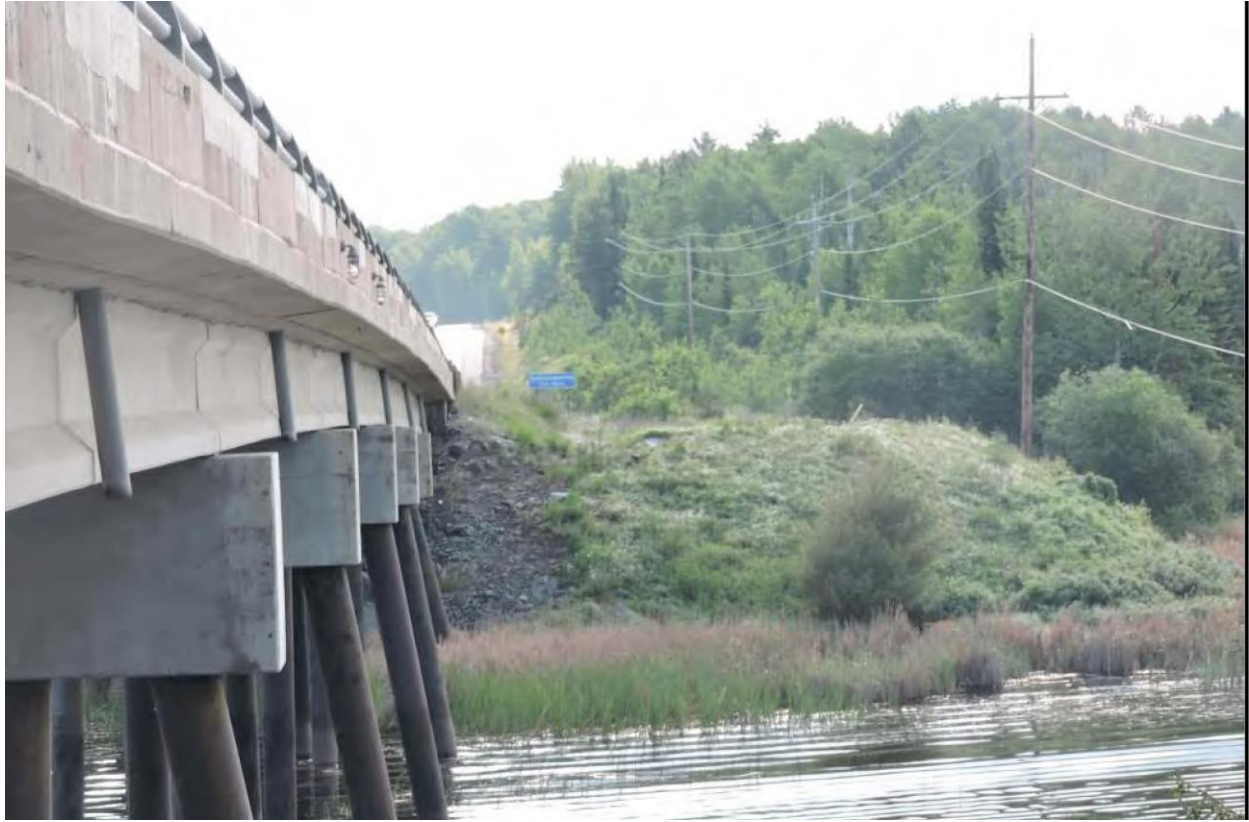
Photograph # 3 – North Embankment, East Side (from OSIM August 2015)

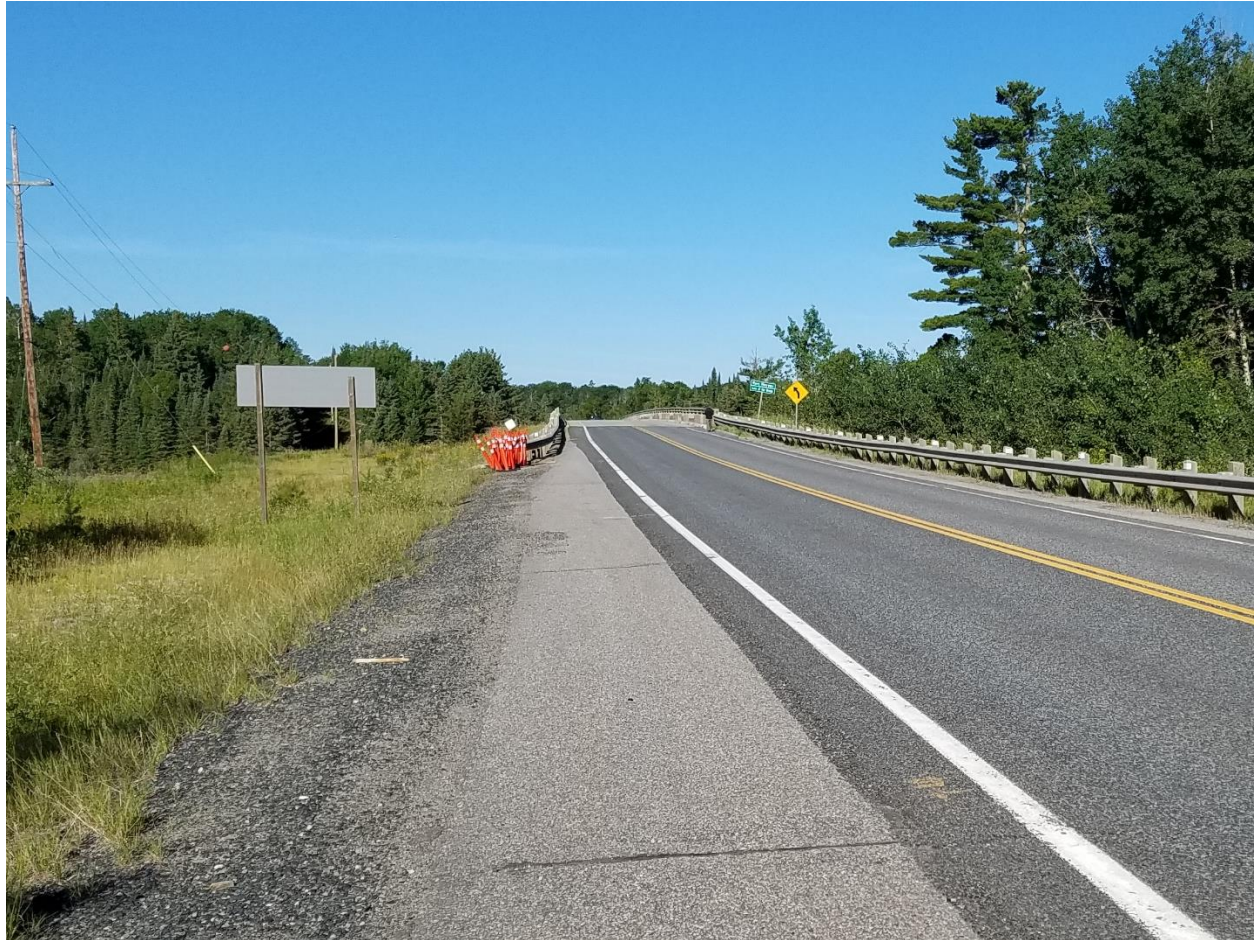
Photograph # 4 – North Approach, looking south (July 2018)

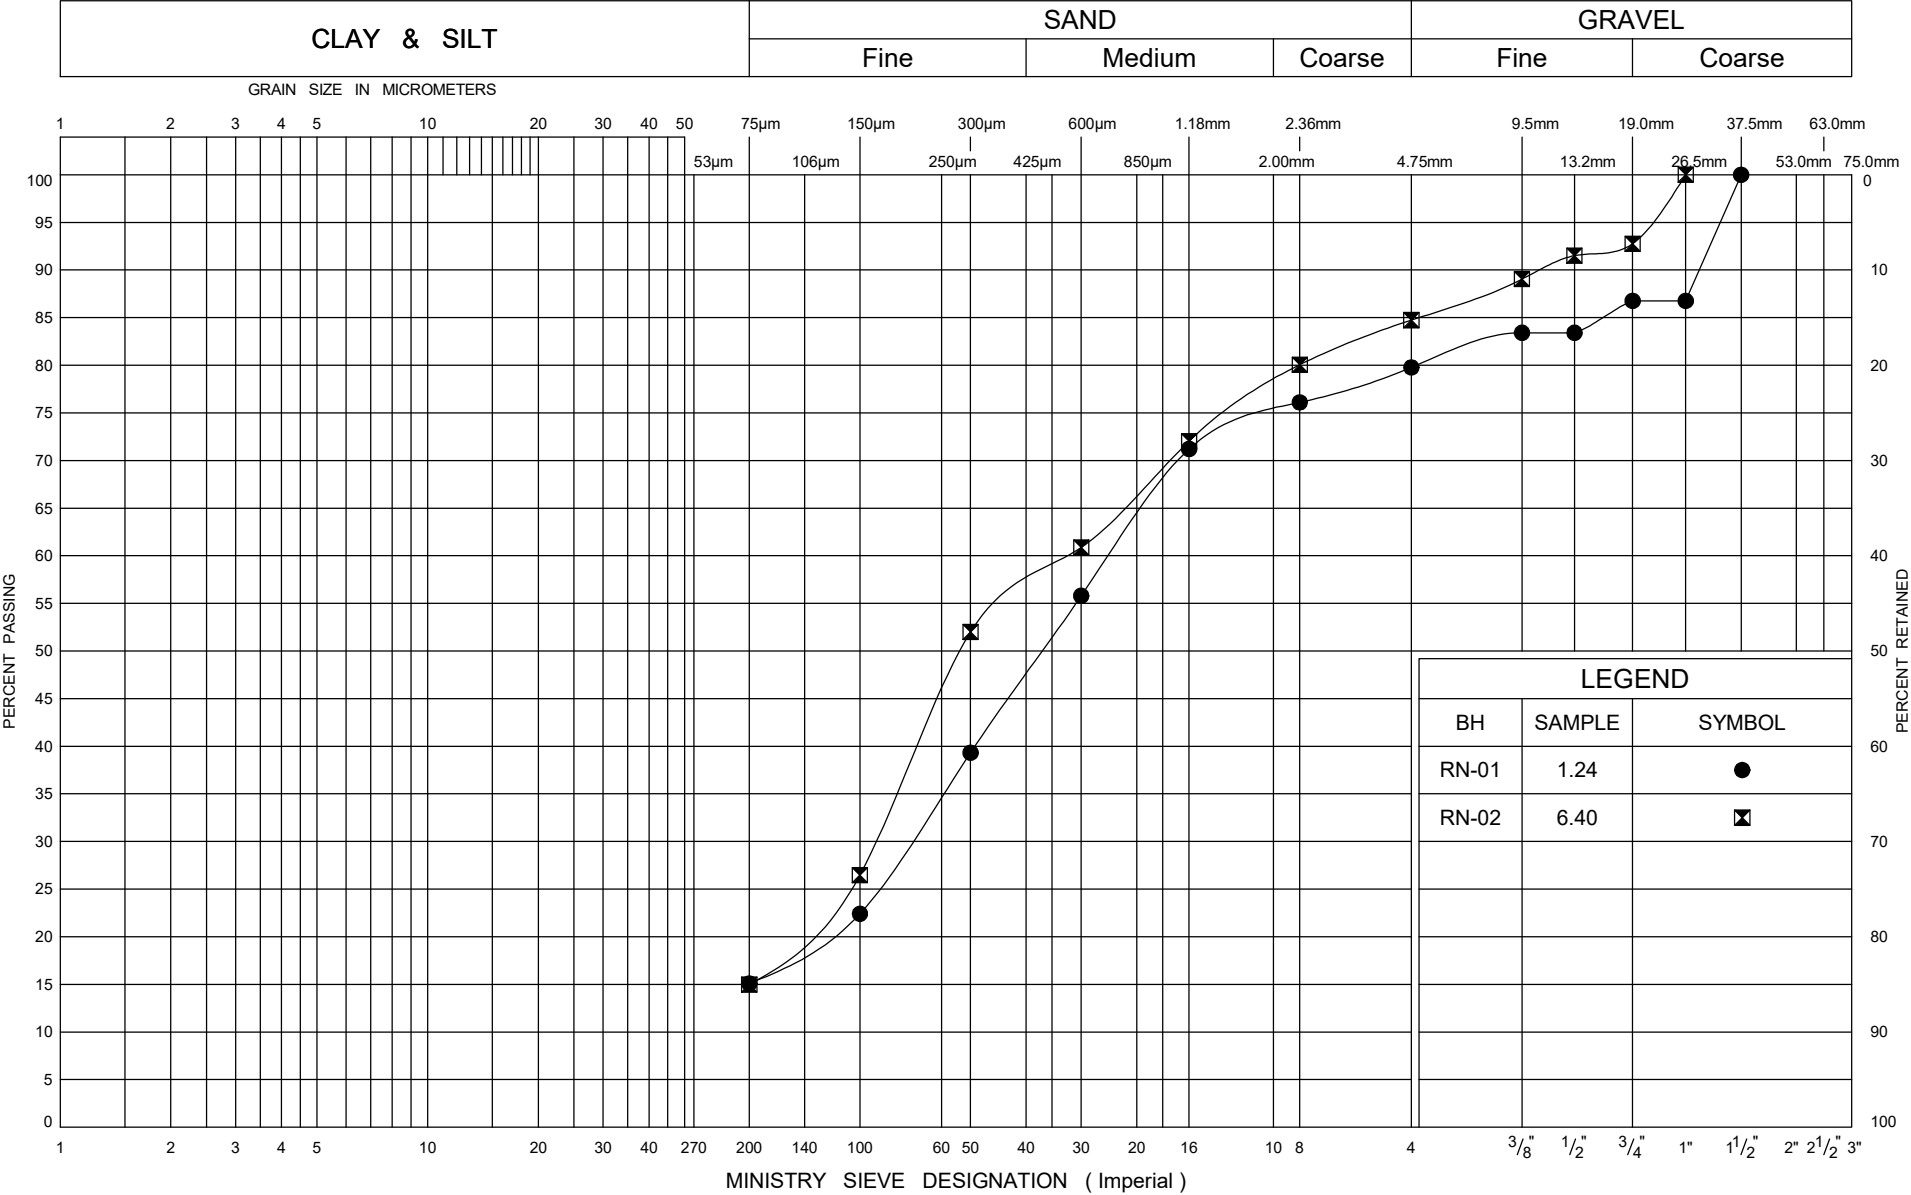
UNIFIED SOIL CLASSIFICATION SYSTEM

The results of grain size distribution analyses conducted on samples of the sand to gravelly sand fill are provided on the Record of Borehole sheets in Appendix B, and illustrated in Figure C1 of Appendix C. The results are summarized as follows:

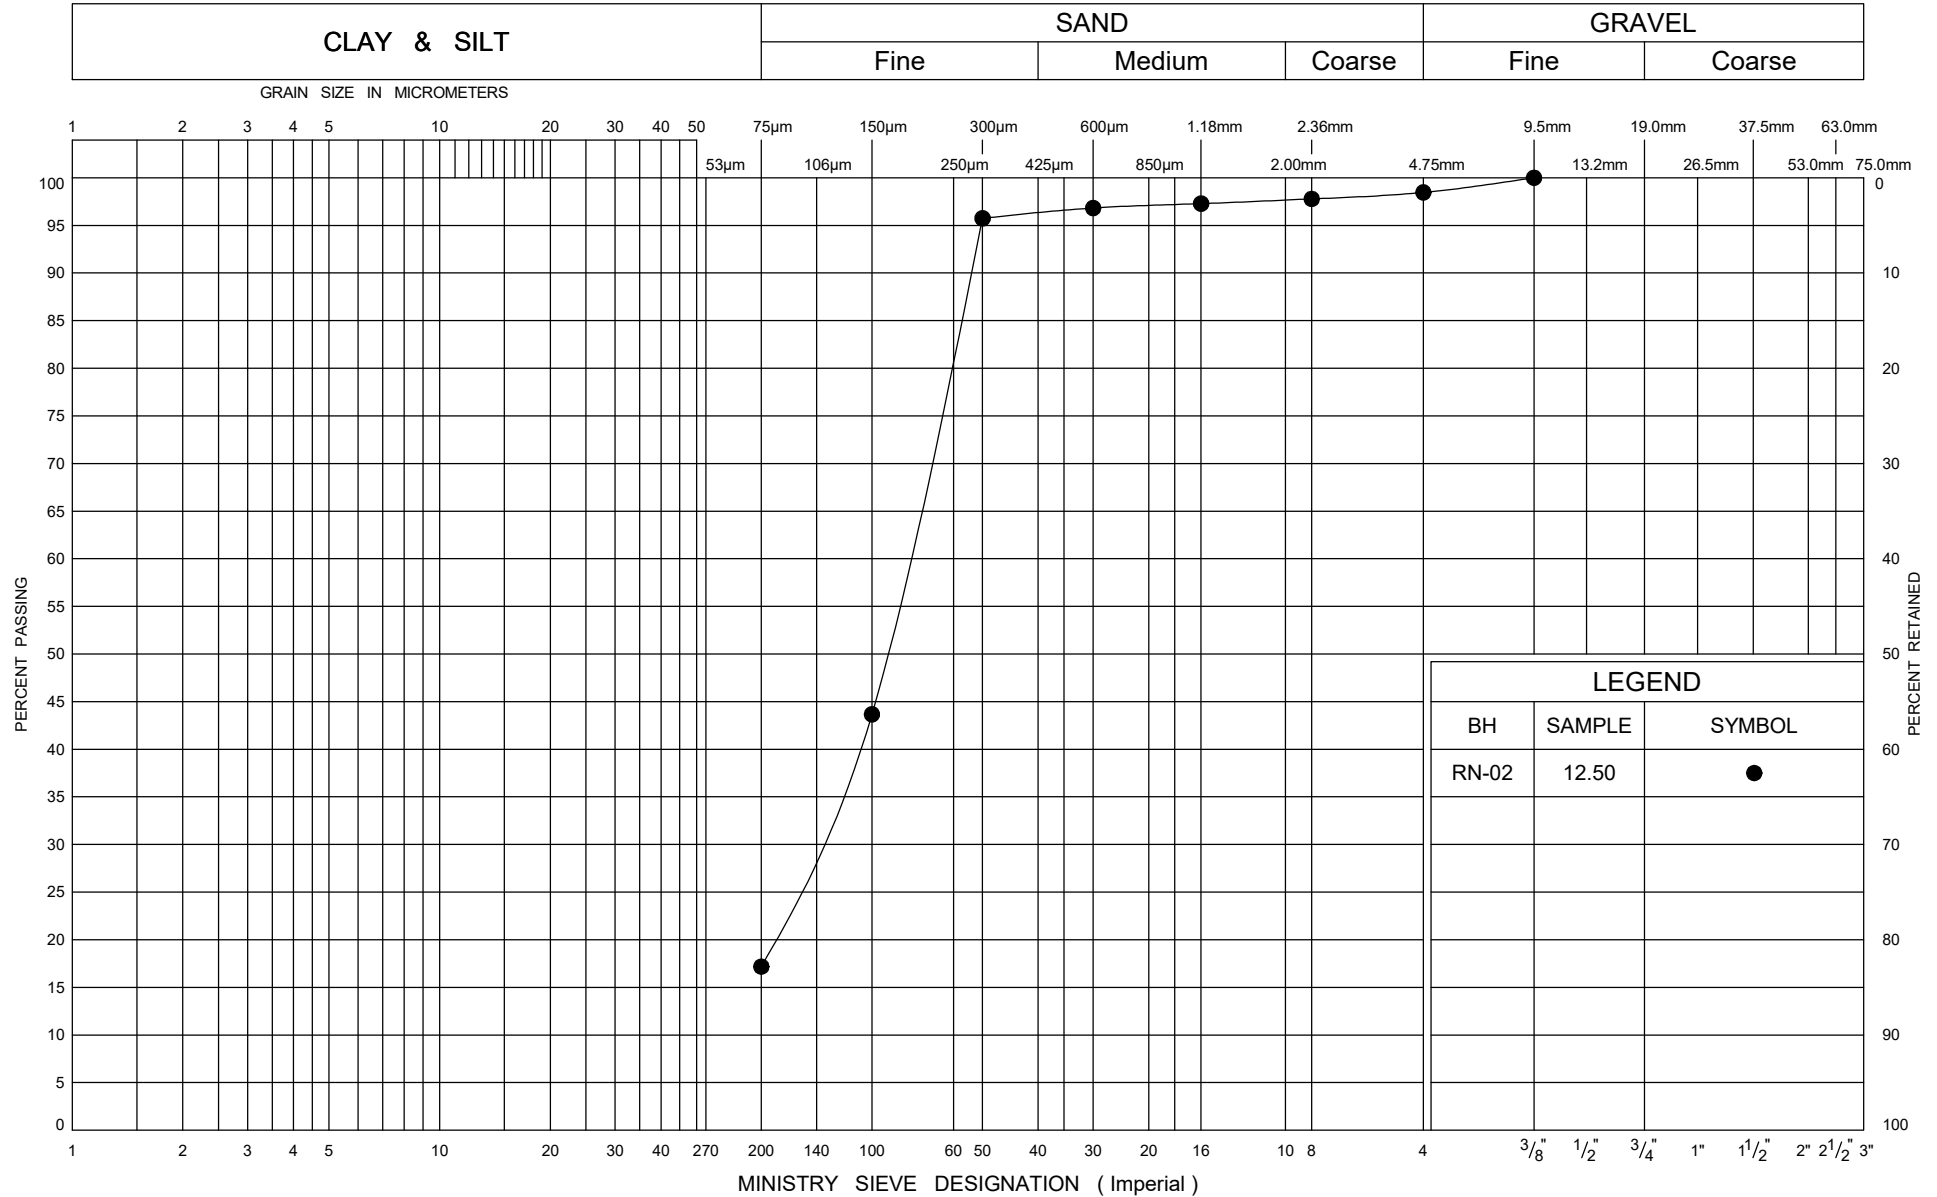
GRAIN SIZE DISTRIBUTION

The results of a grain size analysis conducted on a sample of the sand are provided on the Record of Borehole sheets in Appendix B, and illustrated in Figure C3 of Appendix C. The results are summarized as follows:

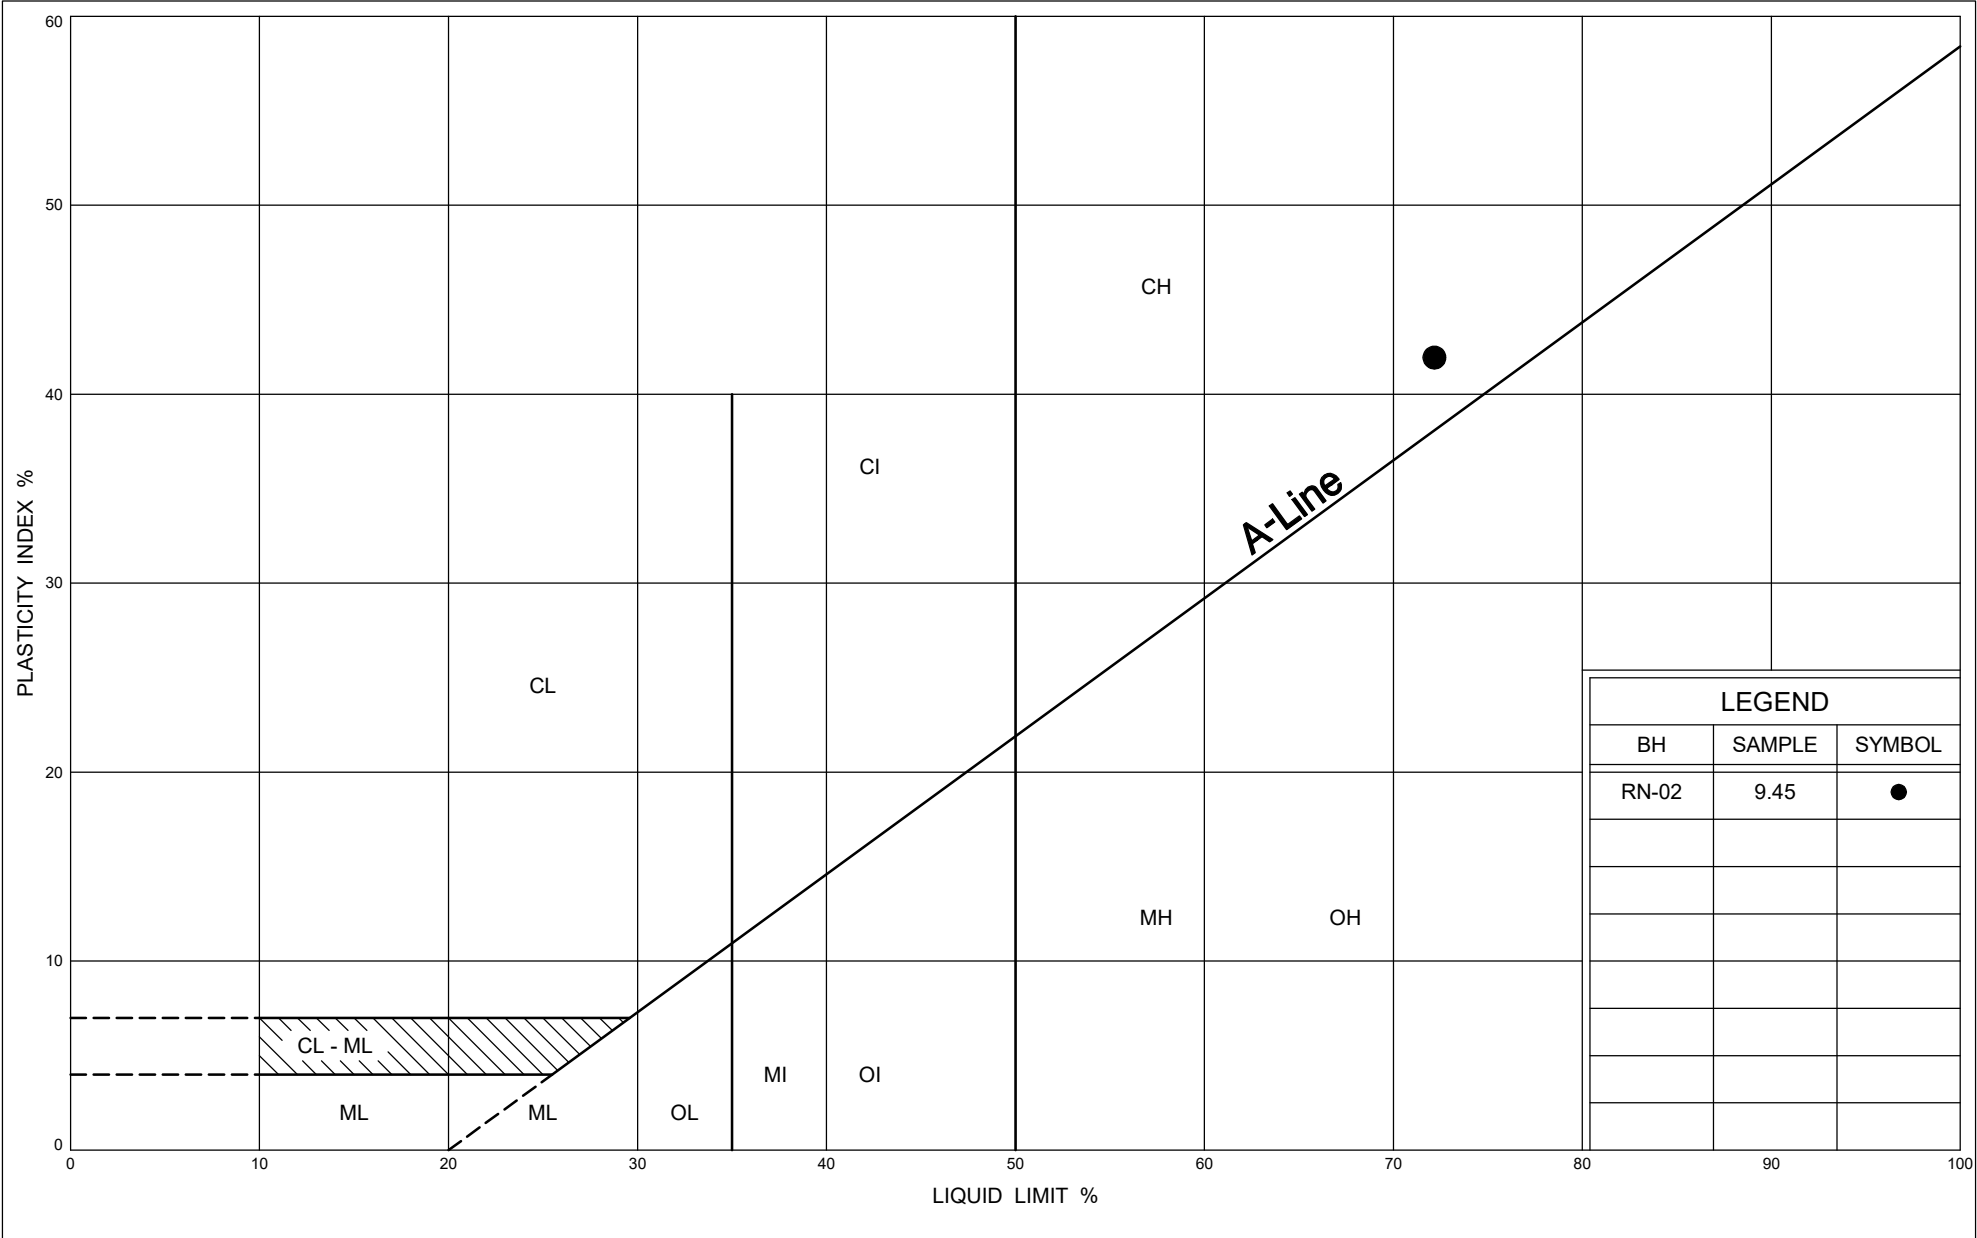
ONTARIO MOT PLASTICITY CHART MTO-18879.GPJ ONTARIO MOT.GDT 9/10/18

The results of a grain size analysis and Atterberg limits test conducted on a sample of the silty clay are provided on the Record of Borehole sheets in Appendix B, and illustrated in Figures C2 and C4 of Appendix C. The grain size results are summarized as follows:

The results of the Atterberg Limits test indicate the layer to be of high plasticity with a group symbol of CH.

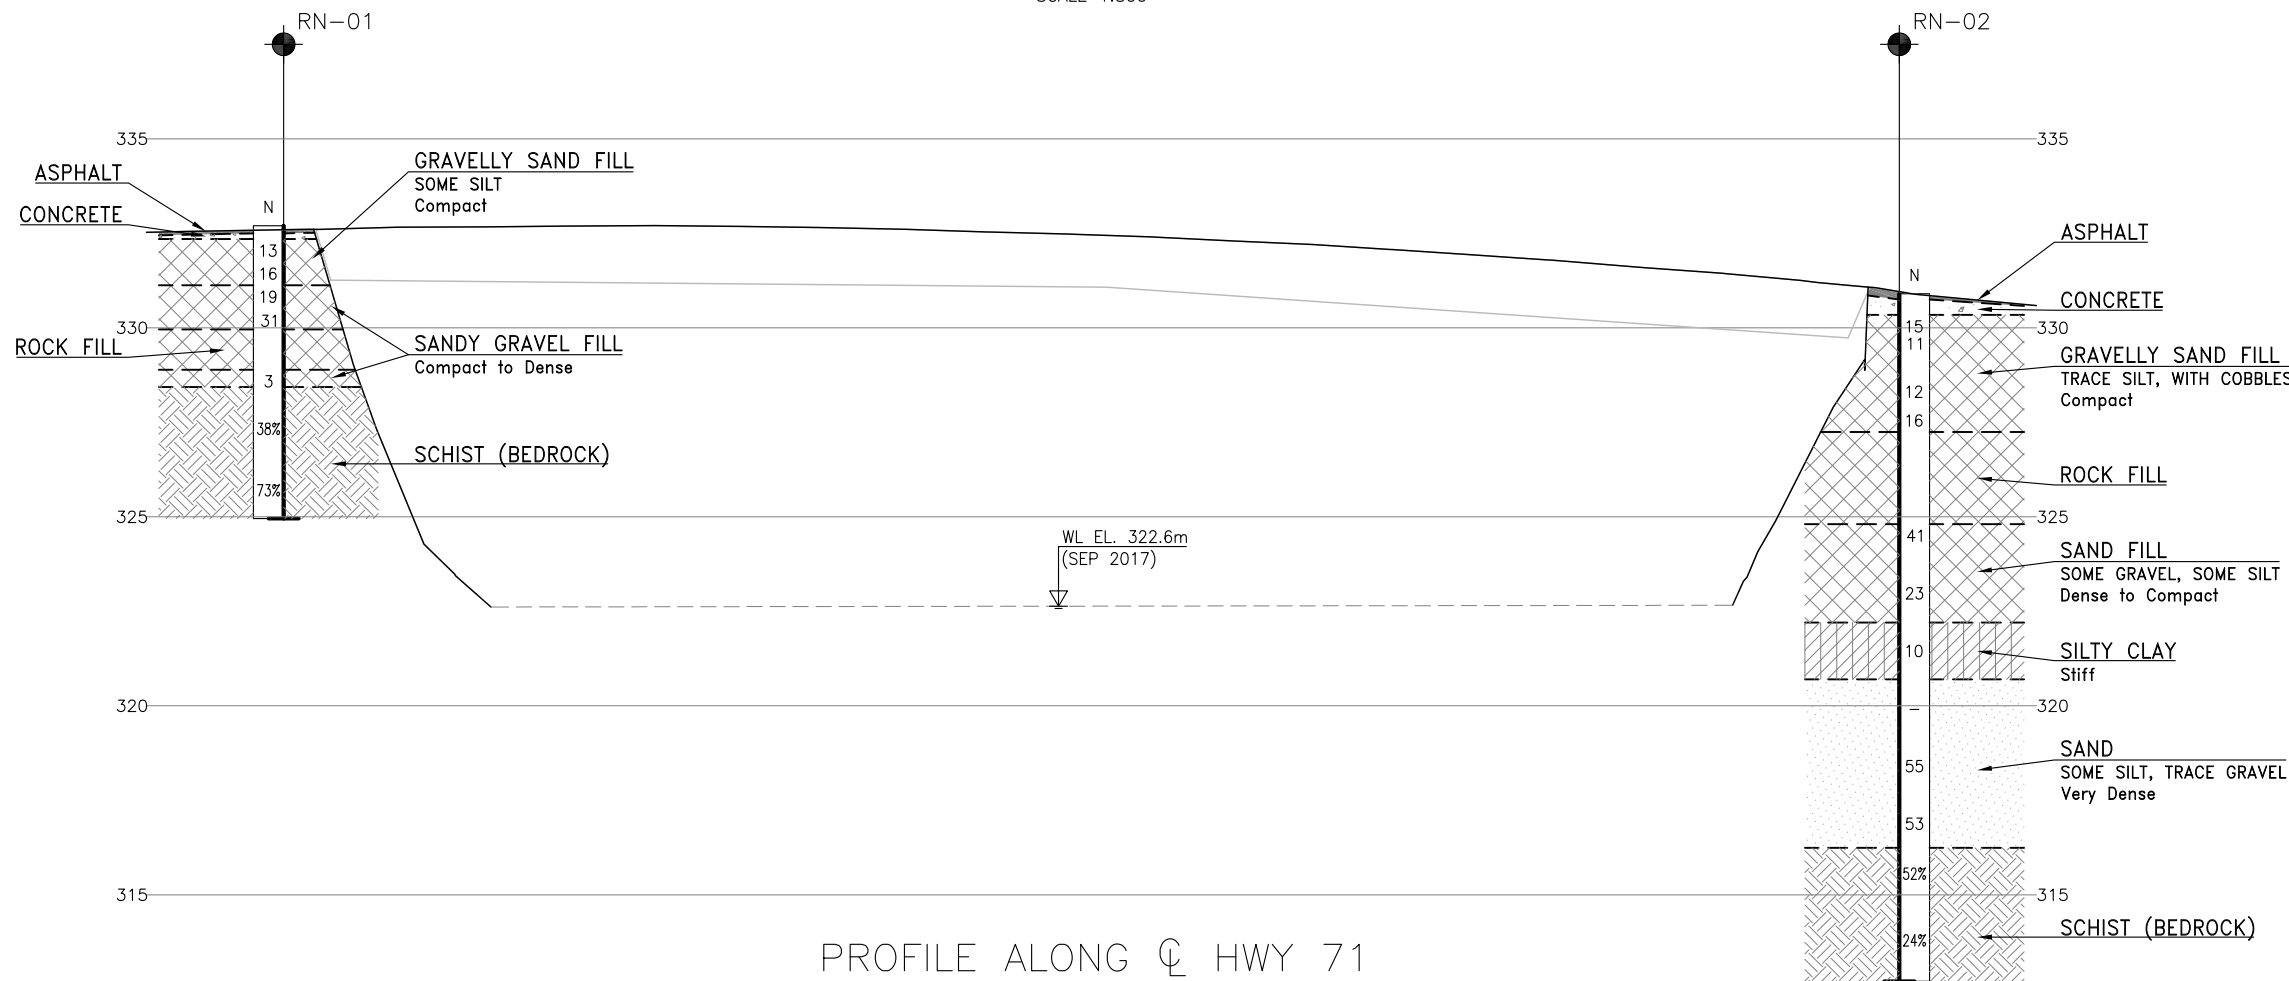
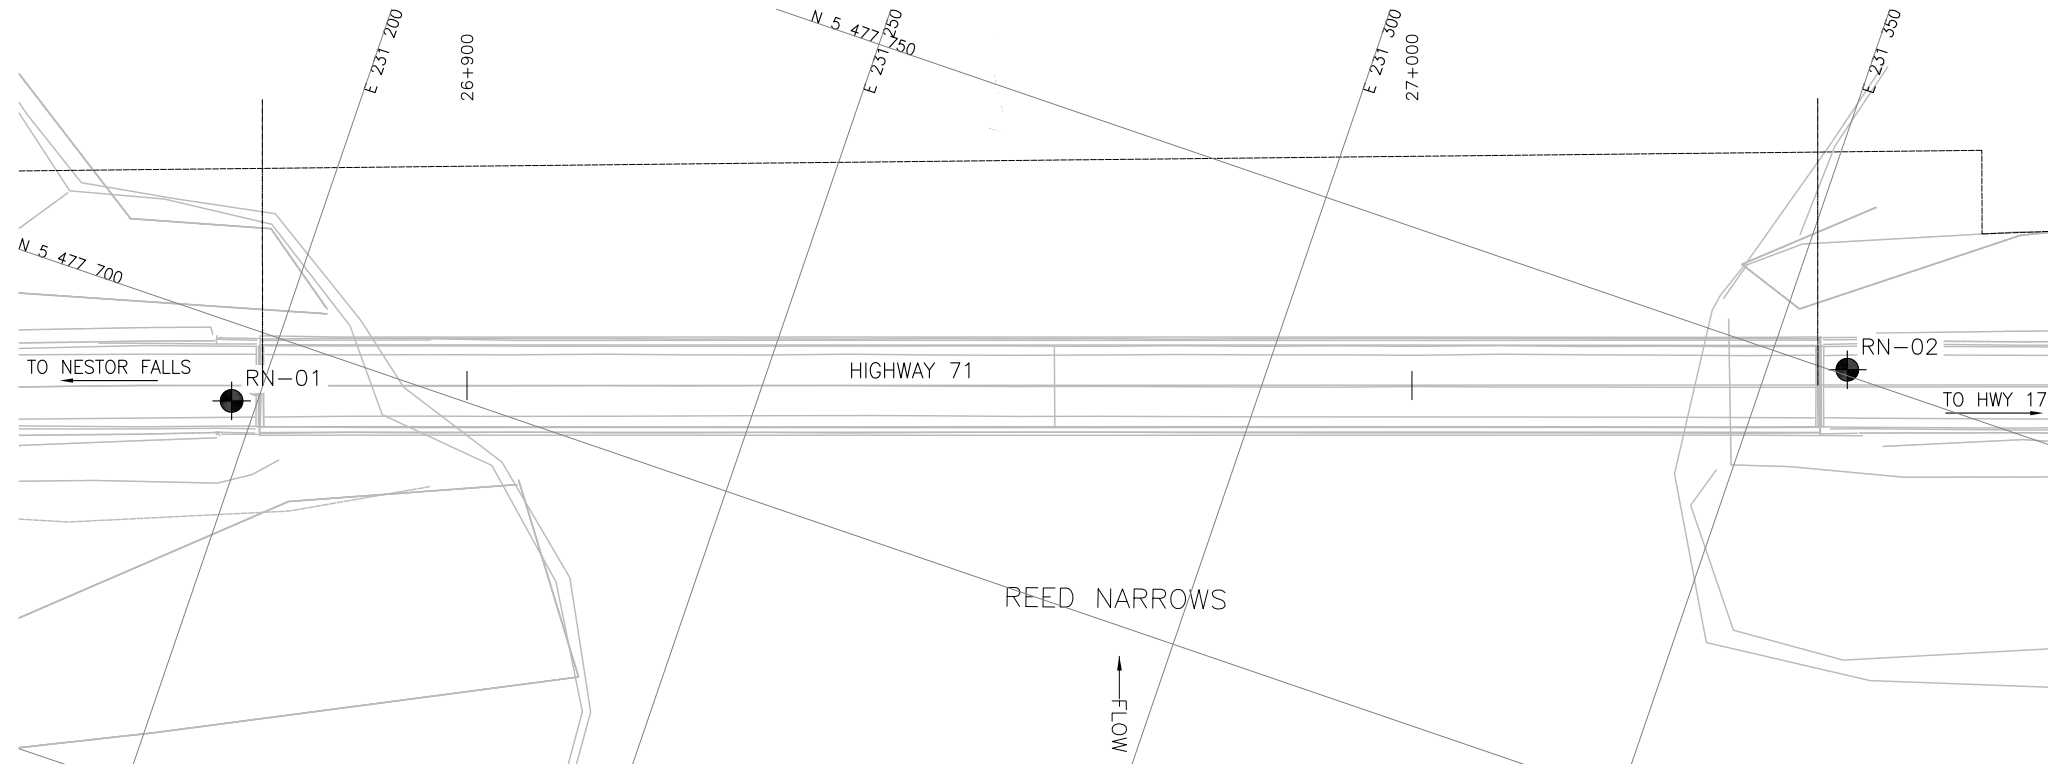
HIGHWAY 71
REED NARROWS BRIDGE
REHABILITATION
BOREHOLE LOCATIONS AND SOIL STRATA

PROFILE ALONG \varnothing HWY 71

The borehole locations and depths are summarized in Table 3.1. The approximate locations of the boreholes are shown on the Borehole Locations and Soil Strata drawing in Appendix F. The locations were established in the field relative to site features, and the ground elevations at the boreholes have been interpreted from topographic and cross-section drawings provided by McIntosh Perry. An accuracy of 0.1 m is inferred.

Reference is made to the Record of Borehole sheets included in Appendix B. Details of the encountered soil stratigraphy are presented on the Record of Borehole sheets and on the Borehole Locations and Soil Strata Drawing included in Appendix F. A general description of the stratigraphy, based on the conditions encountered in the boreholes, is given in the following paragraphs. However, the factual data presented on the Record of Borehole sheets takes
