**FOUNDATION INVESTIGATION REPORT
HIGHWAY 6 (NEW) AND GLANCASTER ROAD
HAMILTON, ONTARIO
W.P. 604-00-01**

SHAHEEN & PEAKER LIMITED

**Project: SPT1105
December 3, 2003**

**FOUNDATION DESIGN REPORT
HIGHWAY 6 (NEW) AND GLANCASTER ROAD
HAMILTON, ONTARIO
W.P. 604-00-01**

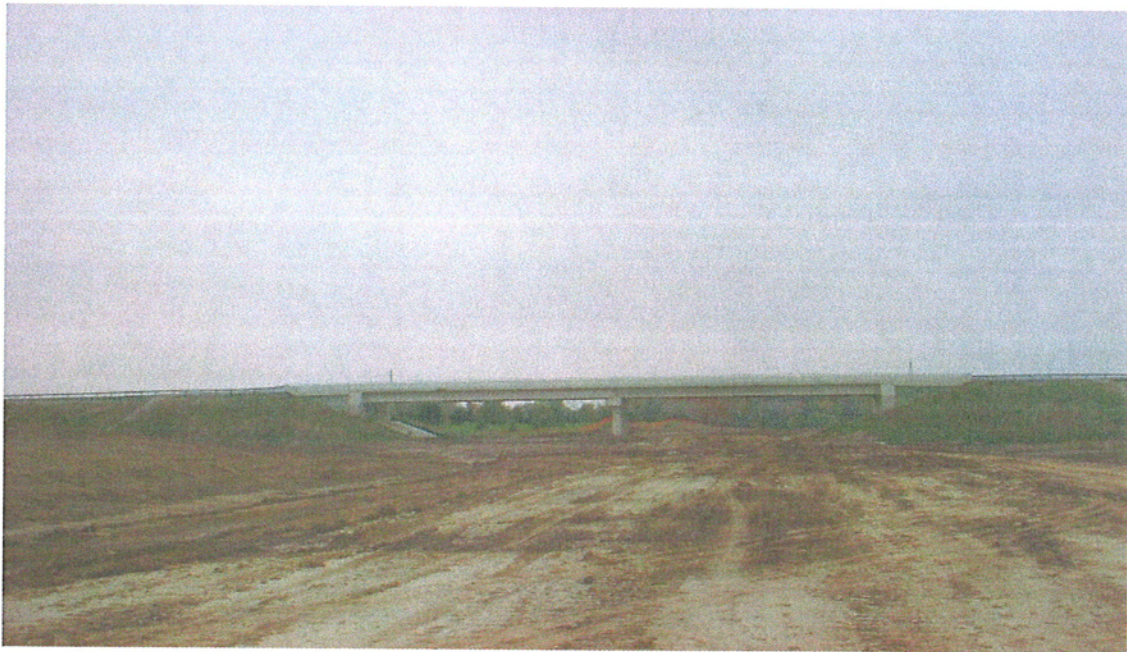
Figure J-1 Bridge View, Looking West
(Photograph Date : October 18, 2003)

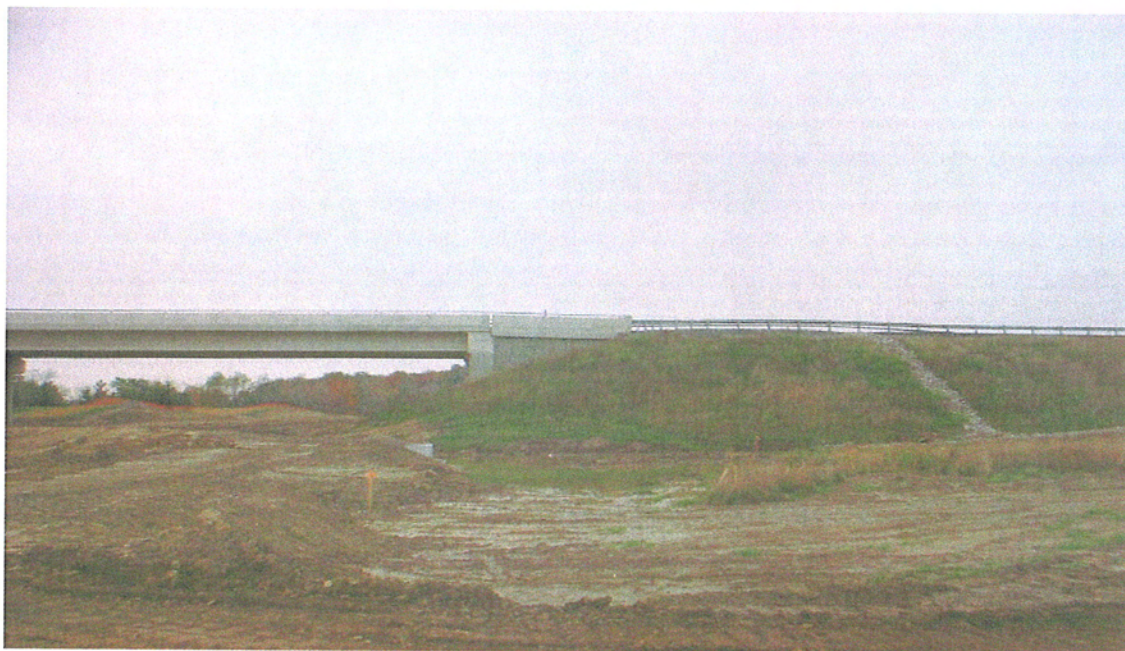
Figure J-2 North Abutment, Looking West
(Photograph Date : October 18, 2003)

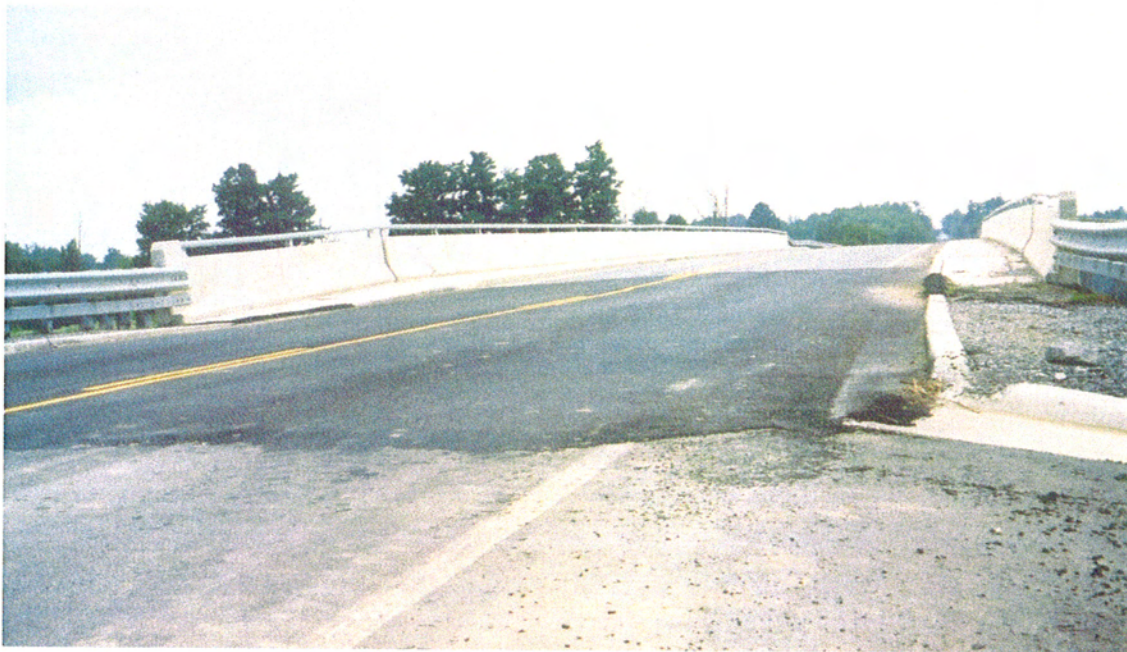
Figure J-3 Asphalt Patching Adjacent to North Abutment
(Photograph Date : August 01, 2003)

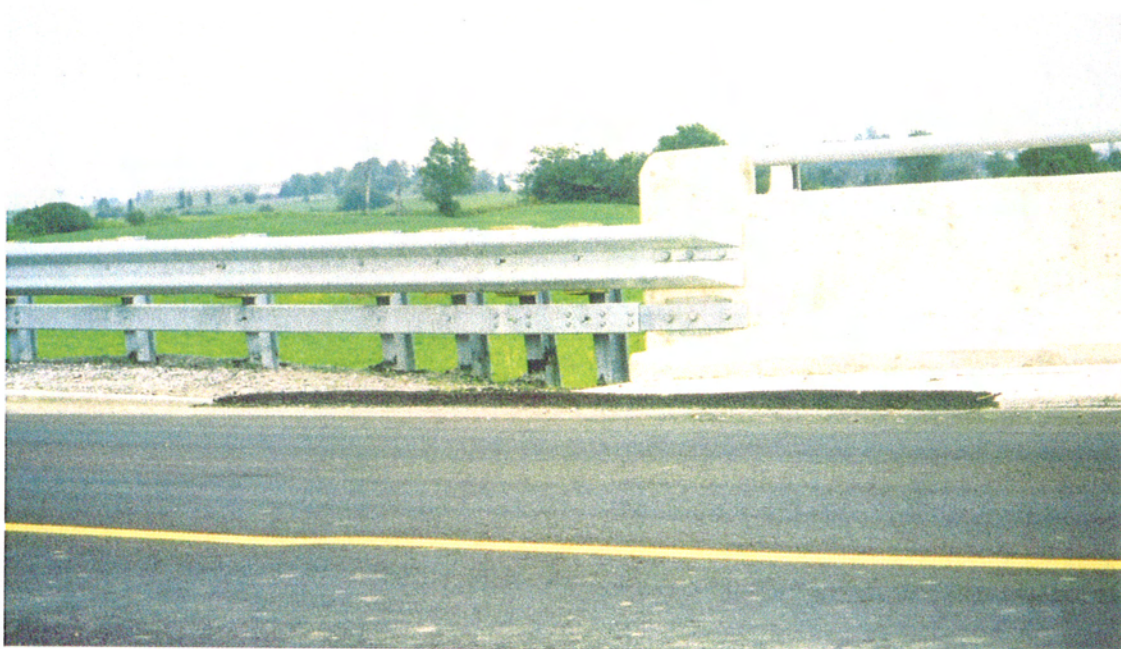
Figure J-4 Sealing of Cracks Adjacent to Asphalt Patching
Near North Abutment
(Photograph Date : August 01, 2003)

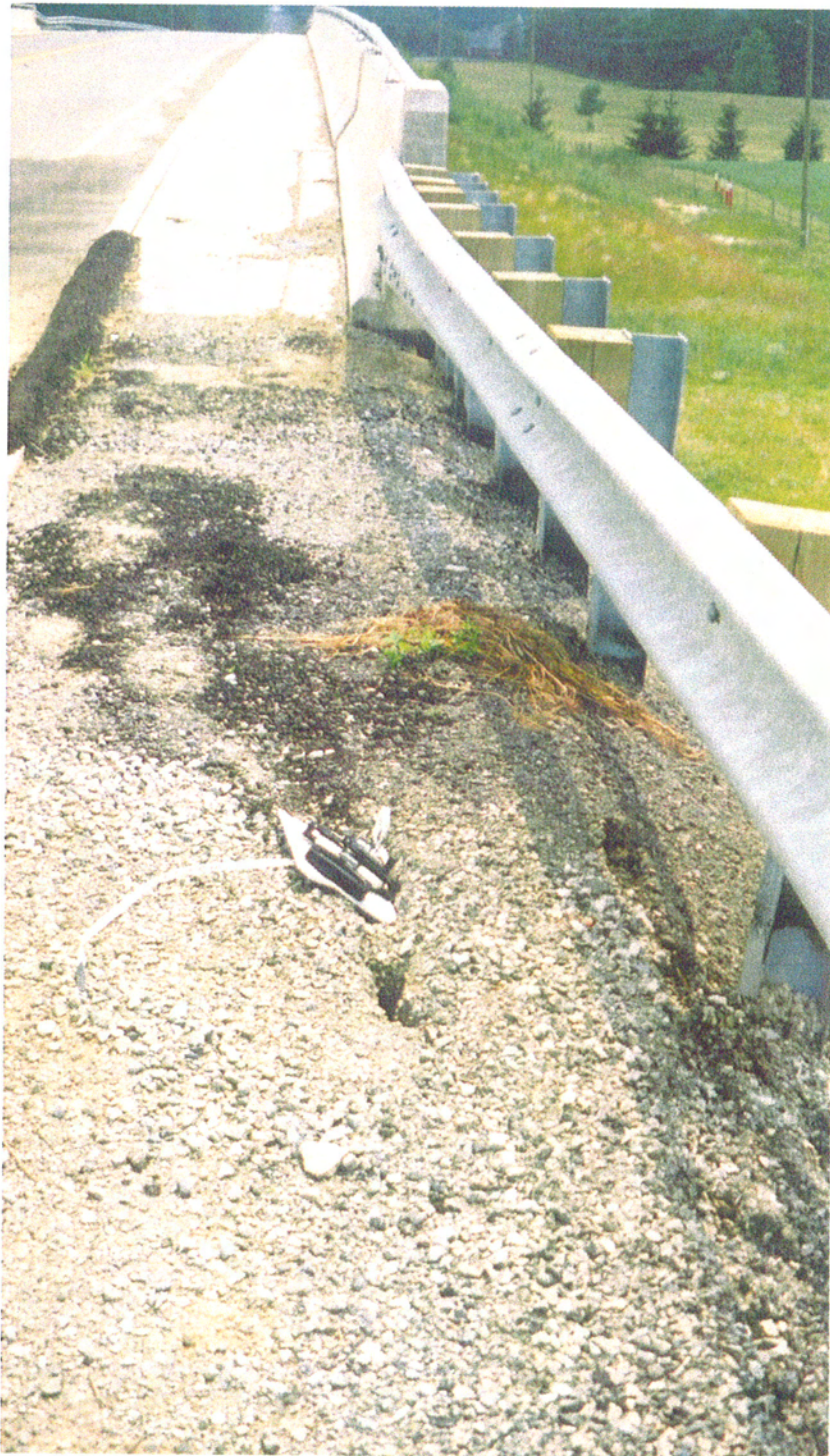
Figure J-5 Crack Along North-West Shoulder
(Photograph Date : August 01, 2003)

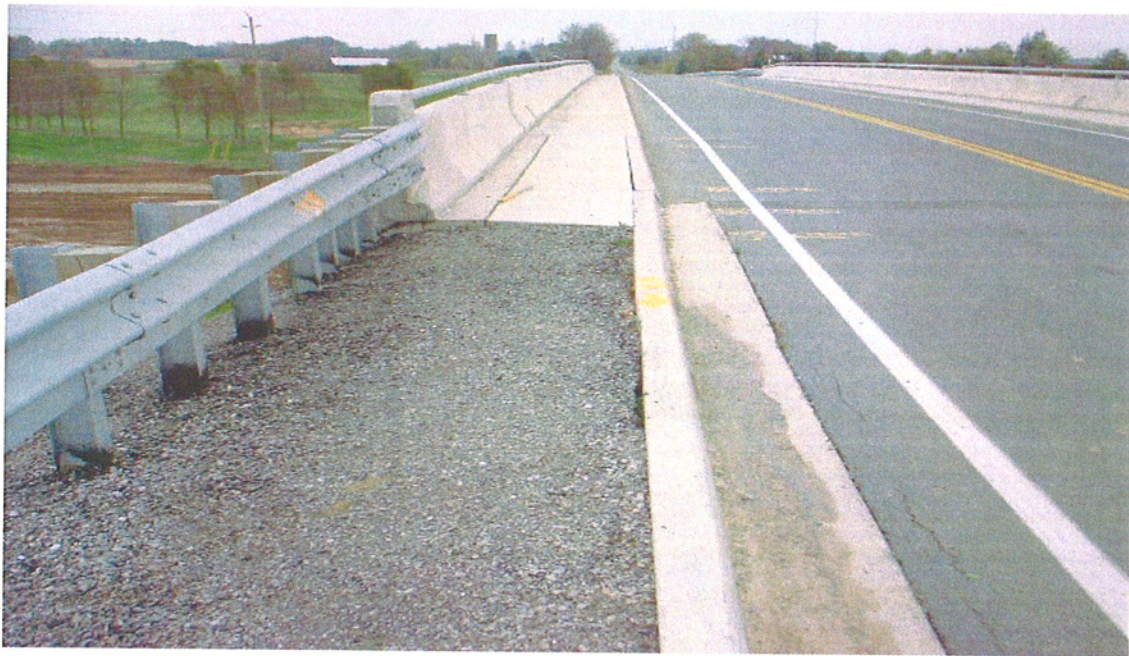
Figure J-6 South of South Abutment, West Shoulder Area,
Various Cracks
(Photograph Date : October 18, 2003)

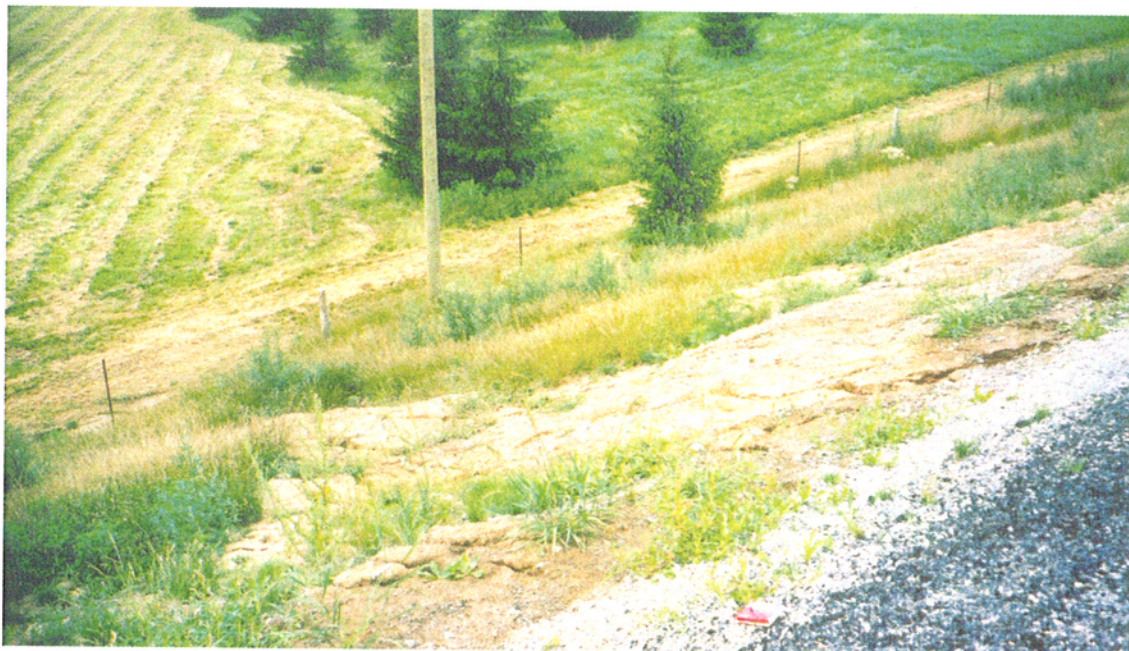
Figure J-7 Slumping and Erosion Along
West Embankment Slope, South of South Abutment
(Photograph Date : August 01, 2003)
