FINAL
FOUNDATION INVESTIGATION REPORT
HIGHWAY 11 SIDING LAKE CREEK CULVERTS,
DISTRICT OF MUSKOKA
AGREEMENT NO. 5017-E-0003
Site Nos.: 42X-0184/C1 & 42X-0184/C2

February 2019
Thurber File: 20244

FINAL
FOUNDATION INVESTIGATION REPORT
HIGHWAY 11 SIDING LAKE CREEK CULVERTS,
DISTRICT OF MUSKOKA
AGREEMENT NO. 5017-E-0003

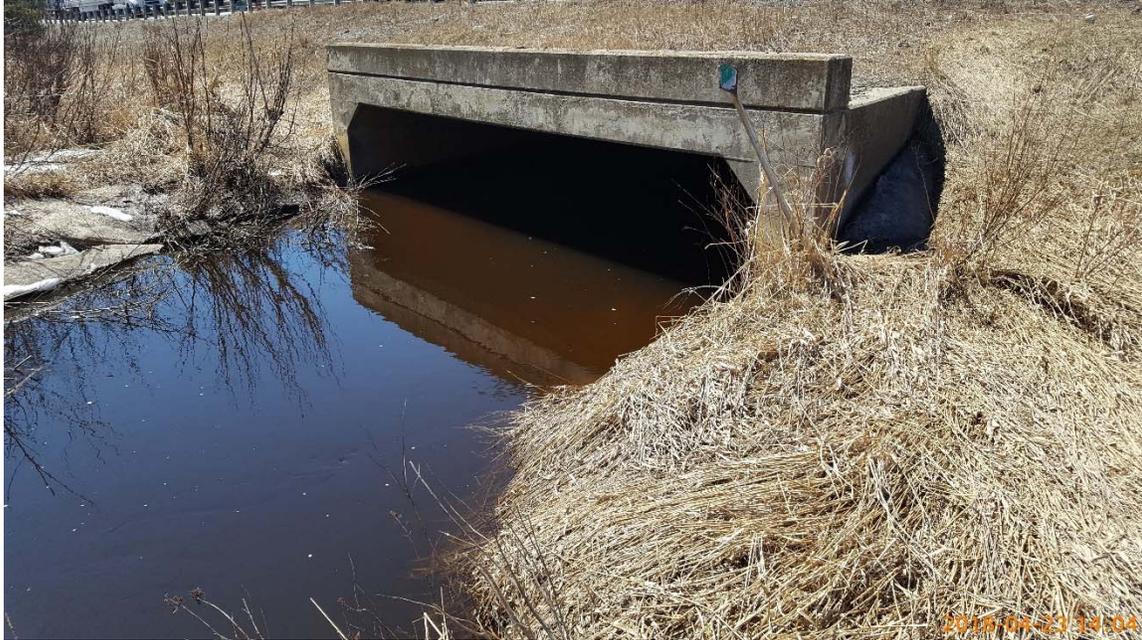
Photo 3. Northbound outlet (42X-0184/C1) looking southeast

The east culvert (Structure No.42X-0184/C1) is located under the northbound lanes and has a span width of 6.1 m, height of 2.4 m, and a length of 30 m. The structure is understood to be a concrete rigid frame box constructed in 1976. Based on site photos provided in Appendix D, headwalls are present at the culvert ends.

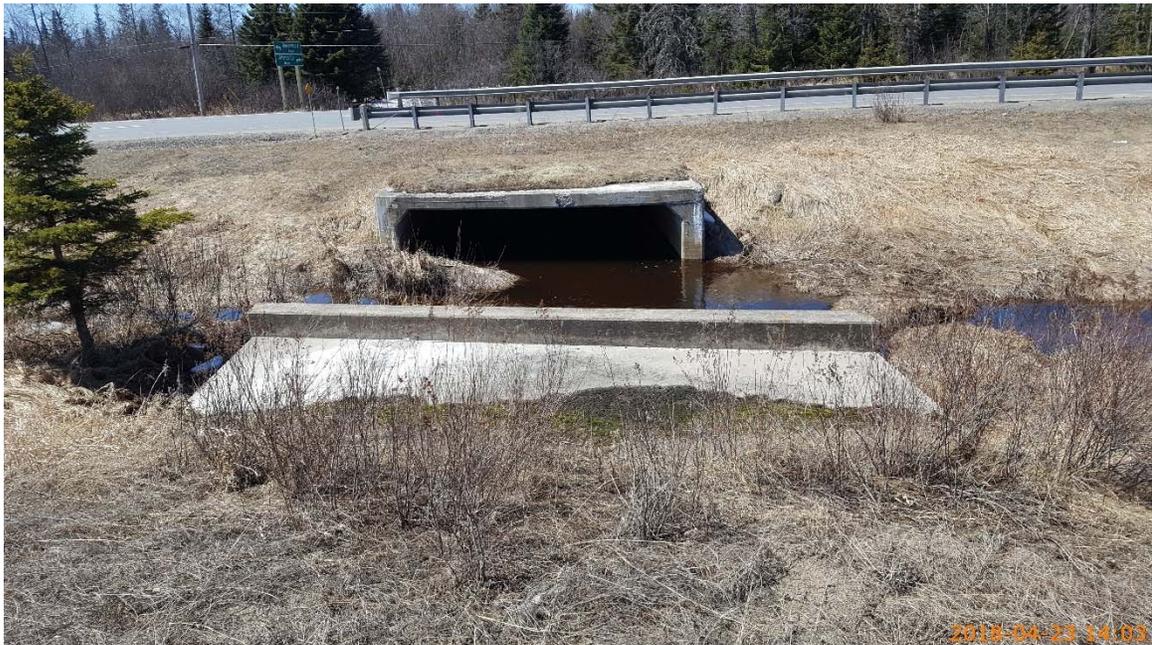
Photo 4. Looking west at culvert ends in median

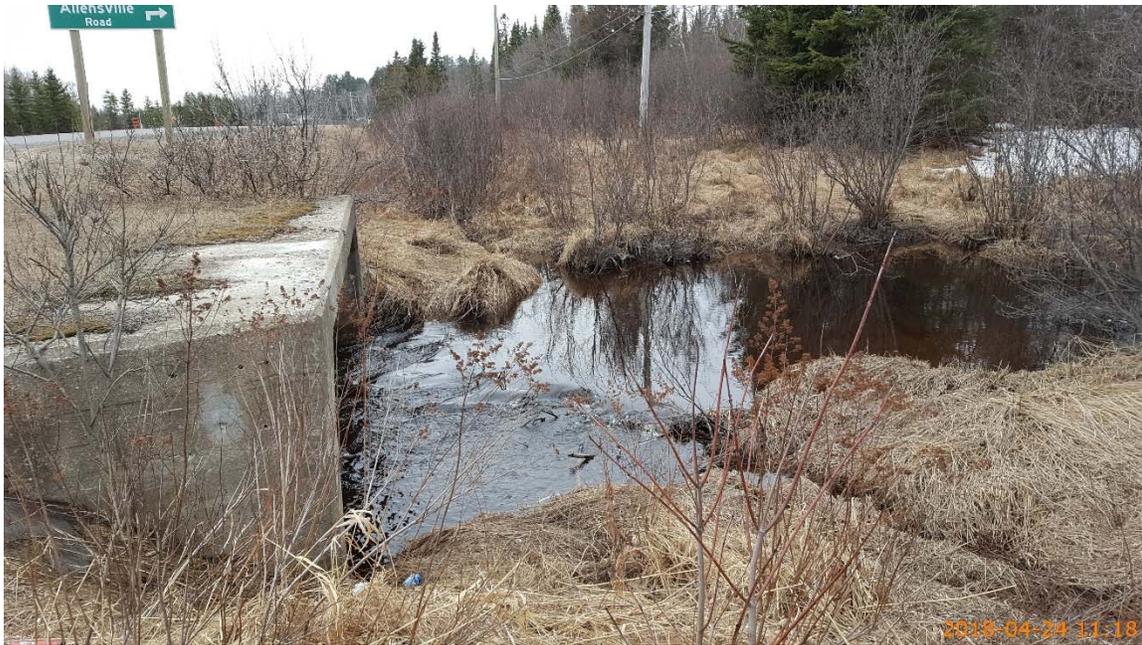
Photo 5. Southbound inlet (42X-0184/C2) looking south

The west culvert (Structure No.42X-0184/C2) is located under the southbound lanes and has a span width of 6.1 m, height of 2.4 m, and a length of 30 m. The structure is understood to be a concrete rigid frame box constructed in 1956. Based on photos provided in Appendix D, no wingwalls or headwalls are present at the culvert ends.
