THURBER ENGINEERING LTD.

MEMORANDUM

PRELIMINARY FOUNDATION ASSESSMENT PIGEON RIVER BRIDGE (SITE 21-023) G.W.P. 4008-13-01 GEOCRES NO. 31D-669

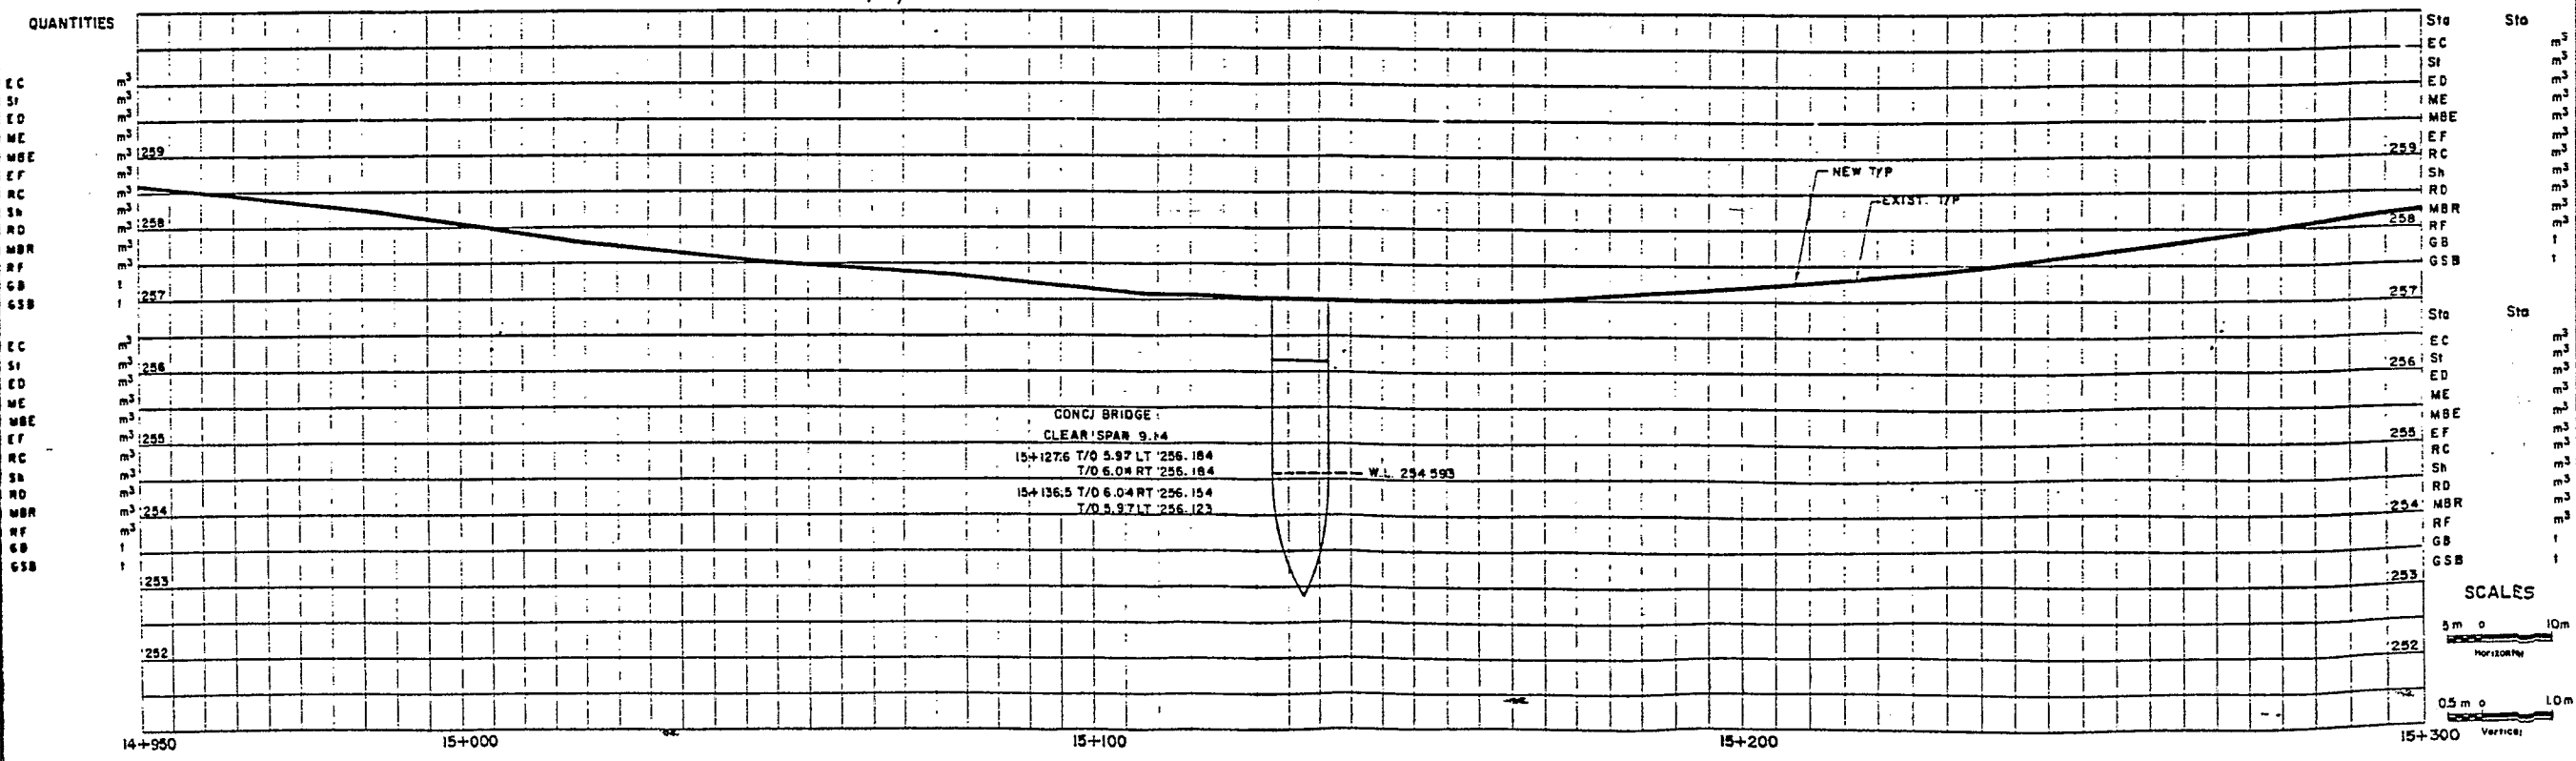
SHEET
5A

CONC. BRIDGE
CLEAR SPAN 9.14
15+127.6 T/O 5.97 LT 256.184
T/O 6.04 RT 256.184
15+136.5 T/O 6.04 RT 256.154
T/O 5.97 LT 256.123

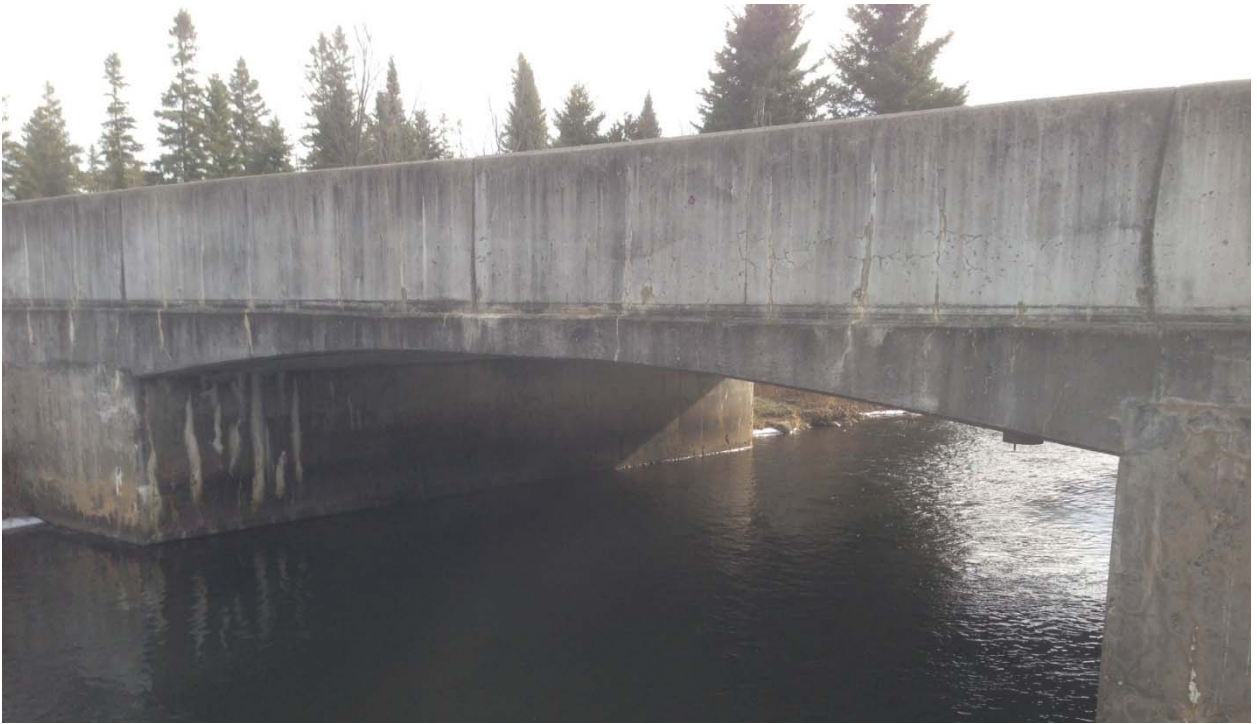
Photo 1 North Elevation of Pigeon River bridge Looking East

There were no obvious signs of settlement or distress at the foundation elements. Concrete spalling and cracking were observed on the abutment walls.

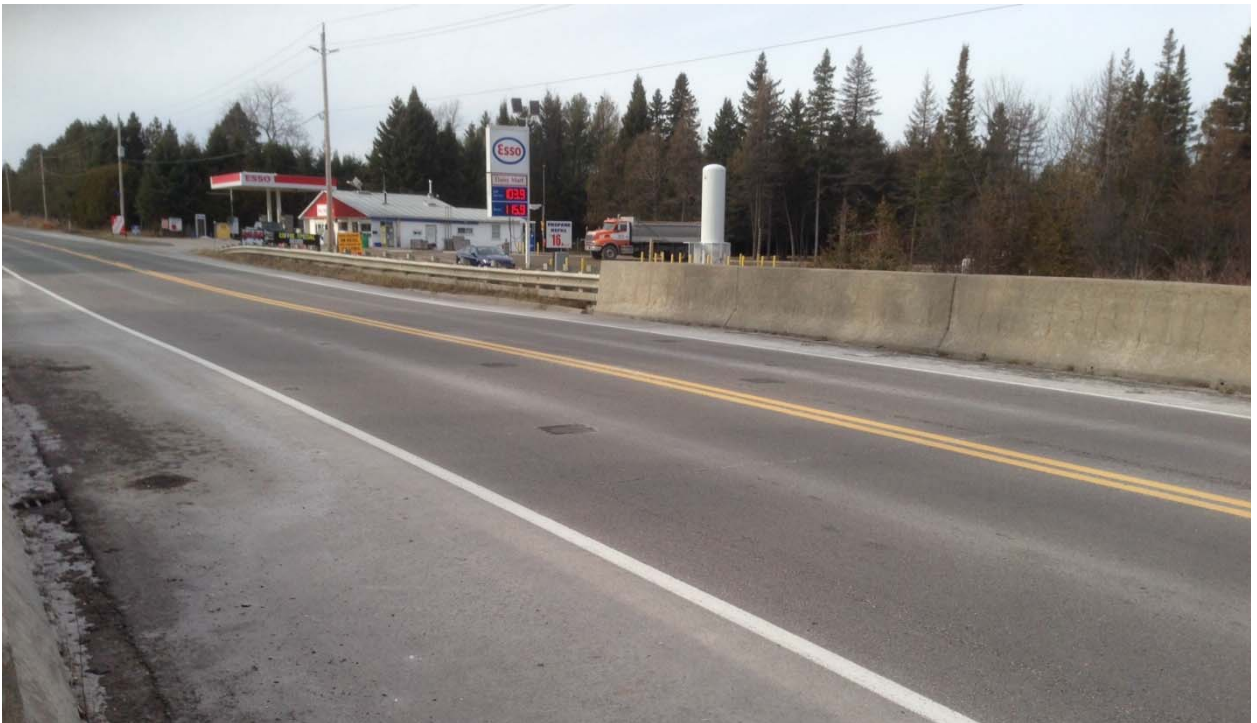
Photo 2 Looking West Over Pigeon River Bridge

The approach slopes appeared to be stable with no obvious signs of instability. All slope faces appeared well vegetated, except for some erosion at the southeast approach slope near the creek water level. There was no visible settlement at the approach slabs although a slight bump was noticed at the west approach.
