**FOUNDATION INVESTIGATION AND DESIGN REPORT
STRAWBERRY CREEK BRIDGE #8 REPLACEMENT
WARE ROAD NORTH, DISTRICT OF THUNDER BAY,
WARE TOWNSHIP, ONTARIO
LATITUDE: 48.604697°, LONGITUDE: -89.471511°
G.W.P. 6014-18-00, SITE No. 48W-054**

Report

Ministry of Transportation Ontario

Date: June 5, 2020
File: 27323

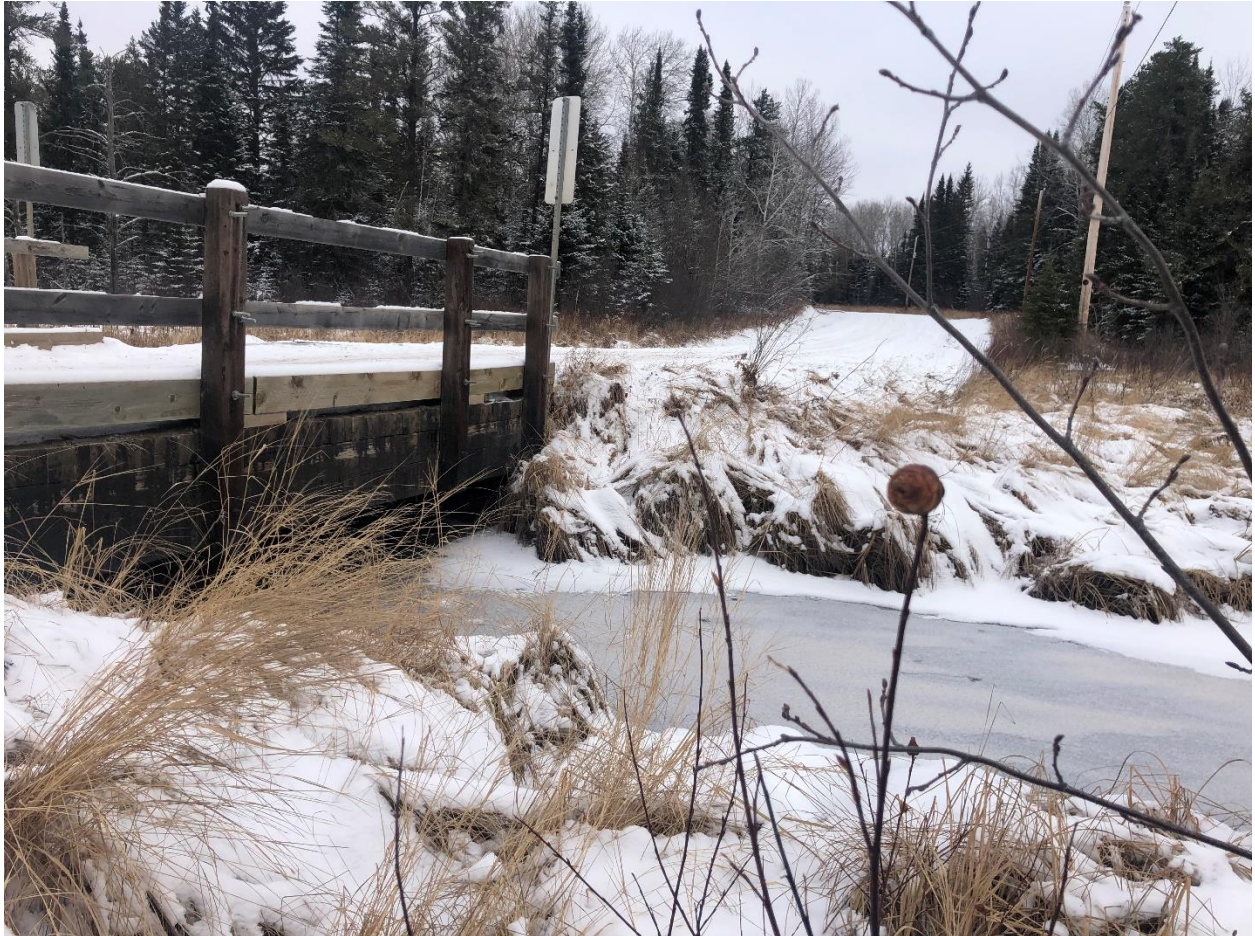
Photo C4: Looking north at east side of bridge and northeast embankment from southeast side.

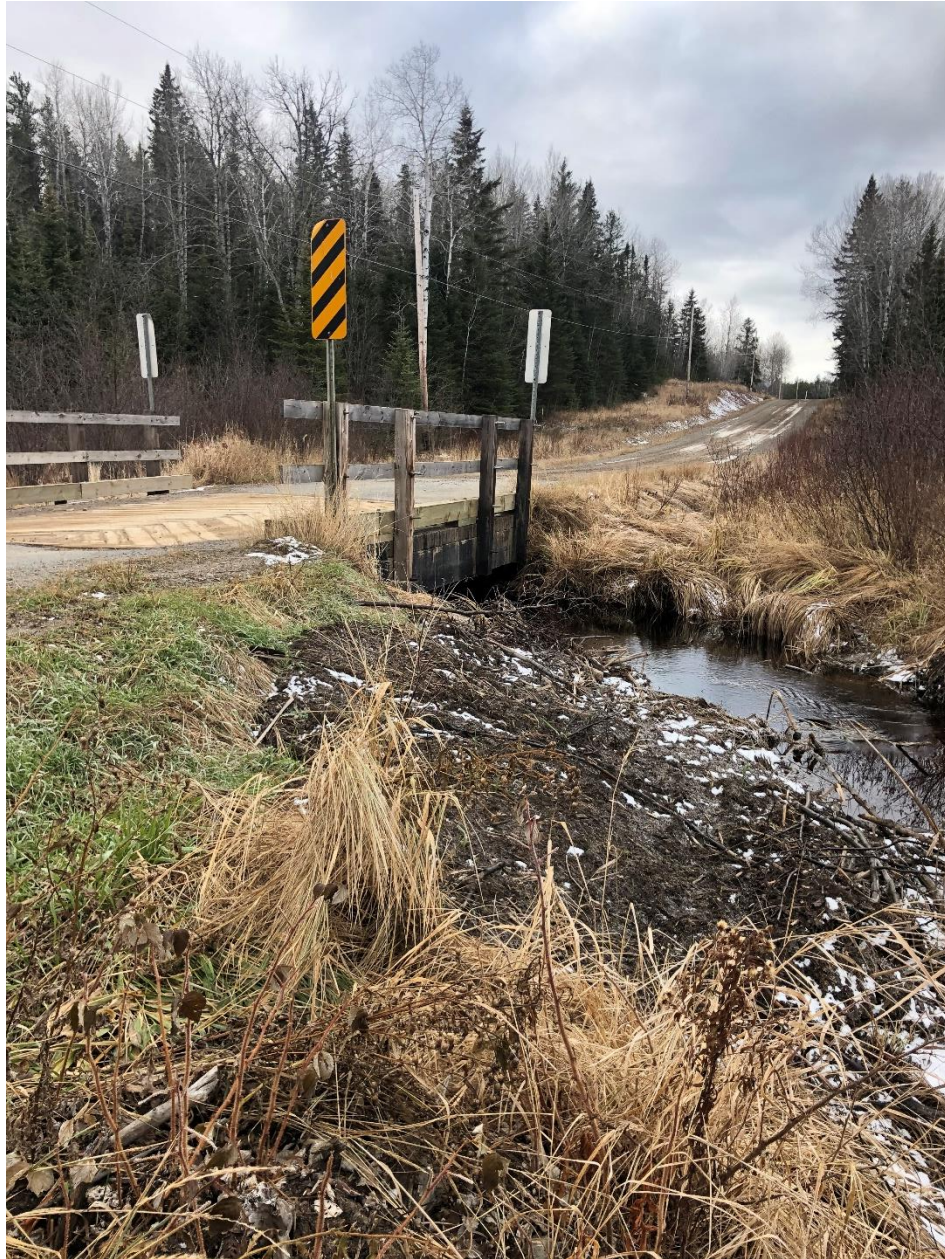
Photo C5: Looking south at northwest embankment and west side of bridge.

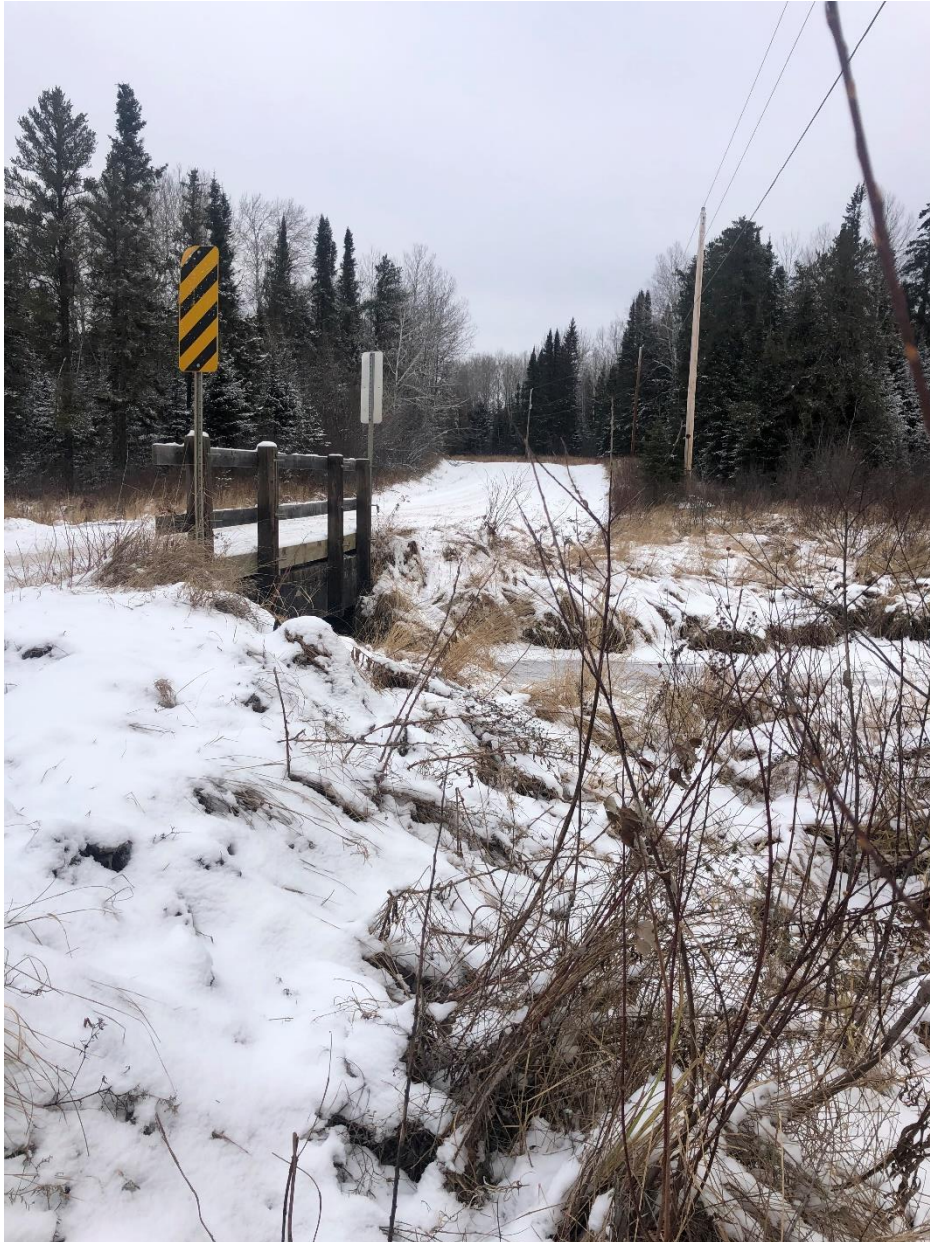
Photo C6: Looking north at southeast embankment and east side of bridge.

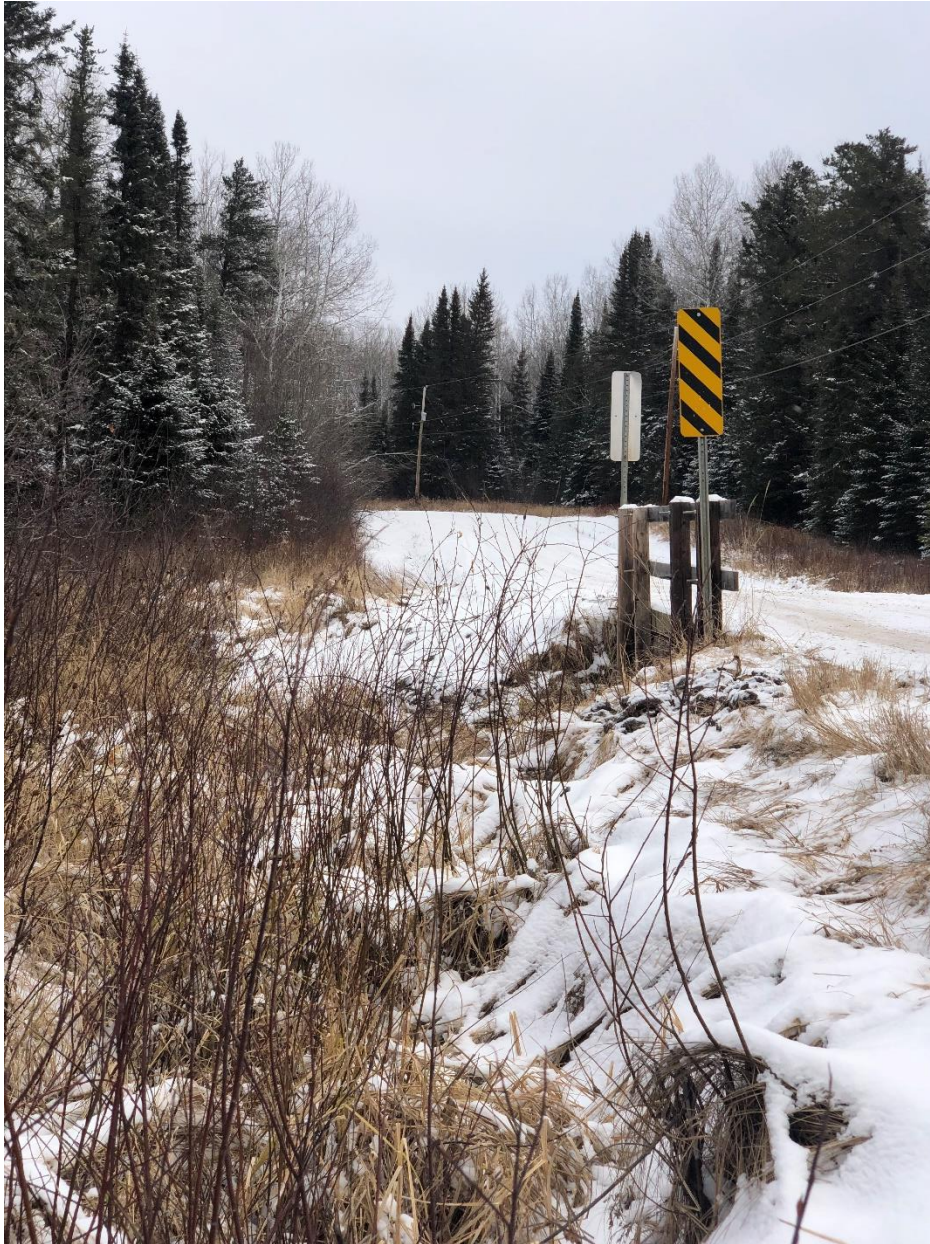
Photo C7: Looking north at southwest embankment and west side of bridge.
