**FOUNDATION INVESTIGATION REPORT
STRAWBERRY CREEK BRIDGE #8 REPLACEMENT
WARE ROAD NORTH, DISTRICT OF THUNDER BAY,
WARE TOWNSHIP, ONTARIO
LATITUDE: 48.604697°, LONGITUDE: -89.471511°
G.W.P. 6014-18-00, SITE No. 48W-054**

GEOCRES Number: 52A-250

Date: June 5, 2020
File: 27323

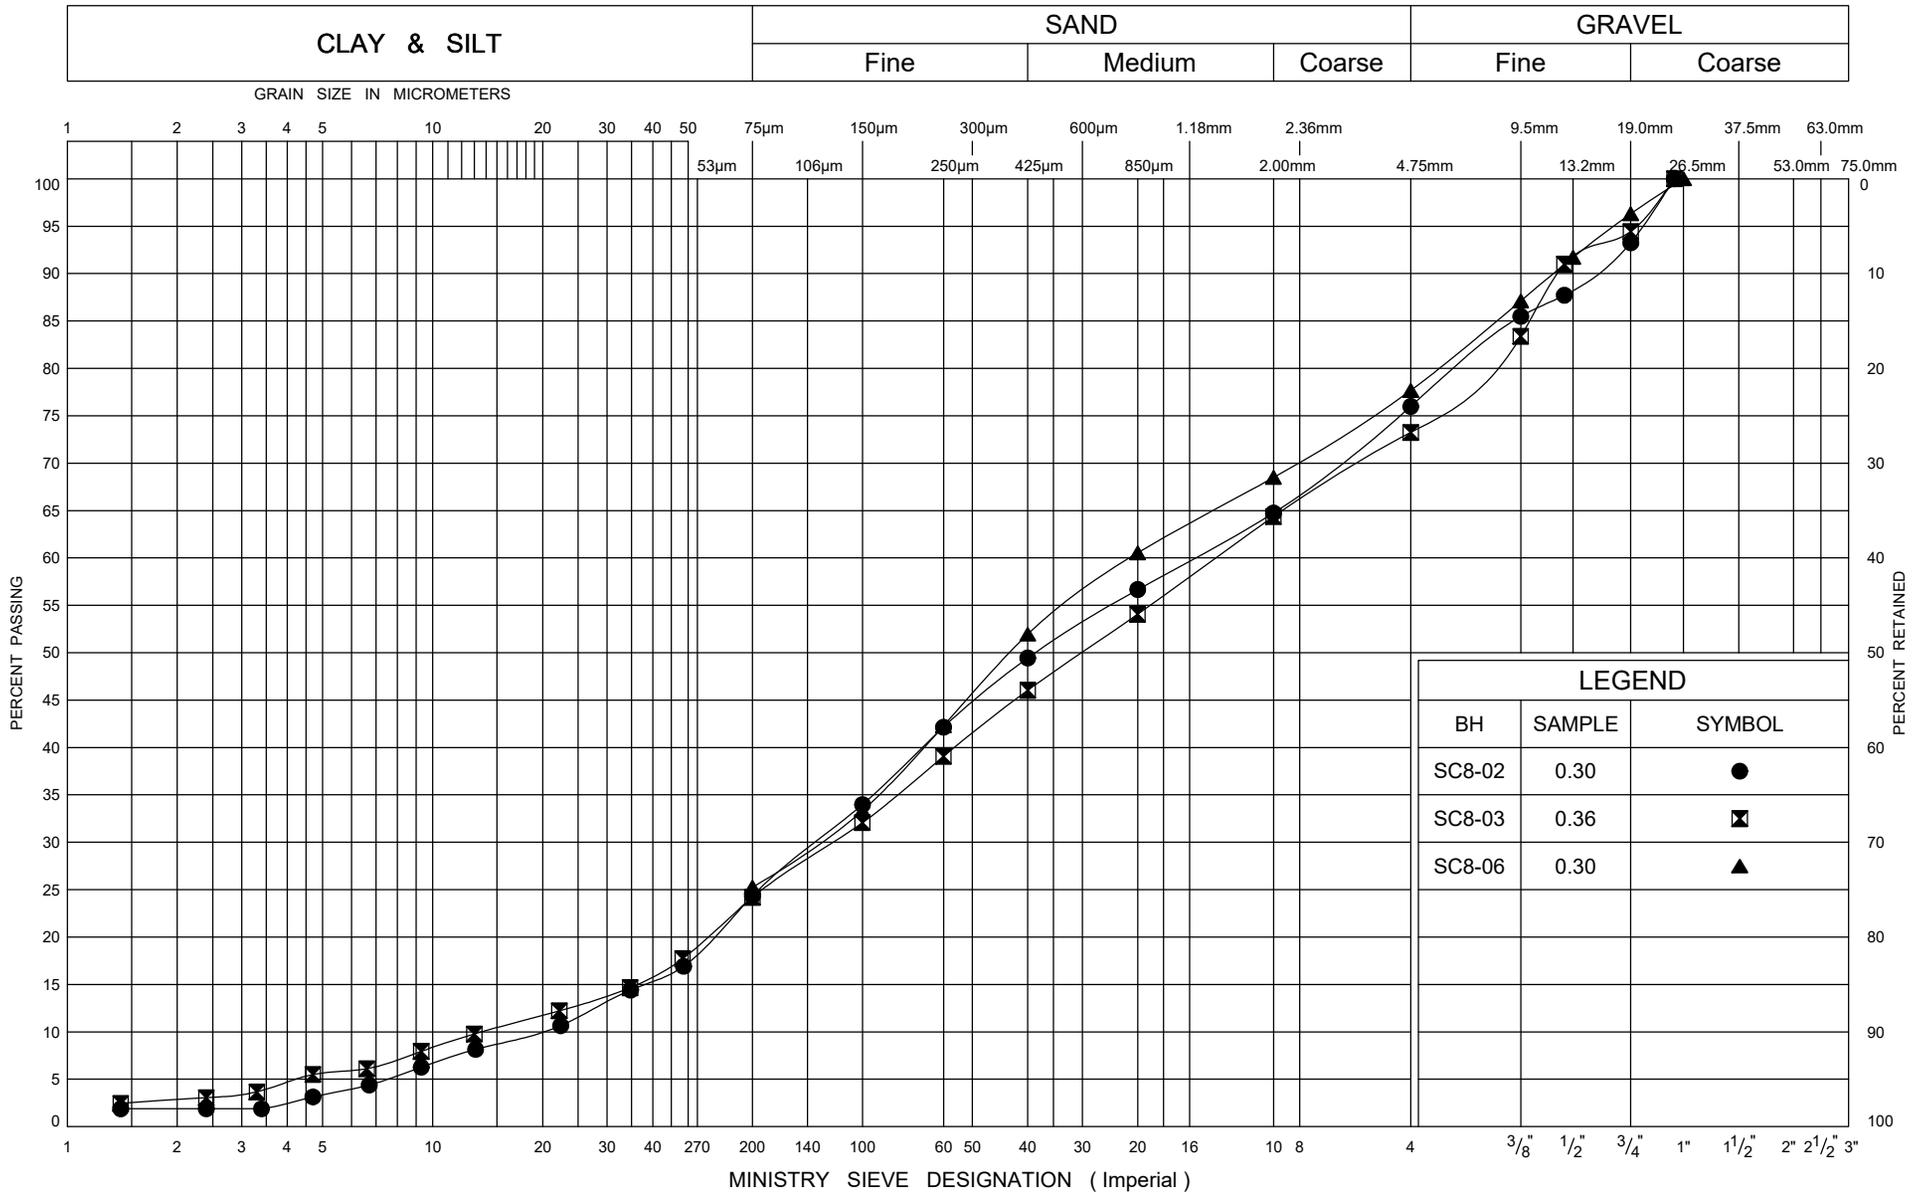
FIG No B1
 W P 6014-18-00
 Strawberry Creek Bridge #8

The results of grain size analyses conducted on samples of the gravelly sand fill are illustrated on Figure B1 in Appendix B. The results are summarized as follows:

Soil Particle	Percentage (%)
Gravel	22 to 27
Sand	49 to 52
Silt	21 to 22
Clay	2 to 3
Silt and Clay	26

Gravelly SAND FILL

A layer of fill ranging from gravelly sand, silty with trace clay to silty sand, trace to some gravel, trace clay was encountered at the ground surface or below the asphalt in all of the boreholes. The fill extended to depths ranging from 0.7 to 1.4 m (Elev. 365.6 to 364.9 m). The fill was loose to very dense, with SPT 'N' values ranging from 5 to greater than 100 blows for 0.3 m of penetration. The measured moisture content in the fill ranged from 4 to 17%.

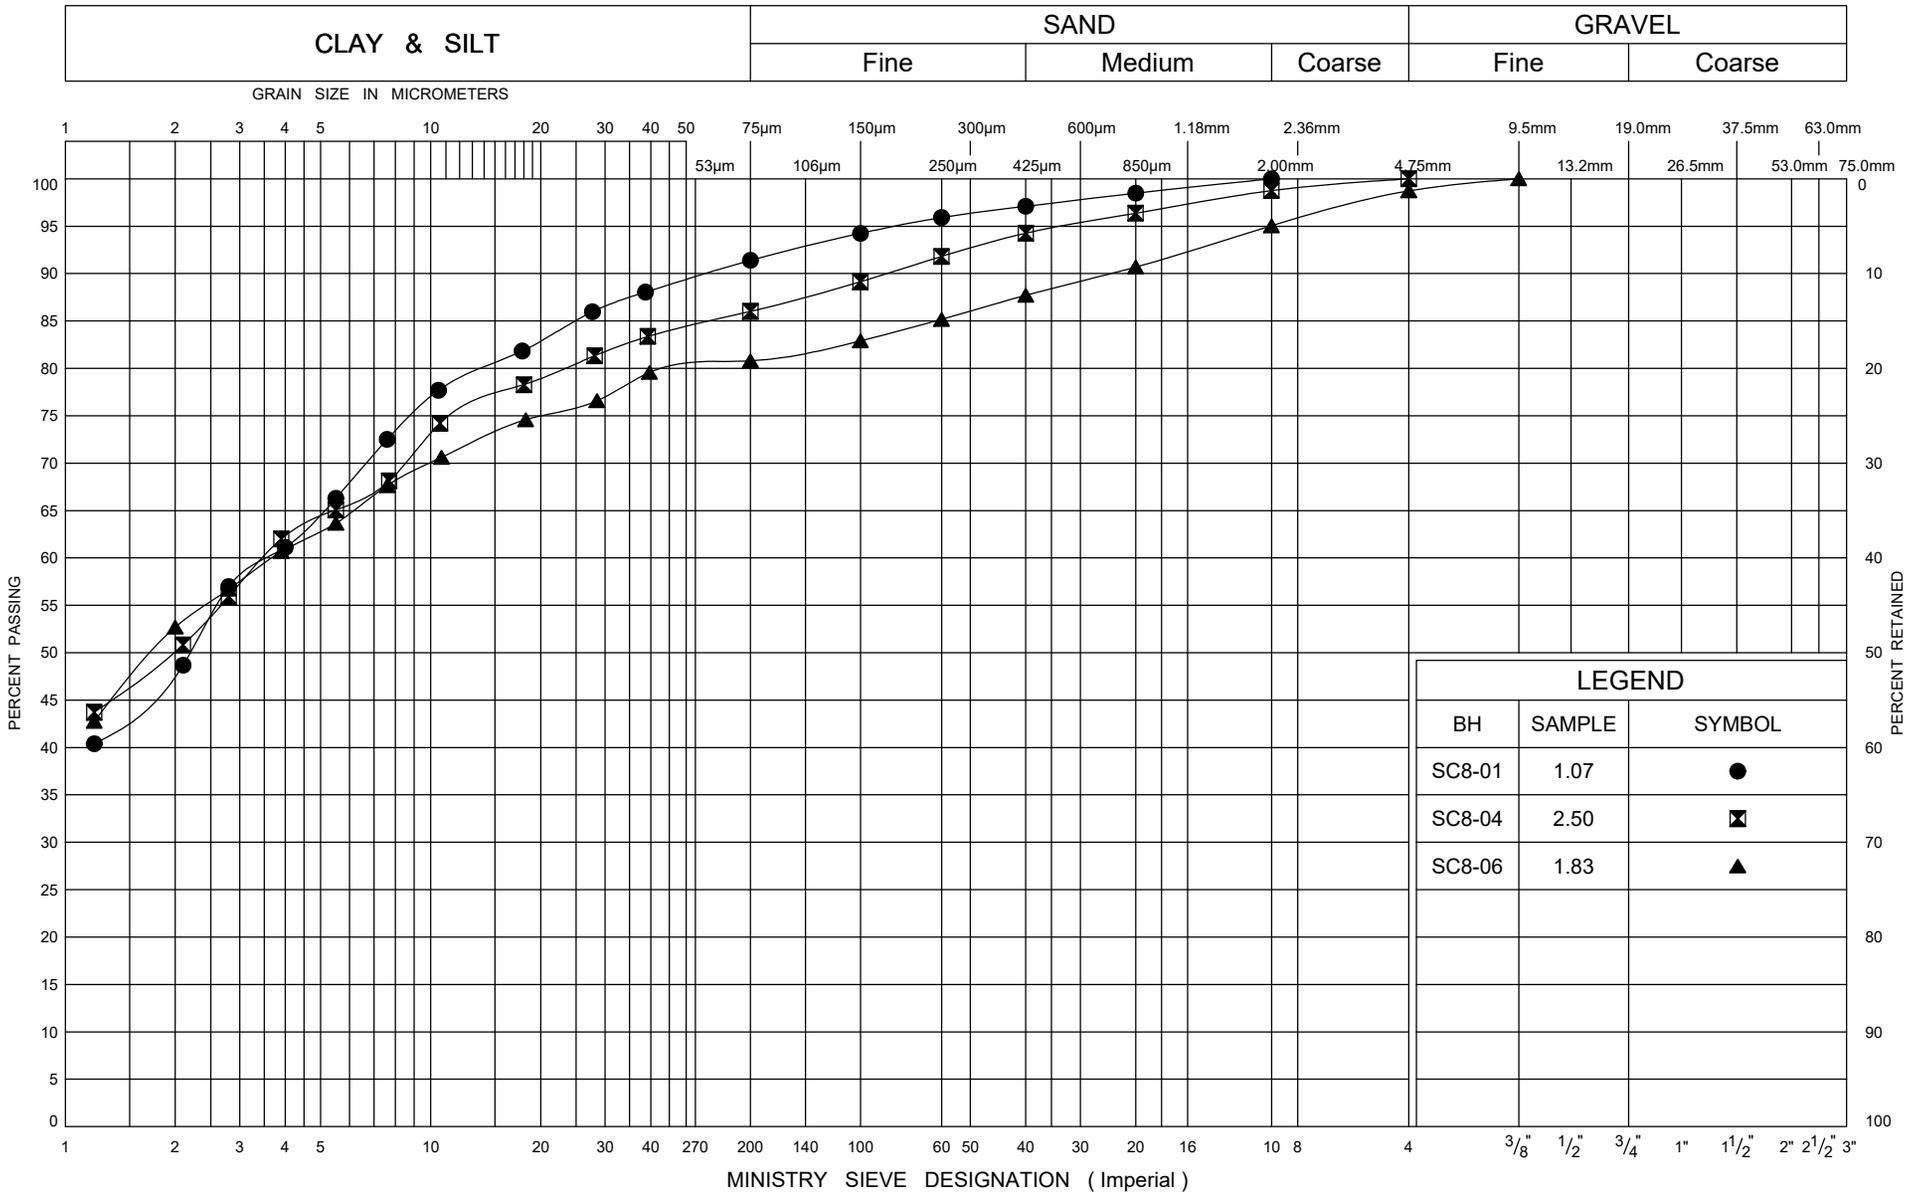
FIG No B2
 W P 6014-18-00
 Strawberry Creek Bridge #8

The results of grain size analyses and Atterberg Limit tests conducted on samples of the silty clay with organics are illustrated on Figures B2 and B7 in Appendix B. The results are summarized as follows:

Soil Particle	Percentage (%)
Gravel	0 to 1
Sand	9 to 18
Silt	28 to 43
Clay	48 to 53

Silty CLAY with Organics

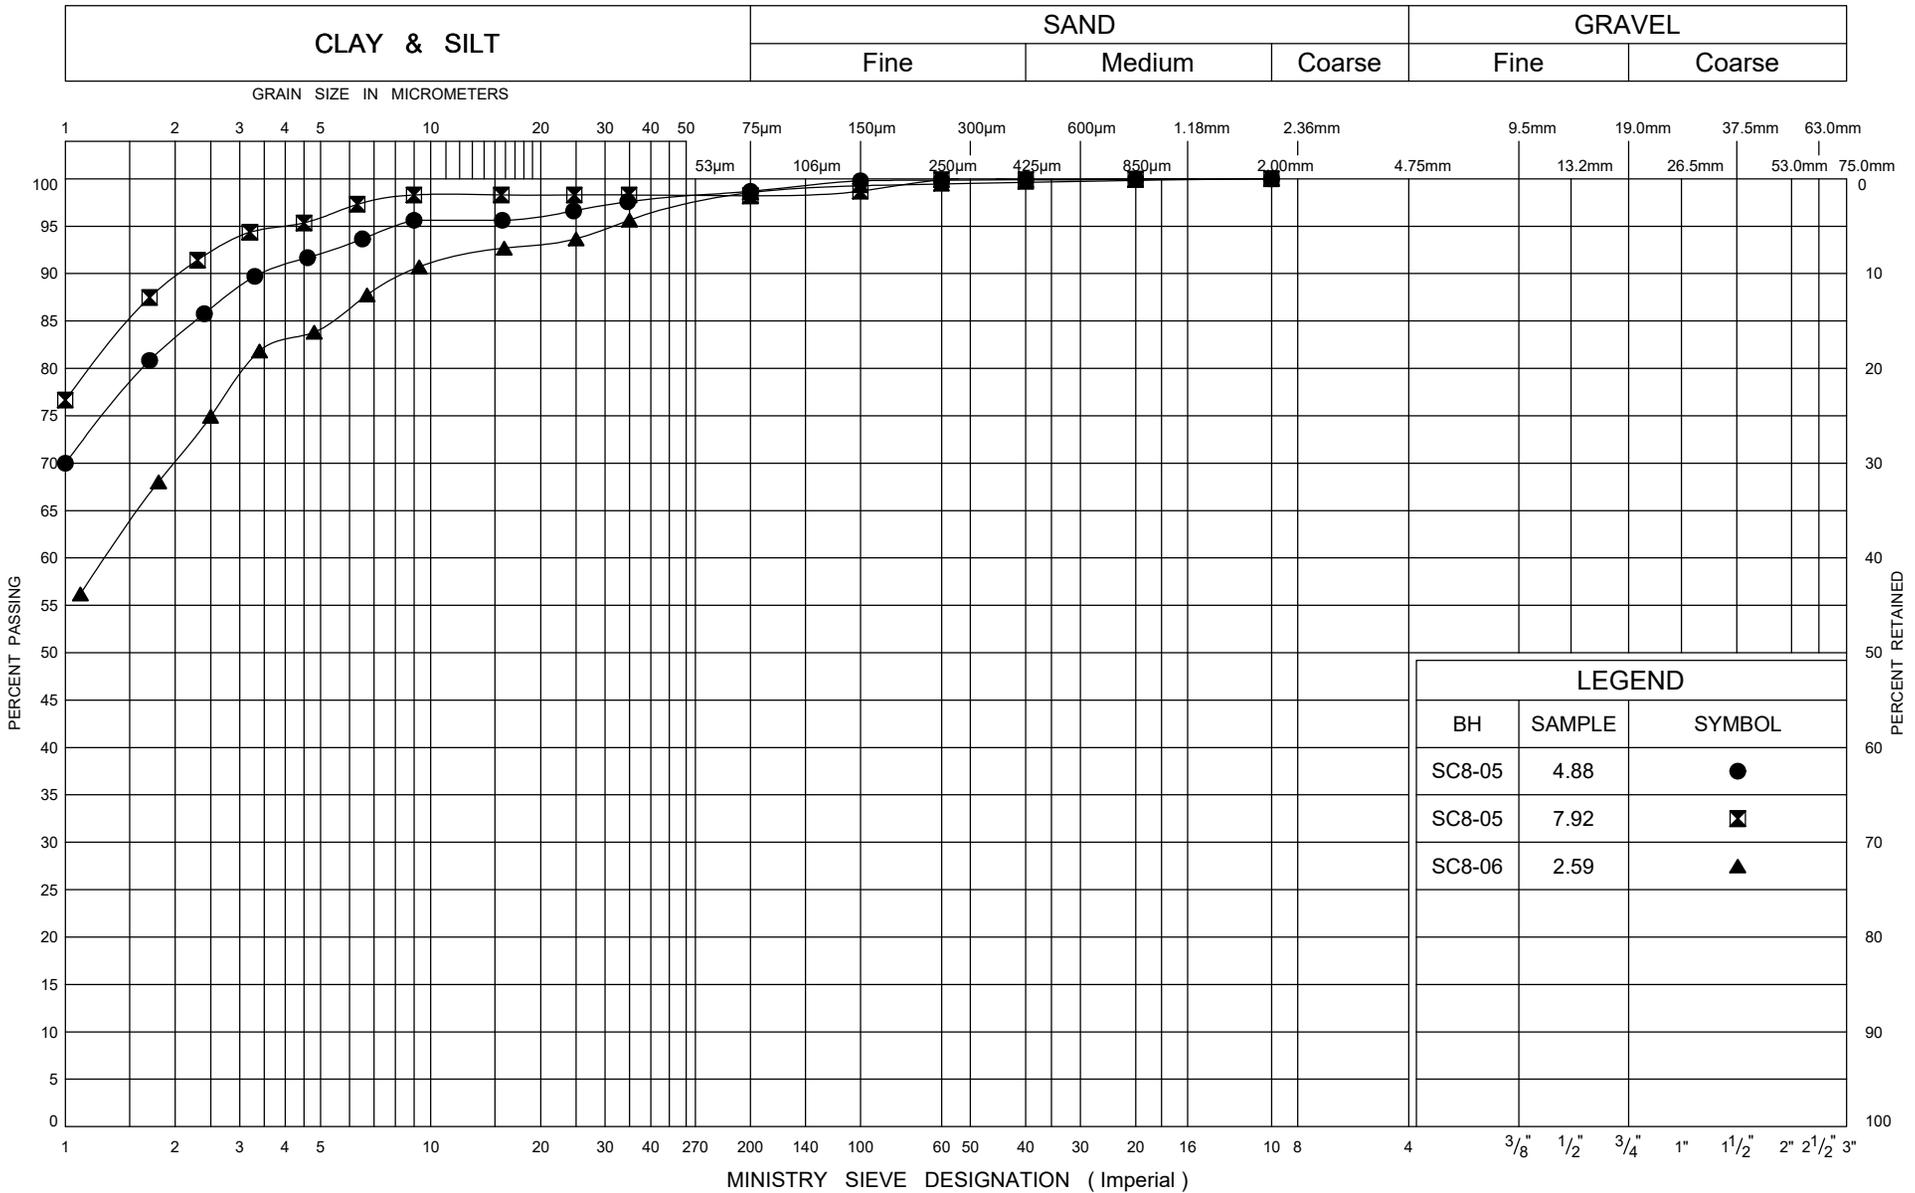
FIG No B4
 W P 6014-18-00
 Strawberry Creek Bridge #8

LEGEND		
BH	SAMPLE	SYMBOL
SC8-05	4.88	●
SC8-05	7.92	⊠
SC8-06	2.59	▲

Silty CLAY

SPT 'N' values recorded in the silty clay ranged from 0 (weight of hammer) to 6 blows per 0.3 m of penetration. In-situ vane shear tests conducted in the silty clay measured undrained shear strengths ranging from 46 to 92 kPa, indicating that the silty clay ranges from firm to stiff. The sensitivity of the silty clay ranged from 1.7 to 3.0, indicating a low to medium sensitivity. The measured moisture content of the silty clay ranged from 36 to 69%, but typically greater than 50%.

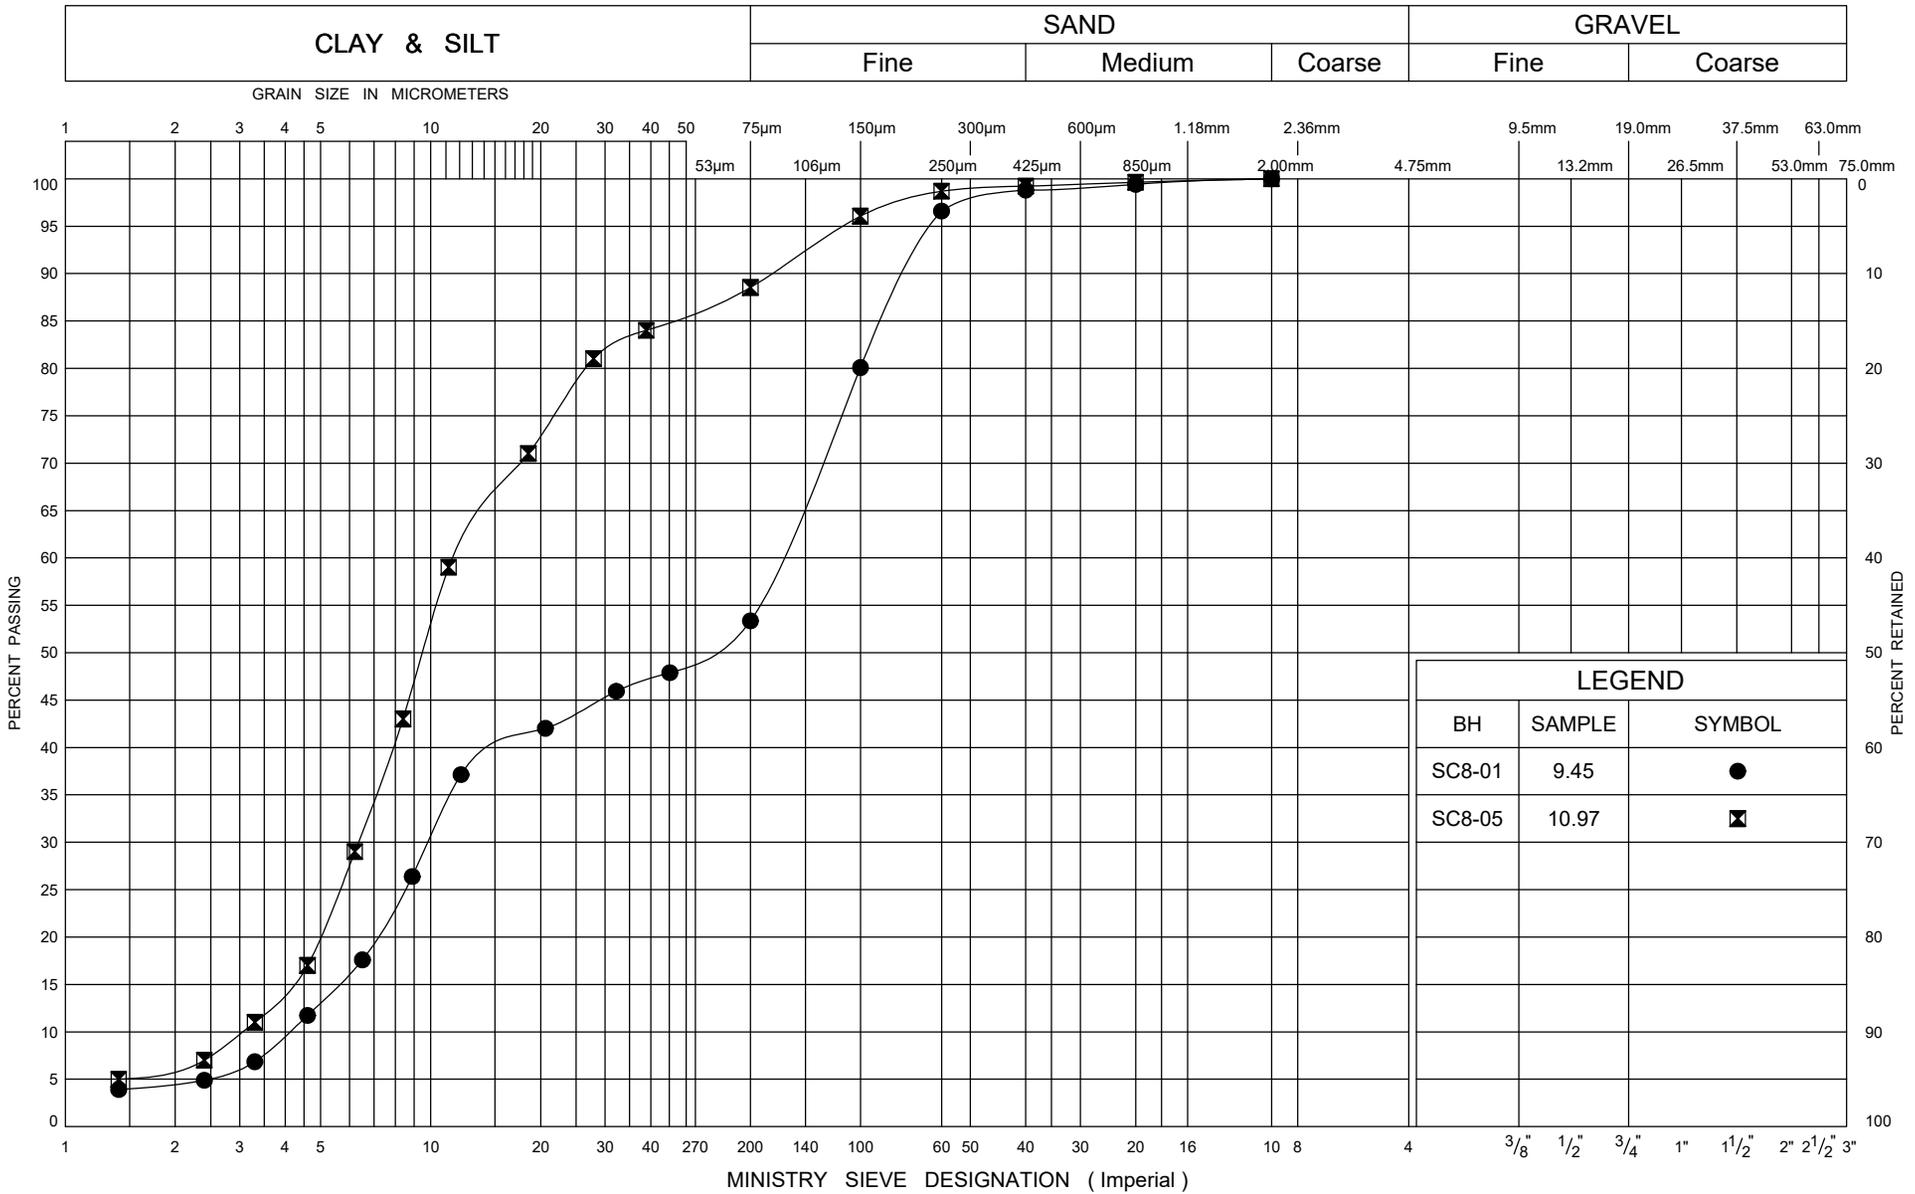
FIG No B5
 W P 6014-18-00
 Strawberry Creek Bridge #8

LEGEND		
BH	SAMPLE	SYMBOL
SC8-01	9.45	●
SC8-05	10.97	⊠

SILT to SILT and SAND

SPT 'N' values measured in the silt to silt and sand deposit ranged from 9 to 17 blows for 0.3 m of penetration, indicating that the deposit is compact. The measured moisture contents in the deposit ranged from 17 to 23%.

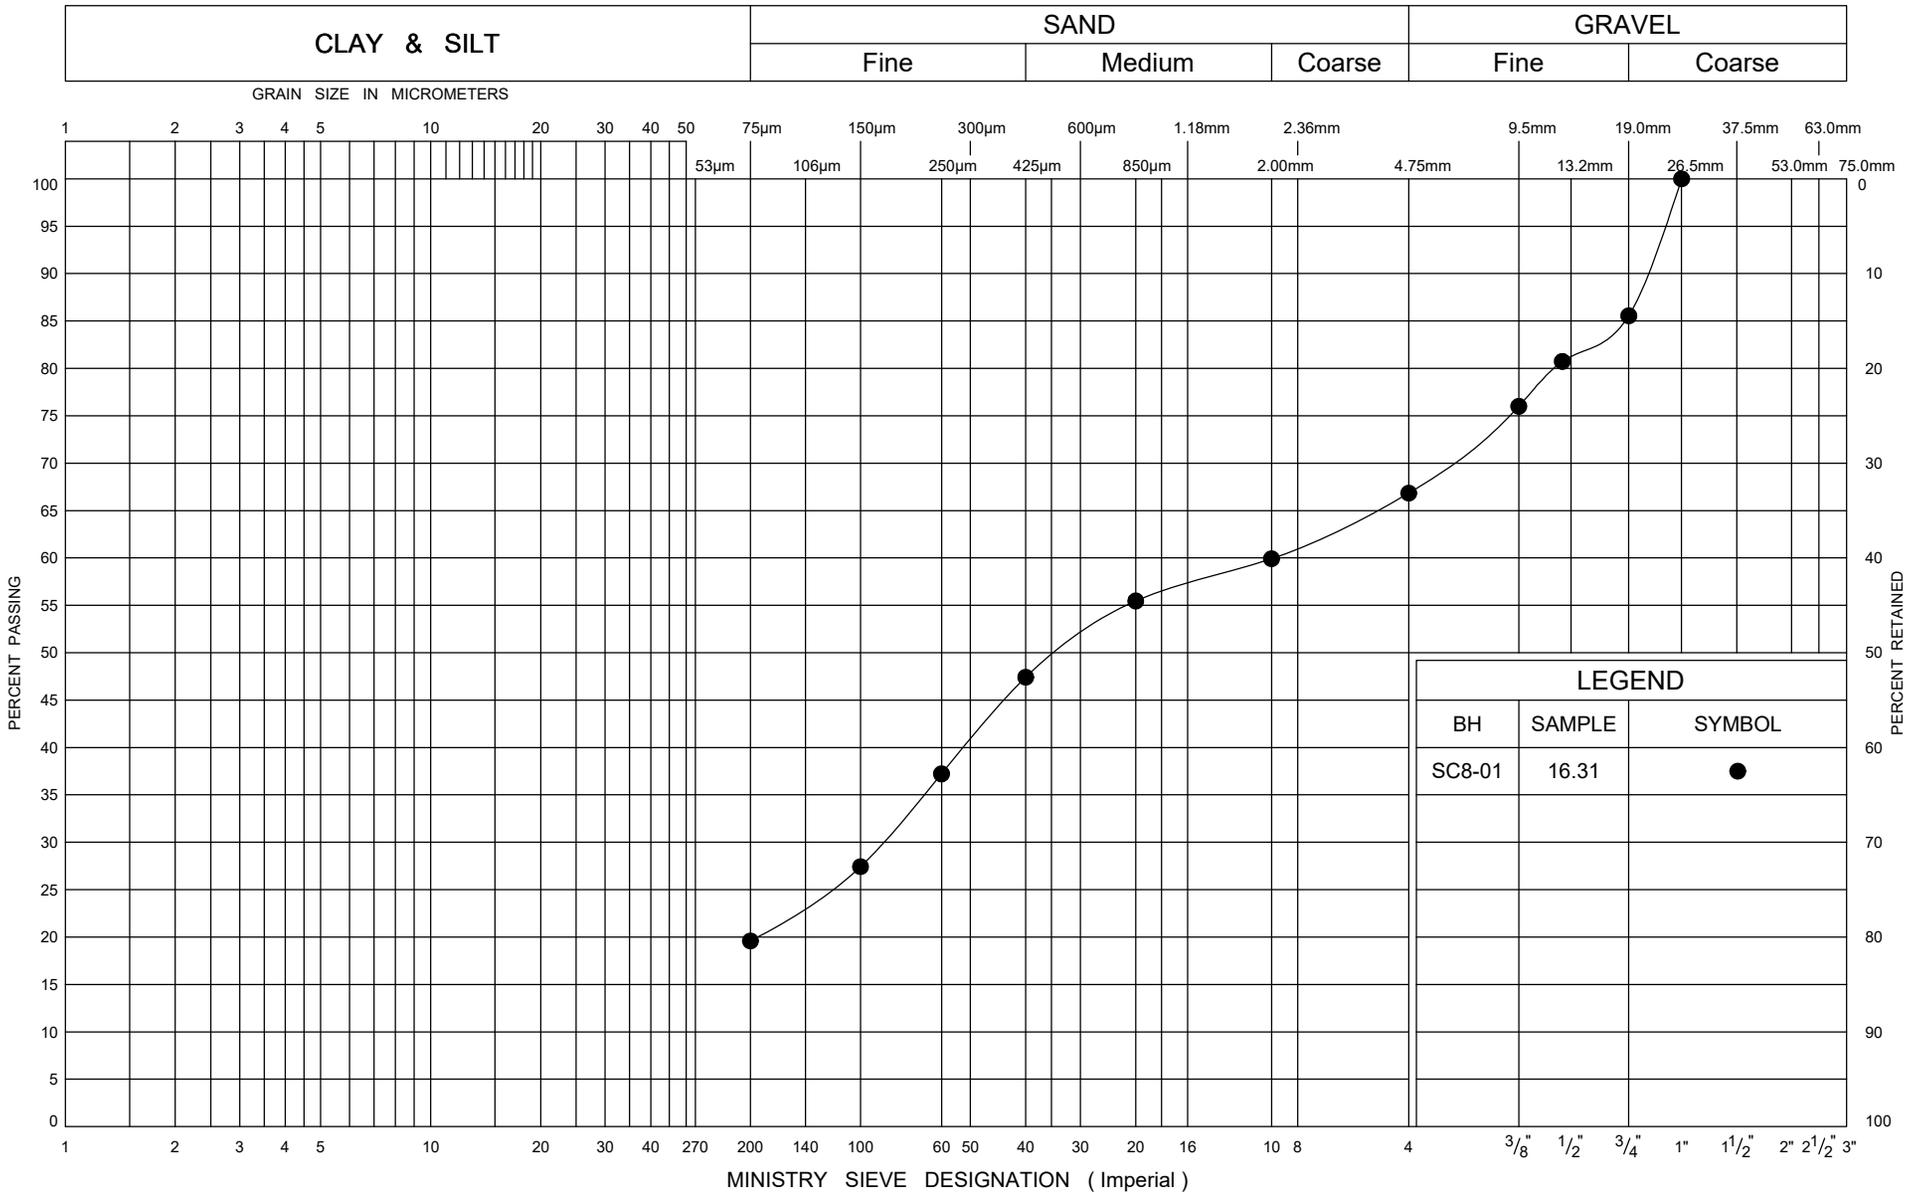
FIG No B6
 W P 6014-18-00
 Strawberry Creek Bridge #8

LEGEND		
BH	SAMPLE	SYMBOL
SC8-01	16.31	●

Gravelly SAND

The SPT 'N' values recorded in the gravelly sand ranged from 29 to greater than 100 blows for 0.3 m of penetration, indicating that the deposit is compact to very dense. The measured moisture content ranged from 2 to 12%.

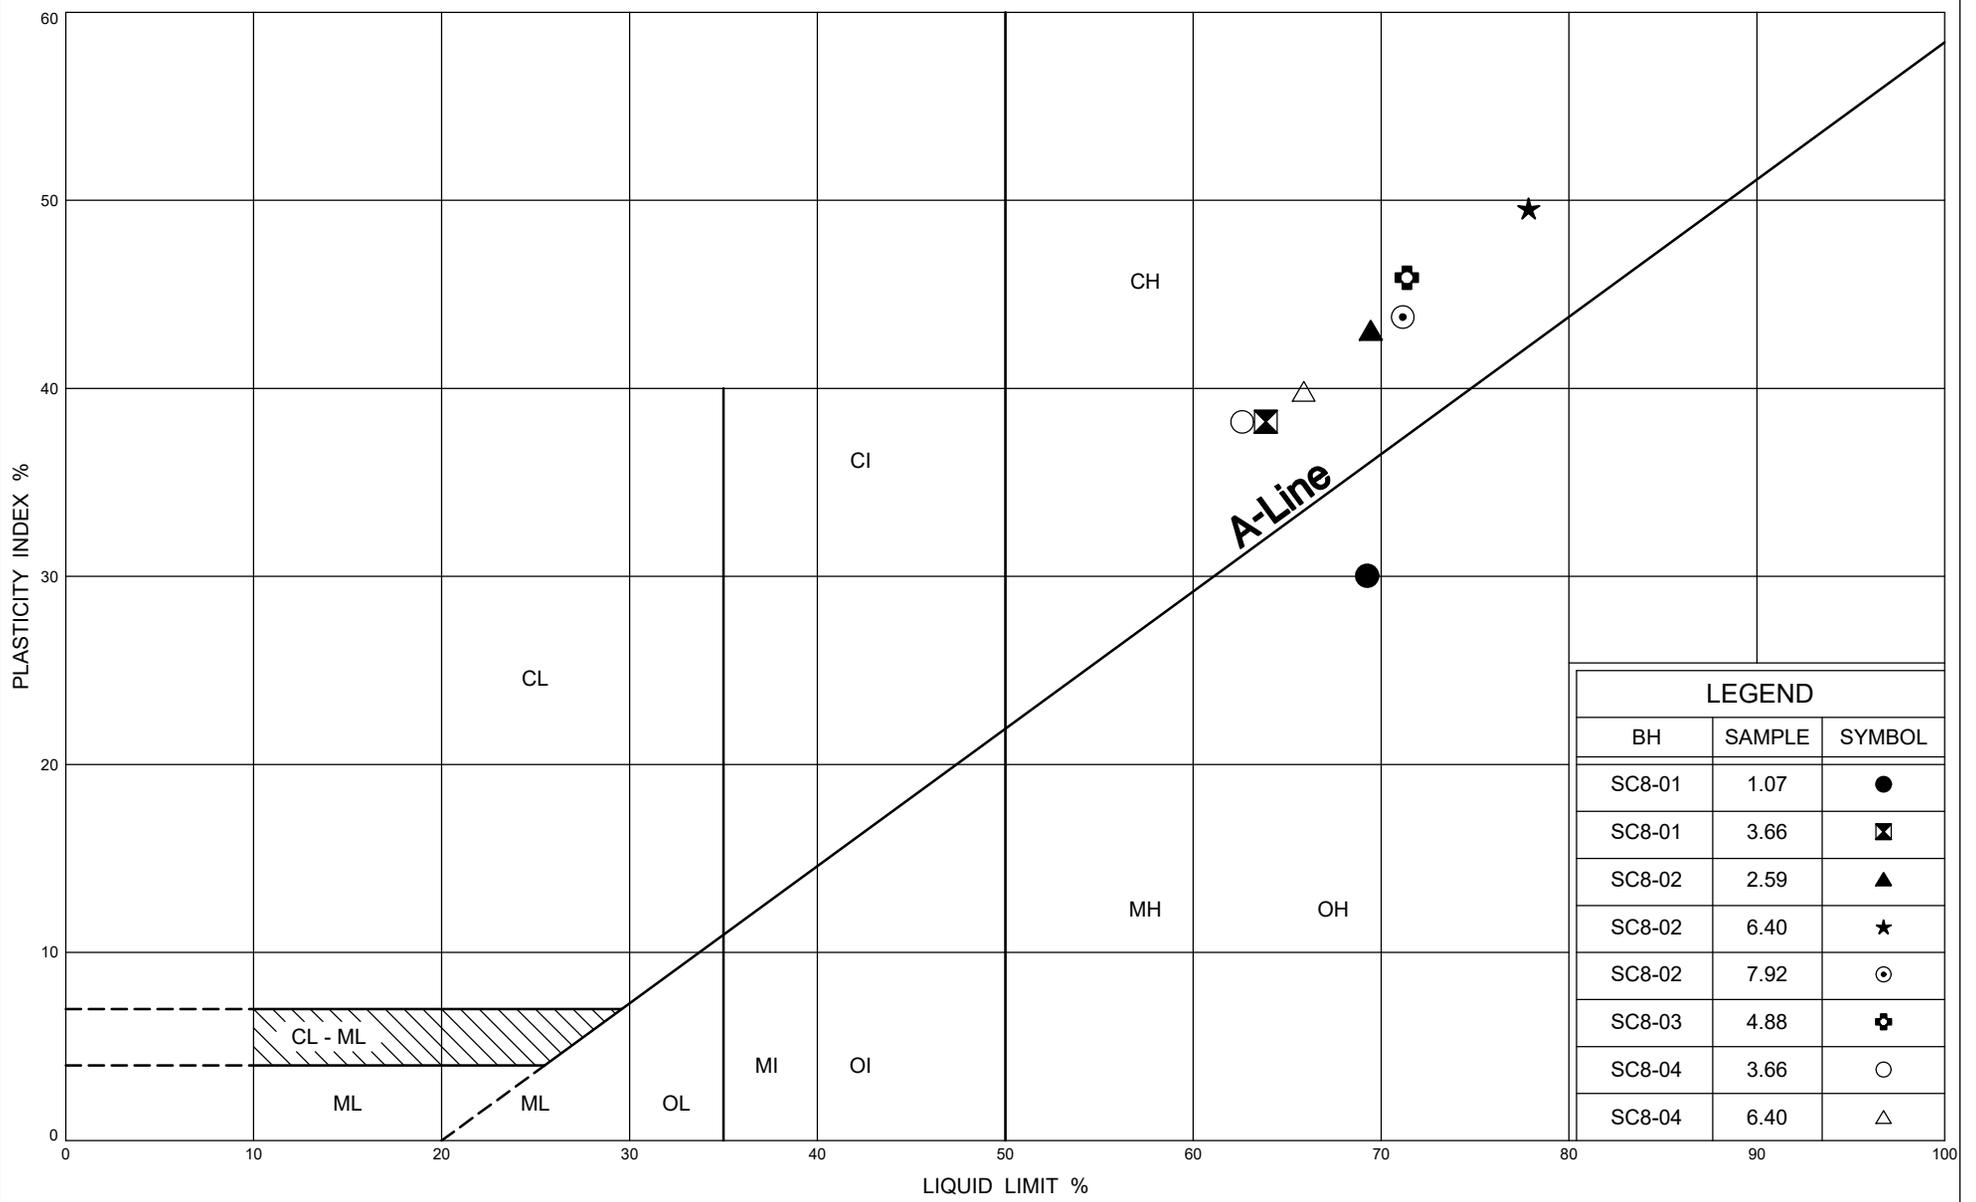
FIG No B7
 W P 6014-18-00
 Strawberry Creek Bridge #8

Soil Property	Percentage (%)
Liquid Limit	70
Plastic Limit	39
Plasticity Index	31

LEGEND		
BH	SAMPLE	SYMBOL
SC8-01	1.07	●
SC8-01	3.66	⊠
SC8-02	2.59	▲
SC8-02	6.40	★
SC8-02	7.92	⊙
SC8-03	4.88	⊕
SC8-04	3.66	○
SC8-04	6.40	△

Silty CLAY

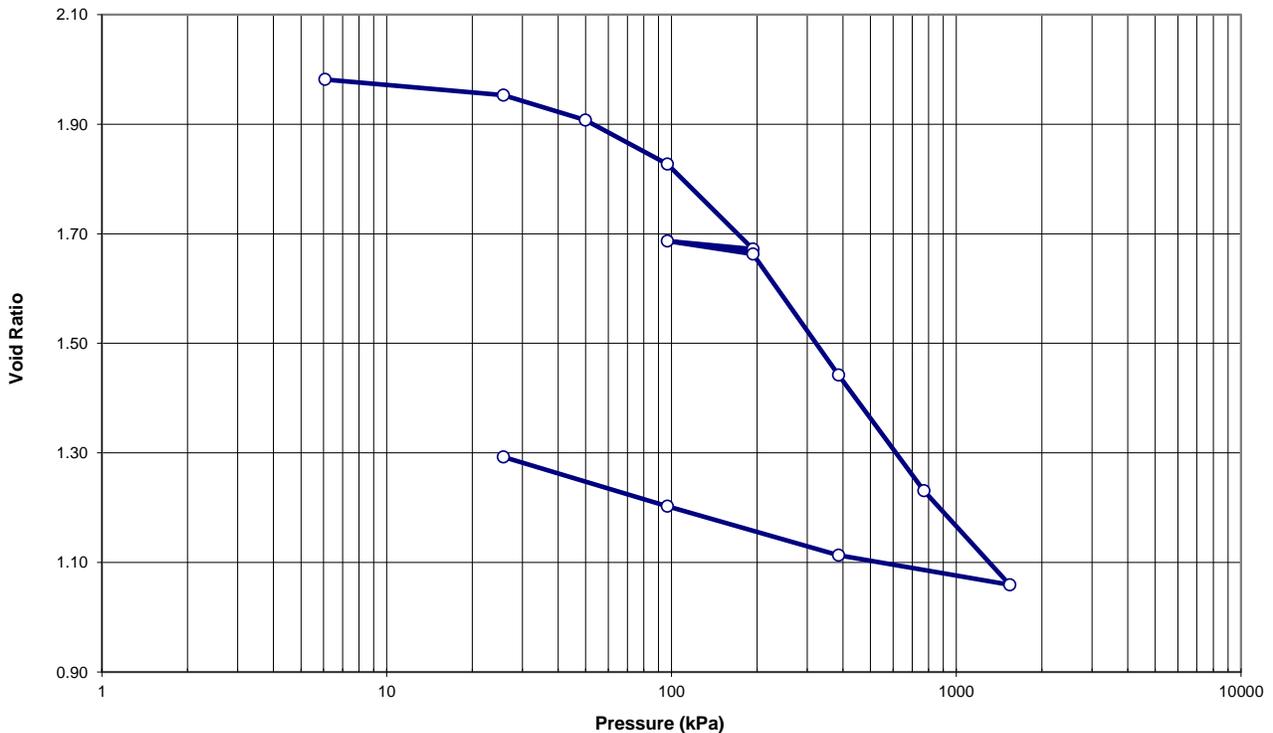
Void Ratio vs. Pressure

SAMPLE: SC8-02 ST1 20'-22'
 Silty clay, trace gravel, reddish brown, moist.
 LL=78, PL=28, I_p = 50

Start of Test	End of Test
Wet Dens. (kg/m ³)	1591.6	1768.7
Dry Dens. (kg/m ³)	932.7	1213.3
Moisture Cont. (%)	70.6	45.8
Void Ratio	1.982	1.293
Saturation (%)	99.1

Project #: 27323
 Client: MTO
 Project Name: Sunshine Creek #2 and Strawberry Creek #8 Bridges
 Sample: SC8-02 ST1 20'-22'

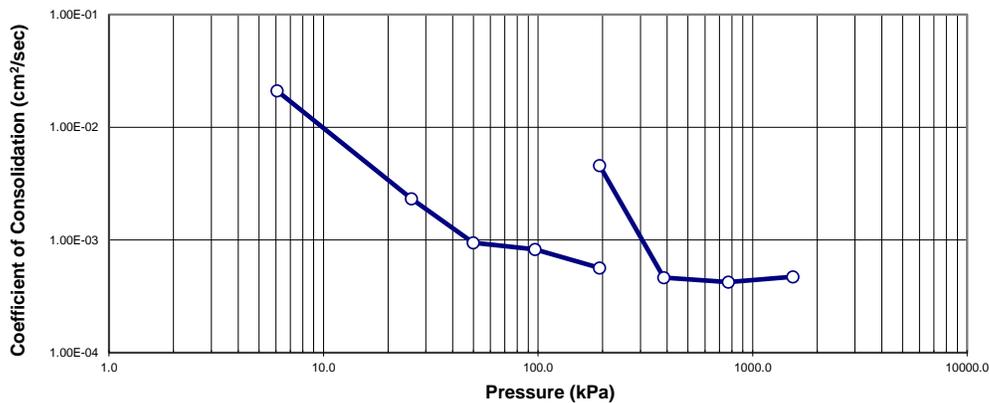
Coefficient of Consolidation vs. Pressure

Notes: C_v and k calculated using t₉₀ values

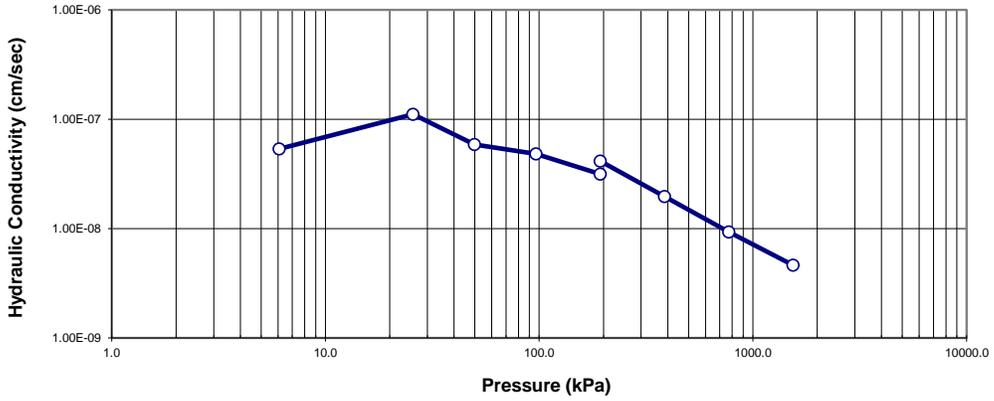
Hydraulic Conductivity vs. Pressure

Project #: 27323
Client: MTO
Project Name: Sunshine Creek #2 and Strawberry Creek #8 Bridges
Sample: SC8-02 ST1 20'-22'

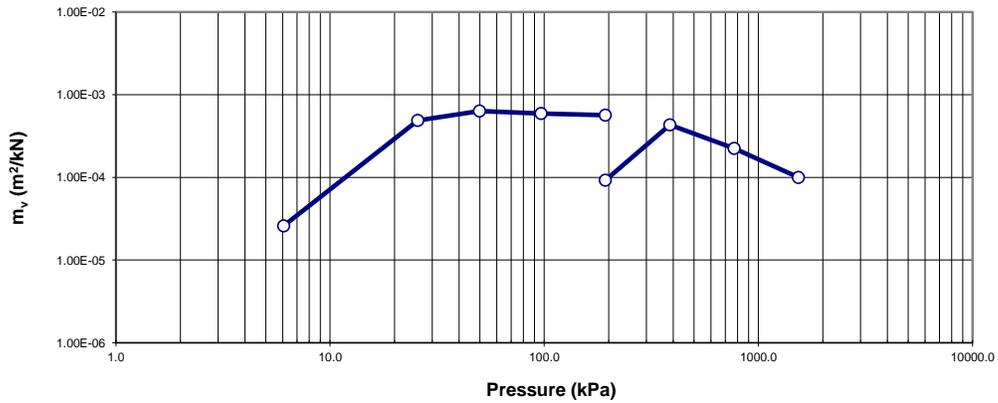
m_v vs. Pressure

Project #: 27323
Client: MTO
Project Name: Sunshine Creek #2 and Strawberry Creek #8 Bridges
Sample: SC8-02 ST1 20'-22'

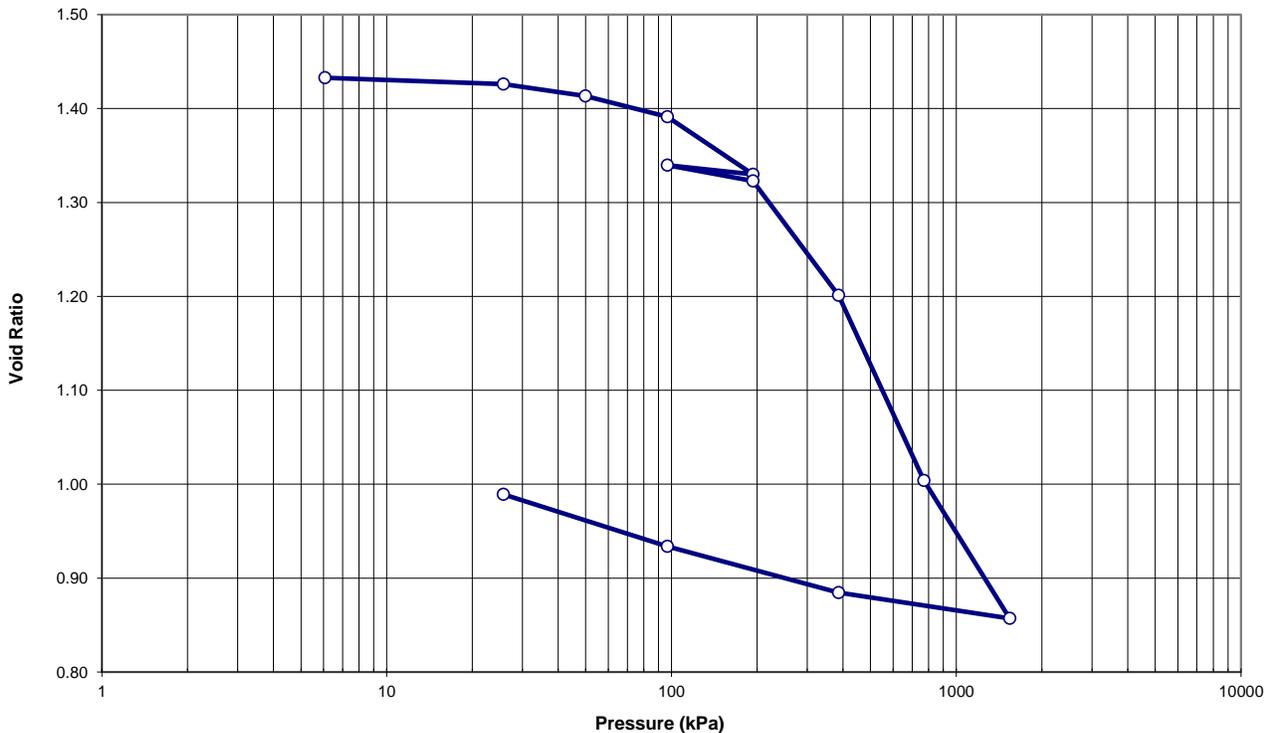
Void Ratio vs. Pressure

SAMPLE: SC8-04 ST1 11'-13'
 Silty clay, trace sand, brown, moist.
 LL=62.7, PL=24.4, I_p = 38.2

<u>Start of Test</u>	<u>End of Test</u>
Wet Dens. (kg/m ³)	1723.9	1895.3
Dry Dens. (kg/m ³)	1155.0	1412.7
Moisture Cont. (%)	49.3	34.2
Void Ratio	1.433	0.989
Saturation (%)	96.6	96.6

Project #: 27323
 Client: MTO
 Project Name: Sunshine Creek #2 and Strawberry Creek #8 Bridges
 Sample: SC8-04 ST1 11'-13'

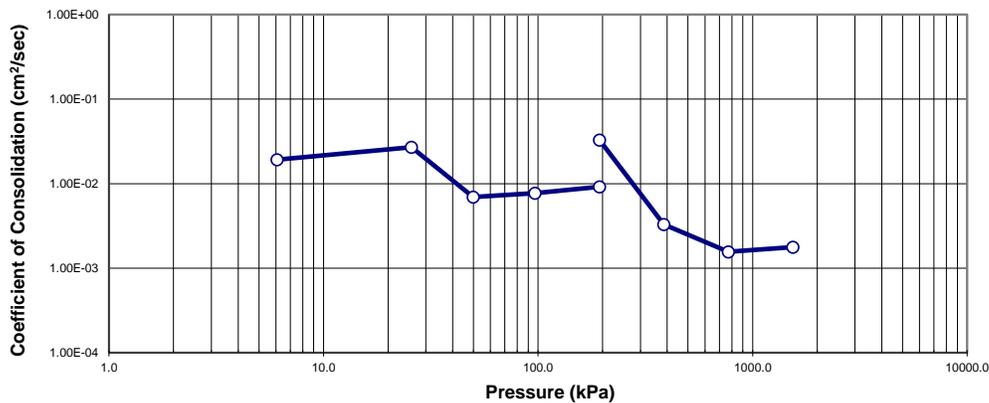
Coefficient of Consolidation vs. Pressure

Project #: 27323
Client: MTO
Project Name: Sunshine Creek #2 and Strawberry Creek #8 Bridges
Sample: SC8-04 ST1 11'-13'

Notes: C_v and k calculated using t₉₀ values

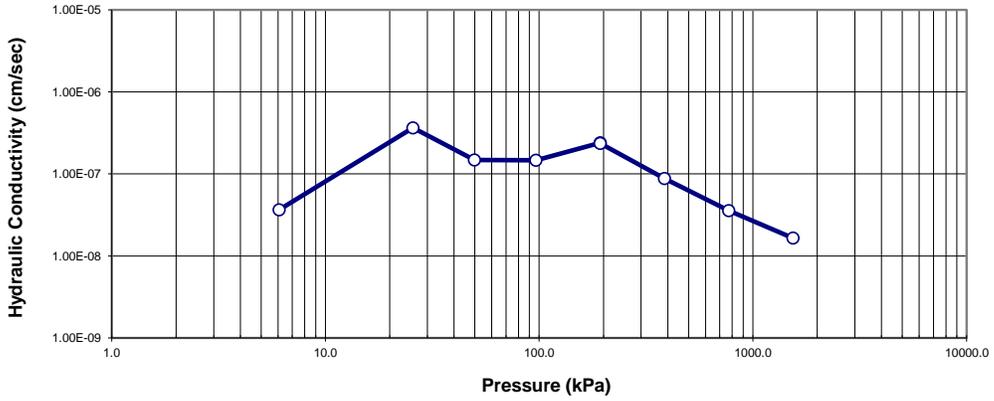
Hydraulic Conductivity vs. Pressure

Project #: 27323
Client: MTO
Project Name: Sunshine Creek #2 and Strawberry Creek #8 Bridges
Sample: SC8-04 ST1 11'-13'

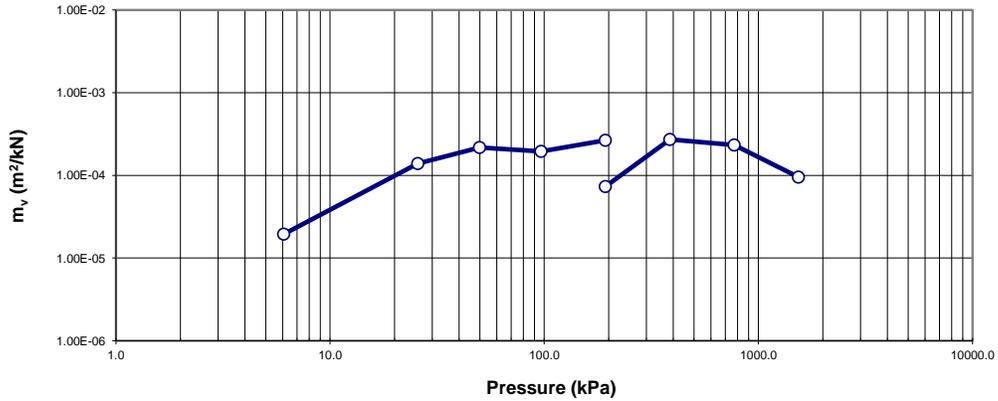
m_v vs. Pressure

Project #: 27323
Client: MTO
Project Name: Sunshine Creek #2 and Strawberry Creek #8 Bridges
Sample: SC8-04 ST1 11'-13'

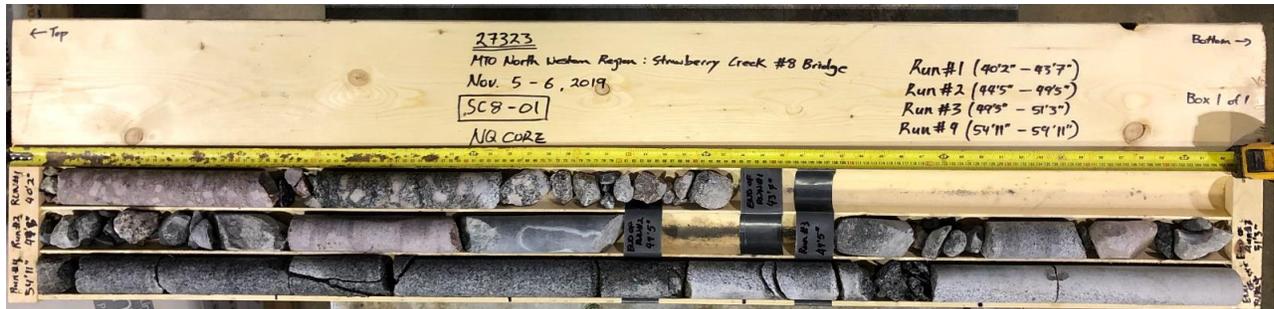
Photo B1: Borehole SC8-01 cobbles and boulders (Runs #1 to #3) and bedrock core (Run #4).

Total Core Recovery (TCR) in the bedrock ranged was 100%, and Solid Core Recovery (SCR) was 95%. The Rock Quality Designation (RQD) determined from the recovered core was 40%, which indicates poor rock quality. The Fracture Index (FI) of the rock, expressed as fractures per 0.3 m of core, ranged from 1 to 5, with one broken zone with FI of greater than 10.

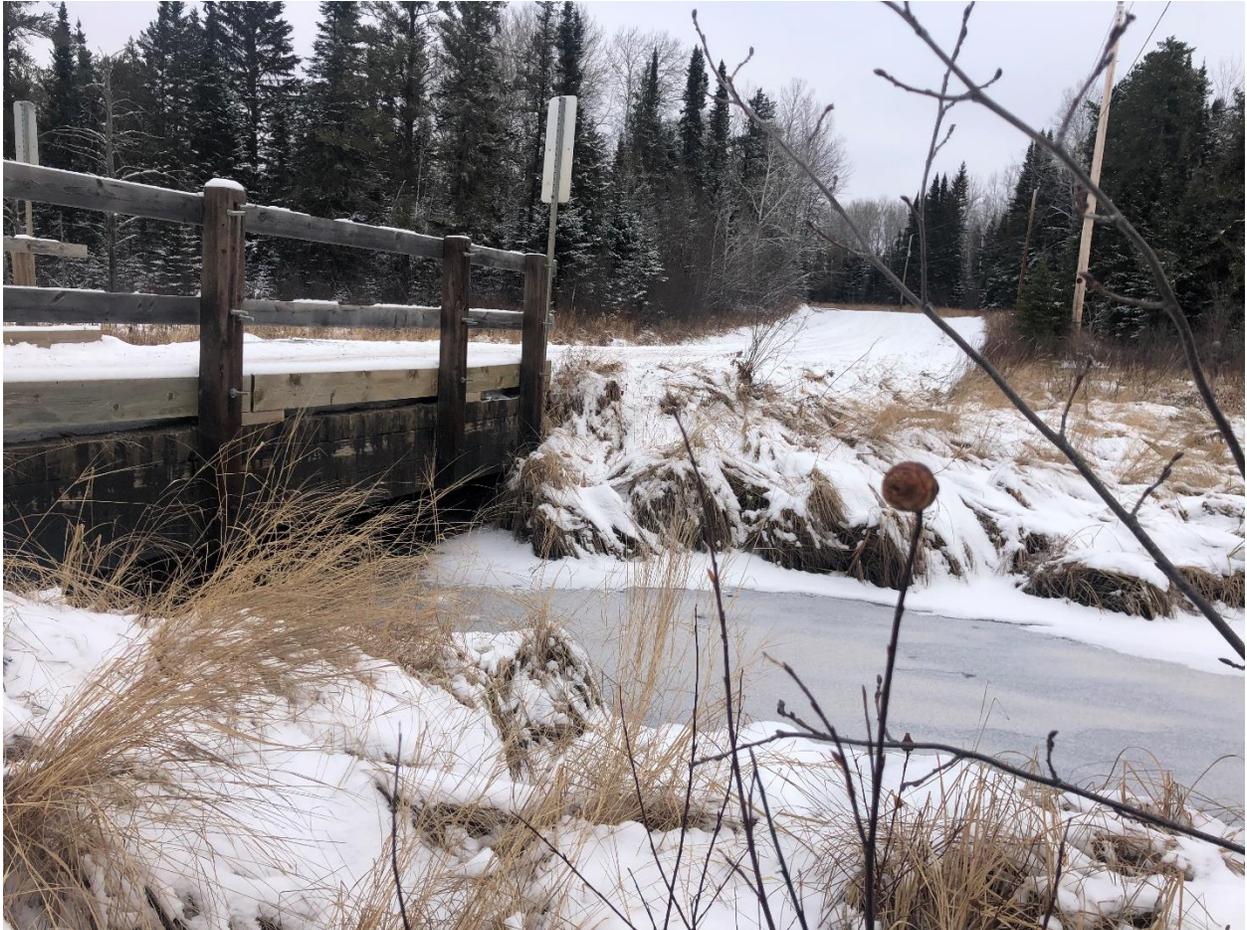
Photo C4: Looking north at east side of bridge and northeast embankment from southeast side.

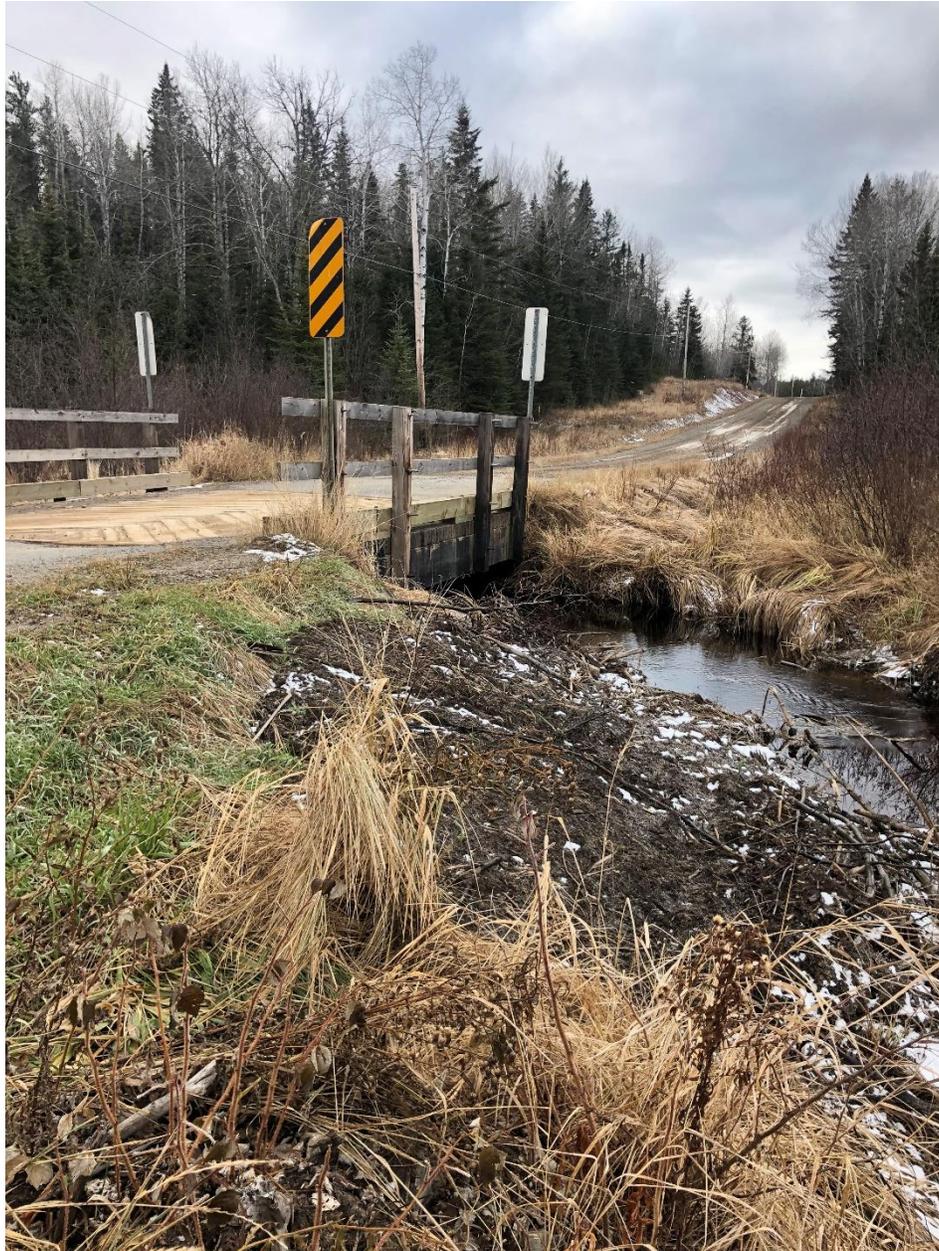
Photo C5: Looking south at northwest embankment and west side of bridge.
