**FOUNDATION INVESTIGATION REPORT
STRAWBERRY CREEK BRIDGE #8 REPLACEMENT
WARE ROAD NORTH, DISTRICT OF THUNDER BAY,
WARE TOWNSHIP, ONTARIO
LATITUDE: 48.604697°, LONGITUDE: -89.471511°
G.W.P. 6014-18-00, SITE No. 48W-054**

GEOCRES Number: 52A-250

Date: June 5, 2020
File: 27323

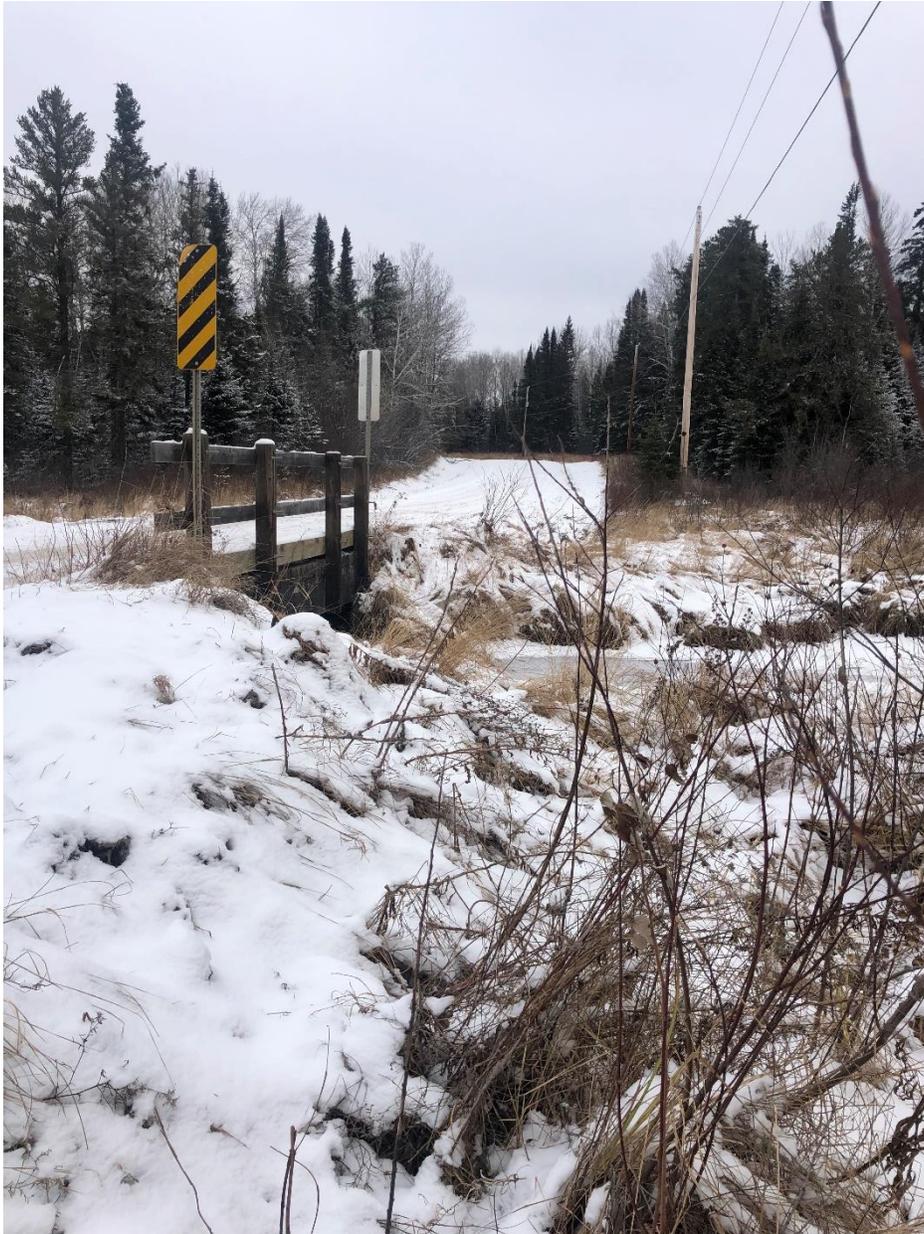
Photo C6: Looking north at southeast embankment and east side of bridge.

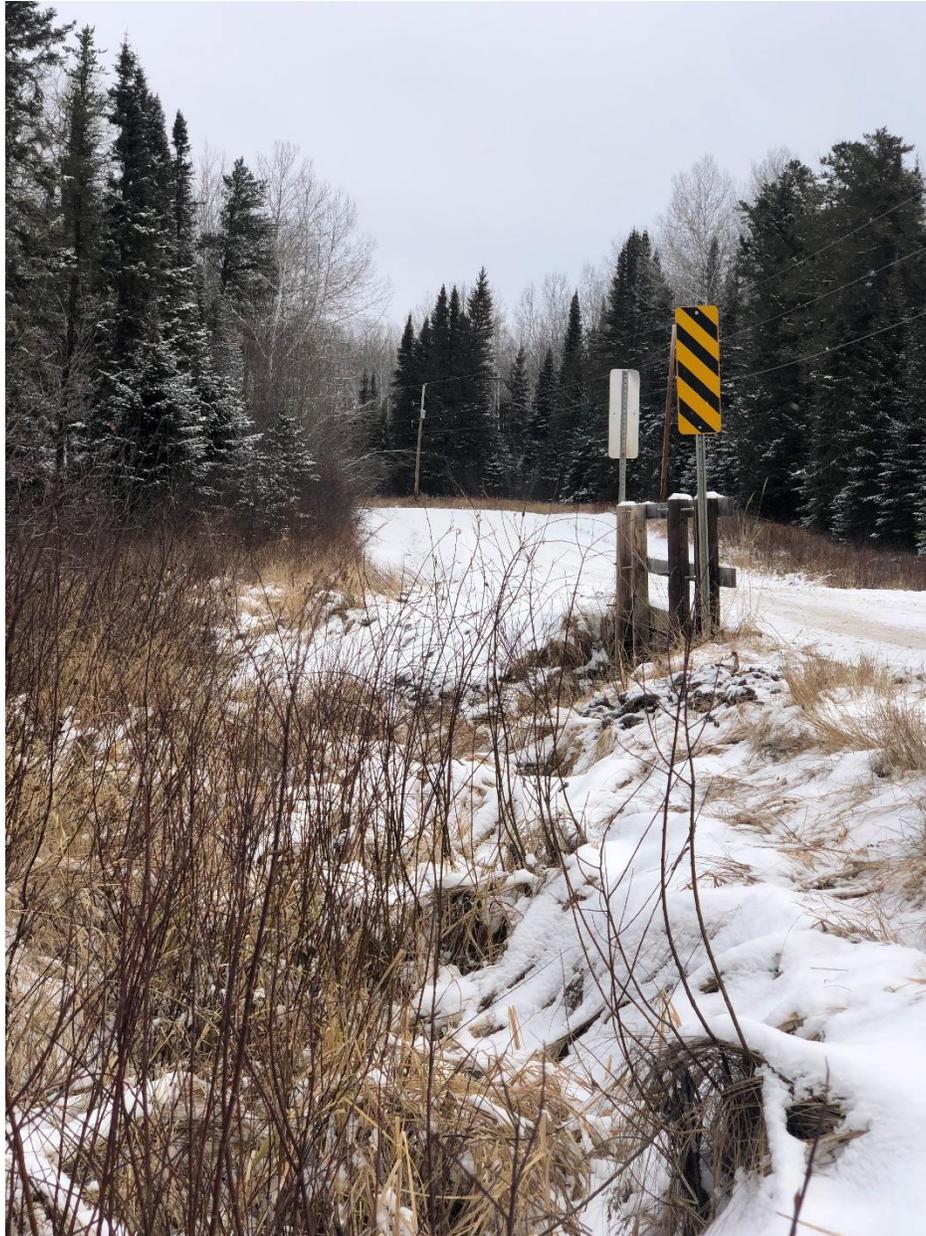
Photo C7: Looking north at southwest embankment and west side of bridge.

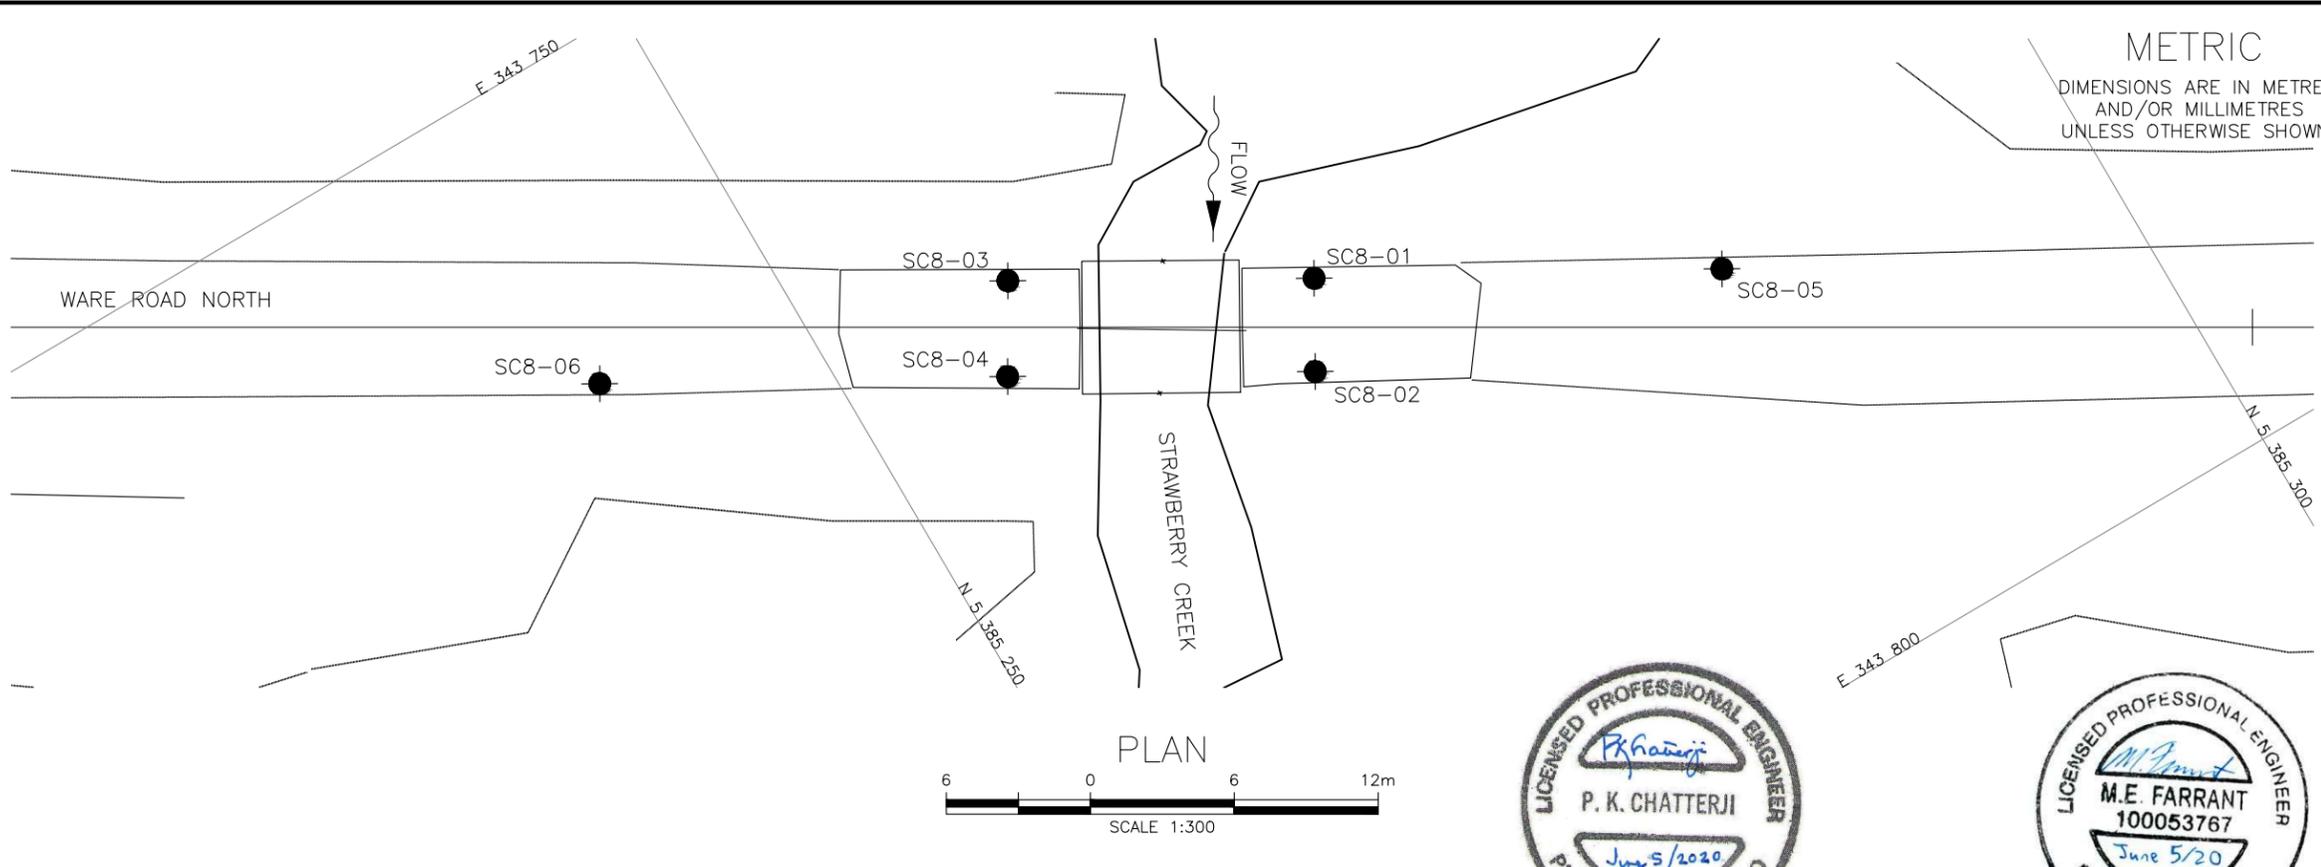
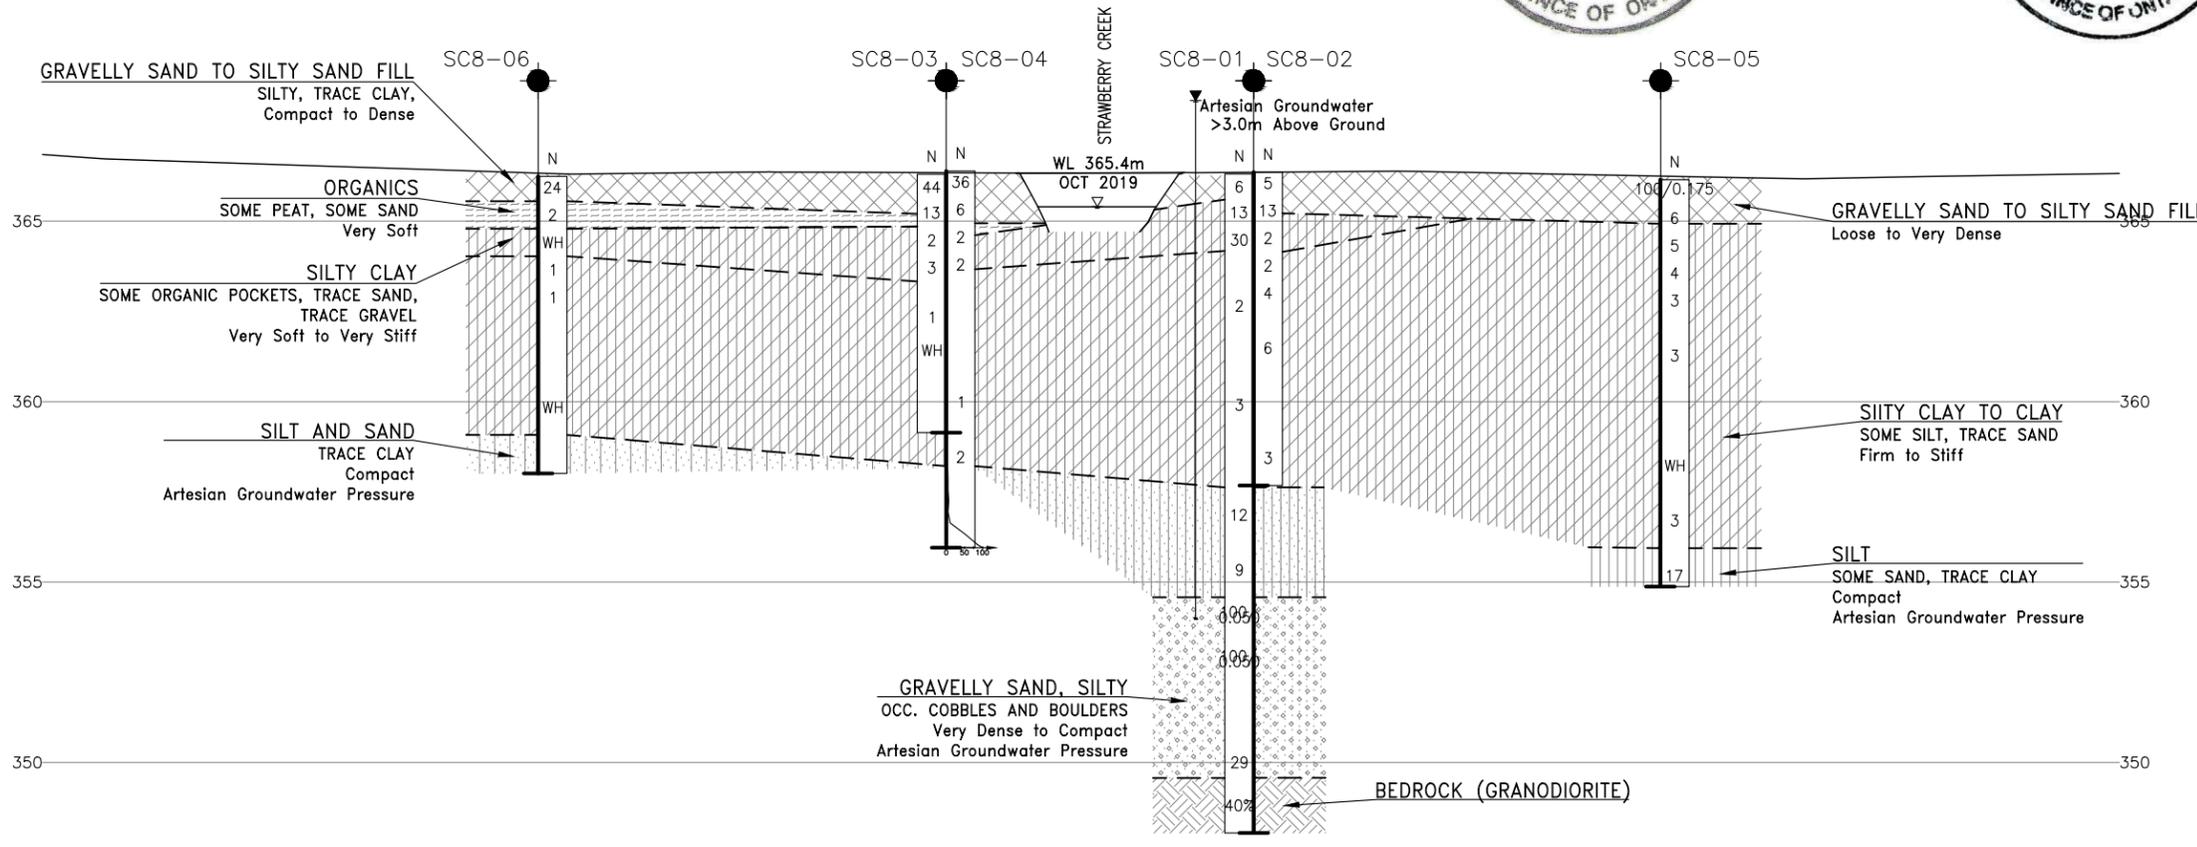
CONT No GWP No 6014-18-00	
STRAWBERRY CREEK BRIDGE #8 REPLACEMENT	
BOREHOLE LOCATIONS AND SOIL STRATA	
SHEET

- NOTES-**
- The boundaries between soil strata have been established only at Borehole locations. Between Boreholes the boundaries are assumed from geological evidence.
 - This drawing is for subsurface information only. Surface details and features are for conceptual illustration.
 - Coordinate system is MTM NAD 83 Zone 15.

PROFILE ALONG WARE ROAD NORTH

The borehole logs are included in Appendix A and the approximate locations of the boreholes are shown on the Borehole Locations and Soil Strata drawings included in Appendix D.

Reference is made to the Record of Borehole sheets included in Appendix A. Details of the encountered soil stratigraphy are presented on the Record of Borehole sheets and on the Borehole Locations and Soil Strata Drawing included in Appendix D. A general description of the stratigraphy, based on the conditions encountered in the boreholes, is given in the following paragraphs. However, the factual data presented on the Record of Borehole sheets takes precedence over this general description and must be used for interpretation of the site conditions. It must be recognized and expected that soil conditions will vary between and beyond the borehole locations.
