**FOUNDATION INVESTIGATION REPORT  
HIDDEN GLEN ROAD ACCELERATION LANE  
HIGHWAY 400 SOUTHBOUND LANES, DISTRICT OF MUSKOKA, ONTARIO  
ASSIGNMENT NO. 5019-E-0016  
G.W.P. 5191-18-00**

**Report**

**LEA Consulting Ltd.**

Date: April 3, 2024  
File: 28317

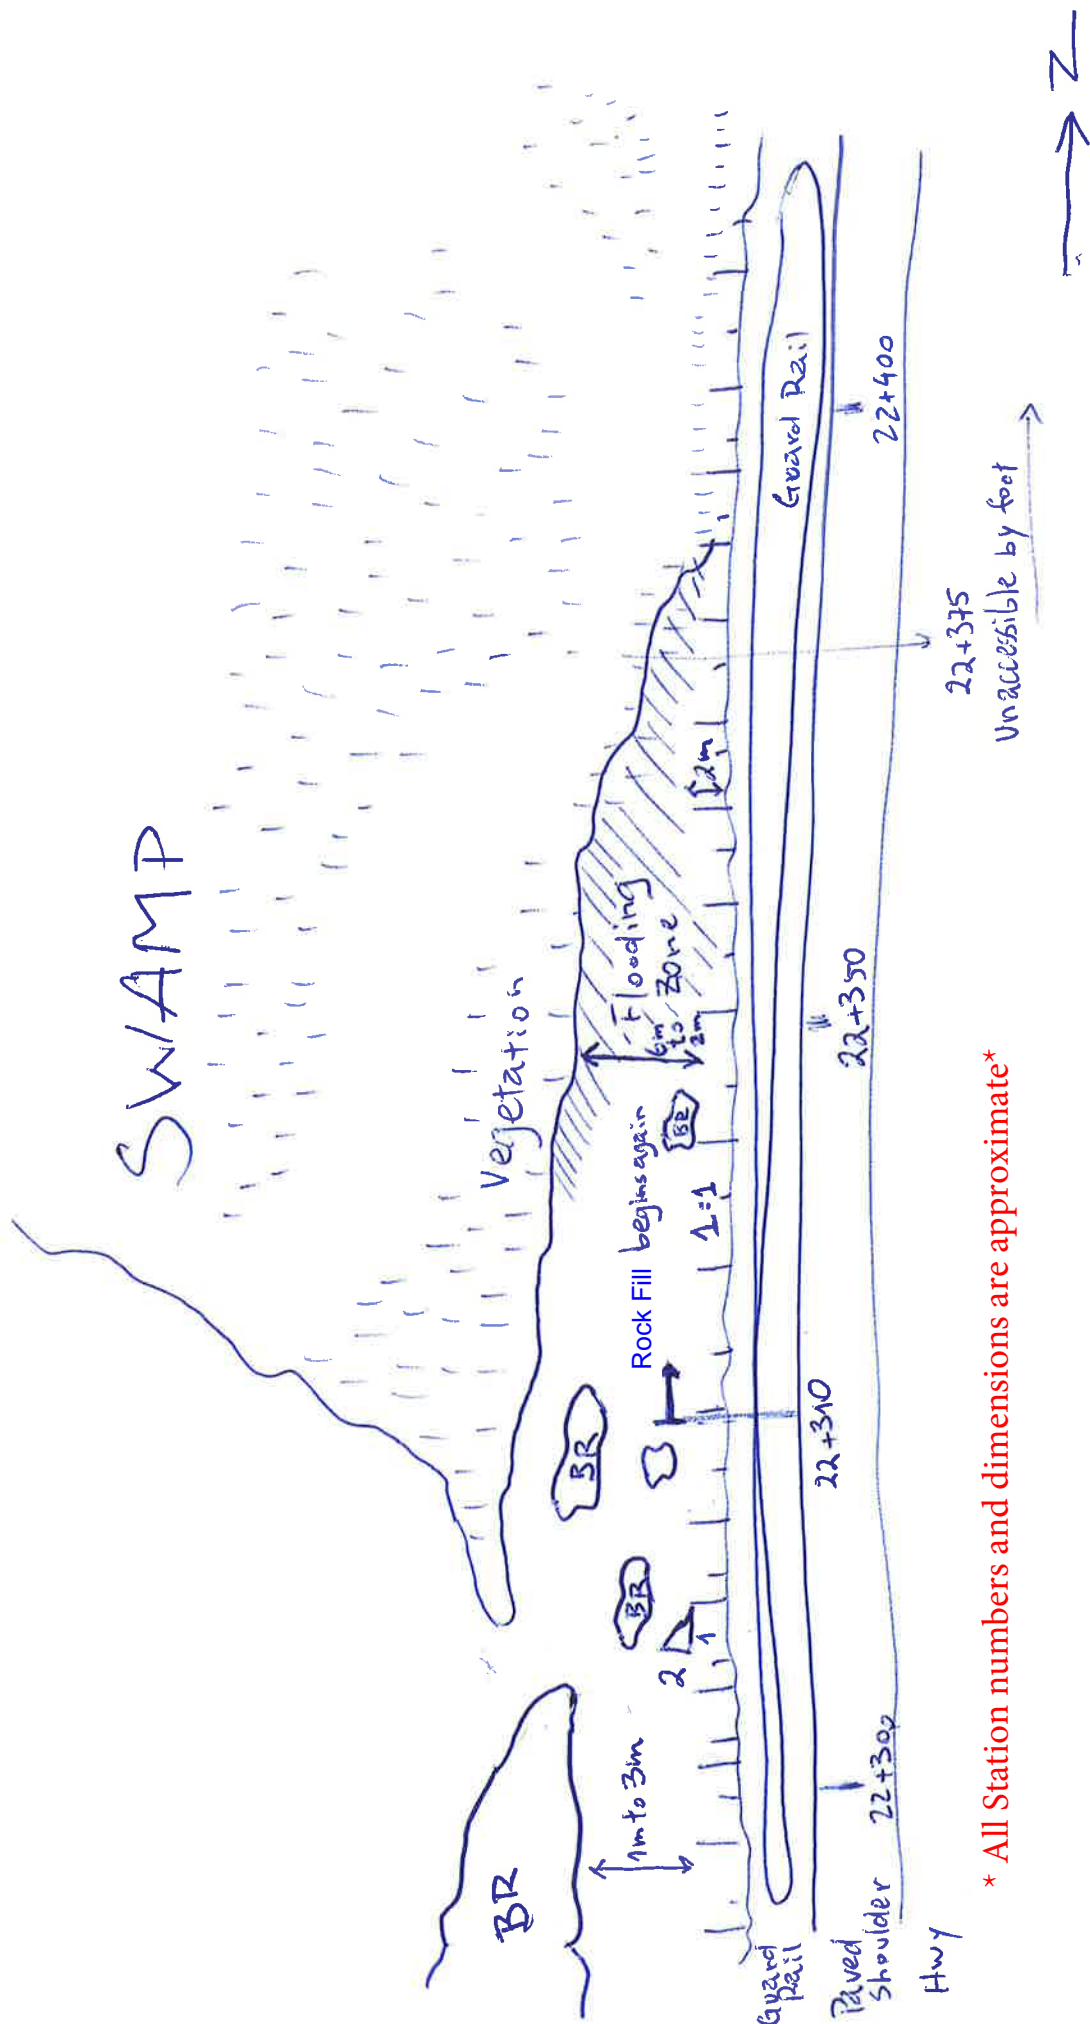
Hidden Glen Acceleration Lane  
 Highway 400, District of Muskoka  
 Field Sketch, Station 22+300 to 22+400

The area between Station 22+370 and 22+420 west of the embankment was noted as a swamp with standing water. The area could not be accessed at the time of the current investigation due to standing water and safety concerns with working in the water.

Three boreholes were attempted/advanced as part of the pavement investigation at the west toe of the embankment/ditch line within the station limits. Two of the three boreholes noted 600 mm of surface water and the third borehole noted 600 mm of peat. This third borehole met refusal below the peat at a depth of 600 mm.

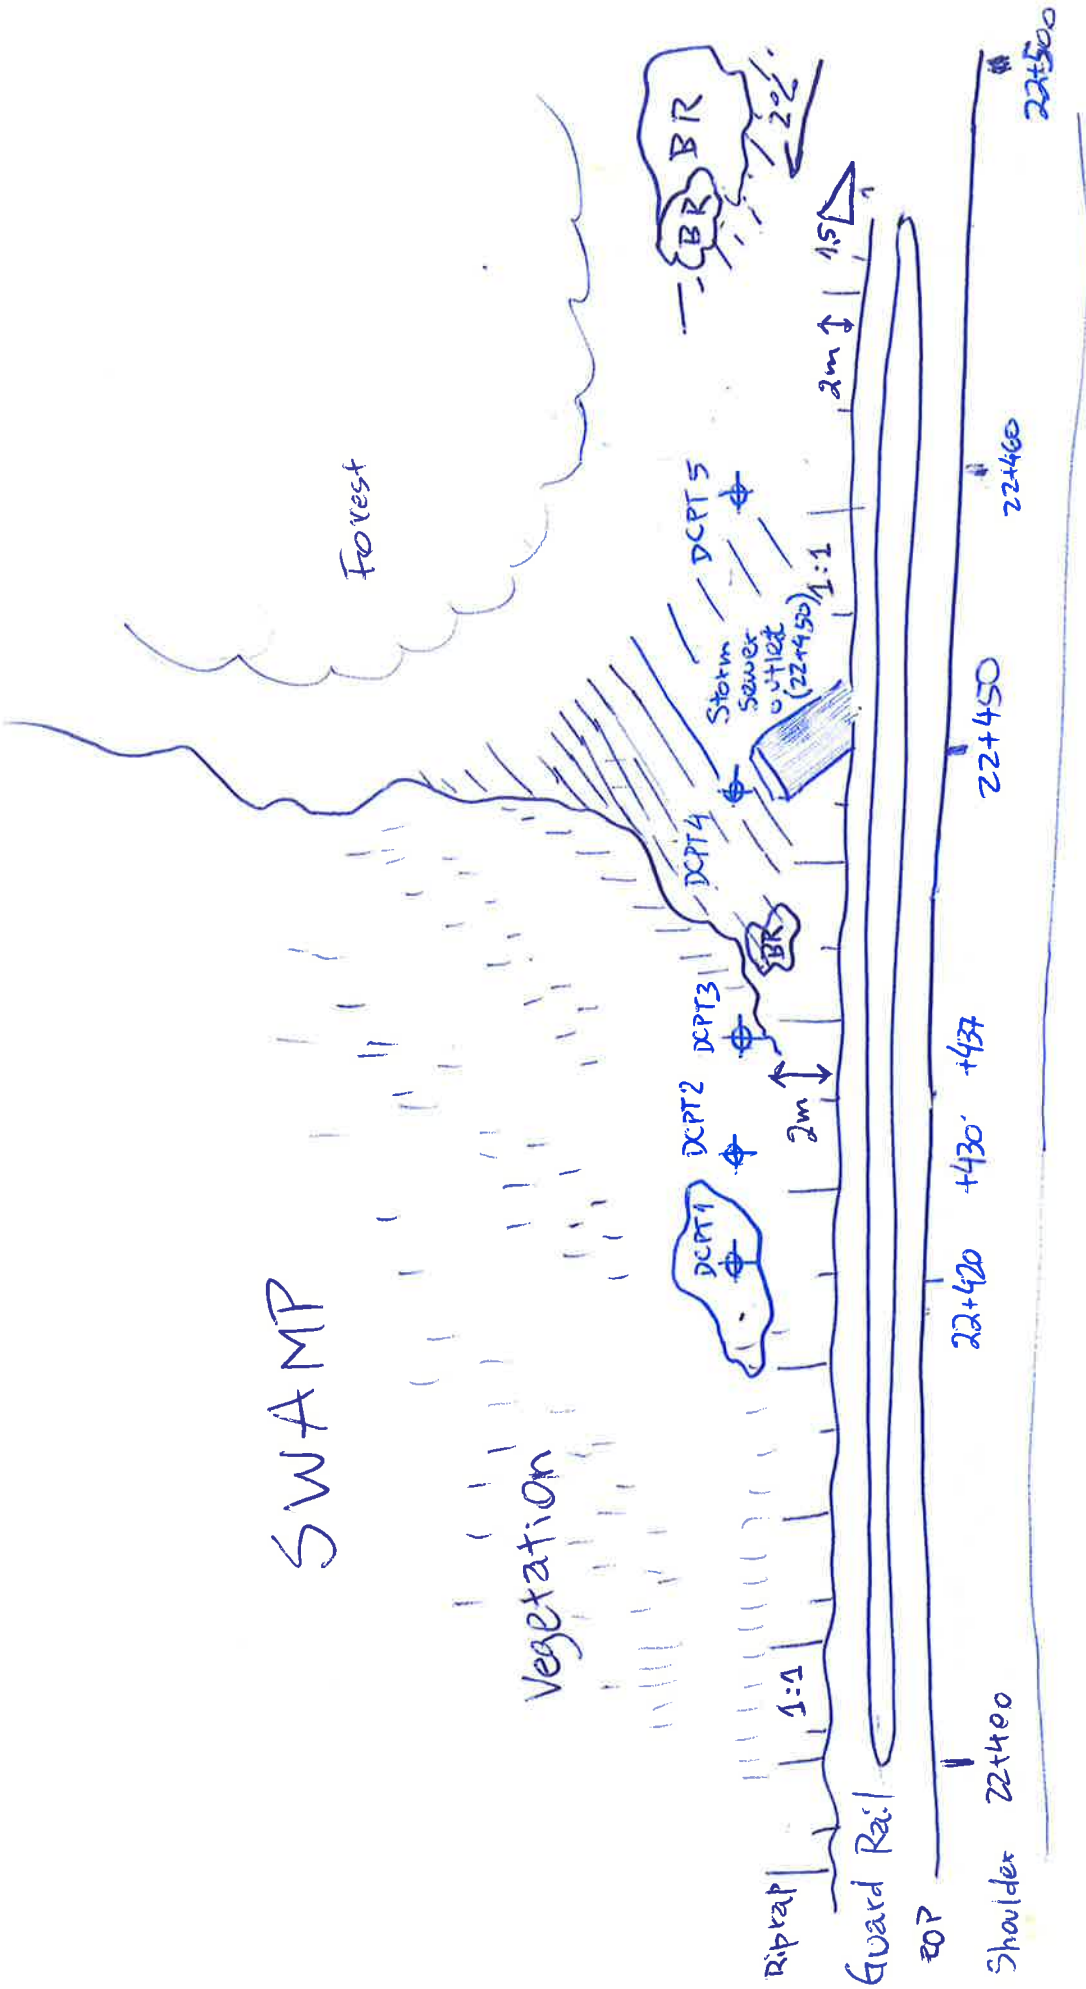
Hidden Glen Acceleration Lane  
Highway 400, District of Muskoka  
Field Sketch, Station 22+400 to 22+500

Area #3 extends from the north edge of the inaccessible area of the swamp near Station 22+420 north to approximately Station 22+480 where bedrock was noted at the ground surface or below a thin layer of topsoil. It includes the west end of a 1.25 m square concrete box culvert. The south end of this area was noted to be wet, and the vegetation was consistent with swampy terrain.

This area was investigated by advancing five DCPTs (DCPT-01 to DCPT-05). The results of the DCPTs are included in Appendix A. Refusal in the DCTPs was encountered at depths ranging from 0.7 m to 1.1 m below ground surface on assumed bedrock. N-values ranged from 0 to 3 (excluding the refusal values at the bottom of each DCPT) indicating a very loose/very soft relative density/consistency.

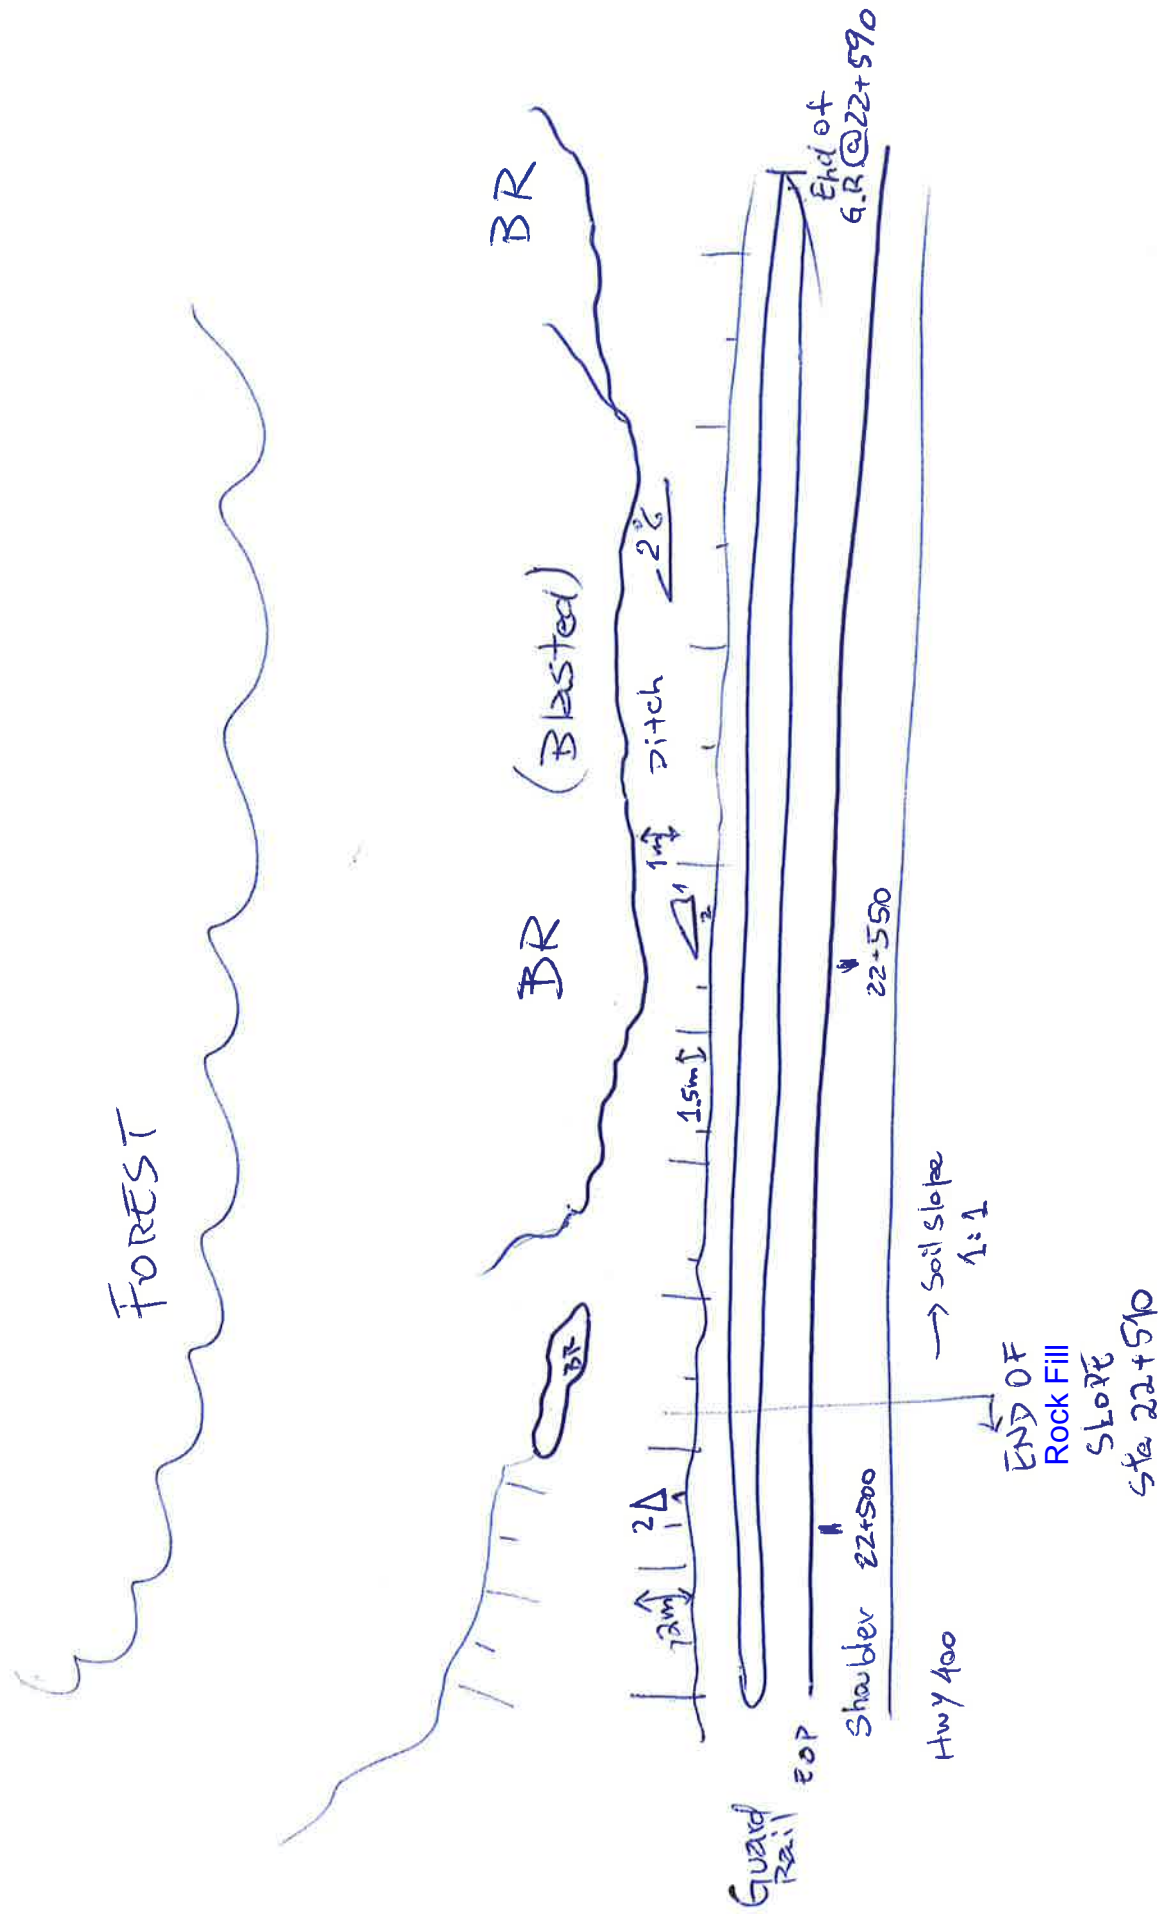
Hidden Glen Acceleration Lane  
Highway 400, District of Muskoka  
Field Sketch, Station 22+500 to 22+590

During the current investigation it was noted that bedrock was exposed at the ground surface or was below a thin layer of topsoil/soil within this area. Additional investigation was not carried out during the current investigation.

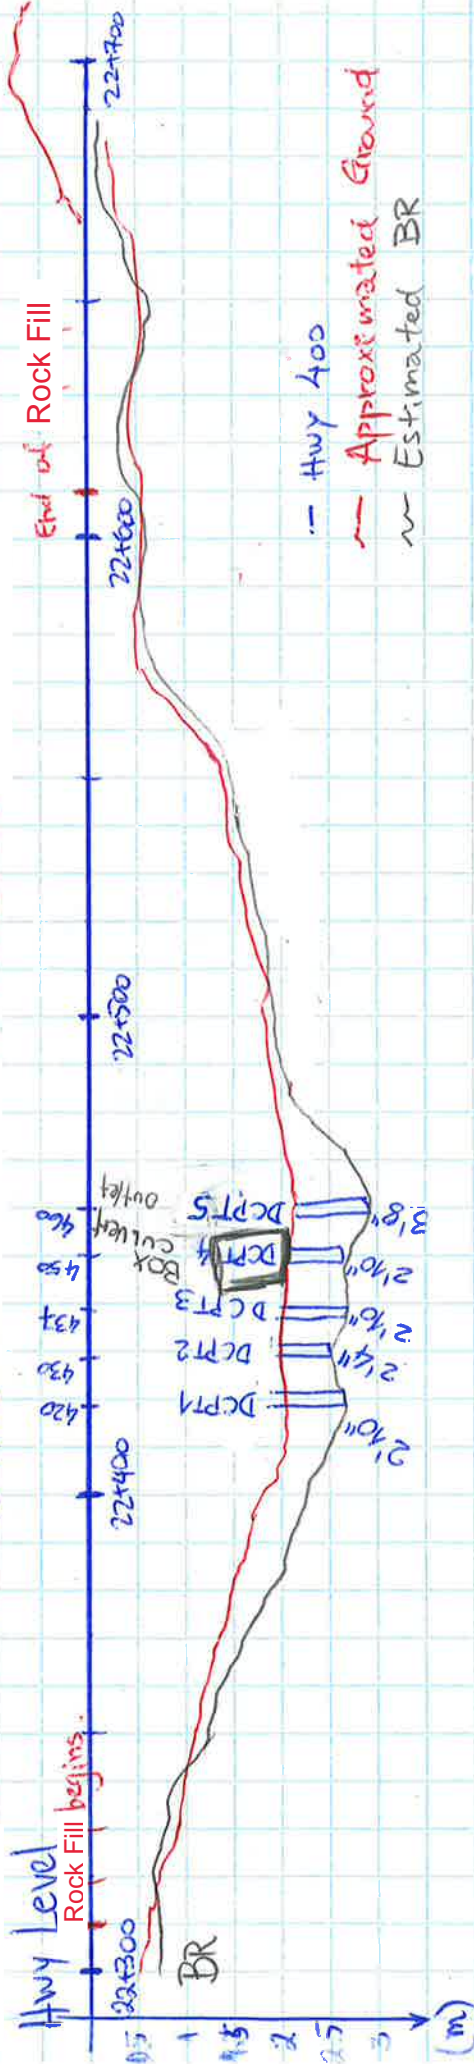
Hidden Glen Acceleration Lane  
Highway 400, District of Muskoka  
Profile, Station 22+300 to 22+700

near surface BR ← 22+345 — SWAMP — 22+465 → Bed Rock is near surface

- \* Swamp inaccessible from 22+375 to 22+410.
- \* DCPT's 2 and 3 in the swamp (under water - 1' to 2').
- \* Riprap 1:1, varies from 0.5m to 2m height.

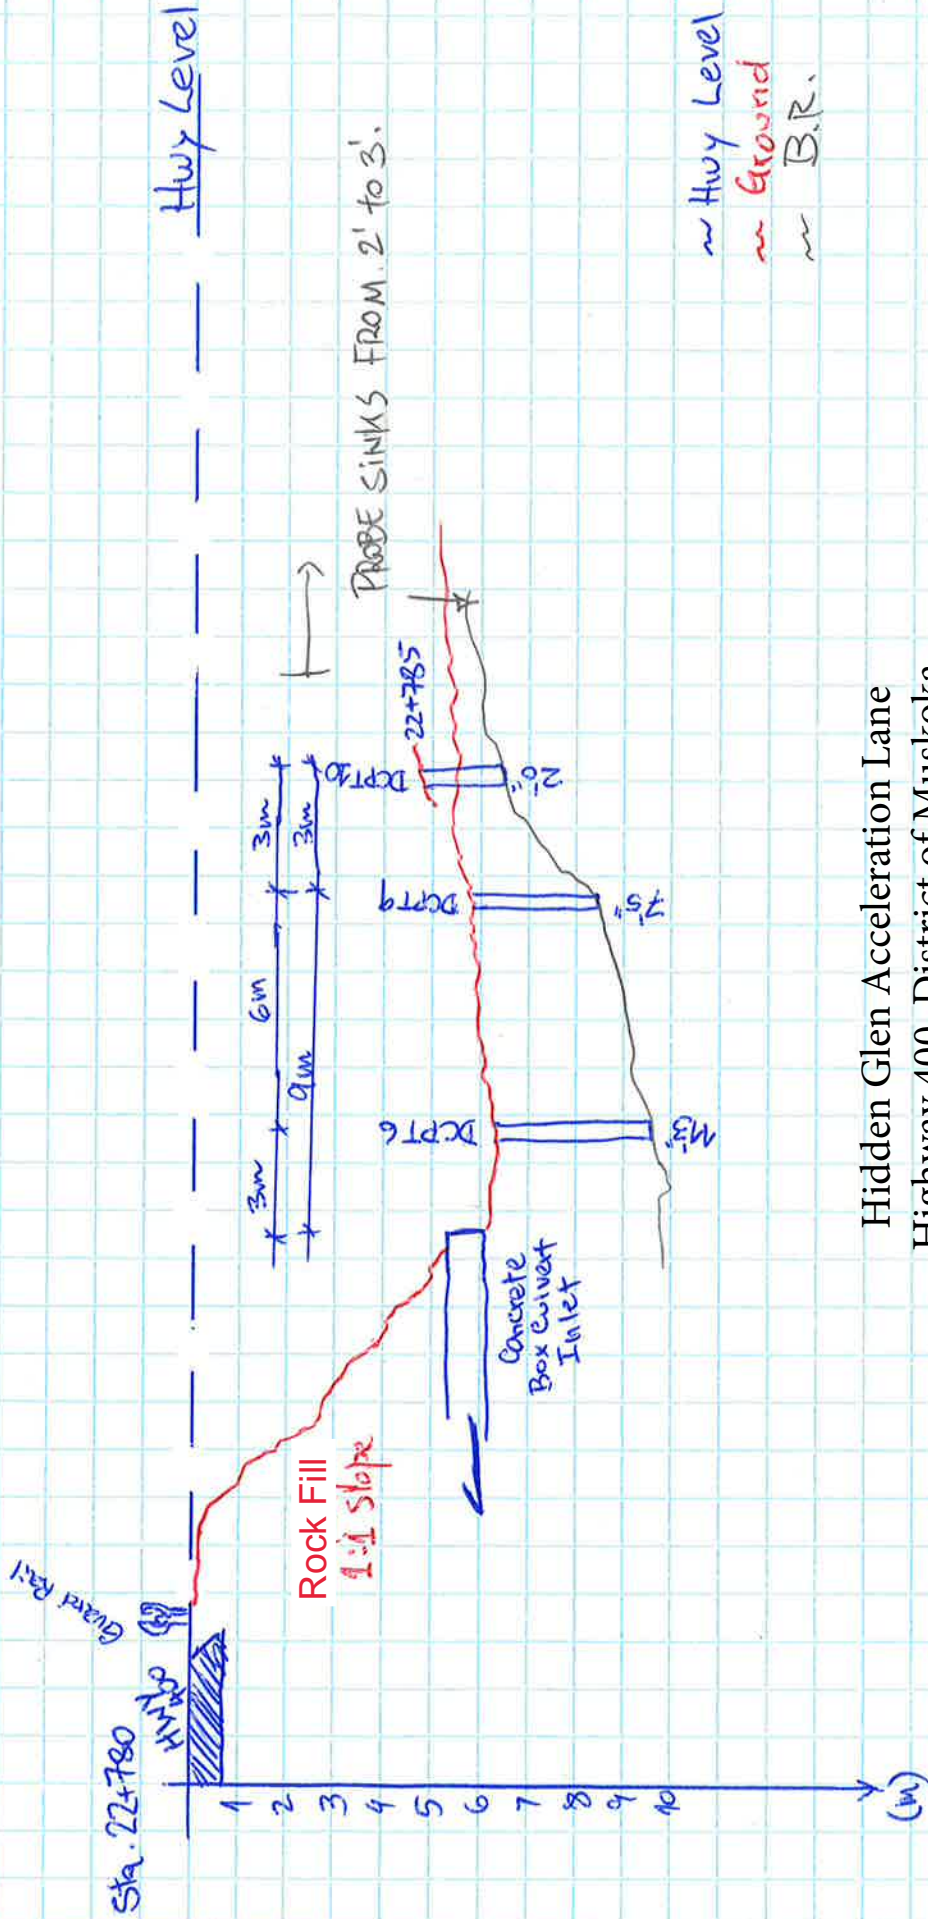
Hidden Glen Acceleration Lane  
Highway 400, District of Muskoka  
Section at Station 22+780

During the current investigation, this area was investigated by carrying out five DCPTs (DCPT-06 to DCPT-10). The DCPTs were located 3 m to approximately 12 m west of the toe of the embankment slope as shown on the sketch in Appendix A. Refusal was encountered at depths ranging from 0.6 m to 3.4 m below the ground surface. The depth to refusal was greatest near the end of the box culvert and decreased to the north, south and west. N-values ranged from 0 to

83 (typically 8 to 30) in the upper 1.2 m and from 1 to 15 (typically 2 to 4) below 1.2 m (excluding the refusal values at the bottom of each DCPT) indicating a compact/stiff to very stiff relative density/consistency in the upper 1.2 m and a very loose/soft relative density/consistency below 1.2m, respectively.

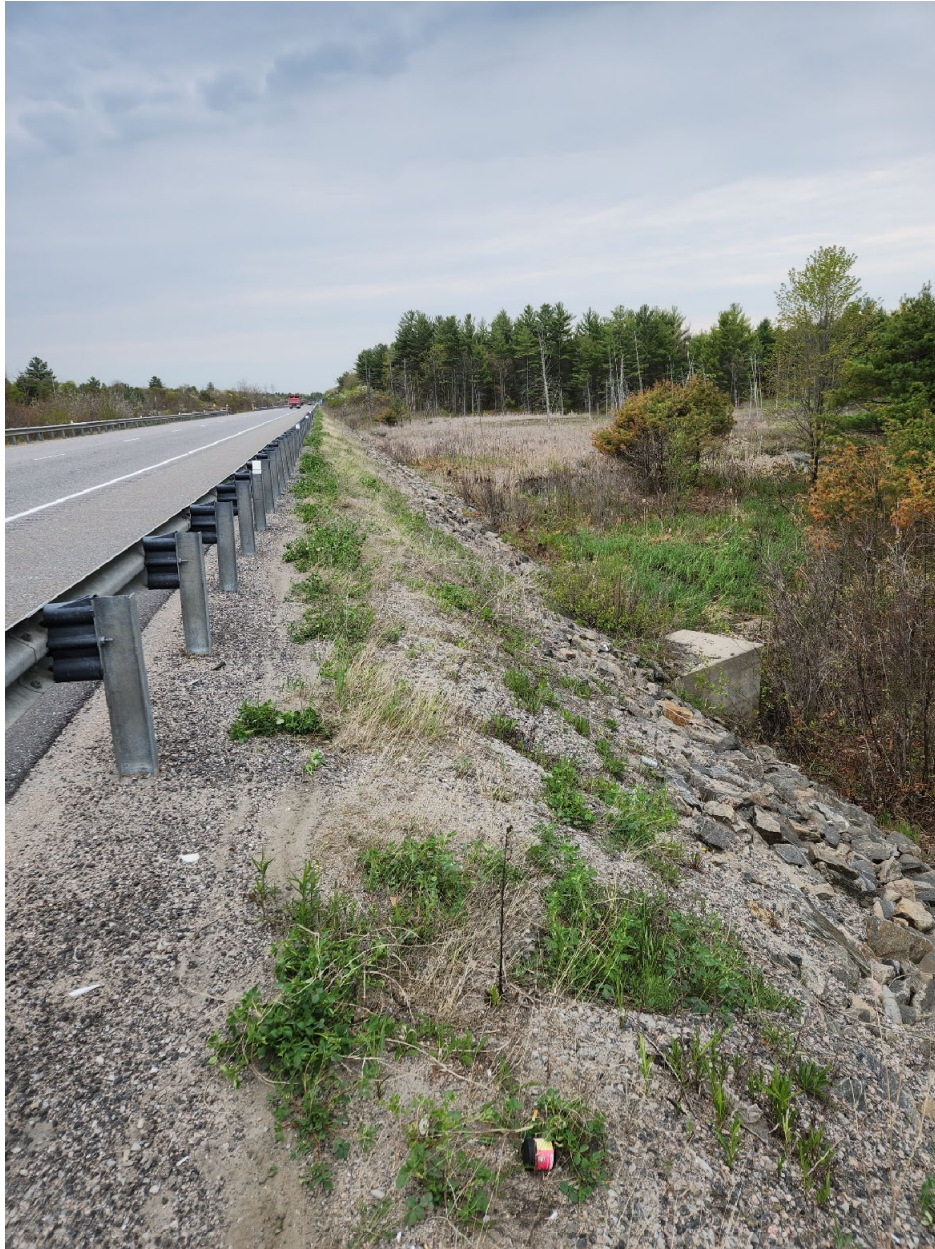
**Photograph #1: Looking south from the top of the embankment slope at Sta. 22+460.**

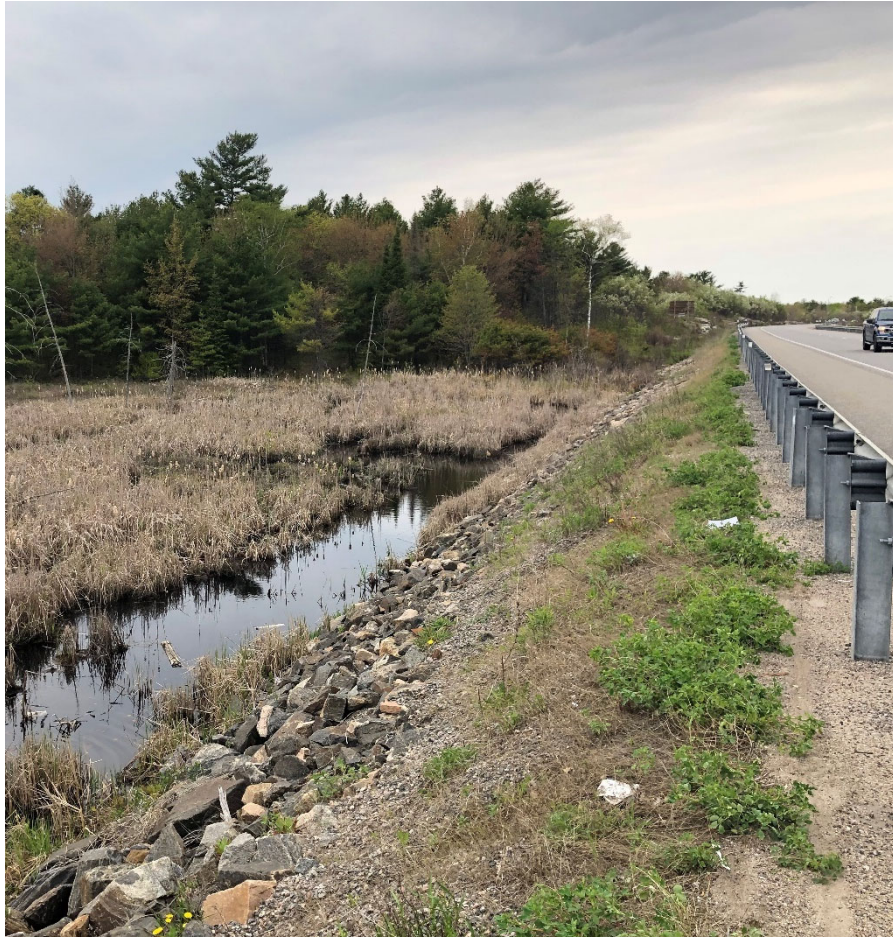
**Photograph #2: Looking north from the top of the embankment slope at Sta. 22+400.**

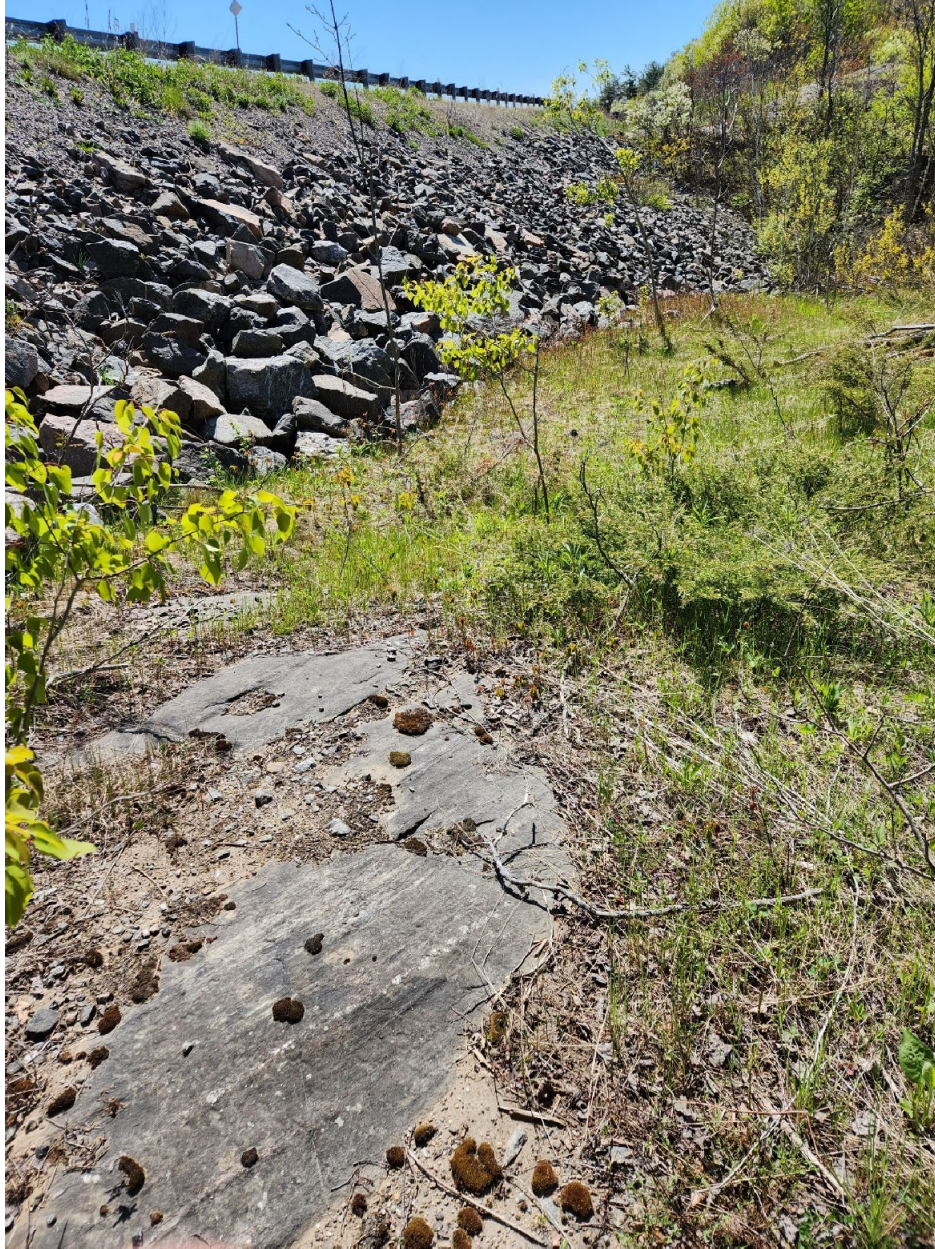
**Photograph #3: Looking south at base of embankment slope of Highway 400 southbound Sta. 22+820.**

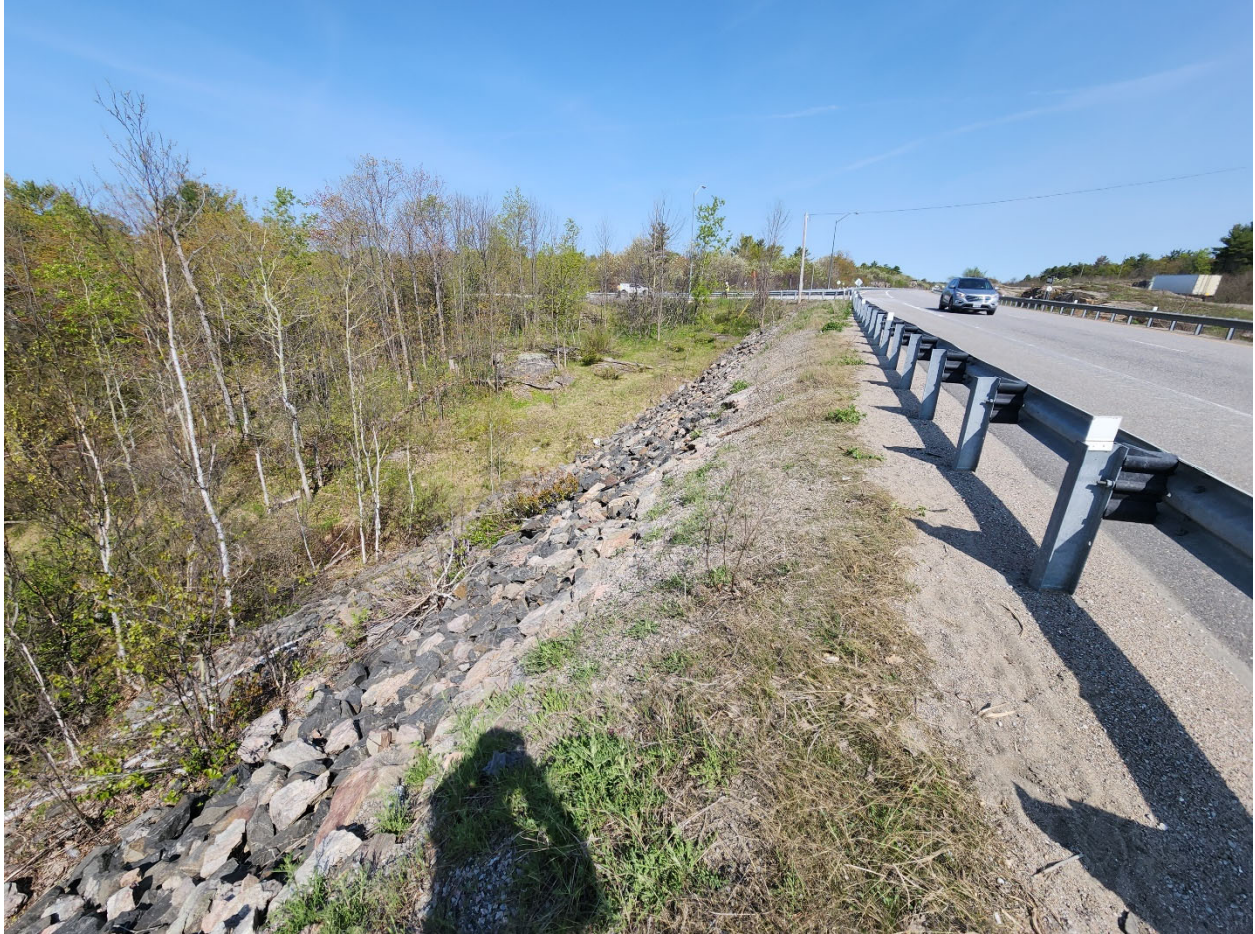
**Photograph #3: Looking north from the top of the embankment slope at Sta. 22+750.**
