**FOUNDATION INVESTIGATION AND DESIGN REPORT
HIGHWAY 556 CULVERT AT STA 10+119 (TOWNSHIP OF DEROCHE)
REHABILITATION OF HIGHWAYS 556 & 532
DISTRICT OF ALGOMA, ONTARIO
ASSIGNMENT NO.: 5020-E-0020
G.W.P. 5221-18-00

GEOCRES Number: 41K-127**

Date: April 24, 2023
File: 31719

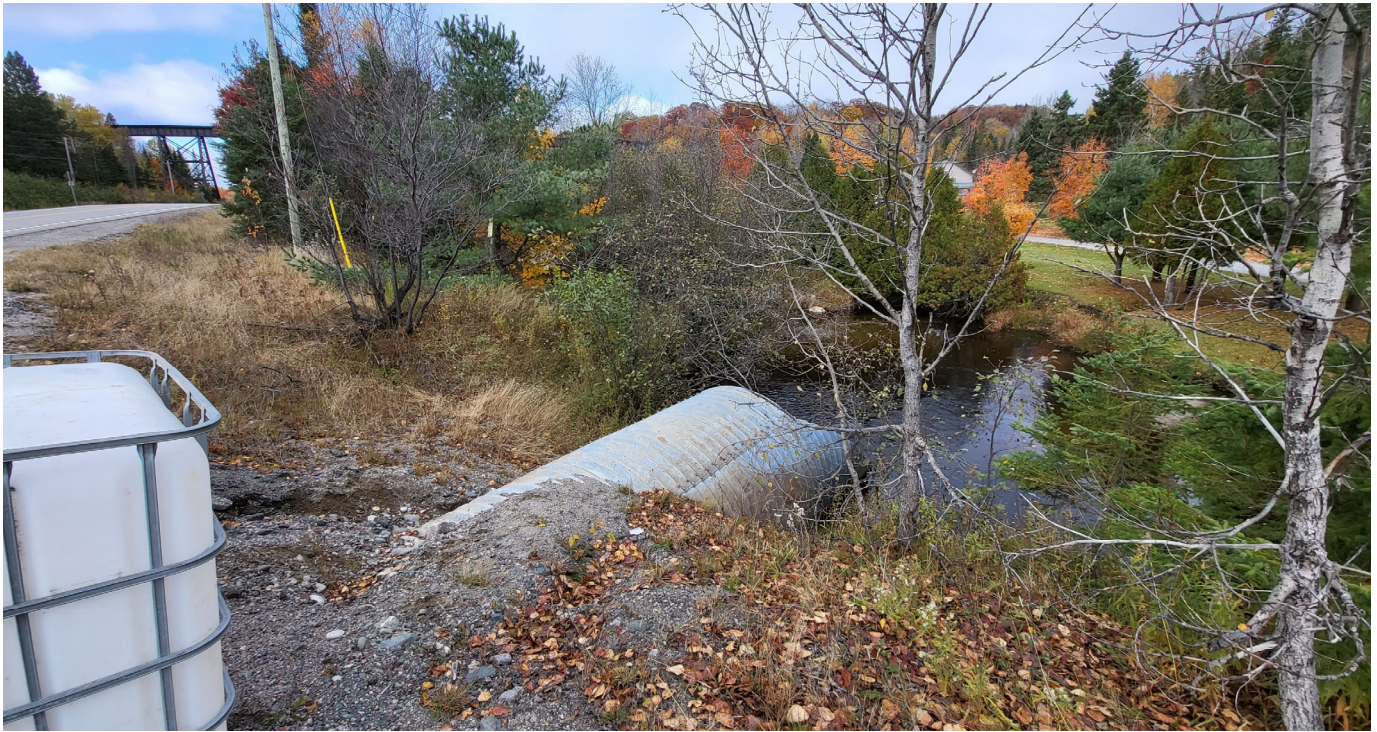
Photograph #1 – North highway embankment at culvert outlet, facing west (October 2022)

Based on visual observations, no signs of slope instability of the embankment were noted near the outlet of the culvert site. Ponded water was observed at the culvert outlet. The embankment side slopes are lightly vegetated with some visible cobbles. Site photographs can be found in Appendix A.

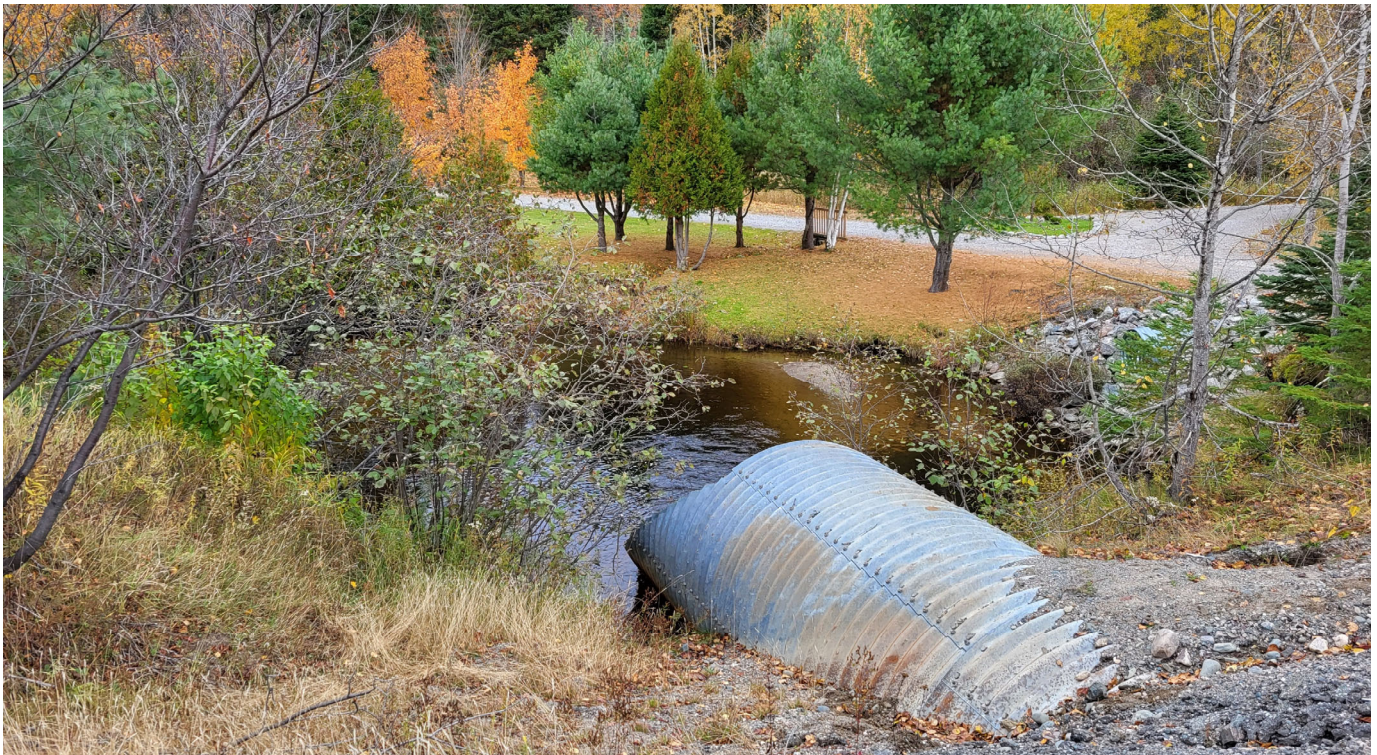
Photograph #2 – North highway embankment at culvert outlet, facing north (October 2022)

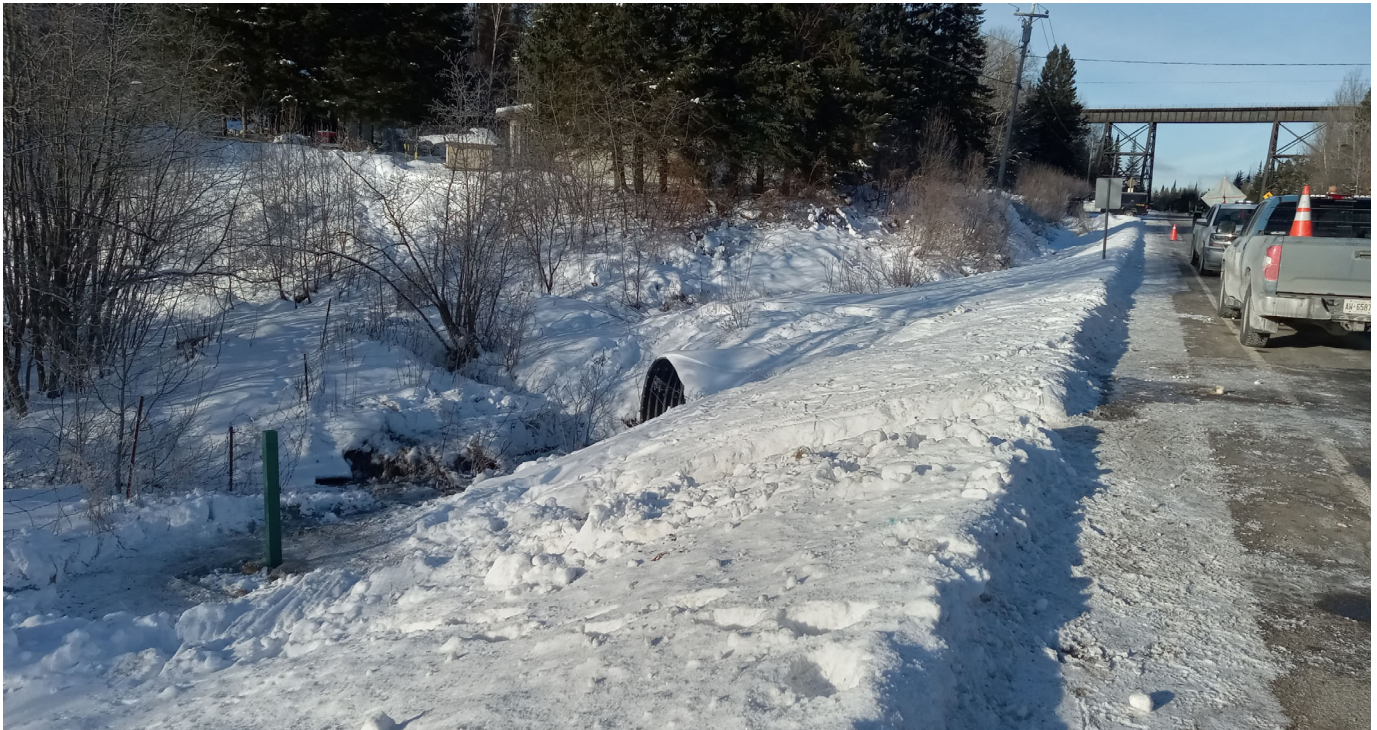
Photograph #3 – South highway embankment at culvert inlet, facing east.

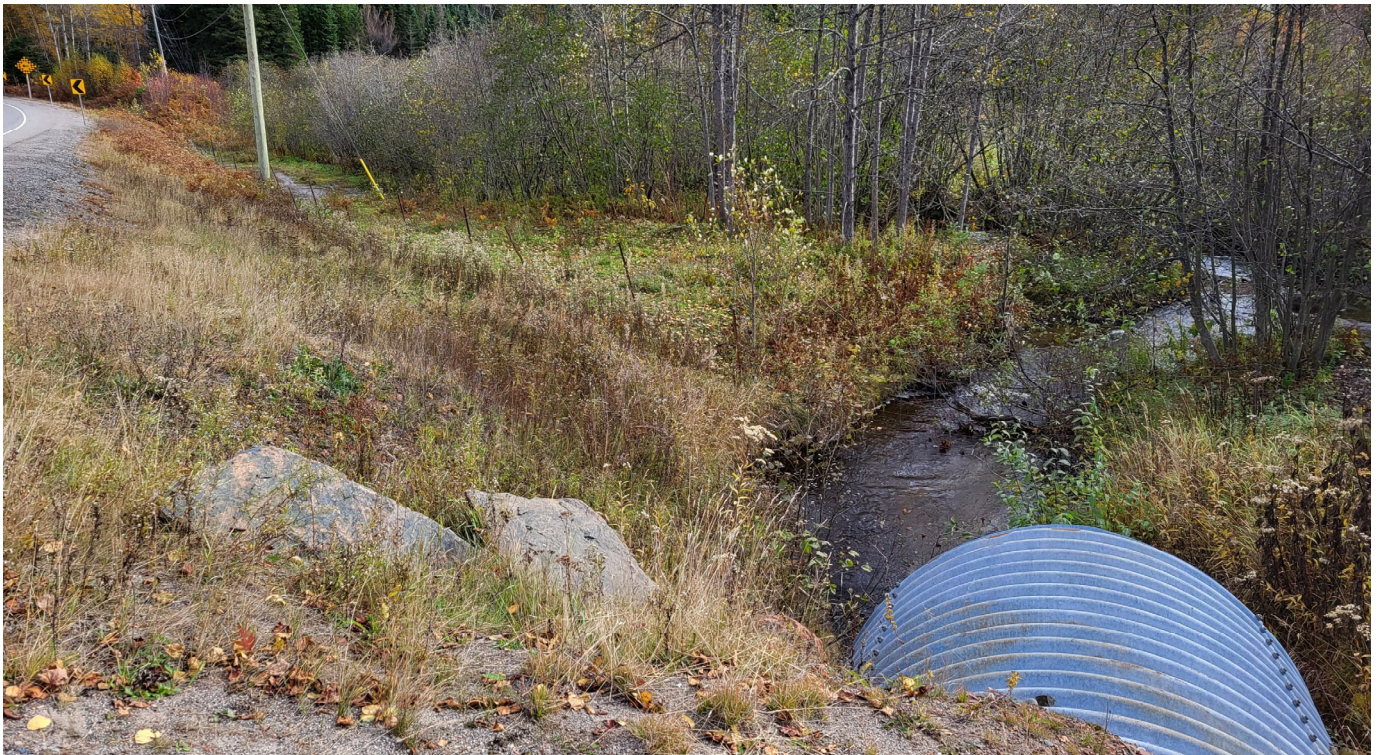
Photograph #4 – South highway embankment at culvert inlet, facing southwest. (October 2022)

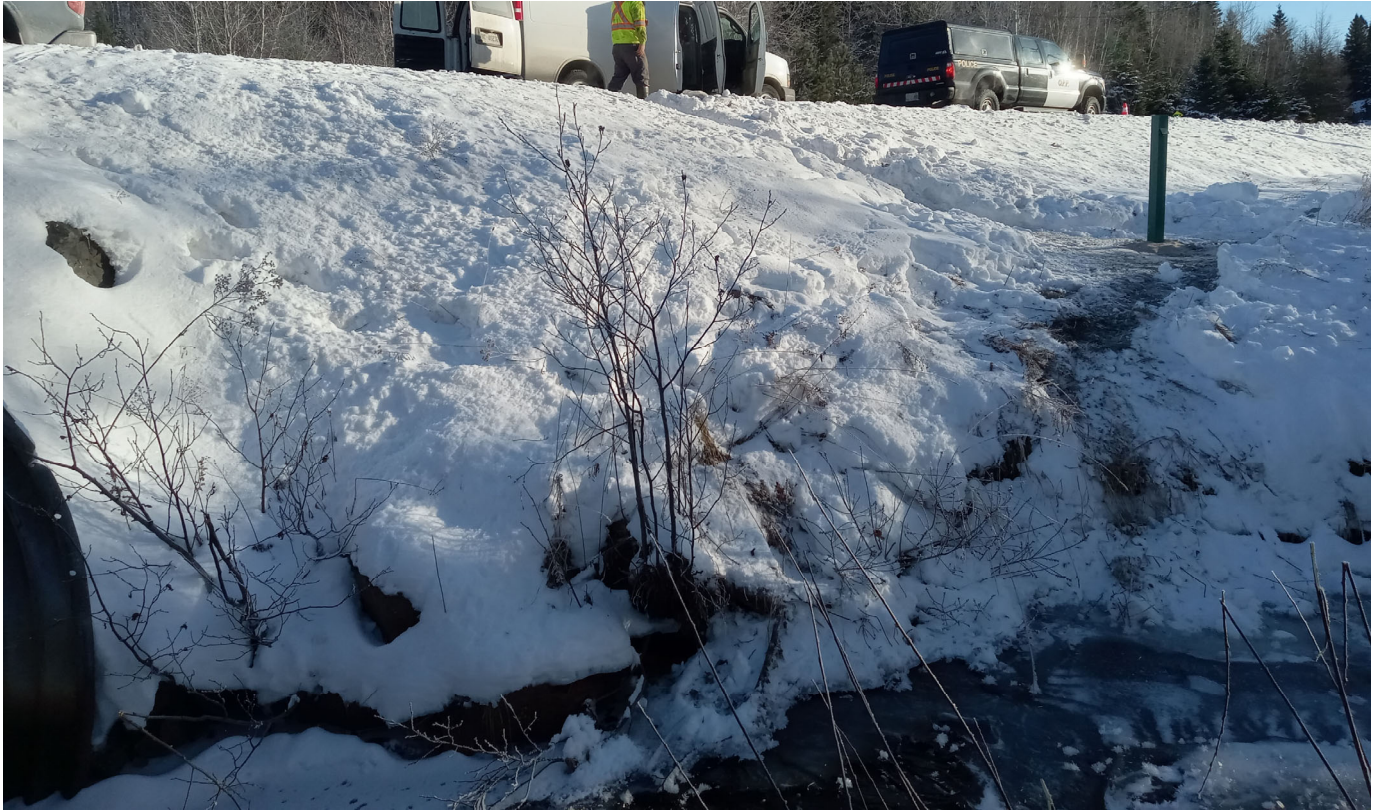
Photograph #5 – South highway embankment at culvert inlet, facing northeast (December 2022)

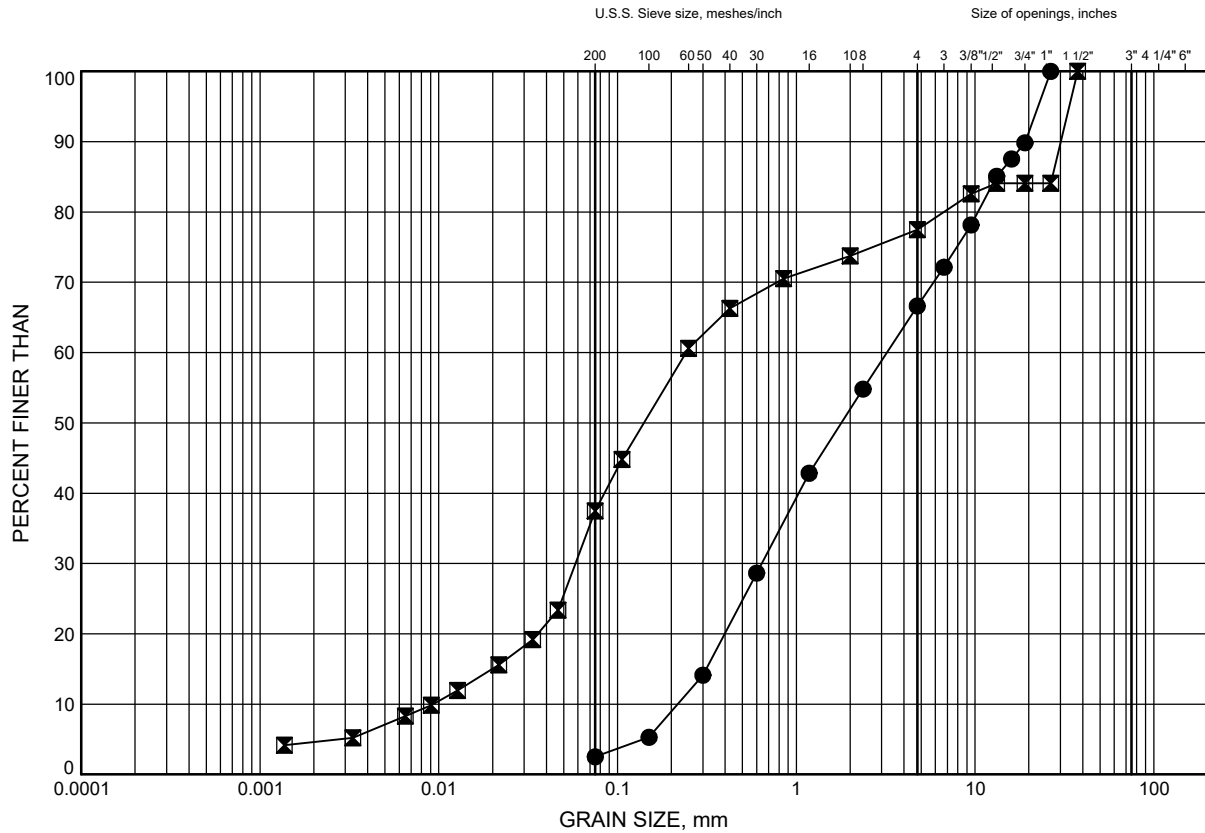
FIGURE C1

Culvert Replacement at Sta. 10+119
GRAIN SIZE DISTRIBUTION

Gravelly SAND to Gravelly SILTY SAND (FILL)

The results of grain size analyses conducted on selected samples of the embankment fill are provided on the Record of Borehole sheets in Appendix B and presented on Figure C-1 of Appendix C. The results are summarized as follows:

Soil Particle	Percentage (%)
Gravel	23 to 33
Sand	40 to 64
Silt and Clay	3 to 37

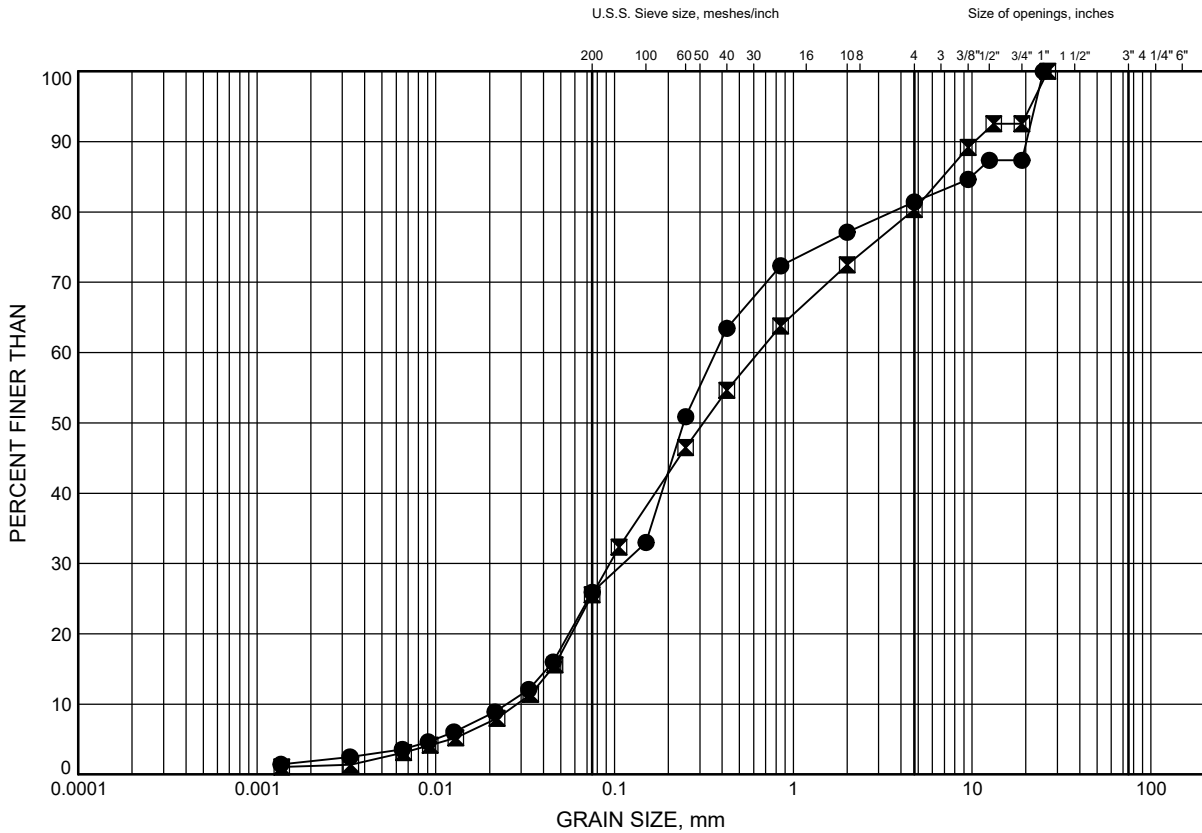
FIGURE C2

Culvert Replacement at Sta. 10+119
GRAIN SIZE DISTRIBUTION

SILTY SAND to Gravelly SILTY SAND

The results of grain size analyses conducted on selected samples of the silty sand are presented on Figure C-2 in Appendix C and summarized as follows:

Soil Particle	Percentage (%)
Gravel	19 to 20
Sand	55 to 56
Silt	24
Clay	1

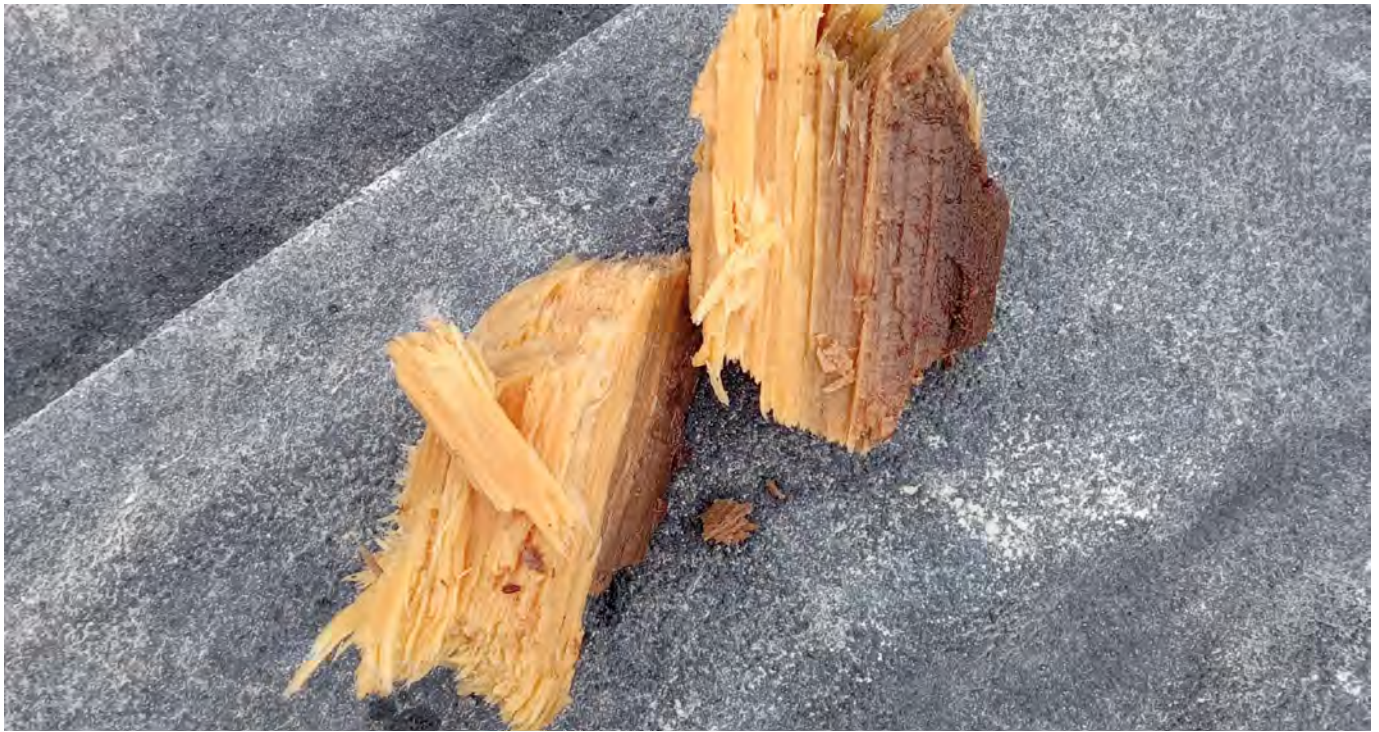
Photograph #6 – Wood fragments recovered in Borehole 10119-02 (December 2022)

Granular embankment fill consisting of gravelly sand, trace non-plastic fines to gravelly silty sand was encountered at ground surface at both borehole locations. Rootlets and wood fragments were noted in samples from Borehole 10119-02. Given that wood fragments were encountered at/near the bottom of the embankment, they could be from timber mats used as part of construction of the existing culvert (see Photograph #6 in Appendix C).

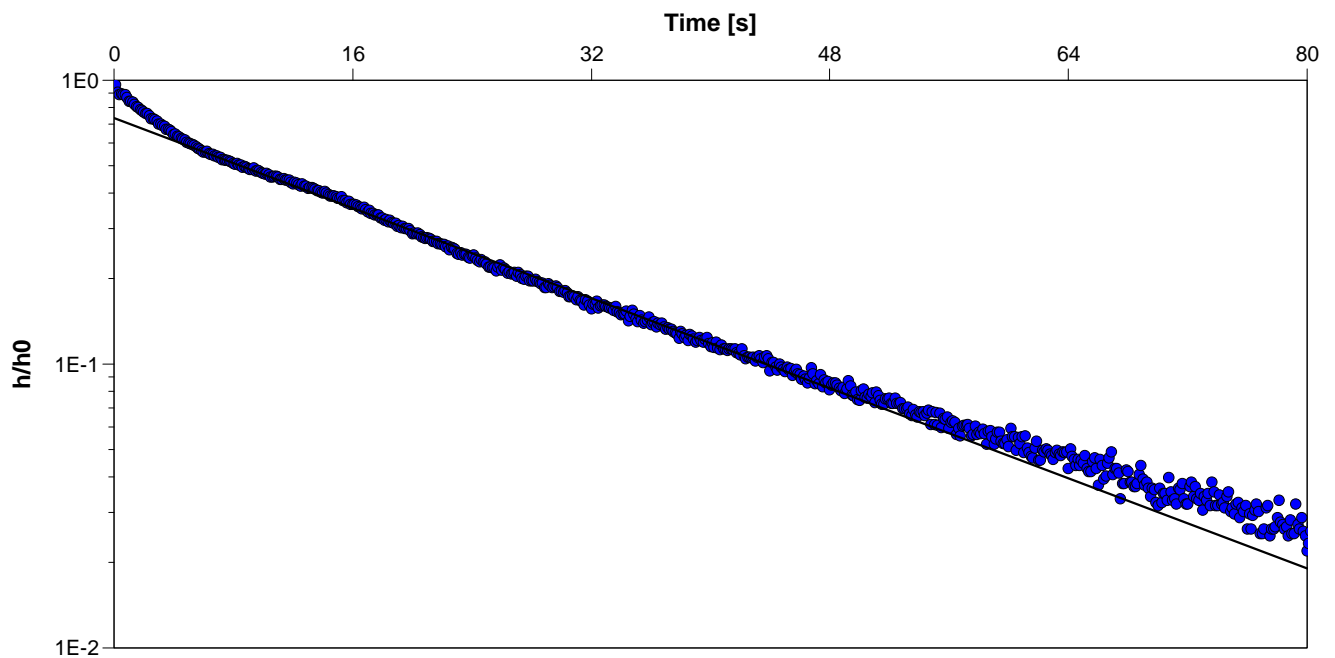
Location: Deroche, Ontario	Slug Test: 10119-01	Test Well: 10119-01
Test Conducted by: BC		Test Date: 2022-12-15
Analysis Performed by: SM	SWRT Analysis	Analysis Date: 2022-12-21
Aquifer Thickness:		
Checked by: DH

Calculation using Hvorslev		
Observation Well	Hydraulic Conductivity [m/s]	
10119-01	1.8×10^{-5}

The SWRT results were analyzed using the Hvorslev method. The SWRT analysis plots are included in Appendix B. The hydraulic conductivity values calculated from the in-situ SWRTs are summarized in the following table:

Monitoring Well	Screen Interval (m bgs)	Screened Geology	Hydraulic Conductivity (m/s)
10119-01	3.4 – 4.9	Silty Sand, some gravel	1.8×10^{-5}
10119-02	5.6 – 7.1	Silty Sand, some gravel	6.2×10^{-7}

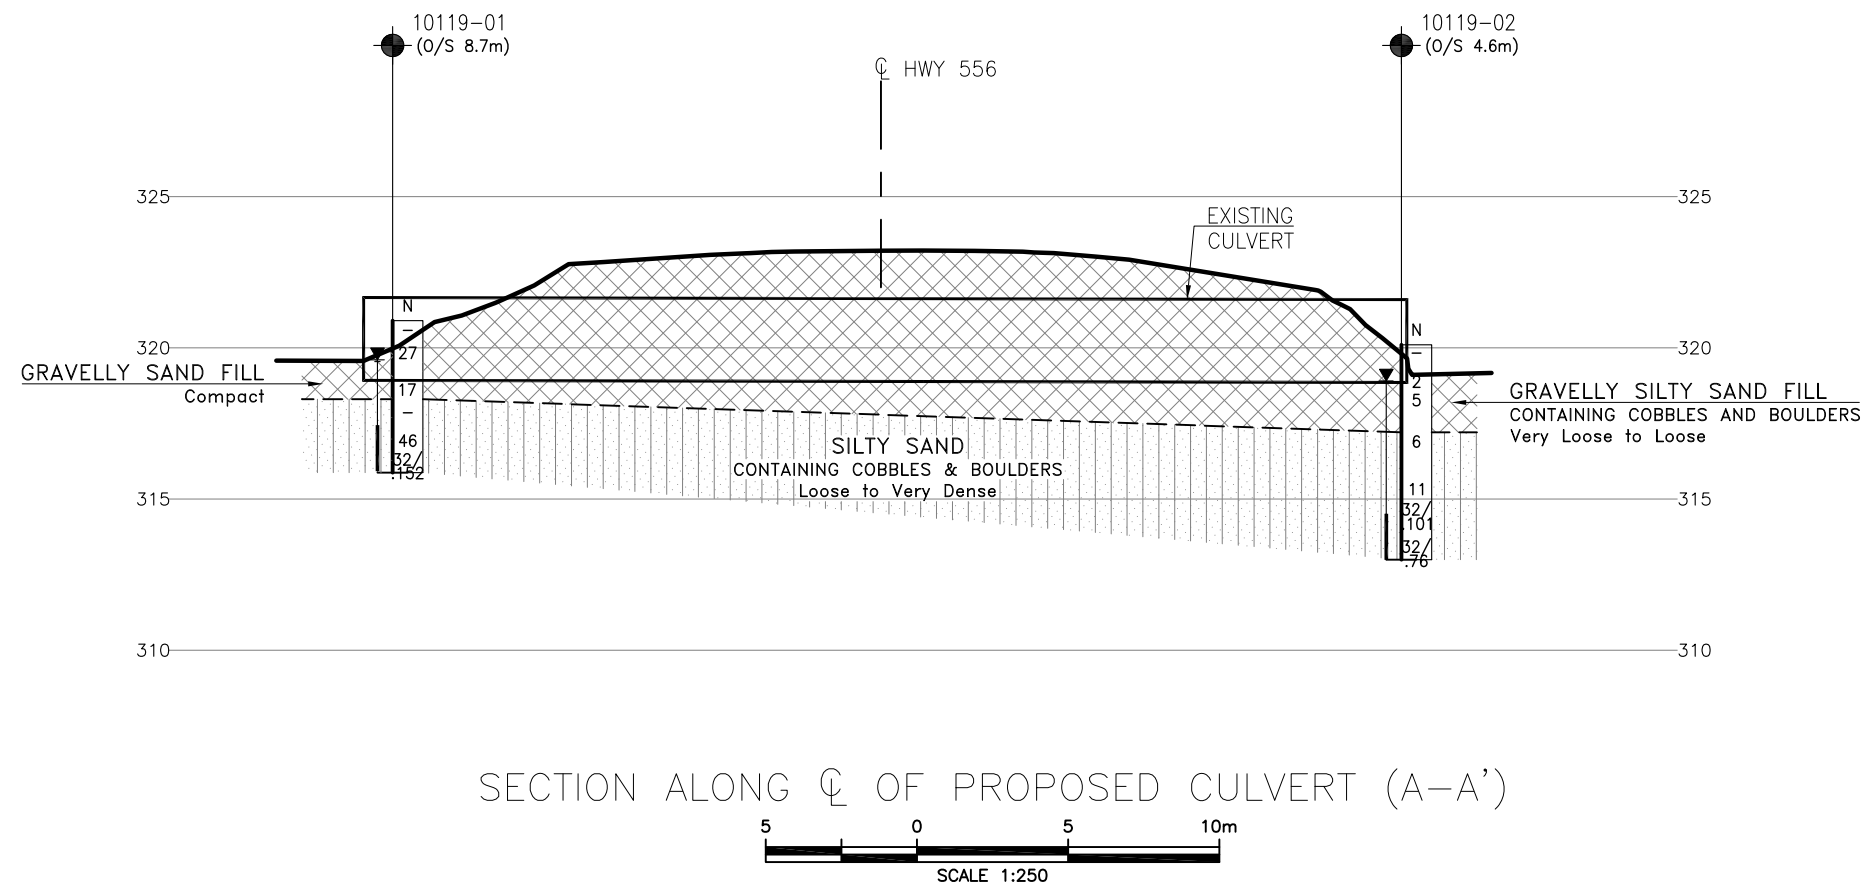
SECTION ALONG C OF PROPOSED CULVERT (A-A')

Reference is made to the Record of Borehole sheets included in Appendix B. Details of the encountered soil stratigraphy are presented on the Record of Borehole sheets and on the Borehole Locations and Soil Strata Drawing included in Appendix D. A description of the stratigraphy, based on the conditions encountered in the boreholes, is given in the following paragraphs. However, the factual data presented on the Record of Borehole sheets takes precedence over this general description and must be used for interpretation of the site conditions. It must be recognized and expected that soil conditions may vary between and beyond the borehole locations.
