**FOUNDATION INVESTIGATION AND DESIGN REPORT
TEMPORARY PROTECTION SYSTEM FOR HIGHWAY 556 CULVERT
REHABILITATION AT STA 14+495 (TOWNSHIP OF DEROCHE)
REHABILITATION OF HIGHWAYS 556 & 532
DISTRICT OF ALGOMA, ONTARIO
ASSIGNMENT No.: 5020-E-0020
G.W.P. 5221-18-00**

Report

AECOM Canada Ltd.

Date: May 26, 2023
File: 31719

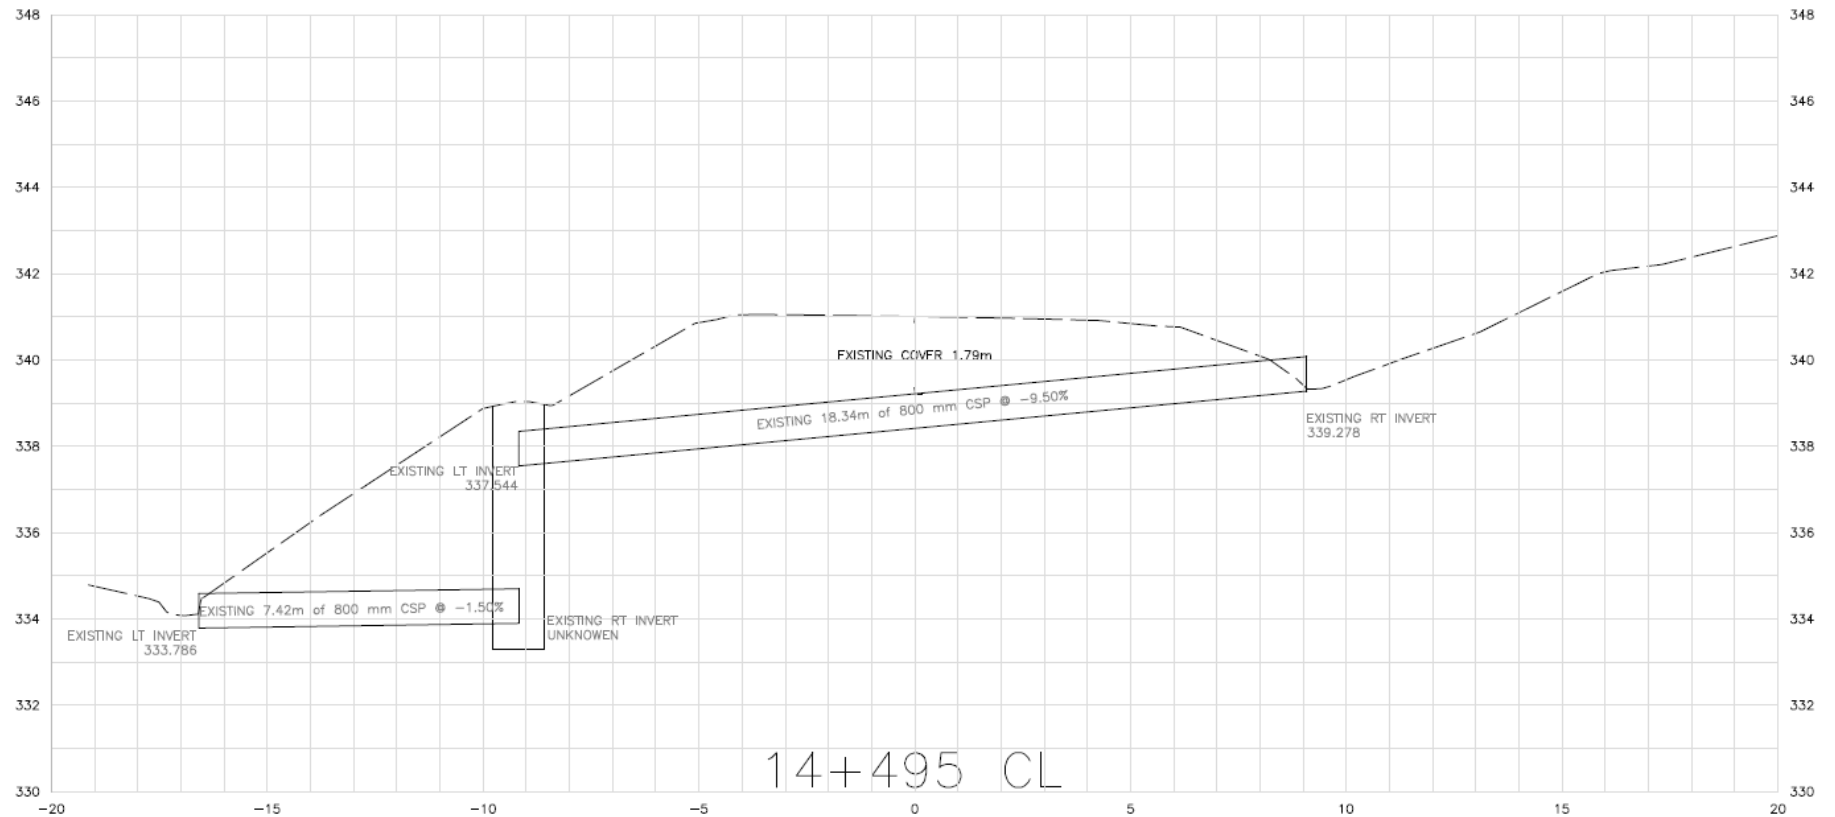
Existing Culvert at STA 14+495 – Township of Deroche
Highway 556 Culvert Rehabilitation
MTO Agreement No. 5020-E-0020

mid-embankment slope. Details of the segmented culvert are summarized below and presented on Figure A1 in Appendix A:

Township and Station	Culvert Size and Type	Length of Culvert Segment (m)	Invert Elevation at Inlet (m)	Invert Elevation at Outlet (m)
Deroche 14+495	800 mm dia. CSP	18.34 m long (south segment, under the highway proper)	339.3 (at south toe of highway embankment)	337.5 (at drop structure)
		7.42 m long (north segment, under the north embankment slope)	333.9 ¹ (at drop structure)	333.8 (at north toe of highway embankment)

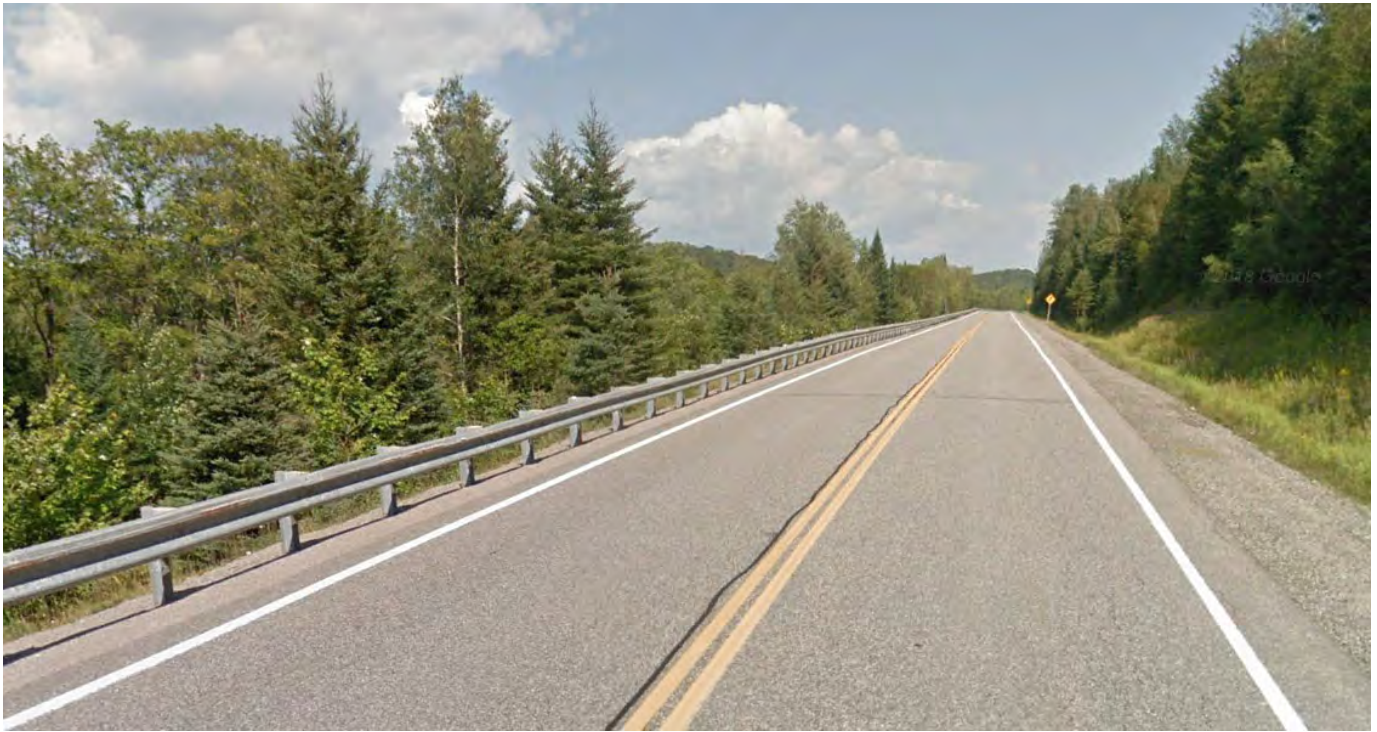
Photograph #1 – Highway 556 near culvert location, facing East. Drop Inlet at ditch to the north.
(Google Streetview imagery, August 2018)

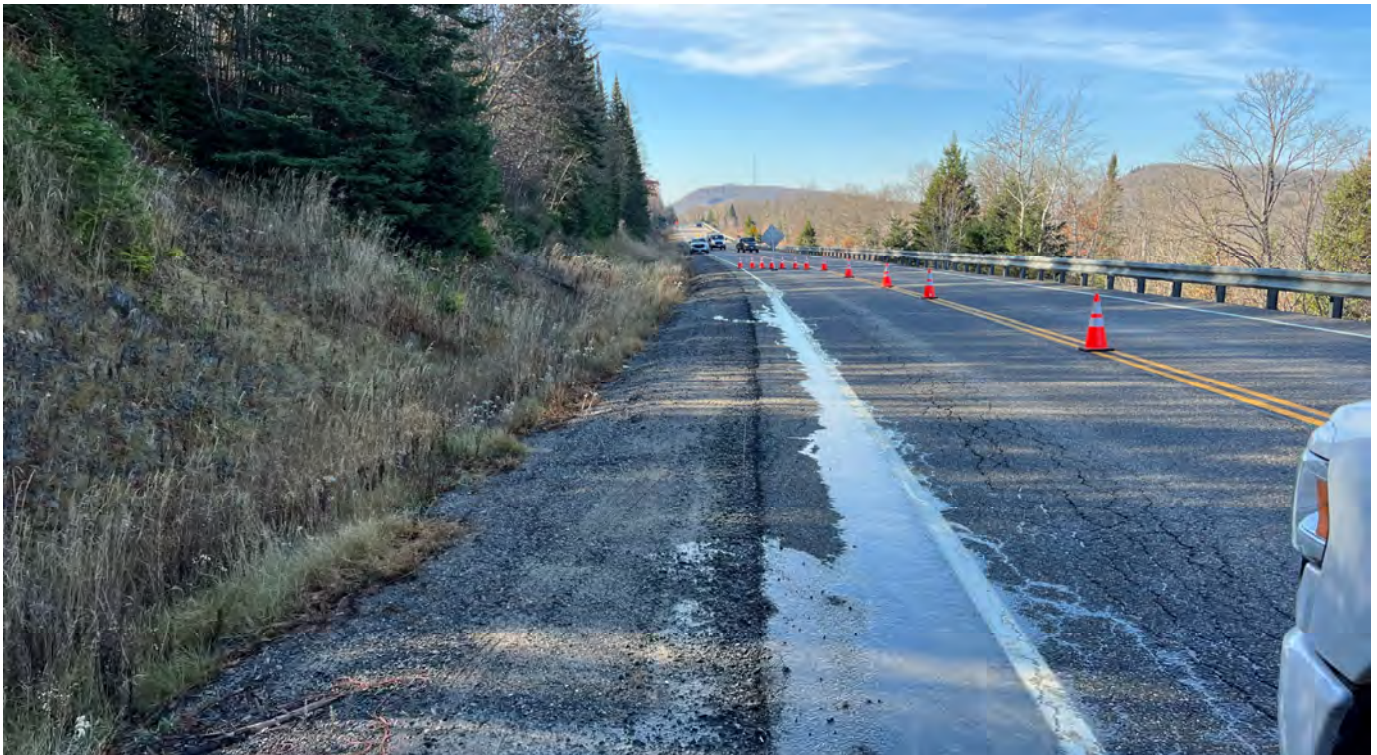
Photograph #2 – Highway 556 near culvert location, facing West. Drop Inlet at ditch to the north.
(November 2022)

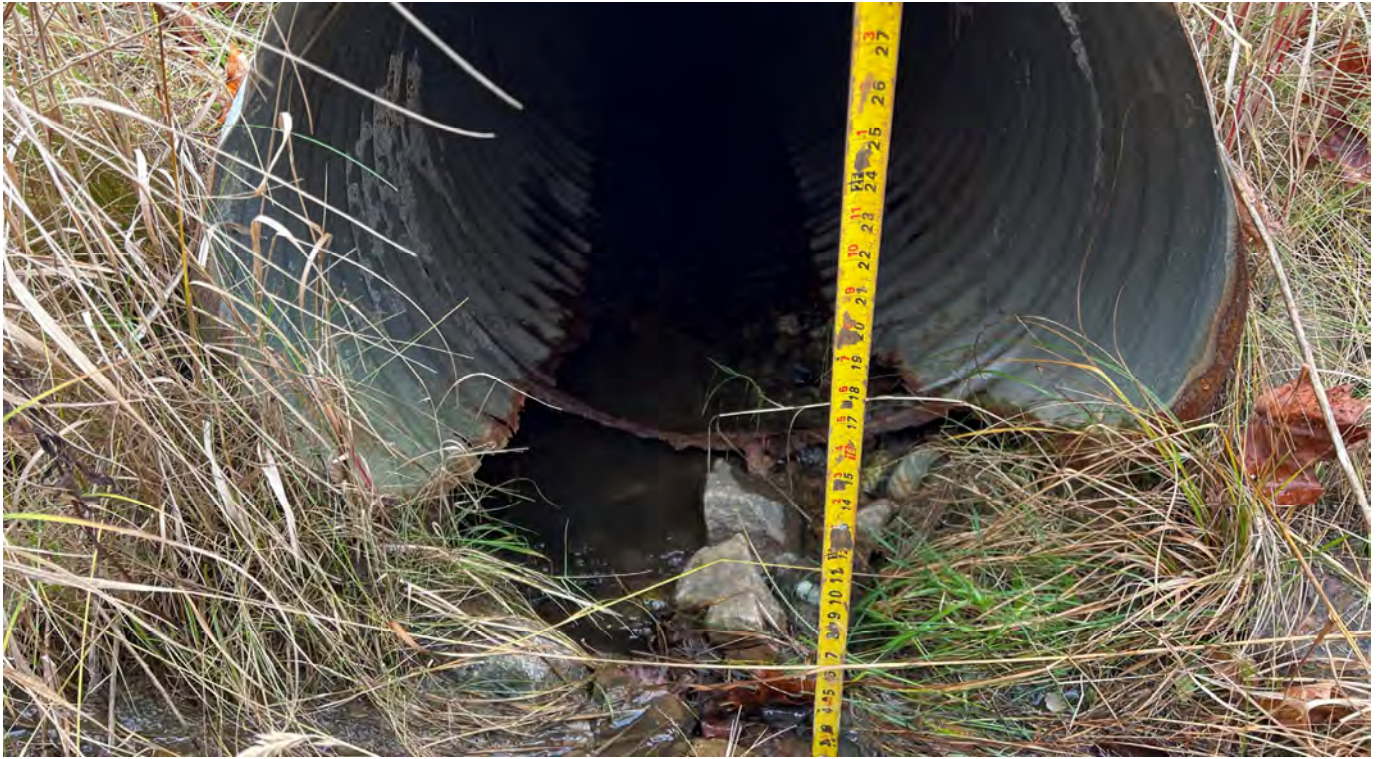
Photograph #3 – Culvert inlet, surrounded by vegetation, facing north. (November 2022)

Based on visual observations, no signs of slope instability of the embankment were noted near the inlet or outlet of the culvert site. The south side of the highway embankment, including the area of the culvert inlet, is generally surrounded by sparse vegetation with mixed forest higher up on the slope, south of the ditch line. The south embankment slope has thick mixed forest cover, and the ditch along the south shoulder is lightly vegetated with some visible cobbles. Site photographs can be found in Appendix A.

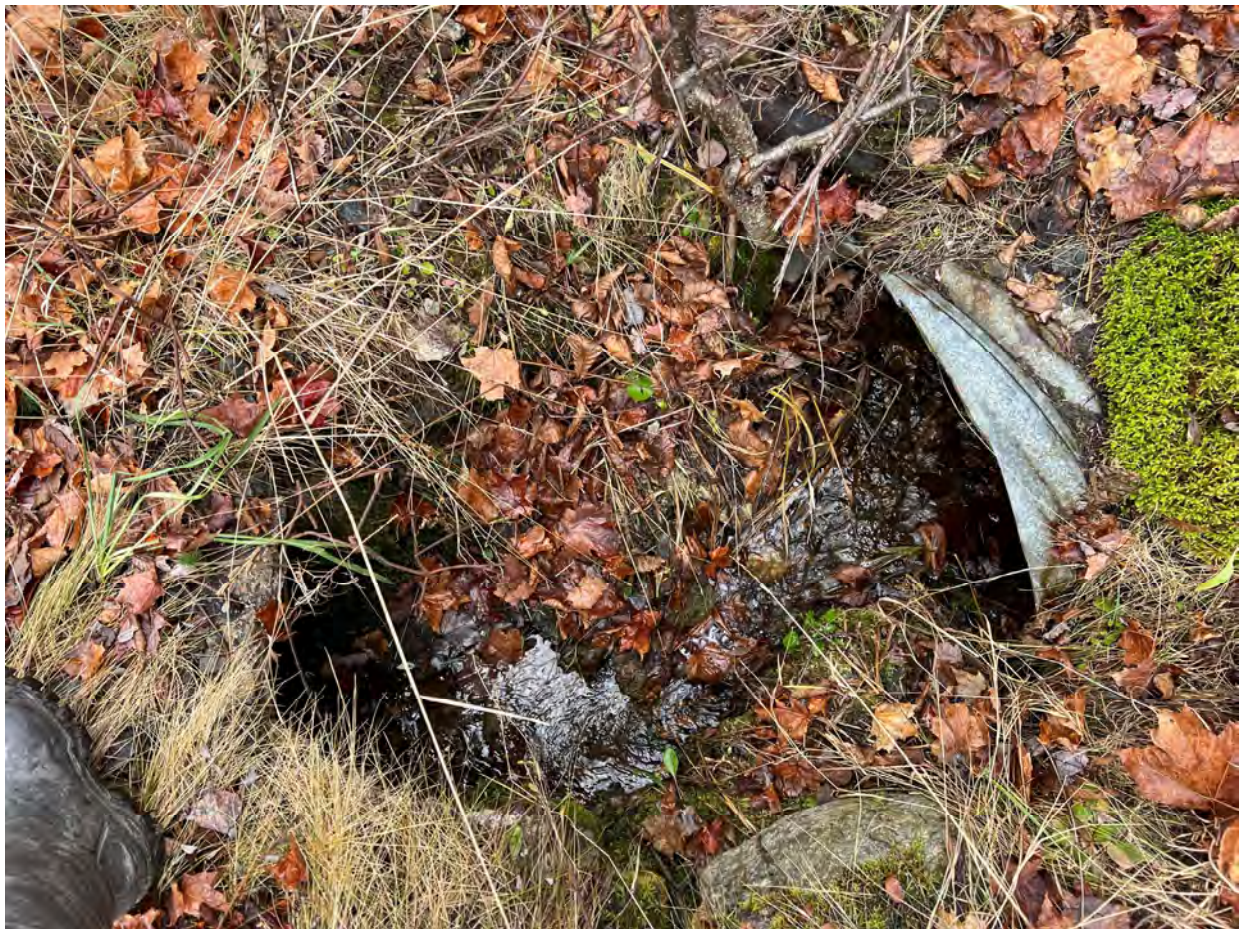
Photograph #4 – Culvert outlet, flowing into downstream / adjacent culvert that outlets into the leased land agreement with Algoma Central Railway. (November 2022)

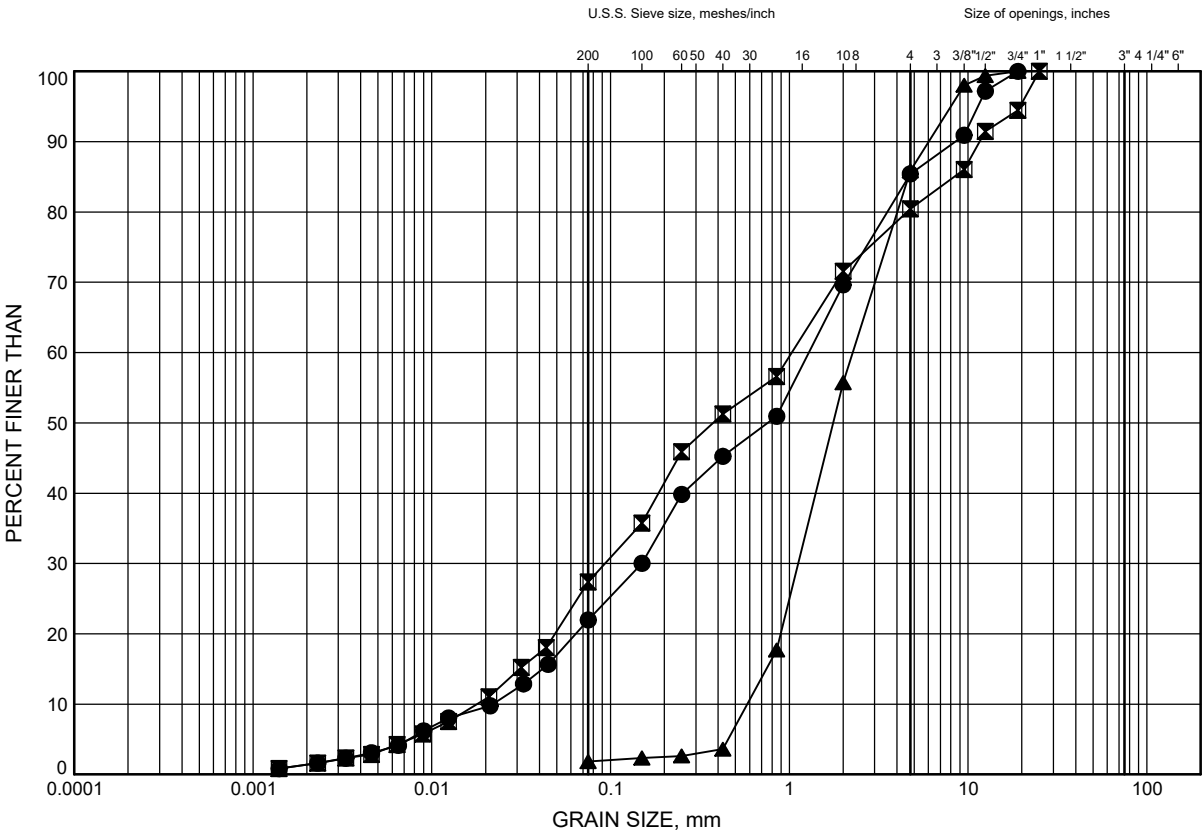
FIGURE C-1

SAND to SILTY SAND

The results of grain size analyses conducted on selected samples of the embankment fill are provided on the Record of Borehole sheets in Appendix B and plotted in Figure C-1 of Appendix C. The results are summarized as follows:

Soil Particle	Percentage (%)
Gravel	14 to 20
Sand	53 to 84
Silt	21 to 26
Clay	1

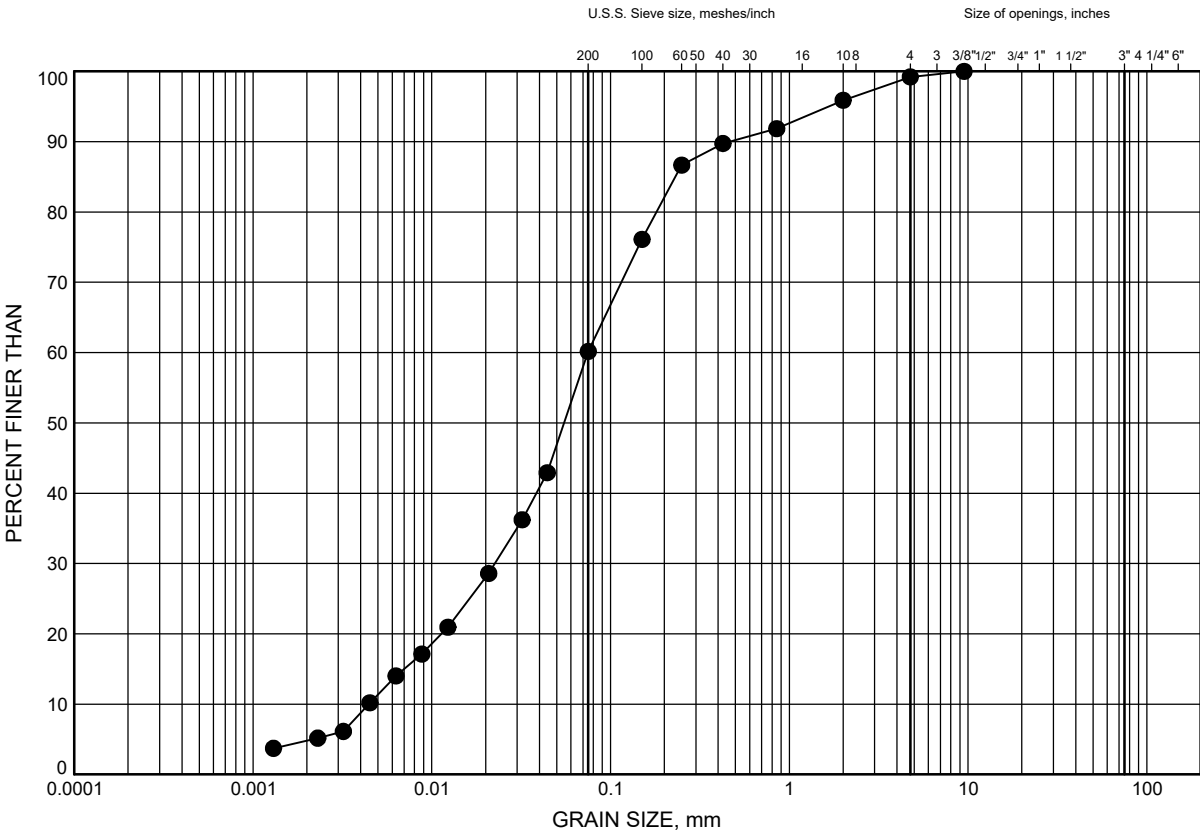
FIGURE C-3

SILT and SAND (Pockets)

The results of a grain size analysis conducted on a sample of the silt and sand pocket within the gravels and cobbles layer is provided on the Record of Borehole sheets for Borehole 14495-02 in Appendix B and plotted in Figure C-3 of Appendix C. The results summarized as follows:

Soil Particle	Percentage (%)
Gravel	1
Sand	39
Silt	55
Clay	5

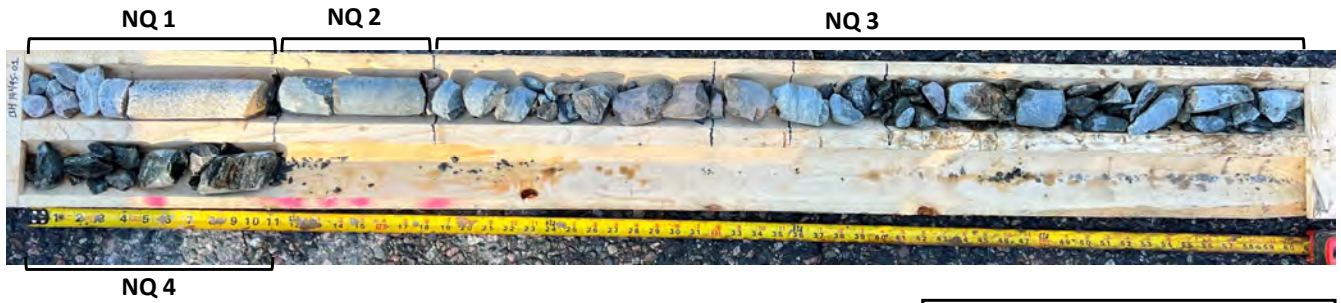
Borehole 19640-01 - Cored Gravels, and Cobbles

NQ 1 – 2.4 m – 2.6 m
NQ 2 – 4.7 m – 4.9 m
NQ 3 – 5.9 m – 8.0 m
NQ 4 – 8.0 – 8.4 m

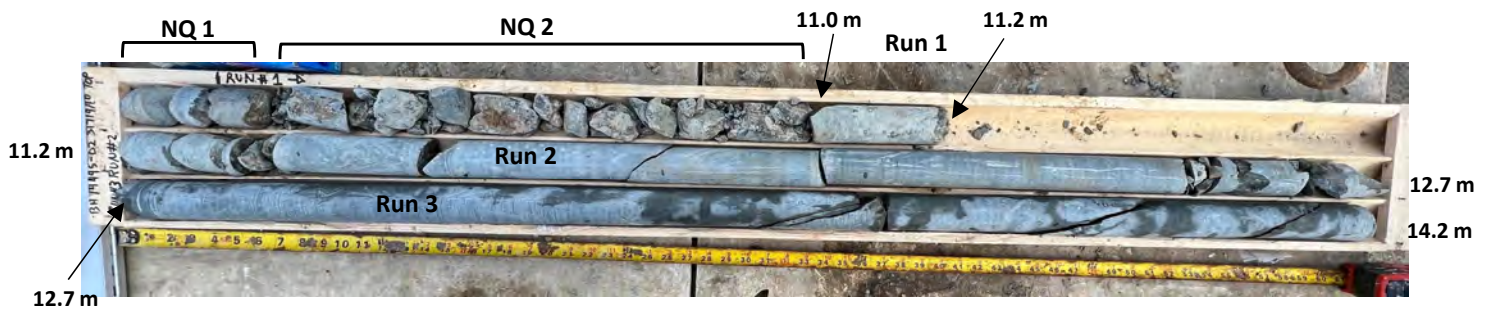
Borehole 14495-02 - Cored Gravels and Cobbles, and Bedrock

NQ 1 – 7.7 m – 9.2 m
NQ 2 – 10.1 m – 11.0 m
Run 1 – 11.0 m – 11.2 m
Run 2 – 11.2 m – 12.7 m
Run 3 – 12.7 m – 14.2 m

This deposit was penetrated using wash boring and NQ coring techniques. Photographs of the gravels, and cobbles recovered from this layer is shown in the Core Box Photographs in Appendix C. From the recovered soil cores, the particle size ranges from 30 mm gravels to 155 mm cobbles.

The bedrock consisted of fresh, strong basalt. The basalt is fine grained, massive, and black in colour. Photographs of the bedrock core are provided in Appendix C. The rock core quality parameters are summarized below:

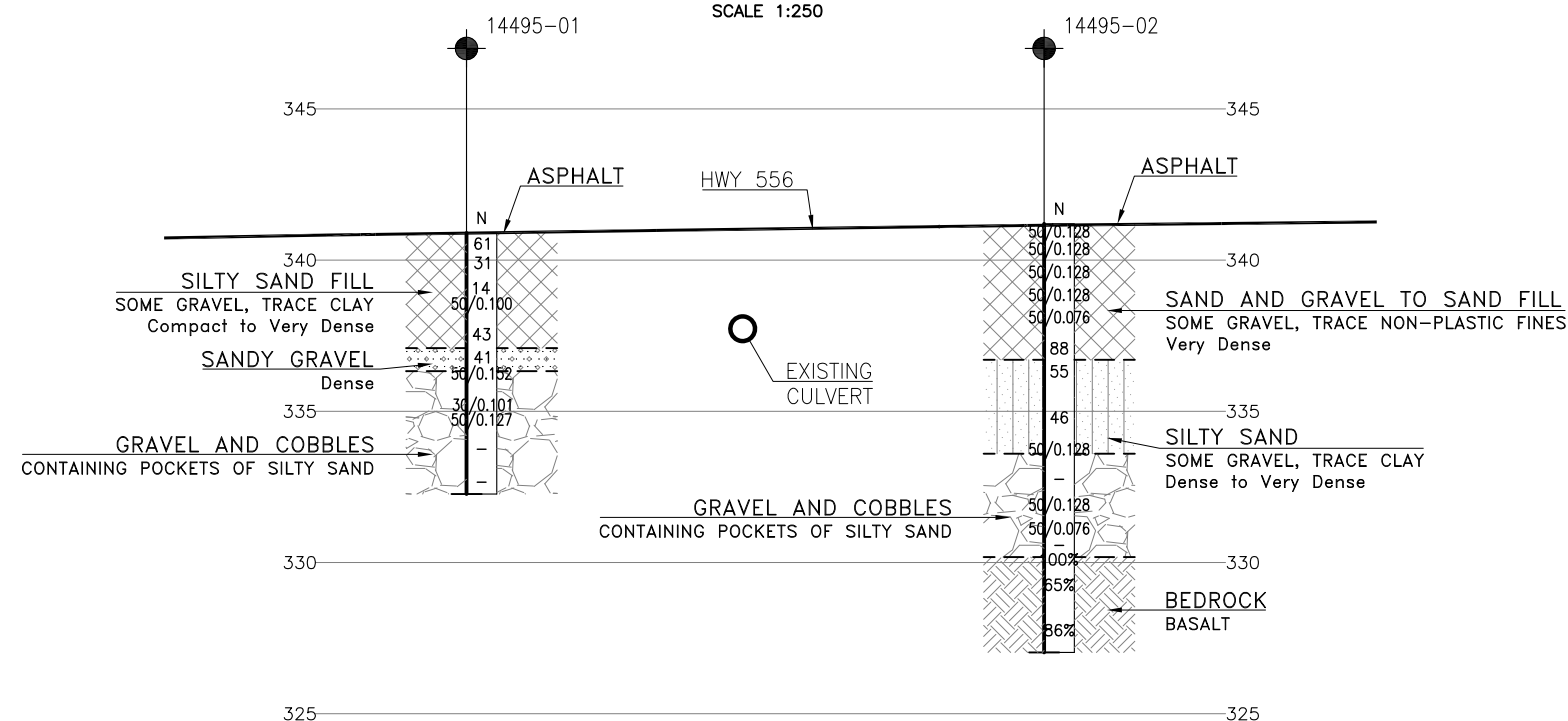
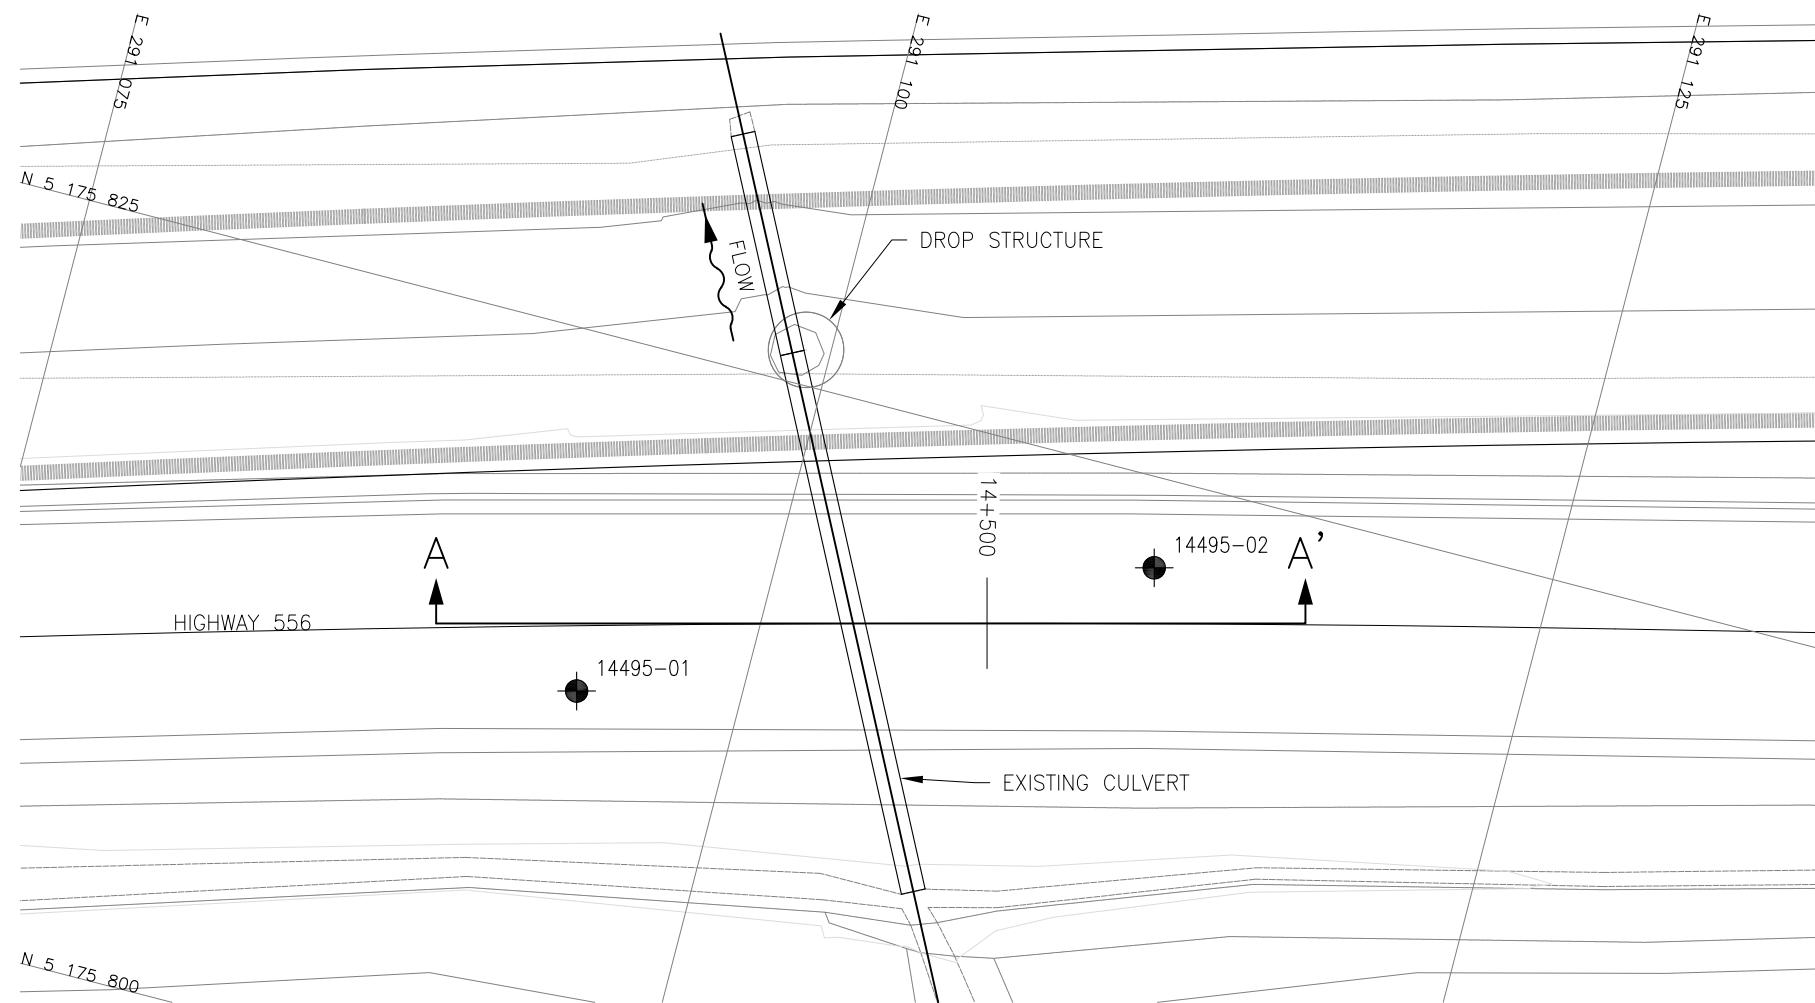
SECTION ALONG HWY 556 (A-A')

- 1) The boundaries between soil strata have been established only at Borehole locations. Between Boreholes the boundaries are assumed from geological evidence.
- 2) This drawing is for subsurface information only. Surface details and features are for conceptual illustration.
- 3) Coordinate system is MTM NAD 83 Zone 13.

Reference is made to the Record of Borehole sheets included in Appendix B. Details of the encountered soil stratigraphy are presented on the Record of Borehole sheets and on the Borehole Locations and Soil Strata Drawing included in Appendix D. A description of the stratigraphy, based on the conditions encountered in the boreholes, is given in the following paragraphs. However, the factual data presented on the Record of Borehole sheets takes precedence over this general description and must be used for interpretation of the site conditions. It must be recognized and expected that soil conditions and the elevation of the soil-bedrock interface may vary between and beyond the borehole locations.
