**FOUNDATION INVESTIGATION REPORT
HIGHWAY 556 CULVERT REPLACEMENT AT STA 18+289
(TOWNSHIP OF DEROCHE)
REHABILITATION OF HIGHWAYS 556 & 532
DISTRICT OF ALGOMA, ONTARIO
ASSIGNMENT No.: 5020-E-0020
G.W.P. 5221-18-00**

Date: April 13, 2023
File: 31719

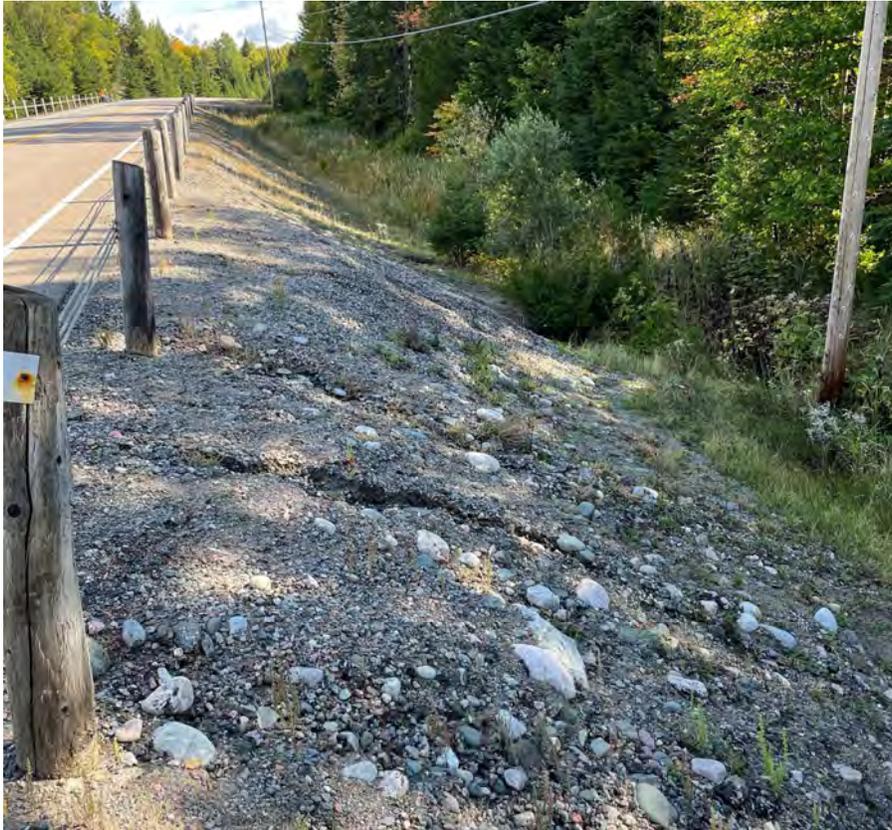
Photograph #1 – Highway 556 south embankment slope, facing East. Inlet at base of embankment slope surrounded by mixed forest (September 2022)

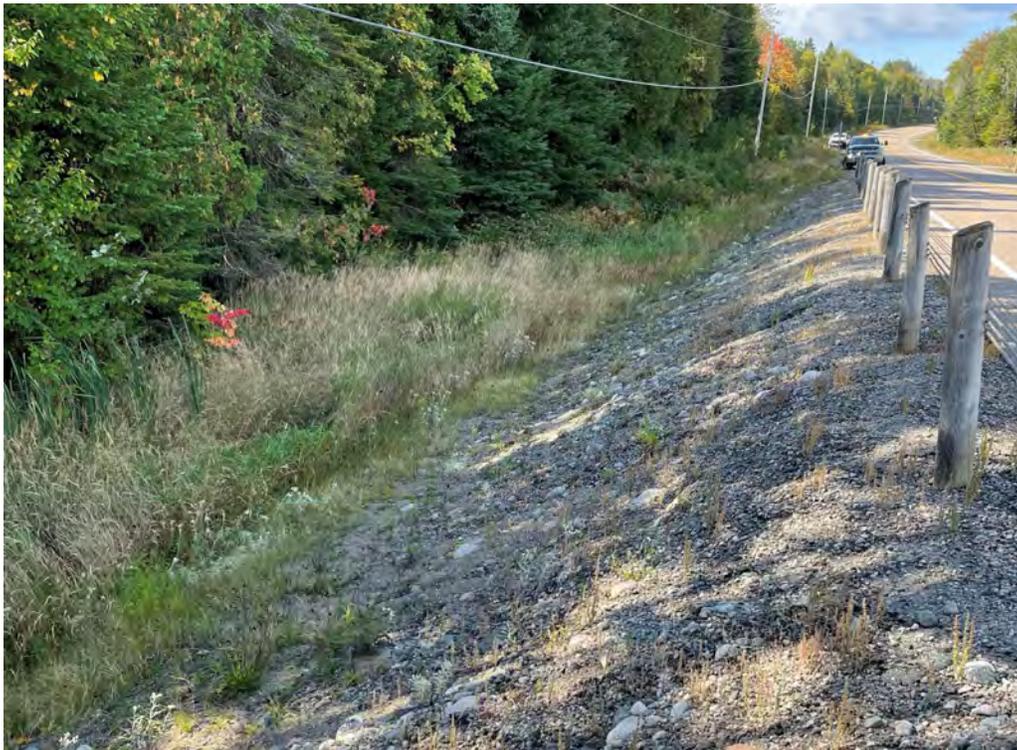
Photograph #2 – Toe of south embankment slope at culvert inlet facing West. Culvert visible in bottom corner (September 2022)

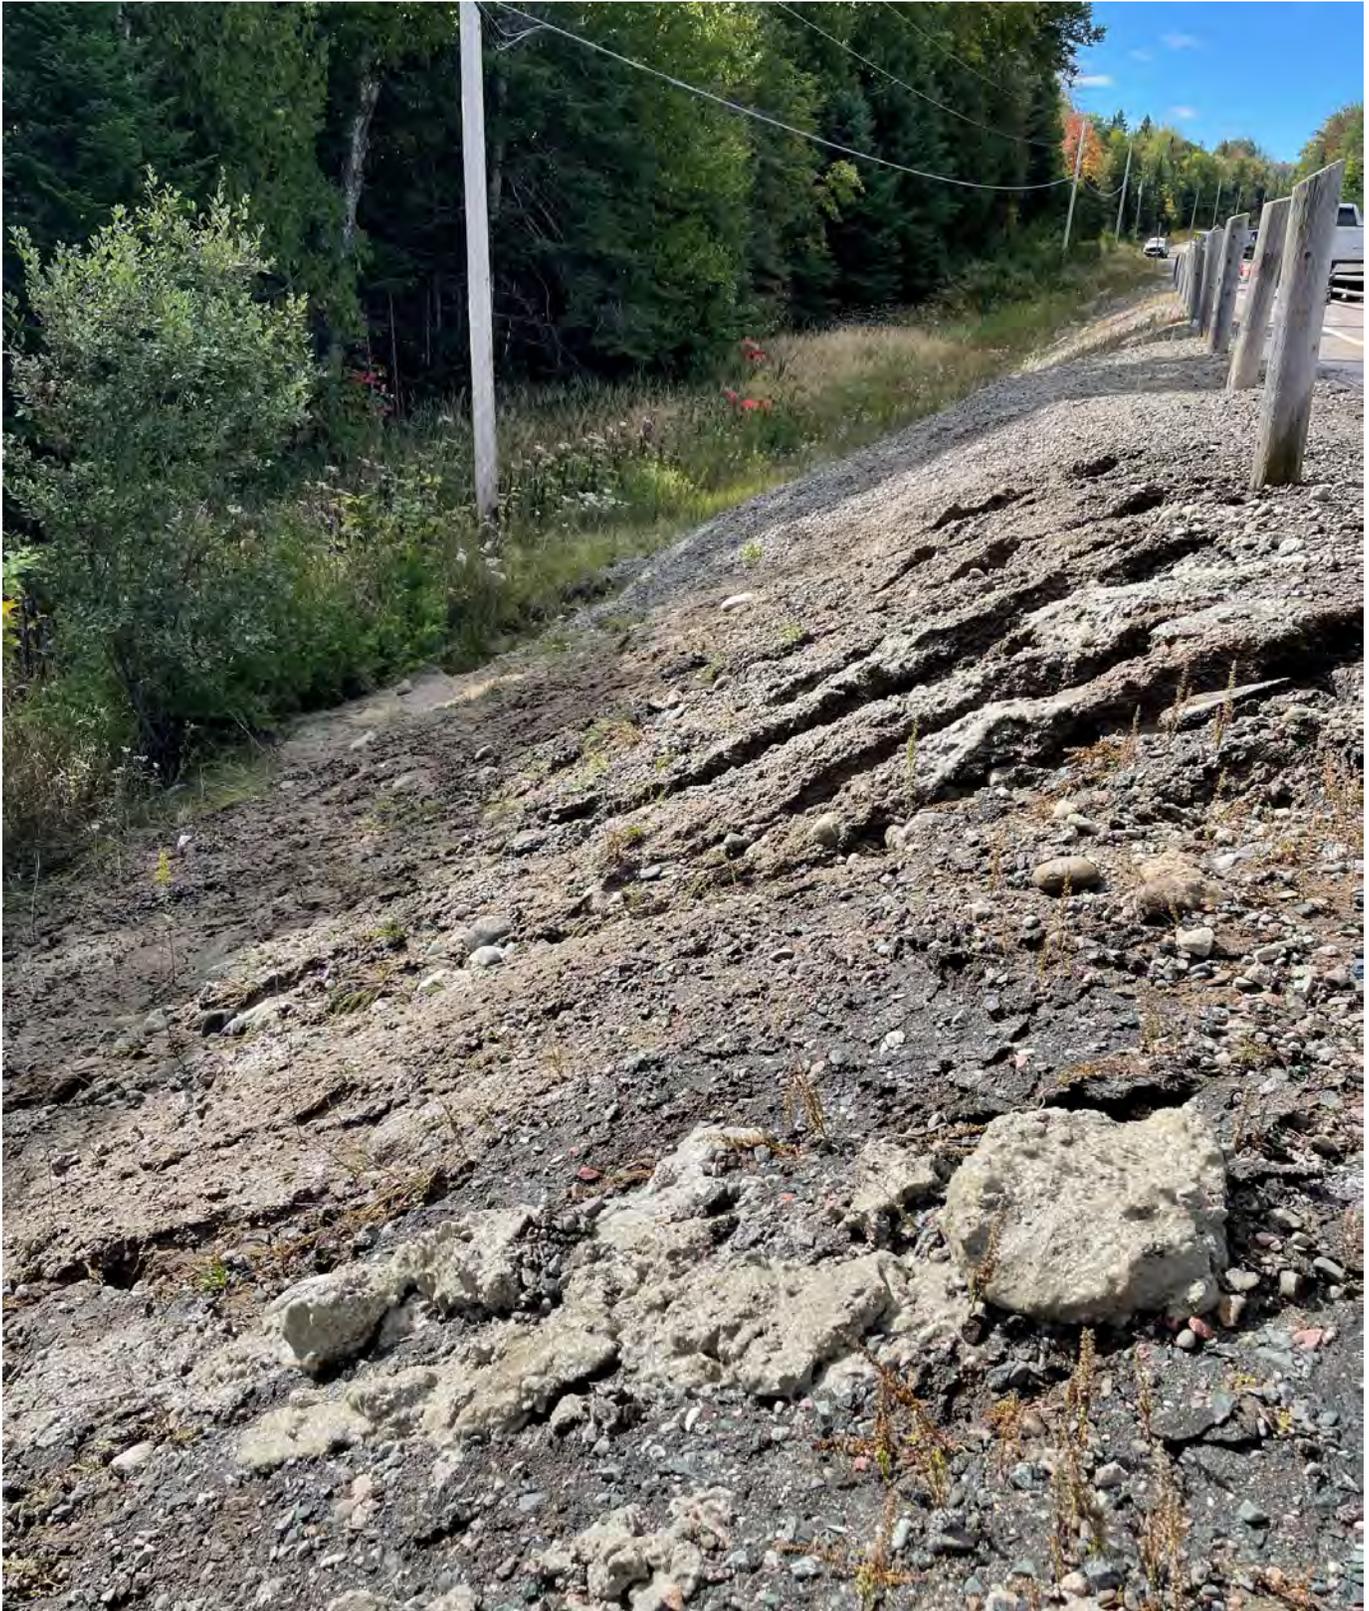
Photograph #5 – Surficial erosion of the unvegetated portion of the south-facing embankment slope, facing west.

Based on visual observations, no signs of slope instability of the embankment were noted near the outlet of the culvert site; however, surficial erosion was observed on the unvegetated portion of the south-facing embankment slope (Photo 5, Appendix A). A small pond of water was observed at the culvert outlet. The south and north sides of the embankment at the toe of the slope were generally surrounded by thick mixed forest, with the embankment side slopes being lightly vegetated with some visible cobbles. In addition, the bottom of the existing culvert at the outlet was observed to be partially damaged by corrosion. Site photographs can be found in Appendix A.

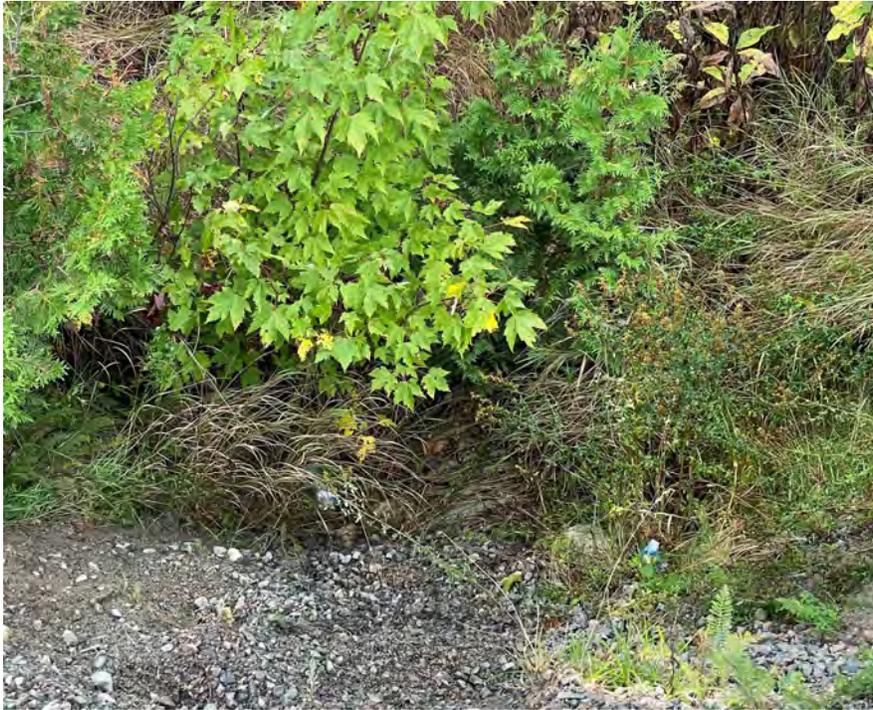
Photograph #6 – Culvert inlet, covered by vegetation

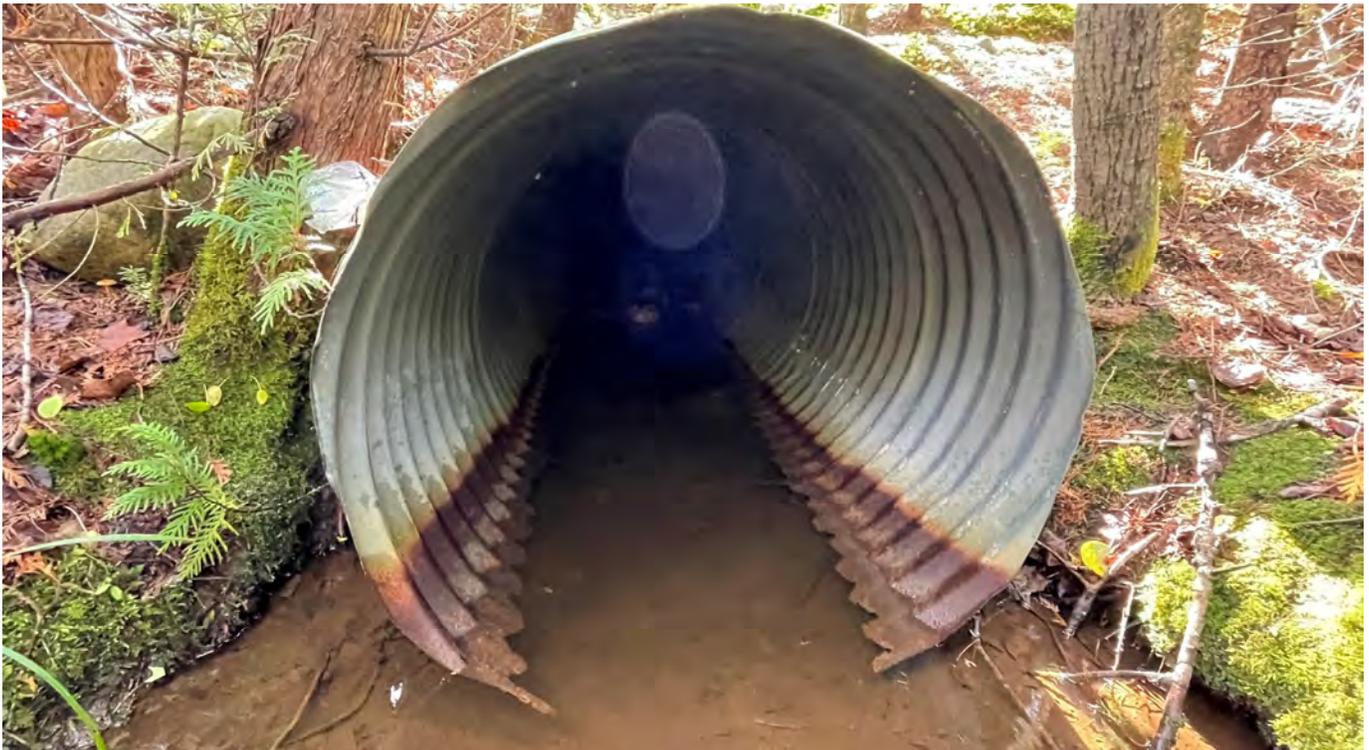
Photograph #7 – Culvert outlet, surrounded by forest vegetation, facing south.

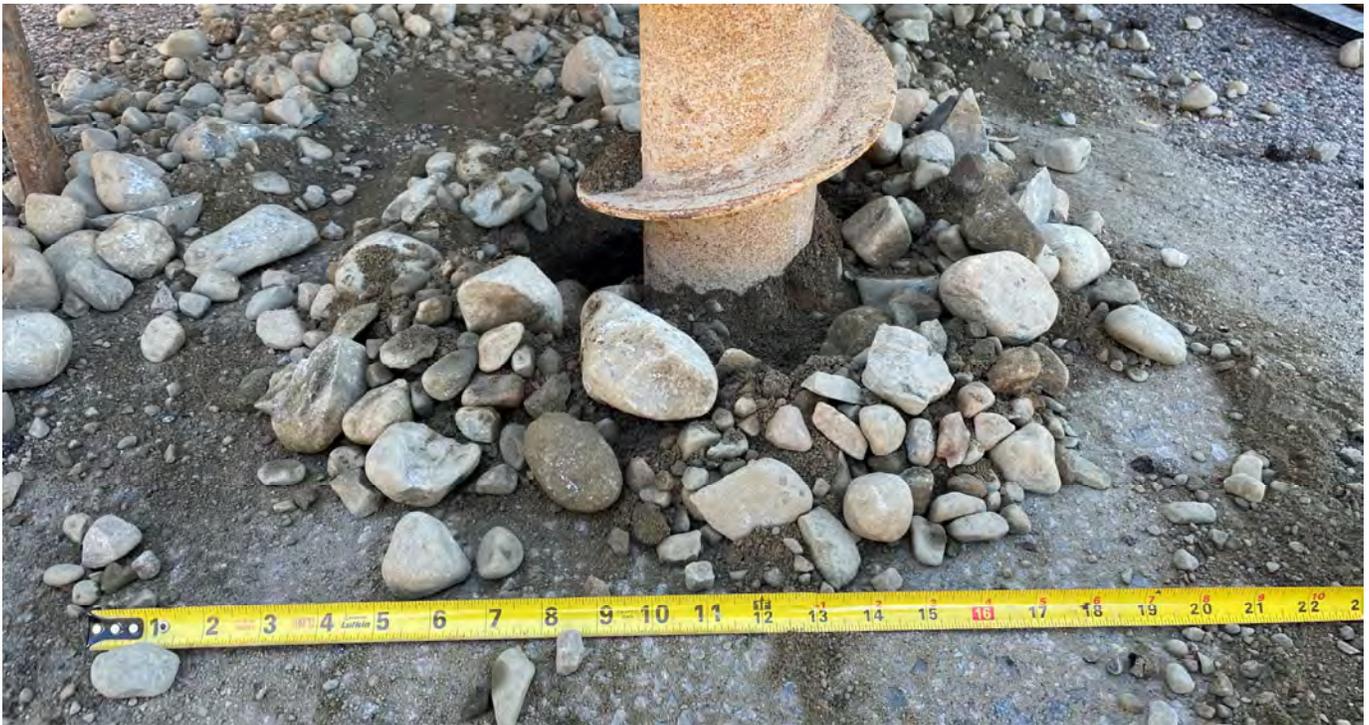
Photograph #8 – Soil cuttings from advancing borehole with augers in embankment fill at Borehole 18289-03. Note gravel and cobble-sized particles in soil cuttings.

Granular embankment fill ranging in composition from gravel to sandy silty gravel to gravelly sand, containing cobbles and possible boulders was encountered underlying the asphalt in Boreholes 18289-02 to 18289-04, and beneath the topsoil in Borehole 18289-05. Cobbles were encountered at varying depths throughout the embankment fill and were cored using an 'NQ' size rock core barrel. Photographs of the cobbles observed in embankment fill cuttings from advancing Borehole 18289-03 are shown in Photographs 8 and 9 in Appendix A. From the recovered cored cobbles and observations of particle sizes in the embankment fill cuttings, the cobbles recovered are up to about 175 mm in size. Boulders may be present as well in the fill.

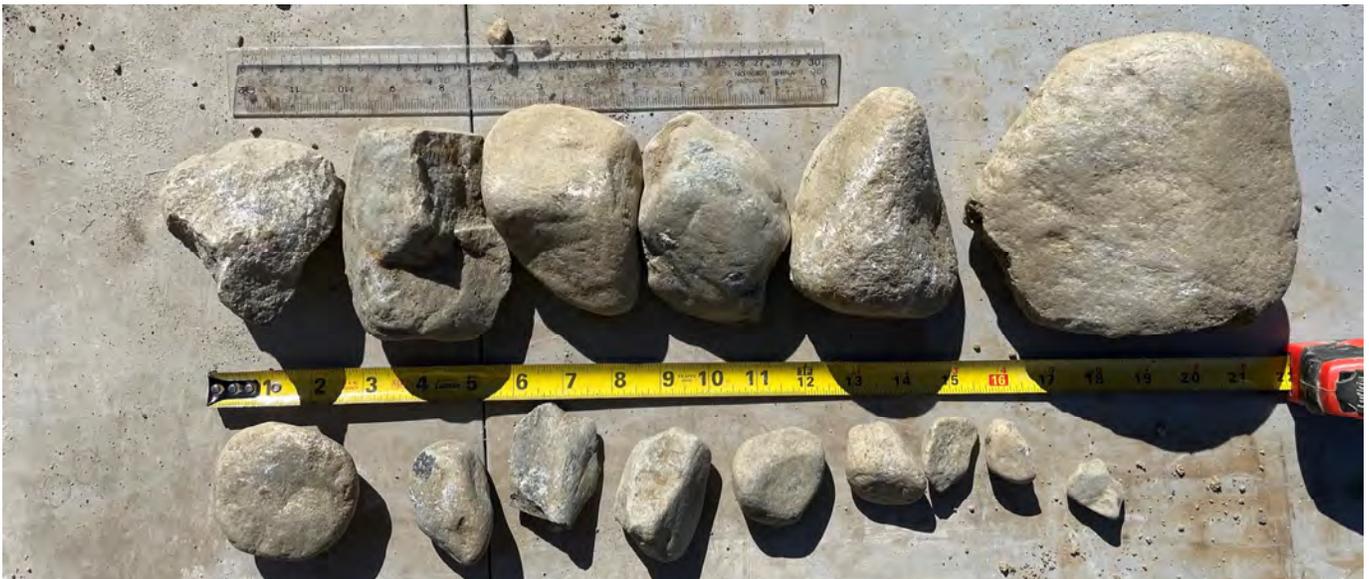
Photograph #9 – Selection of gravel and cobble sized particles recovered from embankment fill soil cuttings from advancing borehole 18289-03 with augers. Largest cobble dimension in above photograph is approximately 175 mm.
