**FOUNDATION INVESTIGATION AND DESIGN REPORT
HIGHWAY 556 CULVERT REPLACEMENT AT STA 19+596
(TOWNSHIP OF DEROCHE)
REHABILITATION OF HIGHWAYS 556 & 532
DISTRICT OF ALGOMA, ONTARIO
ASSIGNMENT No.: 5020-E-0020
G.W.P. 5221-18-00**

Report

AECOM Canada Ltd.

Date: April 24, 2023
File: 31719

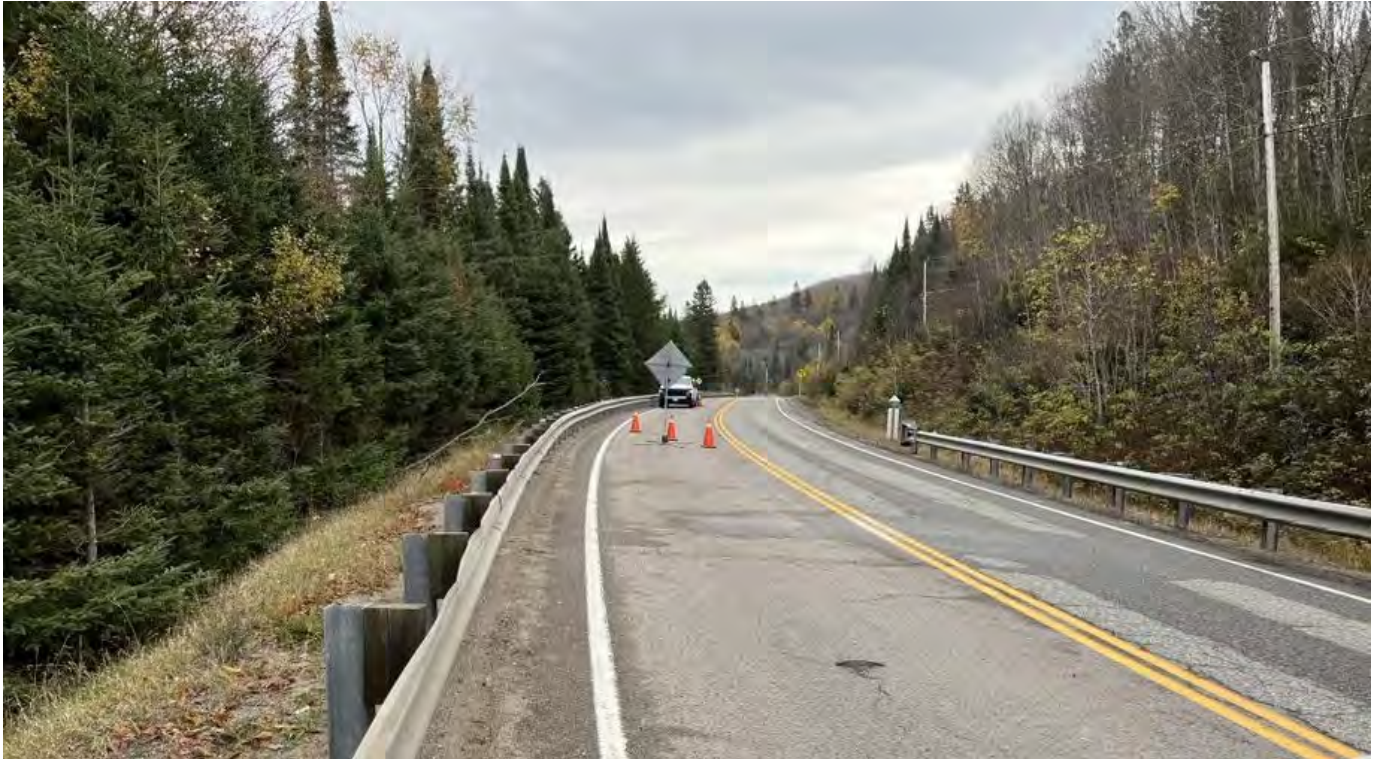
Photograph #1 – Highway 556 at STA 19+596, looking East. Embankment slope facing north is sparsely vegetated (October 2022)

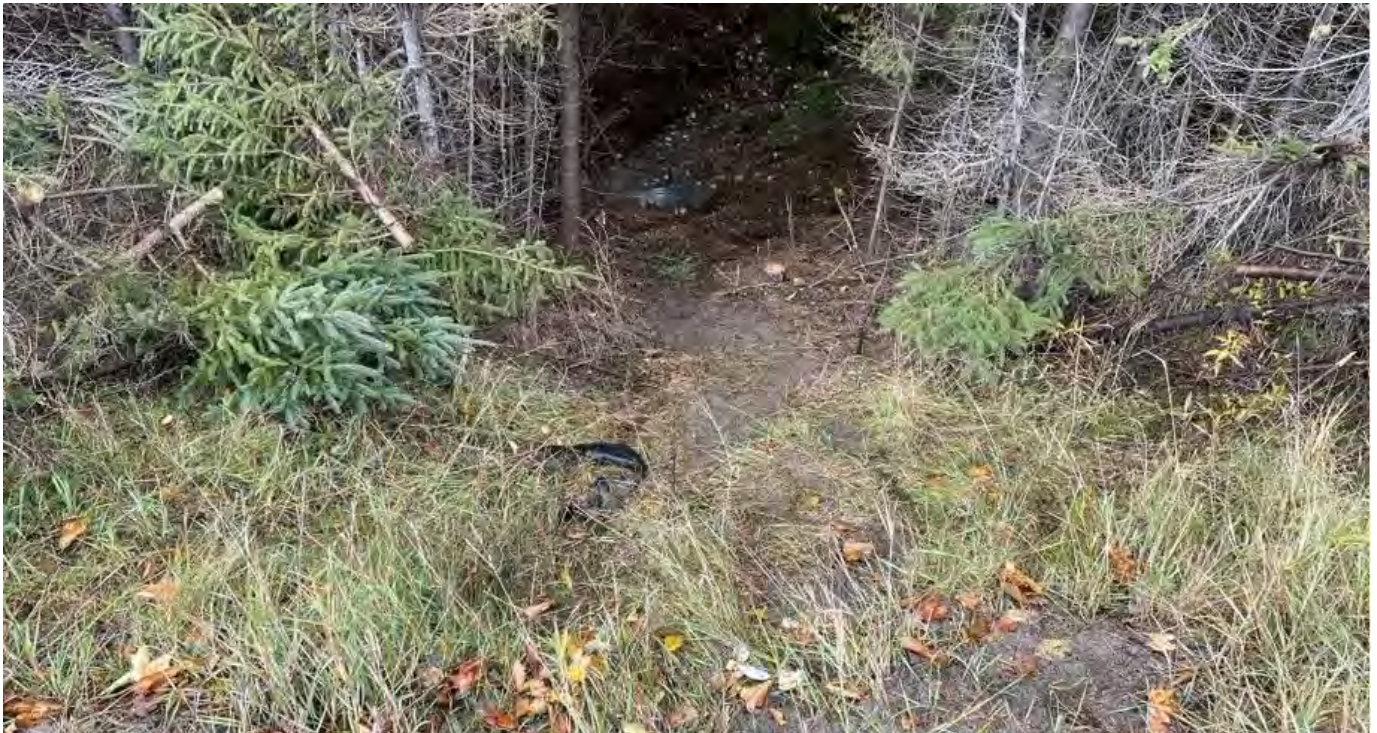
Photograph #2 – North-facing embankment slope at STA 19+596, looking North. Culvert visible in bottom (October 2022)

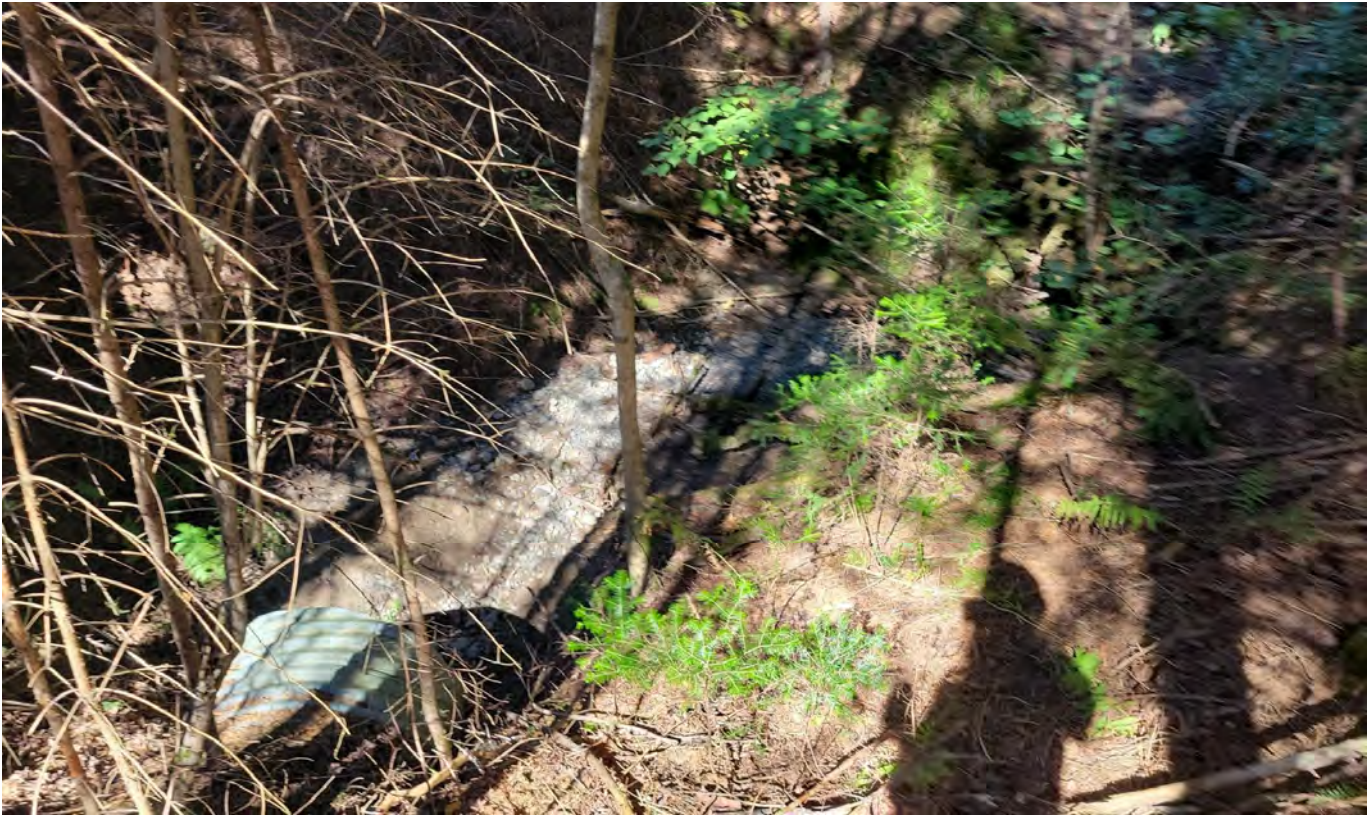
Photograph #3 – Culvert outlet at tow of slope surrounded by mixed forest (September 2022)

A minor amount of water was observed ponded at both inlet and outlet (please see photographs in Appendix A) at the time of the completion of investigation. The water level was surveyed and found to be at approximately Elev. 224.6 m near the culvert outlet and at approximately Elev. 226.0 m at the inlet at the time of investigation.

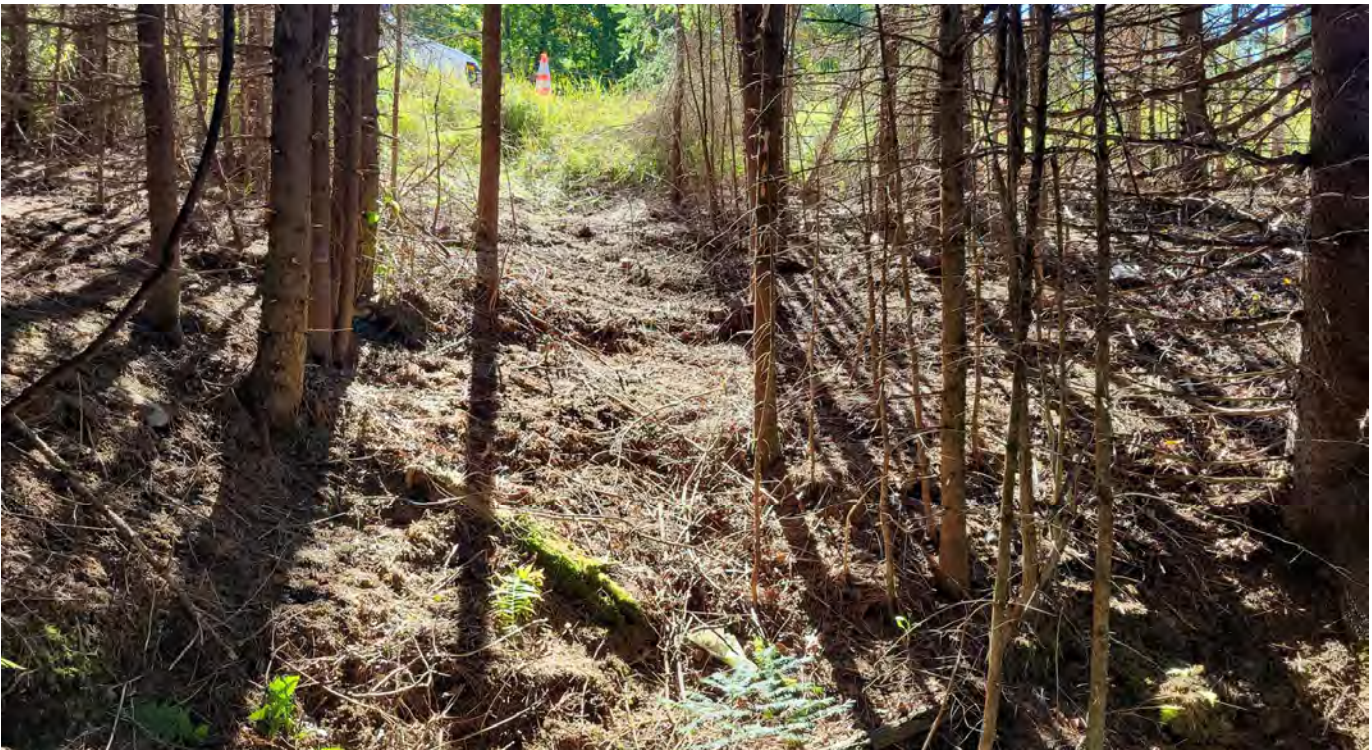
Photograph #4 – Toe of embankment slope at culvert outlet facing South (September 2022)

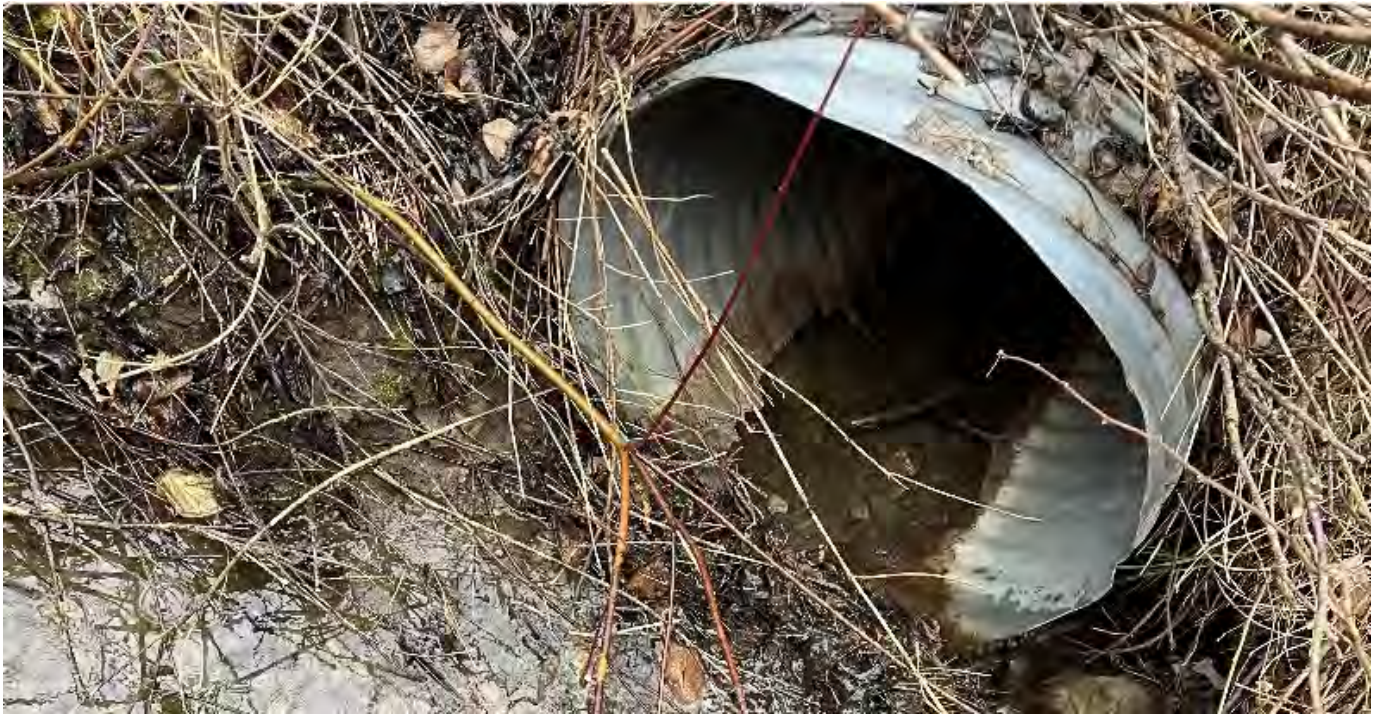
Photograph #5 – Culvert inlet, surrounded by vegetation (November 2022)

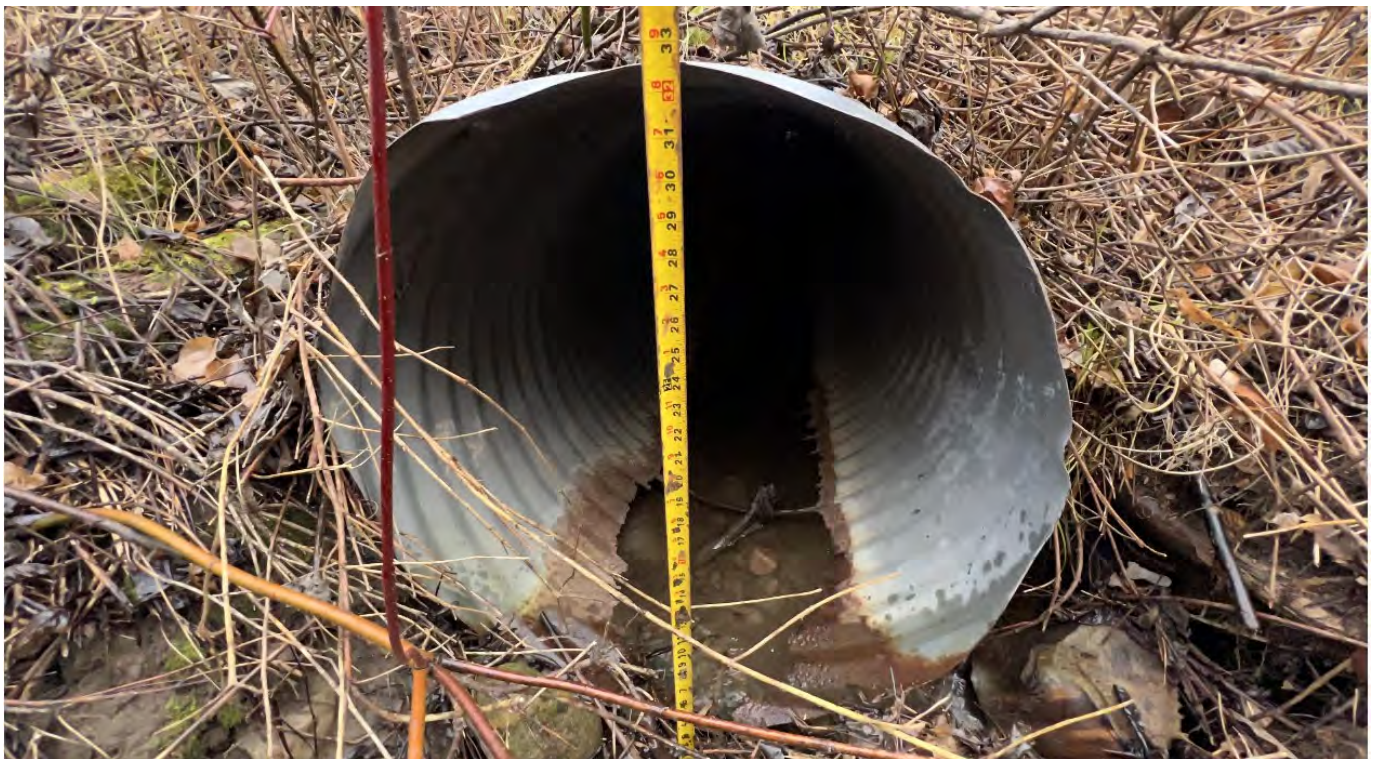
Photograph #6 – Culvert inlet, looking North (November 2022)

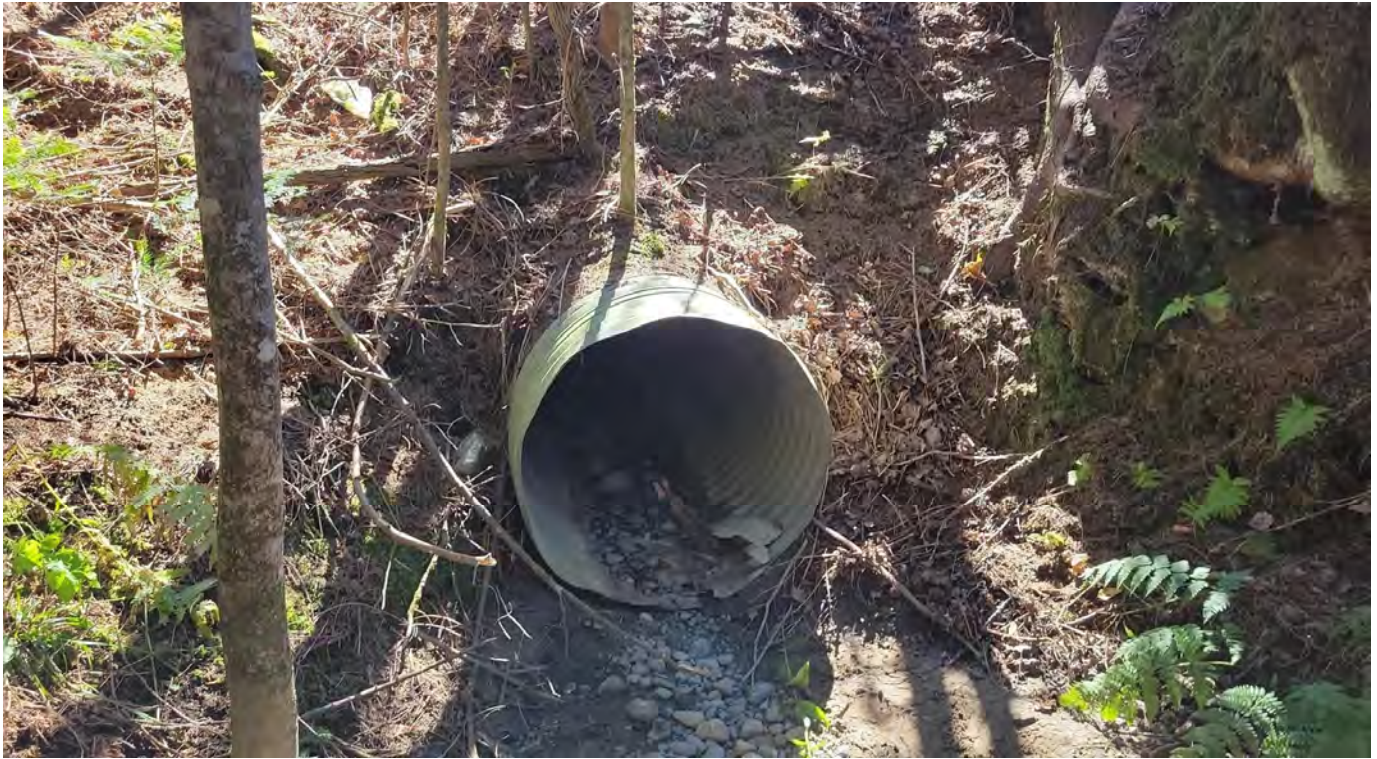
Photograph #7 – Culvert outlet, facing south (September 2022)

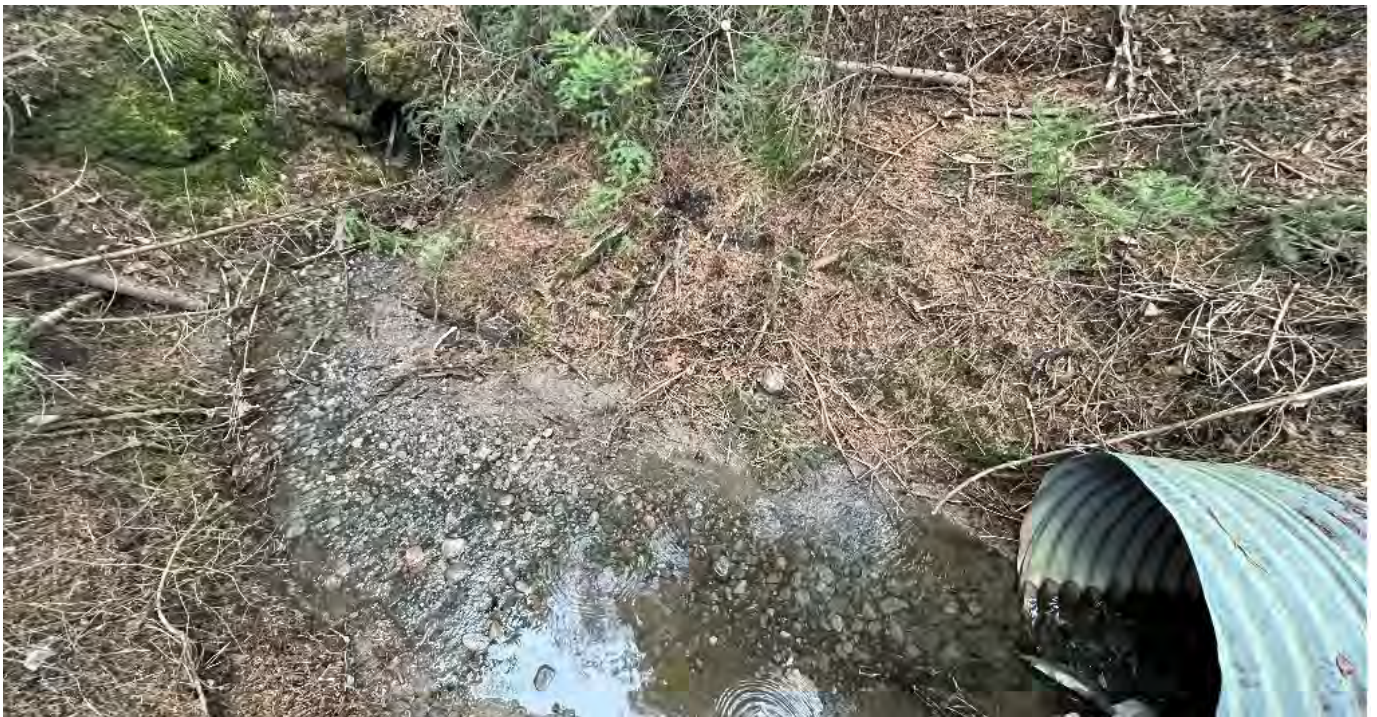
Photograph #8 – Creek downstream of the culvert (October 2022)

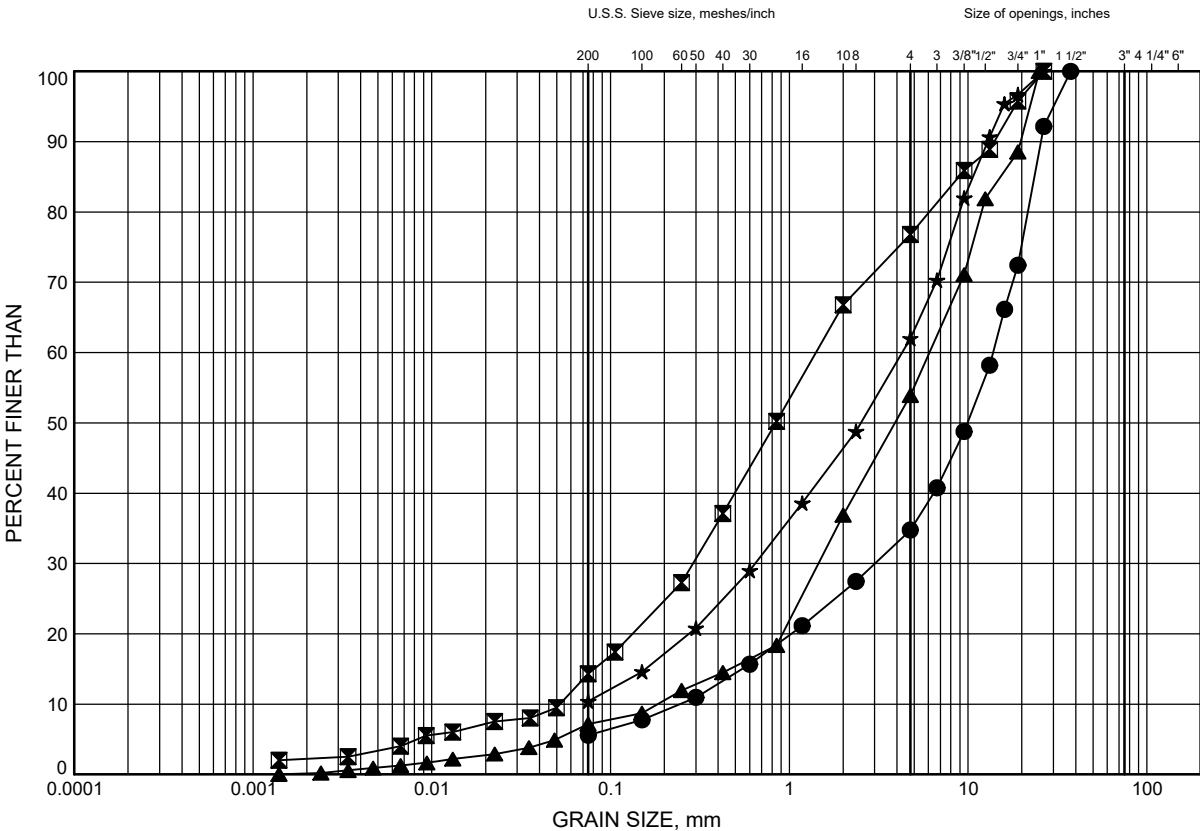
FIGURE C-1A

The results of grain size analyses conducted on selected samples of the embankment fill are provided on the Record of Borehole sheets in Appendix B and plotted in Figures C-1A and C-1B of Appendix C. The results are summarized as follows:

Soil Particle	Percentage (%)
Gravel	3 to 65
Sand	29 to 65
Silt	7 to 30
Clay	2
Silt & Clay	6 to 10

Sandy GRAVEL to Gravelly SAND (FILL)

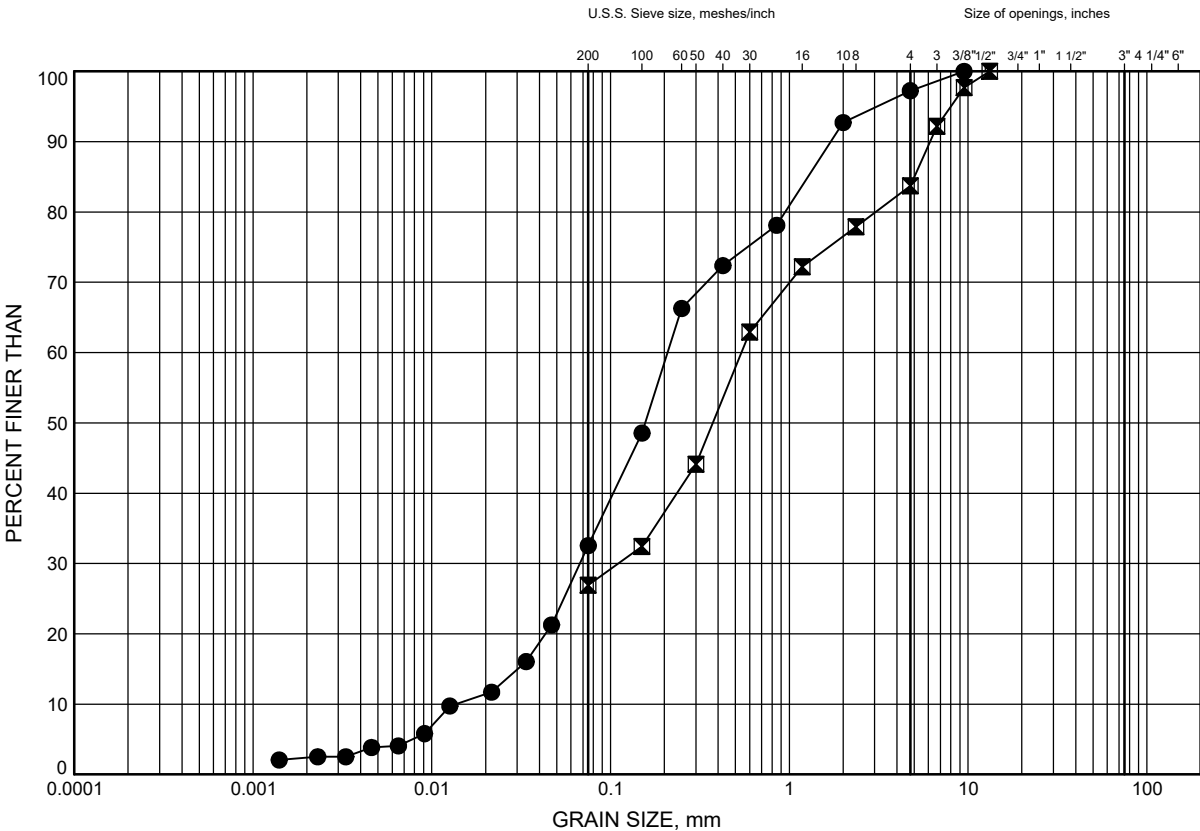
FIGURE C-1B

Silty SAND (FILL)

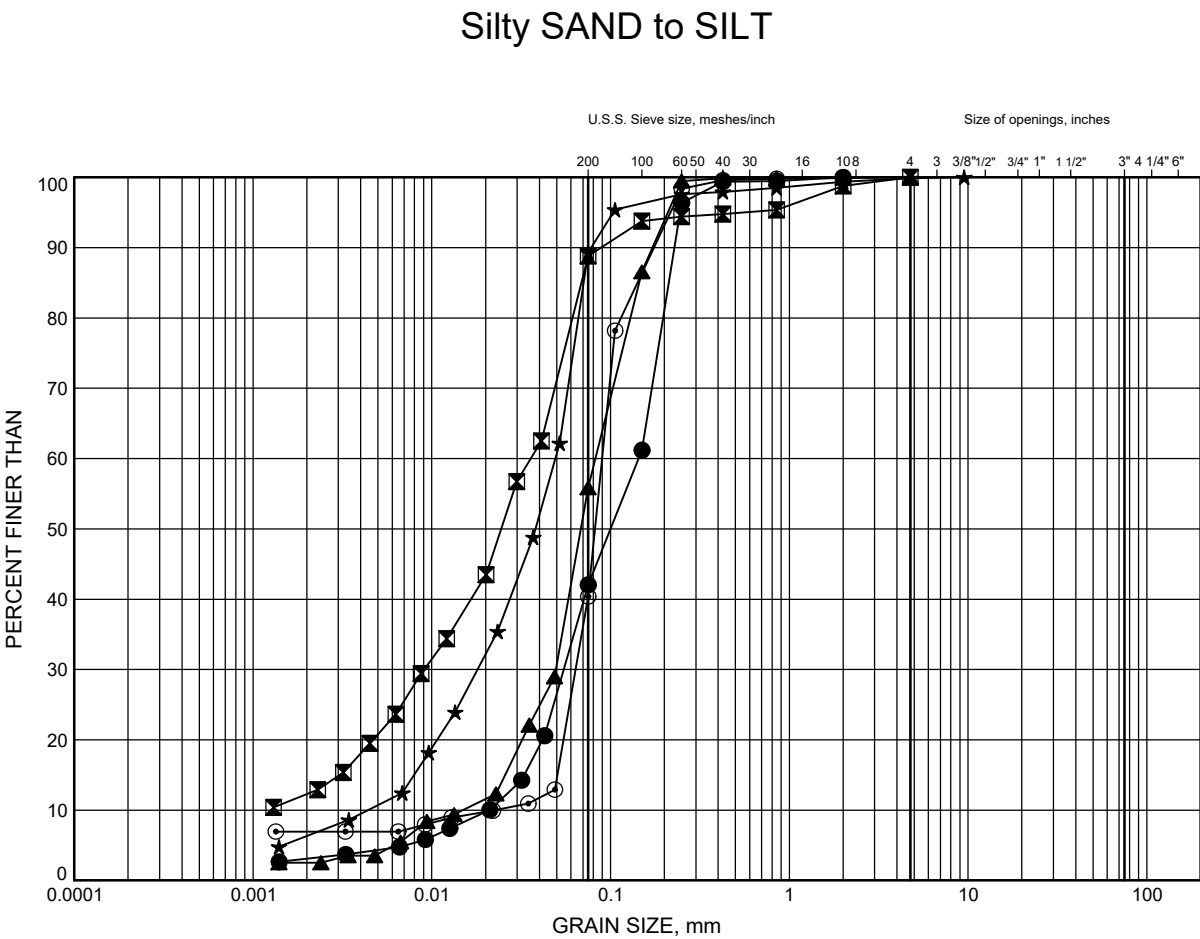
FIGURE C-2

The results of grain size analyses conducted on selected samples of the silty sand to silt deposit are presented on Figure C-2 in Appendix C and summarized as follows:

Soil Particle	Percentage (%)
Gravel	0
Sand	11 to 60
Silt	33 to 83
Clay	3 to 12

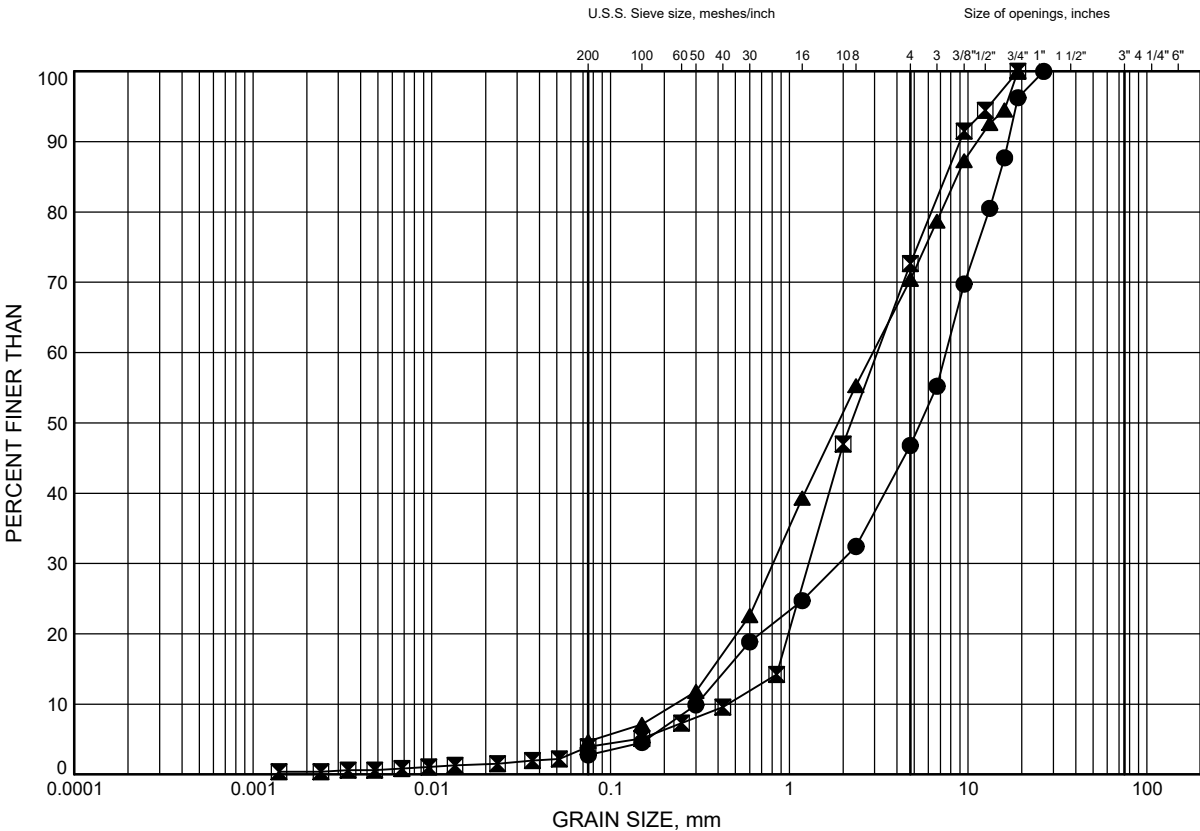
FIGURE C-3

The results of grain size analyses conducted on selected samples of the gravel and sand to gravelly sand layer are presented on Figure C-3, in Appendix C and summarized as follows:

Soil Particle	Percentage (%)
Gravel	27 to 53
Sand	44 to 69
Silt	4
Clay	0
Silt & Clay	3 to 4

GRAVEL and SAND to Gravelly SAND

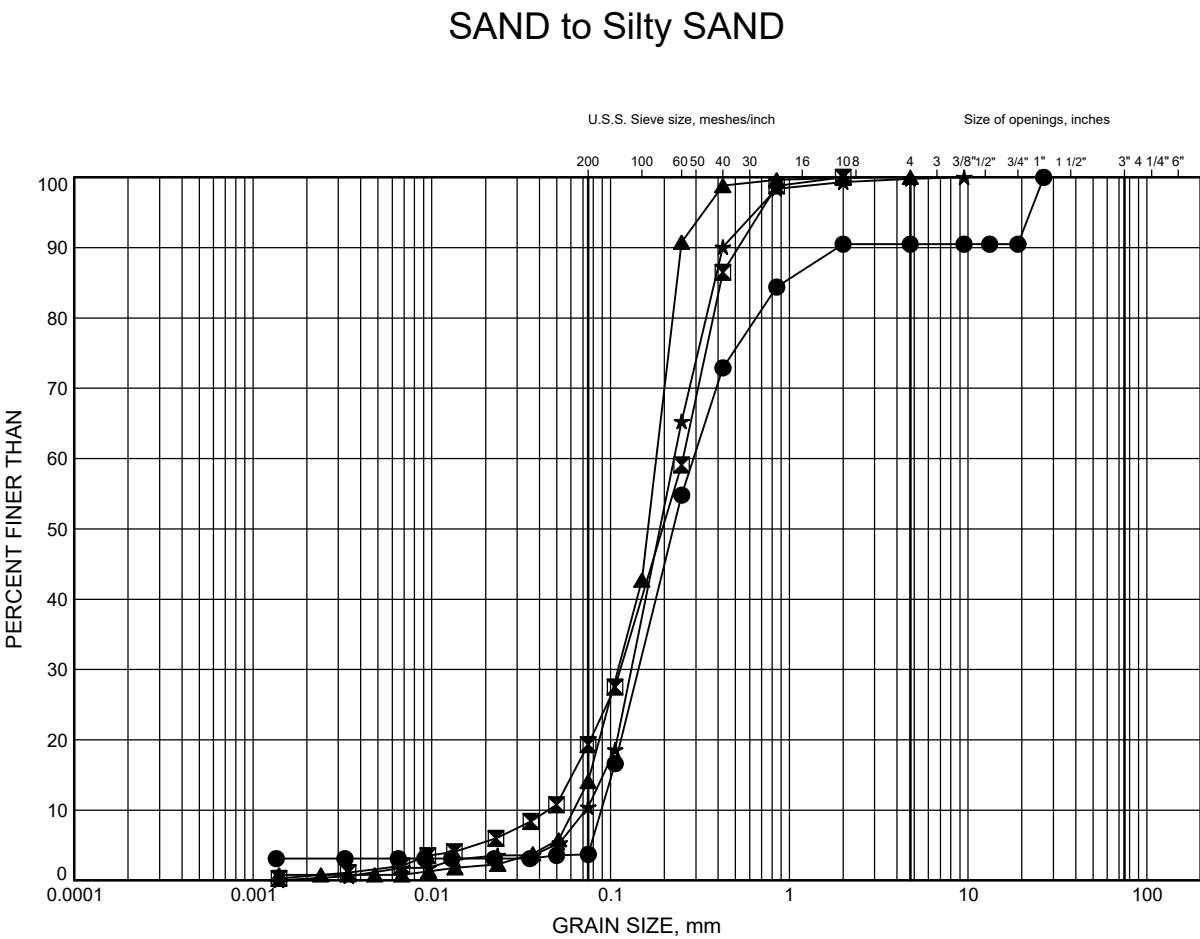
FIGURE C-4

The results of grain size analyses conducted on selected samples of the lower sand deposit are presented on Figure C-4 in Appendix C and summarized as follows:

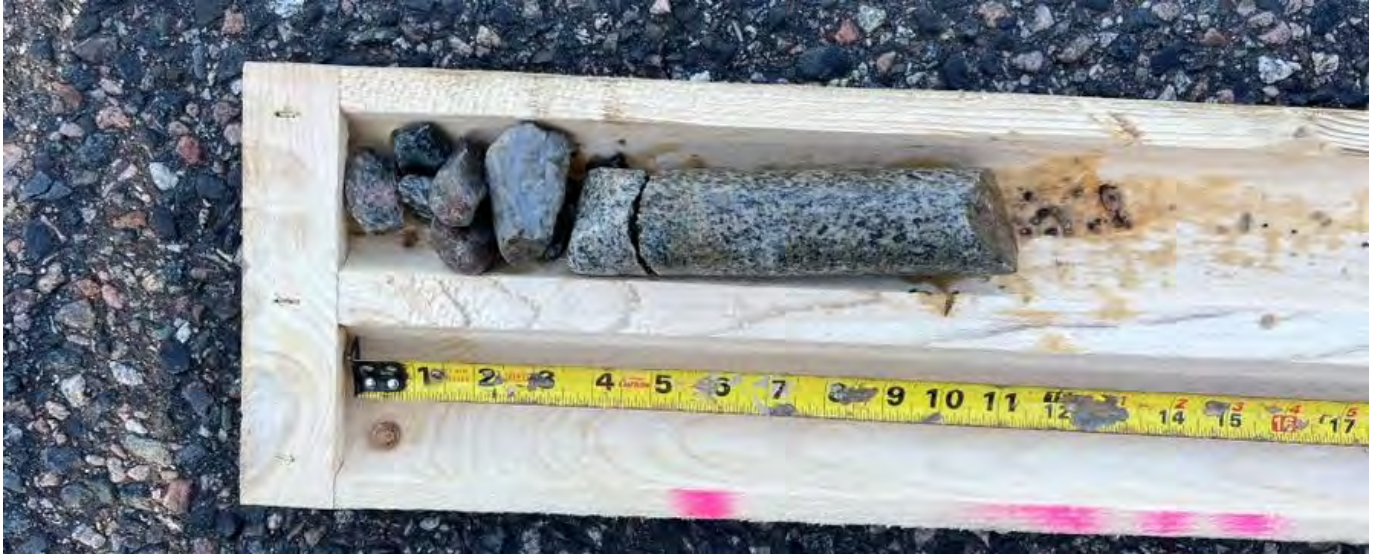
A gravel and sand to gravelly sand deposit containing cobbles was encountered beneath the silty sand to silt deposit in Boreholes 19596-01 to 19596-05. The granular deposit ranged in thickness from 1.5 m to 2.6 m (prior to borehole termination) and extended to depths between 3.4 m and 8.7 m (Elev. 222.2 m to 220.9 m). Cobbles up to 150 mm in diameter were encountered within the gravel and sand deposit in Borehole 19596-01 at depths between 1.7 m and 3.4 m (Elev. 222.9 m to 221.2 m). Coring was required to advance through this deposit. Photographs of the cobble cores are provided in Appendix C.

Photograph #9 – Core sample AW1 from Borehole 19596-01. (November 2022)

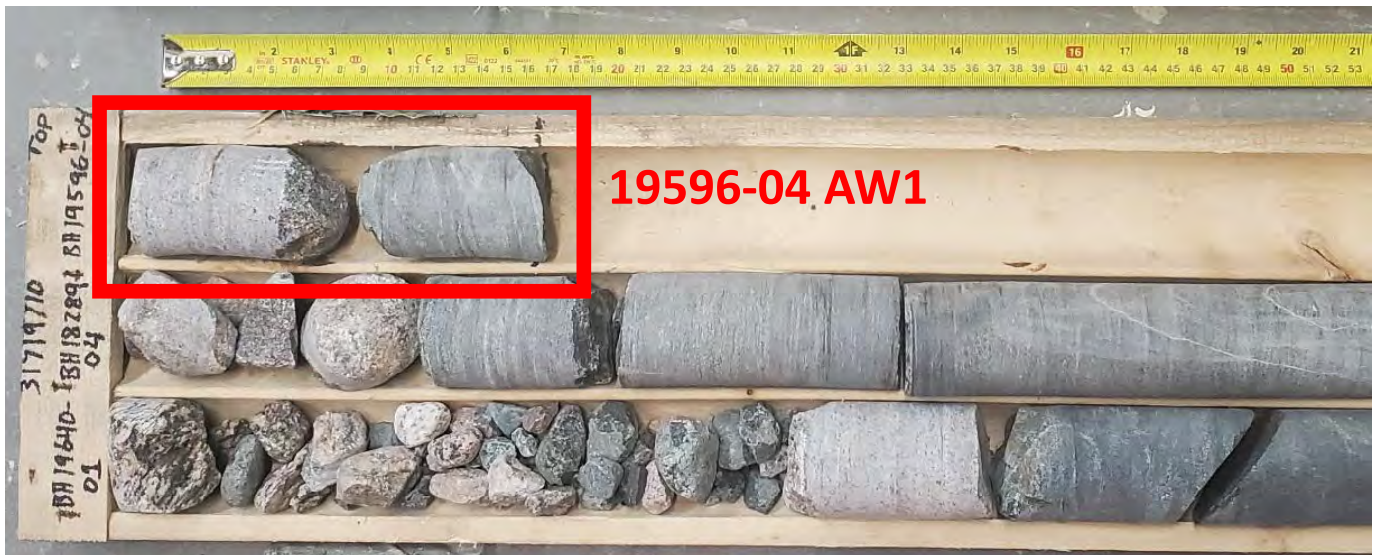
Photograph #10 – Core sample AW1 from Borehole 19596-04. (February 2023)

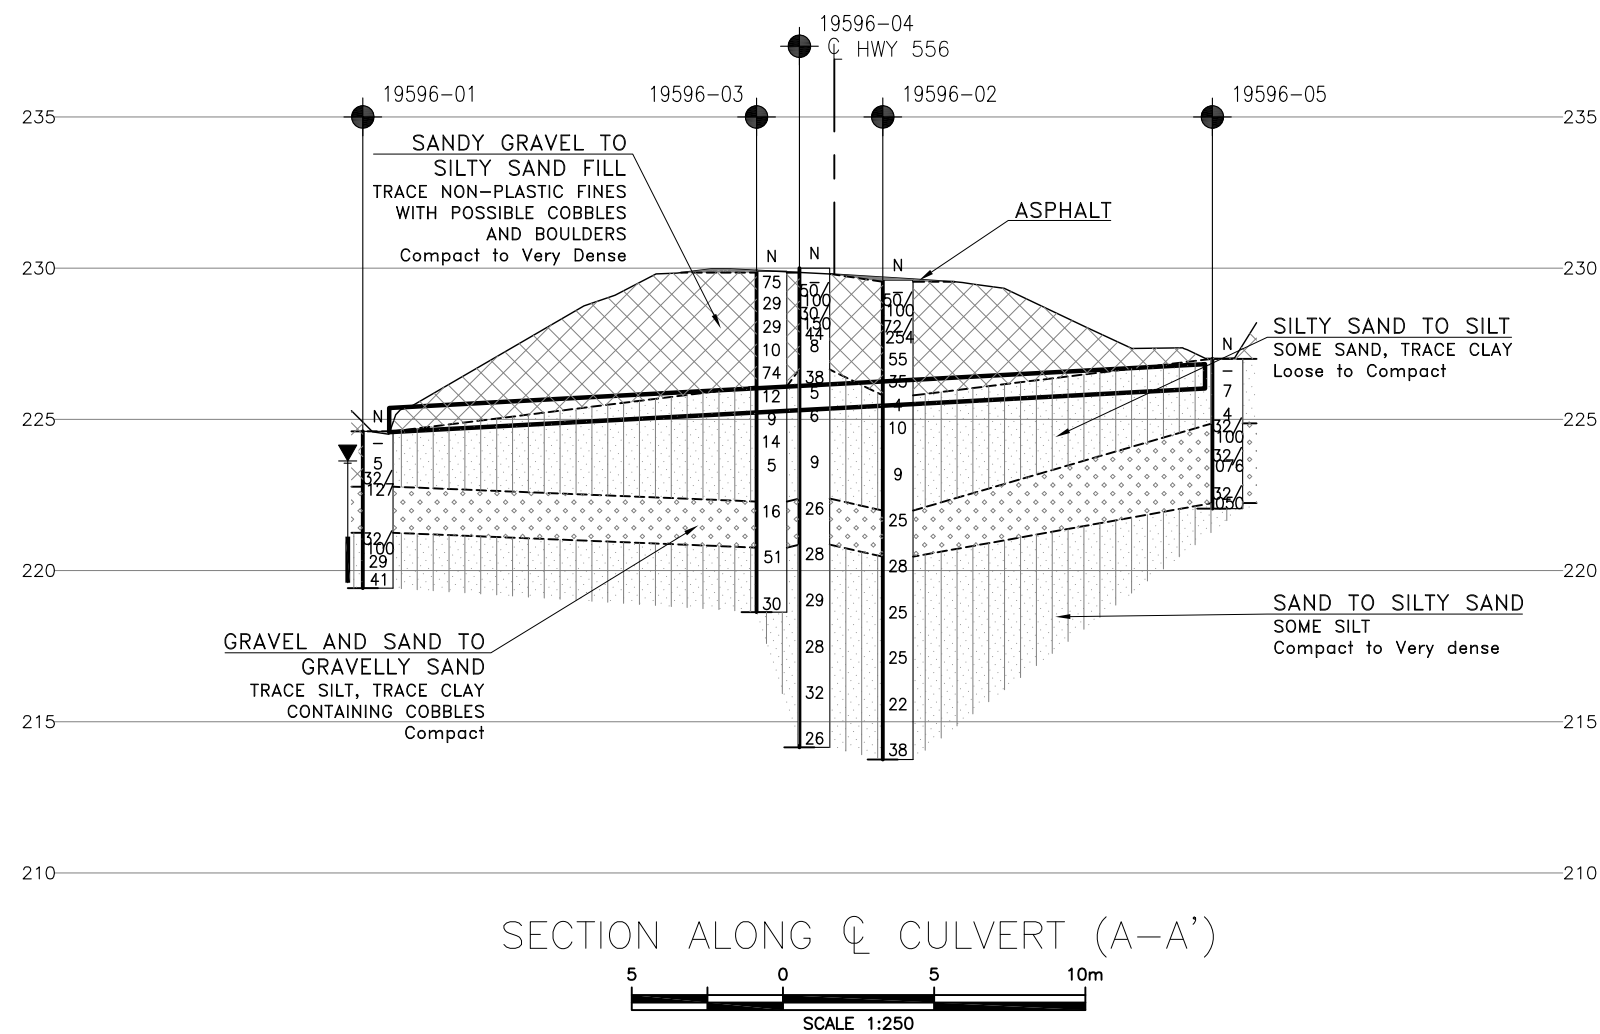
The Record of Borehole sheets for the boreholes are included in Appendix B. The approximate borehole locations are shown on the attached Borehole Locations and Soil Strata Drawing in Appendix D.

Reference is made to the Record of Borehole sheets included in Appendix B. Details of the encountered soil stratigraphy are presented on the Record of Borehole sheets and on the Borehole Locations and Soil Strata Drawing included in Appendix D. A description of the stratigraphy, based on the conditions encountered in the boreholes, is given in the following paragraphs. However, the factual data presented on the Record of Borehole sheets takes precedence over this general description and must be used for interpretation of the site conditions. It must be recognized and expected that soil conditions may vary between and beyond the borehole locations.
