**DRAFT
FOUNDATION INVESTIGATION AND DESIGN REPORT
TEMPORARY PROTECTION SYSTEM FOR HIGHWAY 556 CULVERT
REHABILITATION AT STA 19+640 (TOWNSHIP OF VANKOUGHNET)
REHABILITATION OF HIGHWAYS 556 & 532
DISTRICT OF ALGOMA, ONTARIO
ASSIGNMENT No.: 5020-E-0020
G.W.P. 5221-18-00**

AECOM Canada Ltd.

Date: March 3, 2023
File: 31719

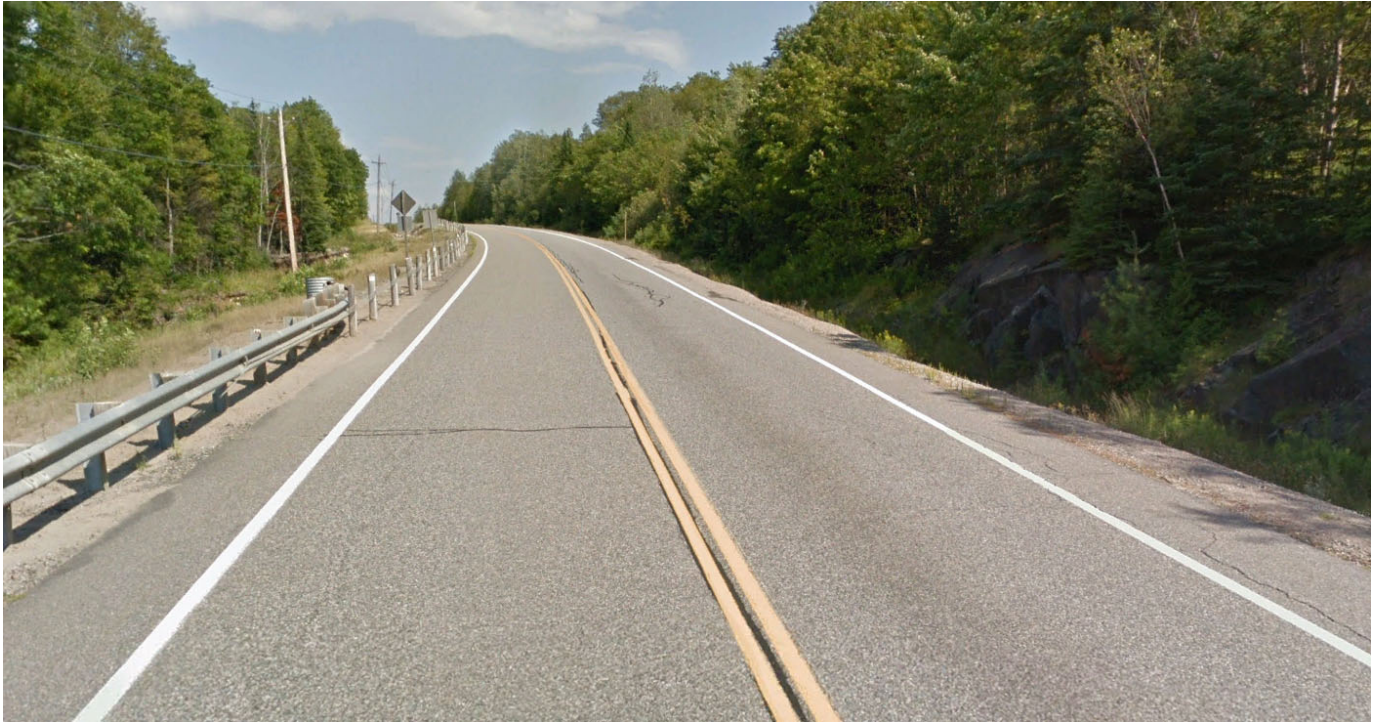
Photograph #1 – Highway 556 near culvert location, facing East. Drop Inlet at ditch to the south. Rock outcrops visible on slope south of ditch (Google Streetview imagery, August 2018)

Based on visual observations, no signs of slope instability of the embankment were noted near the inlet and outlet of the culvert site. The south side of the highway embankment, including the area of the culvert outlet, is generally surrounded by thick mixed forest. The ditch along the south shoulder is lightly vegetated with some visible cobbles and bedrock outcrops. Site photographs can be found in Appendix A.

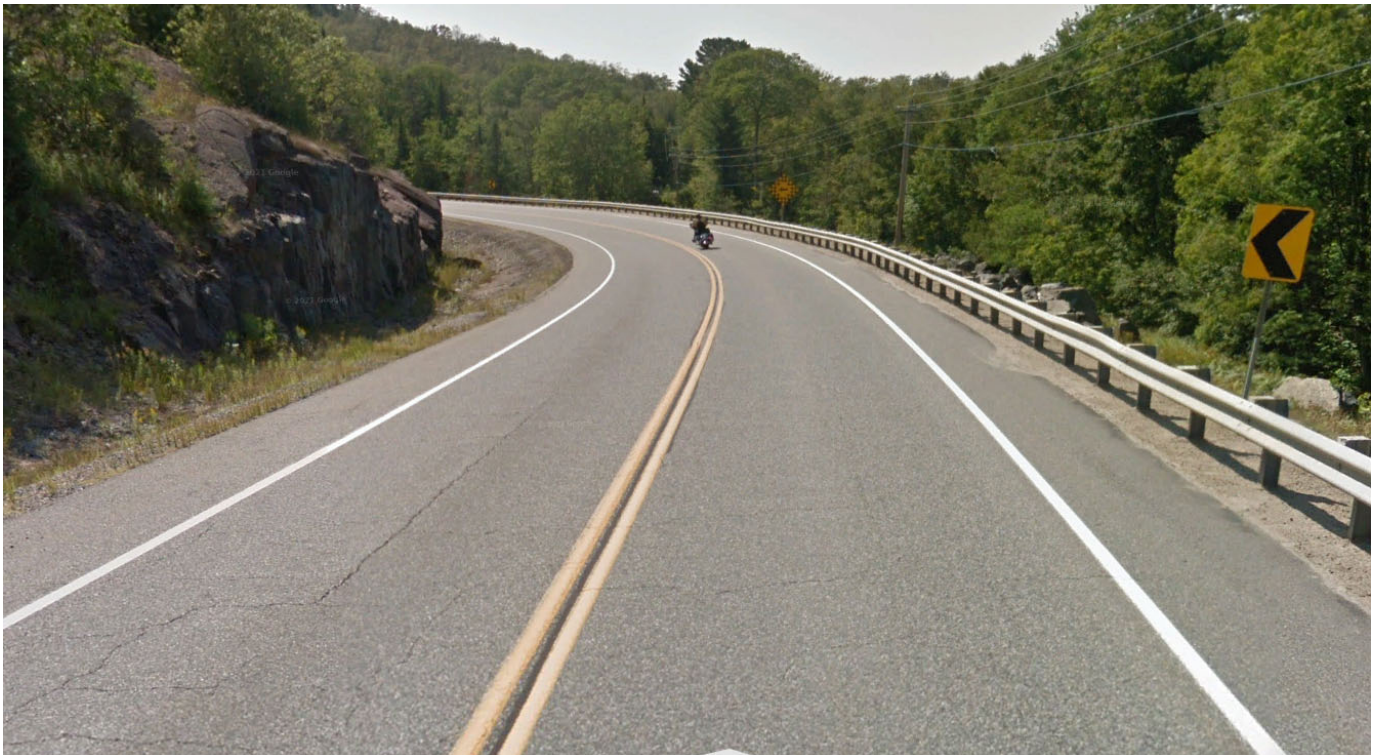
Photograph #2 – Highway 556 near culvert location, facing West. Drop Inlet at ditch to the south. Rock outcrops visible on slope south of ditch near horizontal curve (Google Streetview imagery, August 2018)

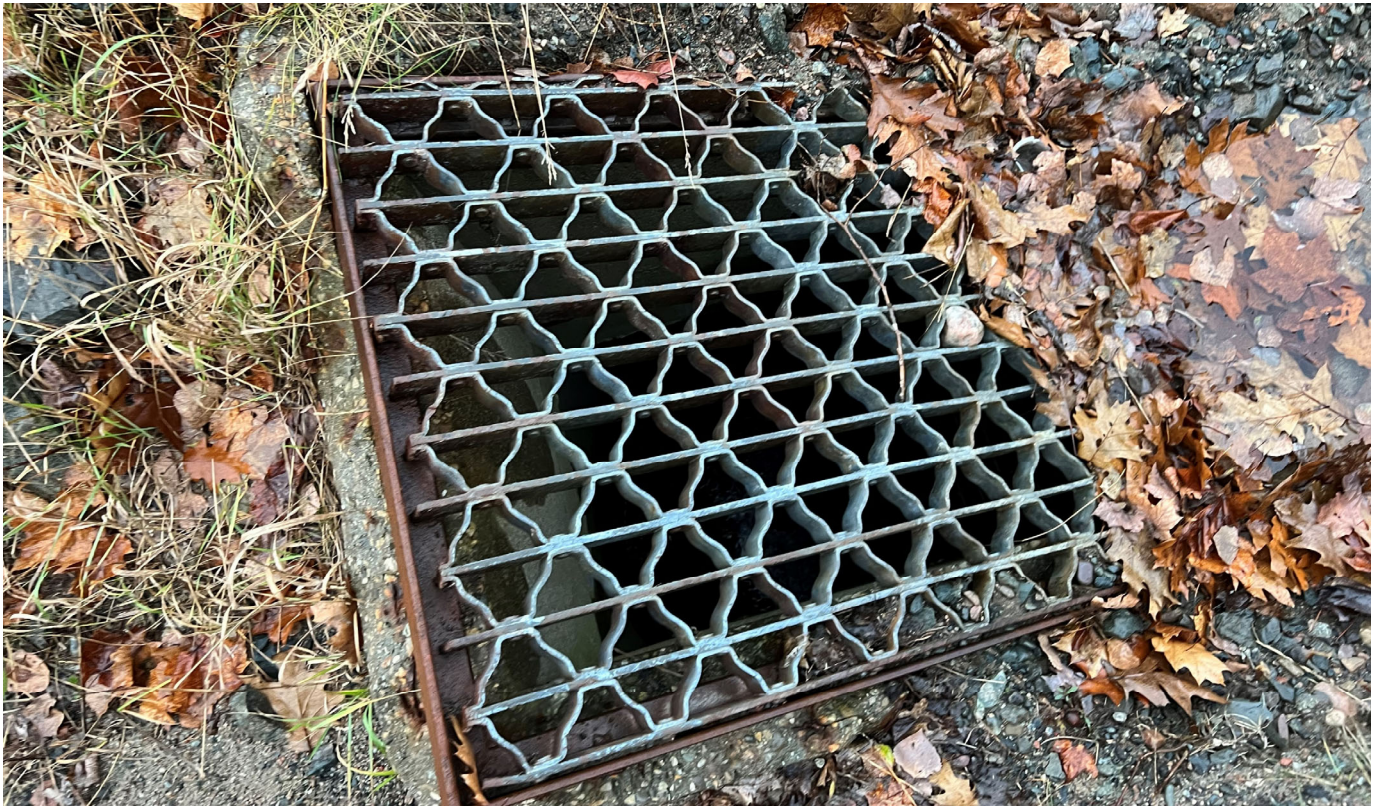
Photograph #3 – Safety grate over drop inlet at the culvert inlet (November 2022)

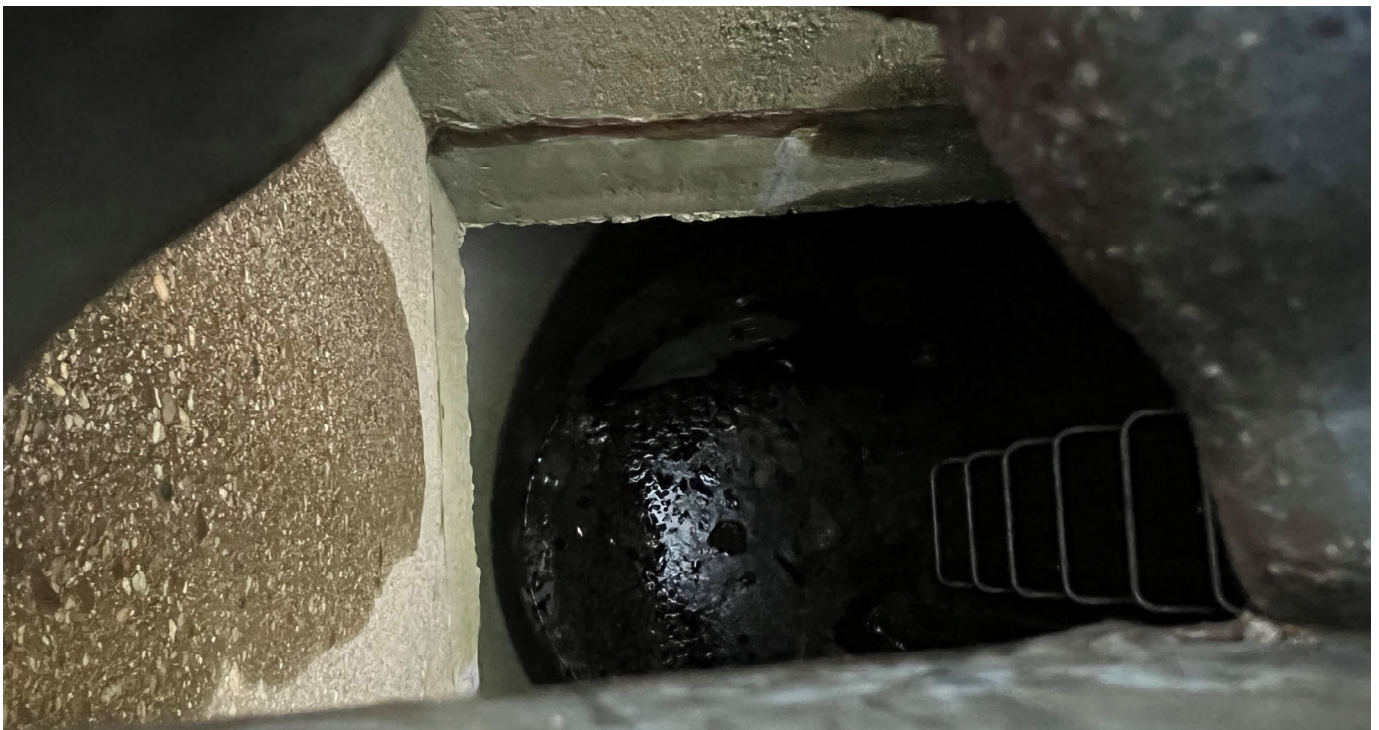
Photograph #4 – Inside drop inlet (November 2022)

Water was measured to be at a depth of 3.6 m below the top of the drop inlet (Elev. 278.8 m). The water at the outlet was found to be surficial at approximately Elev. 276.9 m at the time of the investigation.

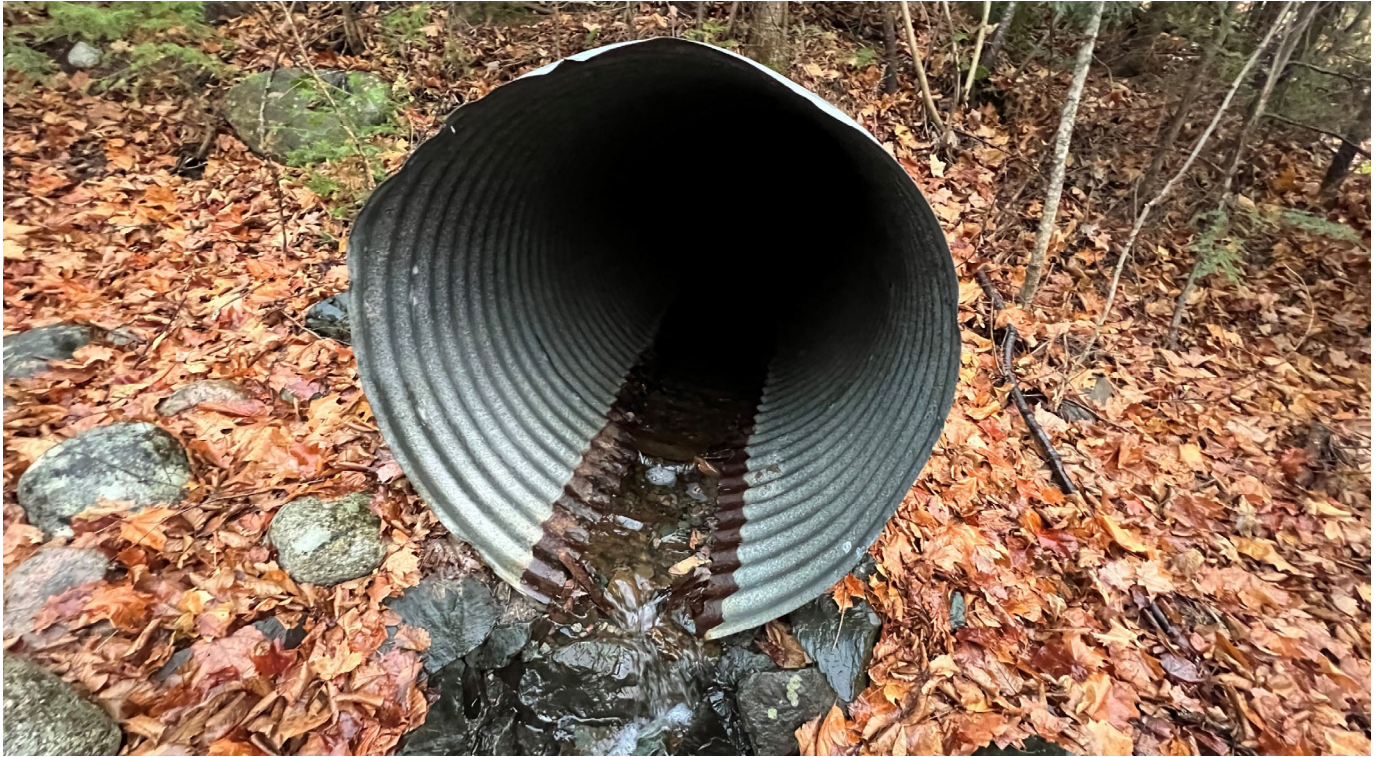
Photograph #5 – Culvert outlet, surrounded by forest vegetation, facing south. (November 2022)

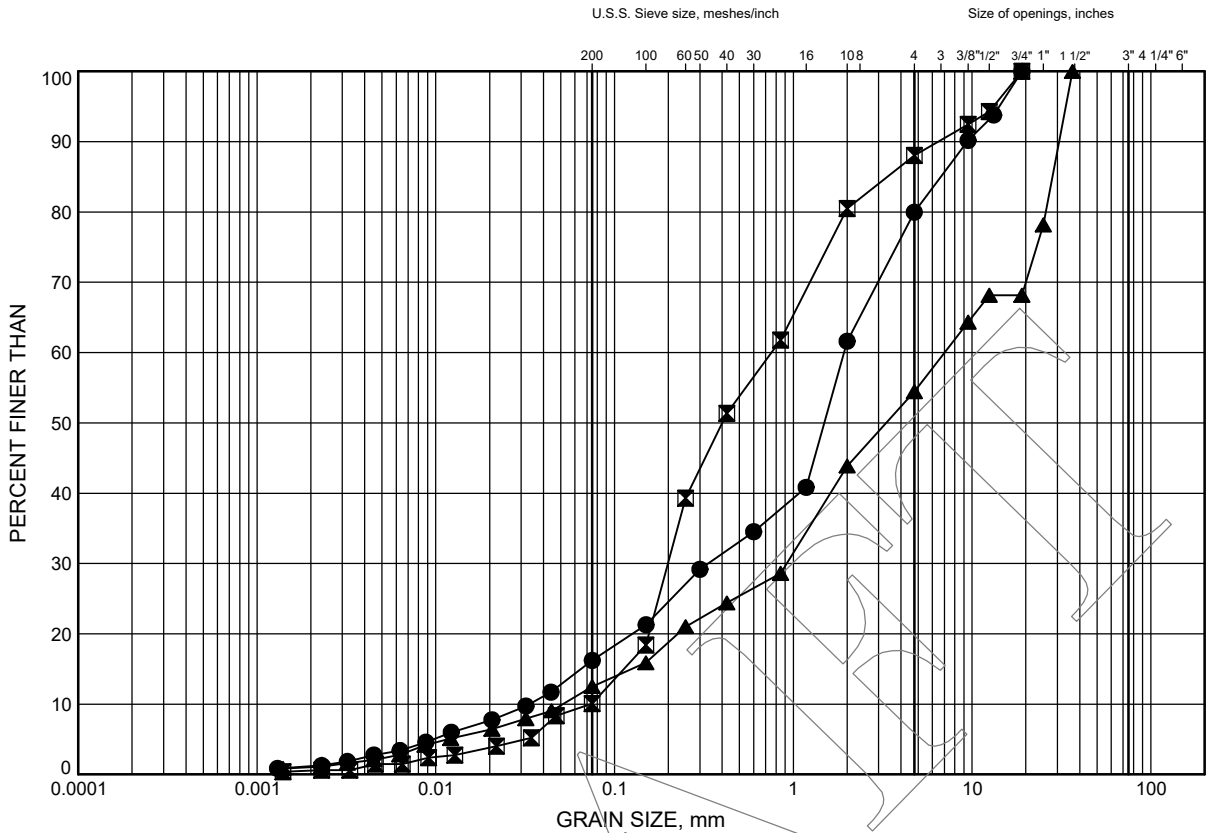
GRAIN SIZE DISTRIBUTION

SAND to Gravelly Silty SAND (FILL)

The results of grain size analyses conducted on selected samples of the embankment fill are provided on the Record of Borehole sheets in Appendix B and plotted in Figure C-1 of Appendix C. The results are summarized as follows:

Soil Particle	Percentage (%)
Gravel	12 to 46
Sand	42 to 78
Silt	10 to 15
Clay	0 to 1

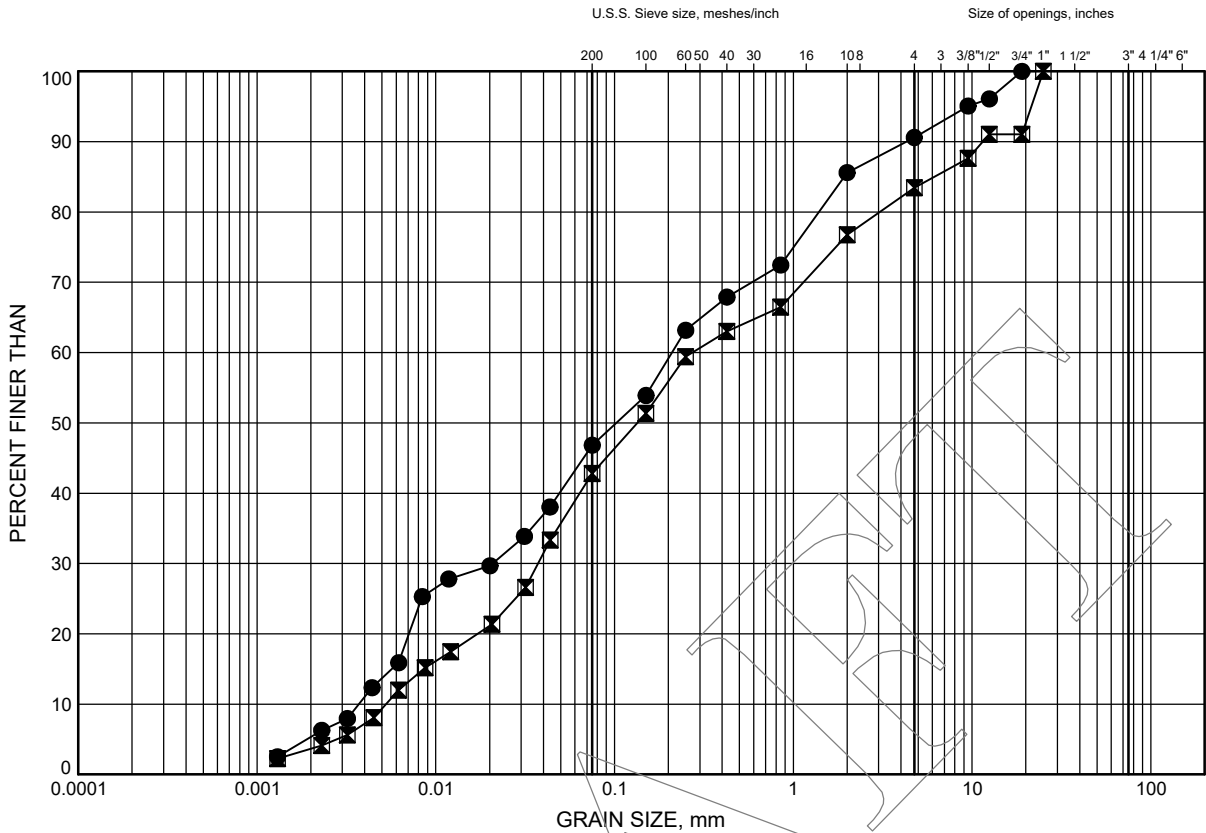
FIGURE C2

Silty SAND

The results of grain size analyses conducted on samples of the silty sand deposit are provided on the Record of Borehole sheets in Appendix B and plotted in Figure C-2 of Appendix C. The results summarized as follows:

Soil Particle	Percentage (%)
Gravel	9 to 17
Sand	41 to 44
Silt	39 to 41
Clay	3 to 6

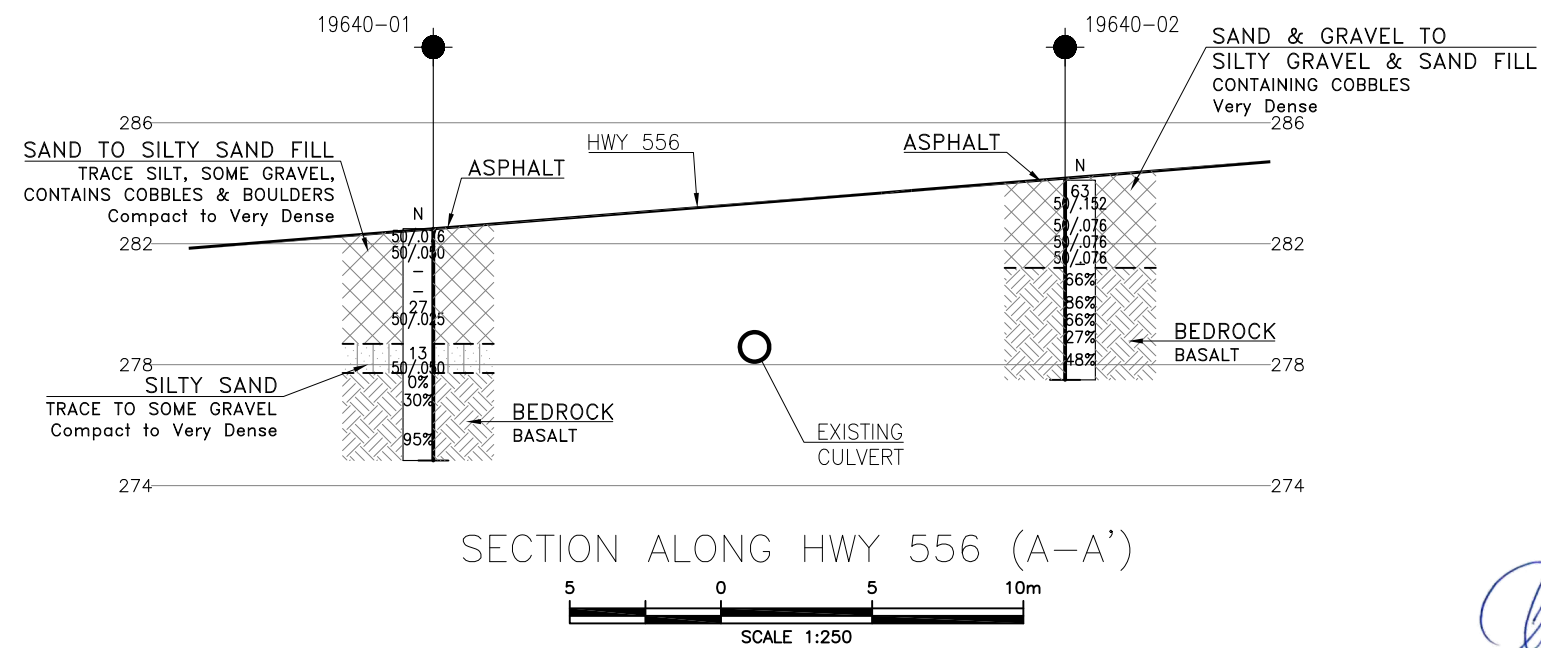
SHEET
1

Borehole Locations and Soil Strata Drawing

Borehole Locations and Soil Strata Drawing included in Appendix D. A description of the stratigraphy, based on the conditions encountered in the boreholes, is given in the following paragraphs. However, the factual data presented on the Record of Borehole sheets takes precedence over this general description and must be used for interpretation of the site conditions. It must be recognized and expected that soil conditions and the elevation of the soil-bedrock interface may vary between and beyond the borehole locations.
