**FOUNDATION INVESTIGATION AND DESIGN REPORT  
TEMPORARY PROTECTION SYSTEM FOR HIGHWAY 556 CULVERT  
REHABILITATION AT STA 19+640 (TOWNSHIP OF VANKOUGHNET)  
REHABILITATION OF HIGHWAYS 556 & 532  
DISTRICT OF ALGOMA, ONTARIO  
ASSIGNMENT No.: 5020-E-0020  
G.W.P. 5221-18-00**

**GEOCRES Number: 41K-126**

Date: April 24, 2023  
File: 31719

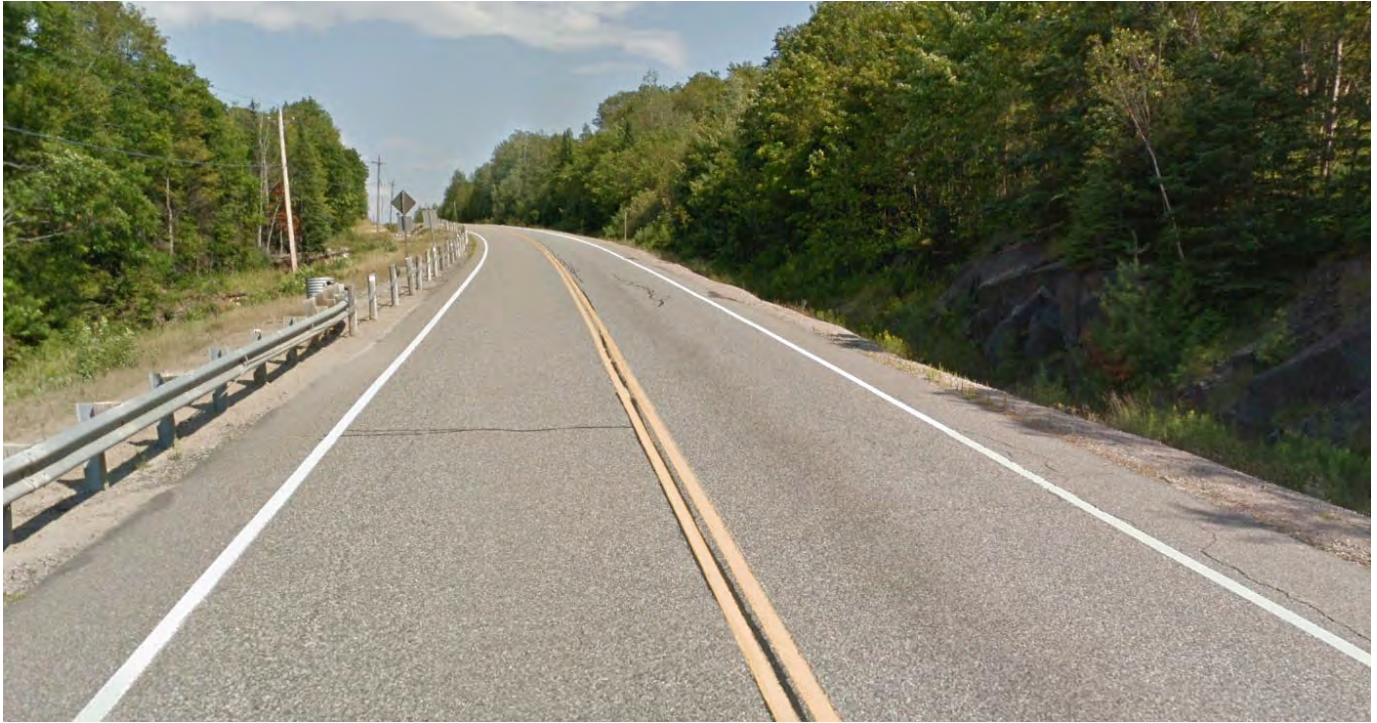
**Photograph #1** – Highway 556 near culvert location, facing East. Drop Inlet at ditch to the south. Rock outcrops visible on slope south of ditch (Google Streetview imagery, August 2018)

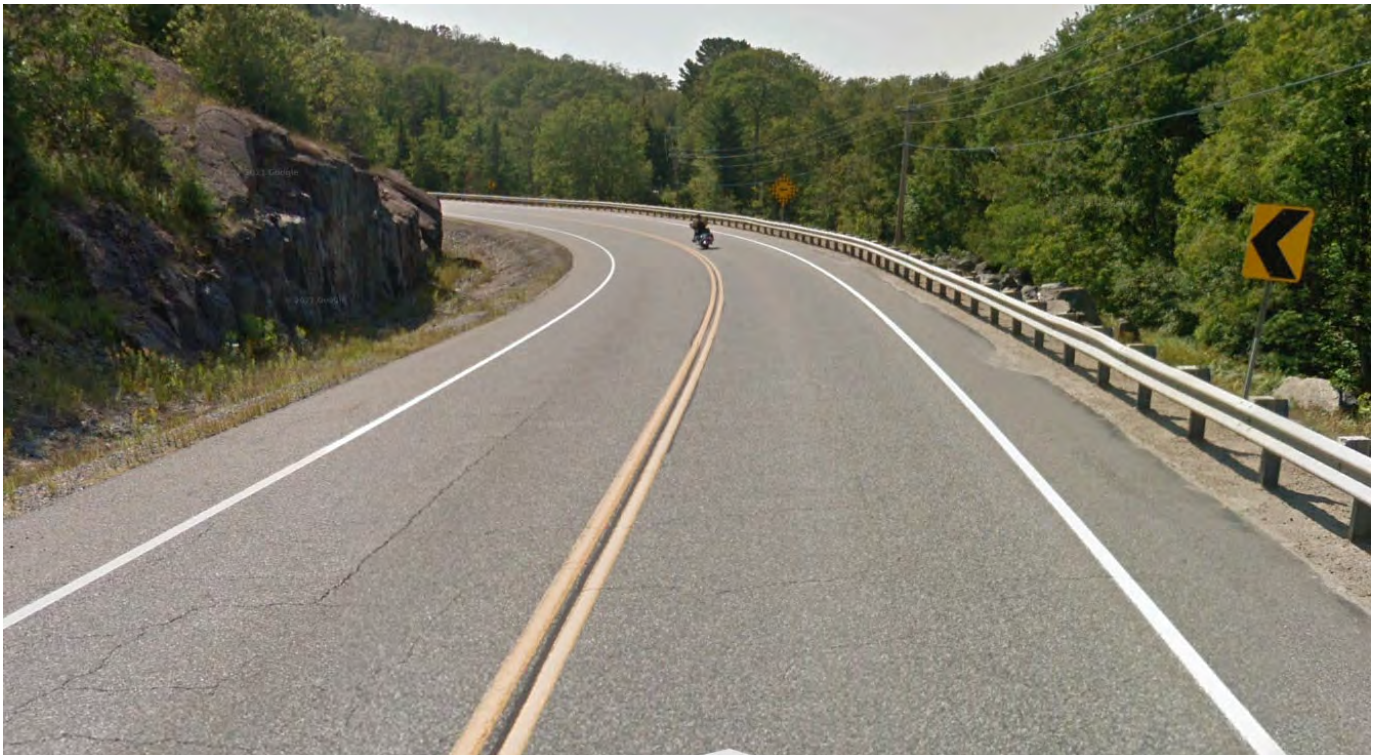
**Photograph #2** – Highway 556 near culvert location, facing West. Drop Inlet at ditch to the south. Rock outcrops visible on slope south of ditch near horizontal curve (Google Streetview imagery, August 2018)

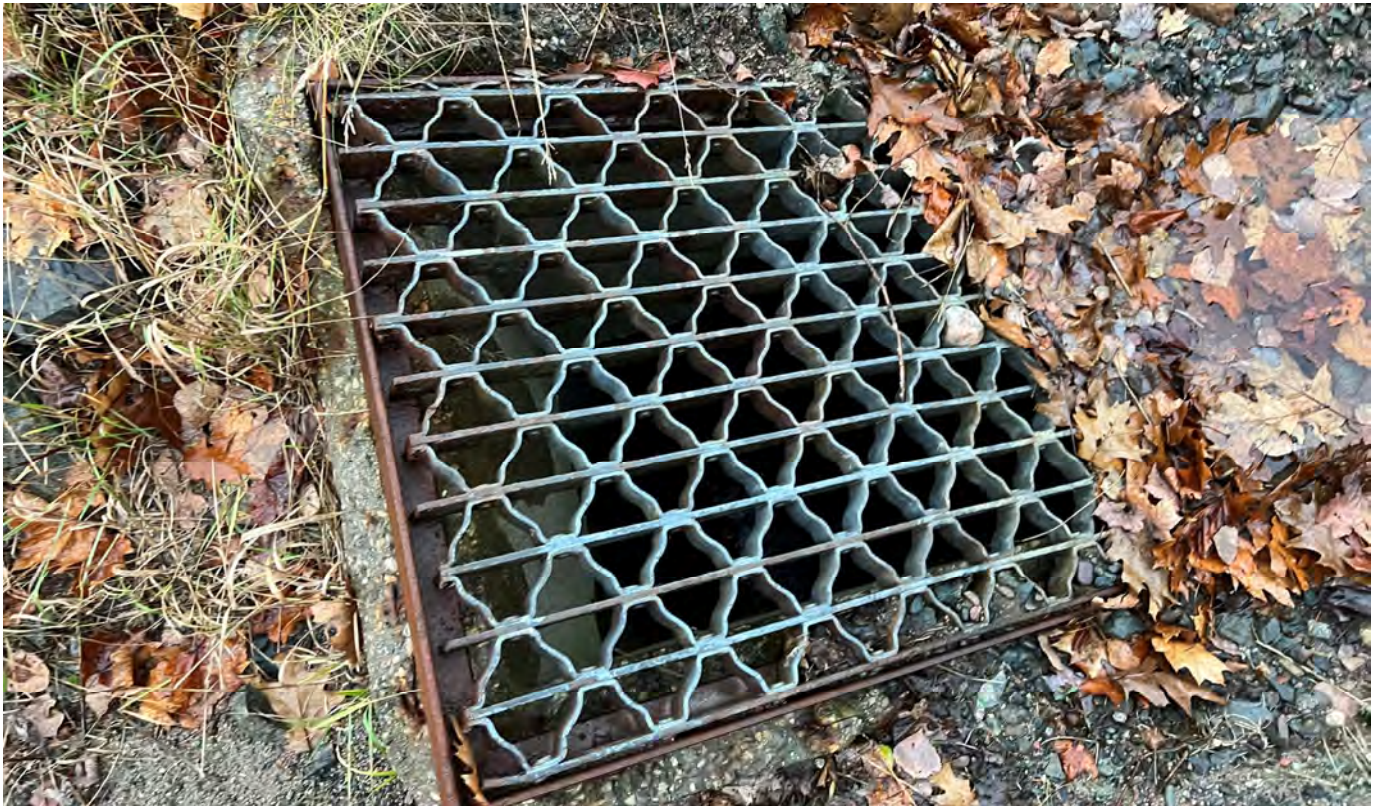
**Photograph #3** – Safety grate over drop inlet at the culvert inlet (November 2022)

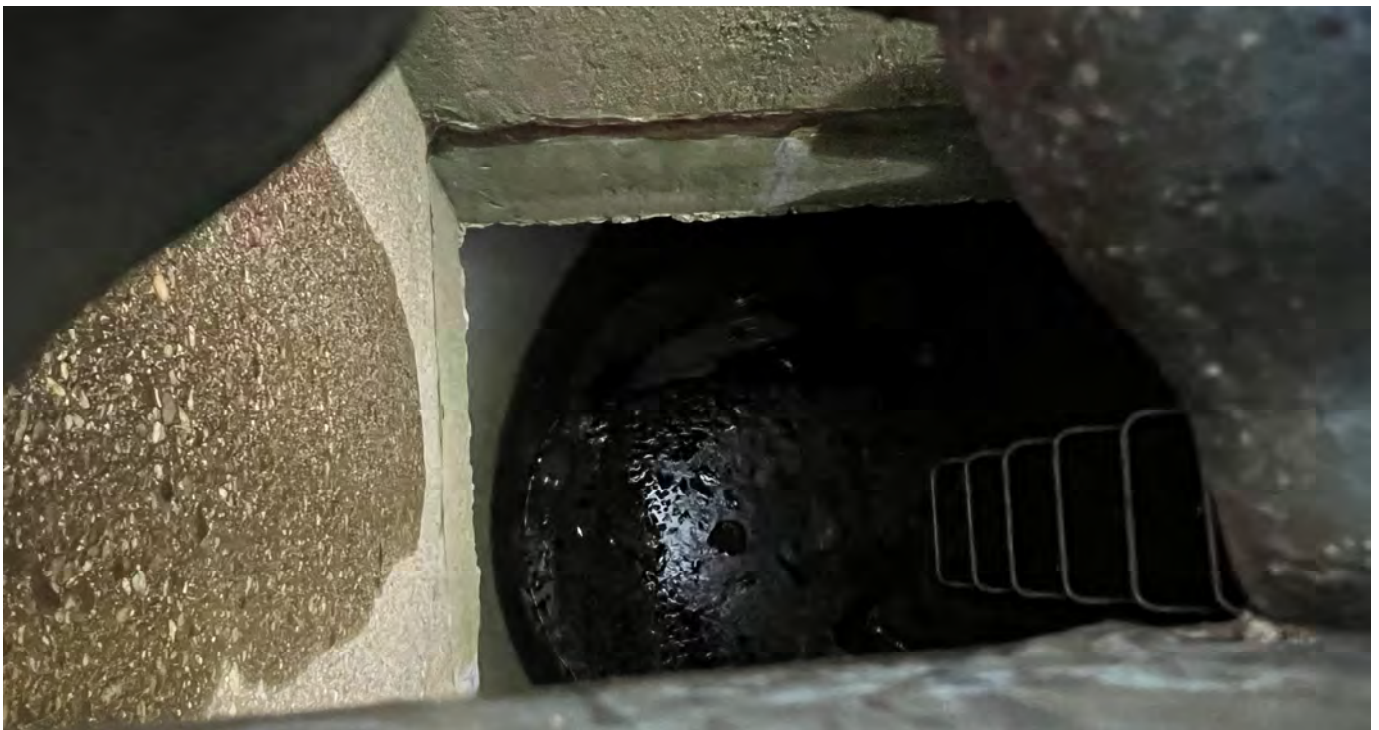
**Photograph #4** – Inside drop inlet (November 2022)

Water was measured to be at a depth of 3.6 m below the top of the drop inlet (Elev. 278.8 m). The water at the outlet was found to be surficial at approximately Elev. 276.9 m at the time of the investigation.

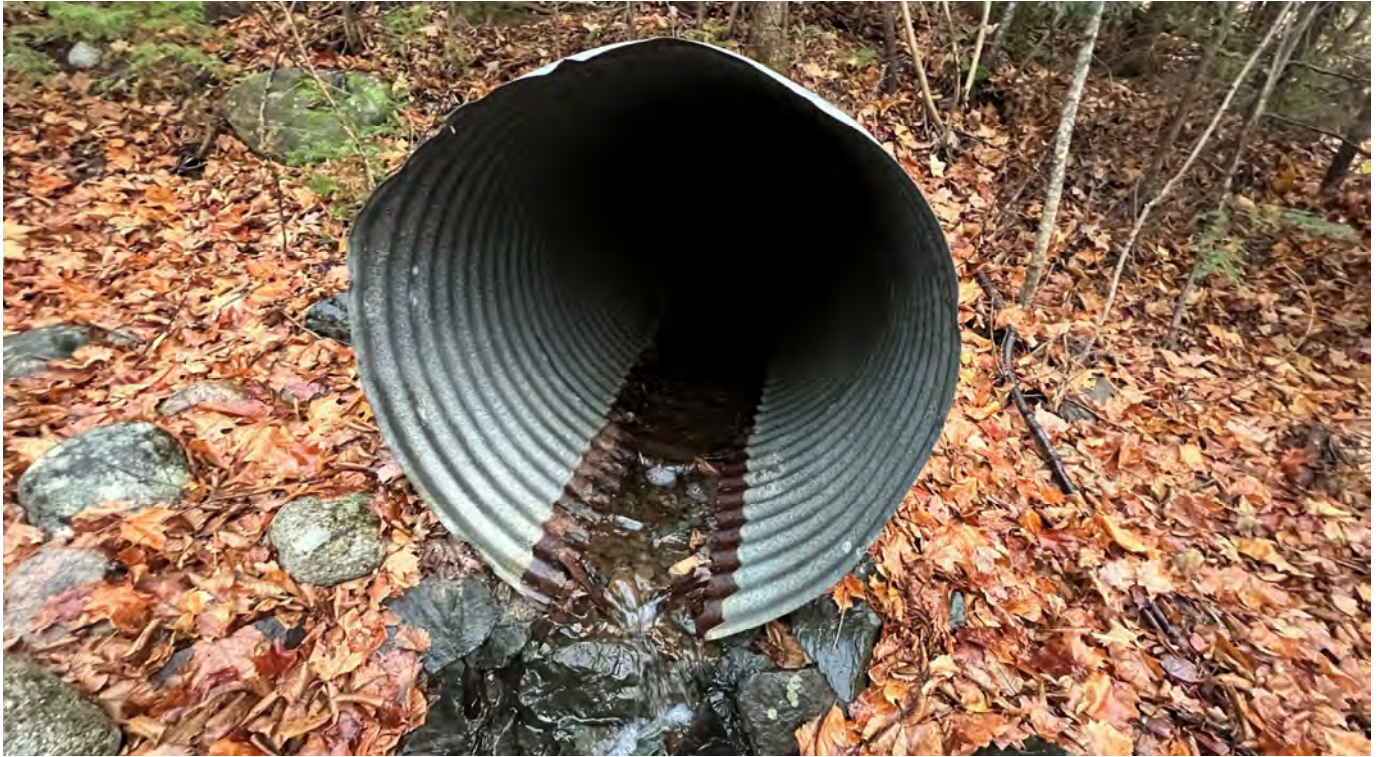
**Photograph #5** – Culvert outlet, surrounded by forest vegetation, facing south. (November 2022)

Based on visual observations, no signs of slope instability of the highway embankment were noted near the inlet and outlet of the culvert site. The south side of the highway embankment, including the area of the culvert outlet, is generally surrounded by thick mixed forest. The ditch along the south shoulder is lightly vegetated with some visible cobbles and bedrock outcrops. Site photographs can be found in Appendix A.

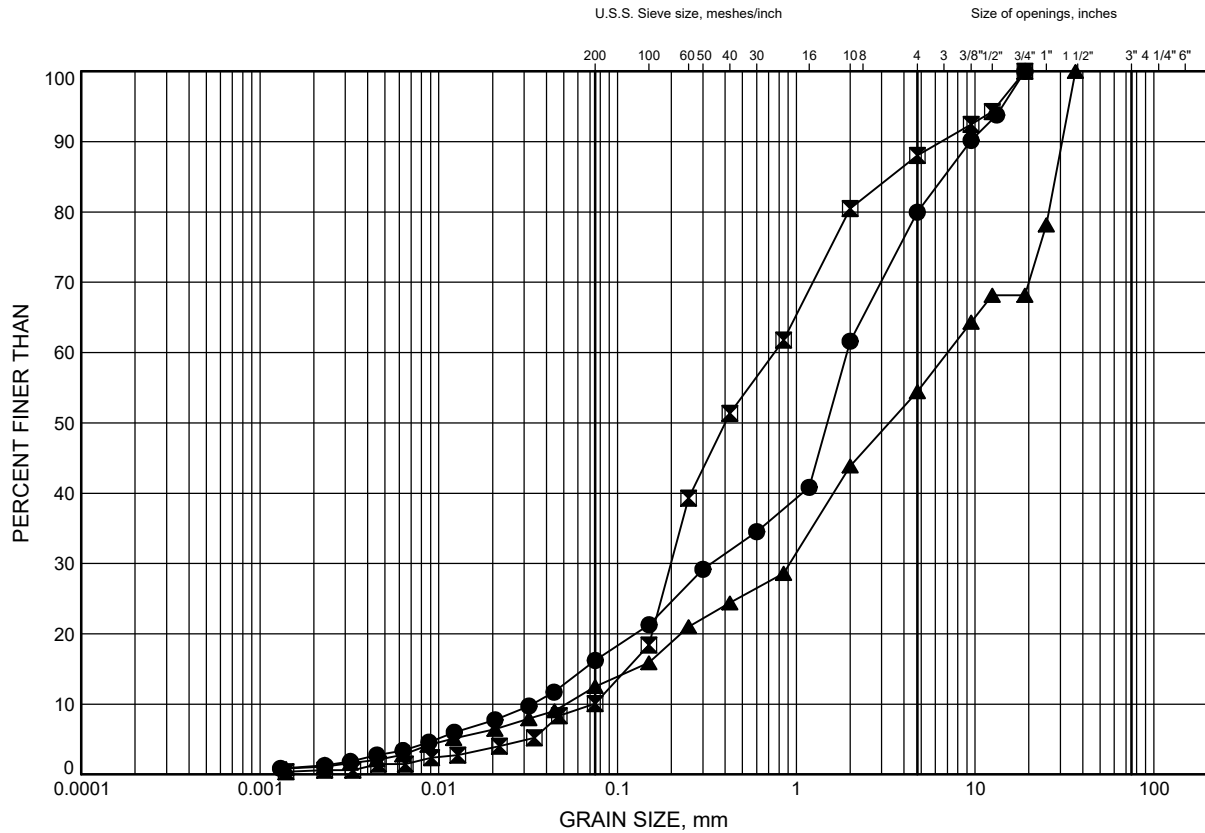
## SAND to Gravelly Silty SAND (FILL)

The results of grain size analyses conducted on selected samples of the embankment fill are provided on the Record of Borehole sheets in Appendix B and plotted in Figure C-1 of Appendix C. The results are summarized as follows:

Soil Particle	Percentage (%)
Gravel	12 to 46
Sand	42 to 78
Silt	10 to 15
Clay	0 to 1

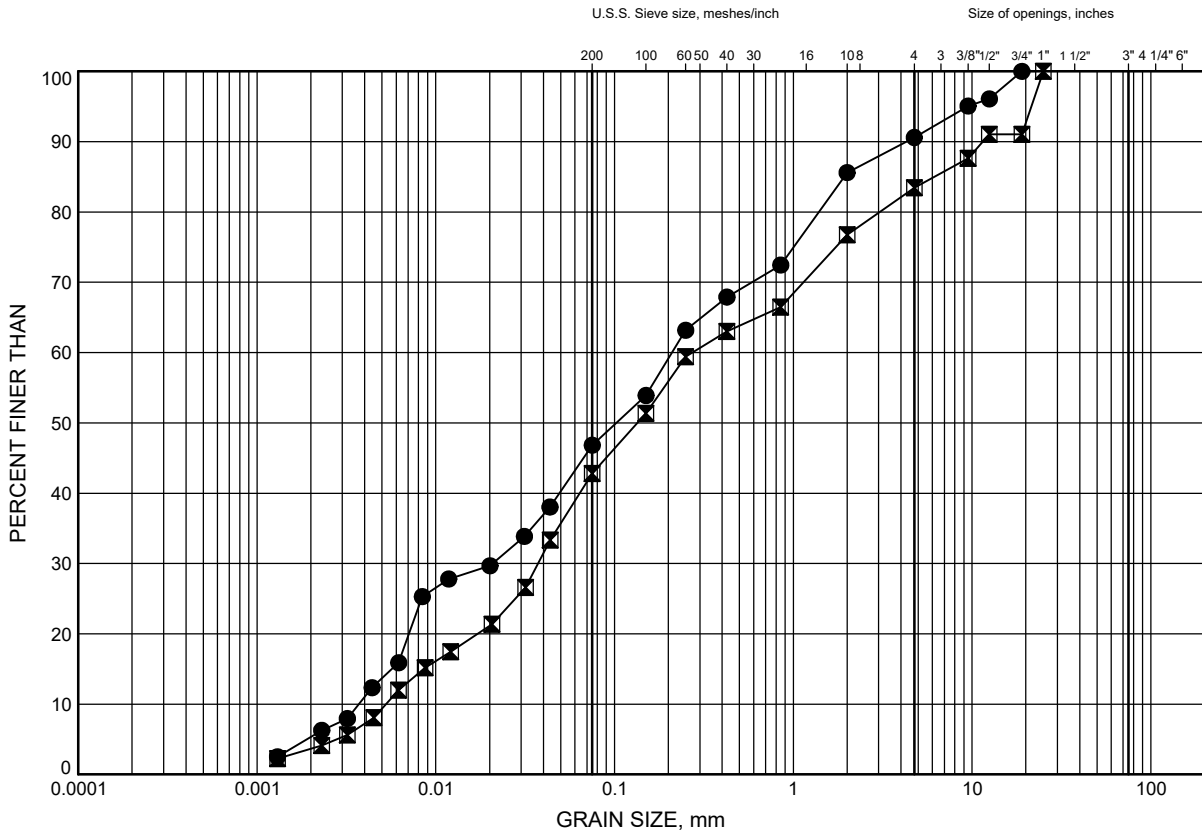
FIGURE C2

### Silty SAND

The results of grain size analyses conducted on samples of the silty sand deposit are provided on the Record of Borehole sheets in Appendix B and plotted in Figure C-2 of Appendix C. The results summarized as follows:

Soil Particle	Percentage (%)
Gravel	9 to 17
Sand	41 to 44
Silt	39 to 41
Clay	3 to 6

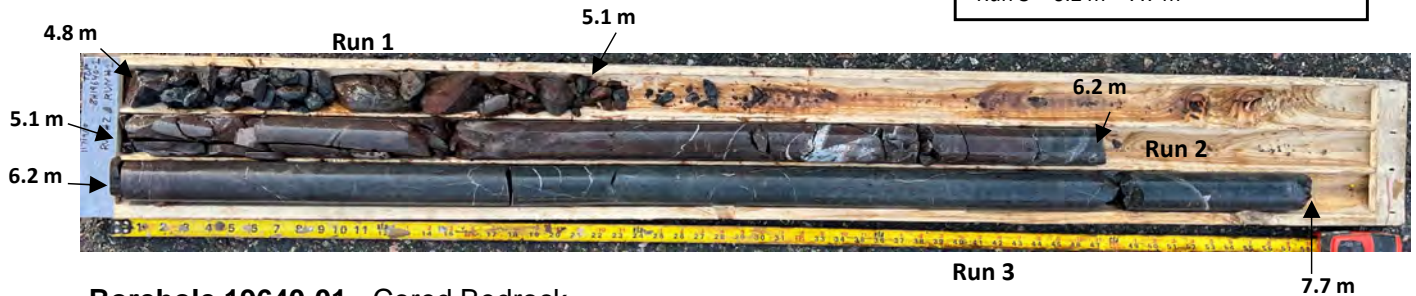
NQ 1 – 1.1 m – 2.1 m  
NQ 2 – 3.1 m – 3.8 m (no recovery)  
Run 1 – 4.8 m – 5.1 m  
Run 2 – 5.1 m – 6.2 m  
Run 3 – 6.2 m – 7.7 m

**Borehole 19640-01 - Cored Bedrock**

The bedrock consisted of slightly weathered to fresh, strong to very strong basalt with quartz veins. The basalt is fine grained, massive, and grey in colour. Photographs of the bedrock core are provided in Appendix C. The rock core quality parameters are summarized below:

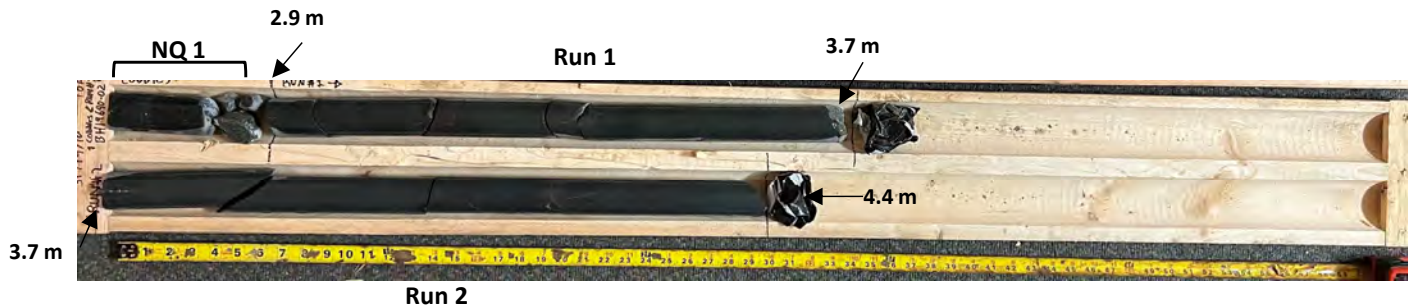
**Borehole 19640-02 - Cored Gravel and Cobbles, Bedrock**

NQ 1 – 2.7 m – 2.8 m  
Run 1 – 2.9 m – 3.7 m  
Run 2 – 3.7 m – 4.4 m  
Run 3 – 4.4 m – 4.8 m  
Run 4 – 4.8 m – 5.3 m  
Run 5 – 5.3 m – 6.6 m

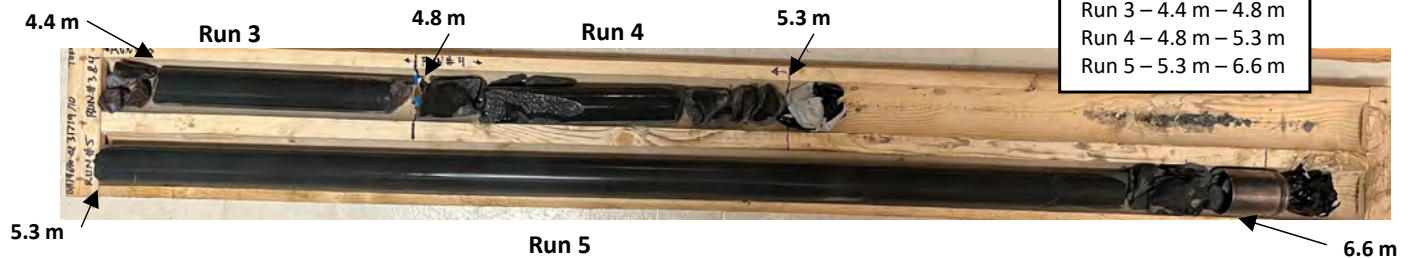
**Borehole 19640-02 – Cored Bedrock**
