**FOUNDATION INVESTIGATION REPORT
TEMPORARY PROTECTION SYSTEM FOR HIGHWAY 556 CULVERT
REHABILITATION AT STA 19+640 (TOWNSHIP OF VANKOUGHNET)
REHABILITATION OF HIGHWAYS 556 & 532
DISTRICT OF ALGOMA, ONTARIO
ASSIGNMENT No.: 5020-E-0020
G.W.P. 5221-18-00**

Report

AECOM Canada Ltd.

Date: April 24, 2023
File: 31719

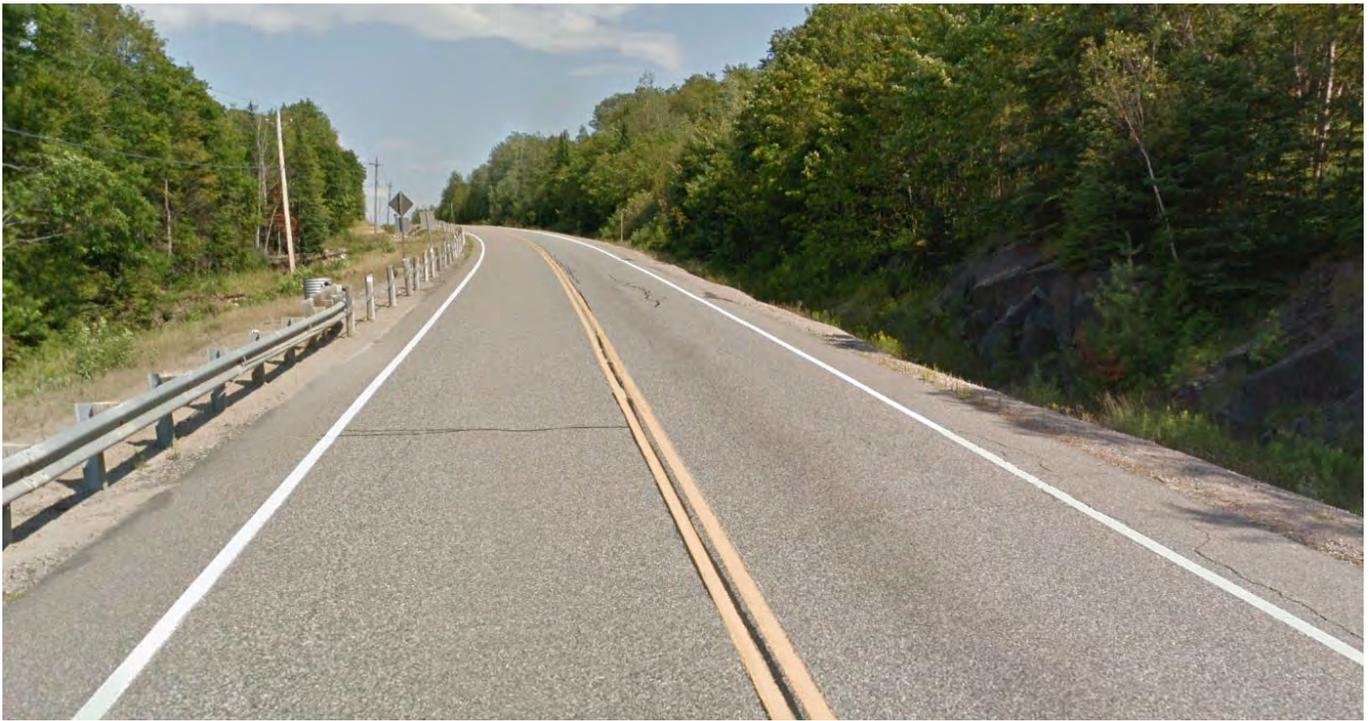
Photograph #1 – Highway 556 near culvert location, facing East. Drop Inlet at ditch to the south. Rock outcrops visible on slope south of ditch (Google Streetview imagery, August 2018)

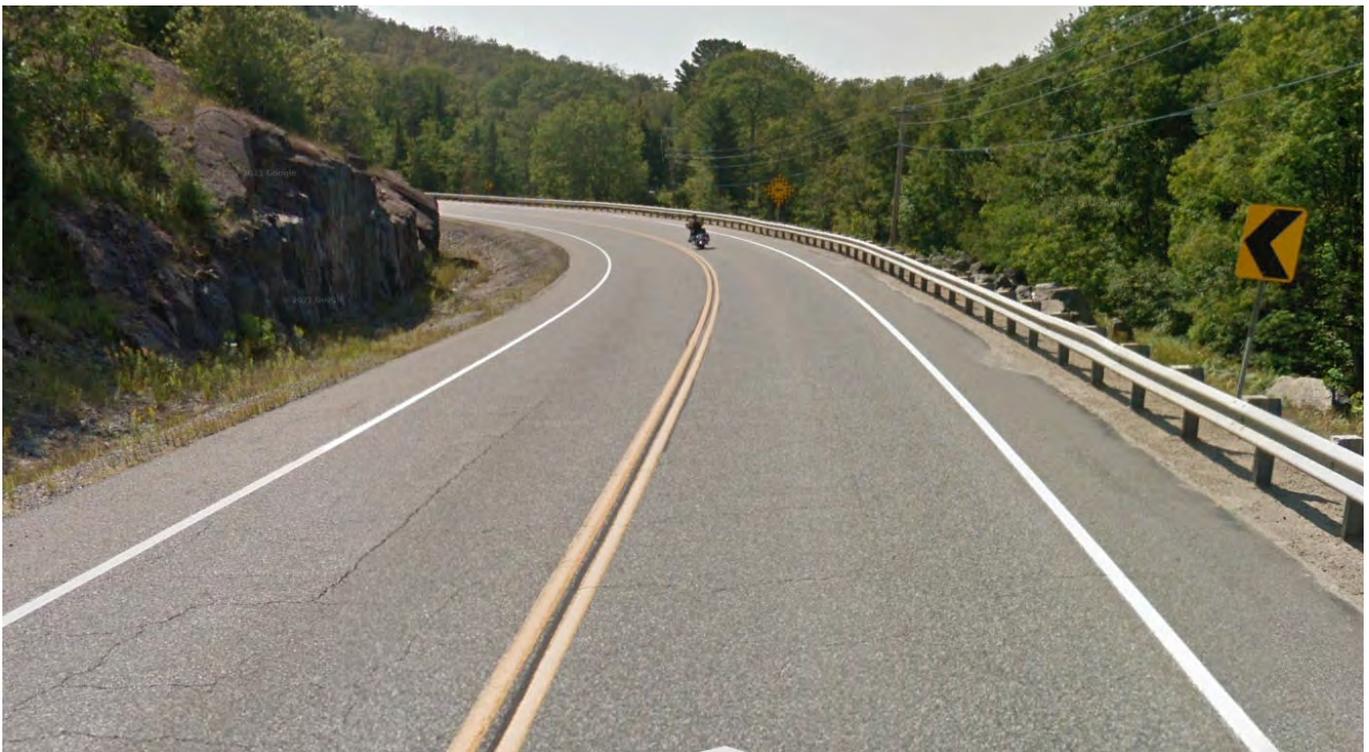
Photograph #2 – Highway 556 near culvert location, facing West. Drop Inlet at ditch to the south. Rock outcrops visible on slope south of ditch near horizontal curve (Google Streetview imagery, August 2018)

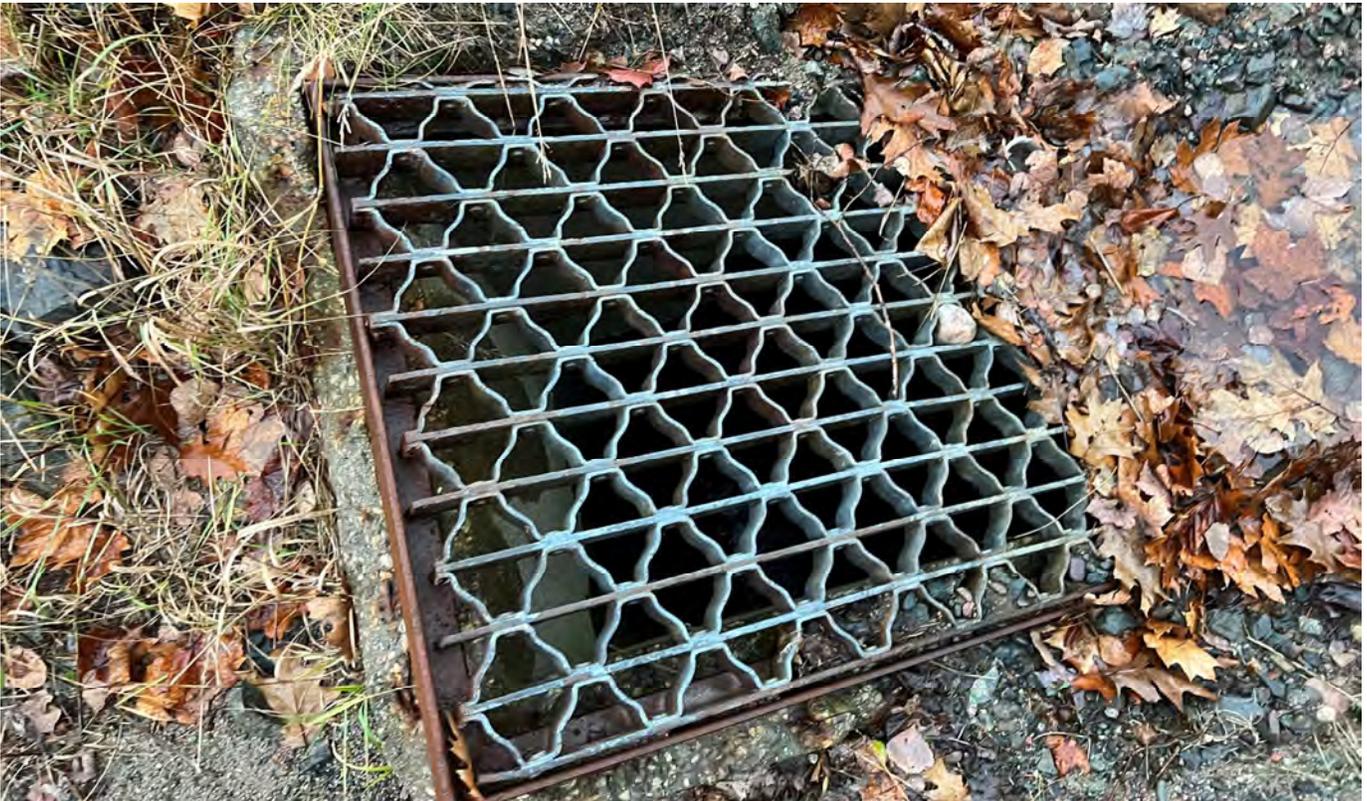
Photograph #3 – Safety grate over drop inlet at the culvert inlet (November 2022)

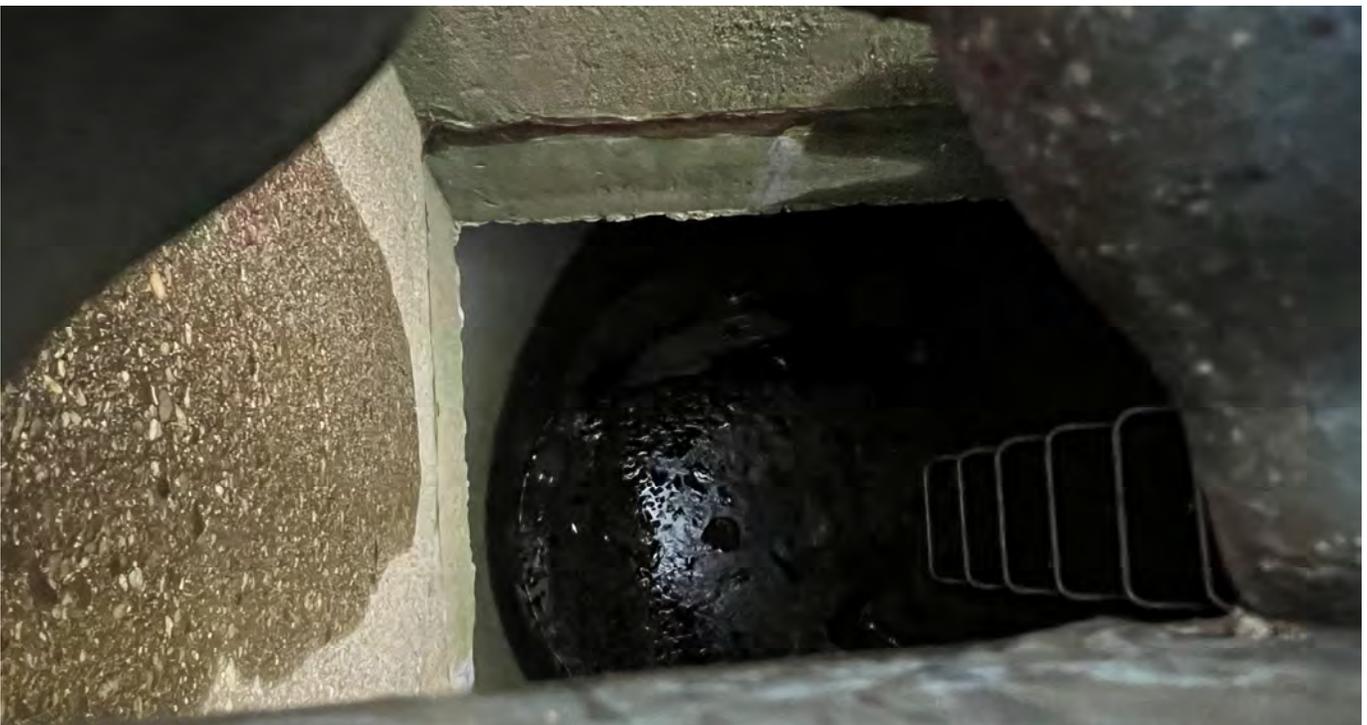
Photograph #4 – Inside drop inlet (November 2022)

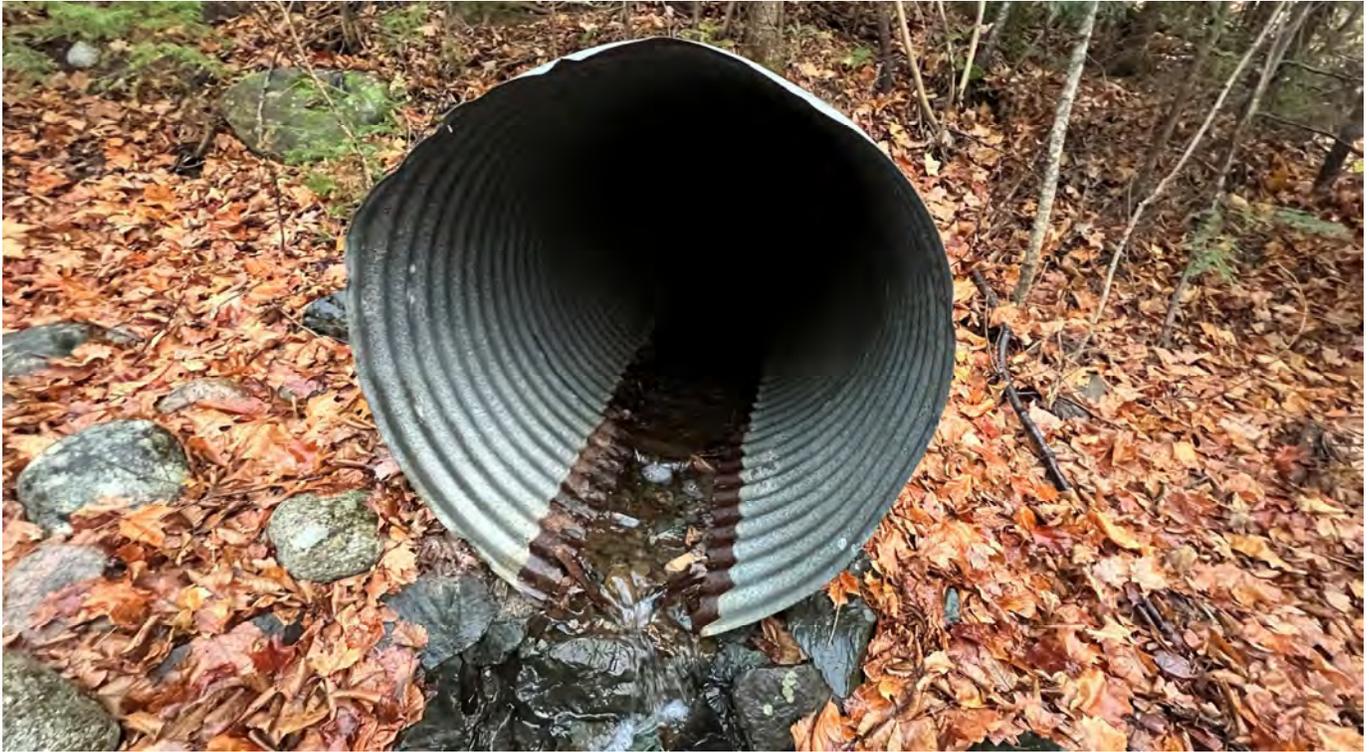
Photograph #5 – Culvert outlet, surrounded by forest vegetation, facing south. (November 2022)

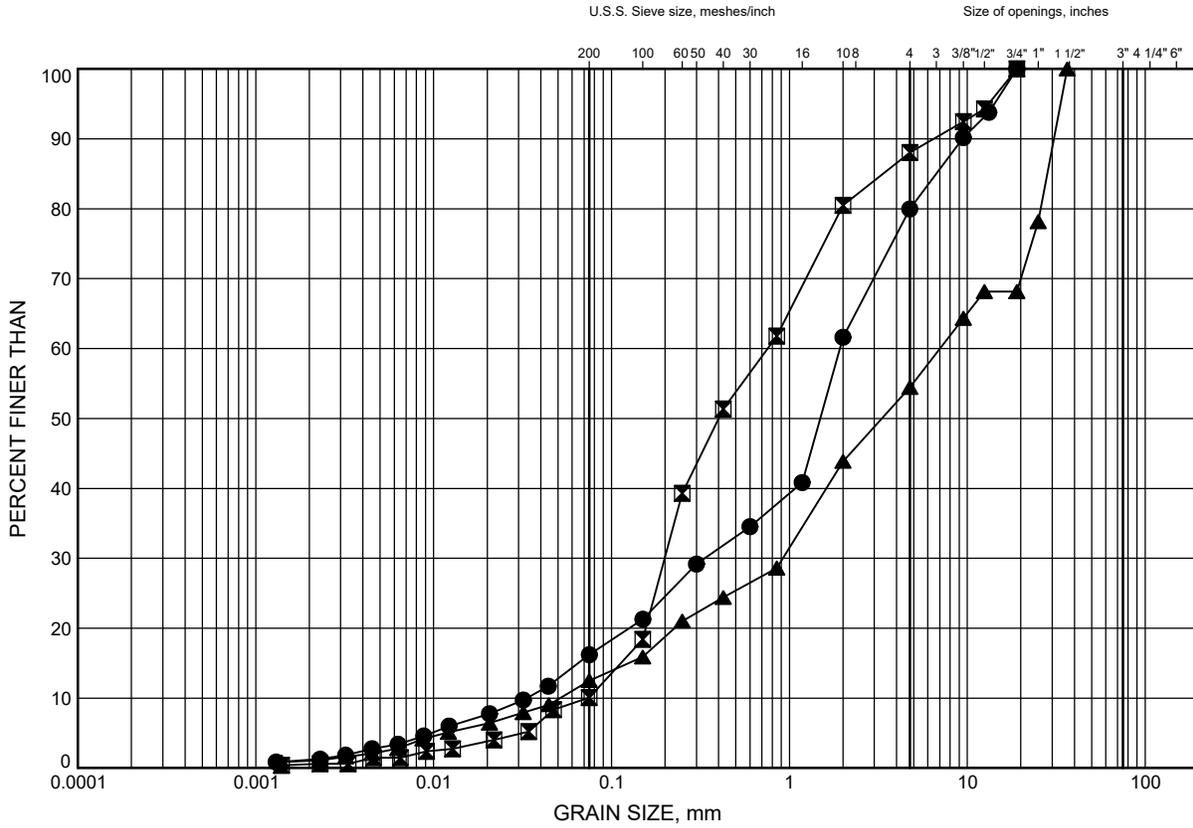
FIGURE C1

The results of grain size analyses conducted on selected samples of the embankment fill are provided on the Record of Borehole sheets in Appendix B and plotted in Figure C-1 of Appendix C. The results are summarized as follows:

Soil Particle	Percentage (%)
Gravel	12 to 46
Sand	42 to 78
Silt	10 to 15
Clay	0 to 1

HWY 556 Culvert Replacement at Sta. 19+640
GRAIN SIZE DISTRIBUTION

SAND to Gravelly Silty SAND (FILL)

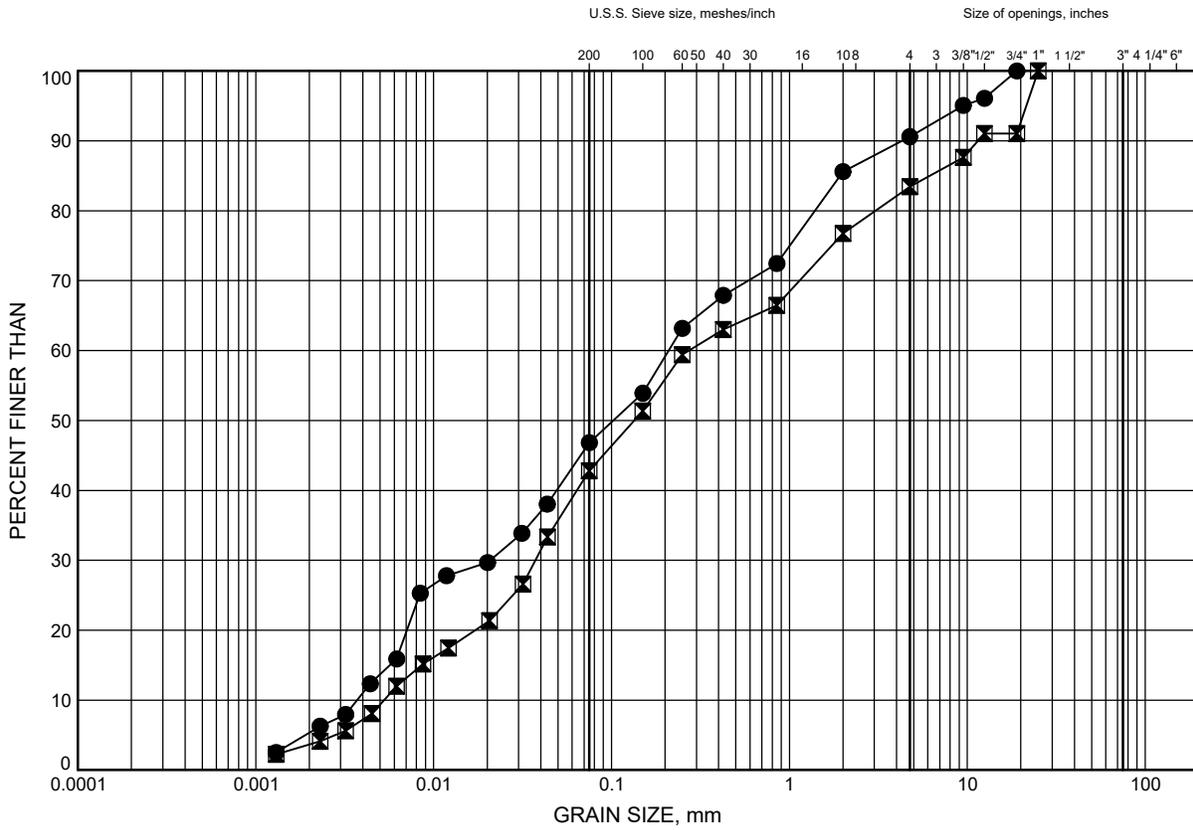
FIGURE C2

The results of grain size analyses conducted on samples of the silty sand deposit are provided on the Record of Borehole sheets in Appendix B and plotted in Figure C-2 of Appendix C. The results summarized as follows:

Soil Particle	Percentage (%)
Gravel	9 to 17
Sand	41 to 44
Silt	39 to 41
Clay	3 to 6

HWY 556 Culvert Replacement at Sta. 19+640
GRAIN SIZE DISTRIBUTION

Silty SAND

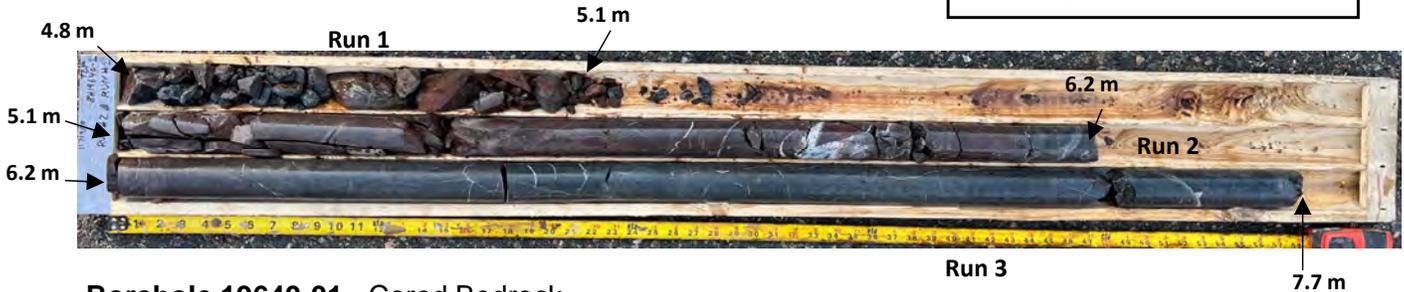
Borehole 19640-01 - Cored Gravel and Cobbles

NQ 1 – 1.1 m – 2.1 m
 NQ 2 – 3.1 m – 3.8 m (no recovery)
 Run 1 – 4.8 m – 5.1 m
 Run 2 – 5.1 m – 6.2 m
 Run 3 – 6.2 m – 7.7 m

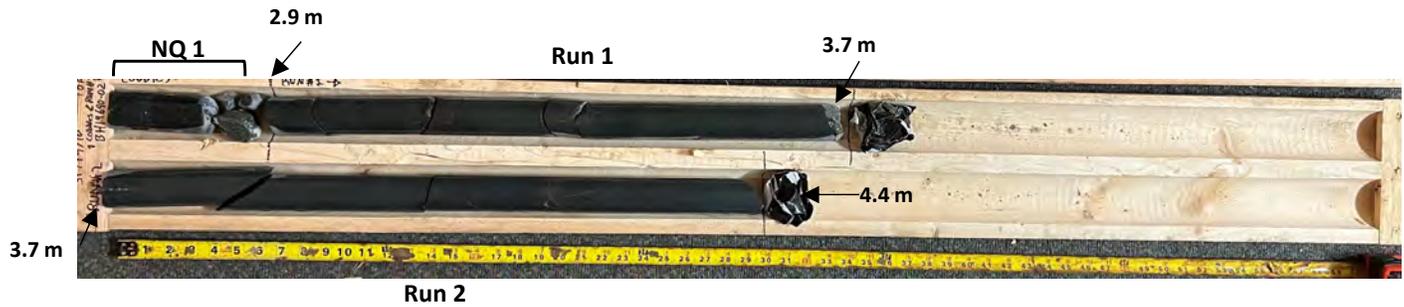
The bedrock consisted of slightly weathered to fresh, strong to very strong basalt with quartz veins. The basalt is fine grained, massive, and grey in colour. Photographs of the bedrock core are provided in Appendix C. The rock core quality parameters are summarized below:

Borehole 19640-01 - Cored Bedrock

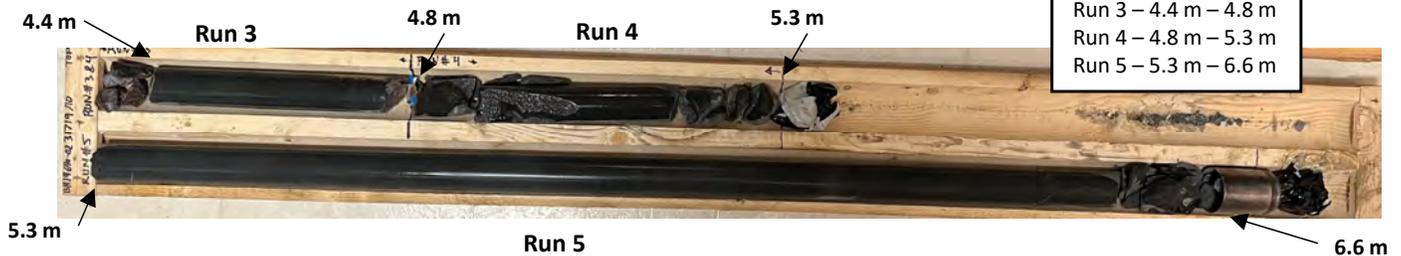
Borehole 19640-02 - Cored Gravel and Cobbles, Bedrock

NQ 1 – 2.7 m – 2.8 m
 Run 1 – 2.9 m – 3.7 m
 Run 2 – 3.7 m – 4.4 m
 Run 3 – 4.4 m – 4.8 m
 Run 4 – 4.8 m – 5.3 m
 Run 5 – 5.3 m – 6.6 m
