**FOUNDATION INVESTIGATION AND DESIGN REPORT
TEMPORARY PROTECTION SYSTEM FOR HIGHWAY 556 CULVERT
REPLACEMENT AT STA 19+741 (TOWNSHIP OF VANKOUGHNET)
REHABILITATION OF HIGHWAYS 556 & 532
DISTRICT OF ALGOMA, ONTARIO
ASSIGNMENT No.: 5020-E-0020
G.W.P. 5221-18-00**

Report

AECOM Canada Ltd.

Date: May 5, 2023
File: 31719

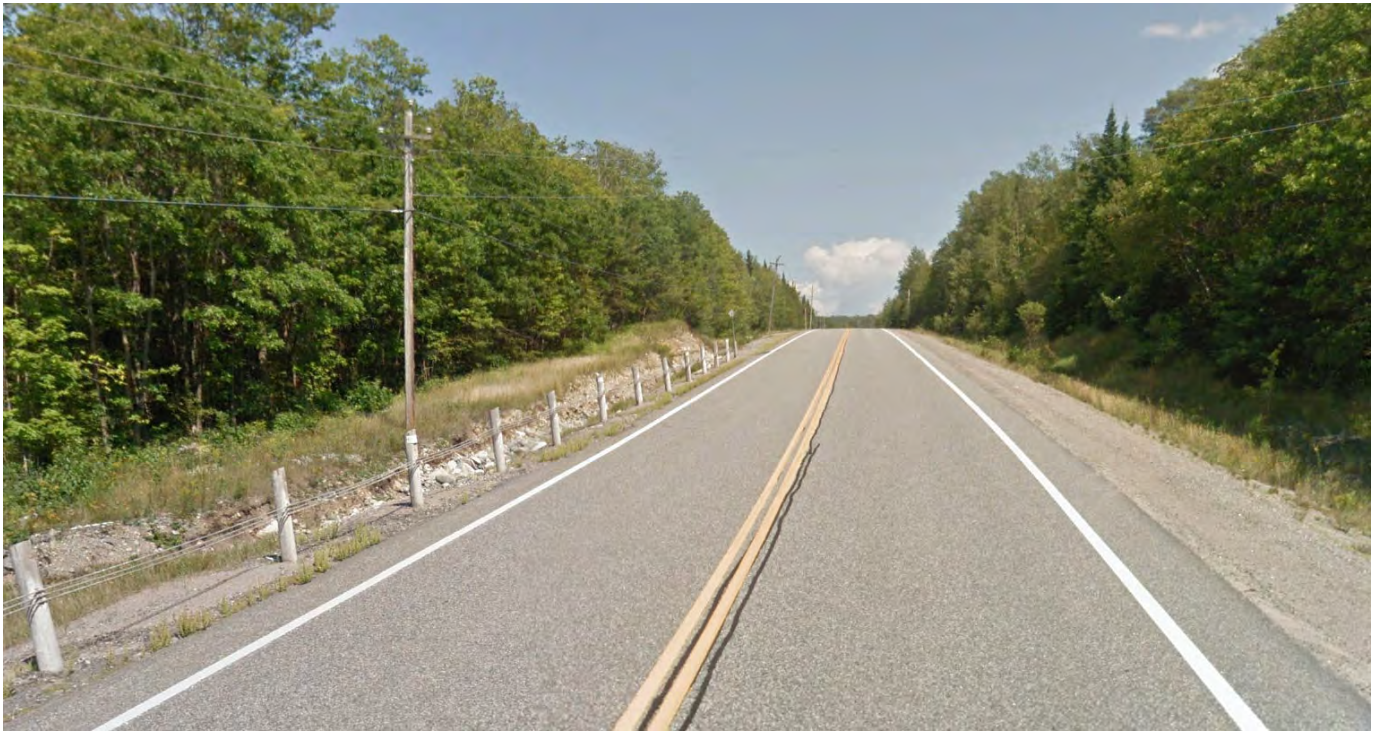
Photograph #1 – Highway 556 near culvert location, facing East. Drop Inlet at ditch to the south. (Google Streetview imagery, August 2018)

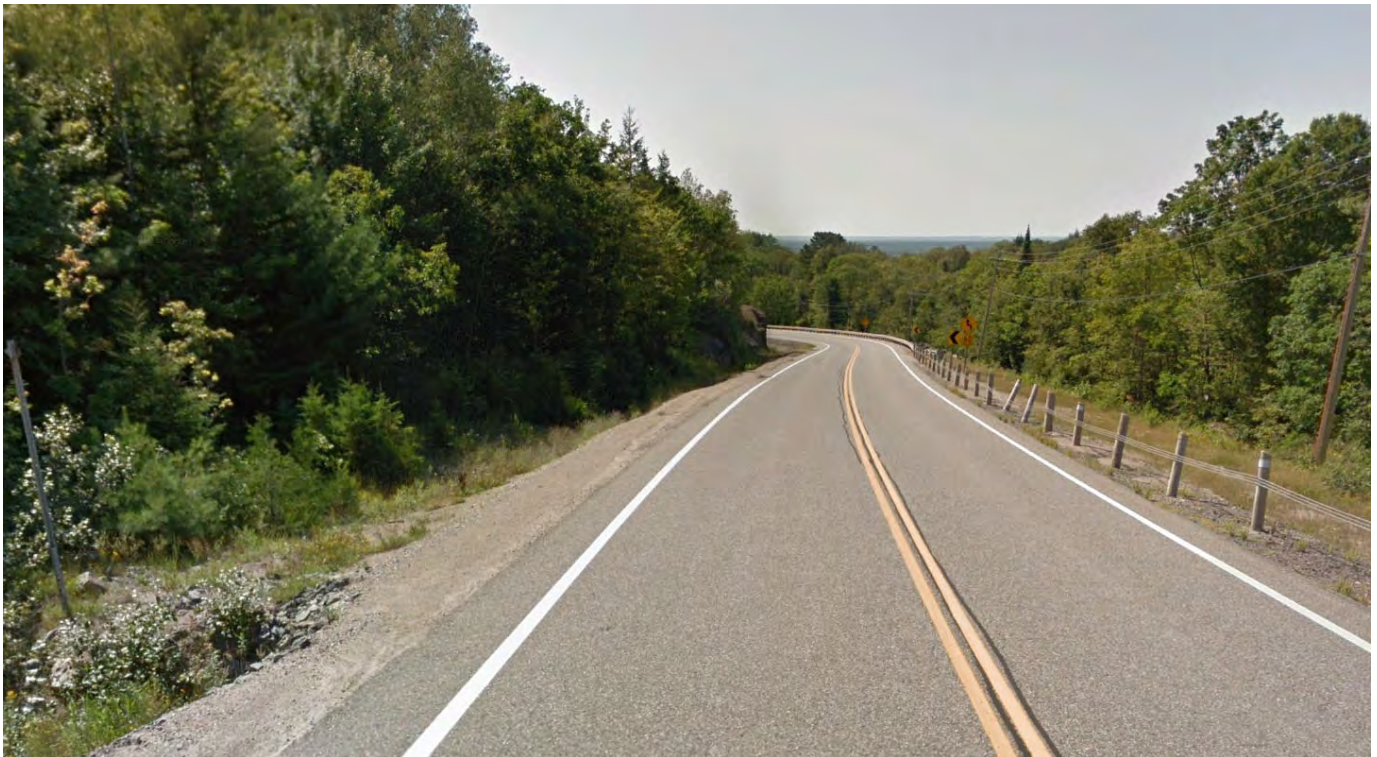
Photograph #2 – Highway 556 near culvert location, facing West. Drop Inlet at ditch to the south. Rock outcrops visible on slope south of ditch near horizontal curve. (Google Streetview imagery, August 2018)

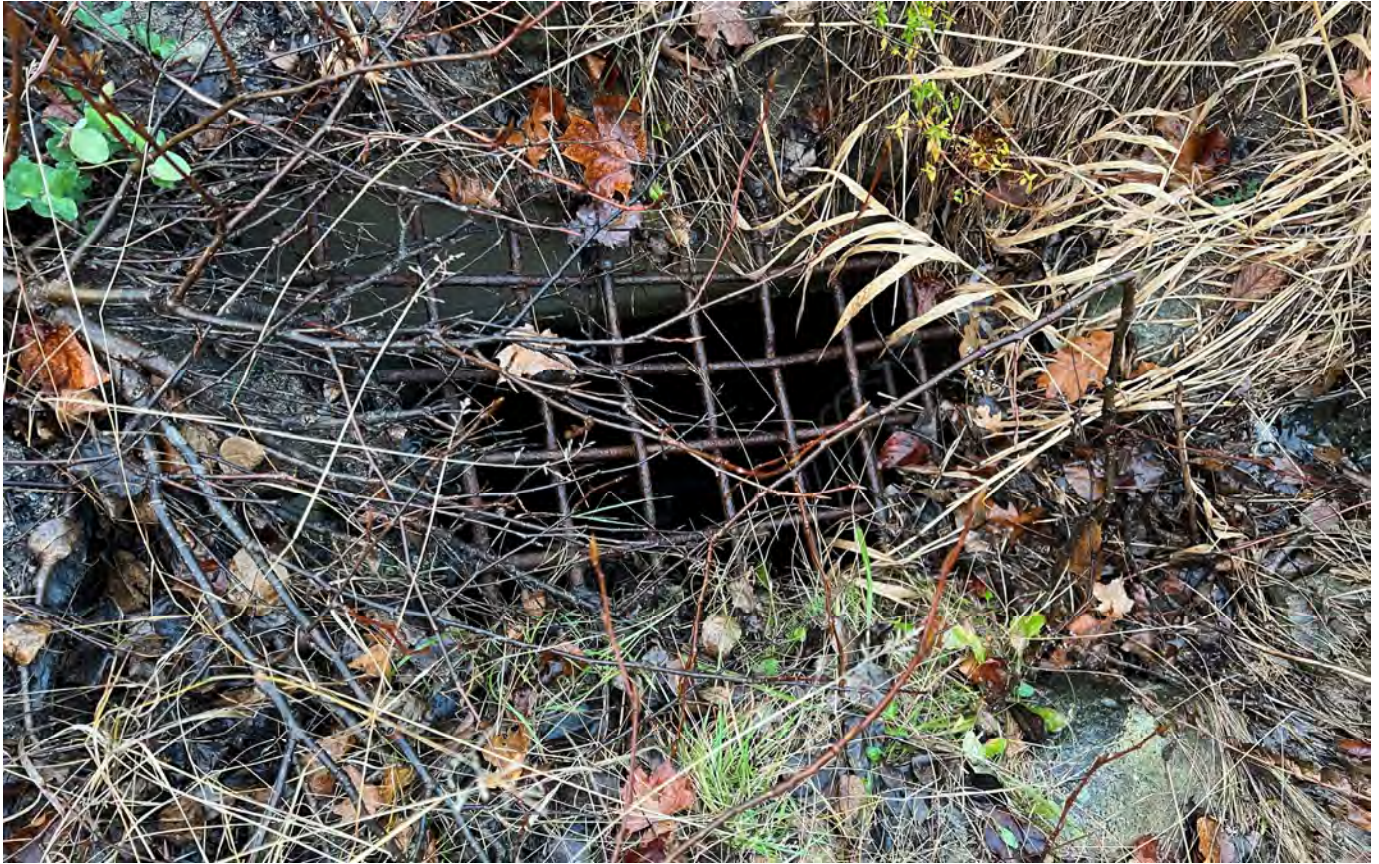
Photograph #3 – Safety grate over drop inlet at the culvert inlet located along ditch line. (November 2022)

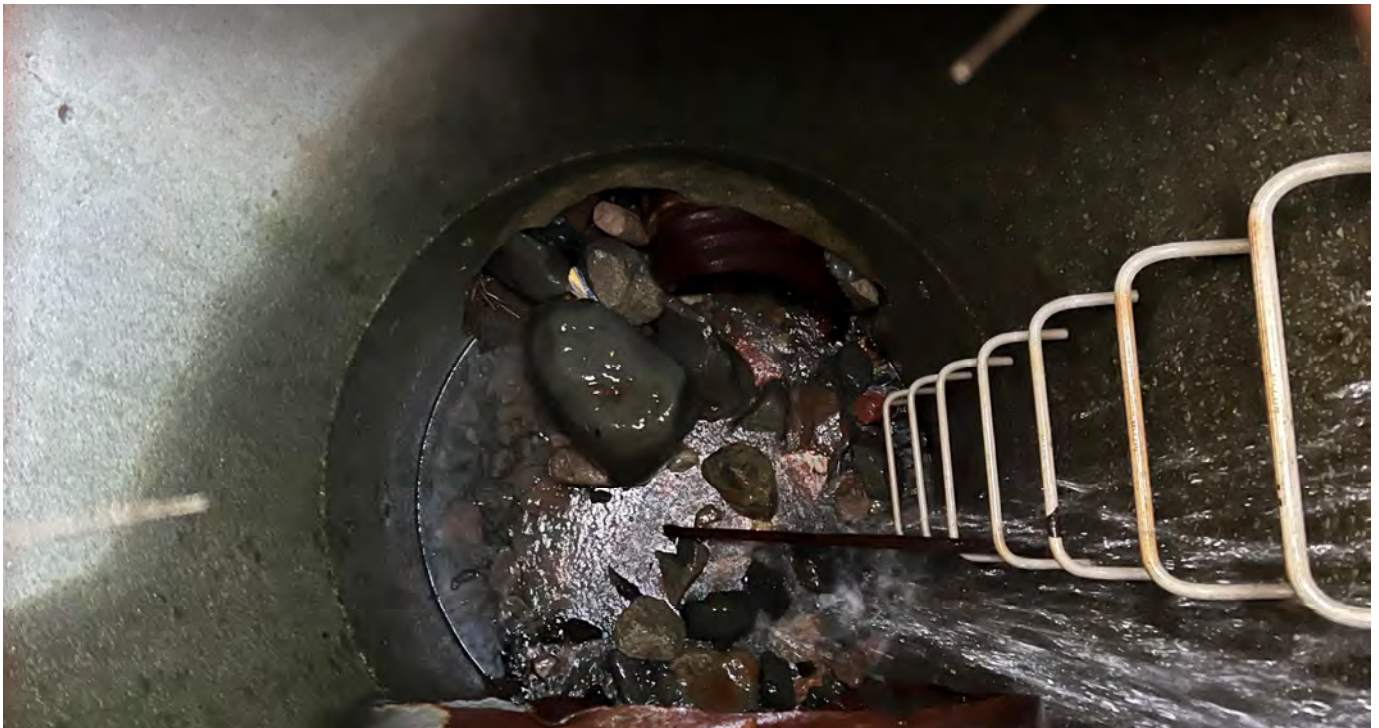
Photograph #4 – Cobbles and boulders inside drop inlet located along ditch line. (November 2022)

In Borehole 19741-02, a 6.7 m thick layer of cobbles and boulders were encountered below the silty sand, which extends to a depth of 15.3 m (Elev. 275.3 m) prior to borehole termination. It should be noted that there were difficulty advancing the NW casing from a depth of 9.4 m to 10.4 m in Borehole 19741-01, and that it was possibly attributed to the deflection of the casing by an obstruction. Given the presence of cobbles and boulders below the silty sand deposit, it is possible that this obstruction was a boulder.

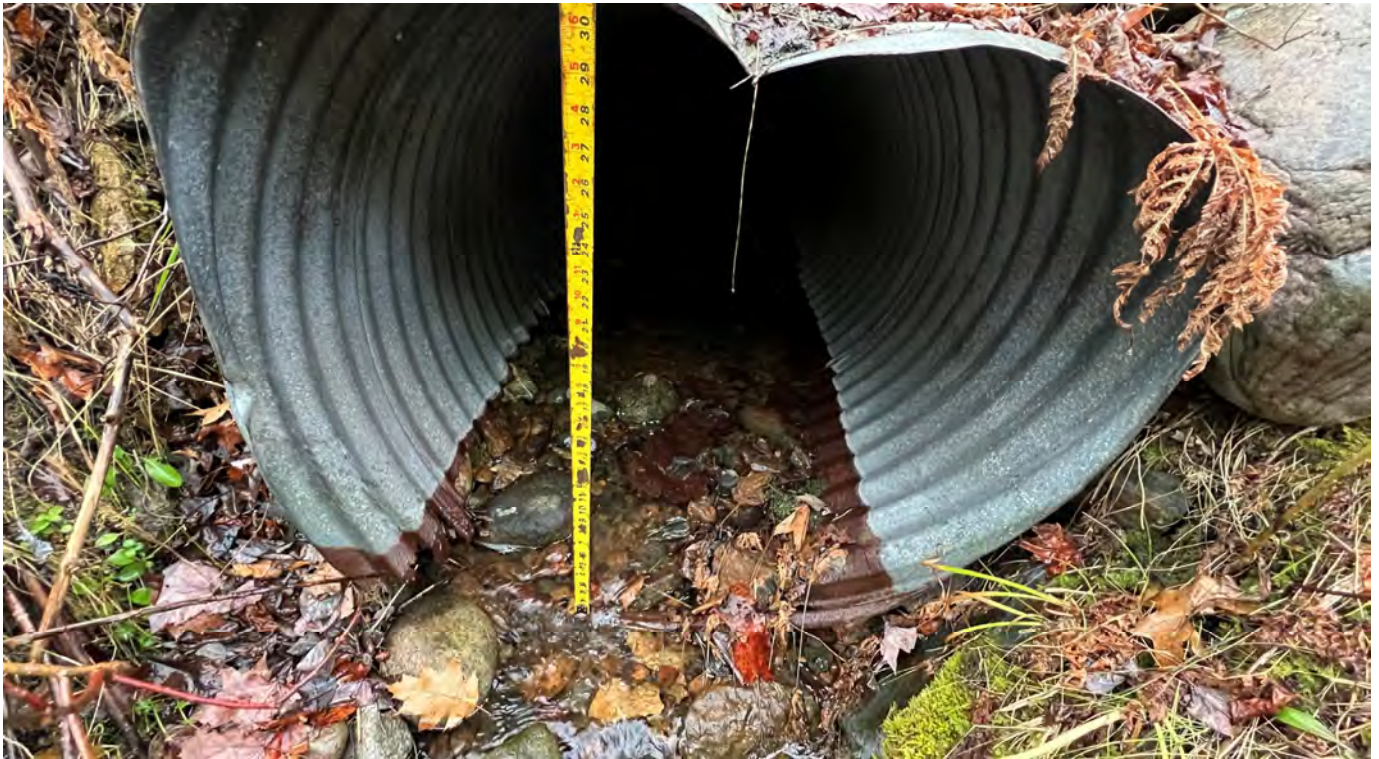
Photograph #5 – Partially crushed culvert outlet, facing south. (November 2022)

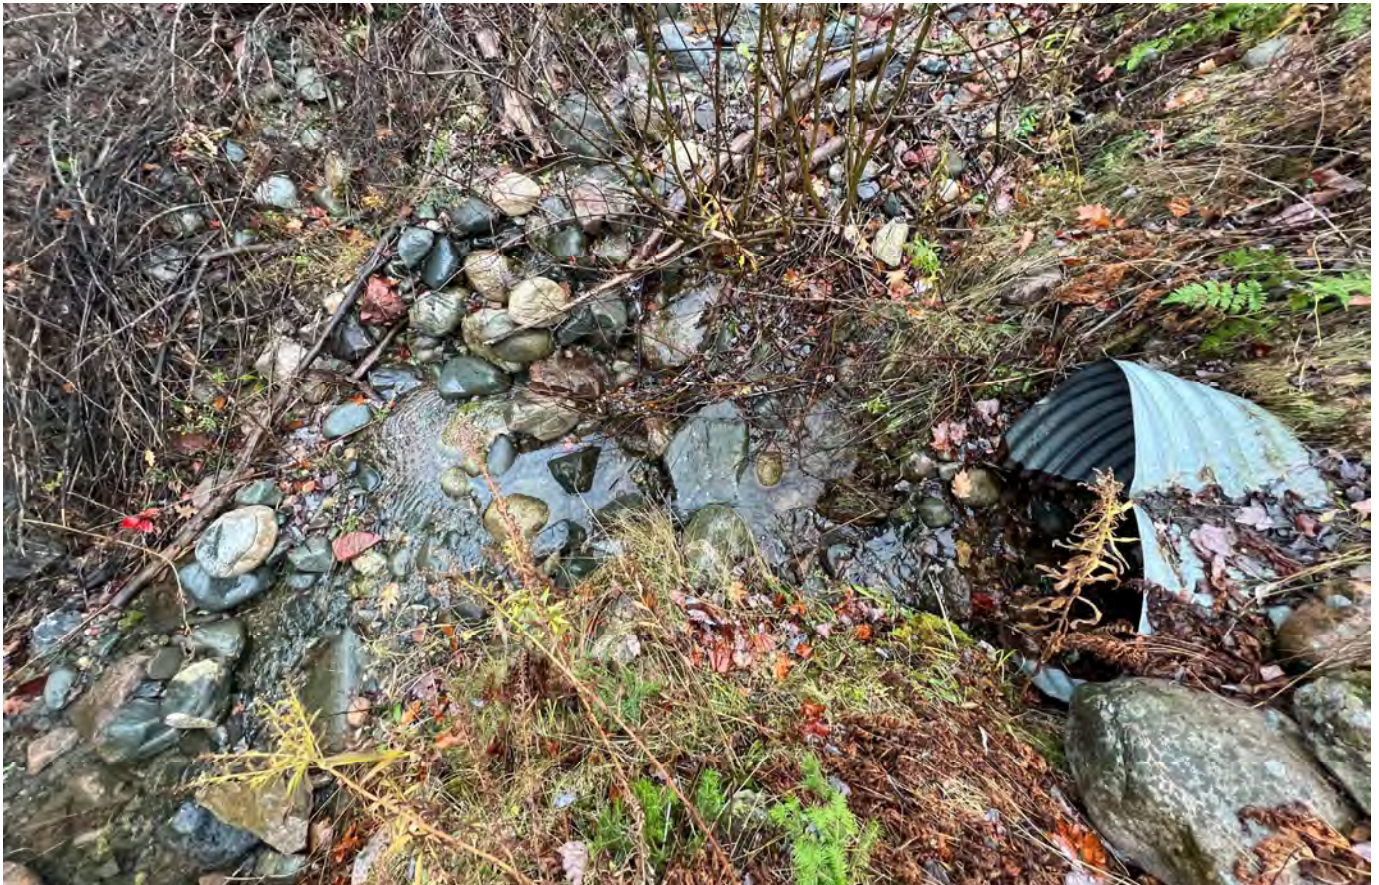
Photograph #6 – Culvert outlet, surrounded by vegetation, facing east. (November 2022)

Water was measured to be at a depth of 3.1 m below the top of the drop inlet located along the ditch line (Elev. 286.9 m). The water at the outlet was found to be surficial at approximately Elev. 285.6 m at the time of the investigation and flowing downhill to a stream (as shown in Photograph 6 in Appendix A).

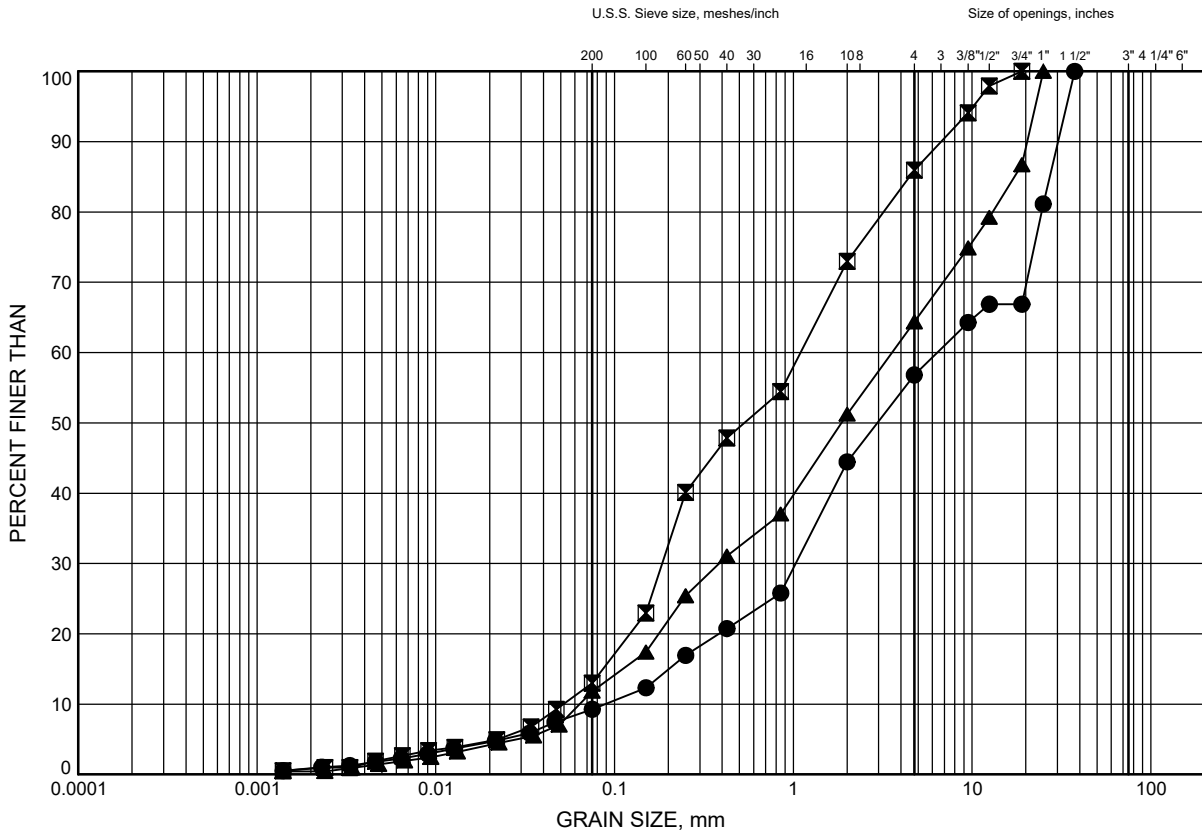
GRAIN SIZE DISTRIBUTION

SAND and GRAVEL to Silty SAND (FILL)

The results of grain size analyses conducted on selected samples of the granular fill are shown on the Record of Borehole sheets in Appendix B and plotted in Figure C-1 of Appendix C. The results are summarized as follows:

Soil Particle	Percentage (%)
Gravel	14 to 43
Sand	48 to 73
Silt	8 to 12
Clay	0 to 1

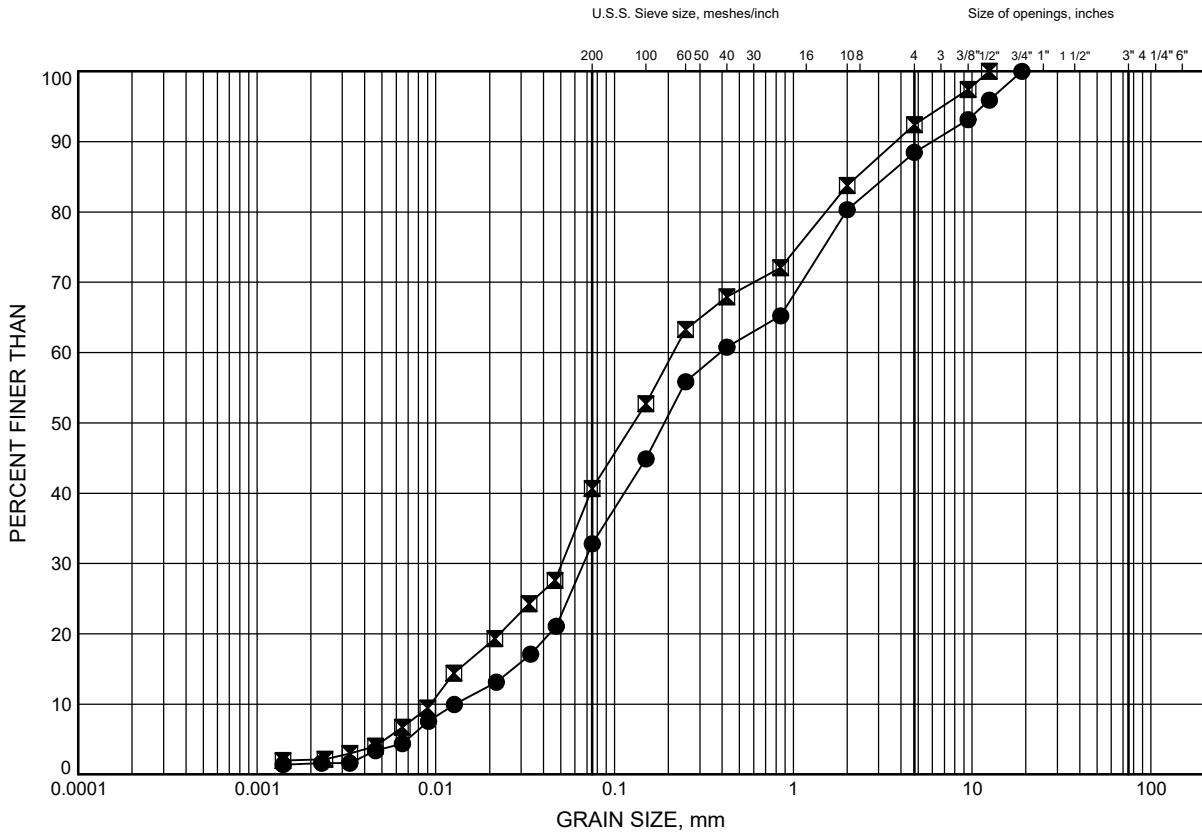
GRAIN SIZE DISTRIBUTION

Silty SAND

Soil Particle	Percentage (%)
Gravel	8 to 12
Sand	52 to 56
Silt	31 to 39
Clay	1

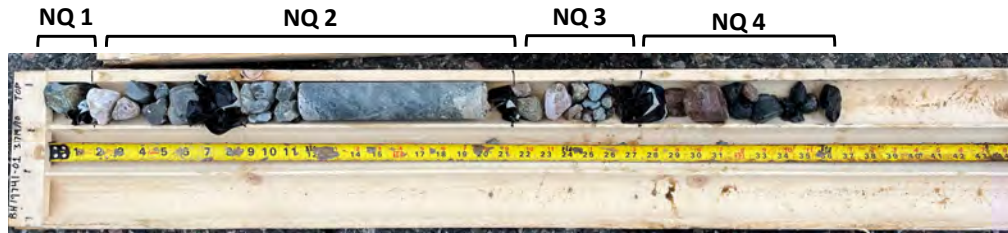
Borehole 19741-01 - Cored Rockfill

NQ 1 – 2.4 m – 2.6 m
NQ 2 – 3.0 m – 3.7 m
NQ 3 – 3.8 m – 4.3 m
NQ 2 – 6.2 m – 6.3 m

through the coarse gravels, and cobbles encountered in the granular embankment fill and through the rockfill. Photographs of the gravels, and cobbles recovered from the embankment fill are shown in the Core Box Photographs in Appendix C. From the recovered soil cores and observations of embankment fill cuttings, the particle size ranges from 15 mm gravels to cobbles up to about 190 mm.

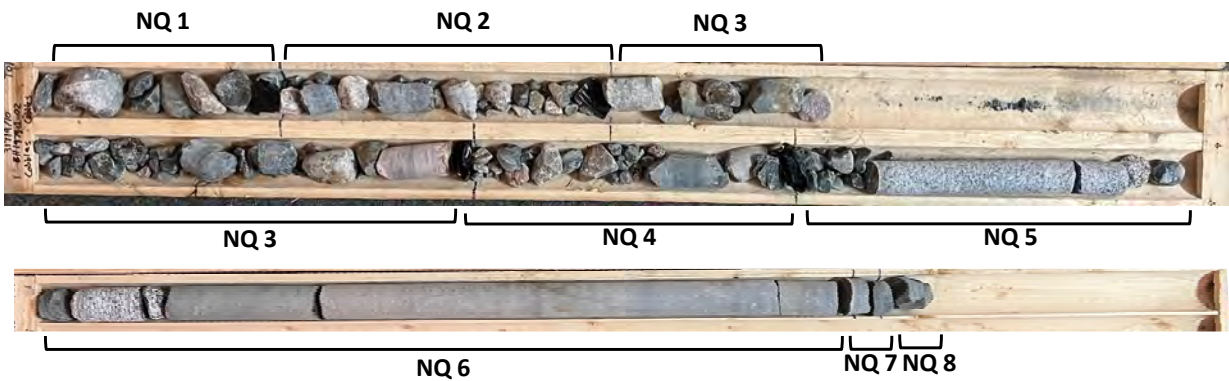
Borehole 19741-02 - Cored Rock Fill, Gravel, Cobbles, and Boulders

NQ 1 – 2.3 m – 3.1 m
NQ 2 – 3.1 m – 3.5 m
NQ 3 – 3.5 m – 5.1 m
NQ 4 – 6.1 m – 6.6 m
NQ 5 – 8.8 m – 9.1 m
NQ 6 – 12.5 m – 13.6 m
NQ 7 – 14.2 m – 14.2 m
NQ 8 – 15.3 m – 15.3 m
