**PRELIMINARY FOUNDATION
INVESTIGATION AND DESIGN REPORTS
EXISTING VIADUCT WEST OF HIGHWAY 401
AND LESLIE STREET, HIGHWAY 401
REHABILITATION FROM LESLIE STREET TO
WARDEN AVENUE, MTO CENTRAL REGION,
G.W.P. 2130-01-00, GEOCREC 30M14-335**

Delcan Corporation
Project: TRANETOB01245AA-AE
December 19, 2011

**PRELIMINARY FOUNDATION
INVESTIGATION REPORT
EXISTING VIADUCT WEST OF
HIGHWAY 401 AND LESLIE STREET,
HIGHWAY 401 REHABILITATION FROM
LESLIE STREET TO WARDEN AVENUE,
MTO CENTRAL REGION,
G.W.P. 2130-01-00, GEOGRES 30M14-335**

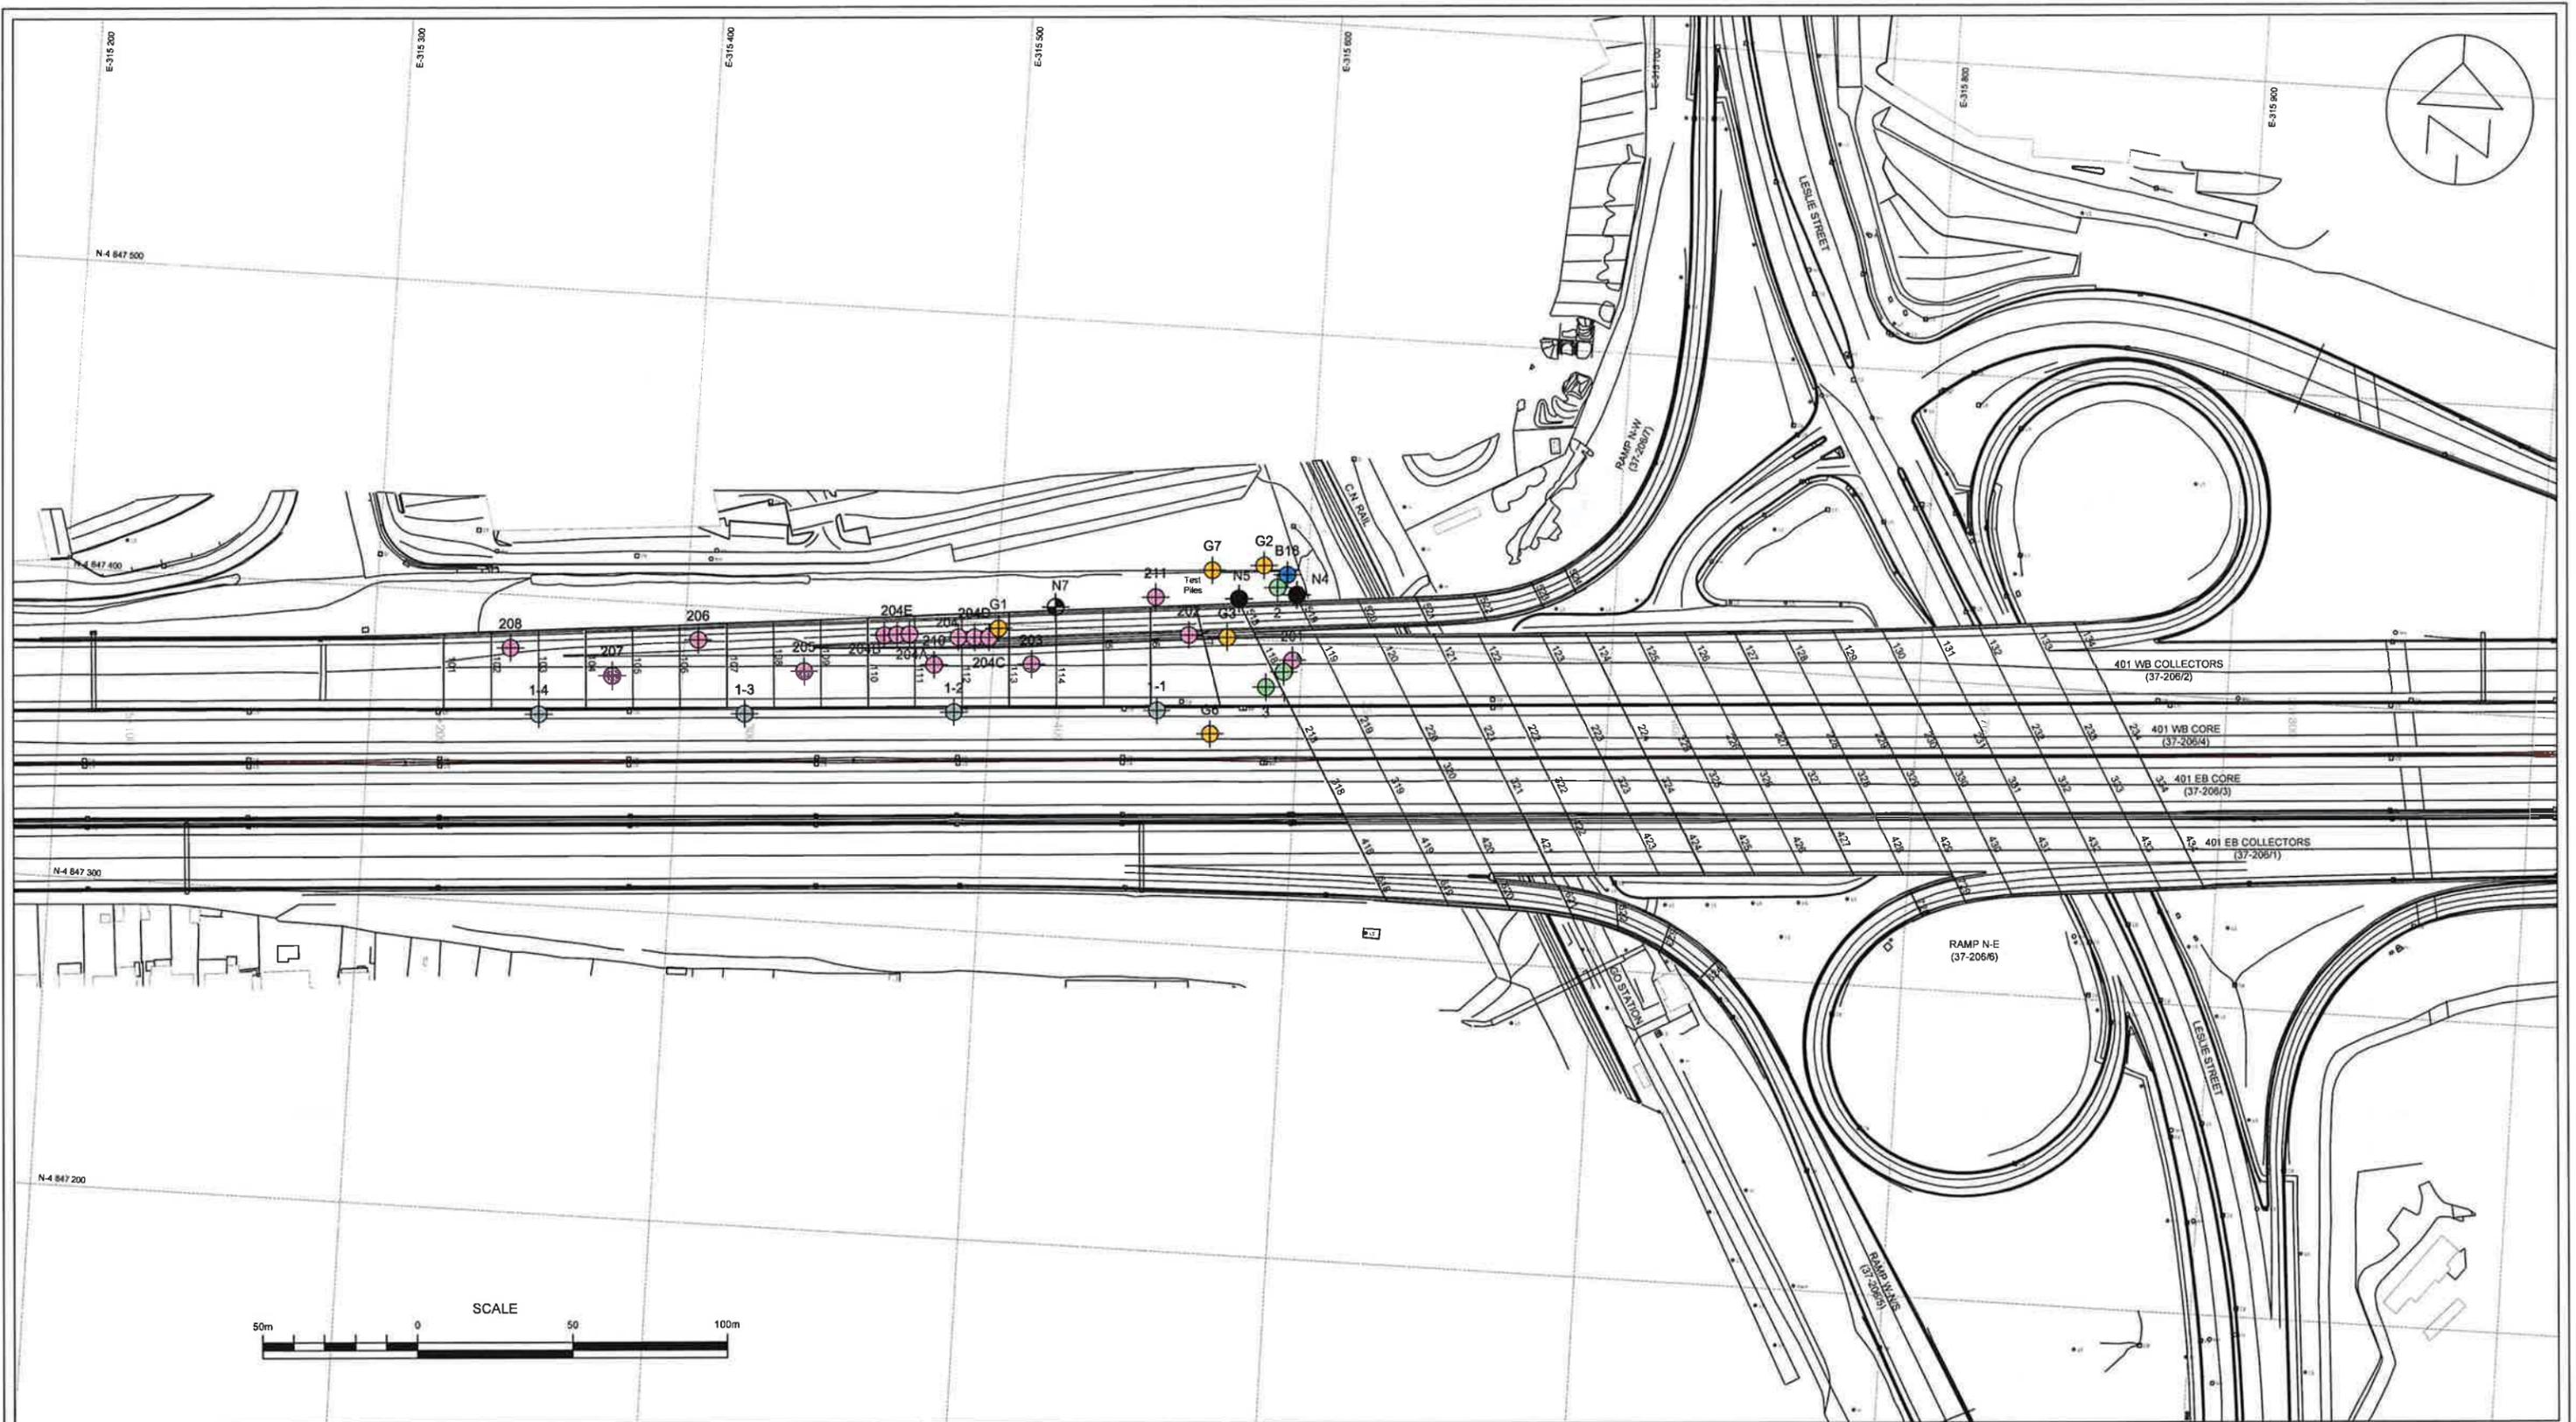
client:	DELSCAN CORPORATION		
project:	VIADUCT HIGHWAY 401 AND LESLIE STREET INTERCHANGE TORONTO, ONTARIO		
title:	SITE AND BOREHOLE LOCATION PLAN		
Project No.	TRANETOBO1245AA-AE	Geocres No.	30M14-335
drawing no:	1

Drawing 1: Site and Borehole Location Plan

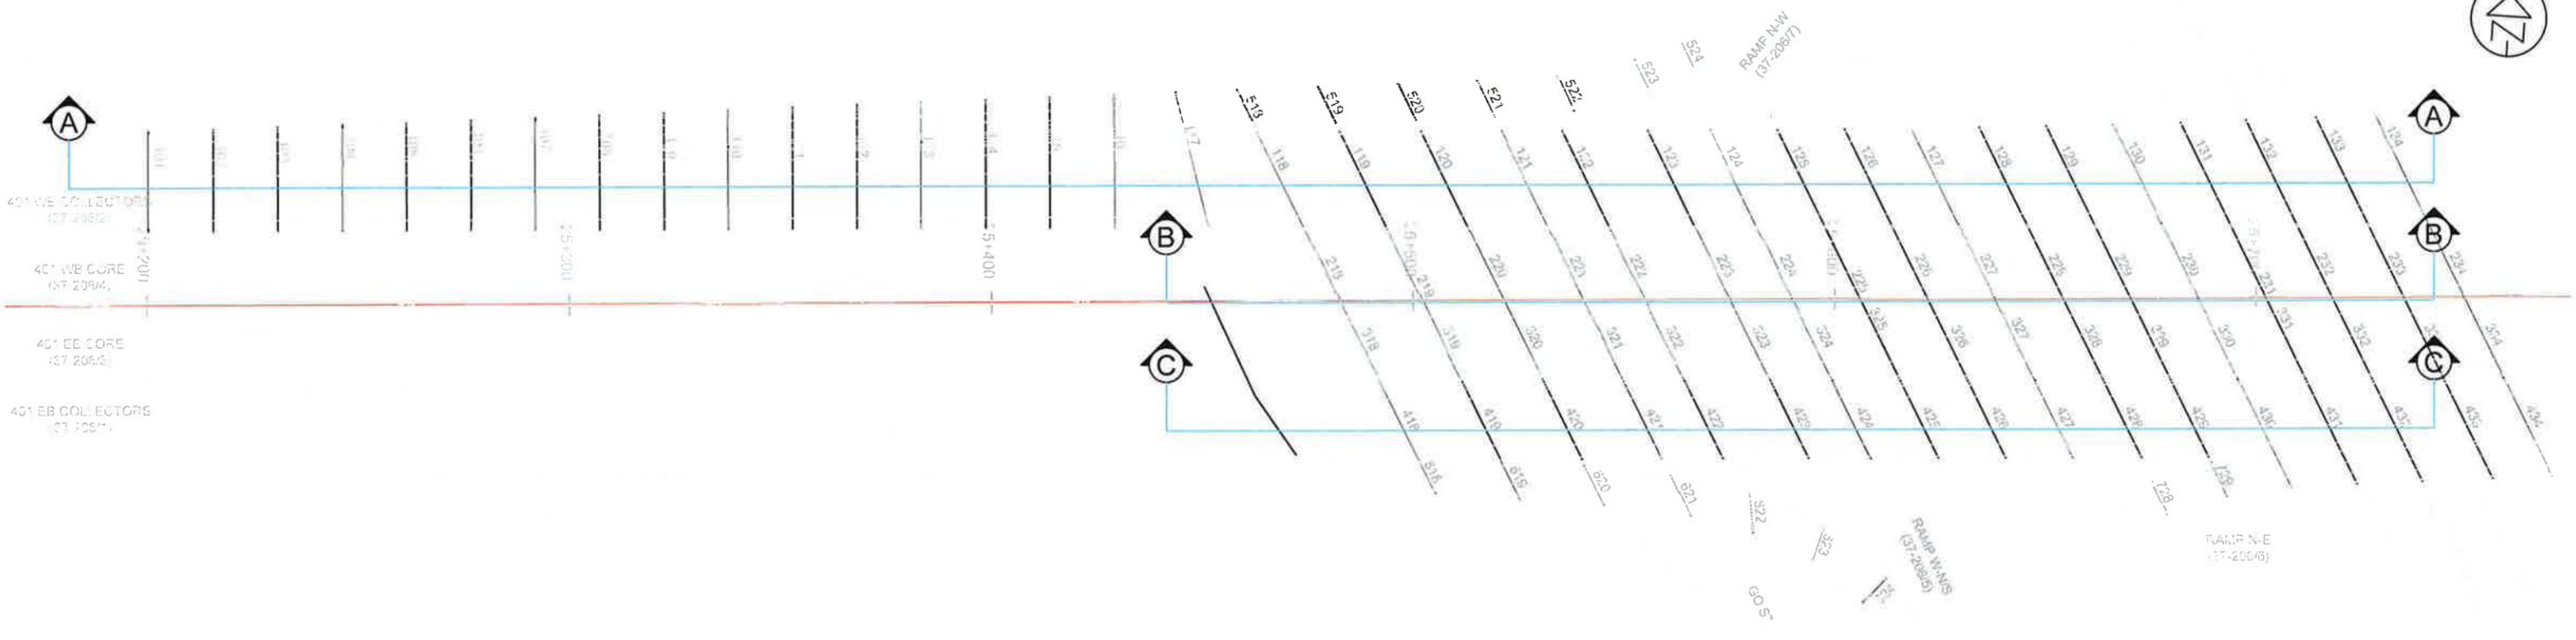
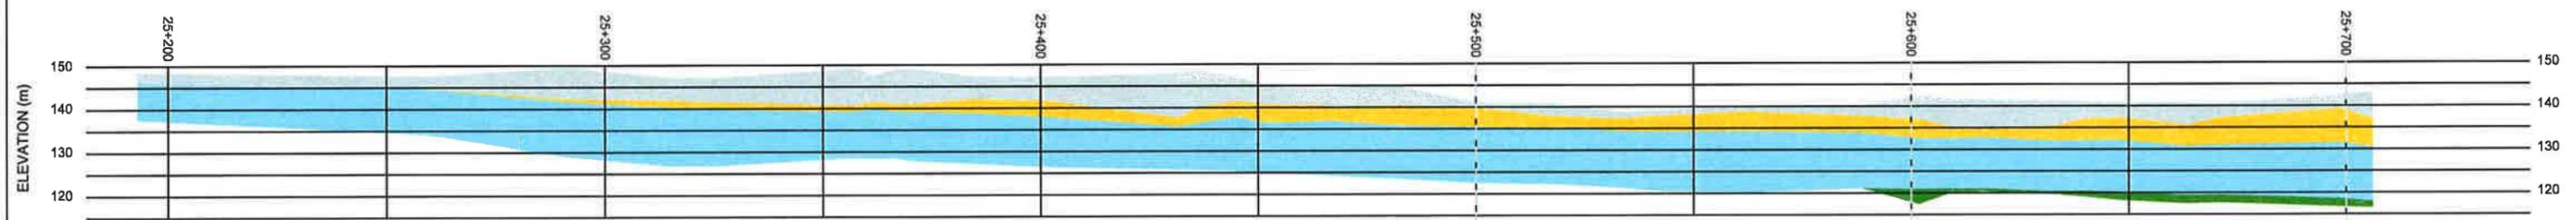
Drawing 2: Estimated Subsurface Profiles

PROFILE A-A
WEST BOUND COLLECTORS
HORIZONTAL SCALE

PROFILE B-B
CENTRELINE OF CORE
HORIZONTAL SCALE

Note the material boundaries indicated on the attached Drawing 2 are approximate and are based on data by others. These boundaries typically represent a transition from one material type to another and should not be regarded as an exact plane of geological change. It should be pointed out that the subsurface conditions will vary across the Highway 401 - Leslie Street interchange area.

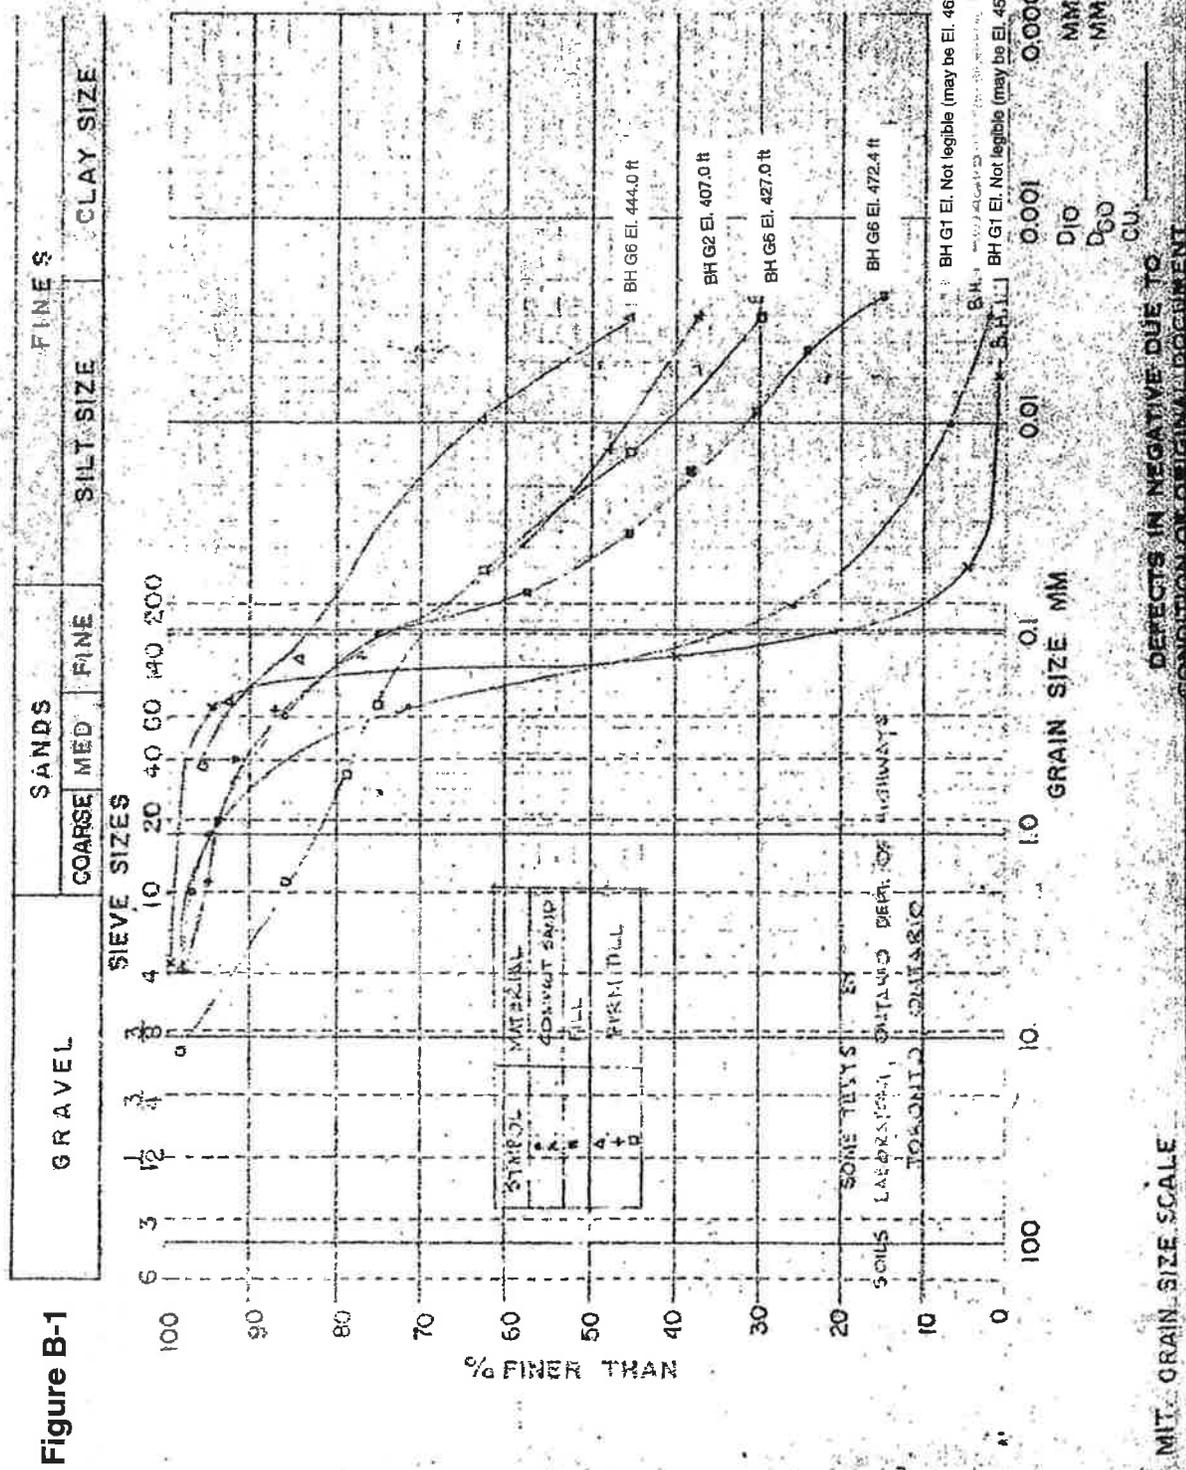
A grain size distribution curves (prepared by Foundation Companies, Canada) for a sample from the fill contacted in Borehole G6* is presented in Figure B-1 in Appendix B. Seven grain size analyses, carried out on samples of the sandy silt fill (Ministry of Transportation Ontario, 1990) are presented in an envelope form in Figure B-2 in Appendix B, in their original form. As also indicated on the Record of Borehole Sheets in Appendix A, the results are as follows;

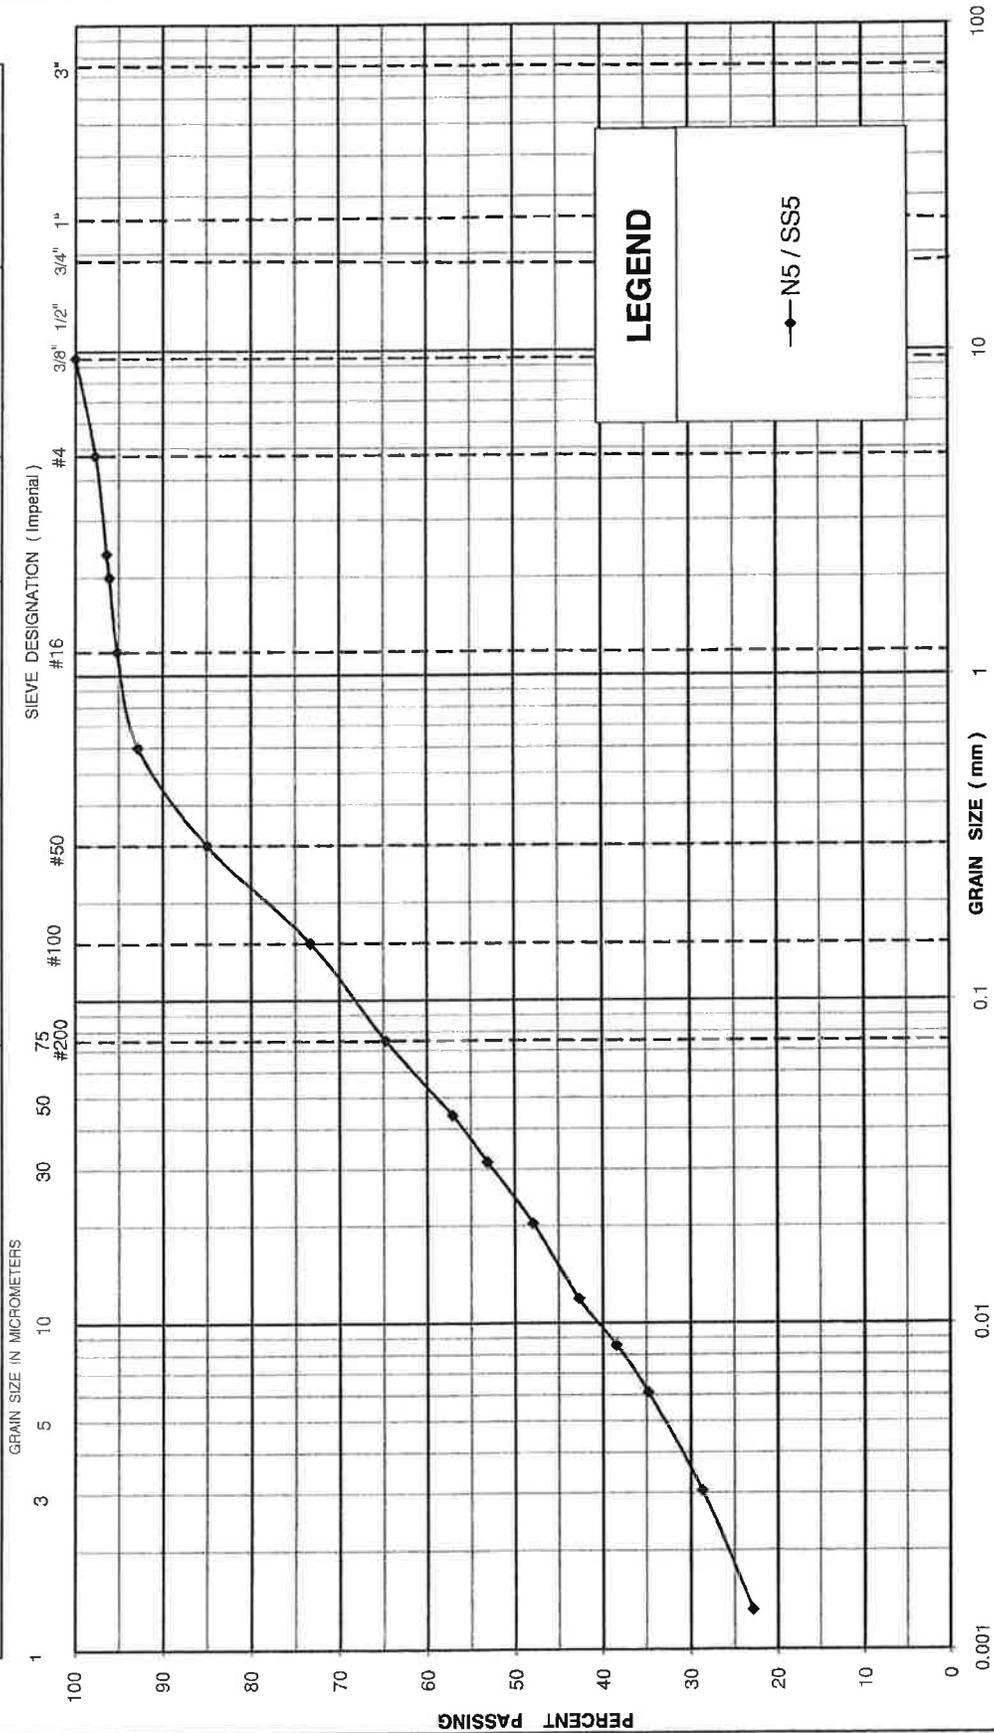
FIGURE NO.: B-15
PROJECT NO: TRANETOBO01245AA
DATE: March, 2010

GRAIN SIZE DISTRIBUTION
FILL: Cohesive Zone within the Fill

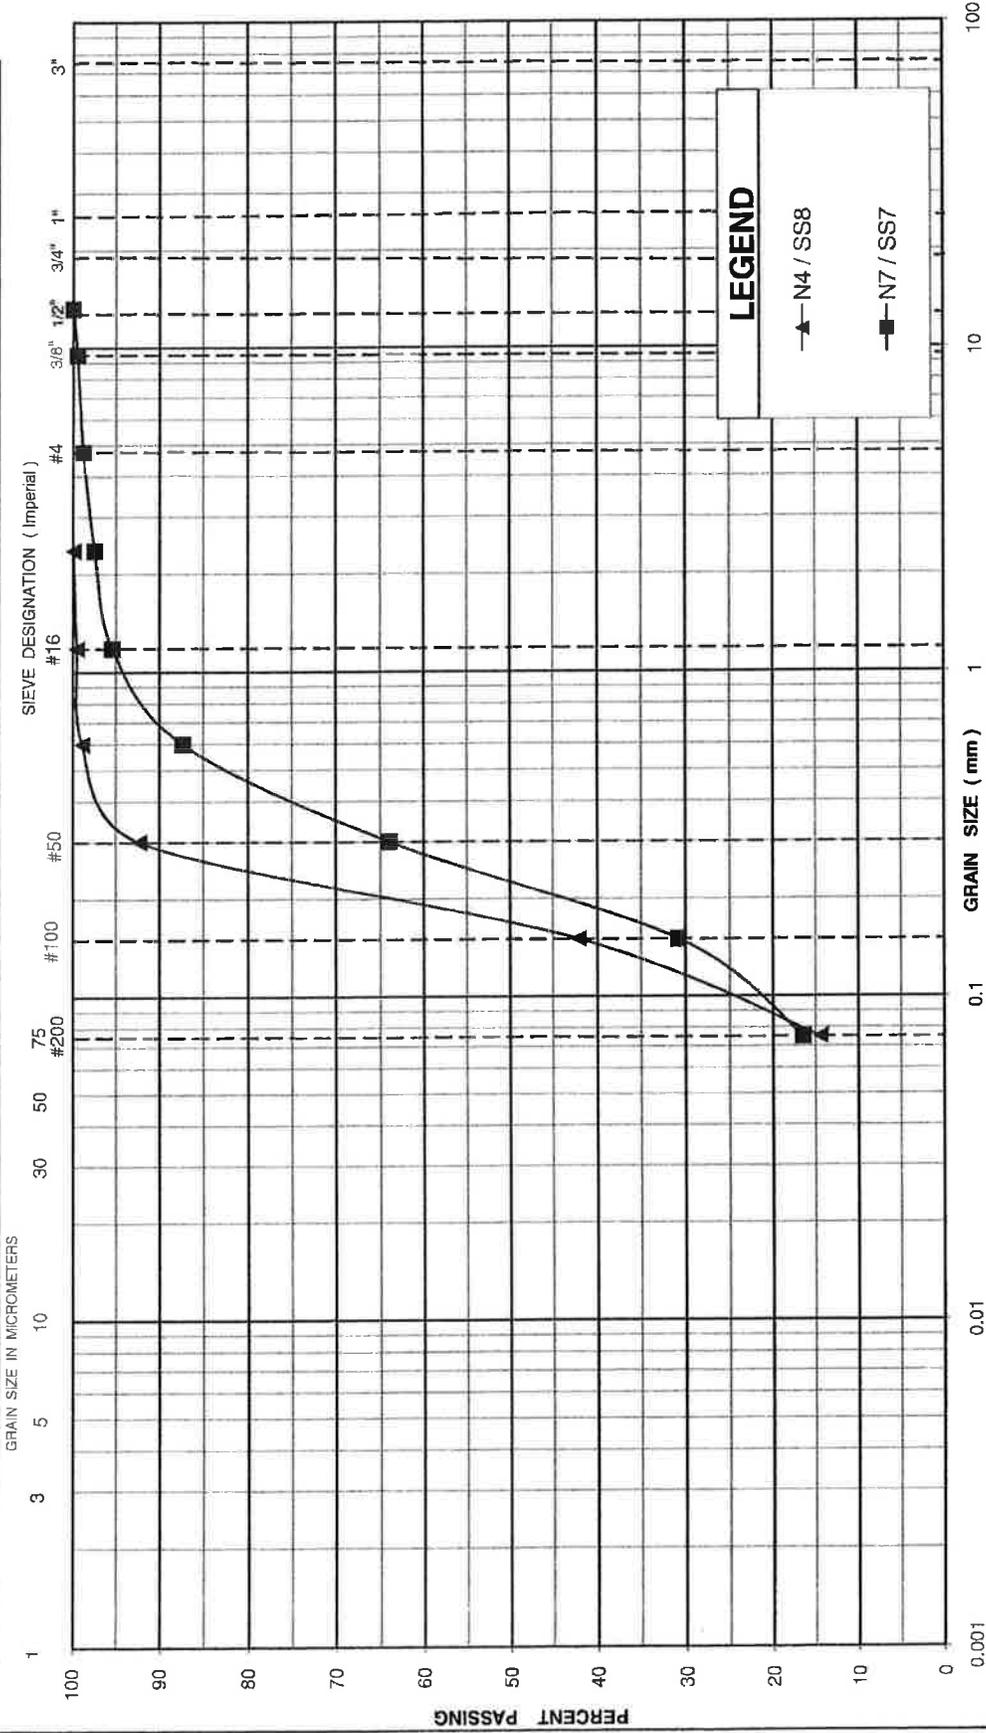
FIGURE NO.: B-17
 PROJECT NO.: TRANETOB01245AA
 DATE: MAR. 2010

GRAIN SIZE DISTRIBUTION SAND

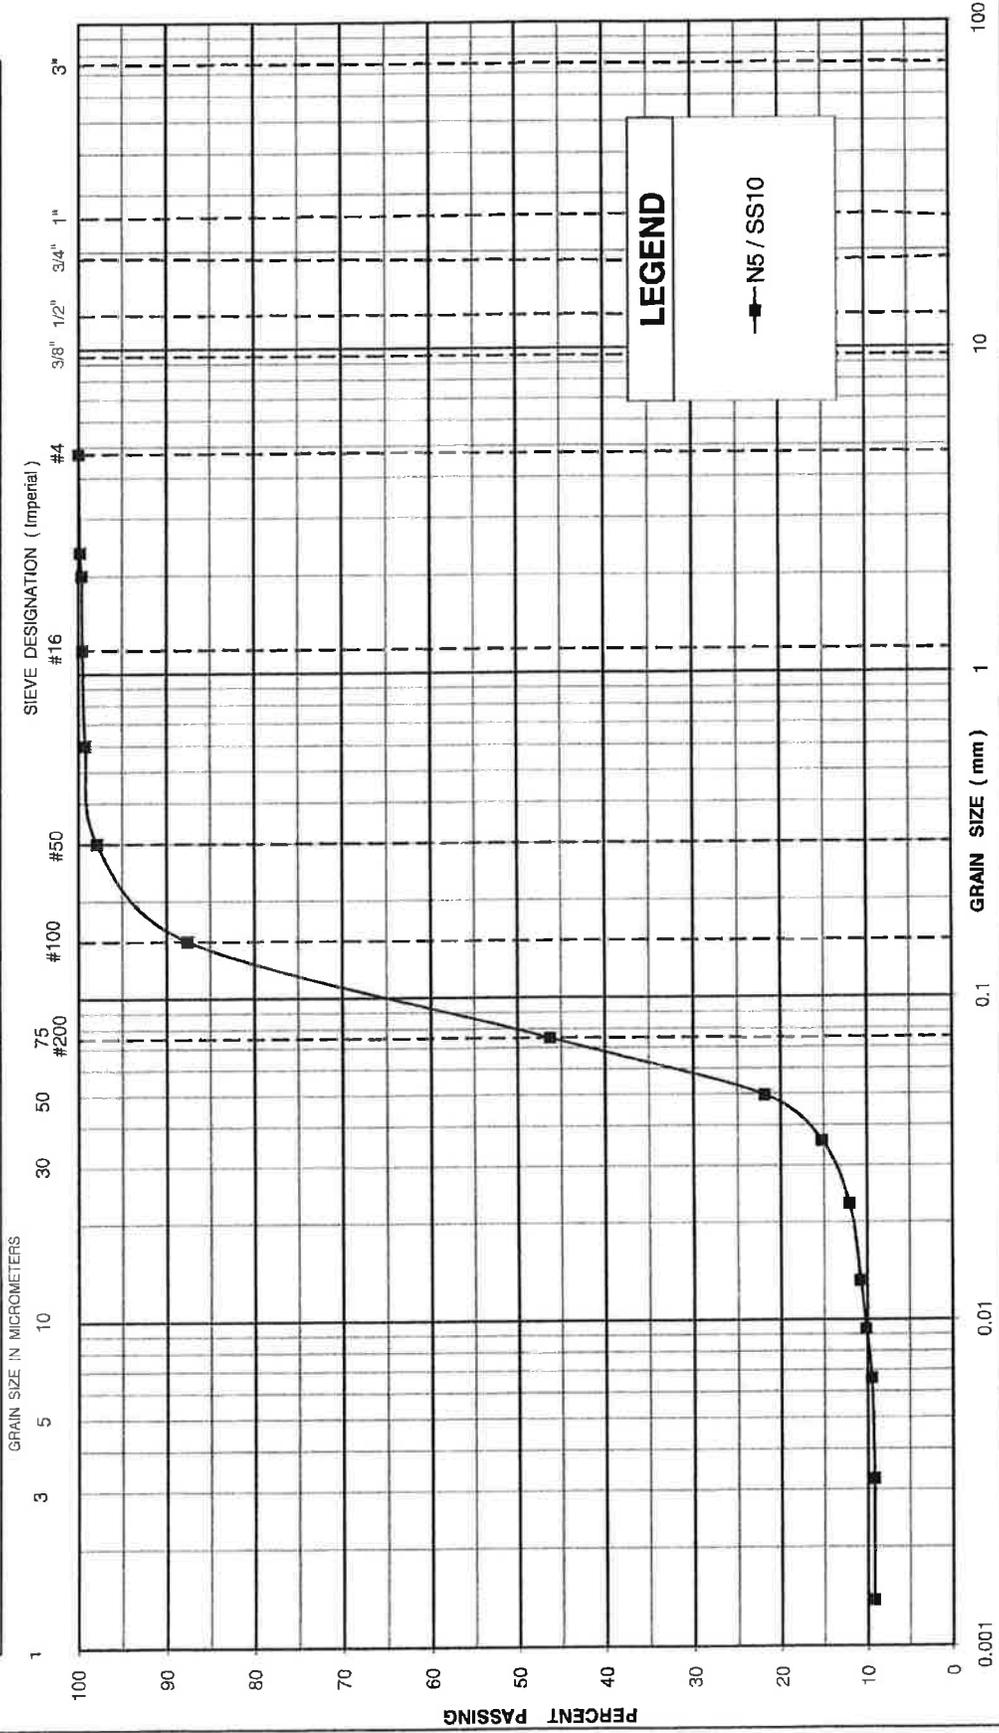
FIGURE NO.: B-18
PROJECT NO: TRANETO01245AA
DATE: MARCH, 2010

GRAIN SIZE DISTRIBUTION
SILTY SAND TO SANDY SILT

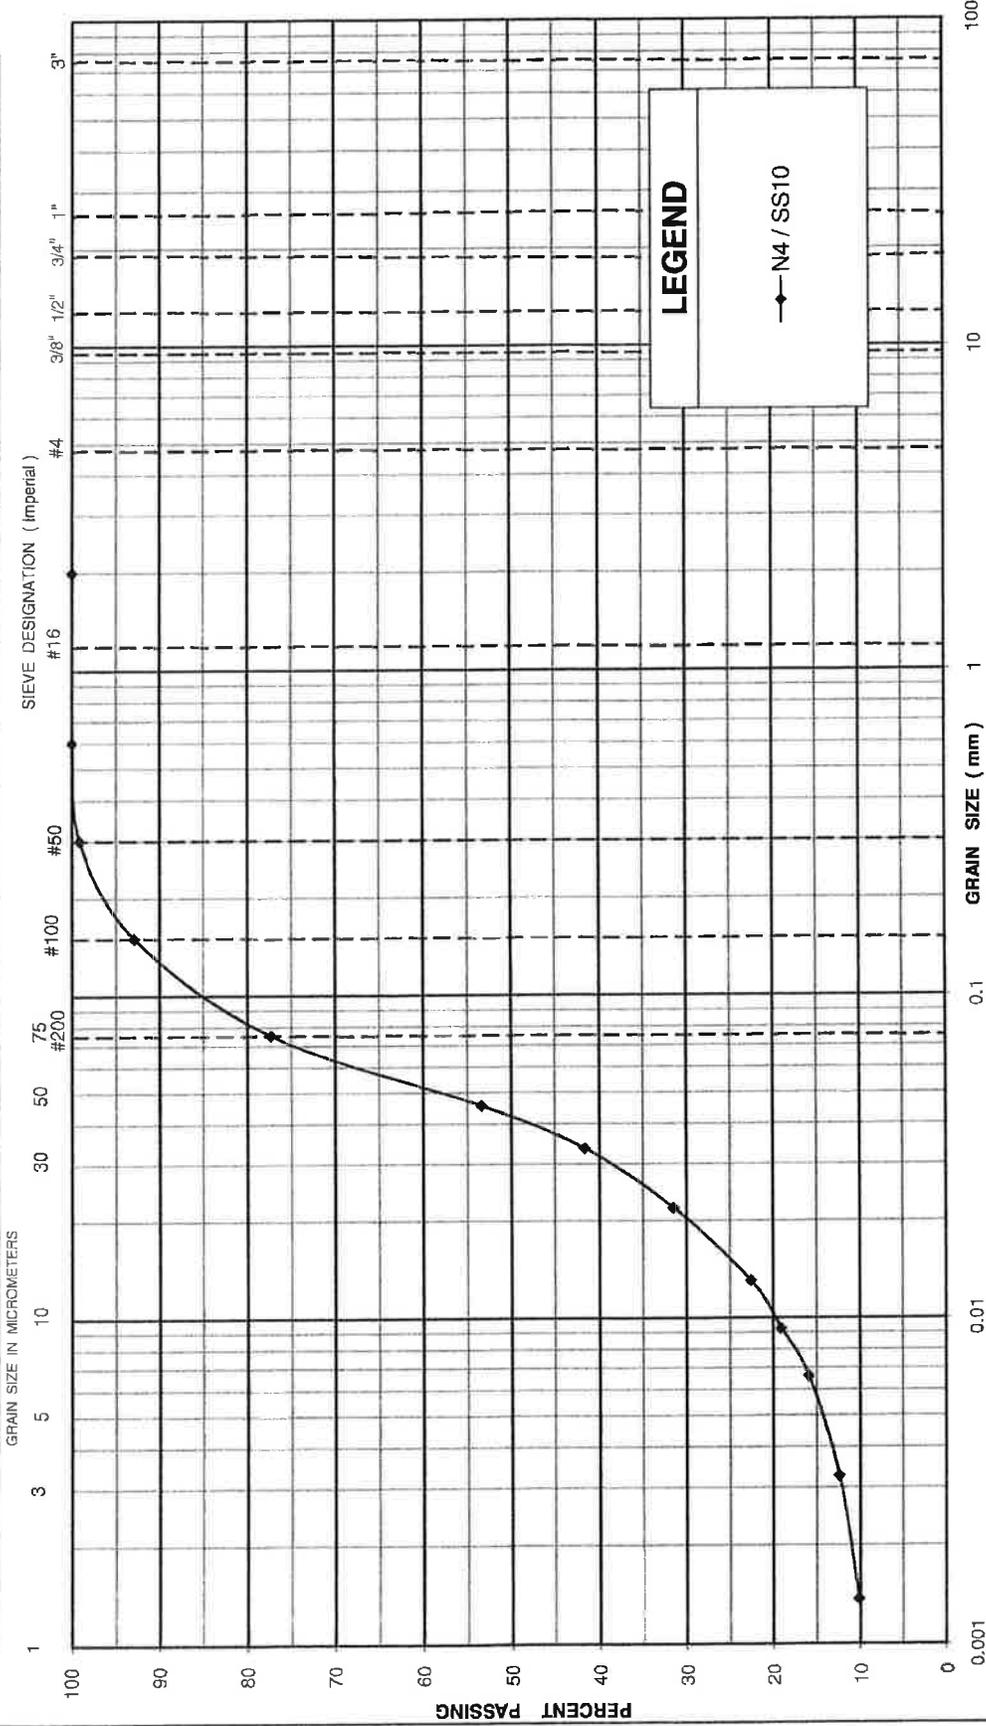
FIGURE NO.: B-19
 PROJECT NO: TRANETOB01245AA
 DATE: MARCH, 2010

GRAIN SIZE DISTRIBUTION
 SILT

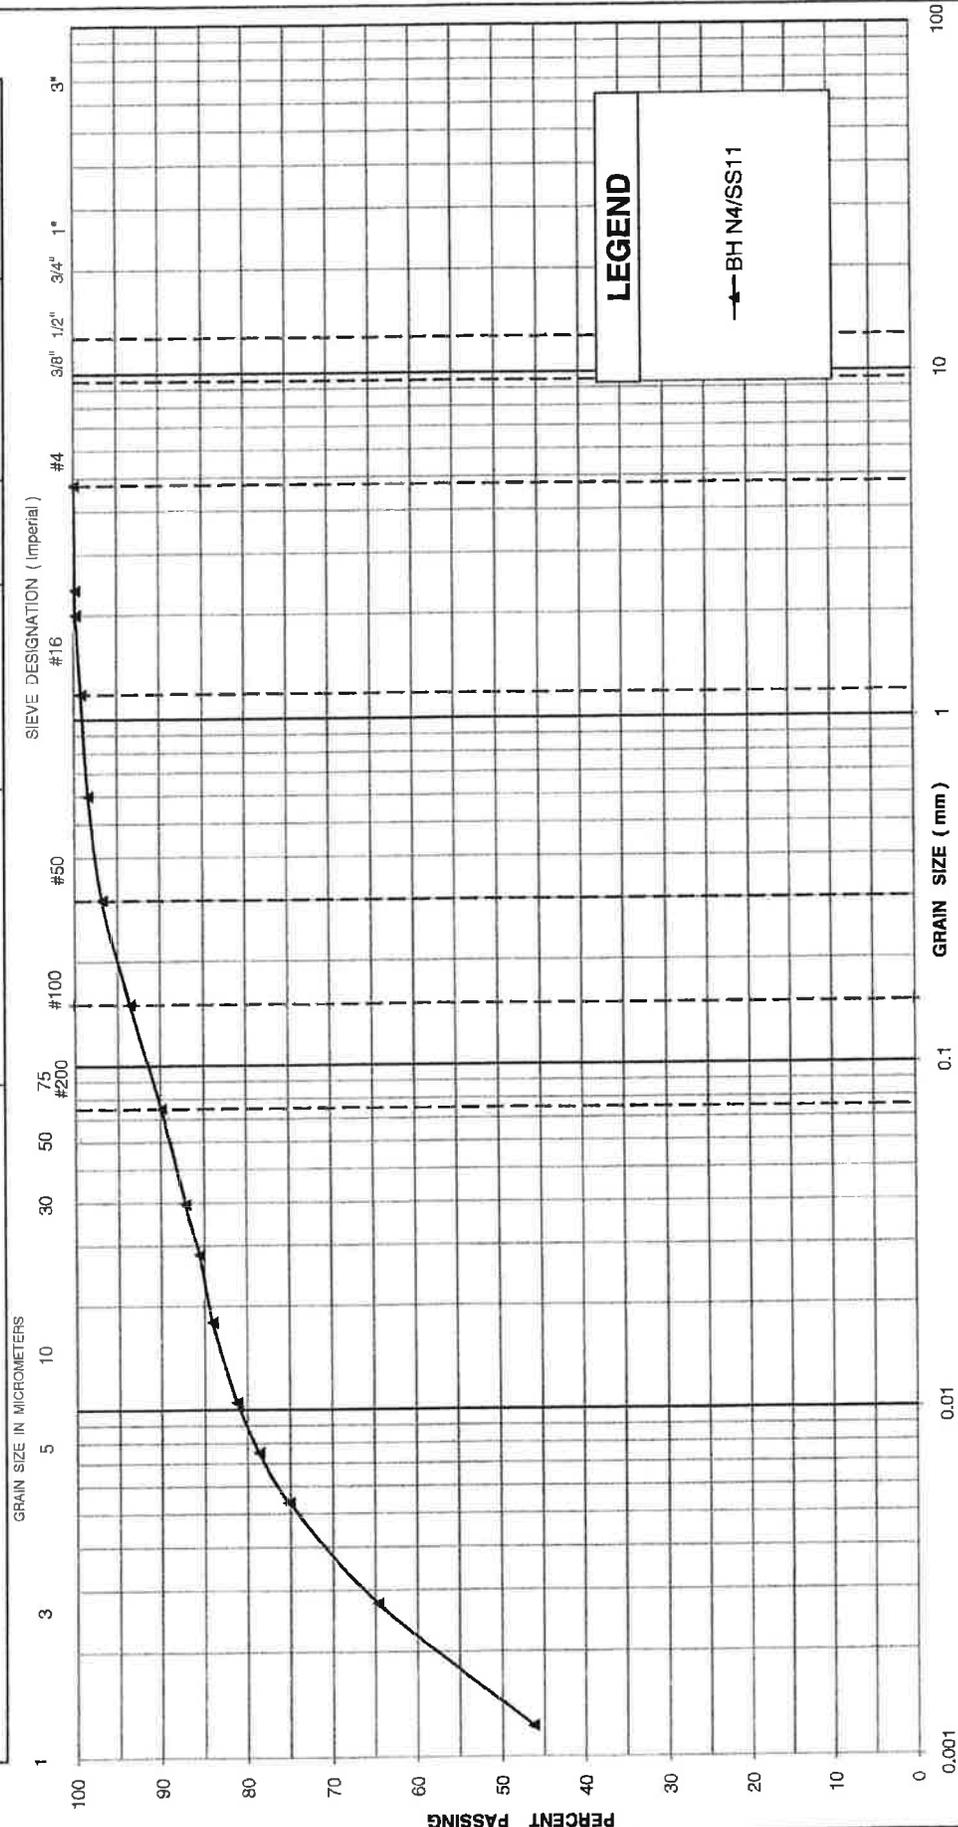
<p>coffey geotechnics SPECIALISTS MANAGING THE EARTH</p>	<p>GRAIN SIZE DISTRIBUTION SILTY CLAY</p>	<p>FIGURE NO.: B-20 PROJECT NO.: TRANETOB01245AA DATE: MARCH, 2010</p>
---	--	--

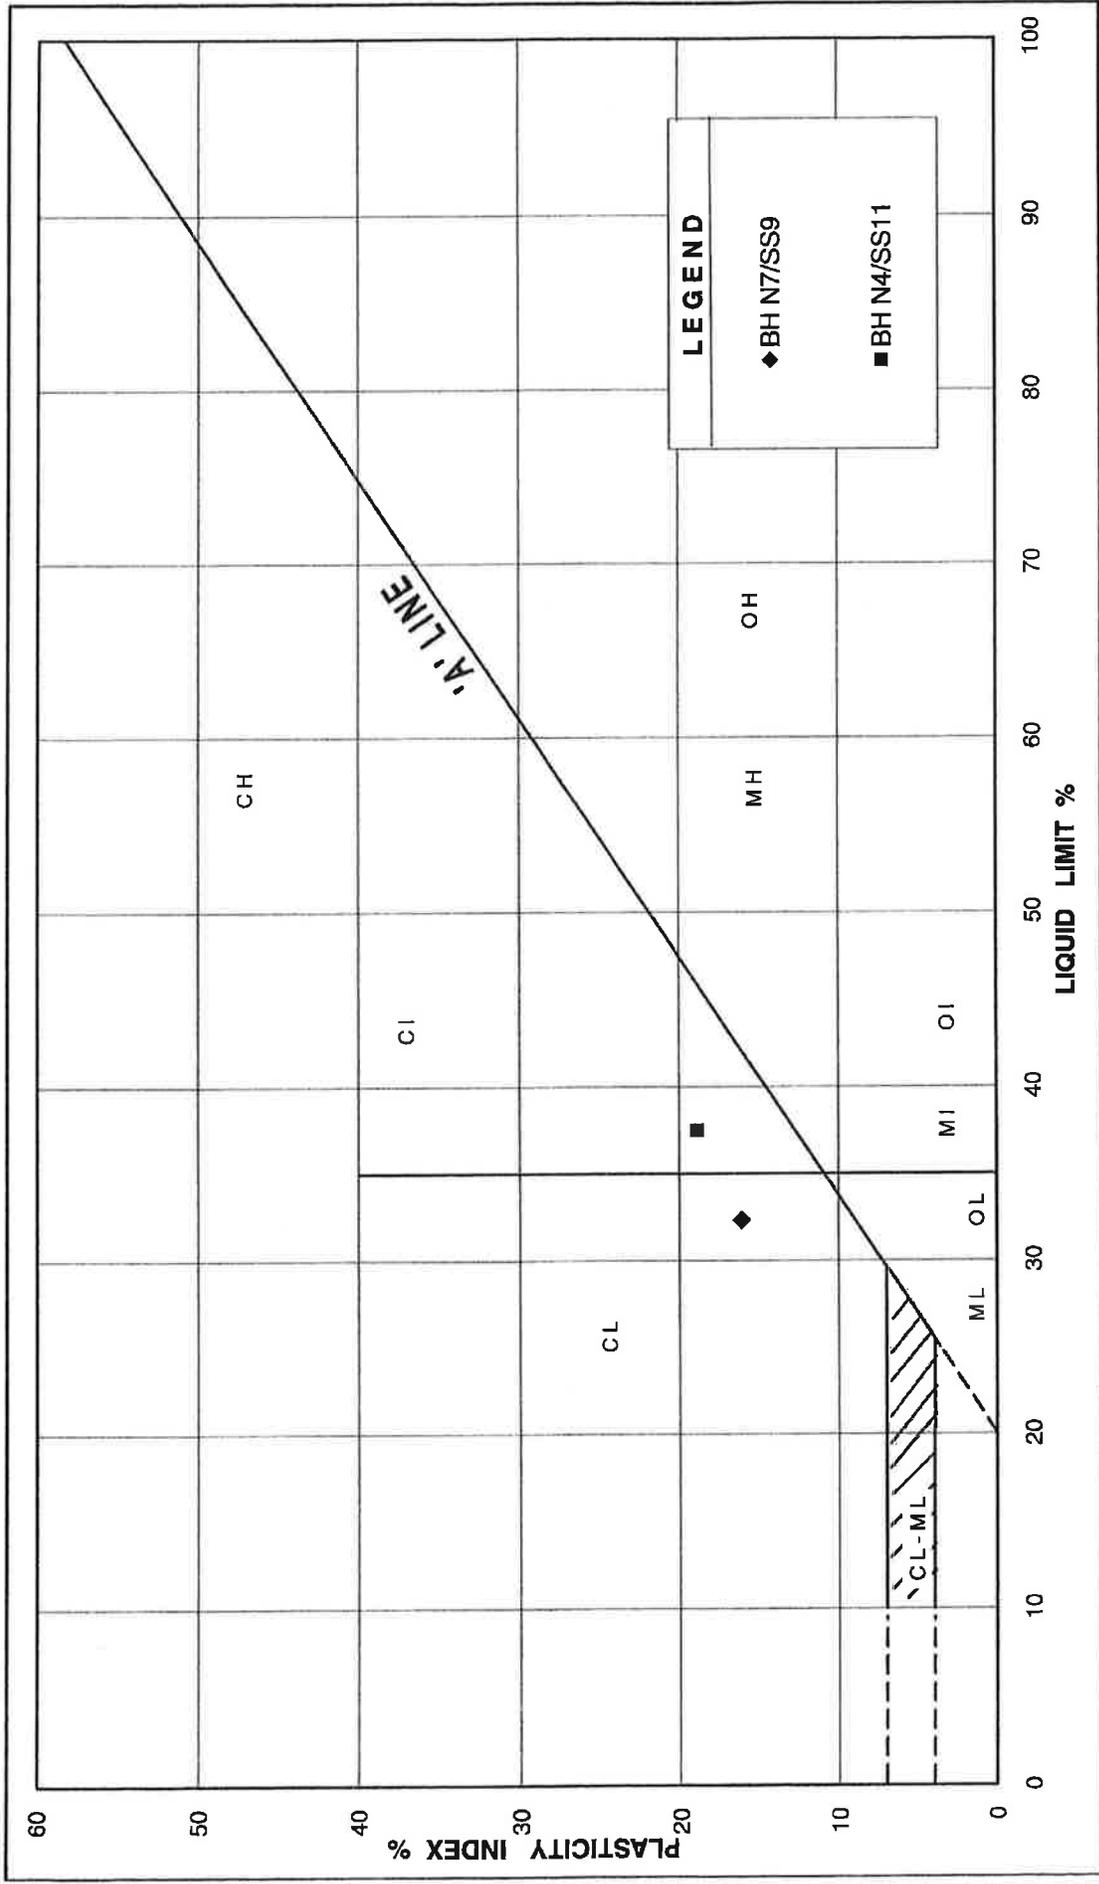
FIGURE No. B-21
 REF. No. TRANETOBO1245AA
 DATE MARCH, 2010

PLASTICITY CHART
 SILTY CLAY

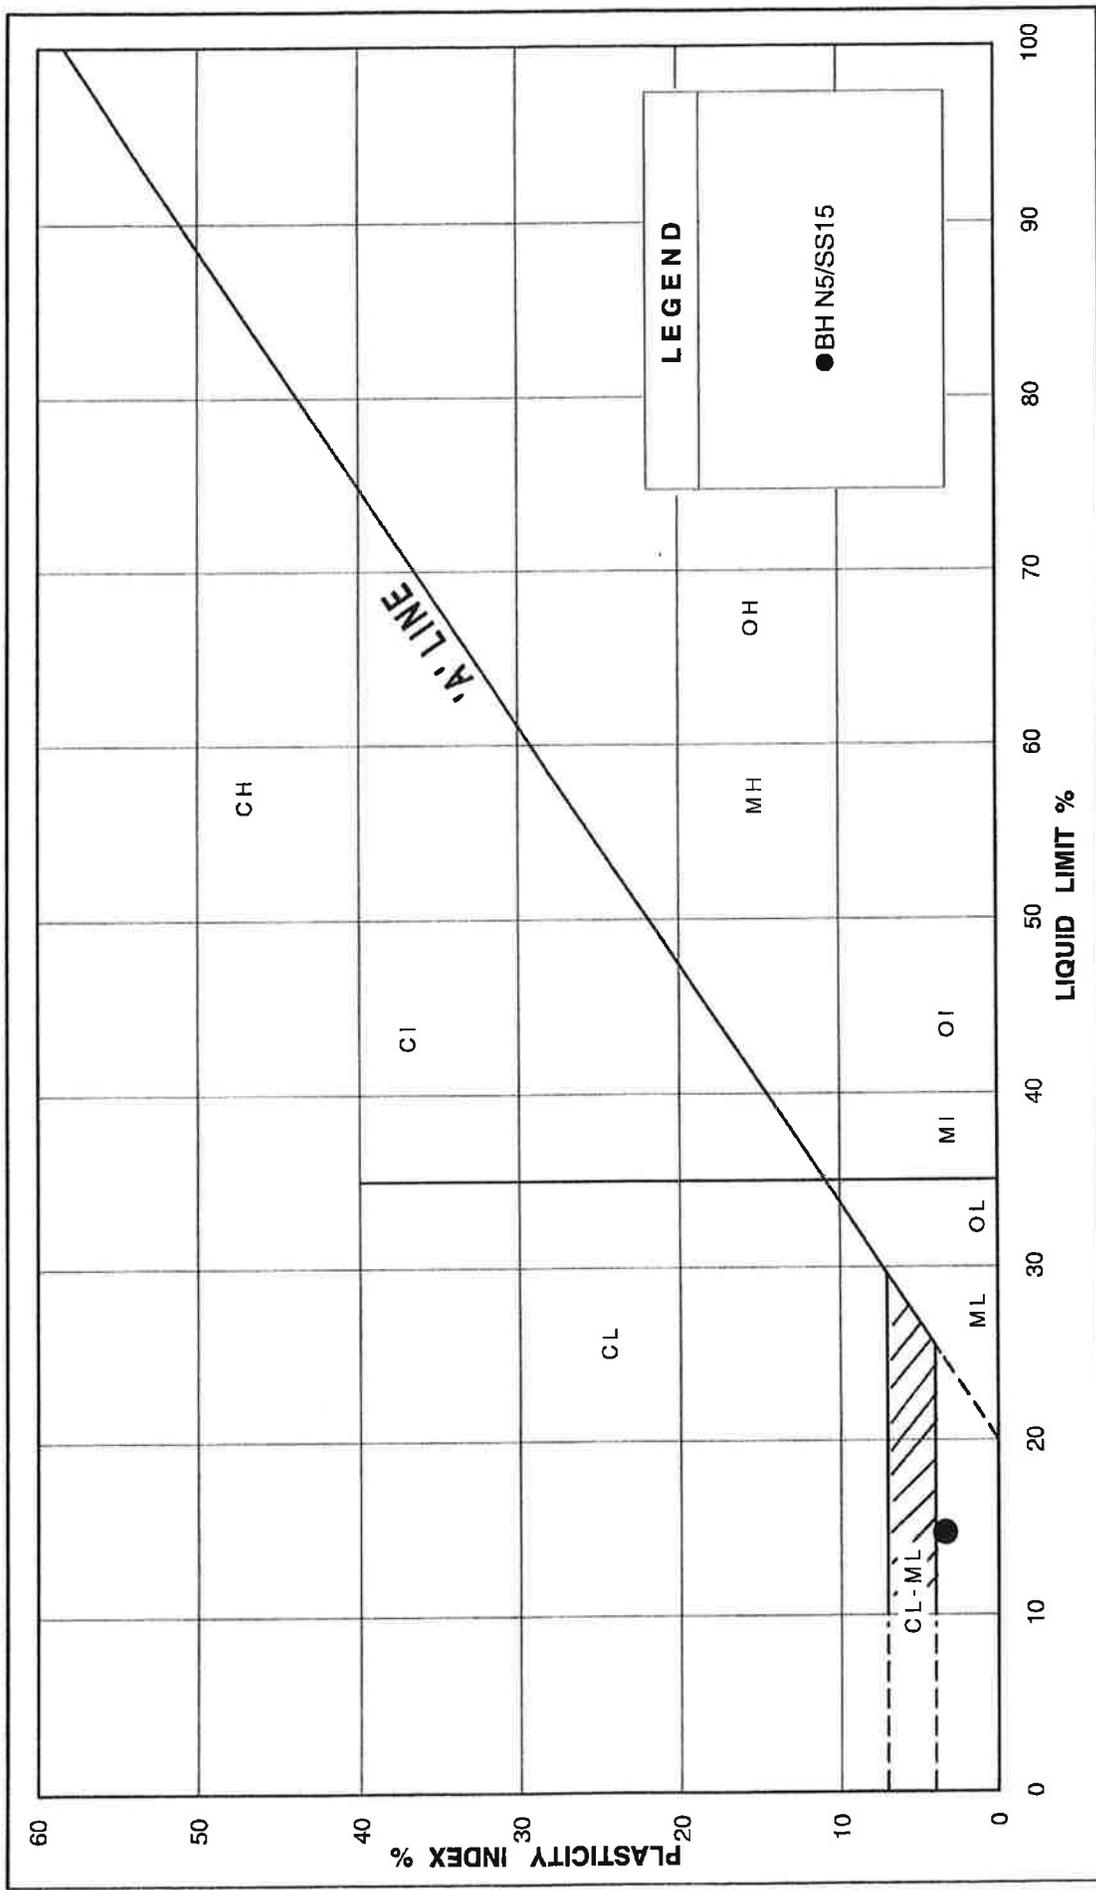
FIGURE No. B-23
 REF. No. TRANETOBO1245AA
 DATE MARCH, 2010

PLASTICITY CHART
LESS PLASTIC ZONE WITHIN SILTY CLAY

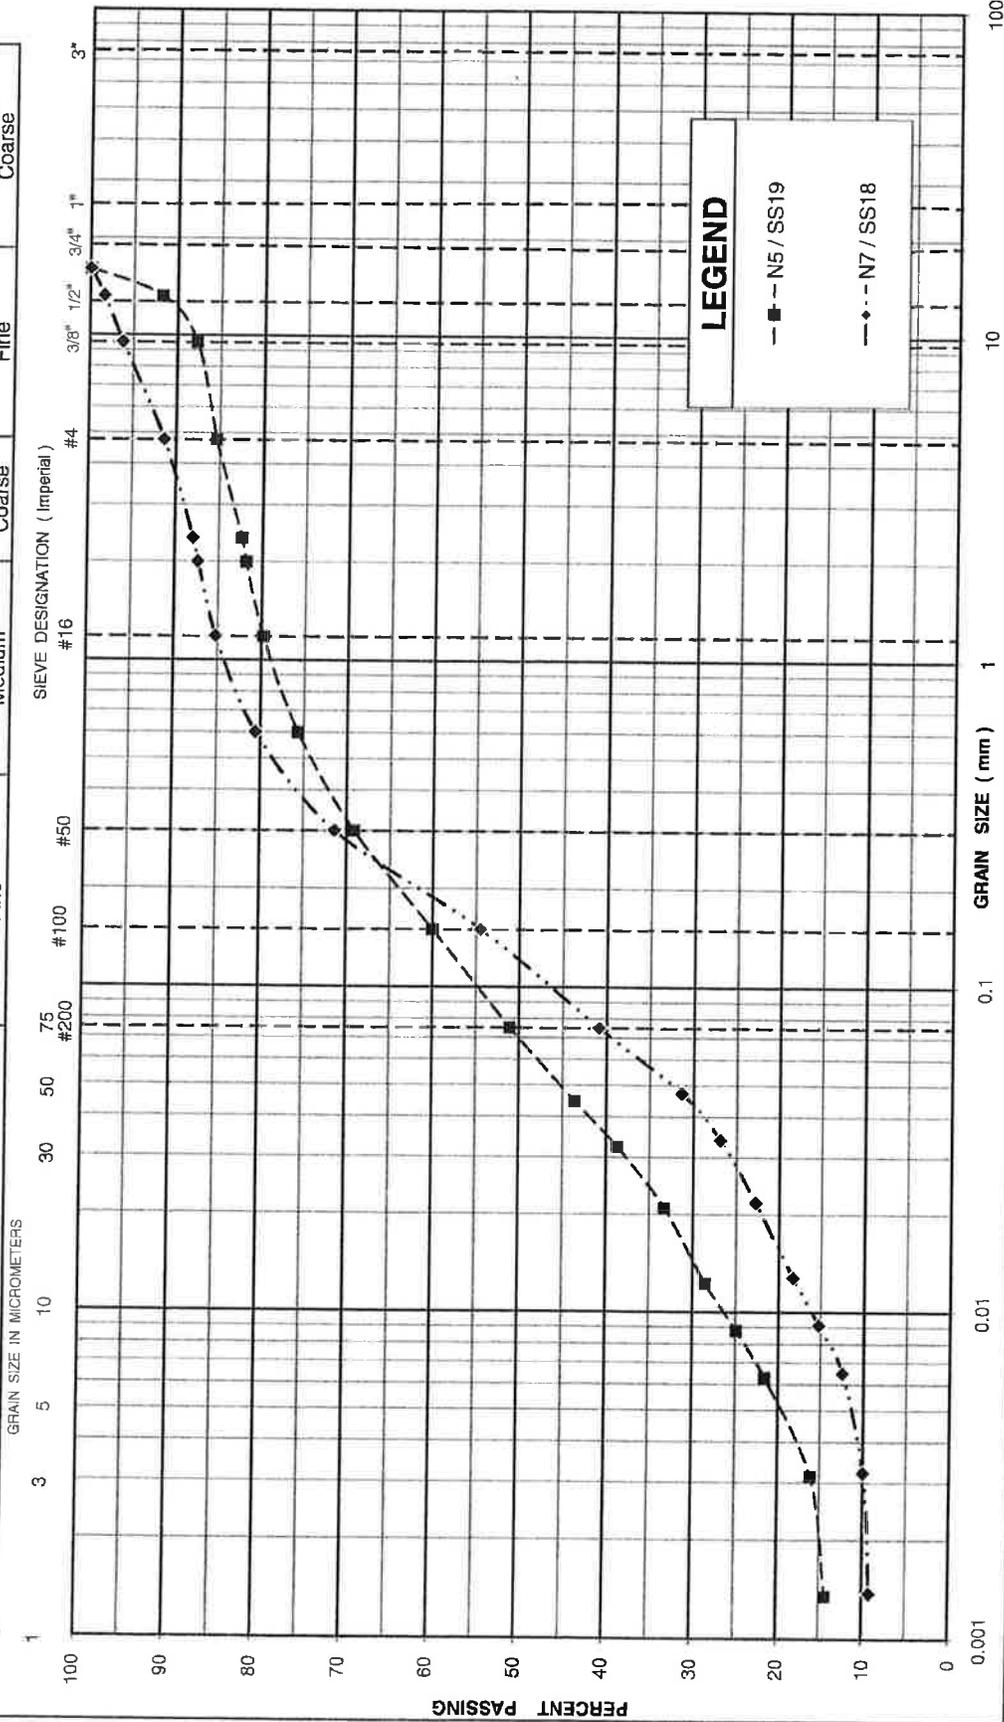
FIGURE NO.: B-26
 PROJECT NO: TRANETOBO01245AA
 DATE: MAR. 2010

GRAIN SIZE DISTRIBUTION
 SANDY SILT TO SILTY SAND TILL
