**PRELIMINARY FOUNDATION
INVESTIGATION AND DESIGN REPORTS
EXISTING VIADUCT WEST OF HIGHWAY 401
AND LESLIE STREET, HIGHWAY 401
REHABILITATION FROM LESLIE STREET TO
WARDEN AVENUE, MTO CENTRAL REGION,
G.W.P. 2130-01-00, GEOCREC 30M14-335**

Delcan Corporation
Project: TRANETOB01245AA-AE
December 19, 2011

**PRELIMINARY FOUNDATION
INVESTIGATION REPORT
EXISTING VIADUCT WEST OF
HIGHWAY 401 AND LESLIE STREET,
HIGHWAY 401 REHABILITATION FROM
LESLIE STREET TO WARDEN AVENUE,
MTO CENTRAL REGION,
G.W.P. 2130-01-00, GEOGRES 30M14-335**

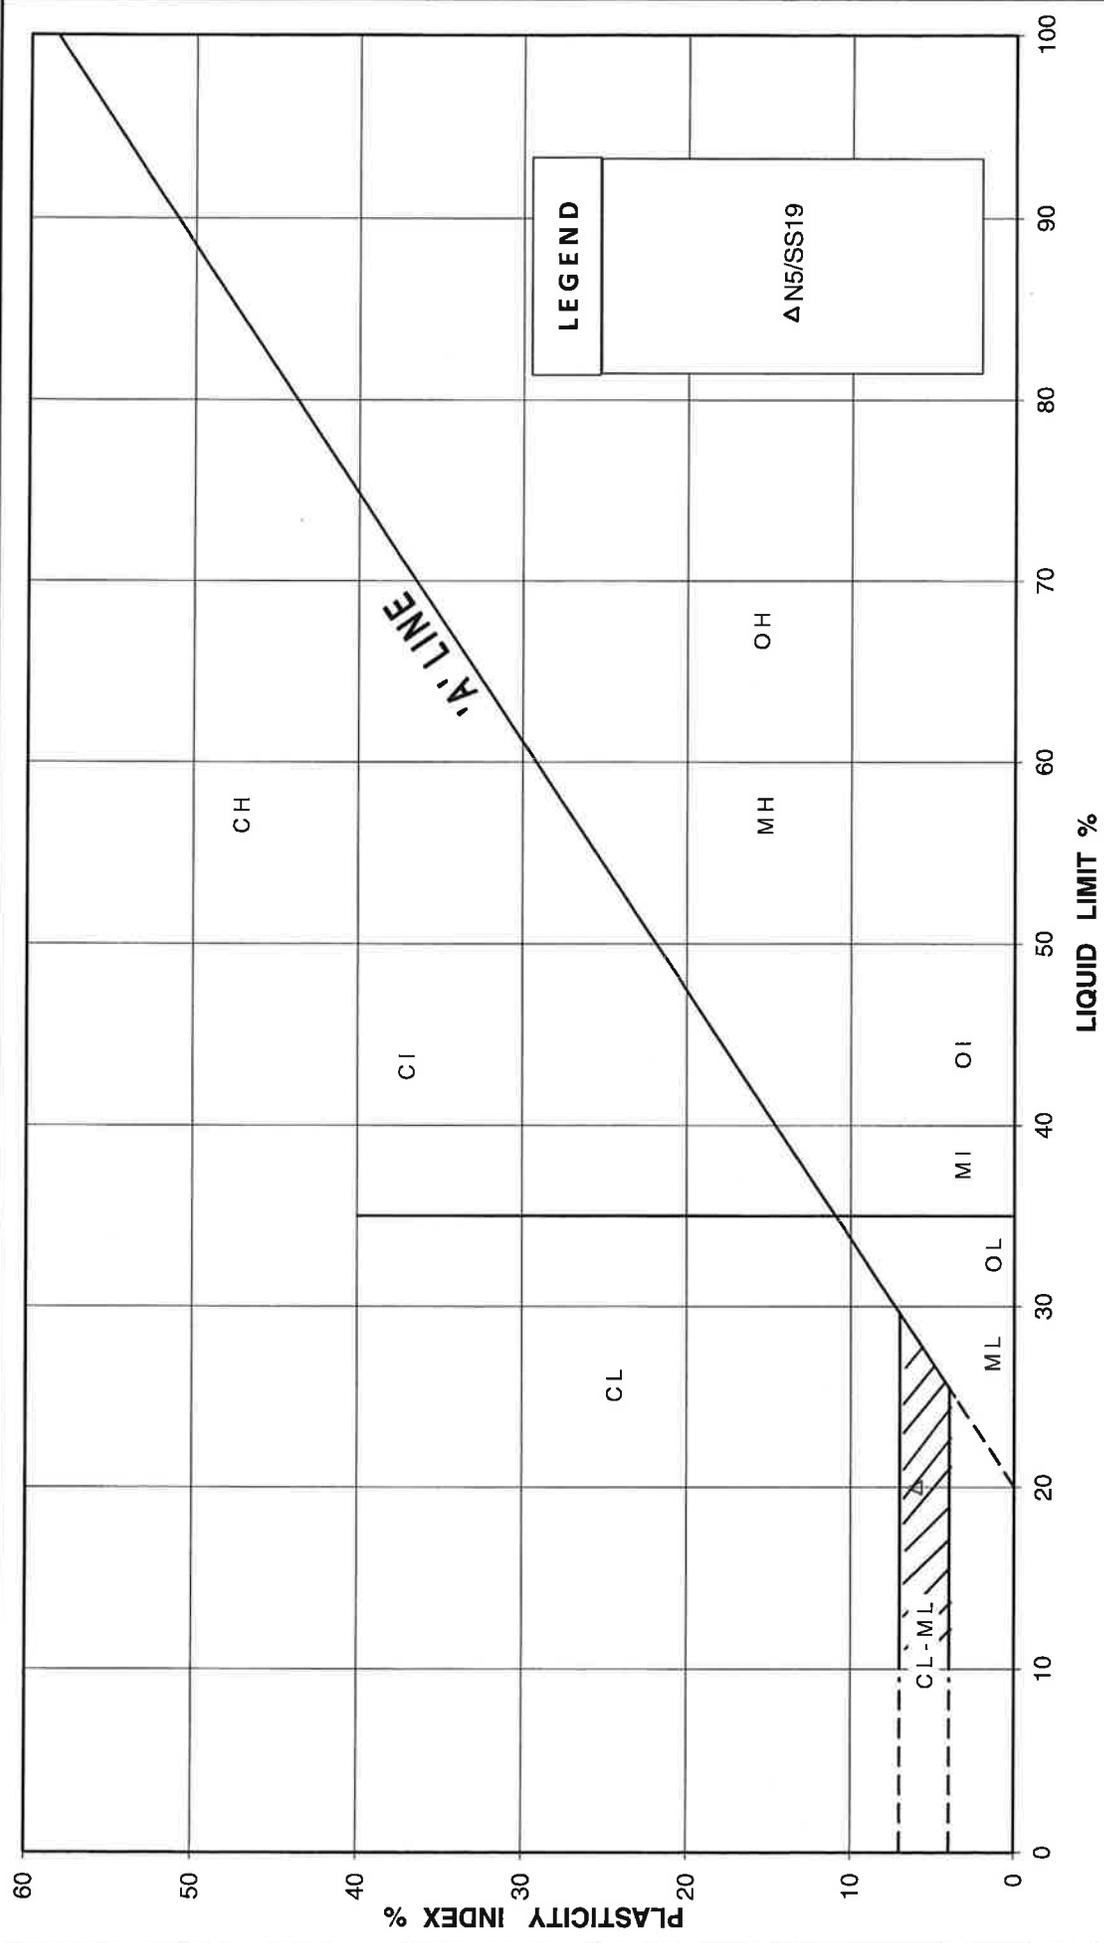
FIGURE No. B-27
 REF. No. TRANETOB01245AA
 DATE

PLASTICITY CHART
 SANDY SILT TO SILTY SAND TILL

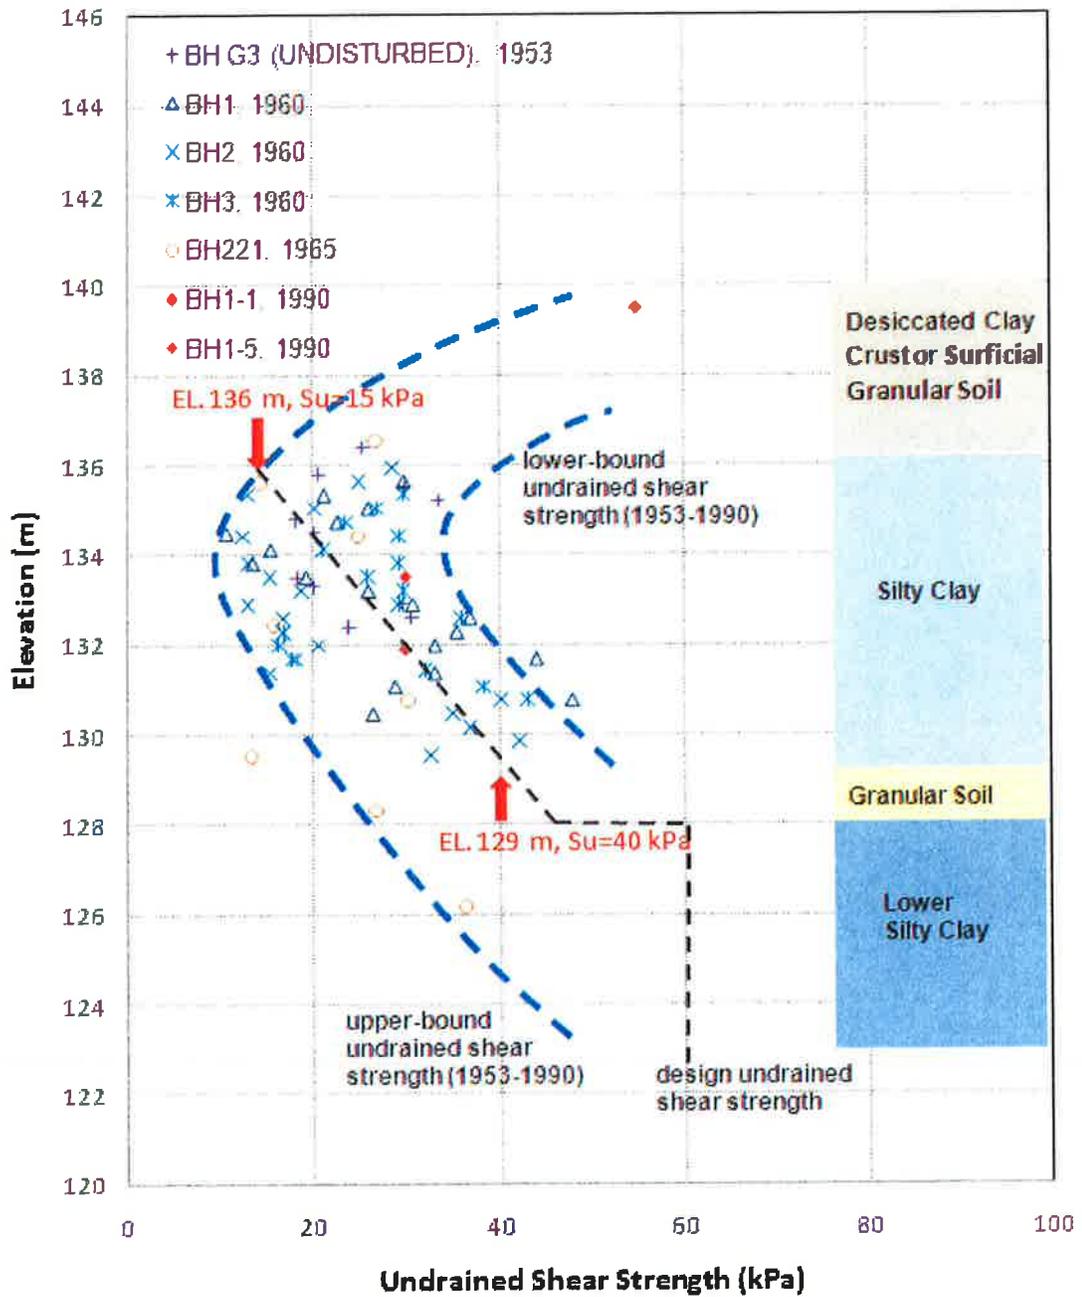
Figure I-1 Upper-bound, lower-bound undrained shear strengths and design undrained shear strength values vs elevation for past construction (1953-1990)

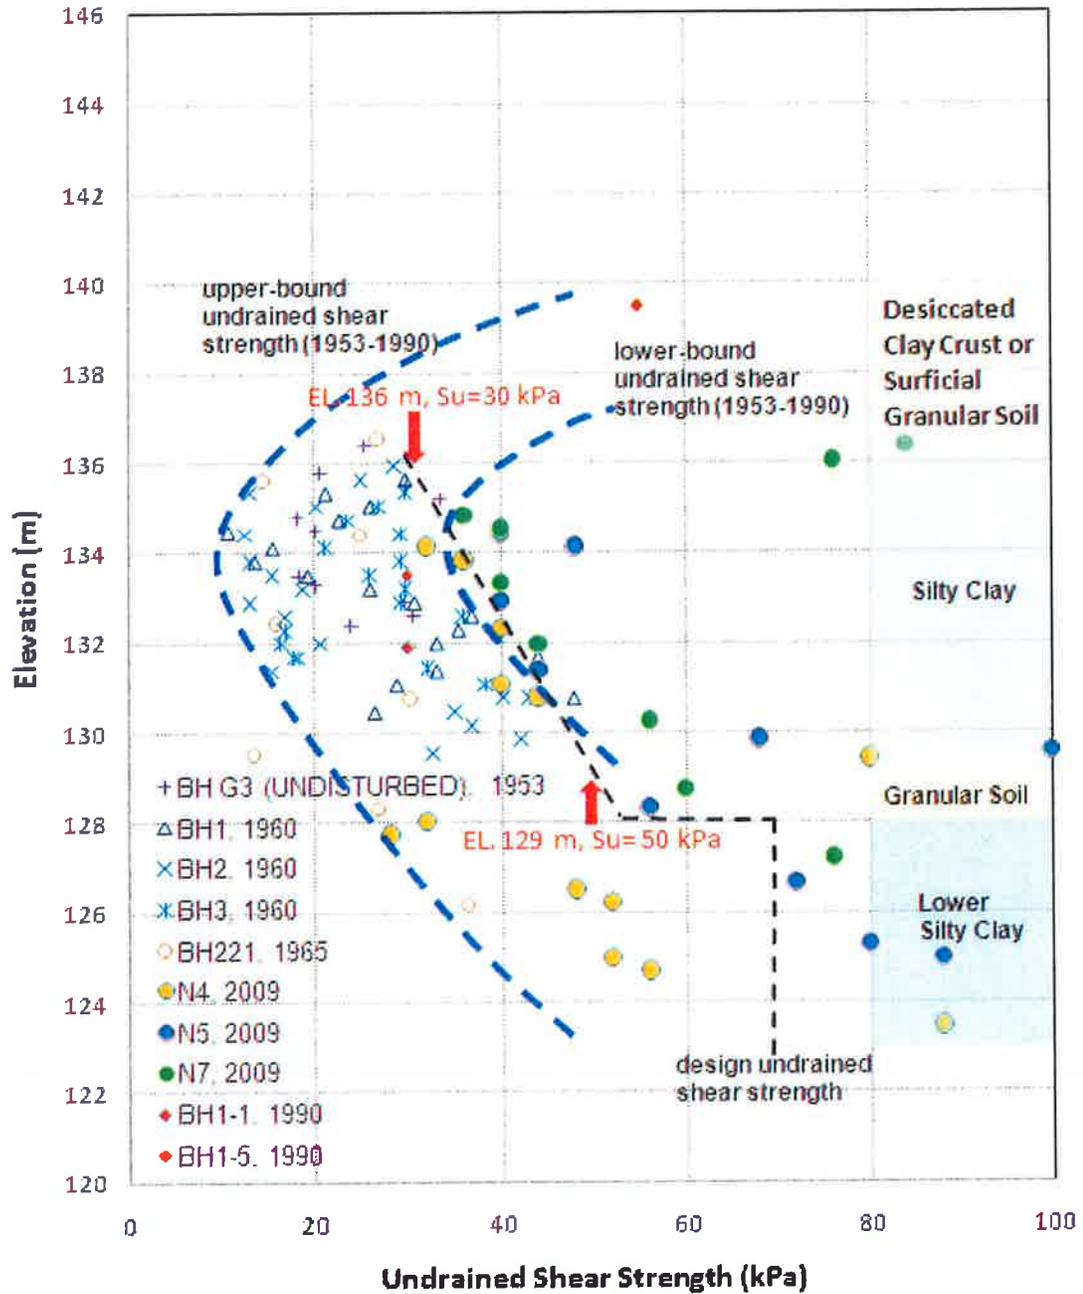
Figure I-2 Design undrained shear strength values vs elevation for a new construction.

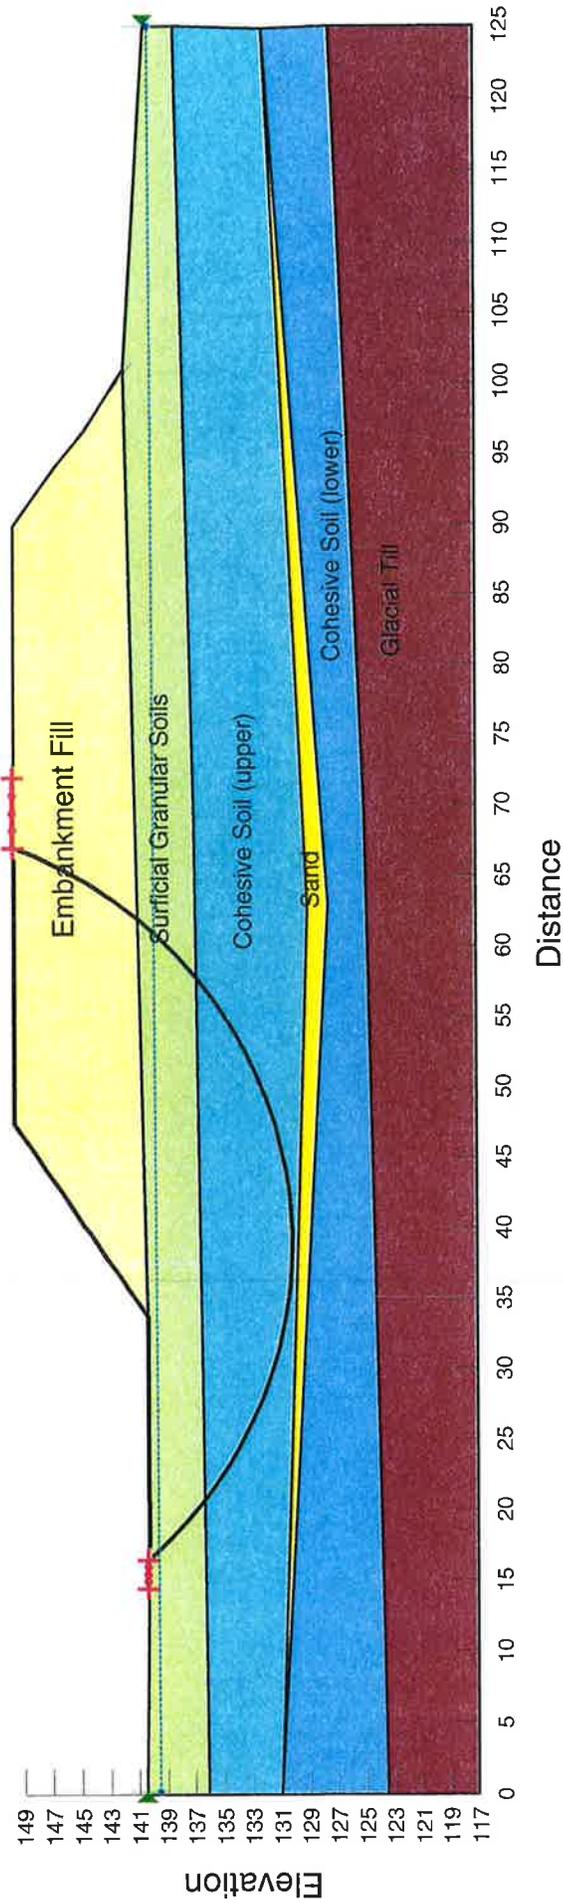
Name: Embankment Fill Model: Mohr-Coulomb Unit Weight: 21 Cohesion: 0 Phi: 32 Phi-B: 0 Piezometric Line: 1
 Name: Surficial Granular Soils Model: Mohr-Coulomb Unit Weight: 20 Cohesion: 0 Phi: 30 Phi-B: 0 Piezometric Line: 1
 Name: Cohesive Soil (upper) Model: S=f(depth) Unit Weight: 18 Piezometric Line: 1 C-Top of Layer: 15 C-Rate of Change: 3.5 Limiting C: 40
 Name: Sand Model: Mohr-Coulomb Unit Weight: 20.5 Cohesion: 0 Phi: 33 Phi-B: 0 Piezometric Line: 1
 Name: Cohesive Soil (Lower) Model: Undrained (Phi=0) Unit Weight: 18.5 Cohesion: 60 Piezometric Line: 1
 Name: Glacial Till Model: Mohr-Coulomb Unit Weight: 22 Cohesion: 0 Phi: 36 Phi-B: 0 Piezometric Line: 1

Figure J-1 Previous embankment failure (short term analysis)

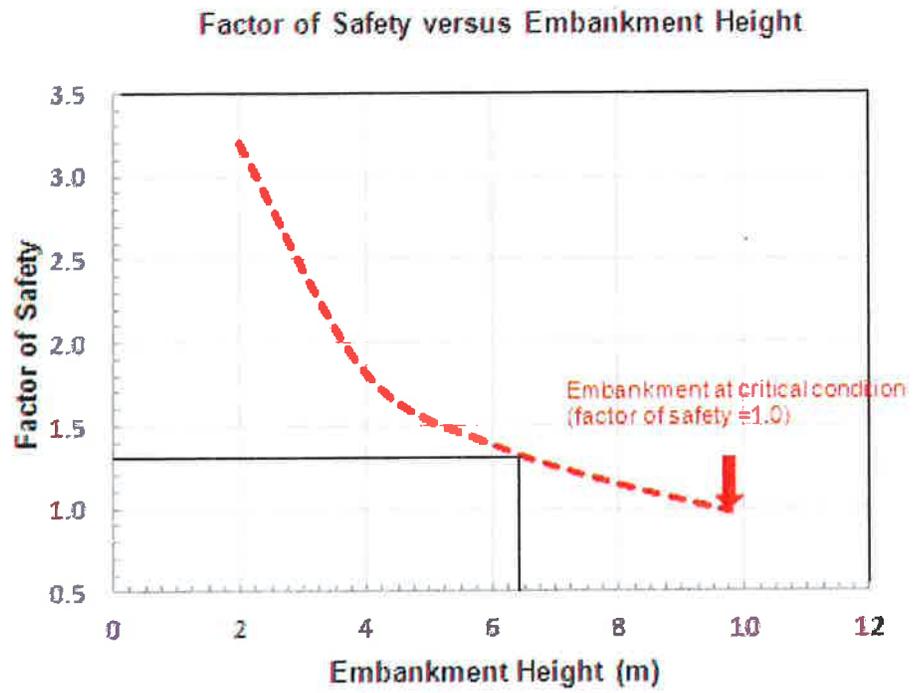
Figure J-2 Factor of safety vs embankment height

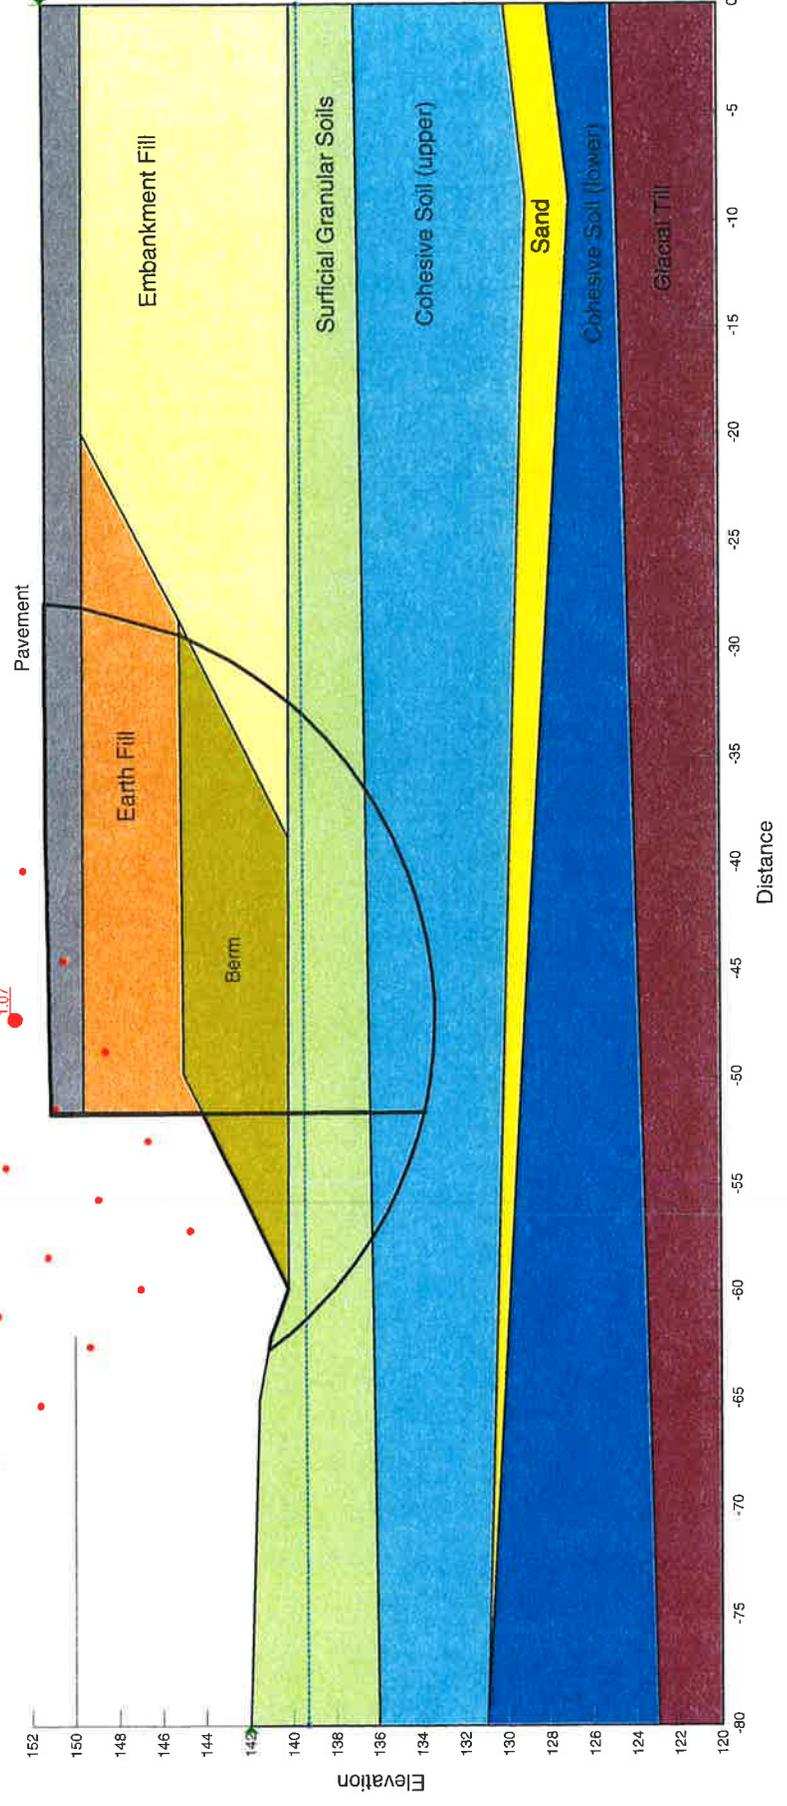
Figure J-4 New embankment with earth fill (short term)

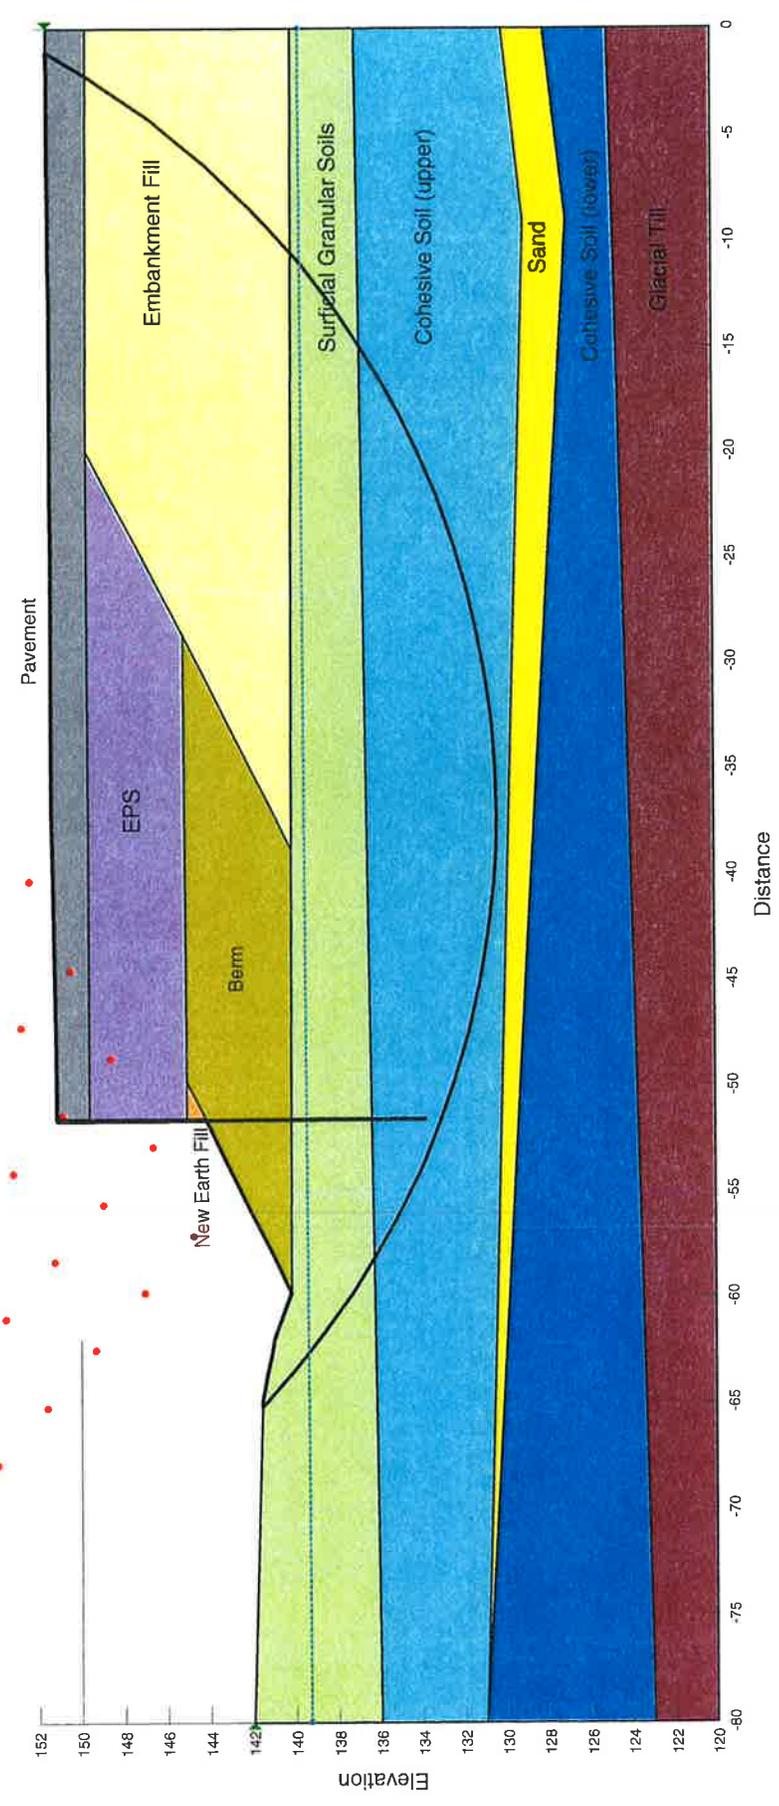
Figure J-5 New embankment with EPS (short term)

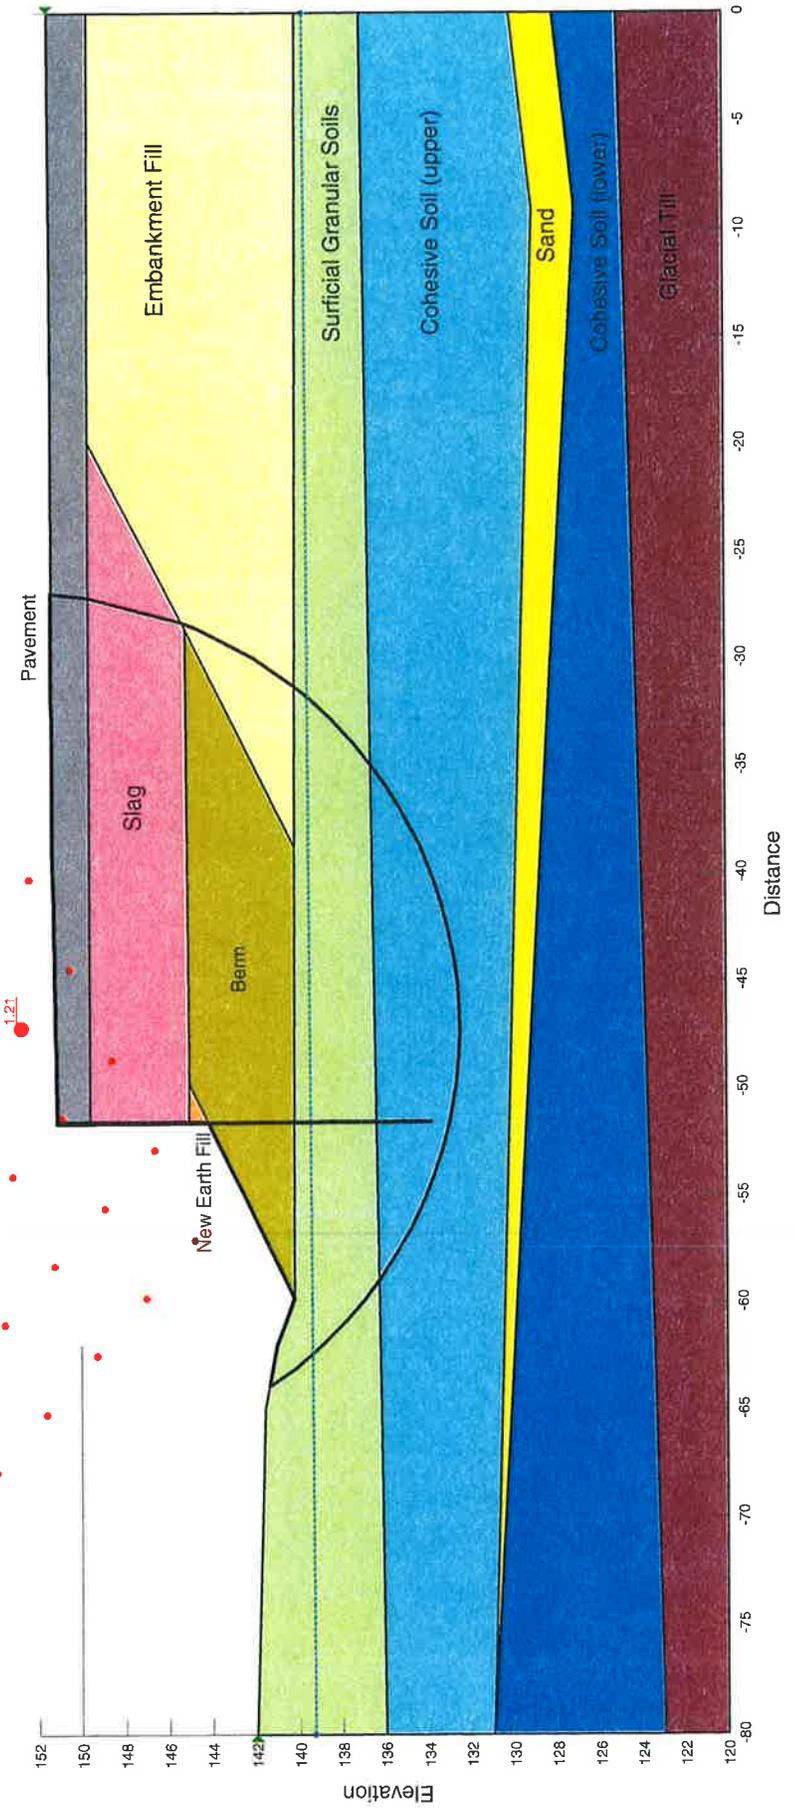
Figure J-6 New embankment with slag (short term)

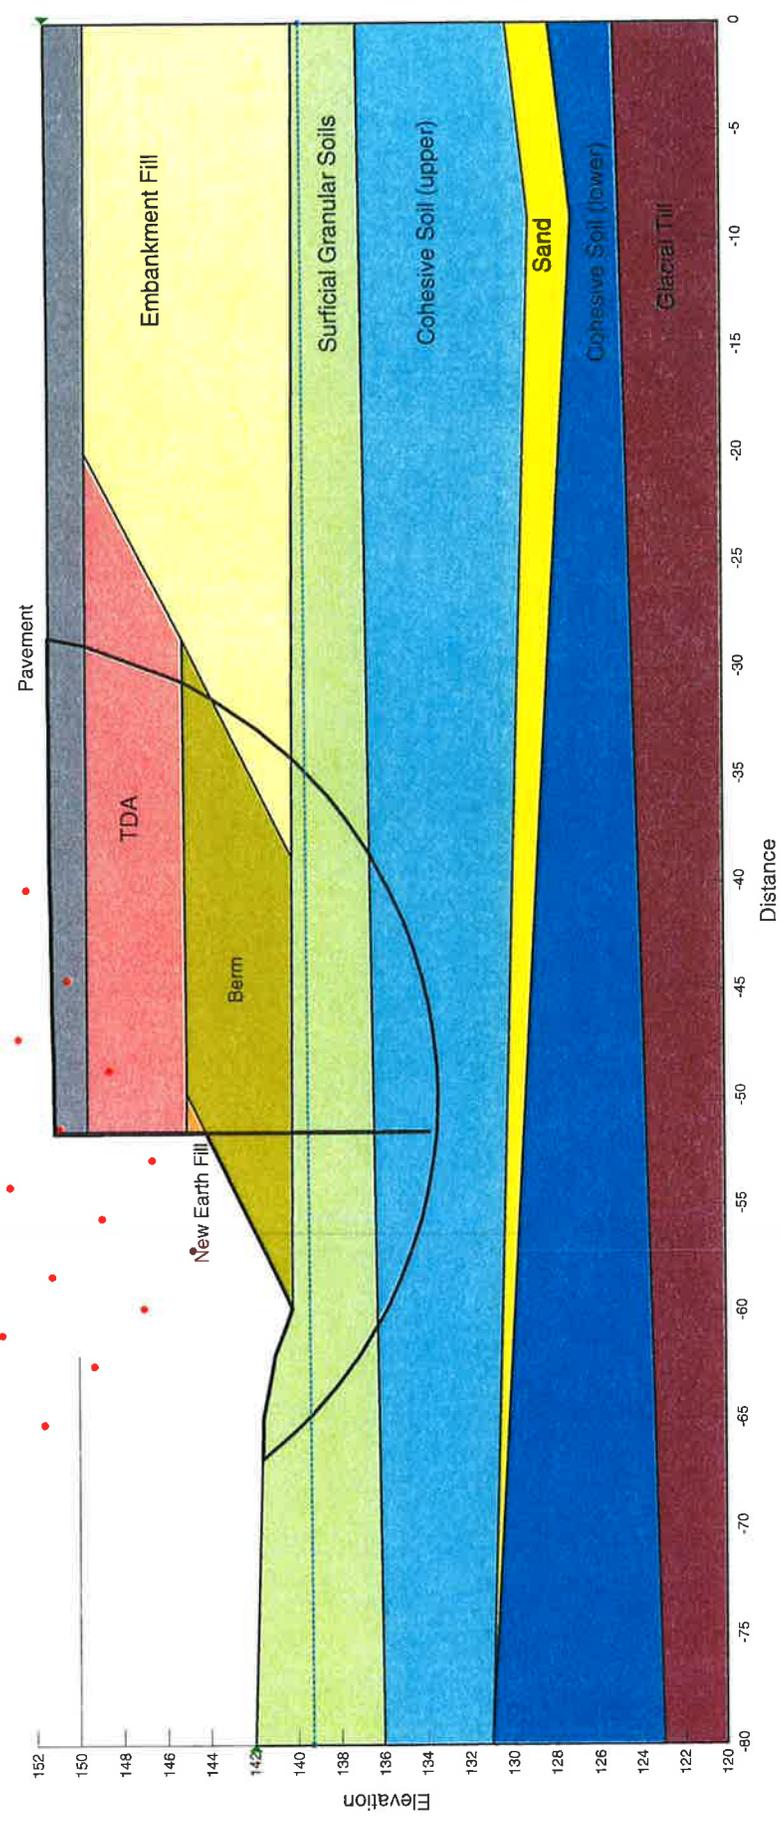
Figure J-7 New embankment with TDA (short term)
