**PRELIMINARY  
FOUNDATION INVESTIGATION REPORT  
HIGHWAY 17 TWINNING, RENFREW AREA  
CULVERT 105  
DUGALD ROAD, STA. 9+890, HORTON TOWNSHIP  
WP 4068-09-00 / ASSIGNMENT NO. 4018-E-0009**

Geocres No.: 31F07-003

December 2024  
Thurber File No.: 24726

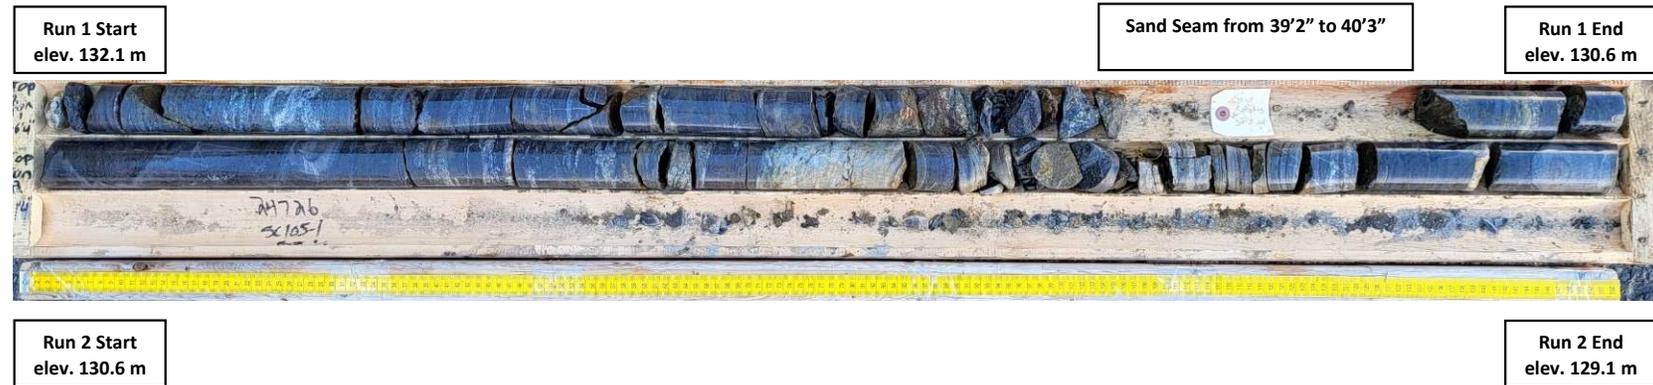
**Borehole SC105-1**  
**Runs 1 and 2**  
**Depth 11.1 to 14.1 m**  
**Elevation 132.1 to 129.1 m**  
**Dry Sample**

**Borehole SC105-1**  
**Runs 1 and 2**  
**Depth 11.1 to 14.1 m**  
**Elevation 132.1 to 129.1 m**  
**Wet Sample**

The bedrock encountered consisted of fine to medium grained, grey to greyish white, strong marble. Sand seams were encountered within the weathered joints. Photographs of the bedrock cores are provided in Appendix C. The rock core quality measurements are summarized in Table 5-1.

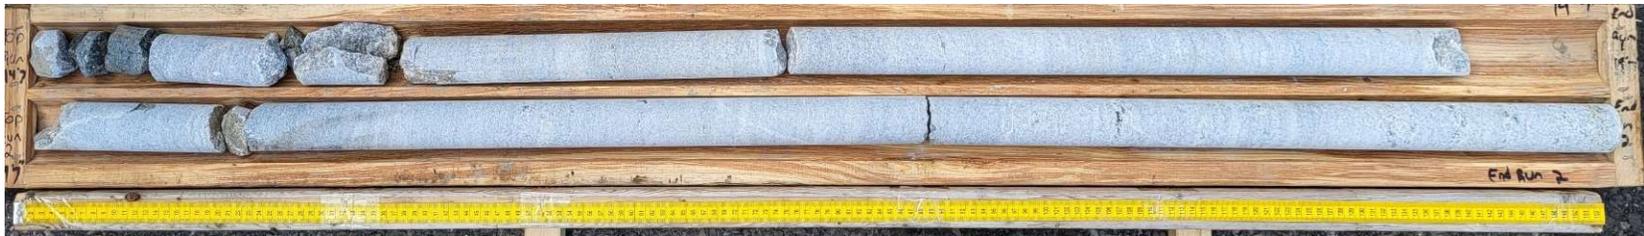
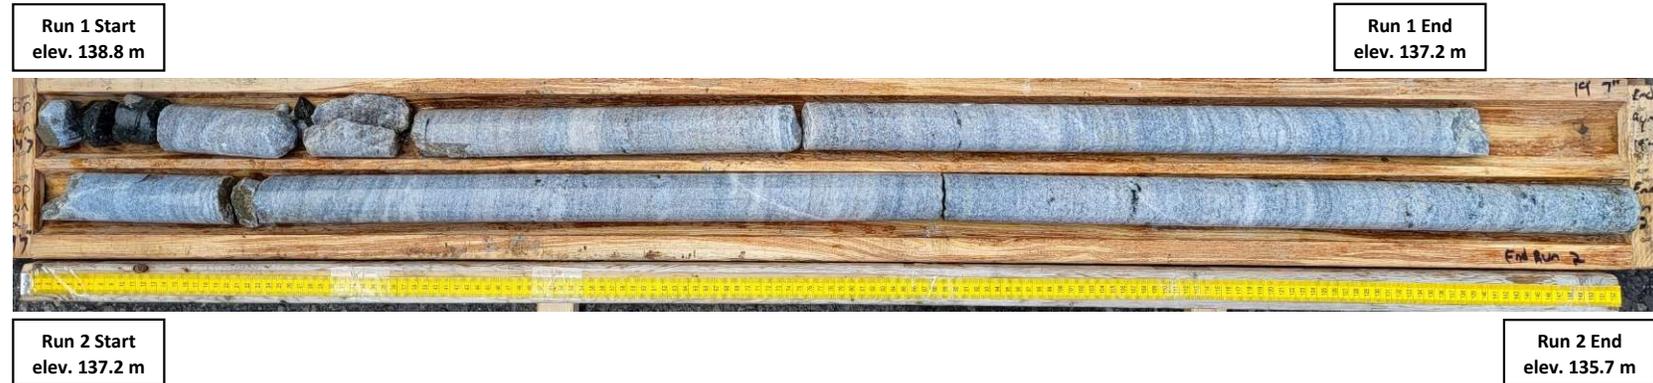
Run 1 Start  
elev. 138.8 m

Run 1 End  
elev. 137.2 m

**Borehole SC105-2**  
**Runs 1 and 2**  
**Depth 4.4 to 7.5 m**  
**Elevation 138.8 to 135.7 m**  
**Wet Sample**

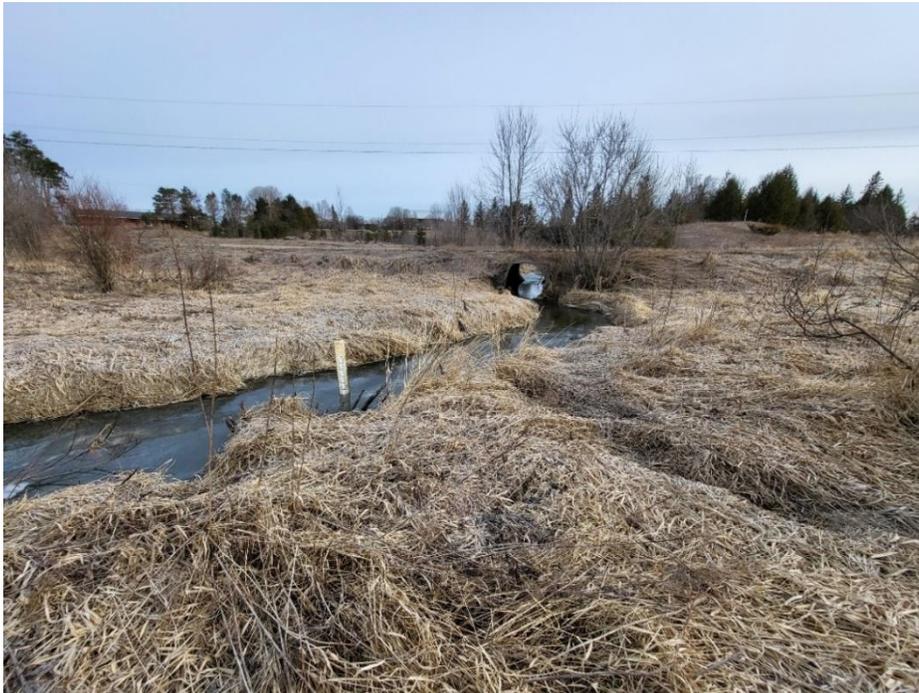
**Photo 1. Looking northeast near Station 9+890 (March 22, 2024)**  
**Note: private driveway and CSP to northeast of the site.**

The land adjacent to the site generally consists of undeveloped agricultural fields. The terrain is relatively flat in the vicinity of the proposed culvert site and generally more rugged along the creek. The area directly adjacent to the proposed culvert is a low-lying marsh dominated with grasses and transitions to mostly farmland with some deciduous trees and shrubs found along the creek line. A driveway crossing an 1,800 mm diameter culvert is currently located approximately 20 m northeast of the site. Overhead utility lines parallel that driveway.
