**PRELIMINARY
FOUNDATION INVESTIGATION REPORT
HIGHWAY 17 TWINNING, RENFREW AREA
CULVERTS 20 AND 20N
STA. 24+936, HORTON TOWNSHIP
WP 4068-09-00 / ASSIGNMENT NO. 4018-E-0009**

Geocres No.: 31F07-006

December 2024
Thurber File No.: 24726

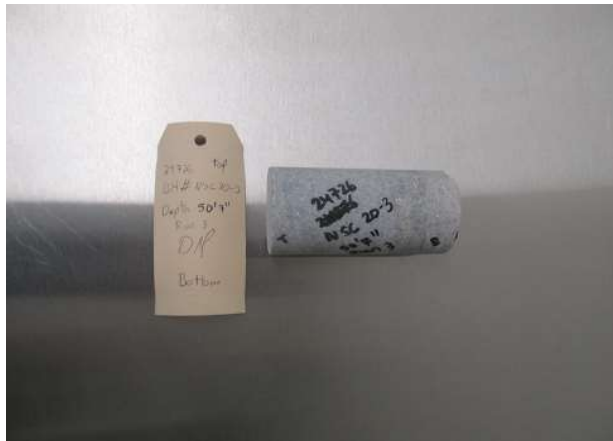
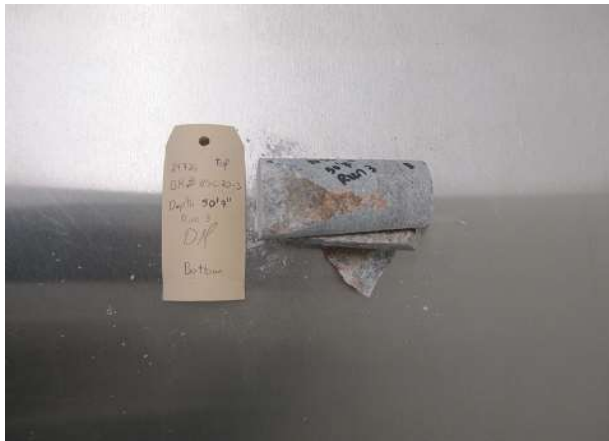
Avg. Height (cm):	9.5	Weight (g):	470.3
Avg. Diameter (cm):	4.7	Wet Density (kg/m ³):	2,853
H. to Dia. Ratio**:	2:1	Dry Density (kg/m ³):	2,853
Cross Sectional Area (cm ²):	17.35	Moisture Content* (%):	N/A
Sample Volume (cm ³):	164.82

ORIGINAL SPECIMEN

FRACTURED SPECIMEN

AVG. RATE OF STRAIN TO FAILURE:	0.250 MPa/s
MAXIMUM COMPRESSIVE LOAD:	113.4 kN
UNCONFINED COMPRESSIVE STRENGTH:	65.4 MPa

The RQD values ranged from 0 to 100% but were typically less than 37%, indicating a bedrock of very poor to poor quality (CFEM, 2023). The fracture index was typically greater than 10 fractures per 0.3 m. The results of unconfined compressive strength tests (UCS) were 54 to 65 MPa, indicating that the tested samples of the bedrock are strong (CFEM, 2023). The UCS test results are included in Appendix C.

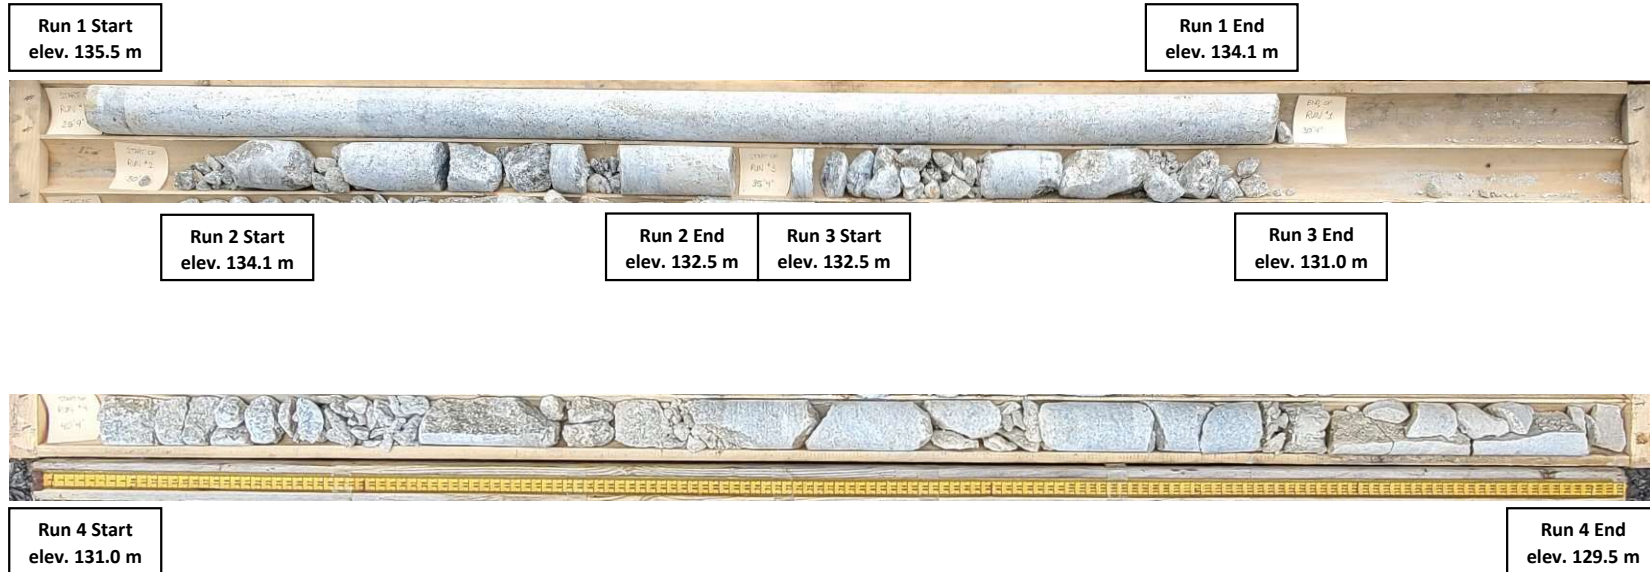
Borehole NSC20-2
Run 1, 2, 3 and 4
Depth 7.8 to 13.8 m
Elevation 135.5 to 129.5 m
Dry Sample

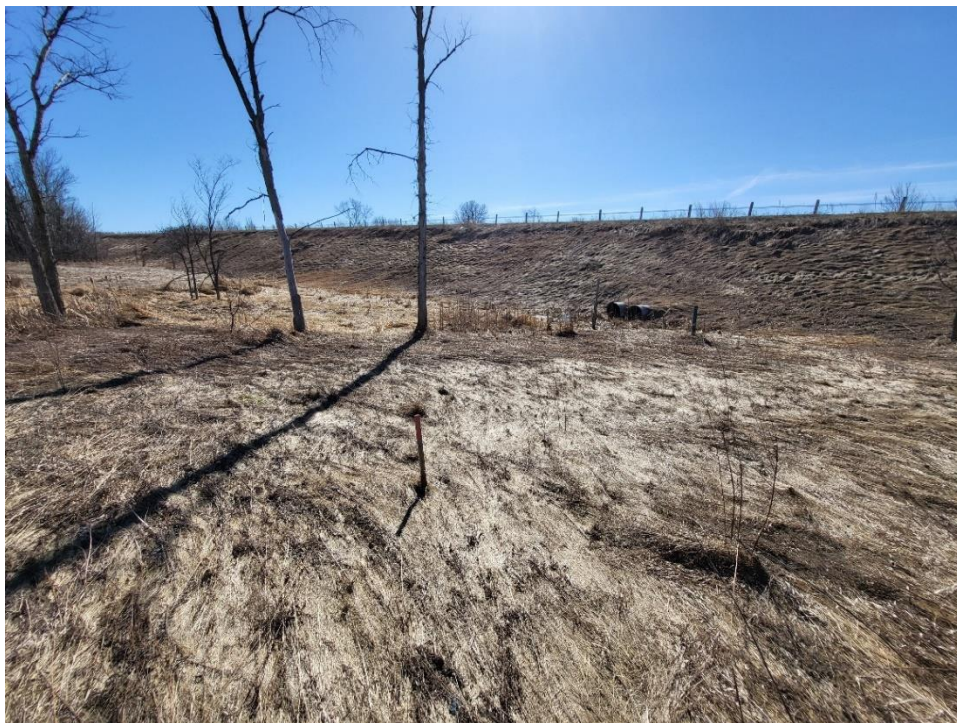
Photo 2. Looking south at culvert inlet (March 12, 2024)

The existing culverts under the existing Highway 17 embankment are twin 1,220 mm diameter, 49.7 m long, corrugated steel pipe (CSP) culverts with an approximate skew of 55° to the highway alignment. The culvert has an approximate gradient of approximately 0.6% with the invert of the culvert being near elevations 142.5 and 142.2 m at the inlet and outlet, respectively. The cover above the existing culvert is approximately 5.0 m at the highway centerline. The creek flows through the culvert under the highway embankment from north to south. It is understood that the general drainage is near parallel to the south side of the highway alignment to the west of the culvert. The depth of standing water near the inlet and outlet was measured as 1,130 mm and 730 mm, respectively, on July 26, 2024.

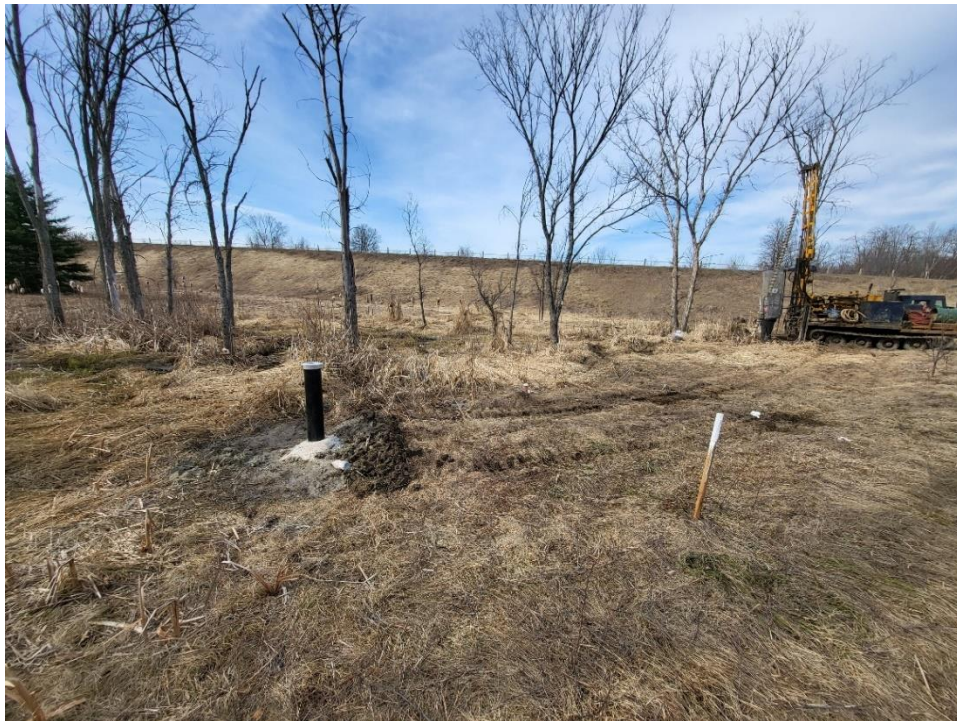
Photo 4. Looking south at the well protection for Borehole NSC20-1 (April 02, 2024)

A 50 mm diameter monitoring well was installed in each of Boreholes NSC20-1 and NS21-09 to allow for measurements of the groundwater level after drilling. The details of the well installations are illustrated on the respective Record of Borehole sheets provided in Appendix B. The monitoring wells installed as part of the current investigation will be decommissioned by Thurber, as outlined in the Hydrogeological Investigation and Design Report.
