**PRELIMINARY  
FOUNDATION INVESTIGATION REPORT  
HIGHWAY 17 TWINNING, RENFREW AREA  
CULVERT 23  
HIGHWAY 17, STA. 10+993, MCNAB TOWNSHIP  
WP 4068-09-00 / ASSIGNMENT NO. 4018-E-0009**

Geocres No.: 31F07-004

December 2024  
Thurber File No.: 24726

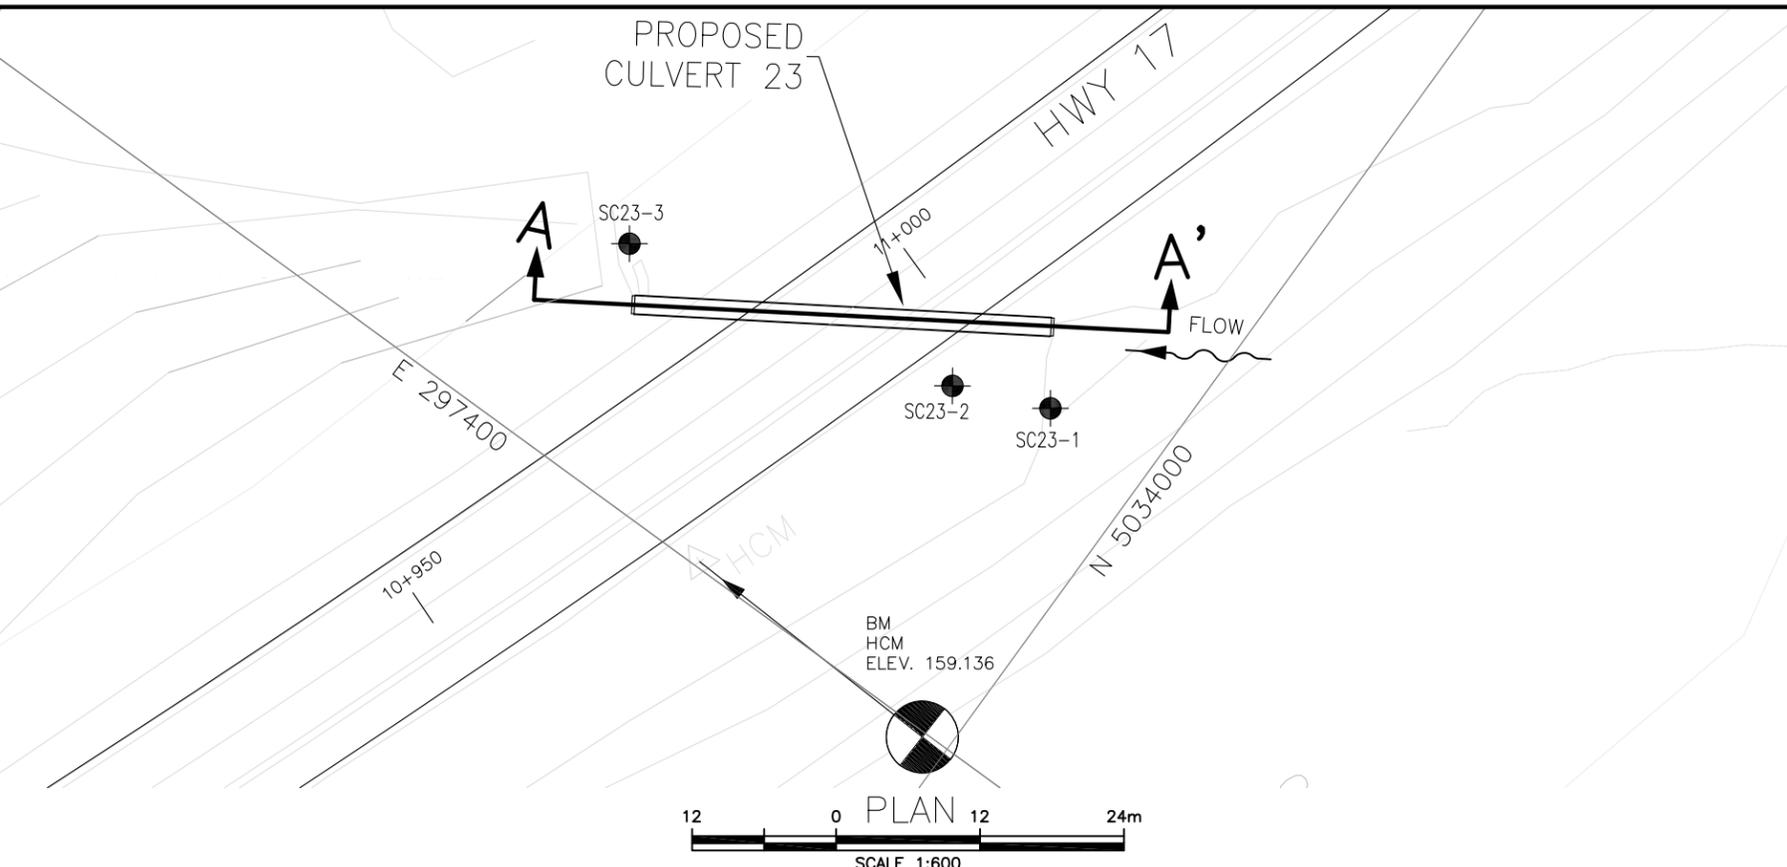
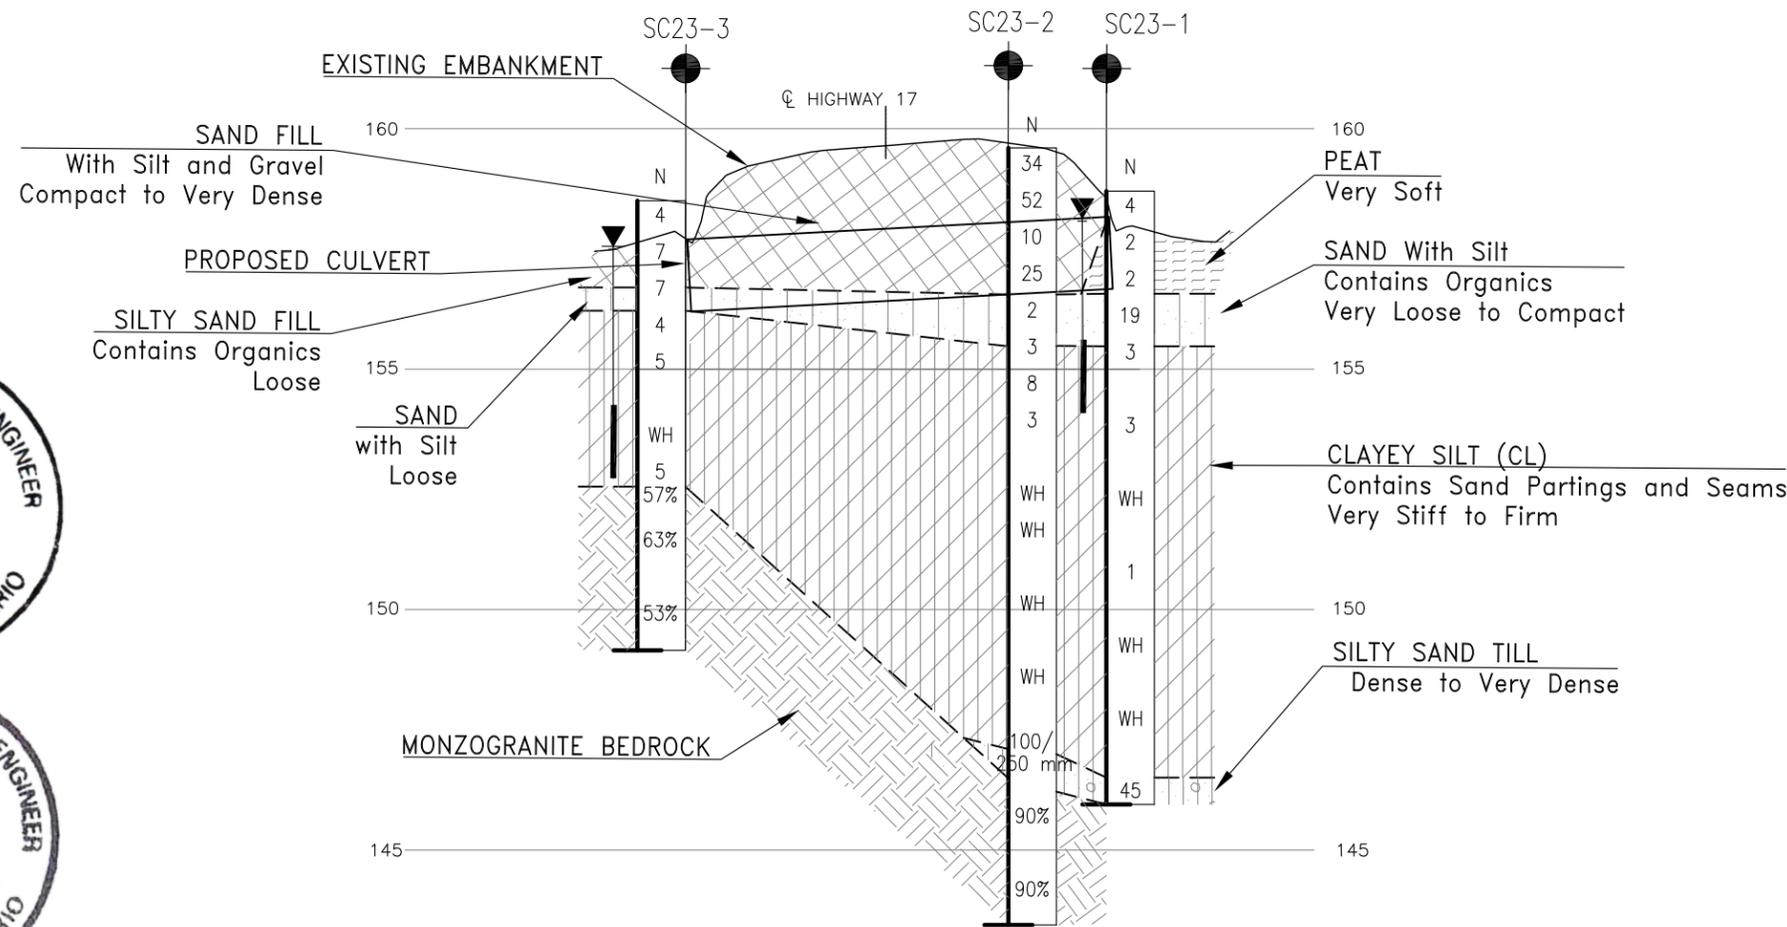
CONT No  
GWP No 4068-09-00  
HIGHWAY 17 TWINNING  
STA. 10+993, MCNAB TOWNSHIP  
CULVERT 23  
BOREHOLE LOCATION PLAN AND SOIL STRATA

Details of the encountered soil stratigraphy are presented on the Record of Borehole sheets included in Appendix B and the Borehole Location and Soil Strata Drawing included in Appendix A. A general description of the stratigraphy based on the conditions encountered in the boreholes is given in the following sections. However, the factual data presented on the Borehole Records takes precedence over the Soil Strata Drawing and the general description. It must be recognized that the soil and groundwater conditions may vary between and beyond borehole locations. Soil classification is in accordance with MTO Guideline for Foundation Engineering Services (GFES) Manual (April 2022) and the 4th Edition of the Canadian Foundation Engineering Manual.

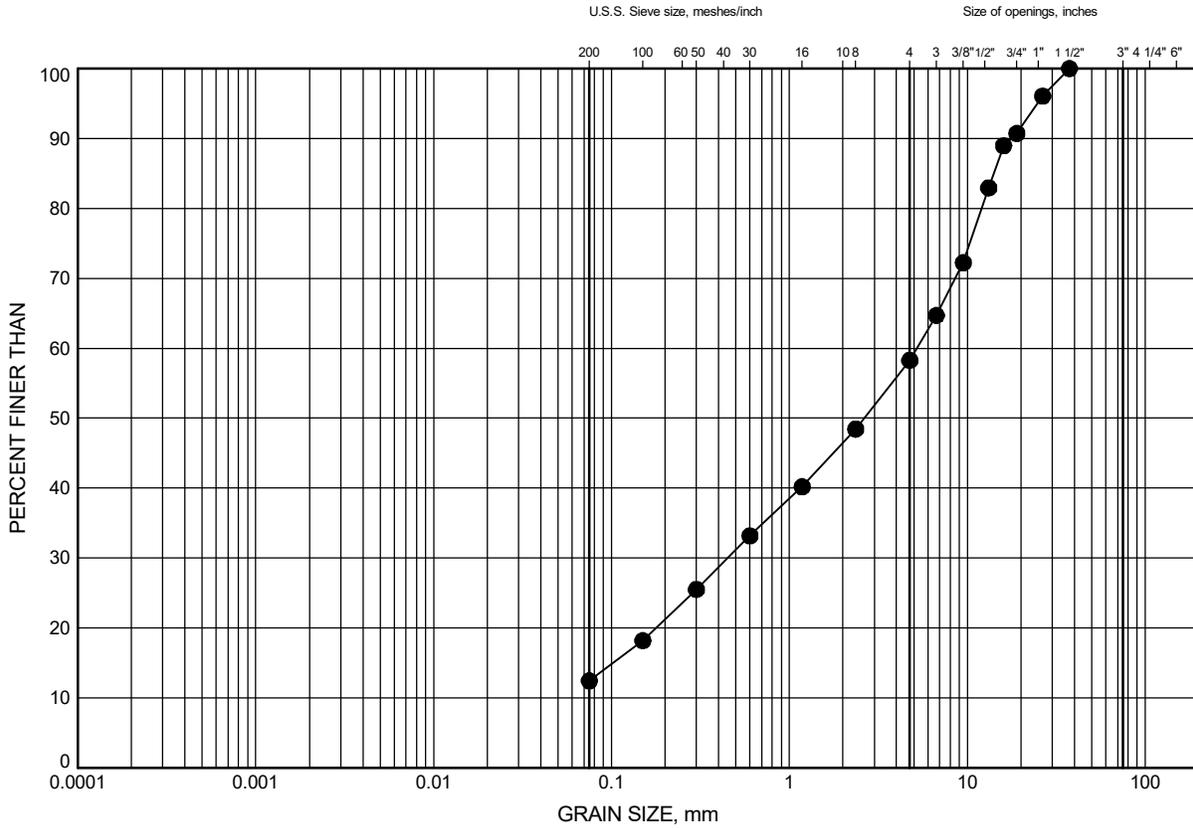
FIGURE C1

**FILL: Sand with Silt and Gravel**

The moisture content of the samples tested ranged from 1 to 23% but typically less than 4%. The results of a grain size analysis conducted on a sample of this fill material are summarized below and are illustrated on Figure C1 in Appendix C.

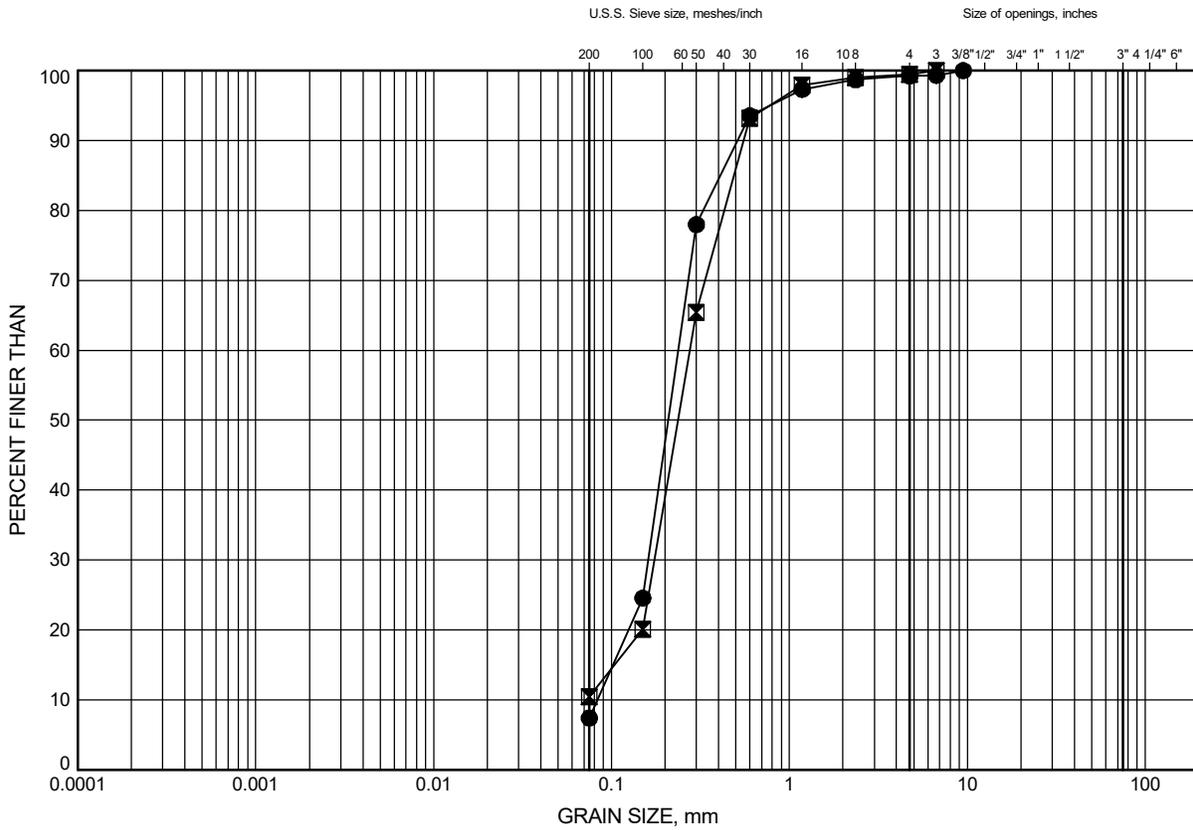
FIGURE C2

**Sand with Silt**

The moisture content of the samples tested ranged from 21 to 68%. The results of gradation analyses completed on two samples of the layer are illustrated in Figure C2 of Appendix C. The results of the tests are summarized below and on the Record of Borehole sheets in Appendix B.

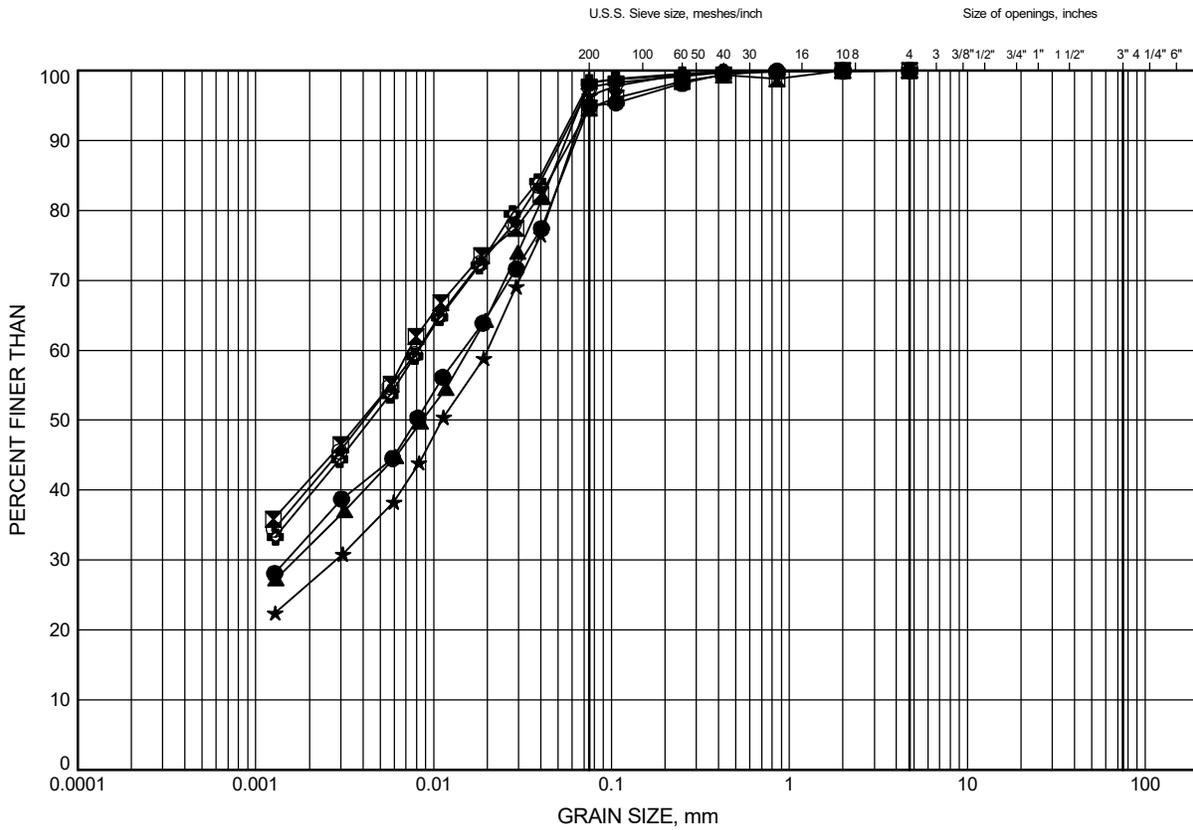
FIGURE C3

**Clayey Silt (CL)**

The moisture content of the samples tested ranged from 18 to 47% but were typically greater than 27%. The results of grain size analysis tests conducted on six samples of this material are summarized in the table below and are illustrated in Figure C3 in Appendix C.

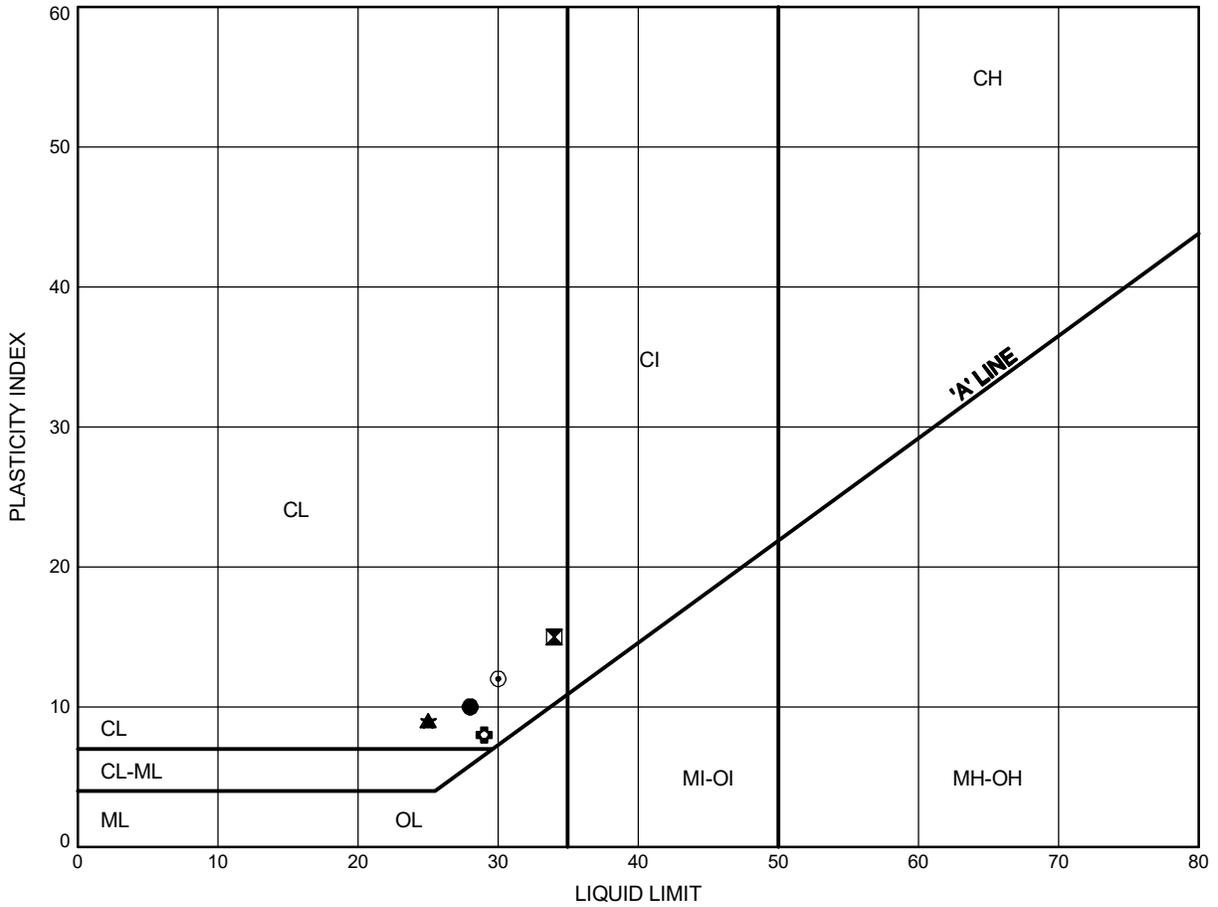
FIGURE C4

Clayey Silt (CL)

SYMBOL	BOREHOLE	DEPTH (m)	ELEV. (m)
●	SC23-1	7.9	150.8
⊠	SC23-2	4.9	154.7
▲	SC23-2	7.9	151.7
★	SC23-2	12.3	147.3
⊙	SC23-3	2.6	155.9
⊕	SC23-3	4.9	153.6

The results of Atterberg Limits testing carried out on six samples of this material are summarized below and are illustrated in Figure C4 in Appendix C. The laboratory results indicate that the clayey silt is of low plasticity (CL).

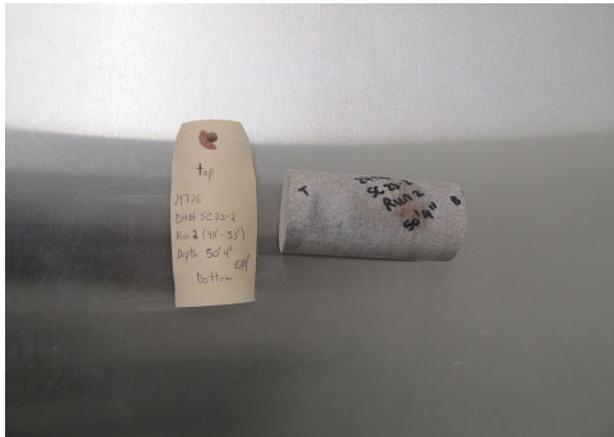
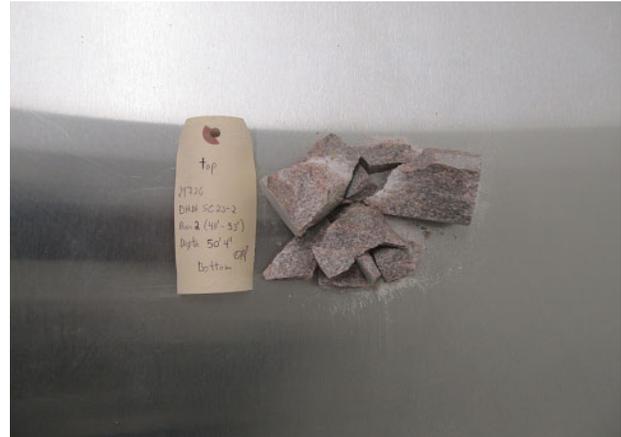
Avg. Height (cm):	9.5	Weight (g):	434.0
Avg. Diameter (cm):	4.7	Wet Density (kg/m <sup>3</sup> ):	2,633
H. to Dia. Ratio**:	2:1	Dry Density (kg/m <sup>3</sup> ):	2,633
Cross Sectional Area (cm <sup>2</sup> ):	17.35	Moisture Content* (%):	N/A
Sample Volume (cm <sup>3</sup> ):	164.82

AVG. RATE OF STRAIN TO FAILURE:	0.250 MPa/s
MAXIMUM COMPRESSIVE LOAD:	223.2 kN
UNCONFINED COMPRESSIVE STRENGTH:	128.6 MPa

The RQD values ranged from 53 to 90%, indicating a bedrock of fair to excellent quality (CFEM, 2023). The results of unconfined compressive strength tests (UCS) were 104 and 128 MPa, indicating that the tested samples of the bedrock are very strong (CFEM, 2023). The UCS test results are included in Appendix C.

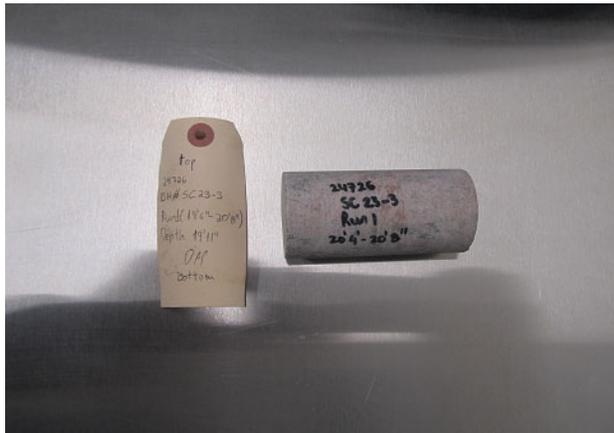
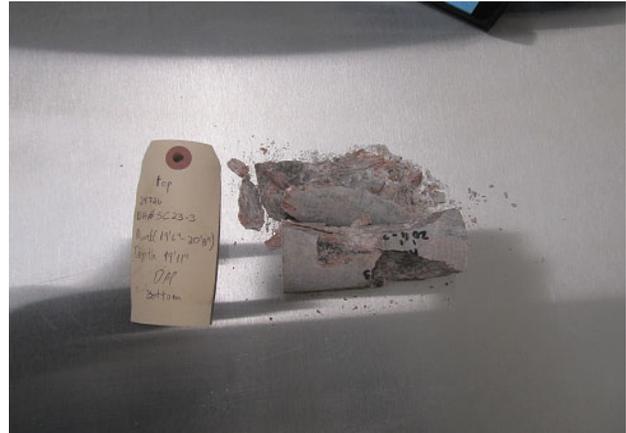
Avg. Height (cm):	9.6	Weight (g):	436.1
Avg. Diameter (cm):	4.7	Wet Density (kg/m <sup>3</sup> ):	2,618
H. to Dia. Ratio**:	2:1	Dry Density (kg/m <sup>3</sup> ):	2,618
Cross Sectional Area (cm <sup>2</sup> ):	17.35	Moisture Content* (%):	N/A
Sample Volume (cm <sup>3</sup> ):	166.55

AVG. RATE OF STRAIN TO FAILURE:	0.250 MPa/s
MAXIMUM COMPRESSIVE LOAD:	181.2 kN
UNCONFINED COMPRESSIVE STRENGTH:	104.4 MPa

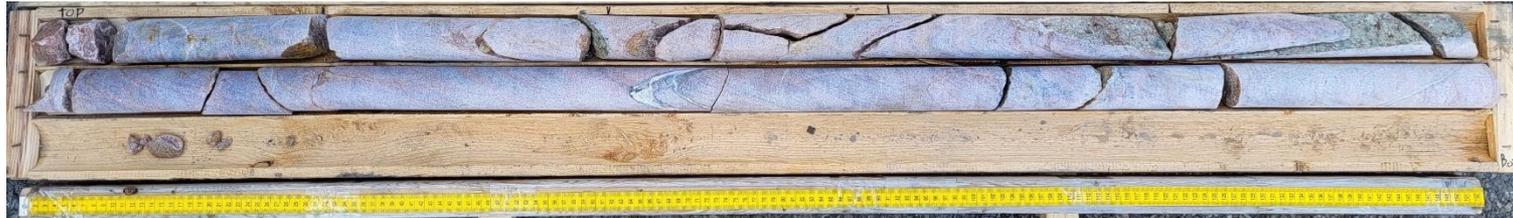
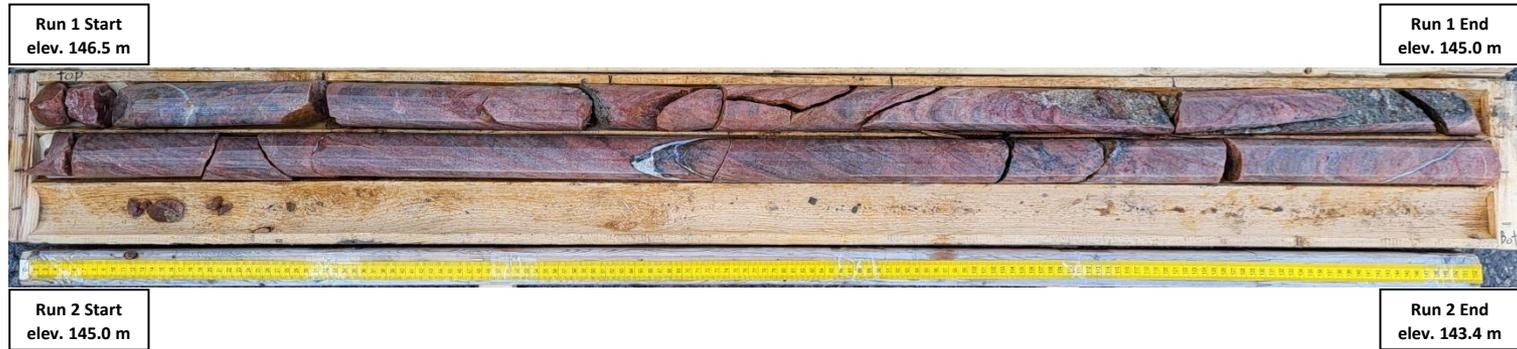
**Borehole SC23-2**  
**Run 1 and 2**  
**Depth 13.1 to 16.2 m**  
**Elevation 146.5 to 143.4 m**  
**Wet Sample**

The bedrock encountered consisted of slightly weathered to fresh jointed, coarse grained, light pinkish red monzogranite. Photographs of the bedrock cores are provided in Appendix C. The rock core quality measurements are summarized in the Table 5-1.

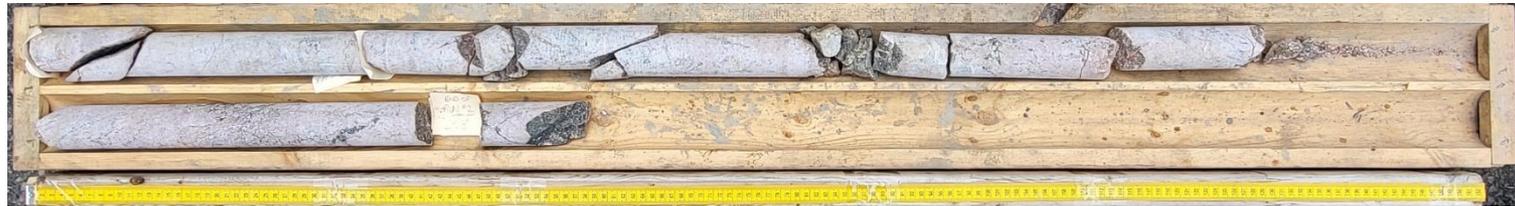
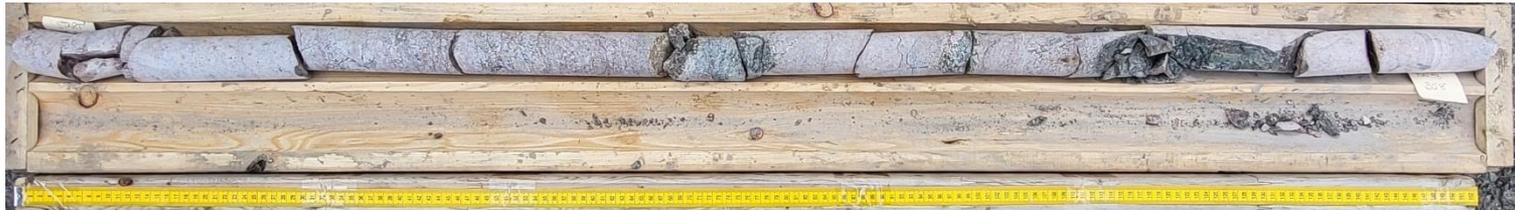
**Borehole SC23-3**  
**Run 1, 2, and 3**  
**Depth 5.9 to 9.3 m**  
**Elevation 152.6 to 149.2 m**  
**Dry Sample**

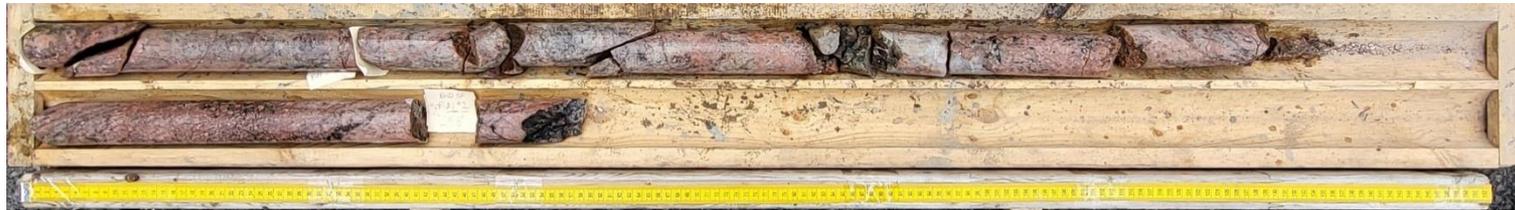
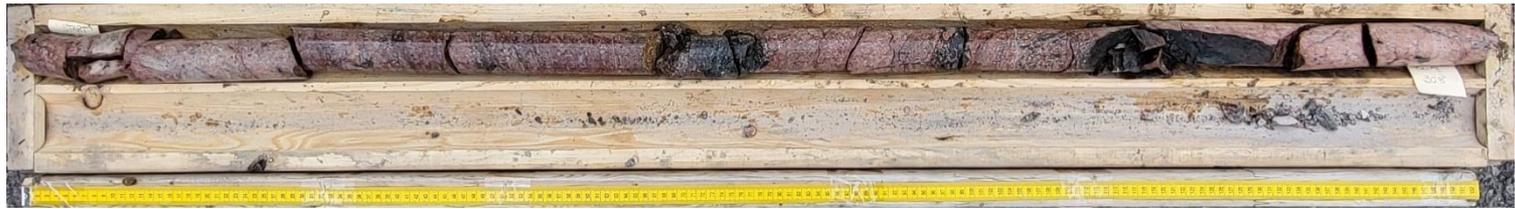
**Borehole SC23-3**  
**Run 1, 2, and 3**  
**Depth 5.9 to 9.3 m**  
**Elevation 152.6 to 149.2 m**  
**Wet Sample**

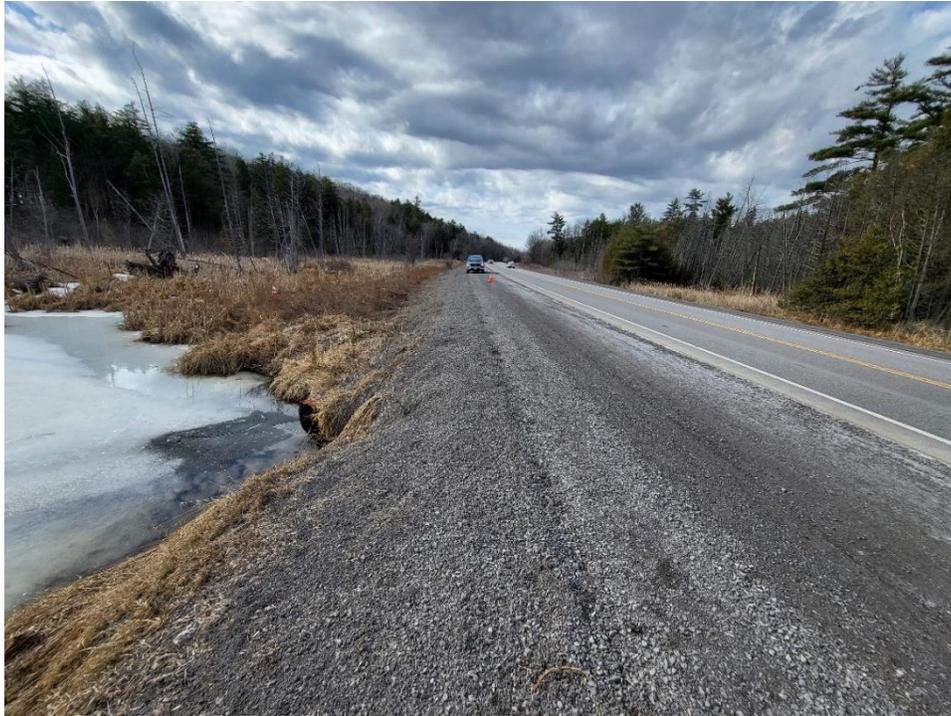
**Photo 1. Looking west along frozen ponded water and culvert inlet (March 5, 2024)**

At the time of the field investigation frozen water was ponded near both inlet and outlet with both ends of the culvert visible (see Photos 1 and 2). However, during Thurber’s site visit on July 26, 2024, the culvert inlet was submerged (see Photo 3), and ponded water had a depth of approximately 0.8 m near the culvert outlet; the water surface was at approximate elevations of 158.4 and 158.0 m near the inlet and outlet, respectively.

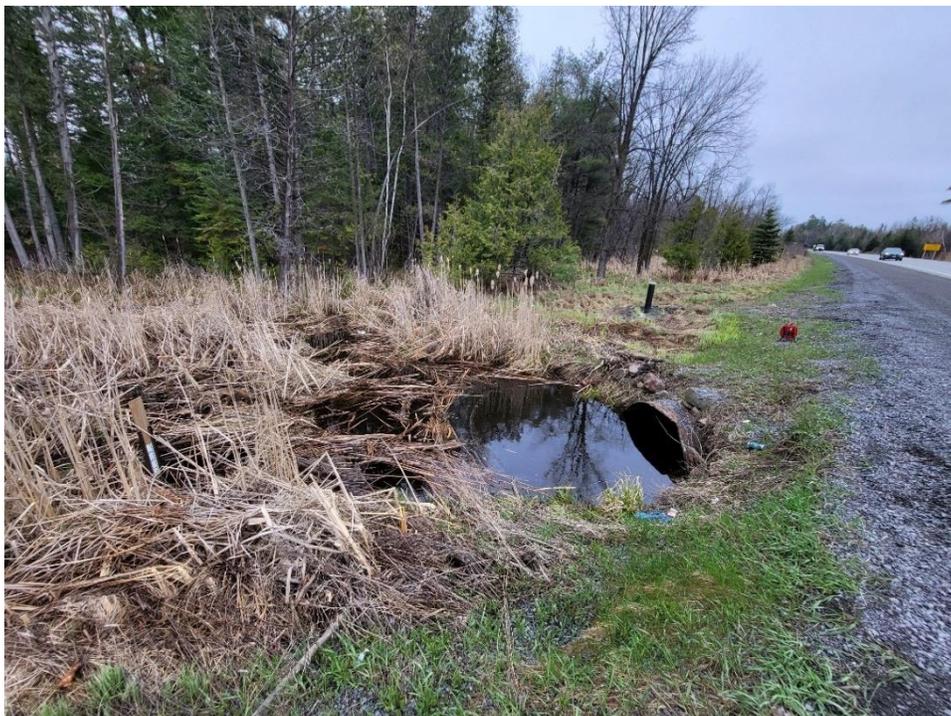
**Photo 2. Looking east along north embankment and culvert outlet (May 01, 2024)**

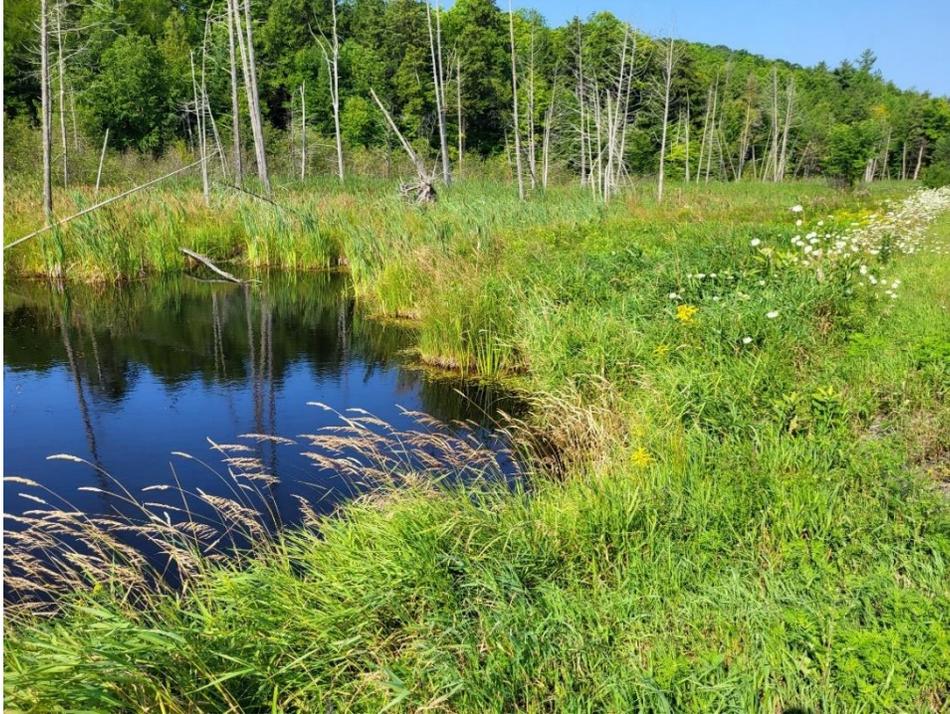
**Photo 3. Looking west along ponded water near culvert inlet (July 26, 2024)**
