**FOUNDATION INVESTIGATION AND DESIGN REPORT
LAMBTON COUNTY ROAD 79 UNDERPASS (SITE 14-355)
STRUCTURAL REHABILITATION
HIGHWAY 402 AND LAMBTON COUNTY ROAD 79 IMPROVEMENTS
GWP 3158-06-00
WATFORD, ONTARIO**

April 15, 2008

07-1130-128-4-2
Geocres No. 40I13-54

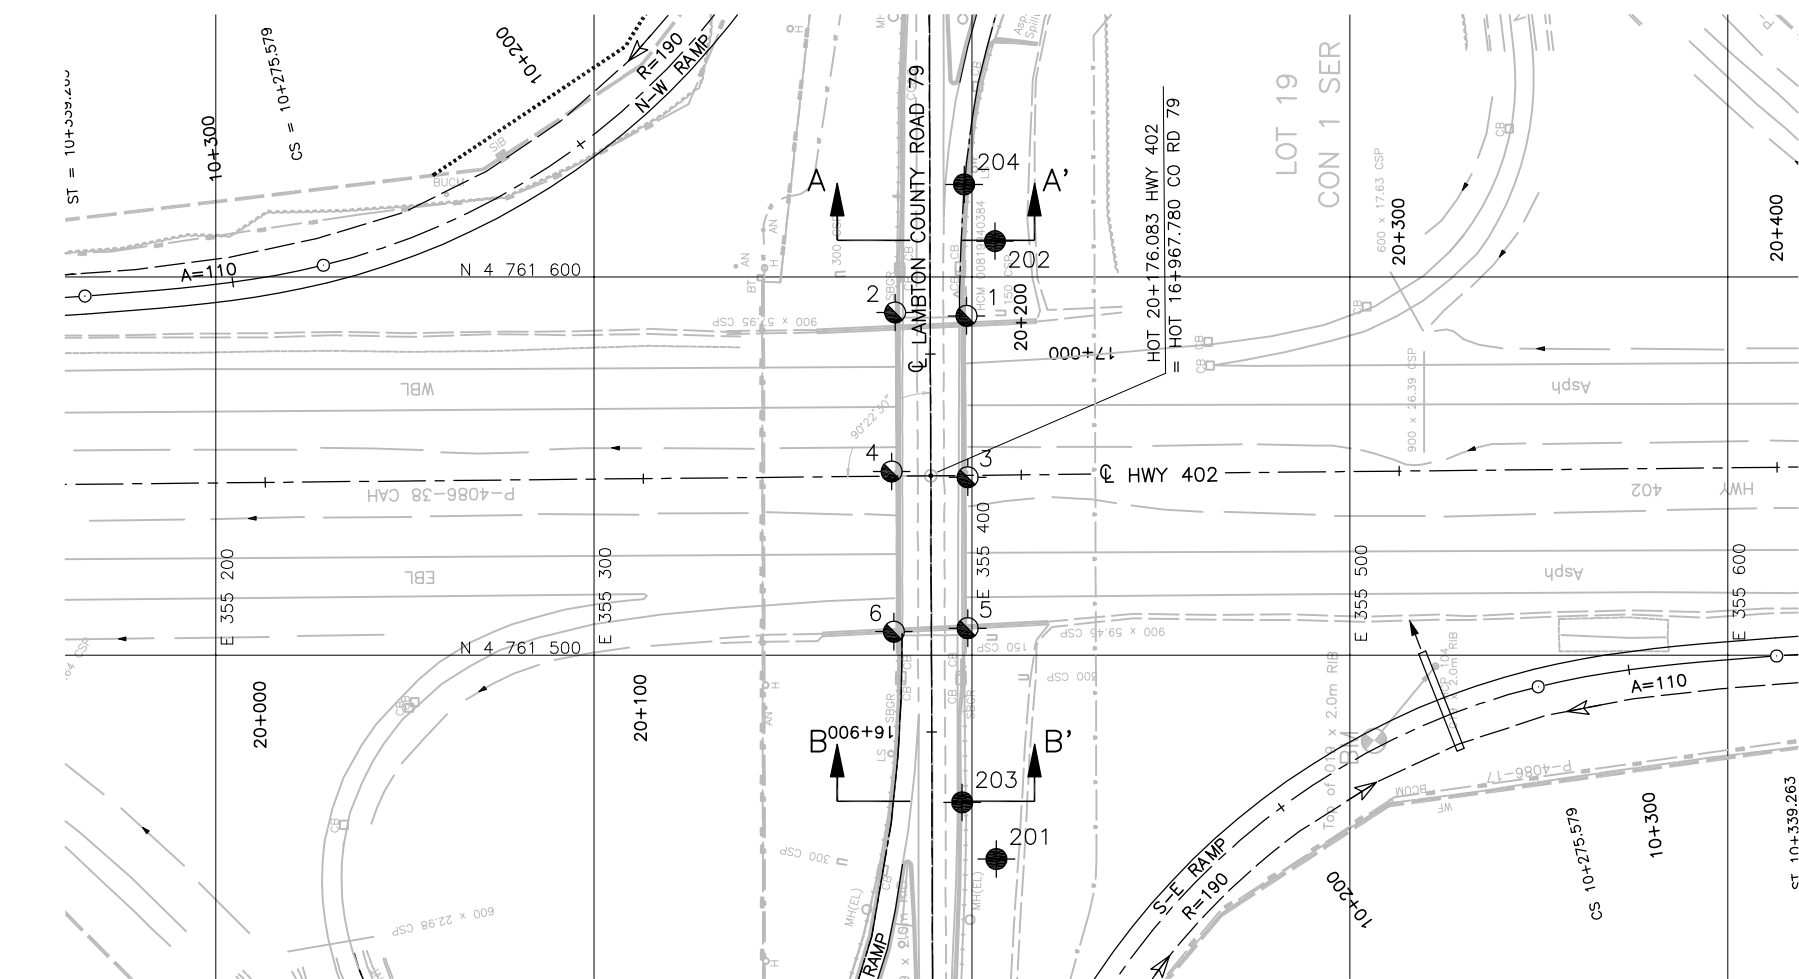
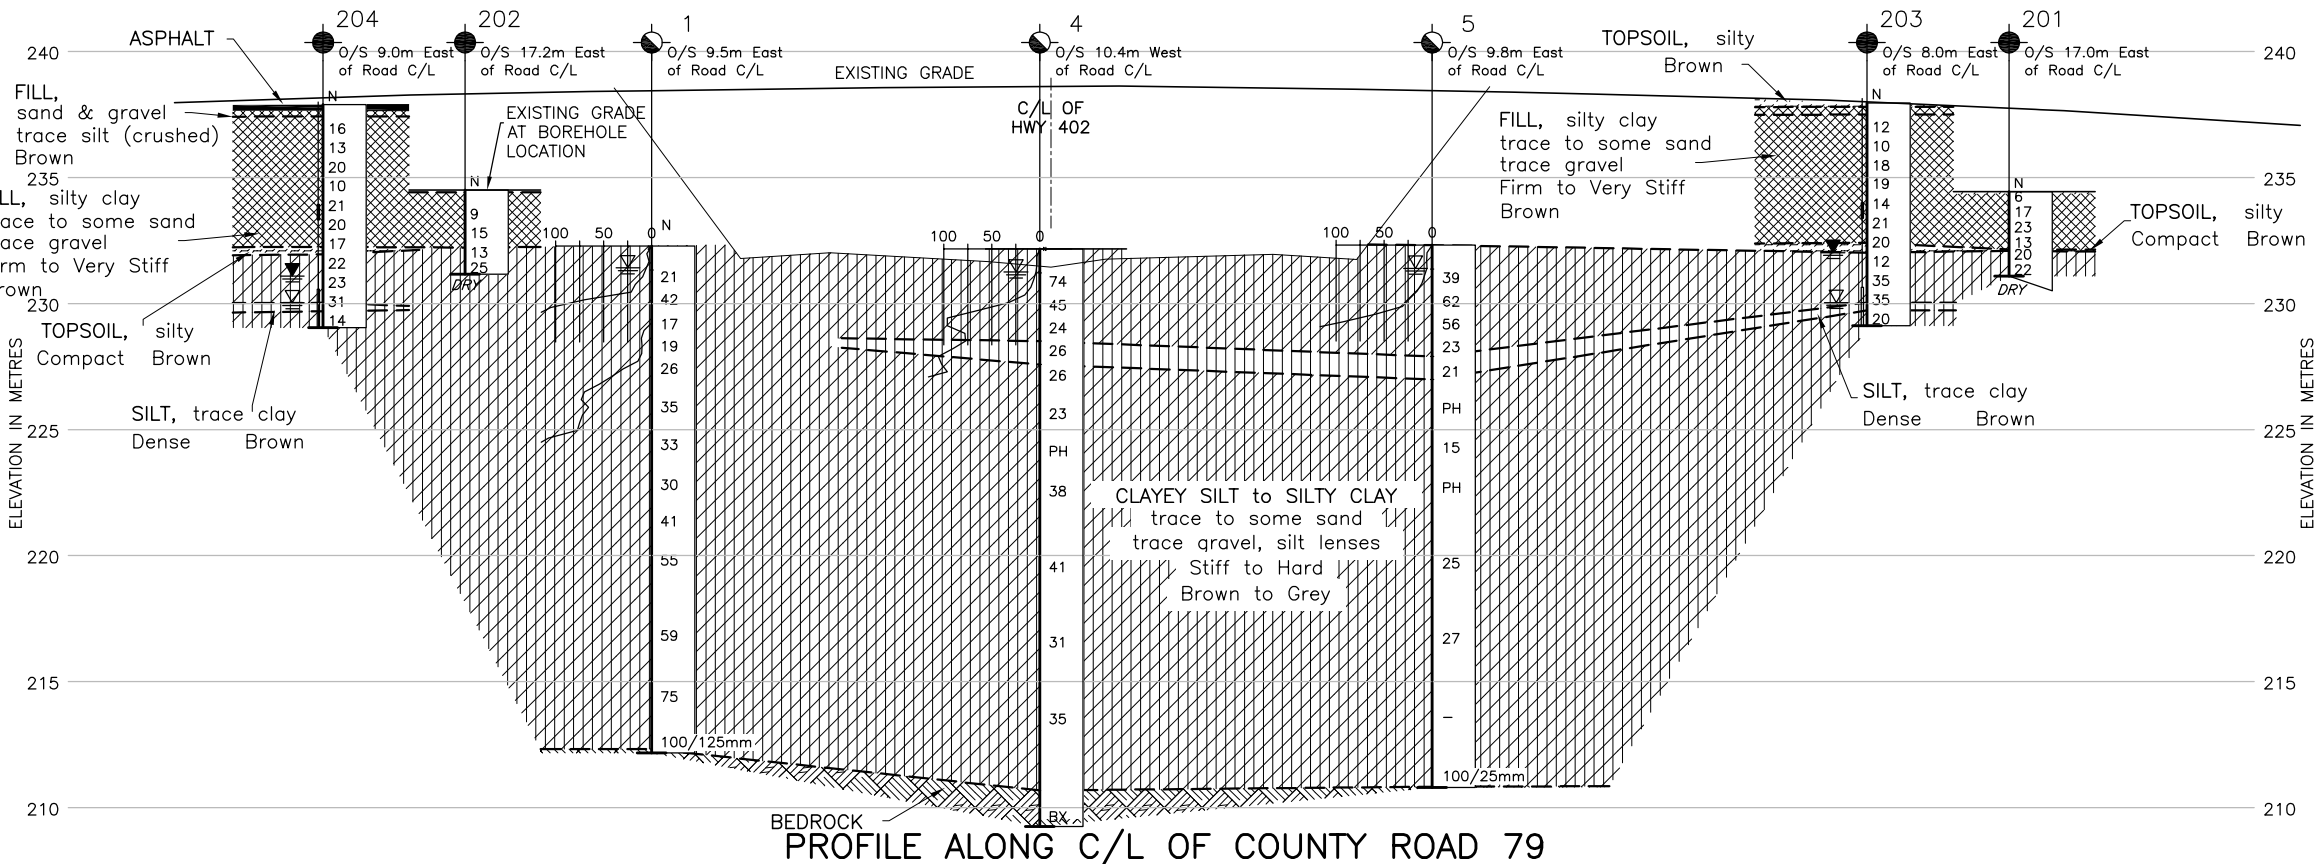
PROFILE ALONG C/L OF COUNTY ROAD 79

The locations and elevations of the boreholes, together with the interpreted stratigraphic profiles, are shown on the attached Drawings 1 and 2. A detailed description of the subsurface conditions encountered in the boreholes is provided on the Record of Borehole sheets and is summarized in the following sections.

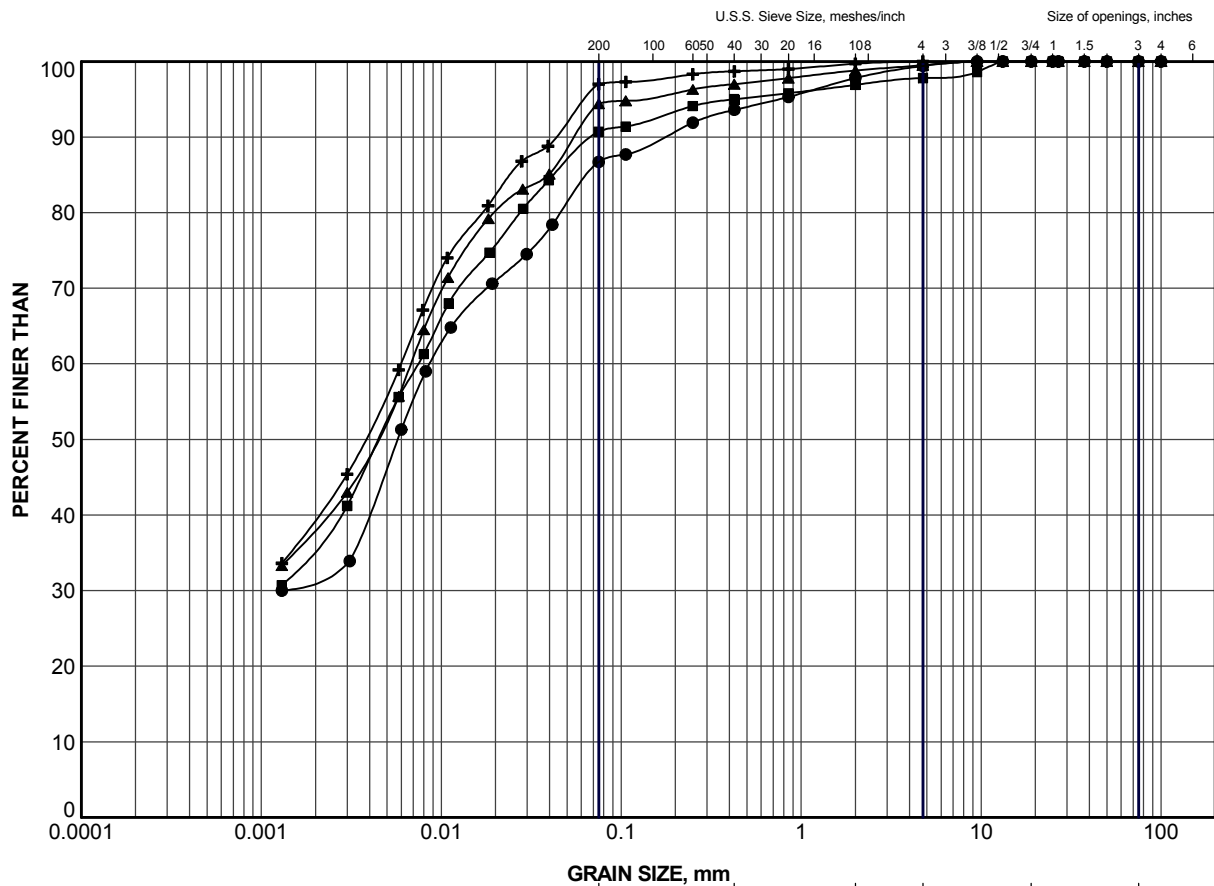
Golder Associates LONDON, ONTARIO				FIGURE A-1

Soil described as clayey silt with traces of sand was found in the boreholes from the previous investigation. The grain size distribution envelope and plasticity chart for the clayey silt materials are shown in Figures 1 and 2, respectively, of Appendix B. Based on comparison of the Atterberg limits and gradation of the samples from the previous boreholes with those from the current investigation, it is interpreted that this material is predominantly clayey silt with an approximately 5 metre thick surficial zone of slightly higher plasticity to about elevation 227.5 metres. In all boreholes except borehole 1, the samples above elevation 227.5 metres generally had liquid limits of 35 per cent or greater and clay and silt contents of approximately 60 per cent and 40 per cent, respectively. The following discussion will consider soils in the previous boreholes with intermediate plasticity above elevation 227.5 metres to be silty clay.

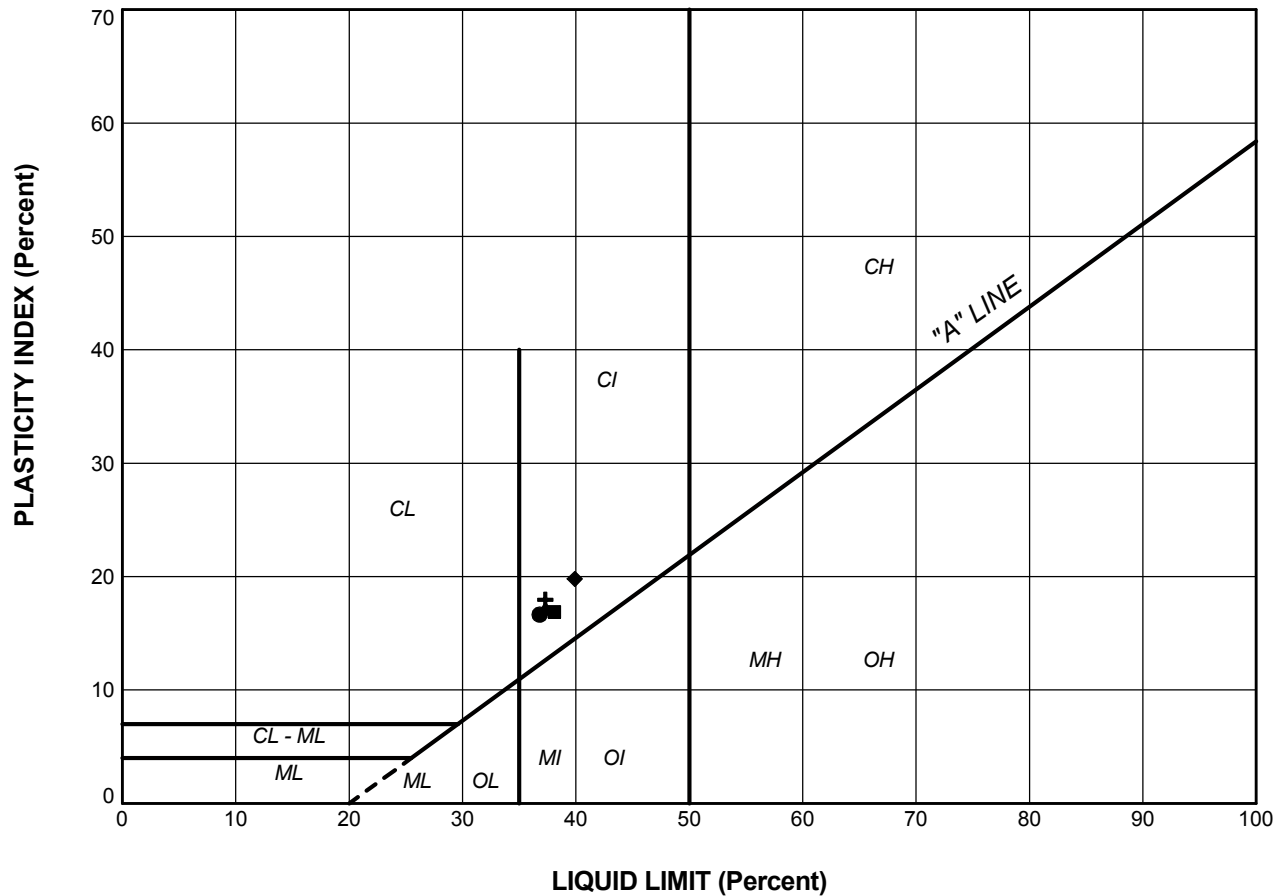
Golder Associates LONDON, ONTARIO			FIGURE A-3

SYMBOL	BOREHOLE	SAMPLE	LL(%)	PL(%)	PI
FILL, silty clay					
●	201	3	36.8	20.2	16.7
■	203	4	38.1	21.2	16.9
+	204	2	37.3	19.4	18.0
◆	204	4	39.9	20.1	19.8
SILTY CLAY					
▲	203	8	37.3	20.1	17.2

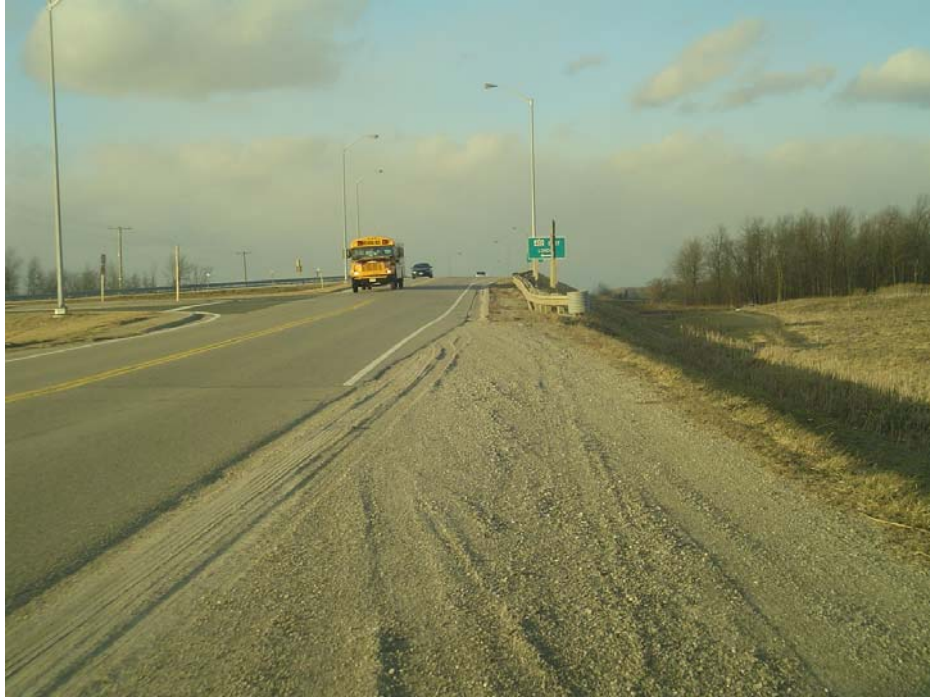
Photo 1: South approach Lambton County Road 79 Underpass Structure.

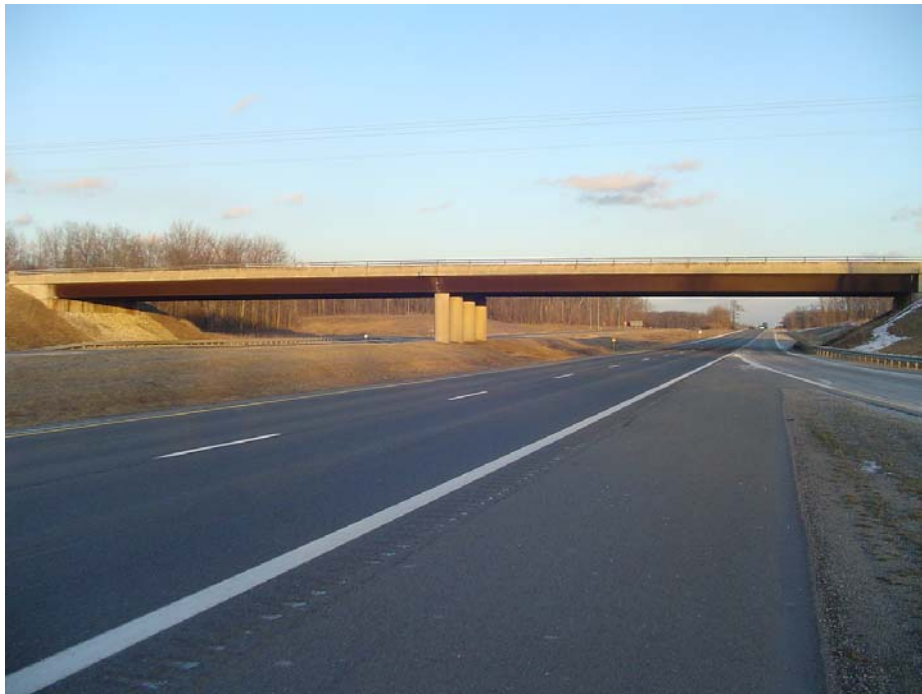
Photo 2: Lambton County Road 79 Underpass Structure, looking east from shoulder of eastbound lanes. NS-E ramp at right of photo.

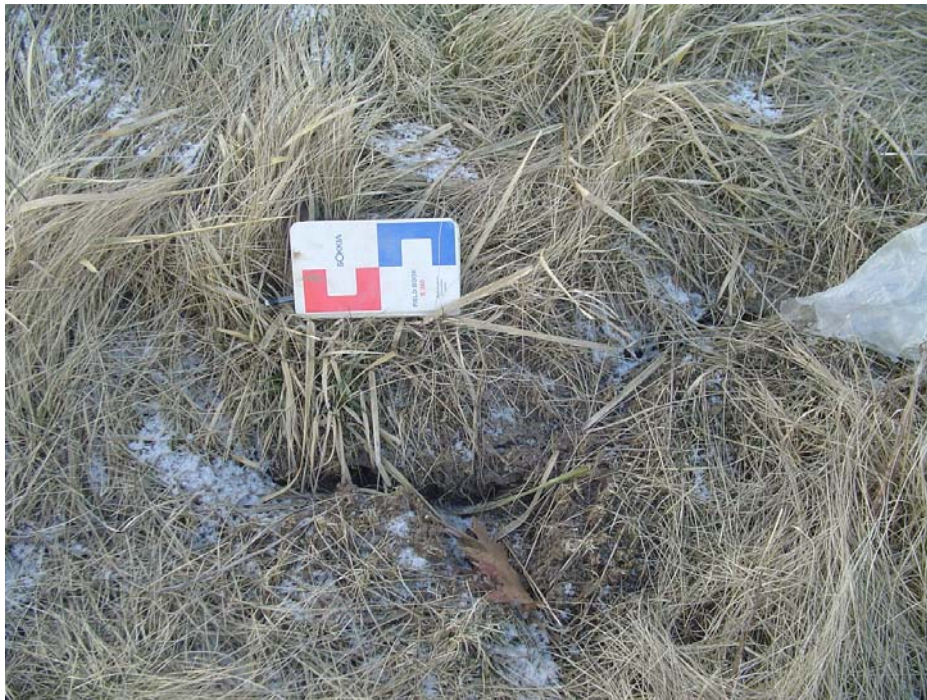
Cracks or distresses behind the slope crest were not observed. Cracking of the slope face was noted in the northeast and southeast quadrants of the approach fills as shown in Photographs 3 to 7 in Appendix C. Differential settlements between the structure and the curbs and gutters on the

approach slabs and approach fills was noted at all four corners of the bridge. These settlements were most apparent at the southeast corner of the bridge. The slope face is moderately well vegetated with grass. However, several bare spots were evident. Beneath the structure, the slopes are covered with rip rap.

Photo 3: Tension crack along southwest approach fill.

The upper 2 metres of fill material could be removed and replaced with Granular A fill at a 26 degree (2.1 horizontal to 1 vertical) slope. The advantages of this strategy are a reduction of the likelihood of surficial failures which could occur if only a toe berm is applied and preservation of the footprint of the existing approach fills. It is therefore the preferred solution from a foundations engineering perspective.

Irrespective of the selected remedial option, adequate erosion protection must be provided to the earthen portion of the slopes in order to mitigate against shallow failures. The slopes should be topsoiled, sodded and seeded in accordance with current MTO standards.

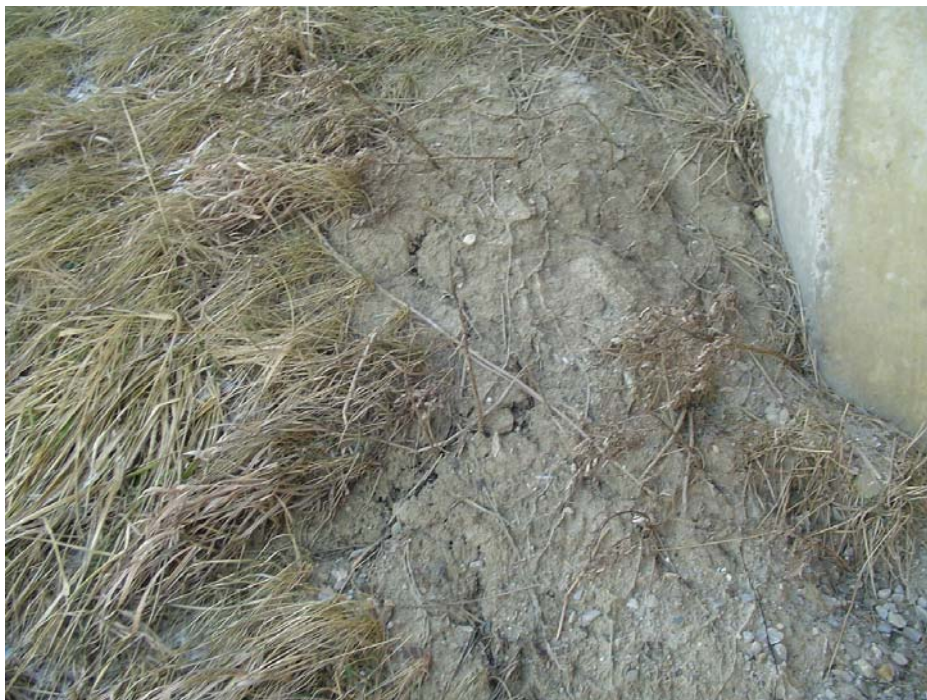
Photo 4: Vertical cracking at abutment in north face of southwest approach fill.

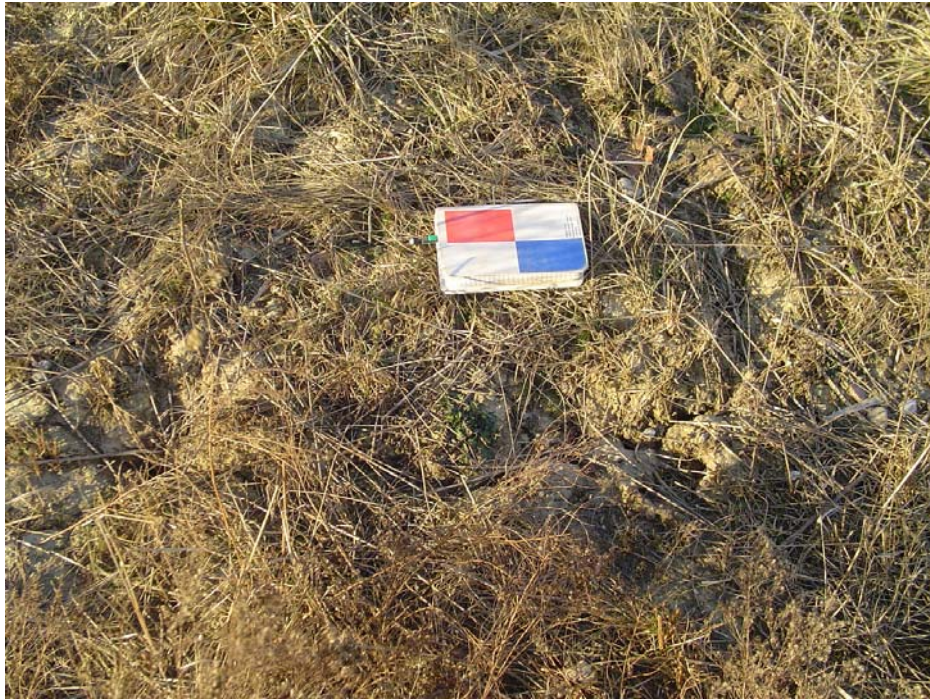
Photo 5: Tension cracks near toe of south face of northwest approach fill.

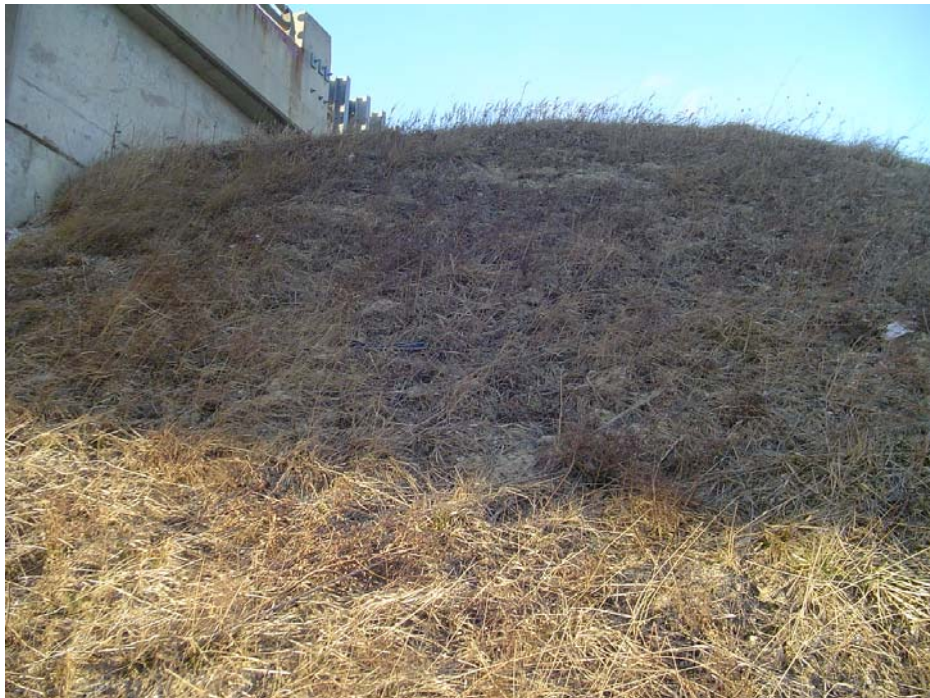
Photo 6: Loss of vegetation on south face of northwest approach fill.

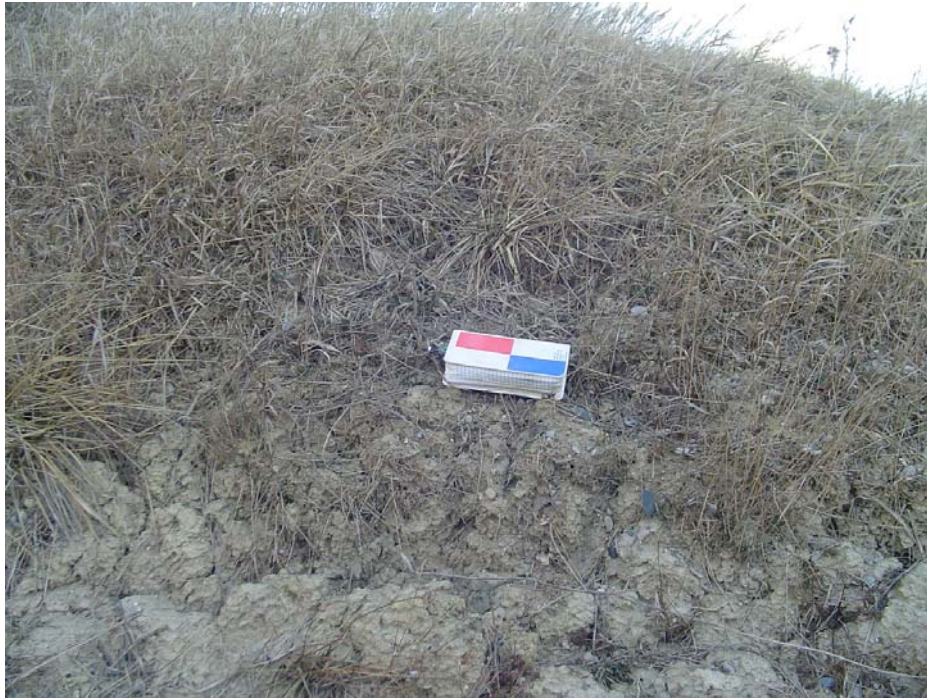
Photo 7: Tension cracks near top of south face of northwest approach fill.

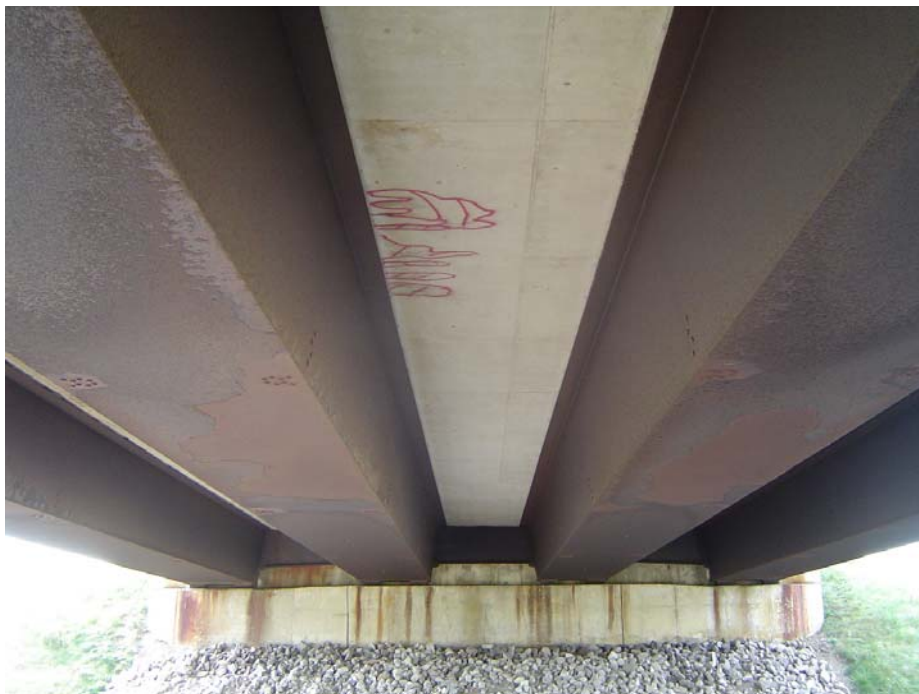
Photo 8: General view of soffit over eastbound lanes, looking towards the south abutment. Rip-rap slope protection is visible at bottom of photograph.
