Foundation Investigation and Design Report

Highway 9 Settlement West of
Highway 400, Township of King,
ON

WO 2013-11019

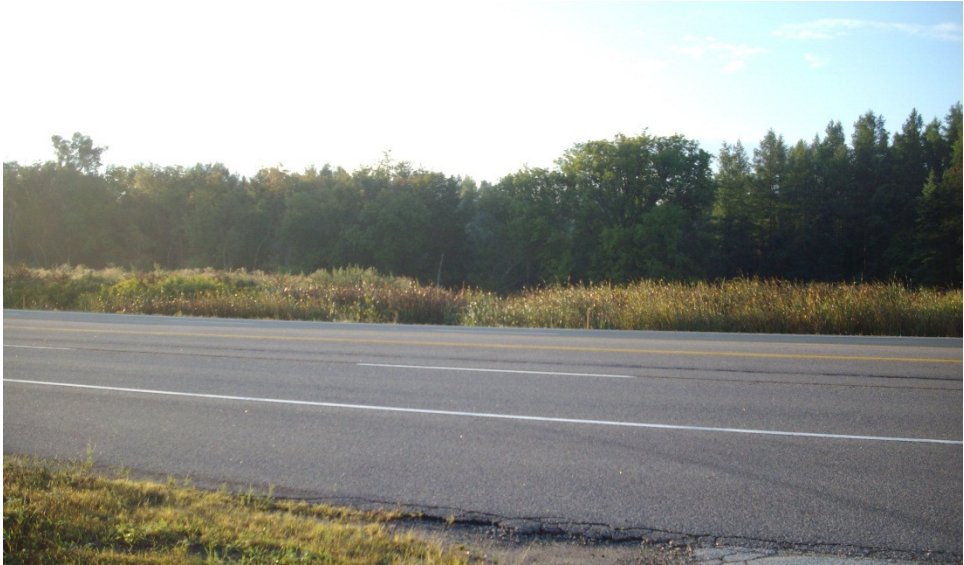
| Site Photo No.: 3 | Looking south towards the settled Hwy 9 Lane (near BH13-2) | | |

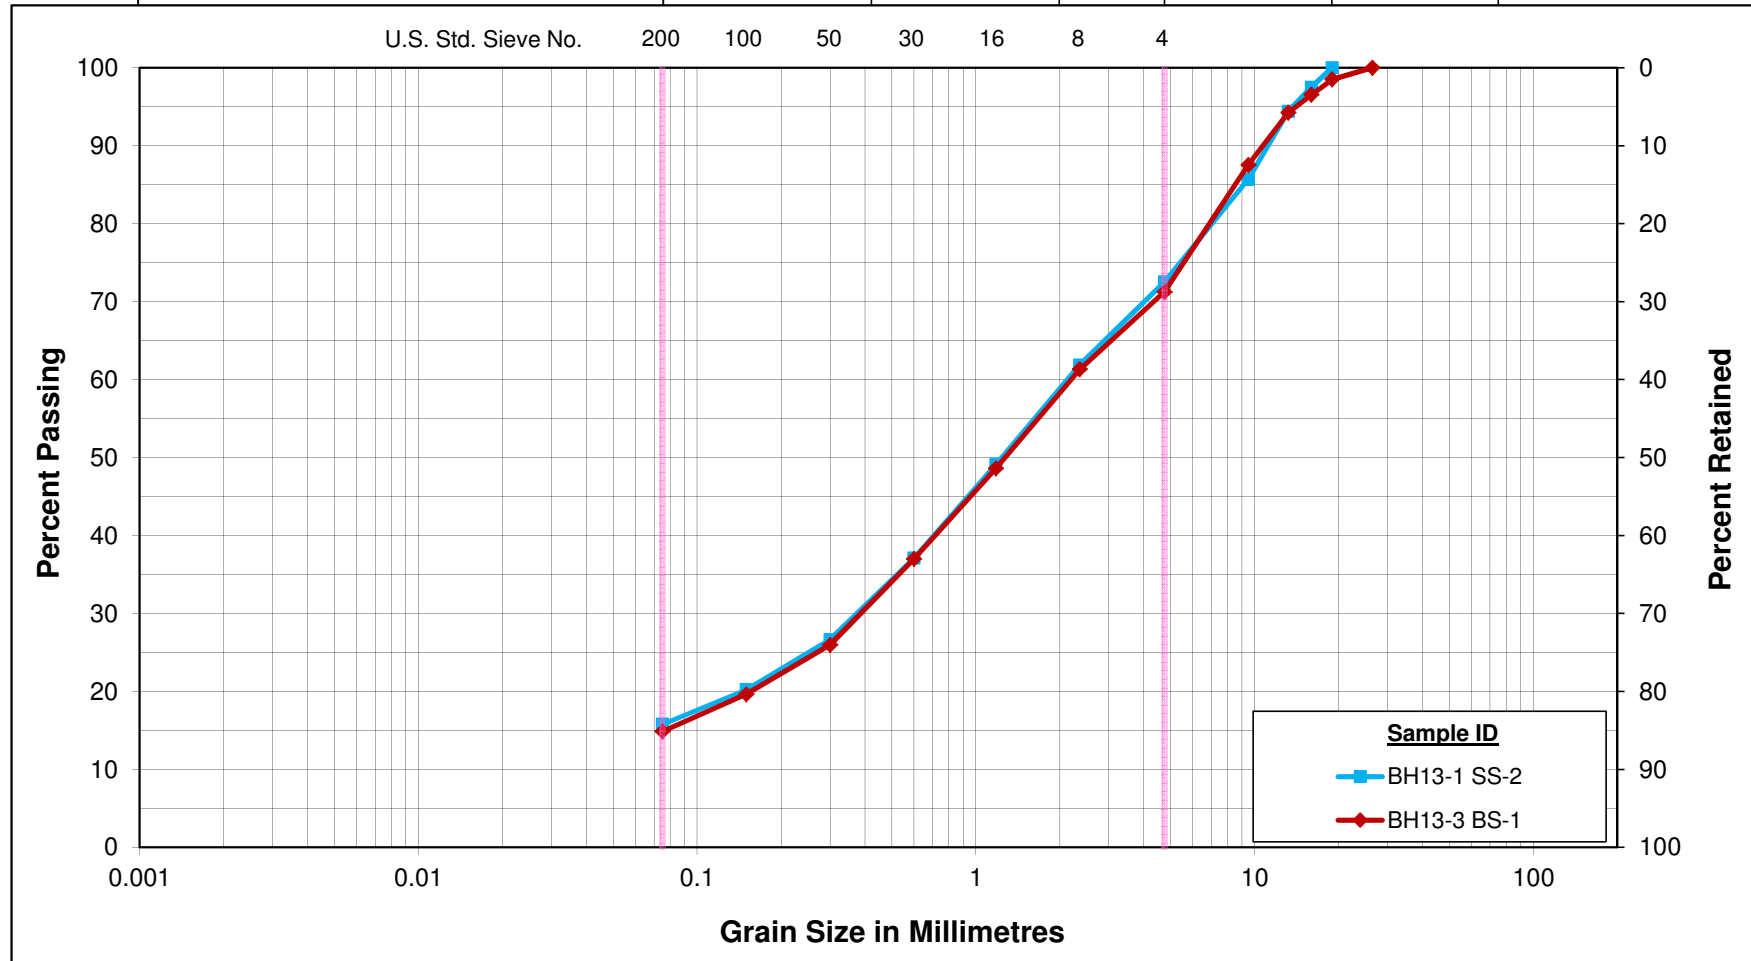
GRAIN SIZE DISTRIBUTION

FILL: Silty sand with gravel (SM)

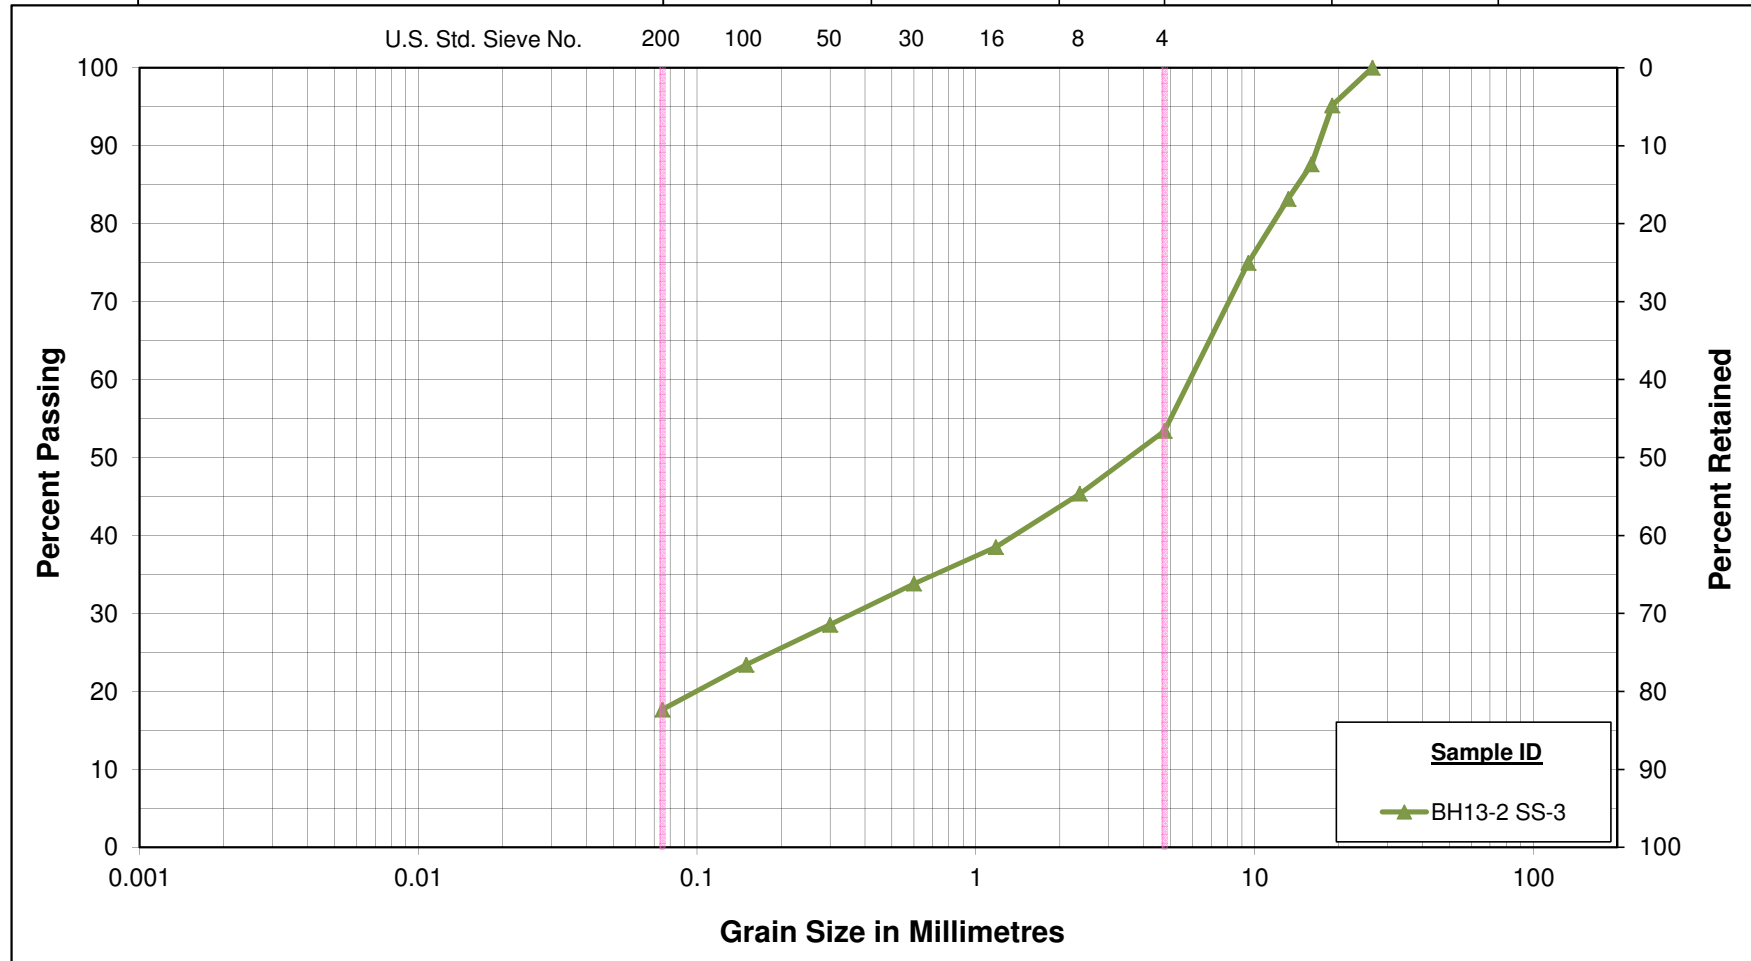
GRAIN SIZE DISTRIBUTION

FILL: Silty gravel with sand (GM)

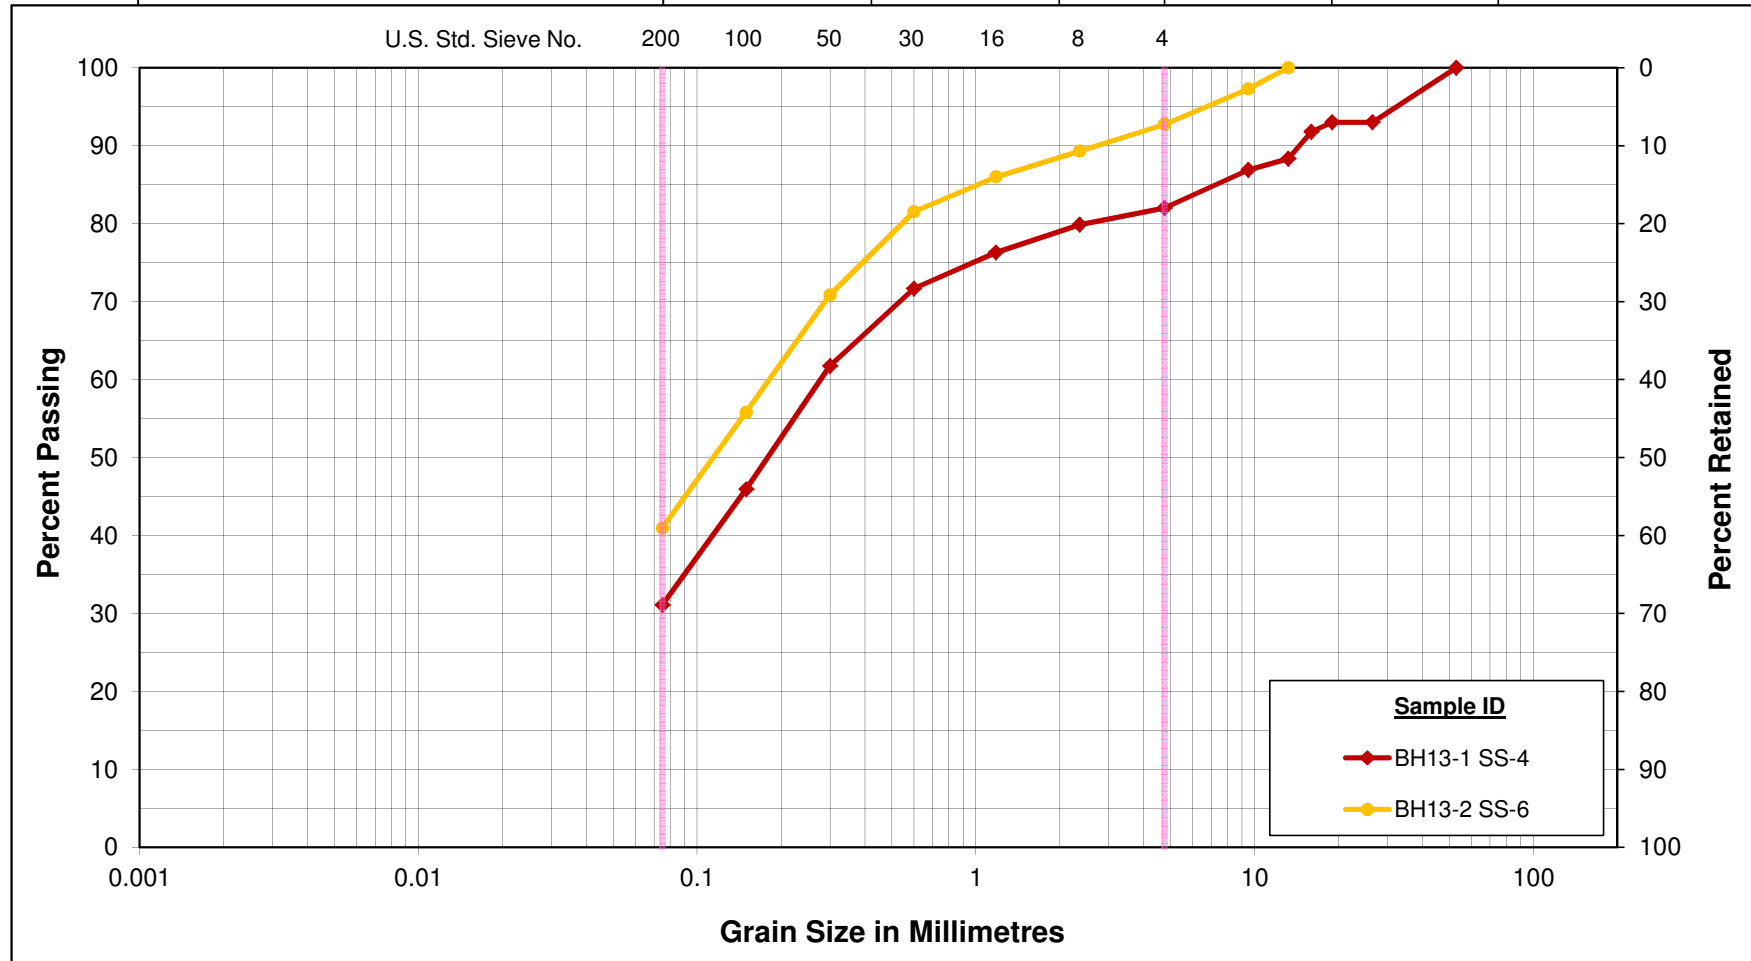
GRAIN SIZE DISTRIBUTION

FILL: Silty sand gravel (SM)

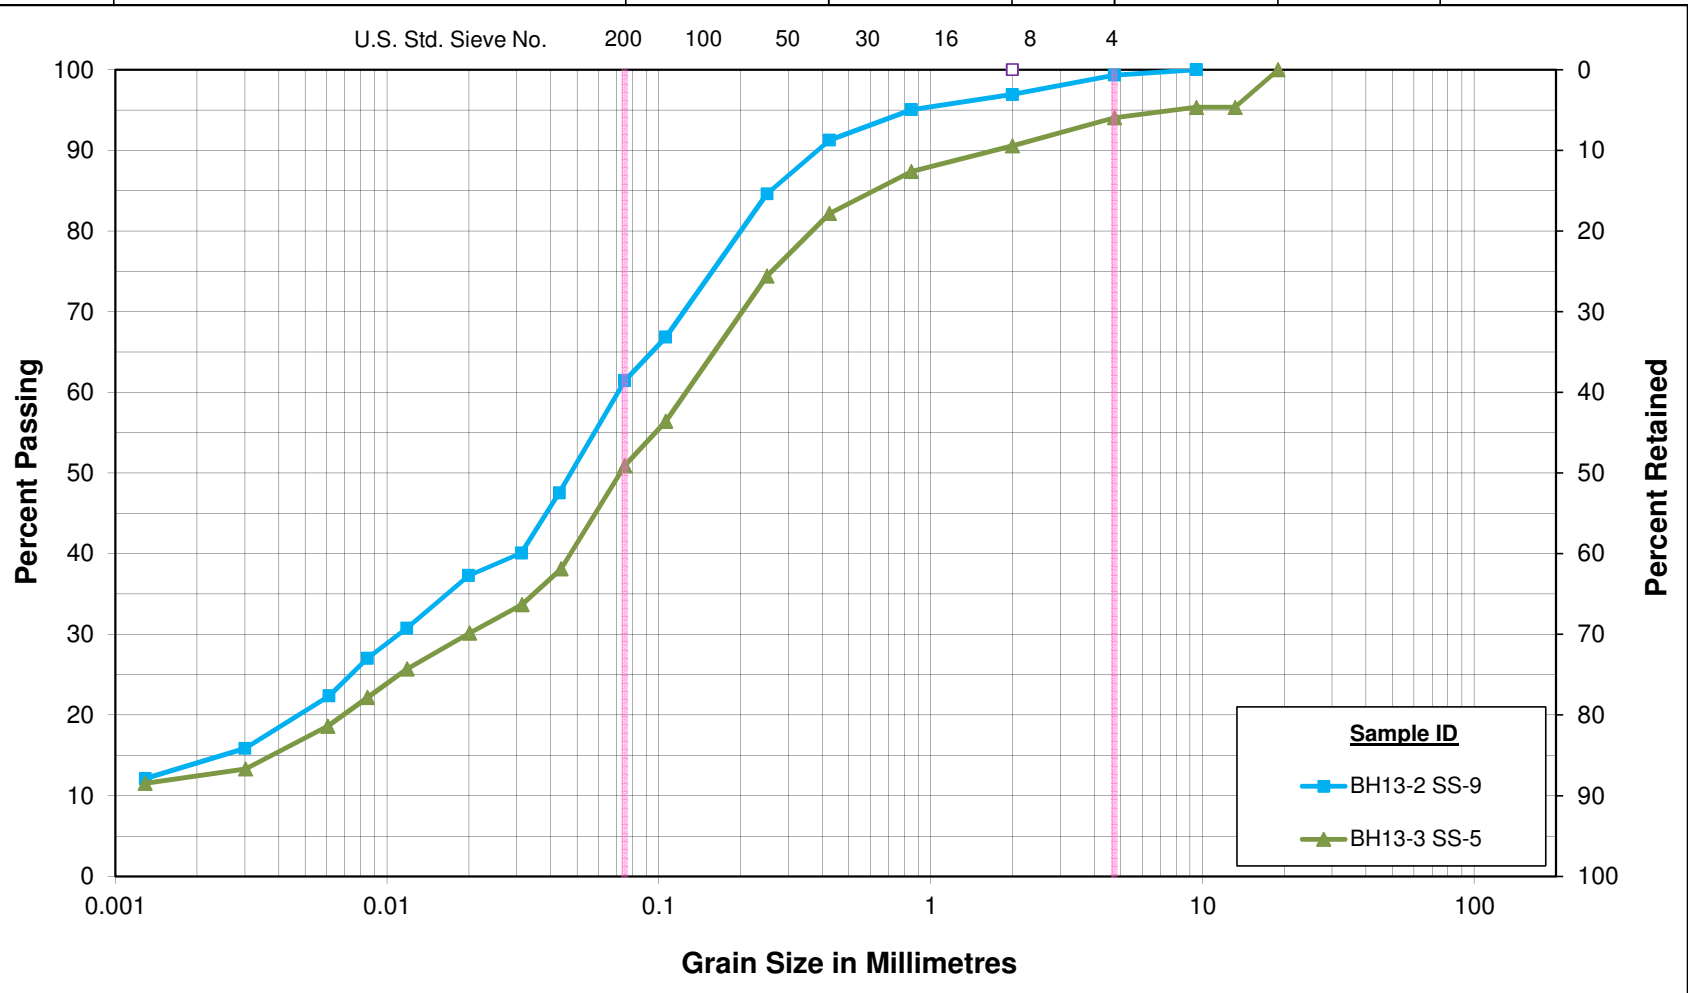
Figure No. 3

GRAIN SIZE DISTRIBUTION
 FILL: Sandy silt (ML) and Sandy silty clay (CL-ML)

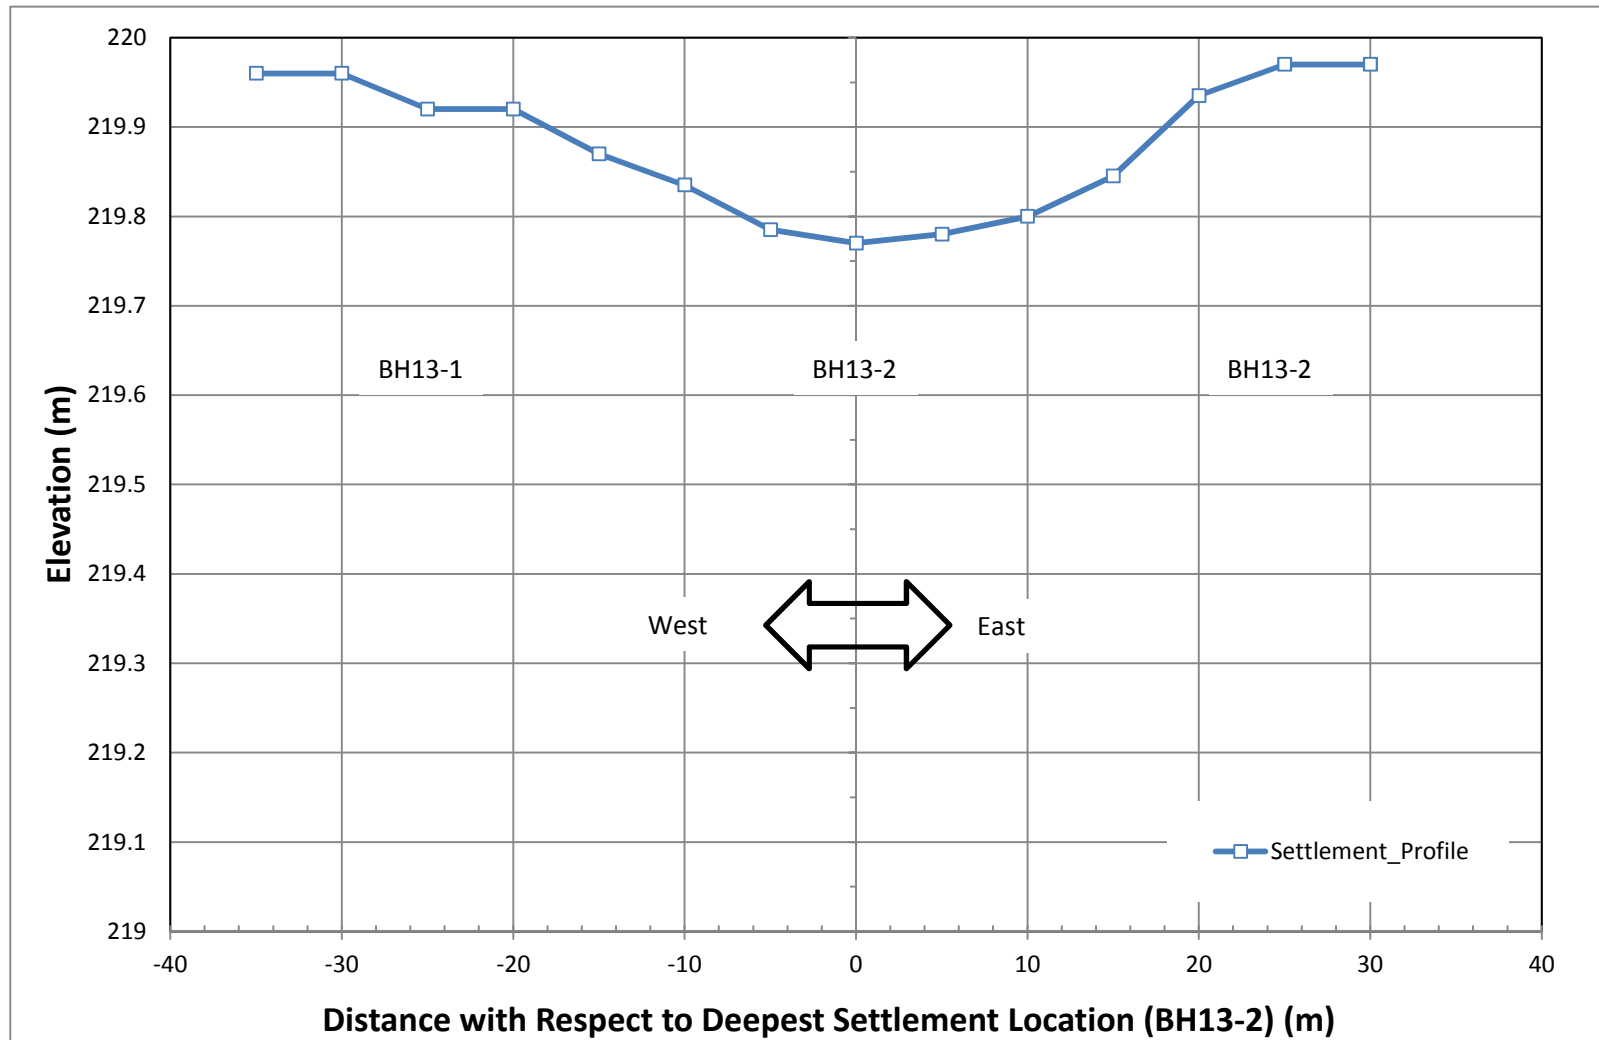
Figure 6
Settlement Profile along the Right EBL

Figure 6 in Appendix D shows the settlement profile. The following is observed.

The observed settlement of 200 mm (Figure 6) is assumed to have occurred between the time of repair (anticipated to be early 2010) and late 2013. This represents a time period of

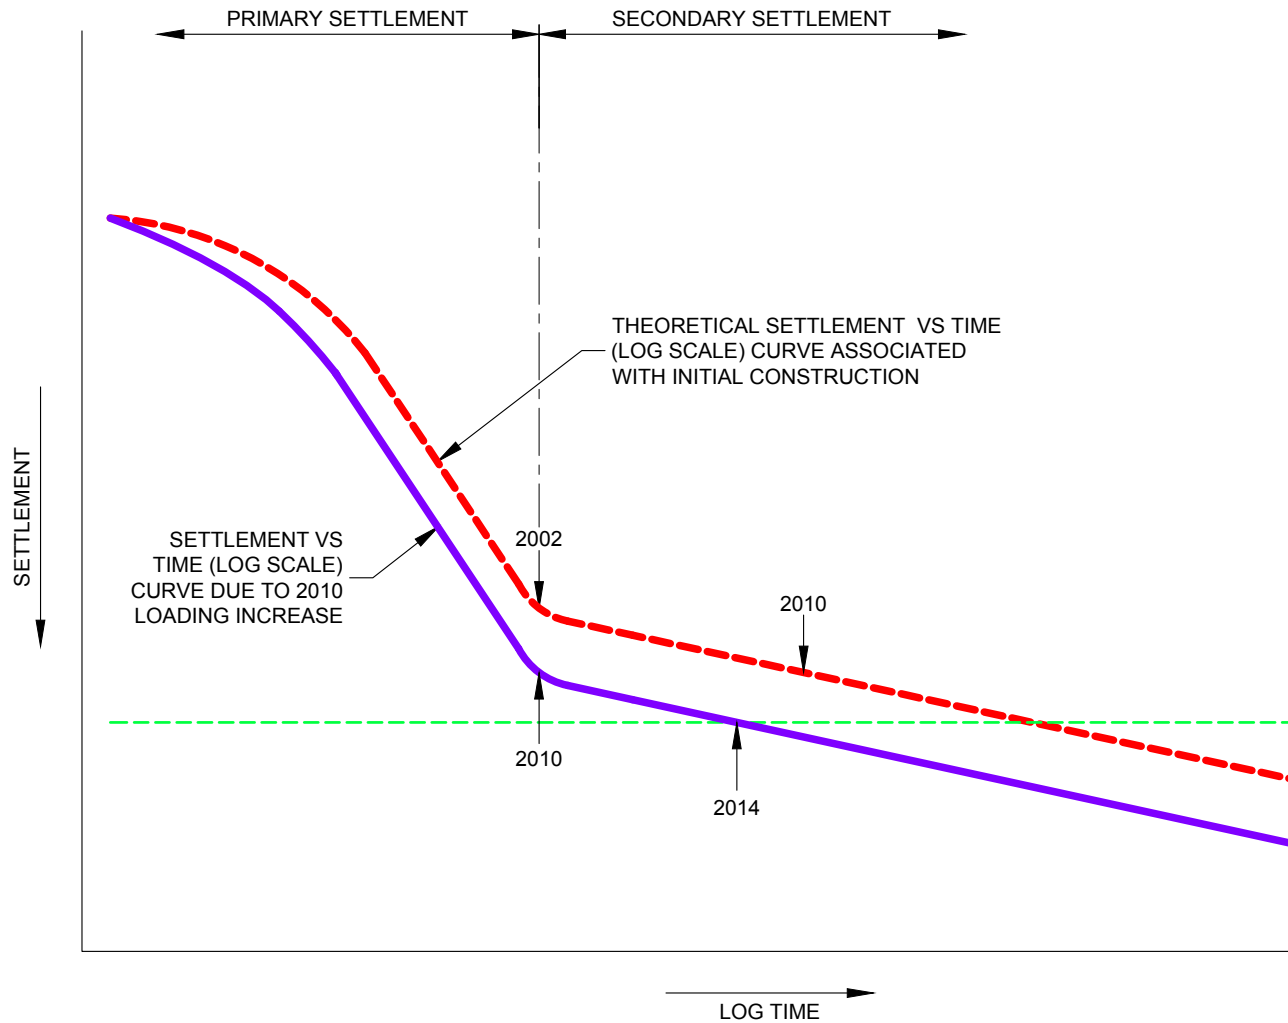
GENERAL INTERPRETATION METHOD :

1. THE INITIAL CONSTRUCTION OF THE WIDENING WOULD HAVE FOLLOWED THE RED SETTLEMENT VERSUS LOG-TIME CURVE.
2. THE PRIMARY CONSOLIDATION OF THE PEAT WOULD HAVE BEEN COMPLETED WITHIN 2 TO 3 WEEKS OF ACHIEVING THE FINAL GRADE.
3. THE SECONDARY SETTLEMENT BETWEEN 2002 AND 2010 WOULD HAVE BEEN SOME AMOUNT GREATER THAN 200 mm. THIS IS ASSUMED SINCE THE SECONDARY SETTLEMENT BETWEEN 2010 AND 2014 IS IN THE ORDER OF 200 mm.
4. IN 2010, RECONSTRUCTION AND REPROFILING WOULD HAVE OCCURRED AS PART OF THE CULVERT REPAIR WORK.
5. REPROFILING OF THE ROADWAY (2010) WOULD HAVE INTRODUCED A NEW LOADING RESULTING IN A REINITIATION OF SECONDARY SETTLEMENT PROCESS.
6. THE CURRENT RATE OF SECONDARY CONSOLIDATION HAS BEEN EVALUATED AS 200 mm/LOG (1460 DAYS/20 DAYS) .
7. THE DESIGN APPROACH IS TO REDUCE THE LOADING ON THE PEAT WHICH WILL TEMPORARILY HALT THE SECONDARY SETTLEMENT.

Figure 7 in Appendix D describes the stress history model assumed in interpreting future anticipated settlements and in developing localized repair options.
