**REPORT ON**

**ROCKFALL HAZARD ASSESSMENT  
HIGHWAY 6 WIDENING  
BETWEEN HIGHWAYS 403 AND 5  
G.W.P. 19-95-00**

August 2005

001-1141F-11

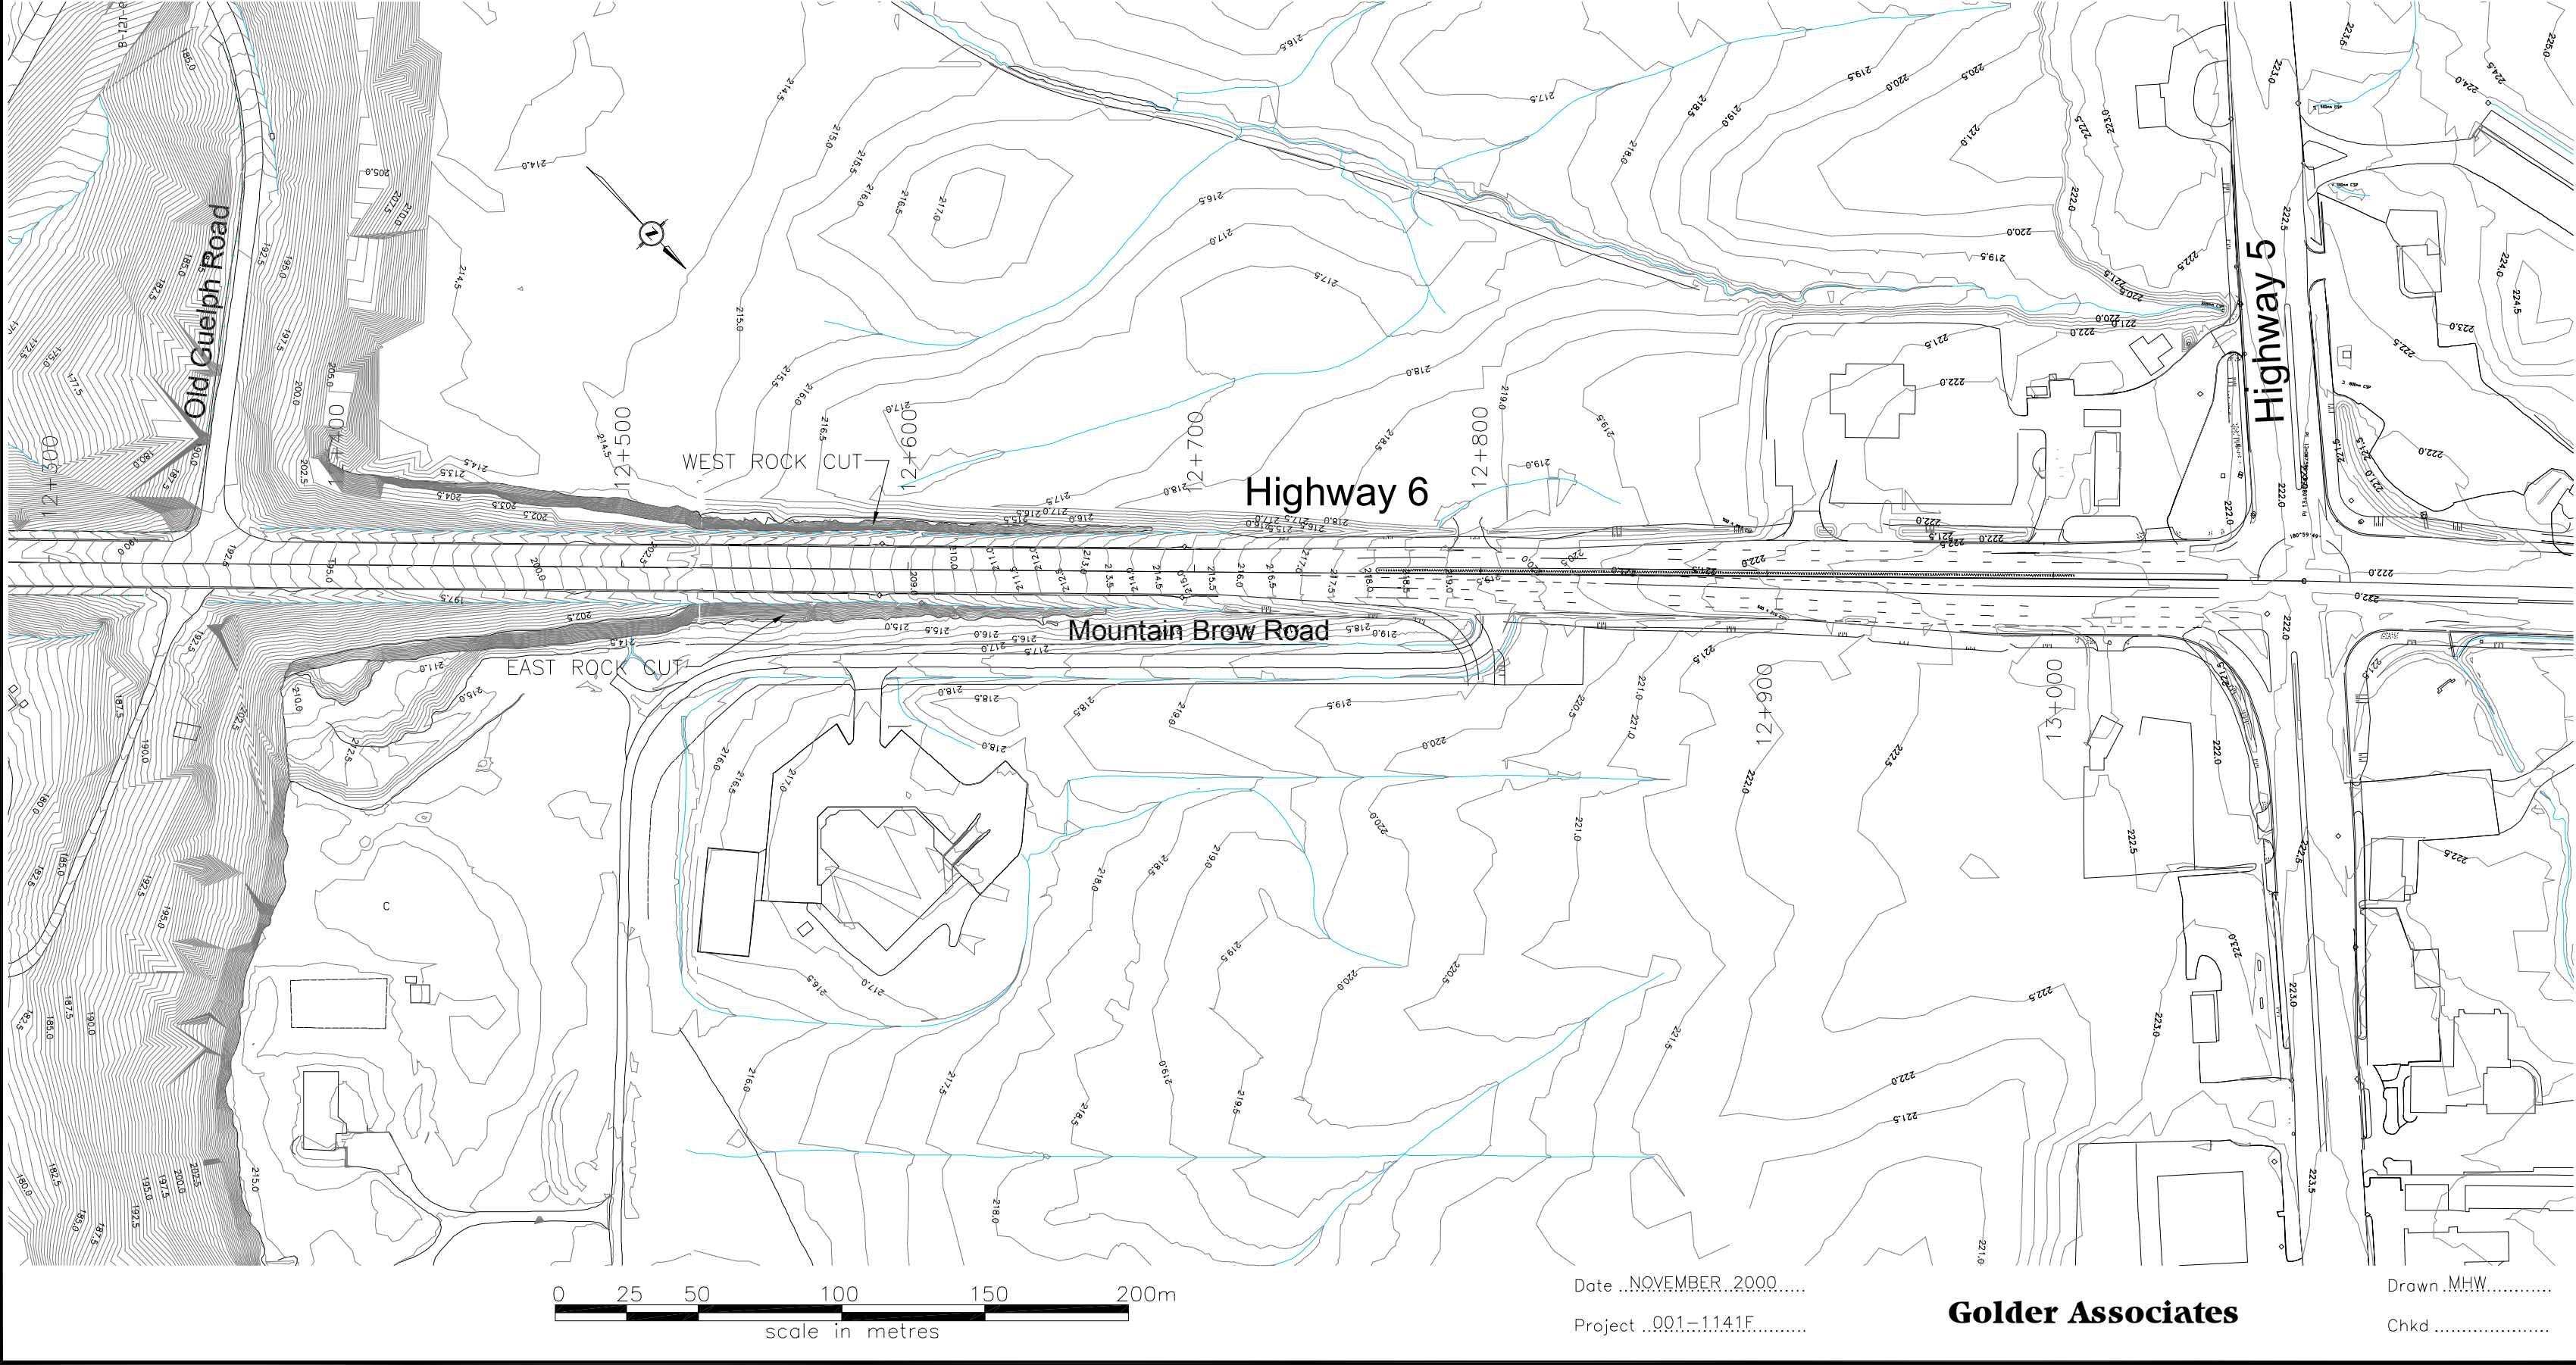
FIGURE 1

Drawings showing the configurations of both the existing and new Highway 6 geometries for the contract area were provided to Golder by URS. At the time of the investigation, the chainages for the new alignment had been staked out by surveyors in the area of concern. The rock cuts are shown in plan on Figure 1.

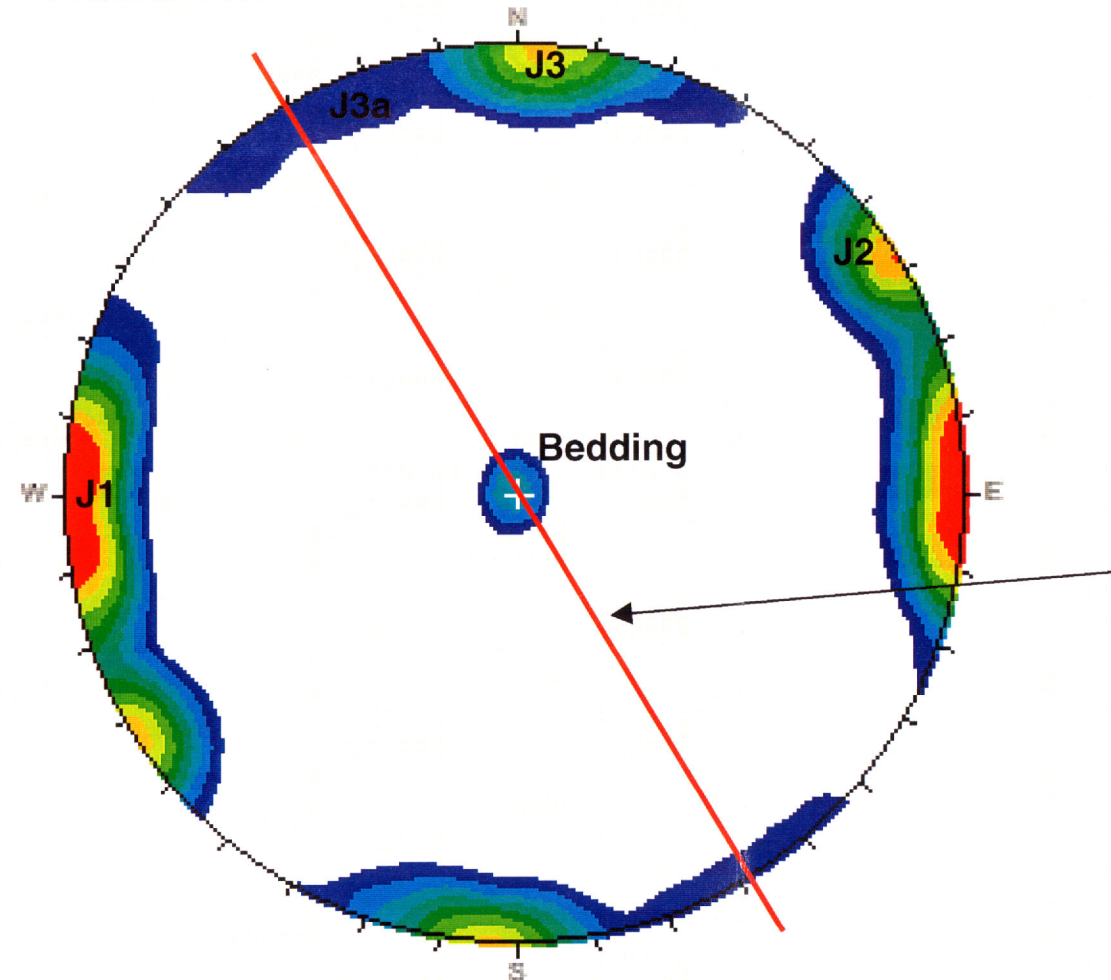
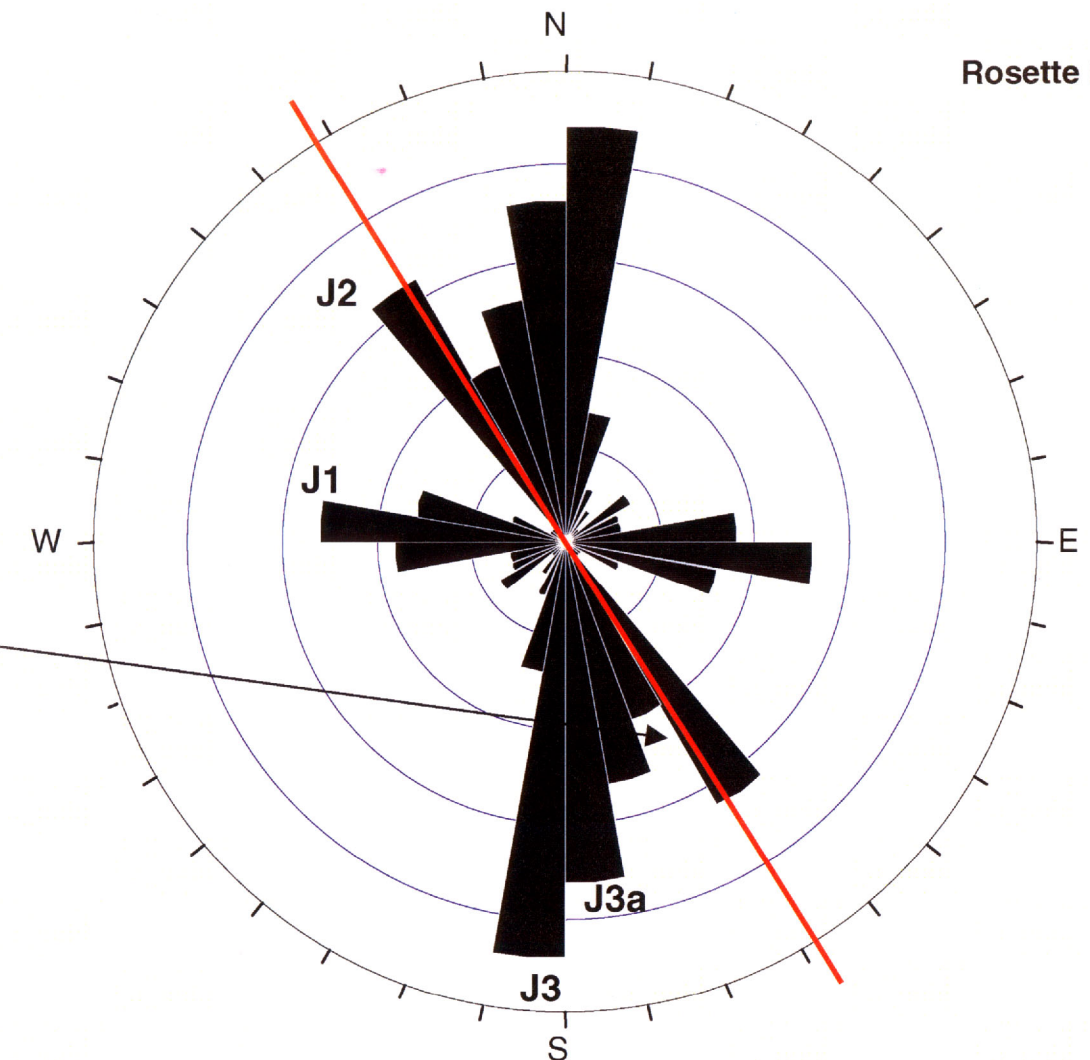
Contour Plot

- \* Toppling instability is the dominant mechanism, through the J2 joint set in both the east and west walls
- \* Planar instability is possible in both the east and west walls, through the J1, J2 and J3 sets
- \* Wedge instability is possible, however due to the steep dip of the identified sets - toppling wedges are more likely to develop- this is substantiated by the lack of typical sliding wedge type failures in the existing cuts.
