Wildlife Underpass  
Highway 69 Four-Laning, Phase 2, Site No. 46-515  
W.P. 5262-07-01, Index No.: 734FDR  
PML Ref.: 06TF052F, May 5, 2009

## SITE INSPECTION REPORT

Comments by D. Wood Associates Ltd. Regarding Structure Foundations

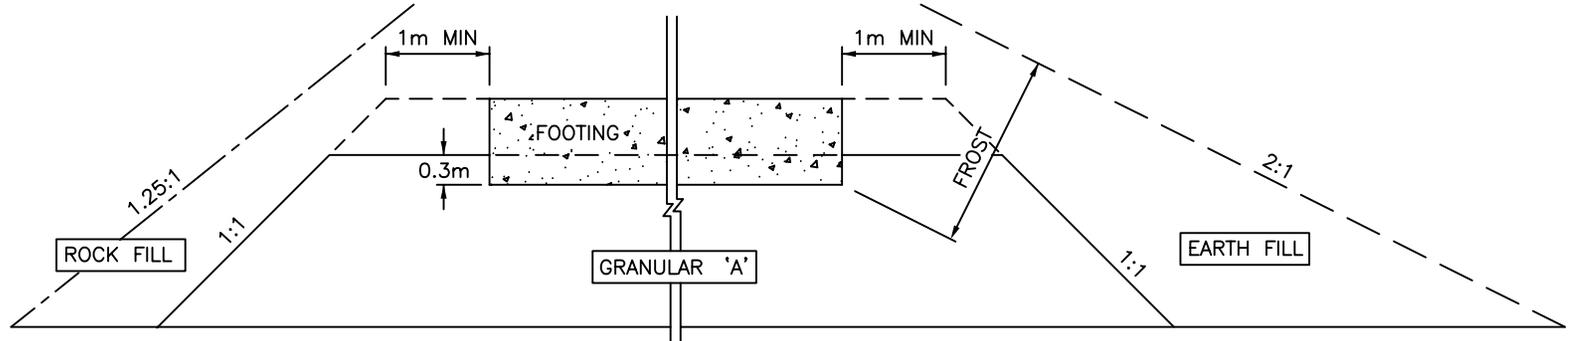
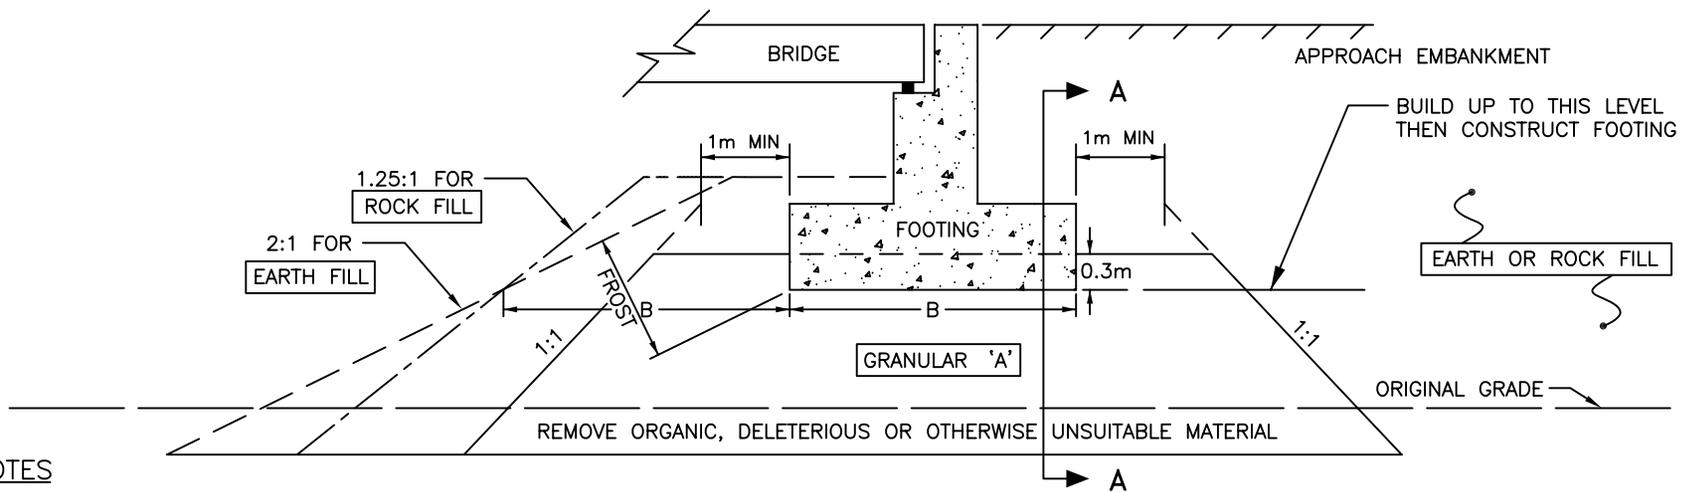
**FIGURE 1: ABUTMENT ON COMPACTED FILL SHOWING GRANULAR 'A' CORE**

1. CONCEPT SHOWN DOES NOT INCLUDE A MIDHEIGHT BERM.
2. LIMITS OF GRANULAR 'A' CORE TO BE DEFINED BY A SITE SPECIFIC SURVEY.
3. REMOVE ORGANIC, DELETERIOUS OR OTHERWISE UNSUITABLE MATERIAL UNDER AREA OF COMPACTED GRANULAR 'A' AND EARTH OR ROCK FILL AS NOTED IN TEXT OF REPORT.
4. PLACE GRANULAR 'A' AND EARTH OR ROCK FILL ON APPROVED SUBGRADE TO BOTTOM OF FOOTING LEVEL, COMPACTED ACCORDING TO CURRENT M.T.O. STANDARDS.
5. CONSTRUCT CONCRETE FOOTING.
6. PLACE REMAINDER OF GRANULAR 'A' AND EARTH OR ROCK FILL INCLUDING MIDHEIGHT BENCHES, AS REQUIRED.
7. REFER TO TEXT OF REPORT FOR FROST DEPTH.
