**CALAMITY CREEK SLOPE FAILURE INVESTIGATION
HIGHWAY 11, 2.9 KM NORTH OF HWY 65 JUNCTION
NEW LISKEARD, ONTARIO
5018-E-0010, WORK ITEMS #7 AND #11**

G.W.P. NO. 5159-12-00

Geocres Number: 31M-133

March 2022

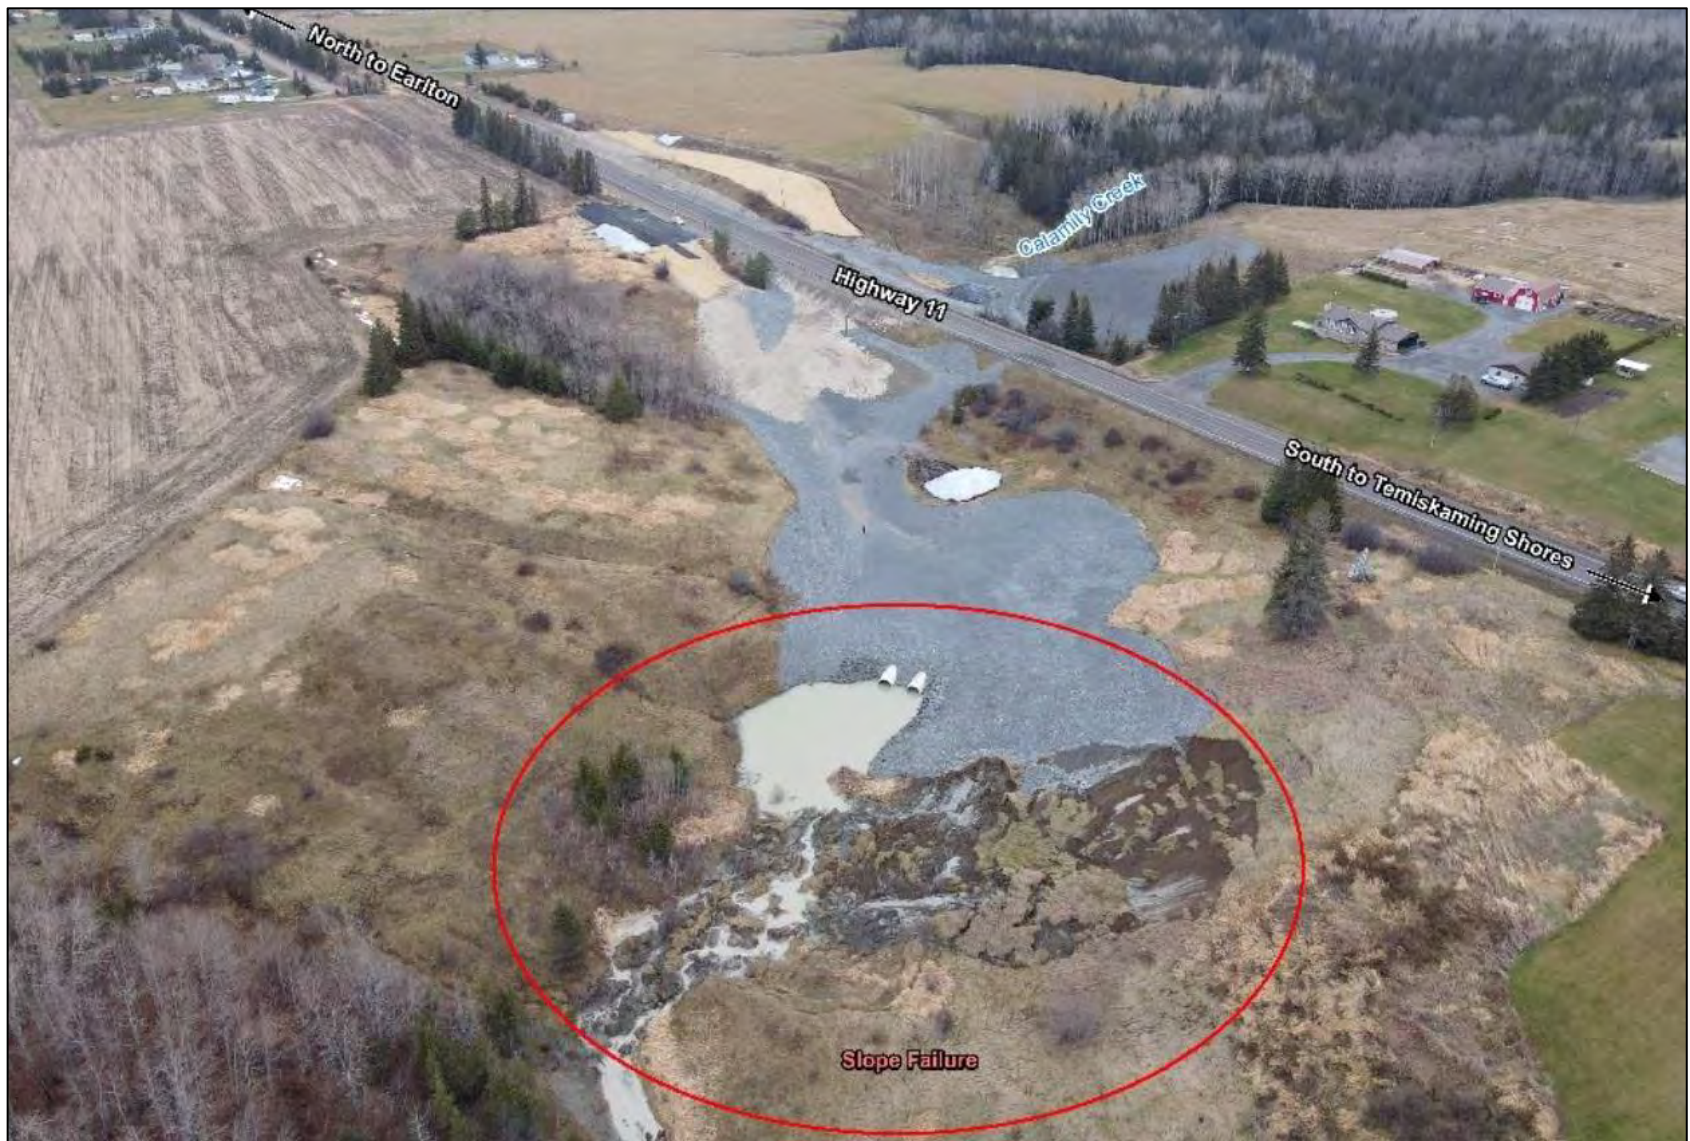
Photo 1: Aerial image from LGL Limited memo (dated November 18, 2020) showing the extent of the landslide on November 10, 2020. The head scarp of the slide has since retrogressed further to the southeast.

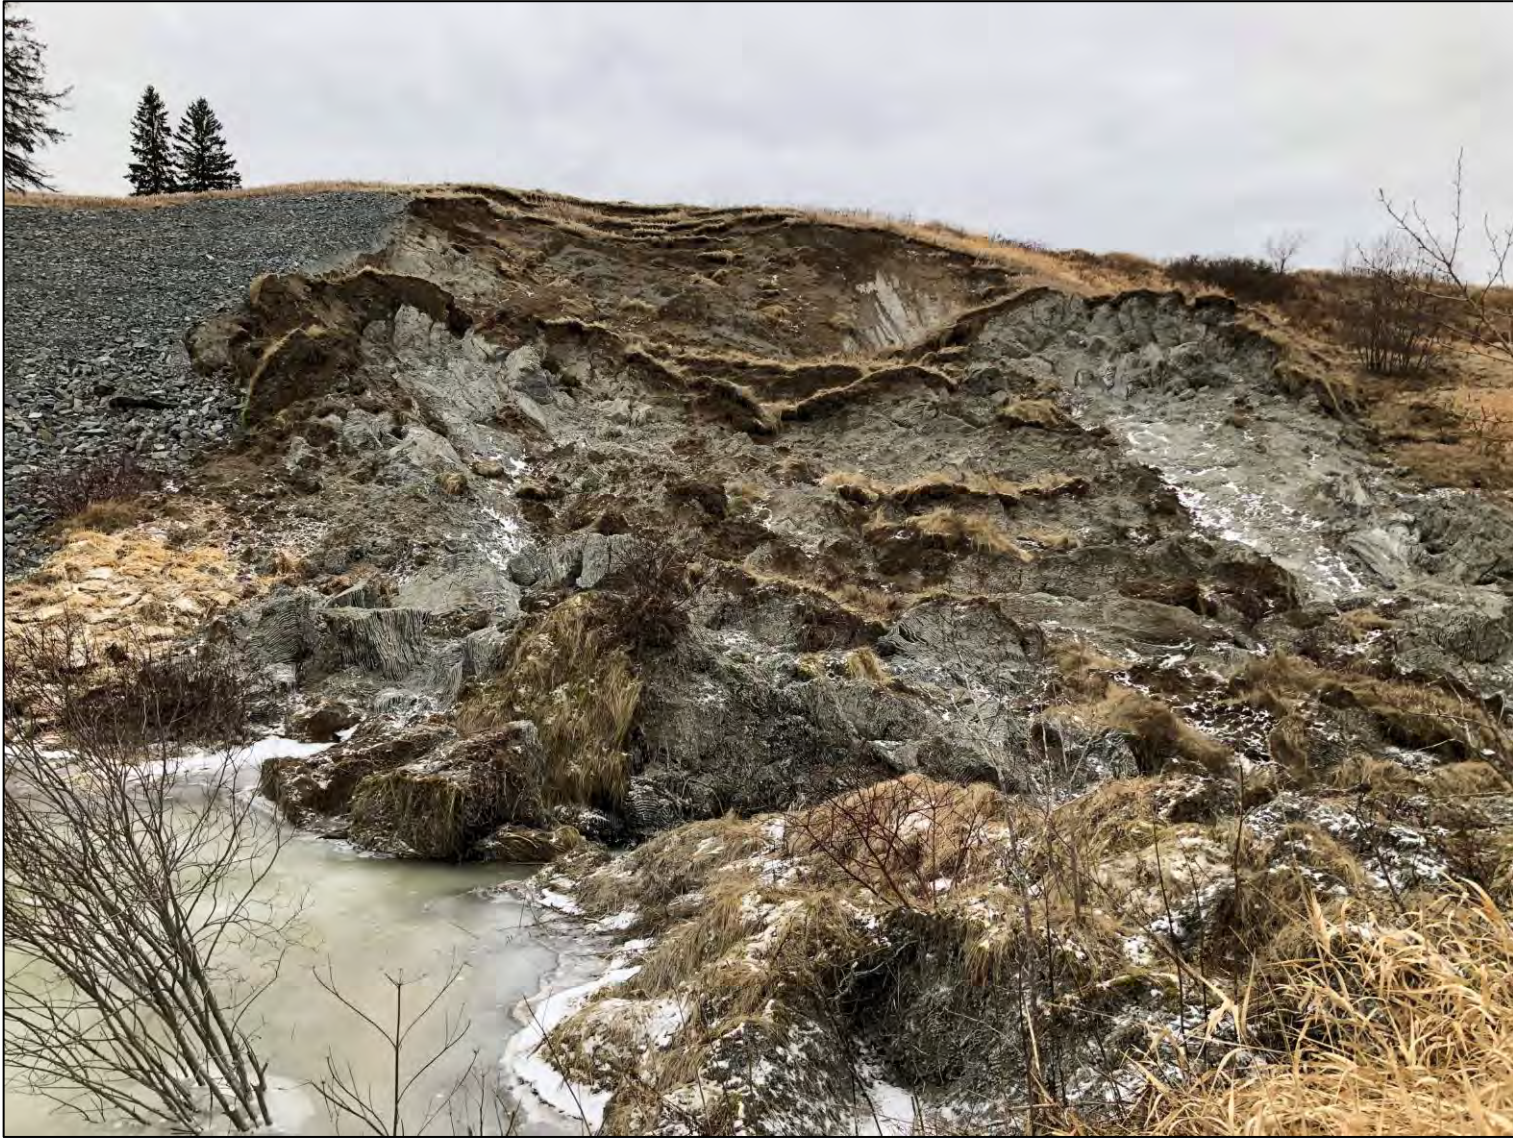
Photo 2: View of the landside from the toe looking up towards the head scarp (looking southeast).

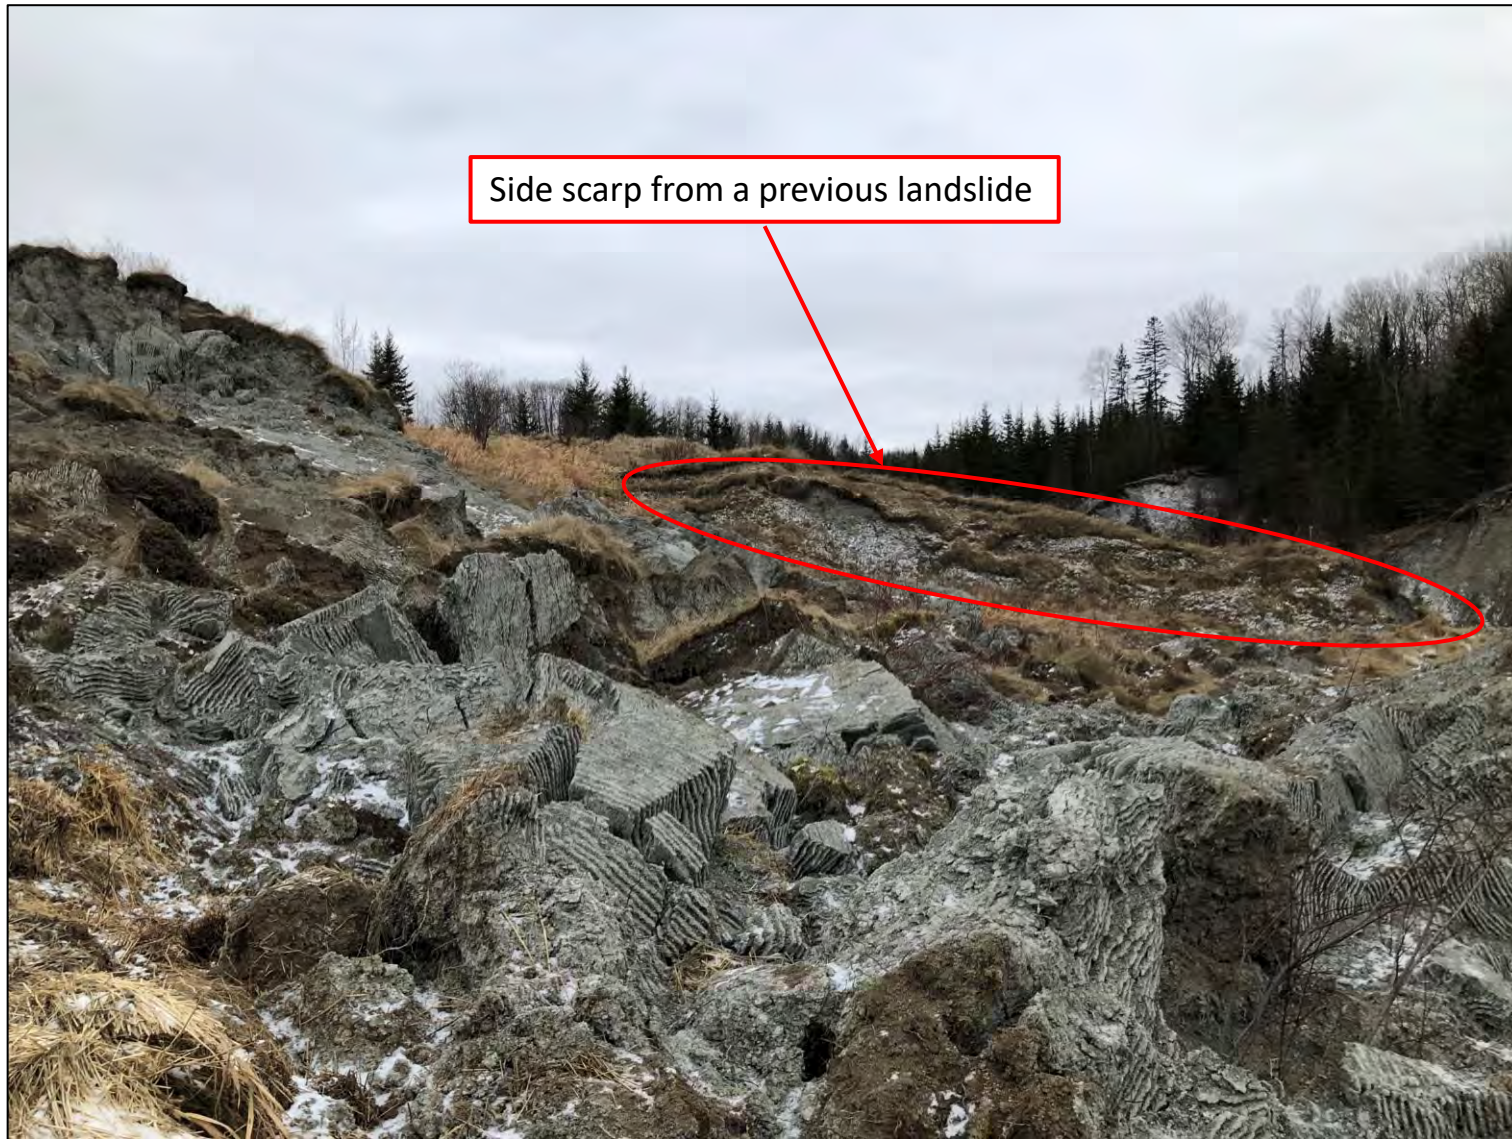
Side scarp from a previous landslide

Photo 3: General view of slide debris, looking west, showing varved clay in the foreground and a old side scarp from a previous landslide.

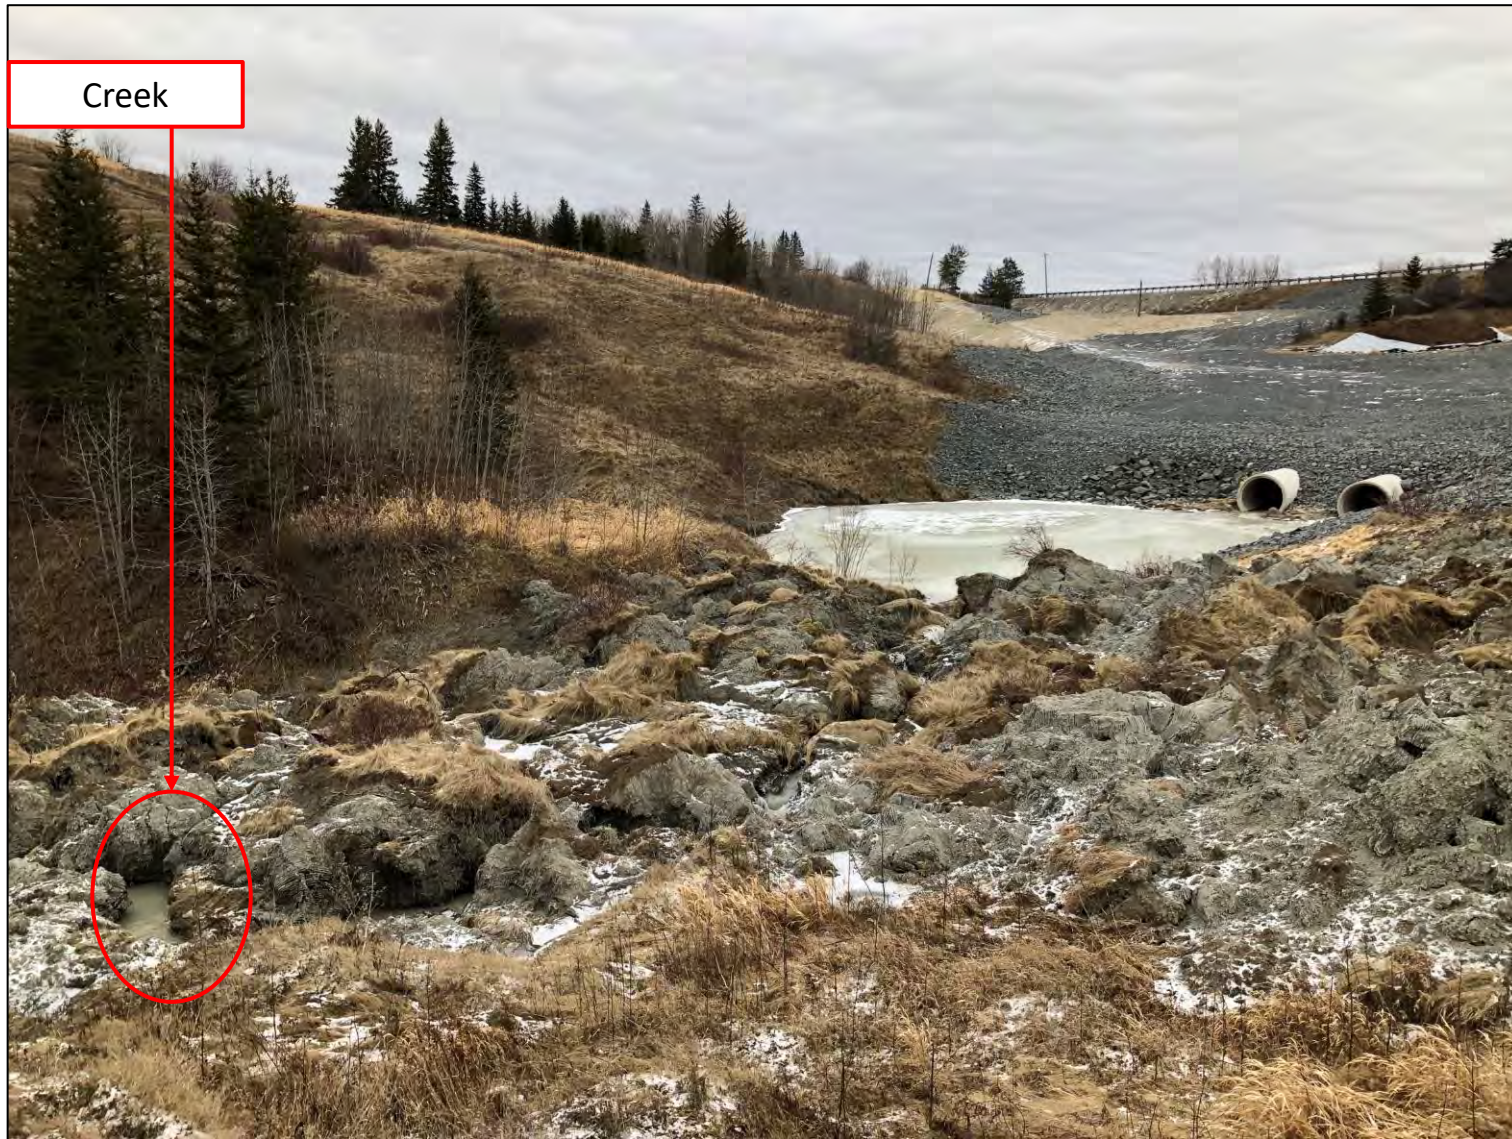
Photo 6: View showing the creek at the toe of slope cutting through the slide debris, looking northeast.

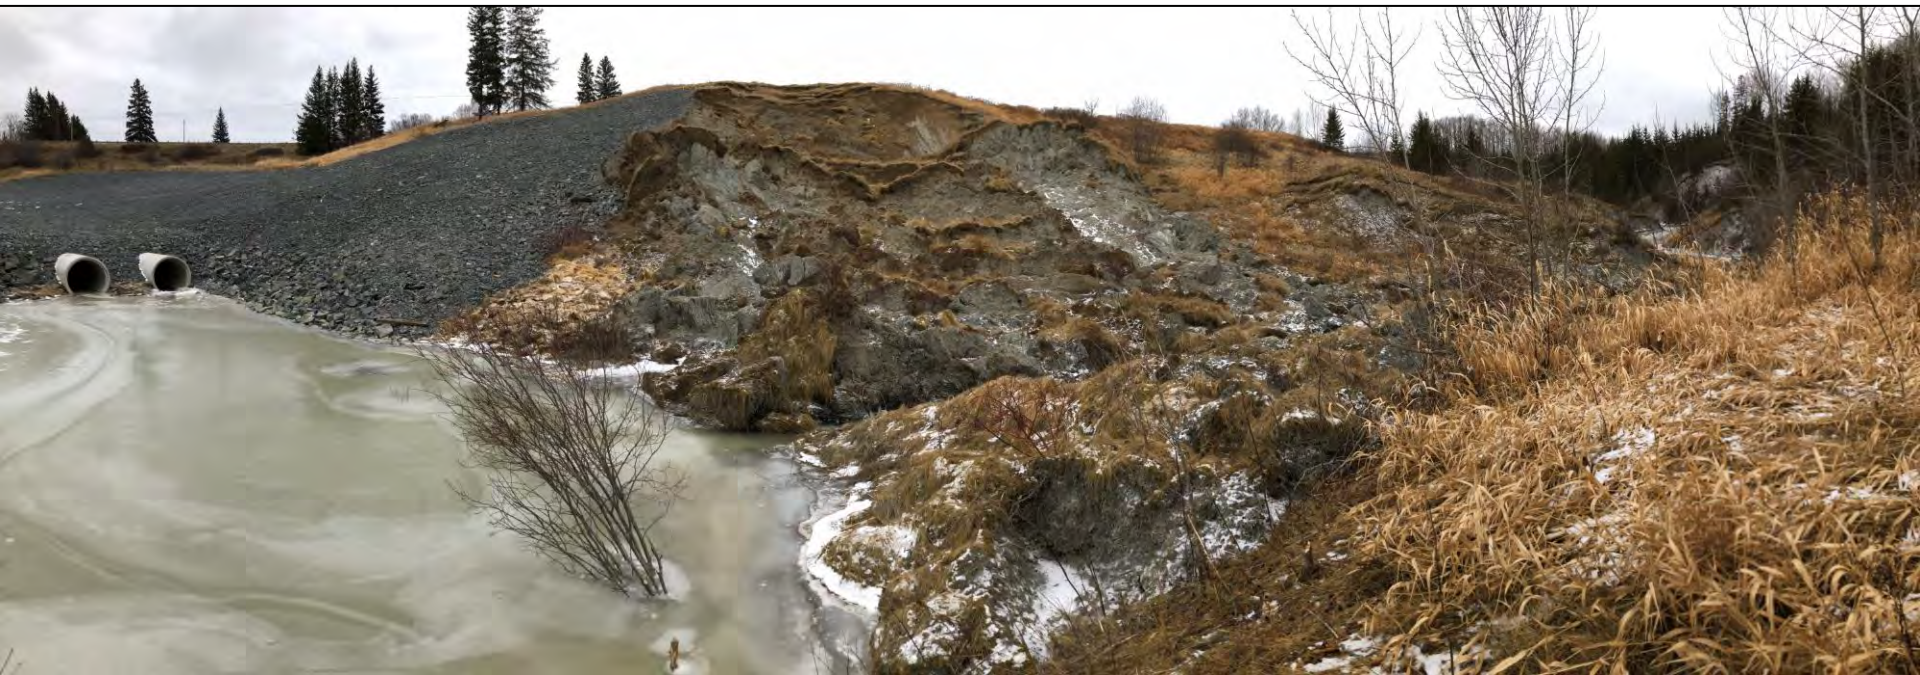
Photo 9: Panoramic view of the landslide, looking east to west, from the toe.

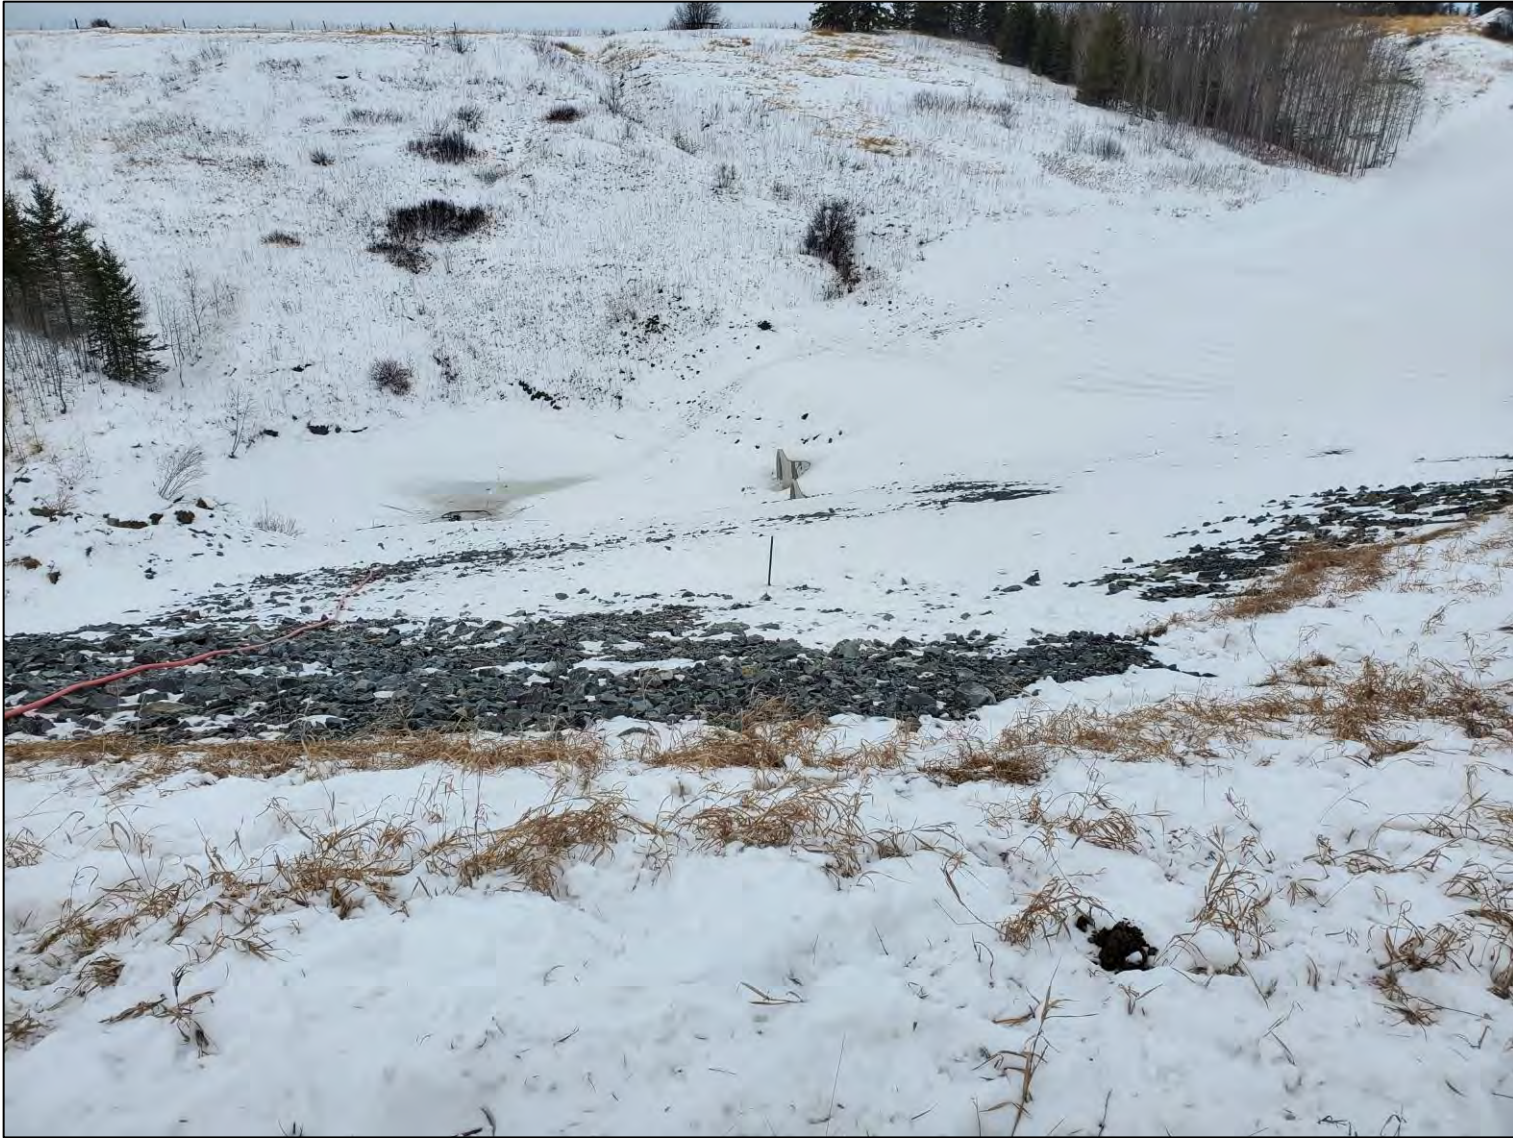
Photo 12: Monument on rockfill slope.

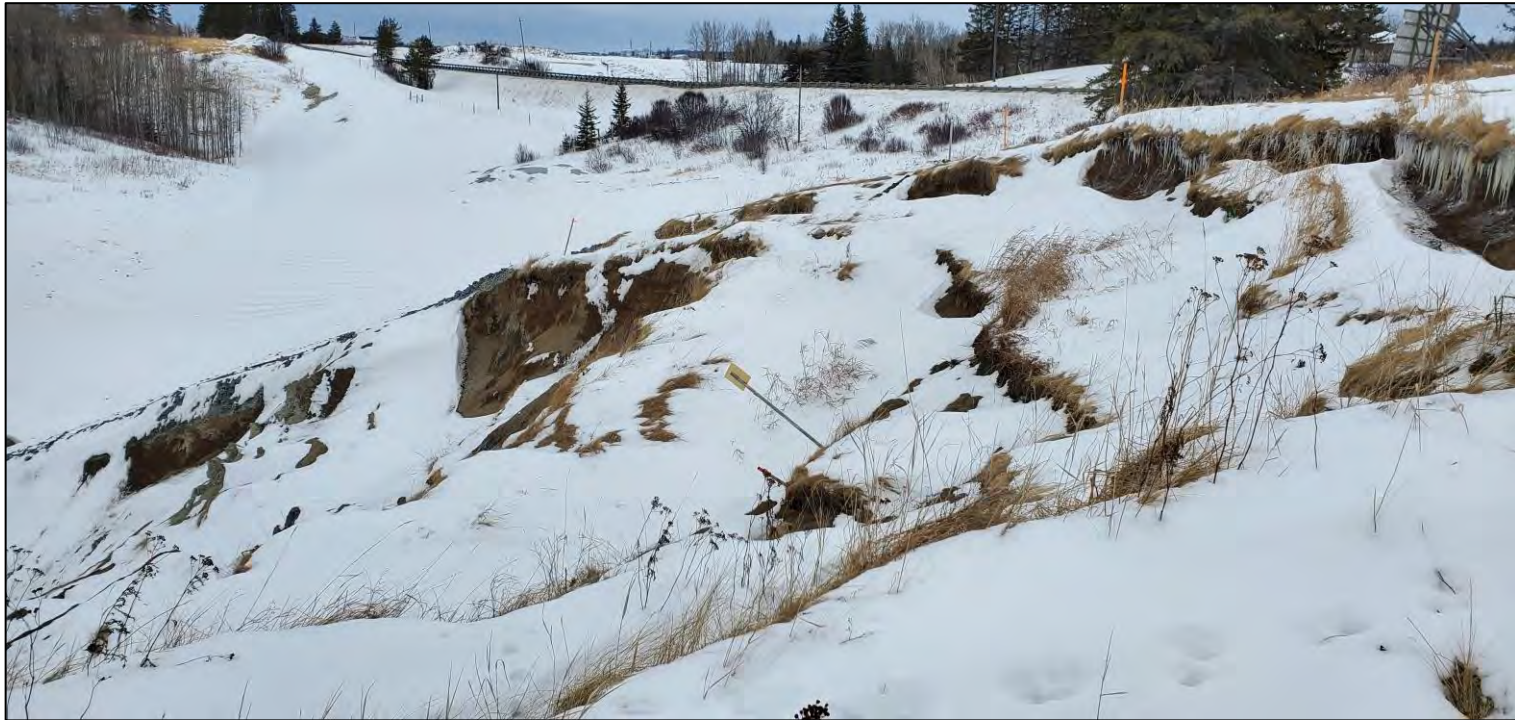
Photo 13: Recent landslide on the north slope of the valley.

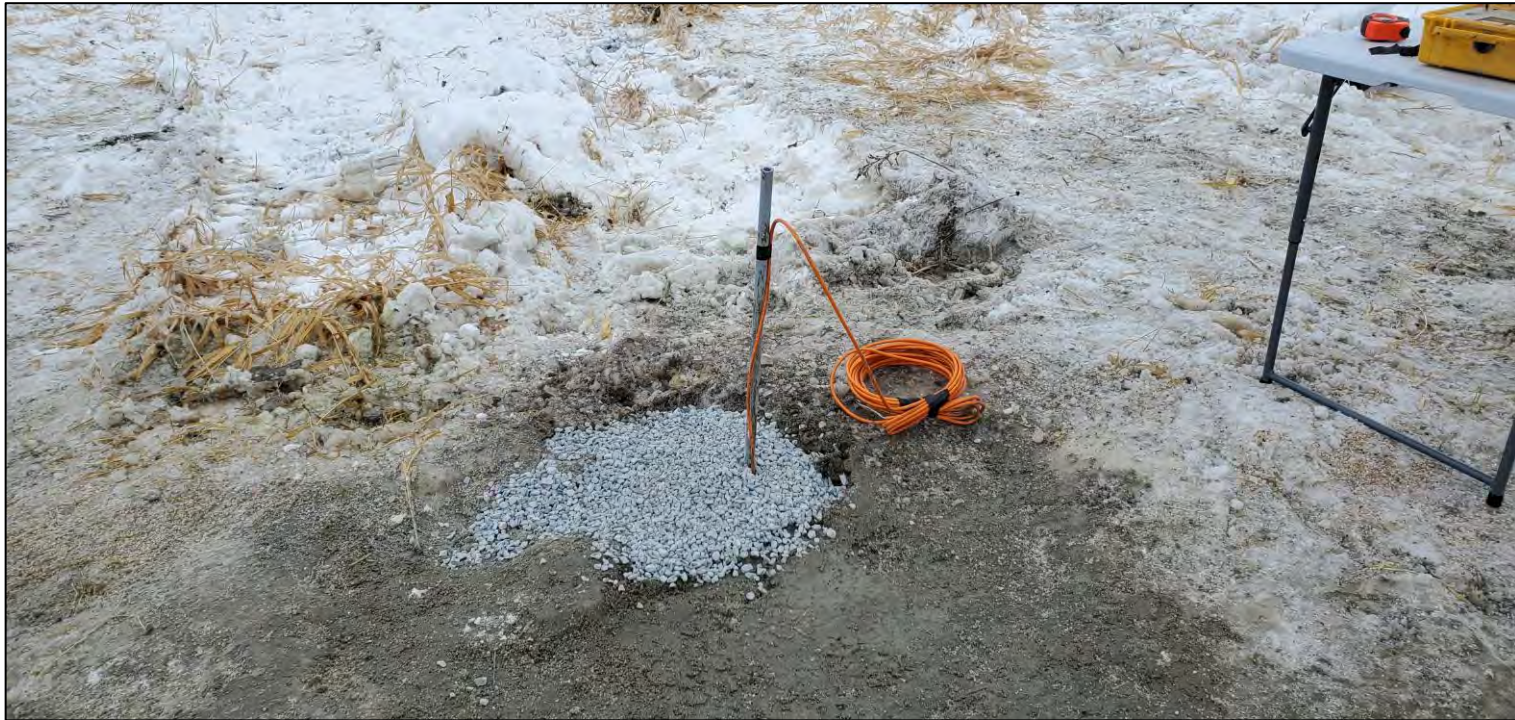
Photo 14: Vibrating wire piezometer upon installation.

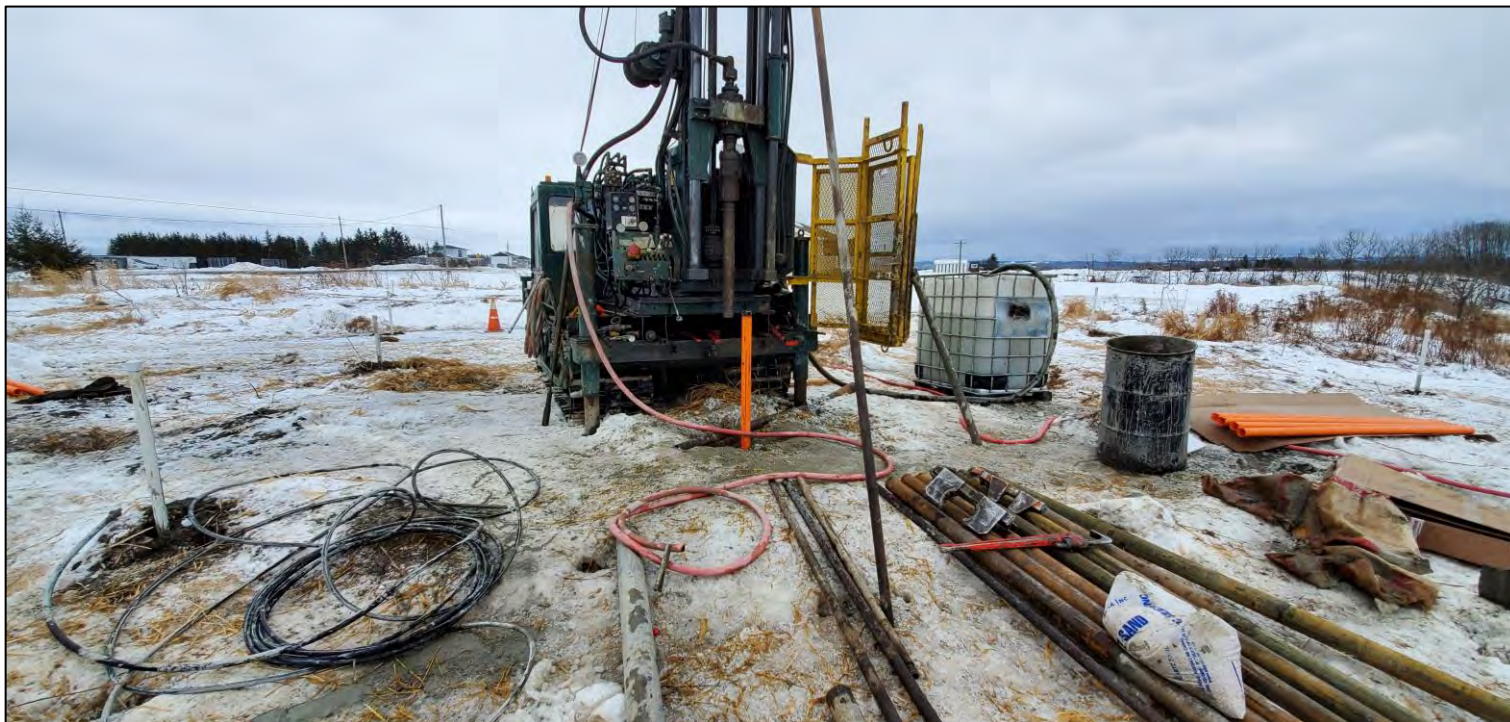
Photo 15: Drilling operations.

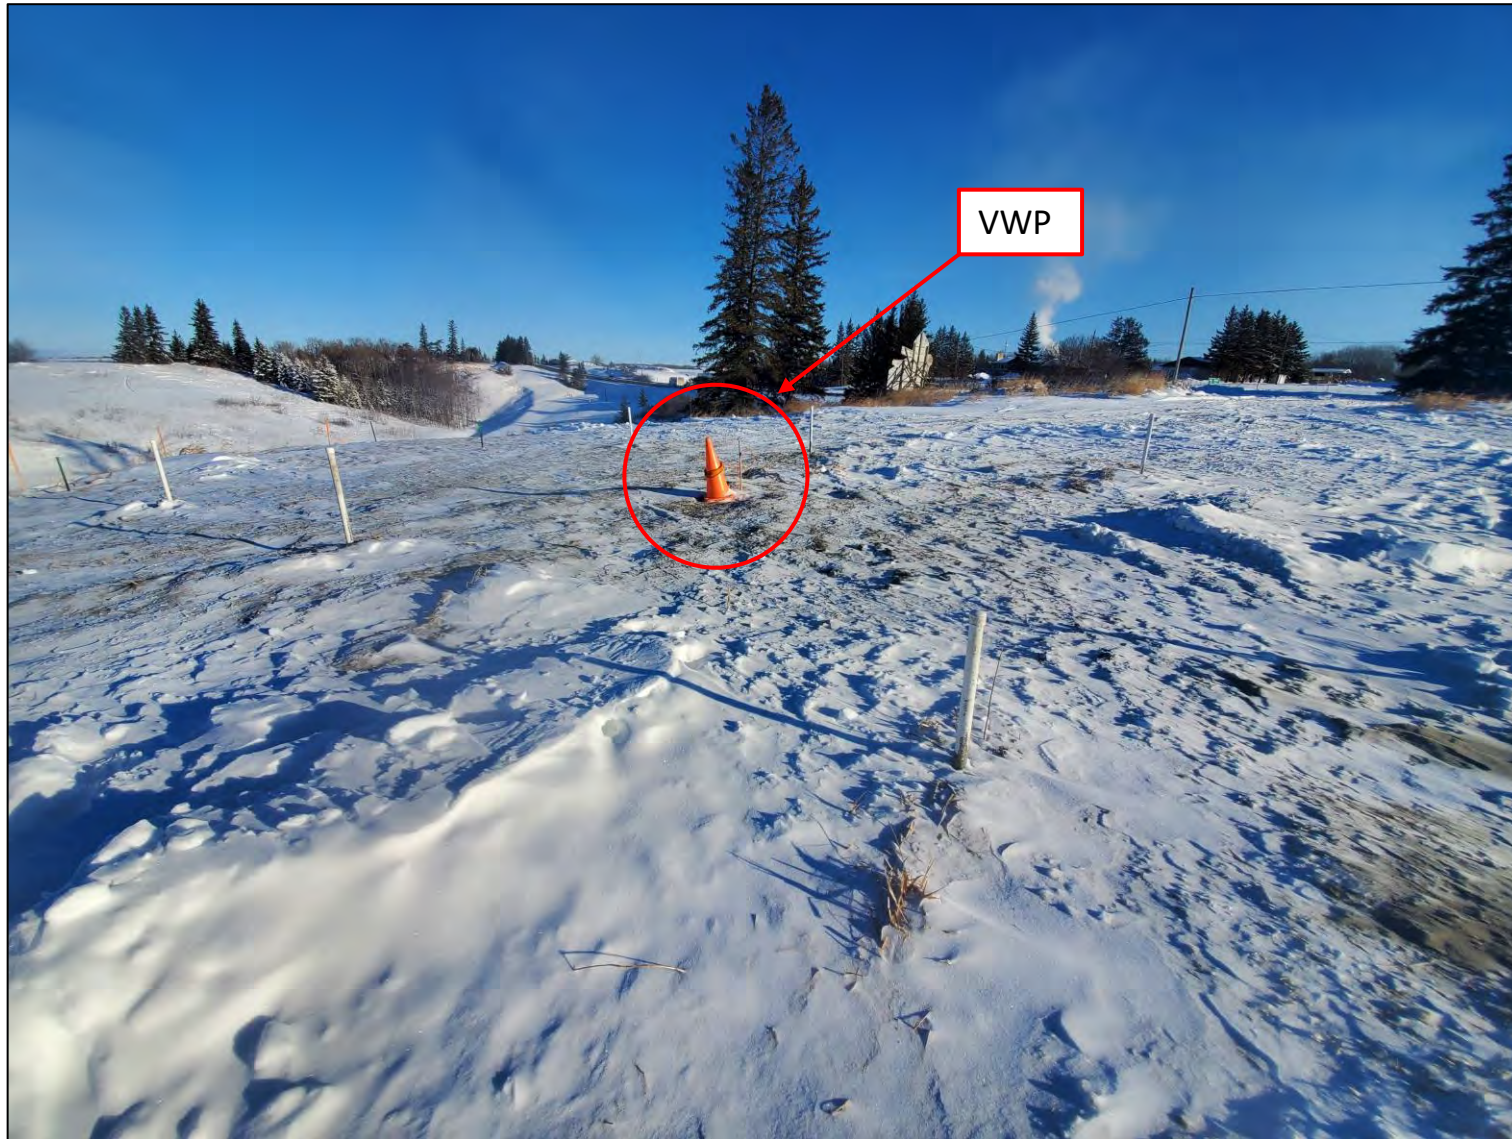
Photo 16: Vibrating wire piezometers installed in January, 2021.

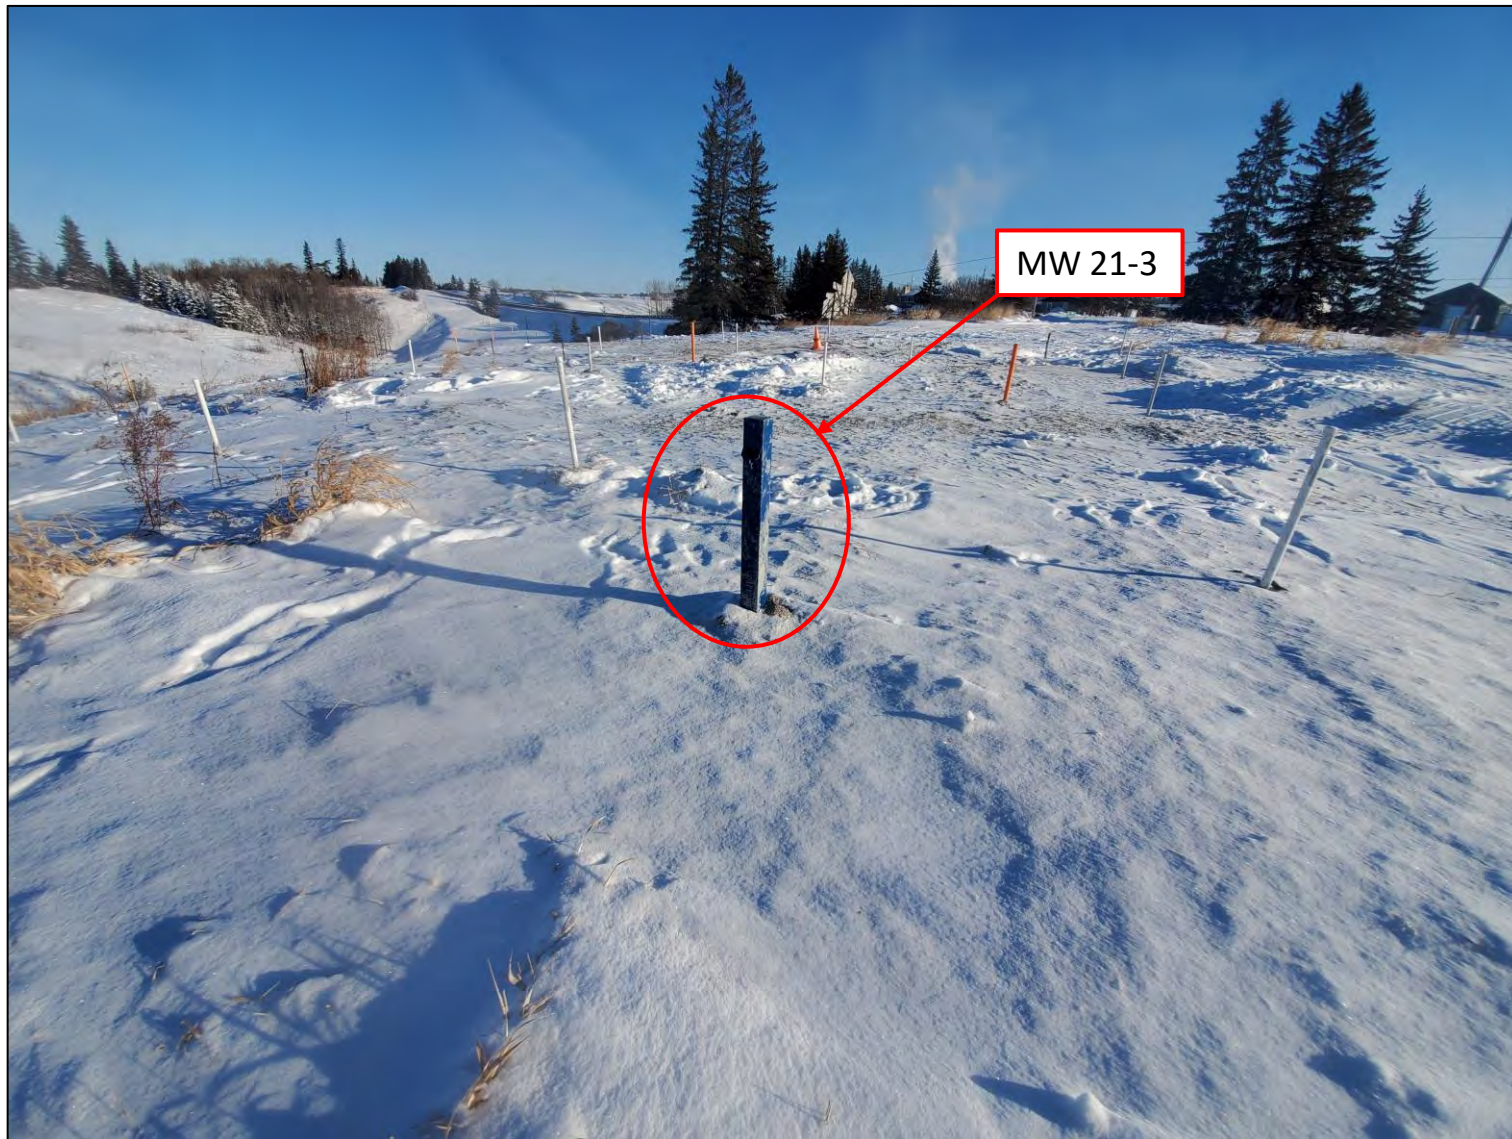
Photo 17: Monitoring well MW 21-3 installed in January, 2021.

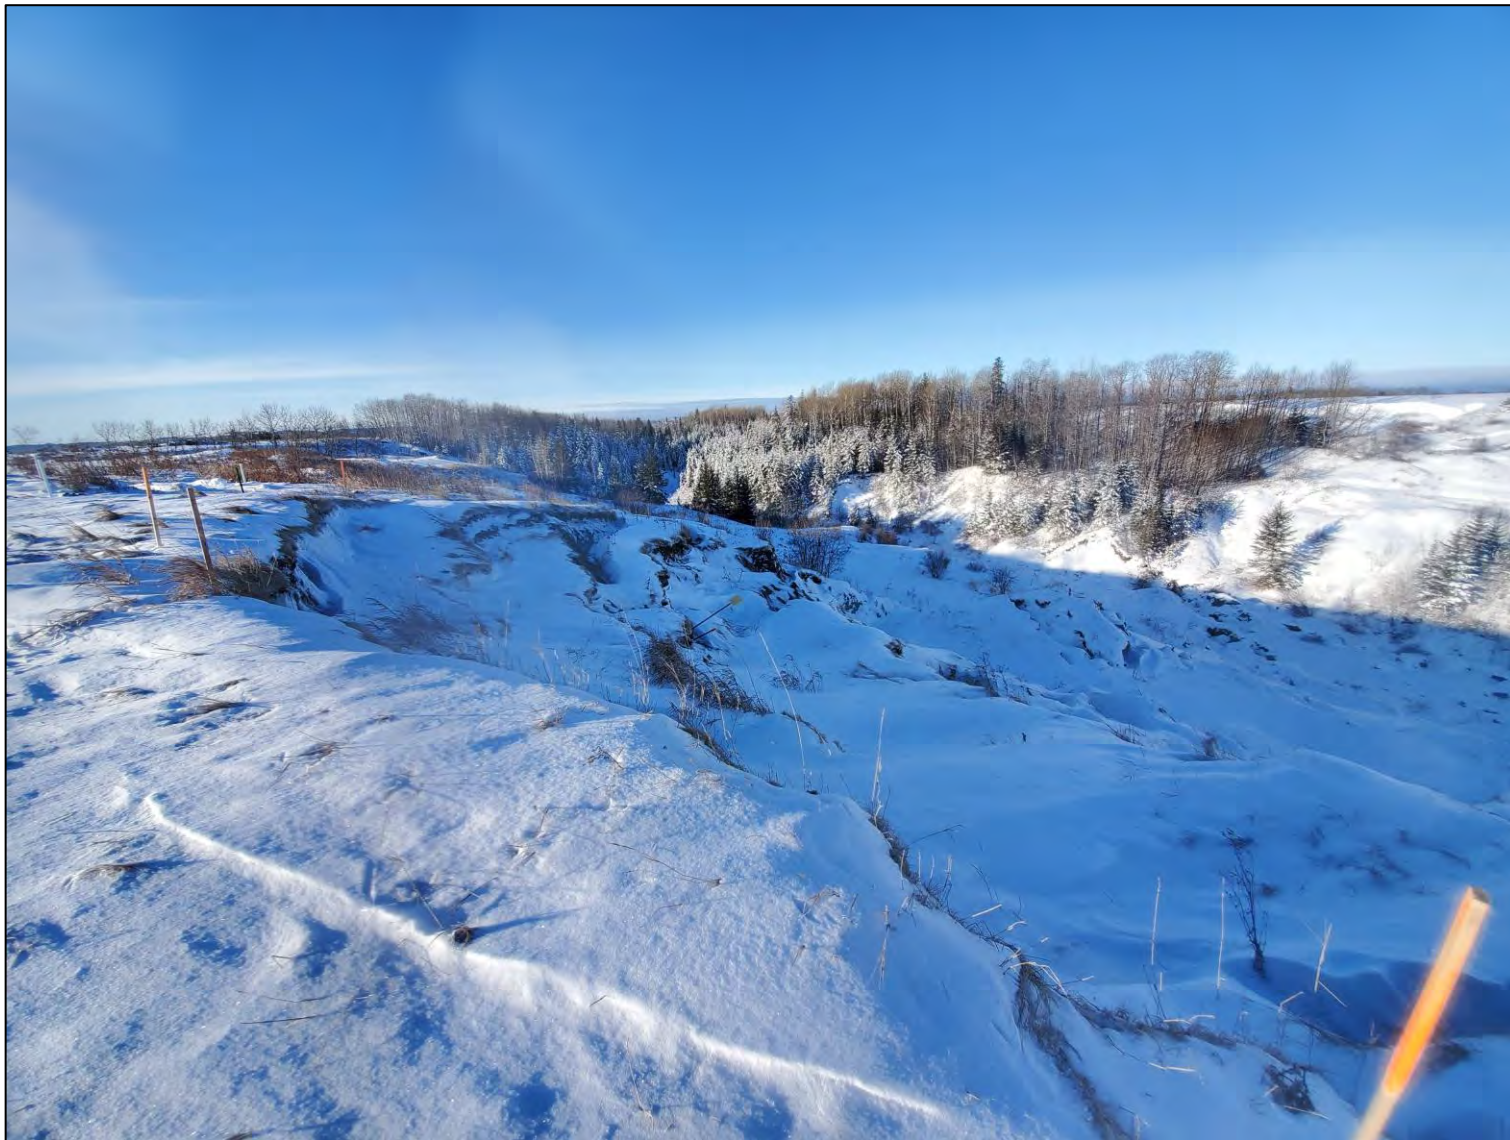
Photo 18: View of Site looking east.

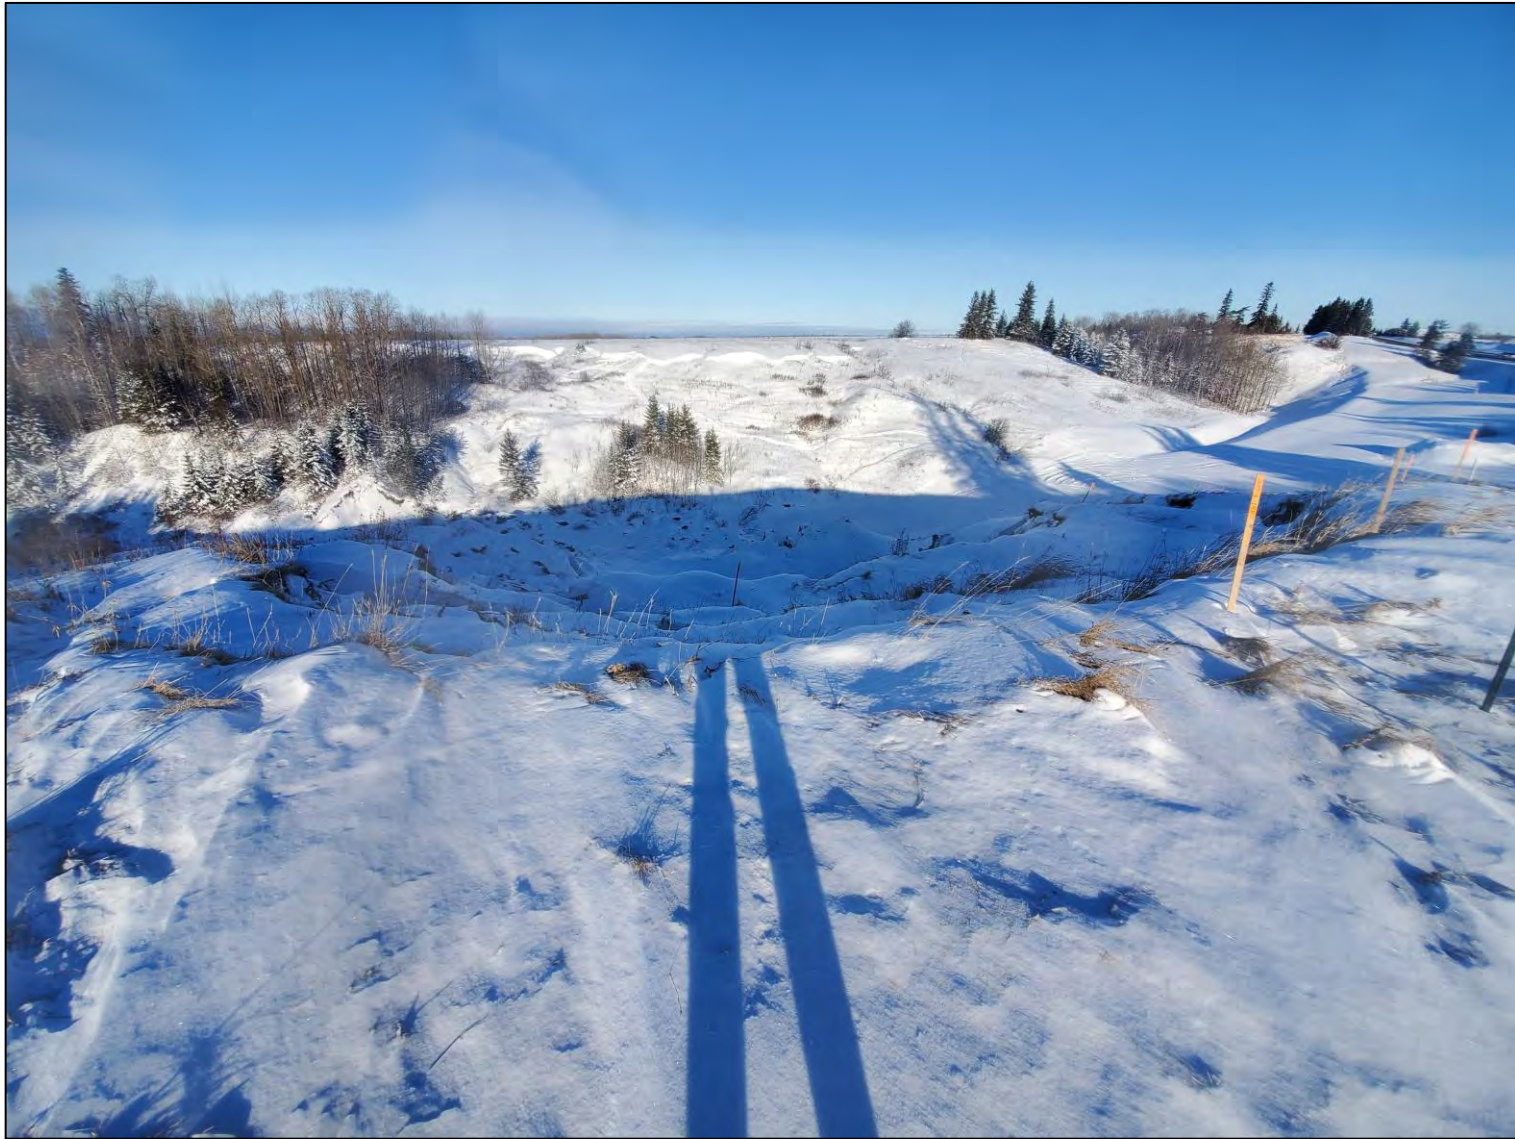
Photo 19: View looking north showing recent landslide on the north slope of the valley.

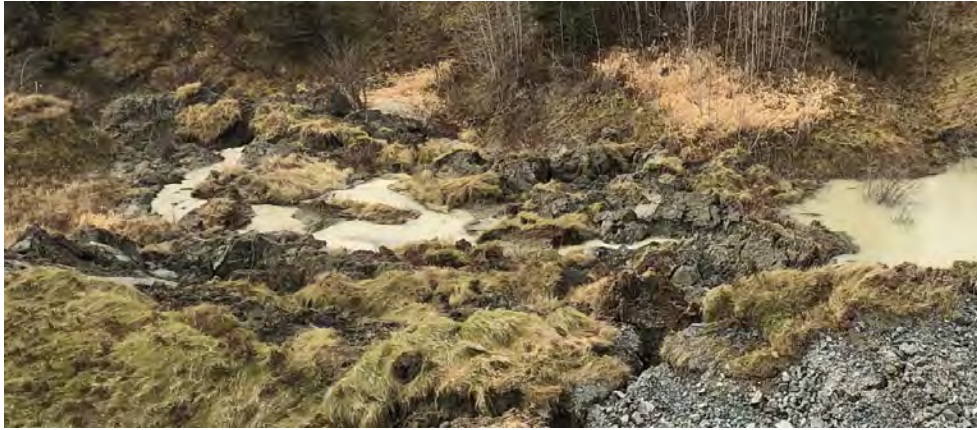
Figure 4: Top View of the Stream on Tuesday – 10 November 2020

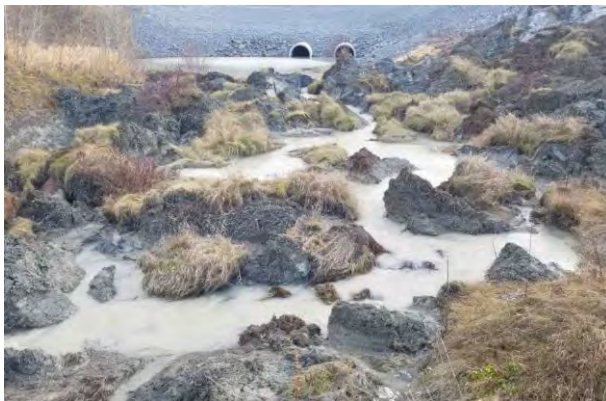
Figure 5: Stream Condition on Tuesday facing Northerly- 10 November 2020

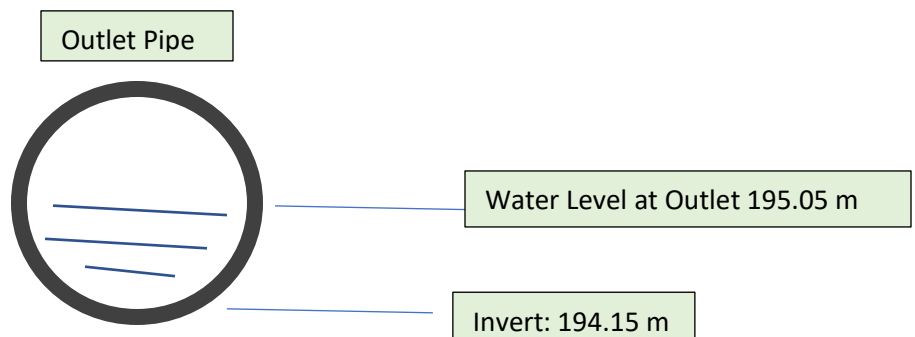
At 11:14 am, due to slow drainage of at the outlet, the water elevation at the NW outlet culvert was 195.05 while the invert of the outlet pipe is 194.15 (0.900 m of water)

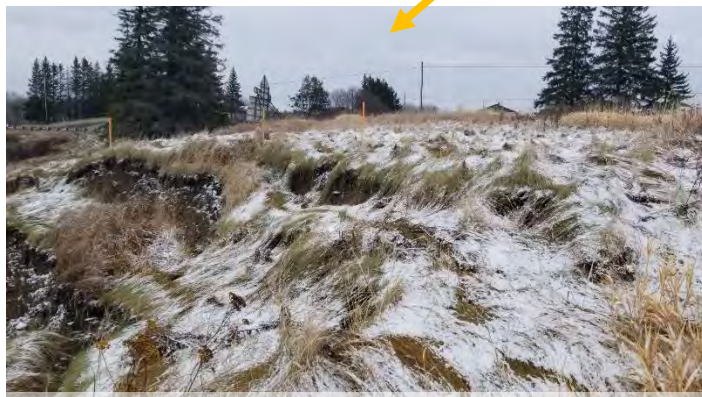
- 1- Since Friday, the failed upper portion of the slope has shown further movement by losing more ground (see figure 10) and more tension crack appeared when compared to last Friday Nov 13th, 2020.
- 2- A new additional tension cracks has been observed East of the original noted failure (See Figure 9).

Figure 10: Top of Failed Slope Facing Easterly – 16th Nov 2020
