**CALAMITY CREEK SLOPE FAILURE INVESTIGATION
HIGHWAY 11, 2.9 KM NORTH OF HWY 65 JUNCTION
NEW LISKEARD, ONTARIO
5018-E-0010, WORK ITEMS #7 AND #11**

G.W.P. NO. 5159-12-00

Geocres Number: 31M-133

March 2022

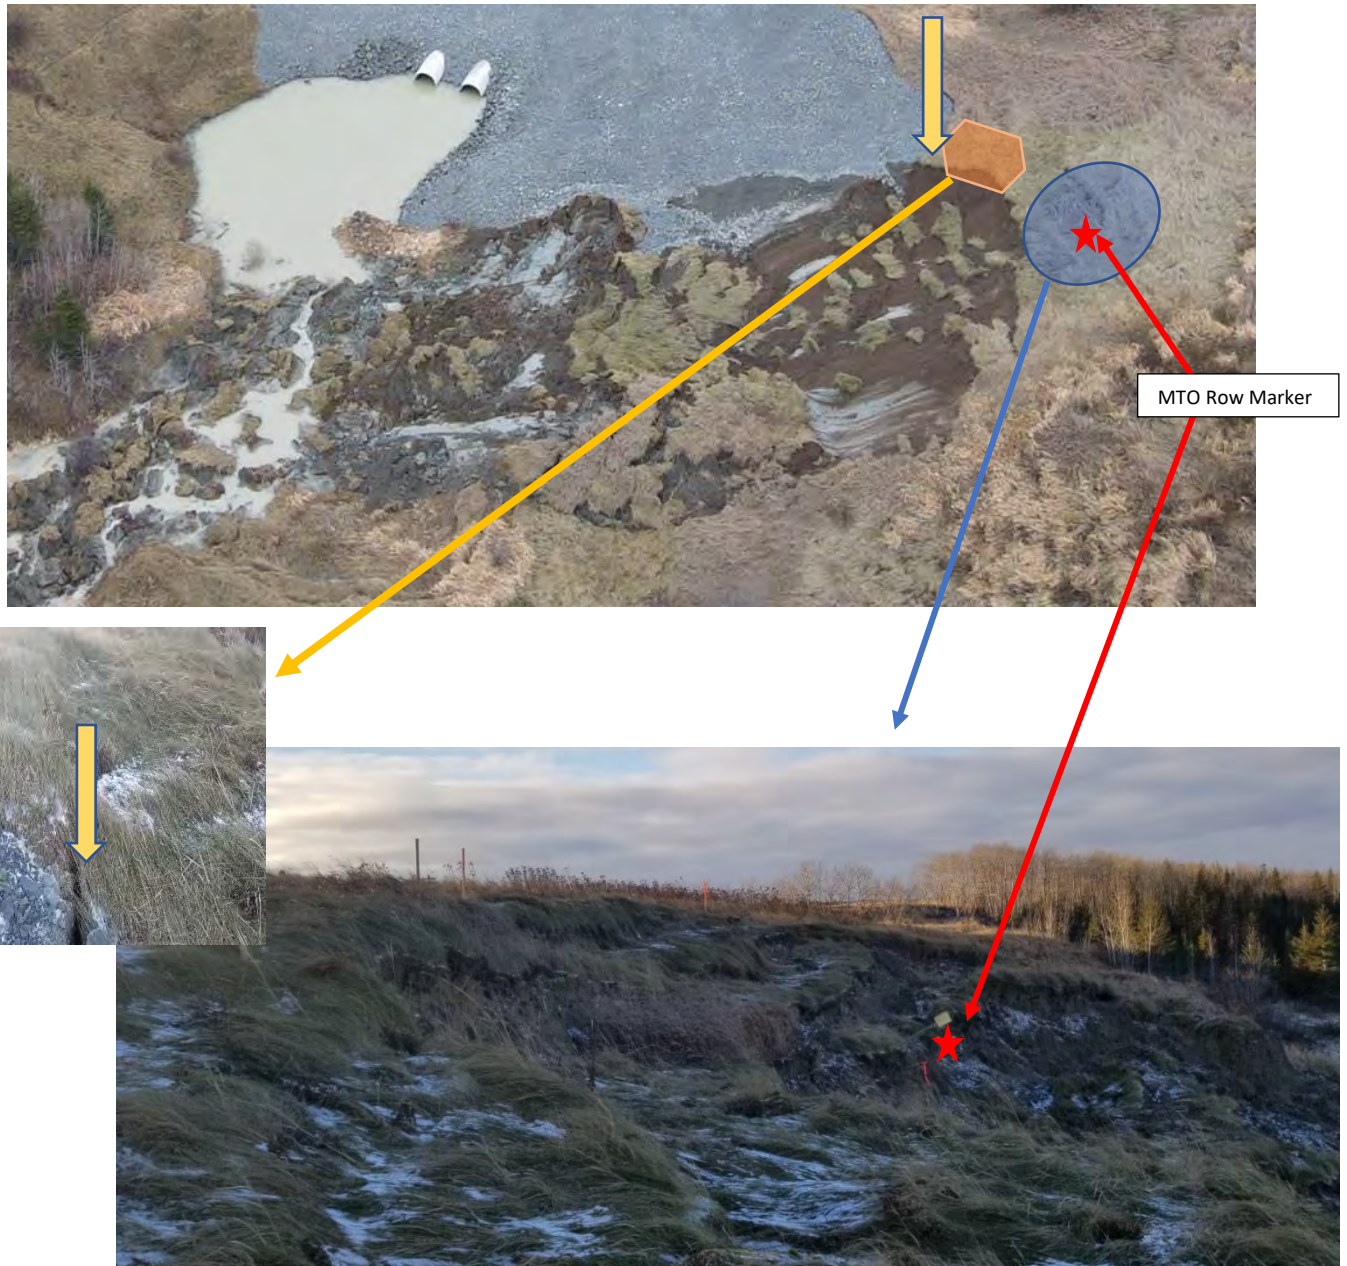
Today observations noted that both areas show signs of further movement.

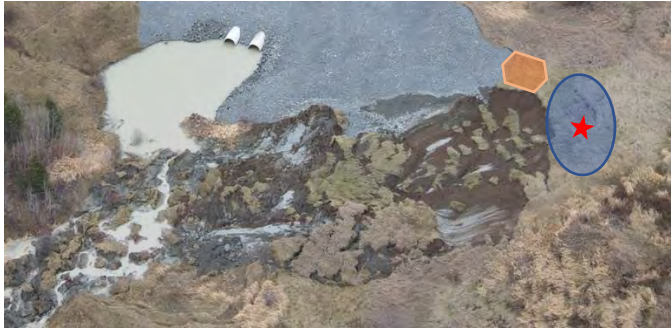
- 1- Evolution the **Blue Marked Area**: More movement were noted today when compared to yesterday pictures.

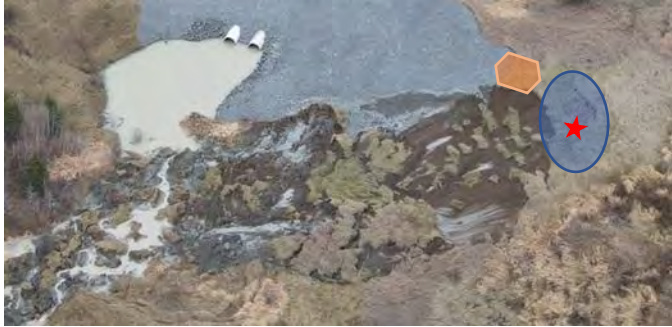
- 2- Evolution the **Orange Marked Area**: More movement were noted today when compared to yesterday pictures. The tension crack that developed between the failed slope and the rock protected area is increasing in width and length. We added (2) additional survey stakes adjacent to the ground tension cracked noted yesterday.

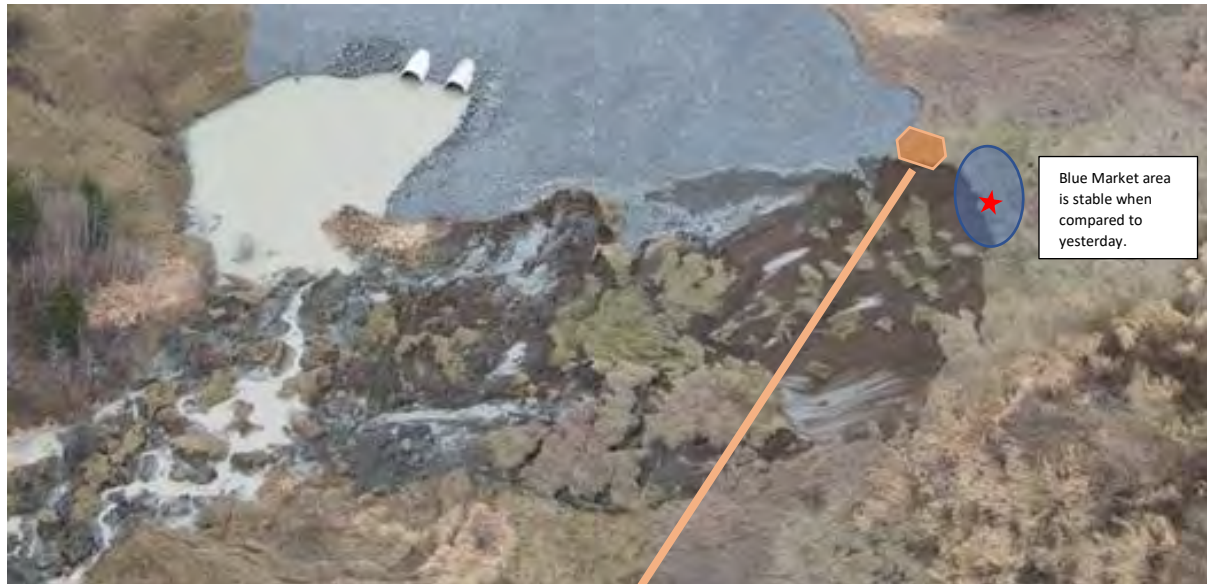
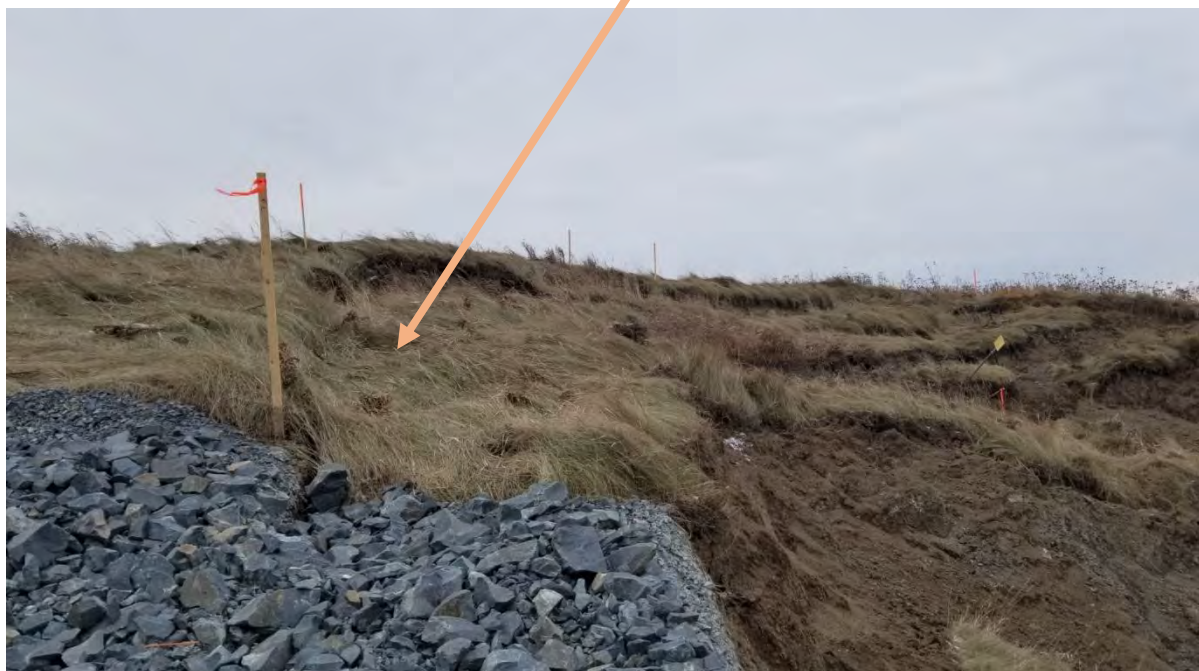
From observation at 8:20am this morning the creek channel shows no changes. Water elevation measurement at the outlet pile was(194.700 m) which is slightly lower than yesterday water level. It does not appear that the upper portion of the south slope has moved. However, the newest tension crack that developed this week (Marked in Orange) shows a sign of movement.

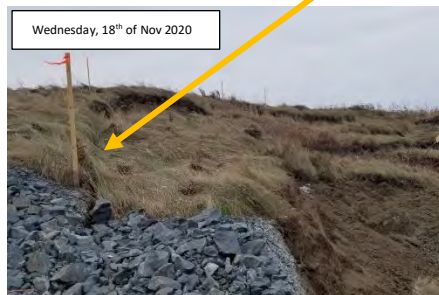
The upper portion appears to show no sign of movement. On the other hand, the recent tension crack that developed this week has showed signs of movement (Marked in Orange). Survey stake that was placed earlier this Wednesday (18th of Nov 2020) commenced to shift – See picture below.

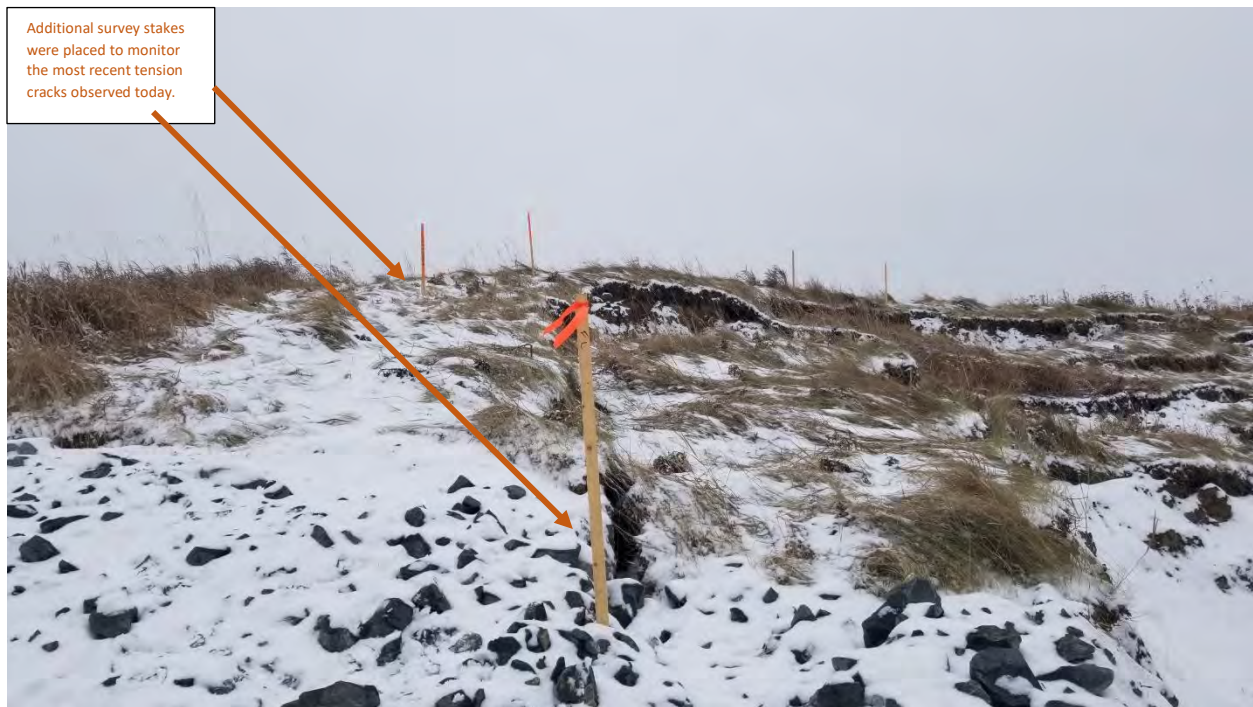
Based on today site visit, the Inspector identified that the upper portion of the south slope (Blues marked area) shows signs of movement. The secondary location (Orange marked area) that was developed last week has shown signs of further movement. There have been additional tension cracks more easterly. Inspector Installed new reference survey stakes to monitor them.

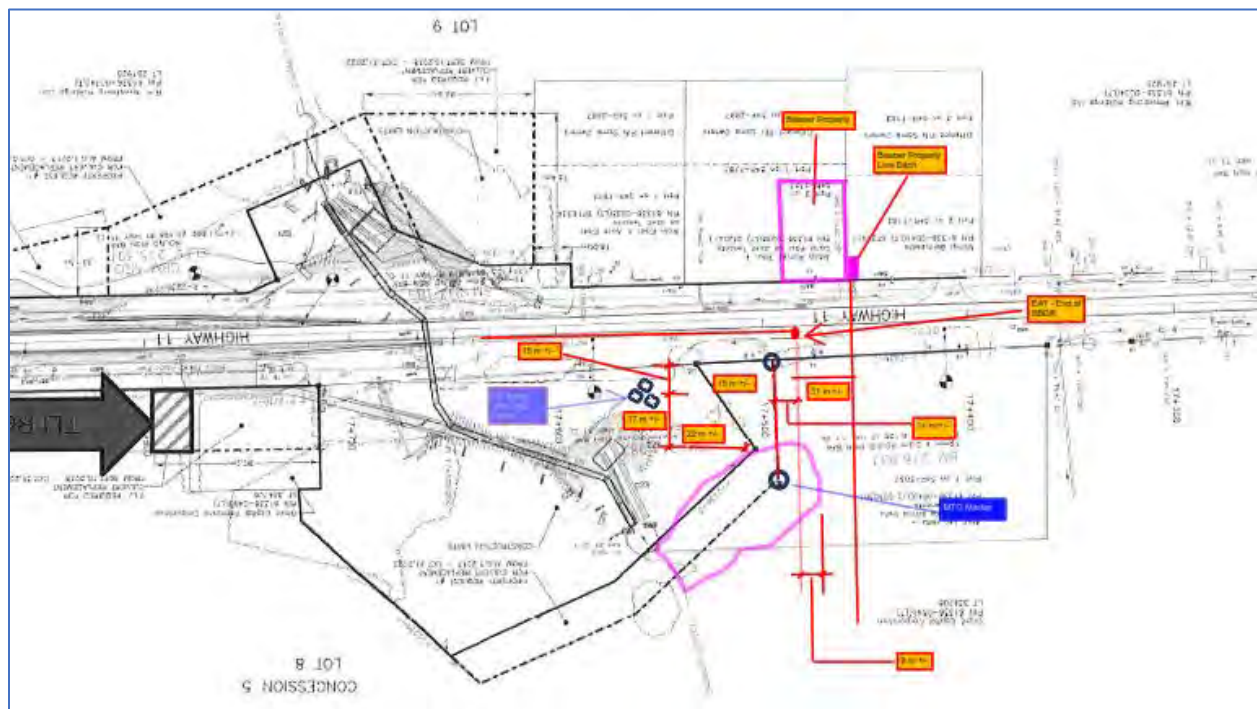
The CA team conducted a site measurement to markup the limits of the slope failure on the TLI documents.

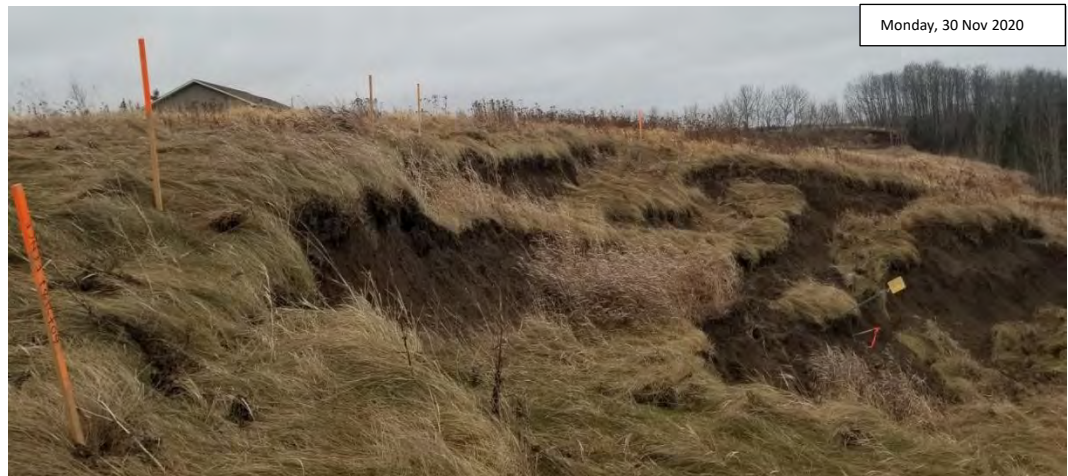
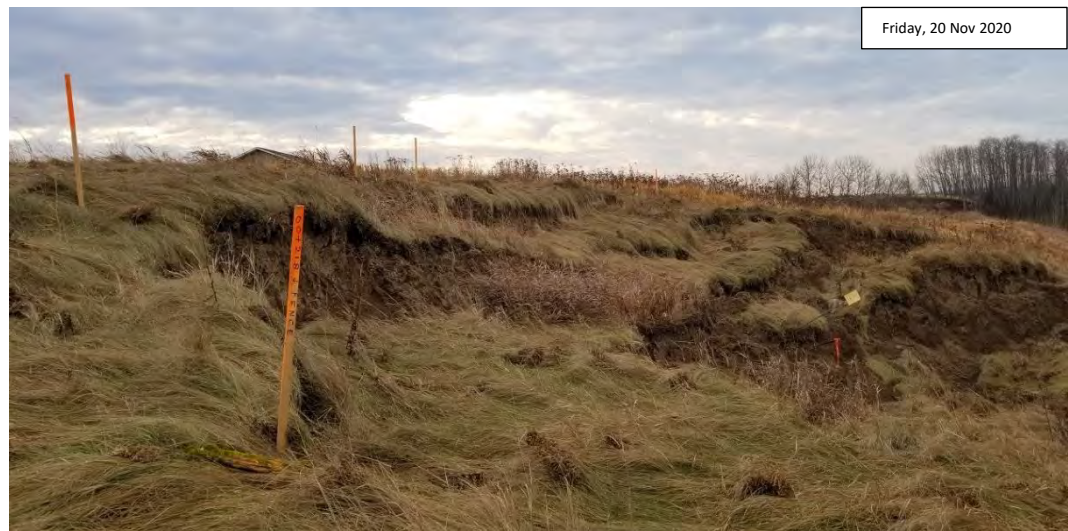
a- West of South Slope (Blue Marked Area)

The CA Team conducted slope failure monitoring this morning. It was determined that there were no changes to the downstream creek channel. Furthermore, it was confirmed that there were no additional tension cracks on the upper portion of the south slope. However, it was noted that the top of the (2) areas (East and West of the South slope – Blue and Orange marked areas) has moved further when compared to last week.

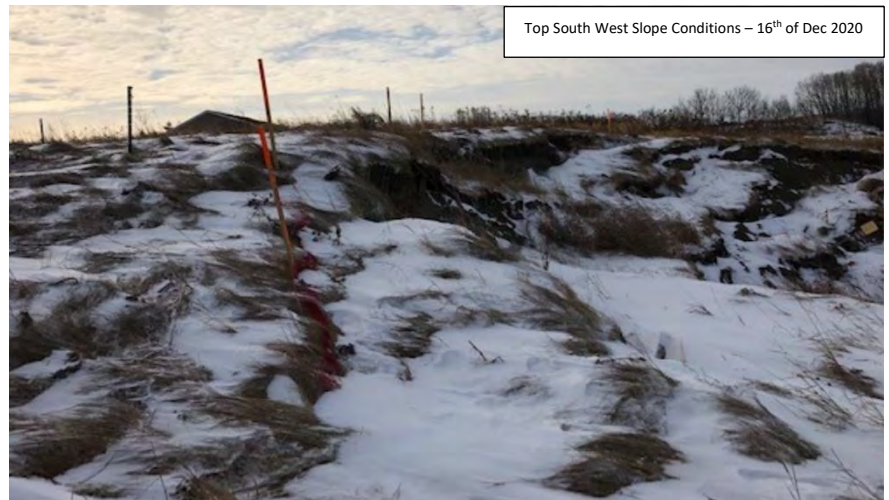
Site monitoring was conducted this morning. There were 4-8 inch of snow on the ground. The upper portion of the failed slope and the latest tension crack shows no signs of movement when compared to Monday the 14th of Dec 2020. For instance, the survey stakes (Placed by the CA team) did not show any signs of movement.

Note: Survey Stakes were placed exactly where a tension crack were detected.

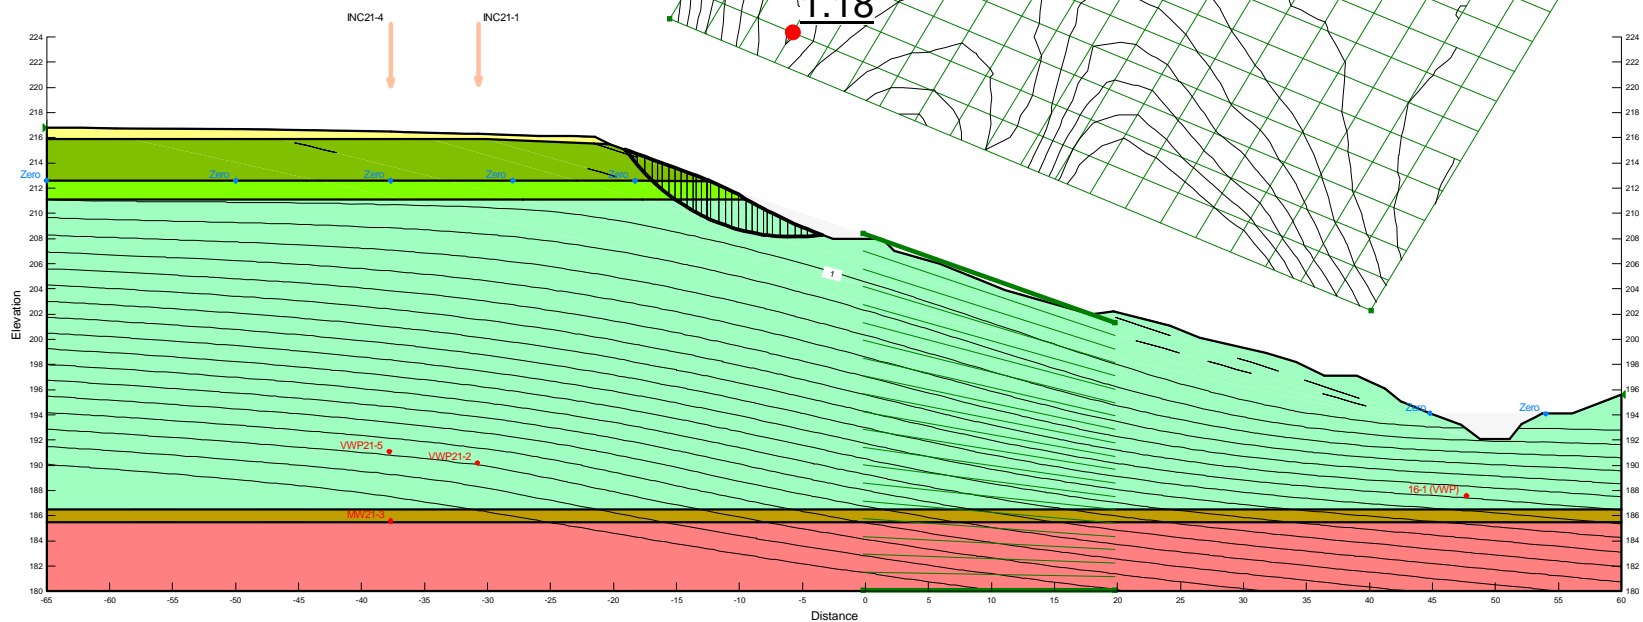
Project Calamity Creek		
Analysis 01) Permanent, static-drained conditions (upper slope only)		
Seismic Coefficient H: g, V: g	Last Run 01/27/2022, 11:39:40 AM	Scale 1:600

Additional Details
 Name: Section A-A
 Comments: Slope Stability Assessment
 Method: Morgenstern-Price, Half-Sine
 Minimum Slip Surface Depth: 3.05 m
 Entry: (-19.060893, 215.04942) m, Exit: (-3.4373404, 208.30702) m
 Center: (-5.7803404, 224.35054) m, Radius: 16.213696 m

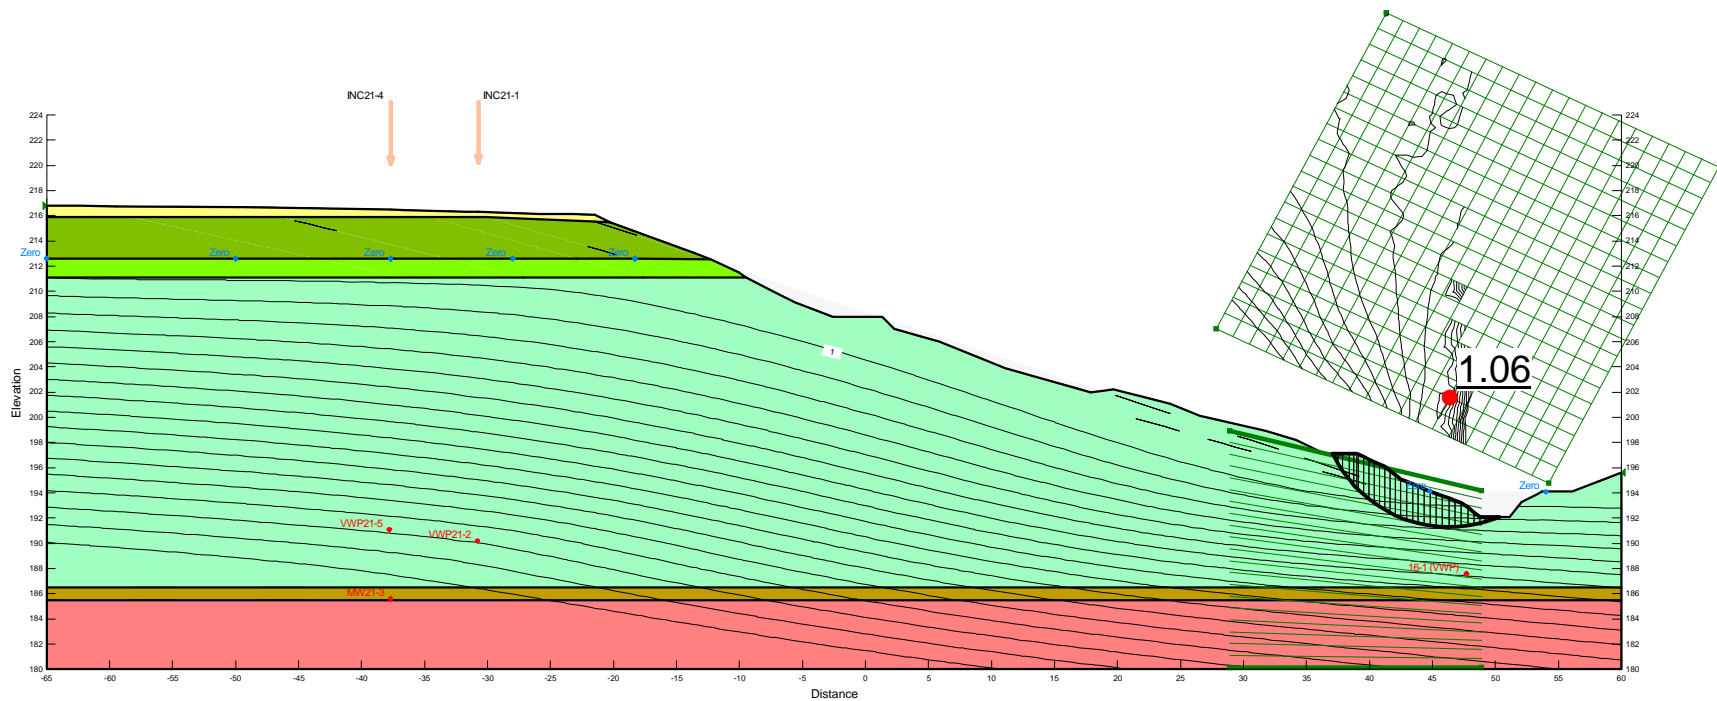
Project Calamity Creek		
Analysis 02) Permanent, static-drained conditions (lower slope only)		
Seismic Coefficient H: g, V: g	Last Run 01/27/2022, 11:38:09 AM	Scale 1:600

Additional Details
 Name: Section A-A
 Comments: Slope Stability Assessment
 Method: Morgenstern-Price, Half-Sine
 Minimum Slip Surface Depth: 3.05 m
 Entry: (37.08808, 197.1) m, Exit: (50.352671, 192.1) m
 Center: (46.345496, 201.56423) m, Radius: 10.277603 m

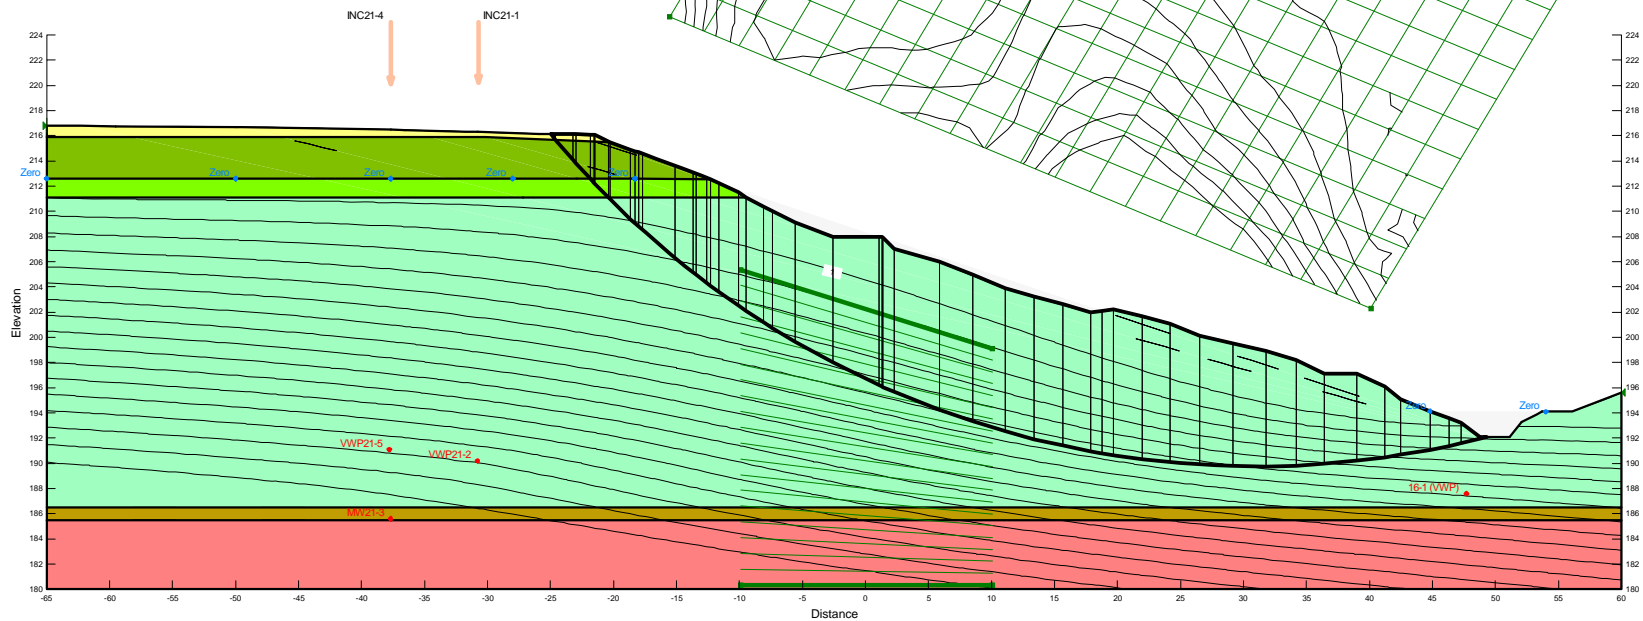
Project		
Calamity Creek		
Analysis		
03) Permanent, static-drained conditions (global slope)		
Seismic Coefficient	Last Run	Scale
H: g, V: g	01/27/2022, 11:38:22 AM	1:60

Additional Details
Name: Section A-A
Comments: Slope Stability Assessment
Method: Morgenstern-Price, Half-Sine
Minimum Slip Surface Depth: 3.05 m
Entry: (-24.987943, 216.13425) m, Exit: (49.289313, 192.1) m
Center: (30.993214, 262.3495) m, Radius: 72.592974 m

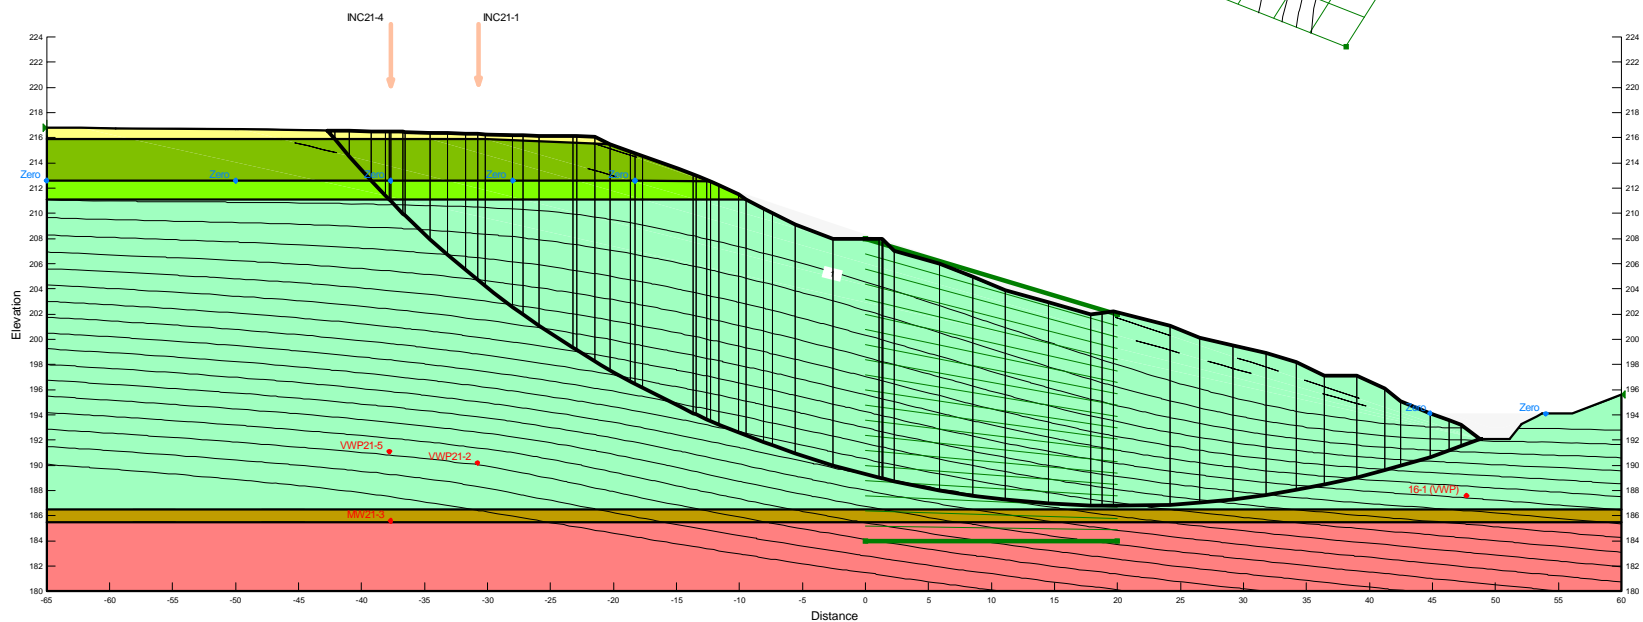
Project Calamity Creek		
Analysis 04) Temporary, static-undrained (global slope)		
Seismic Coefficient H: g, V: g	Last Run 01/27/2022, 11:37:23 AM	Scale 1:600

Additional Details
 Name: Section A-A
 Comments: Slope Stability Assessment
 Method: Morgenstern-Price, Half-Sine
 Minimum Slip Surface Depth: 1.52 m
 Entry: (-42.707601, 216.58143) m, Exit: (48.892475, 192.1) m
 Center: (20.032792, 267.725) m, Radius: 80.944561 m

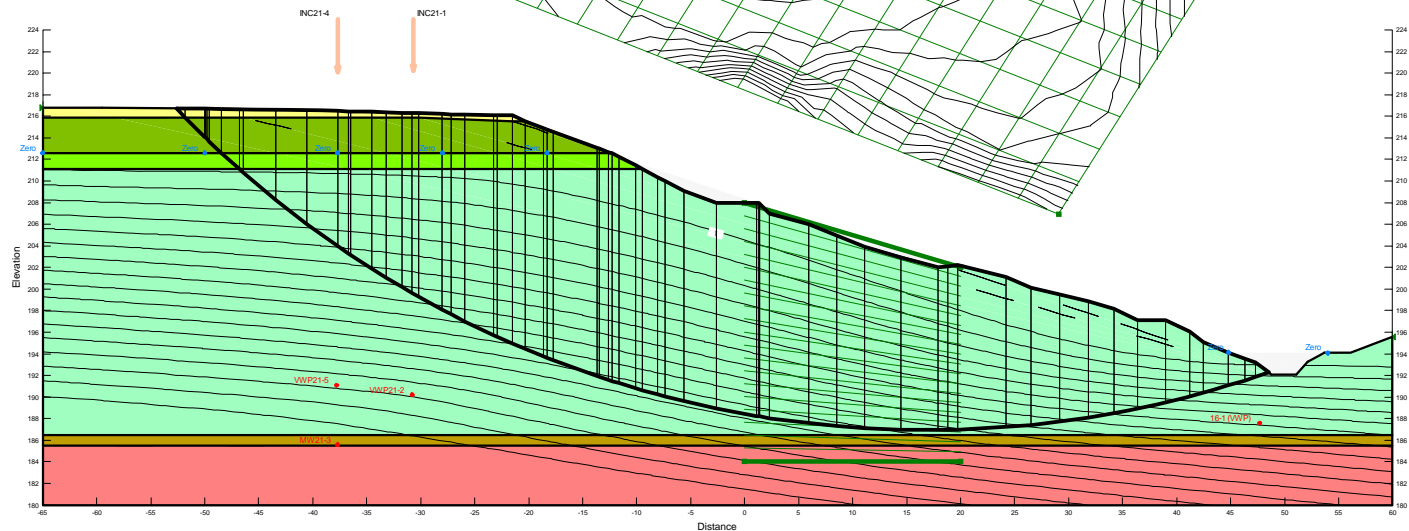
Project Calamity Creek		
Analysis 05) Temporary, static-undrained with 2475 yr earthquake		
Seismic Coefficient H: 0.115g, V: g	Last Run 01/27/2022, 11:38:34 AM	Scale 1:700

Additional Details
 Name: Section A-A
 Comments: Slope Stability Assessment
 Method: Morgenstern-Price, Half-Sine
 Minimum Slip Surface Depth: 1.52 m
 Entry: (-52.609675, 216.7174) m, Exit: (48.528627, 192.29815) m
 Center: (16.895843, 282.93737) m, Radius: 96.000527 m

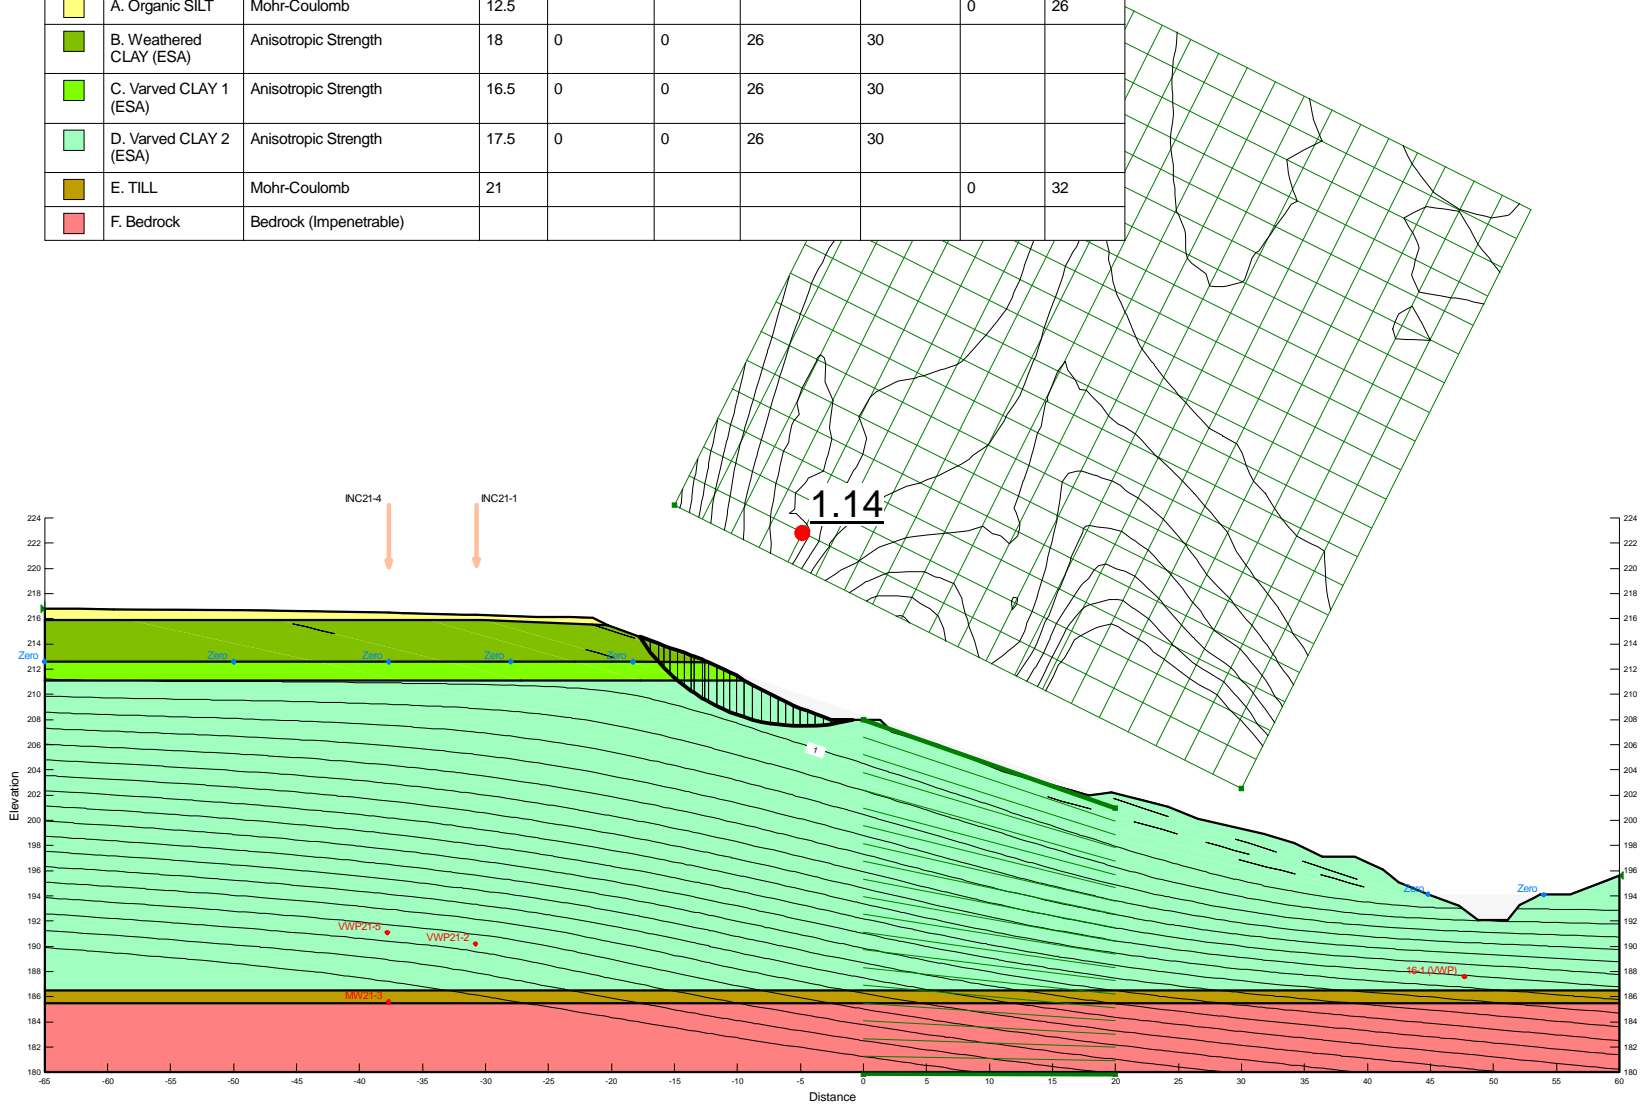
Project	
Calamity Creek	
Analysis	
06) 5% PWP Increase, static-drained conditions (upper slope only)	
Seismic Coefficient	Last Run
H: g, V: g	01/27/2022, 11:39:15 AM
Scale	1:600

Additional Details
 Name: Section A-A
 Comments: Slope Stability Assessment
 Method: Morgenstern-Price, Half-Sine
 Minimum Slip Surface Depth: 3.05 m
 Entry: (-17.792177, 214.58806) m, Exit: (-0.86304181, 208) m
 Center: (-4.85, 222.8) m, Radius: 15.327617 m

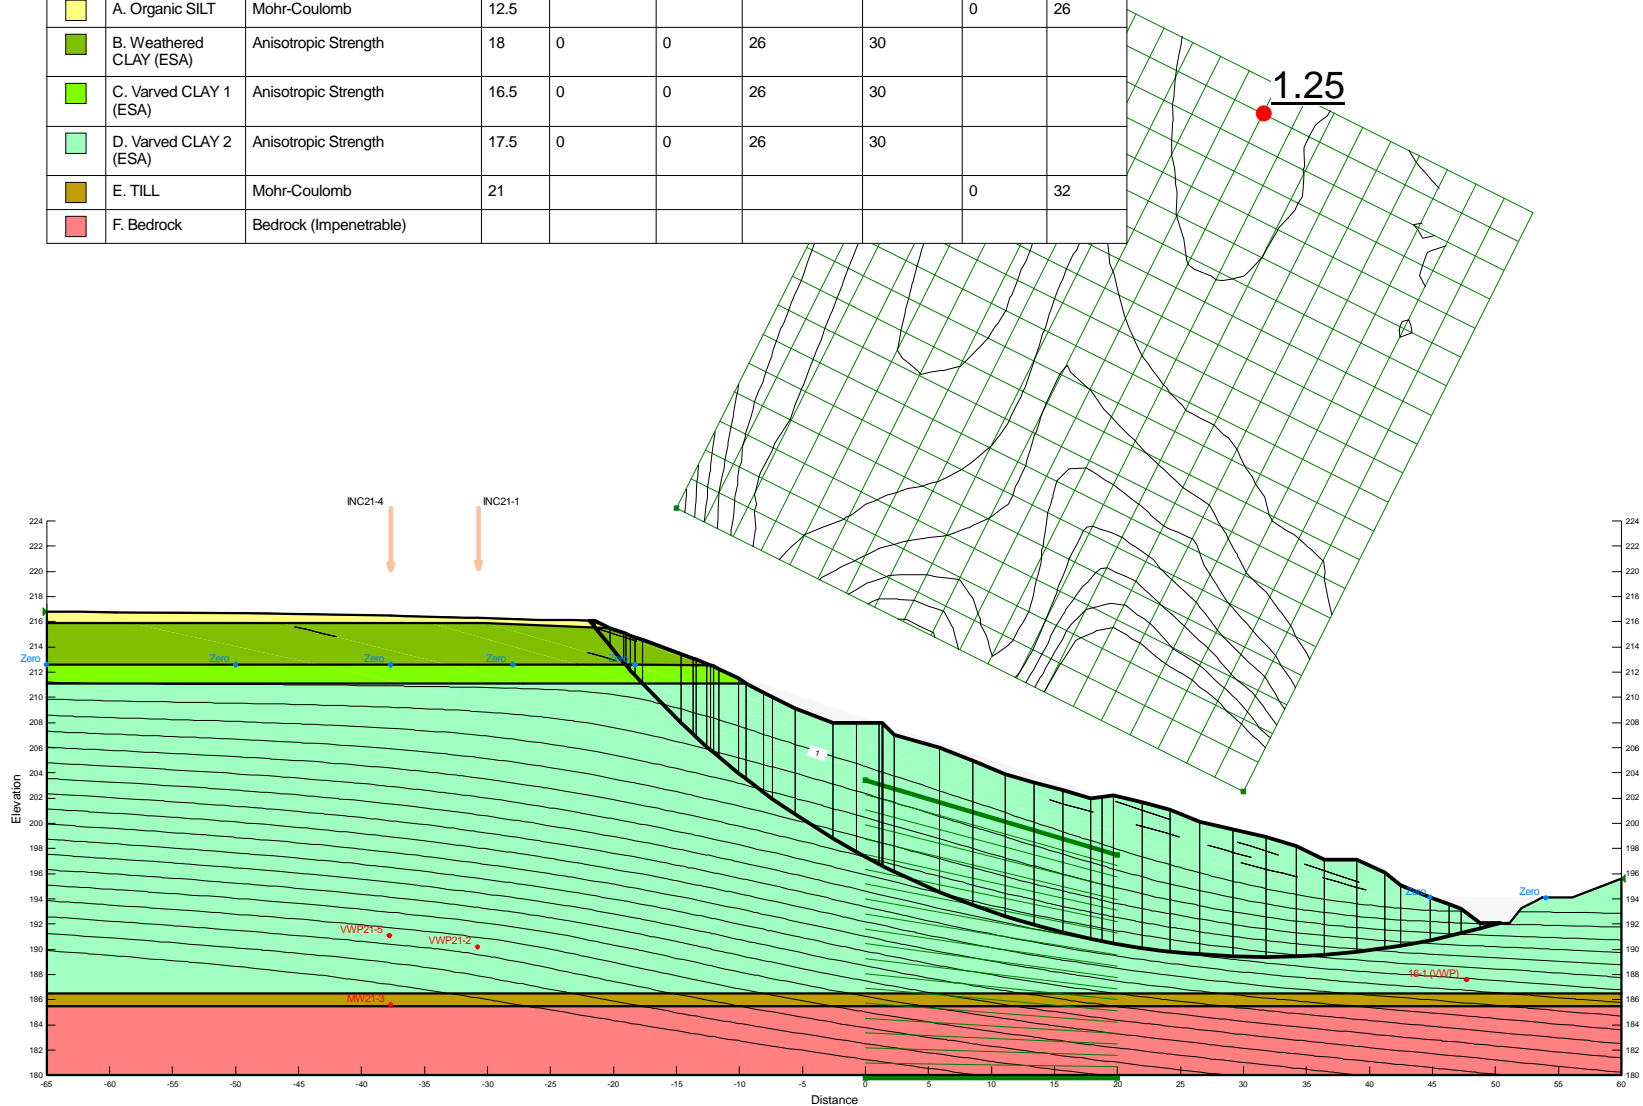
Project Calamity Creek		
Analysis 07) 5% PWP Increase, static-drained conditions (global slope)		
Seismic Coefficient H: g, V: g	Last Run 01/27/2022, 11:38:48 AM	Scale 1:600

Additional Details
 Name: Section A-A
 Comments: Slope Stability Assessment
 Method: Morgenstern-Price, Half-Sine
 Minimum Slip Surface Depth: 3.05 m
 Entry: (-21.88264, 216.10376) m, Exit: (50.396024, 192.1) m
 Center: (31.6, 256.325) m, Radius: 66.918915 m

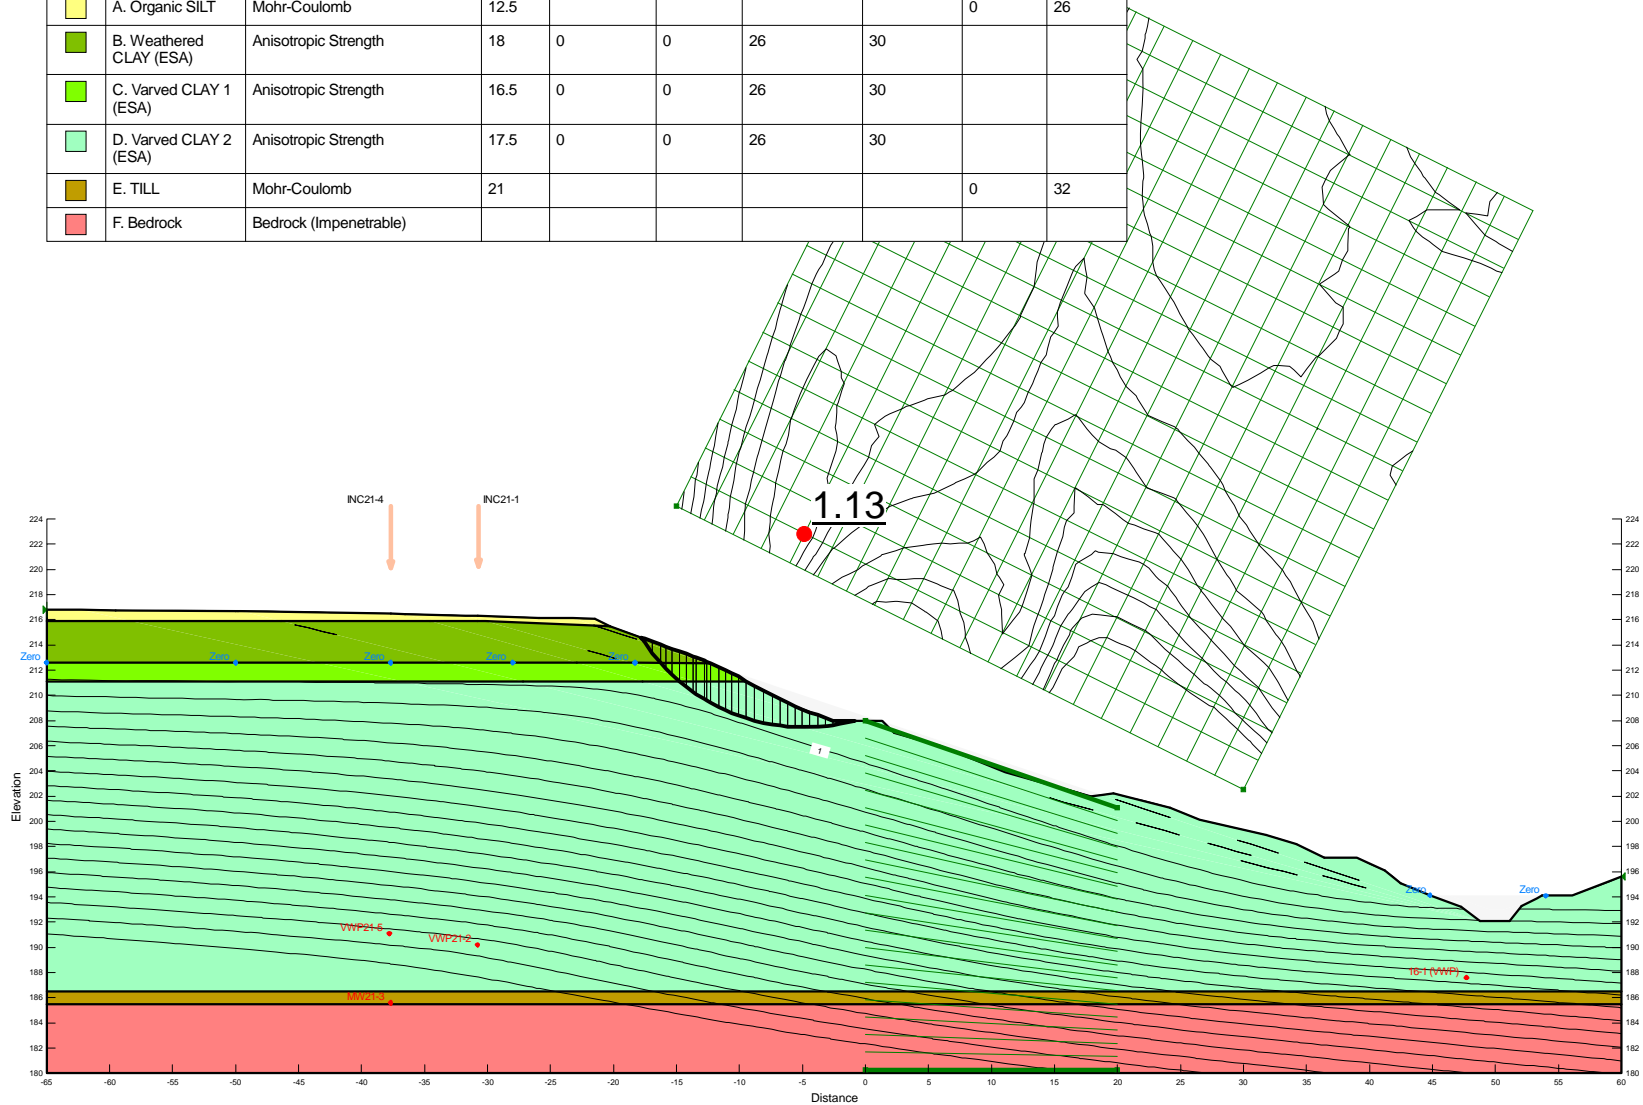
Project Calamity Creek		
Analysis 08) 10% PWP Increase, static-drained conditions (upper slope only)		
Seismic Coefficient H: g, V: g	Last Run 01/27/2022, 11:39:29 AM	Scale 1:600

Additional Details
Name: Section A-A
Comments: Slope Stability Assessment
Method: Morgenstern-Price, Half-Sine
Minimum Slip Surface Depth: 3.05 m
Entry: (-17.796067, 214.58948) m, Exit: (-0.85333741, 208) m
Center: (-4.85, 222.8) m, Radius: 15.330144 m

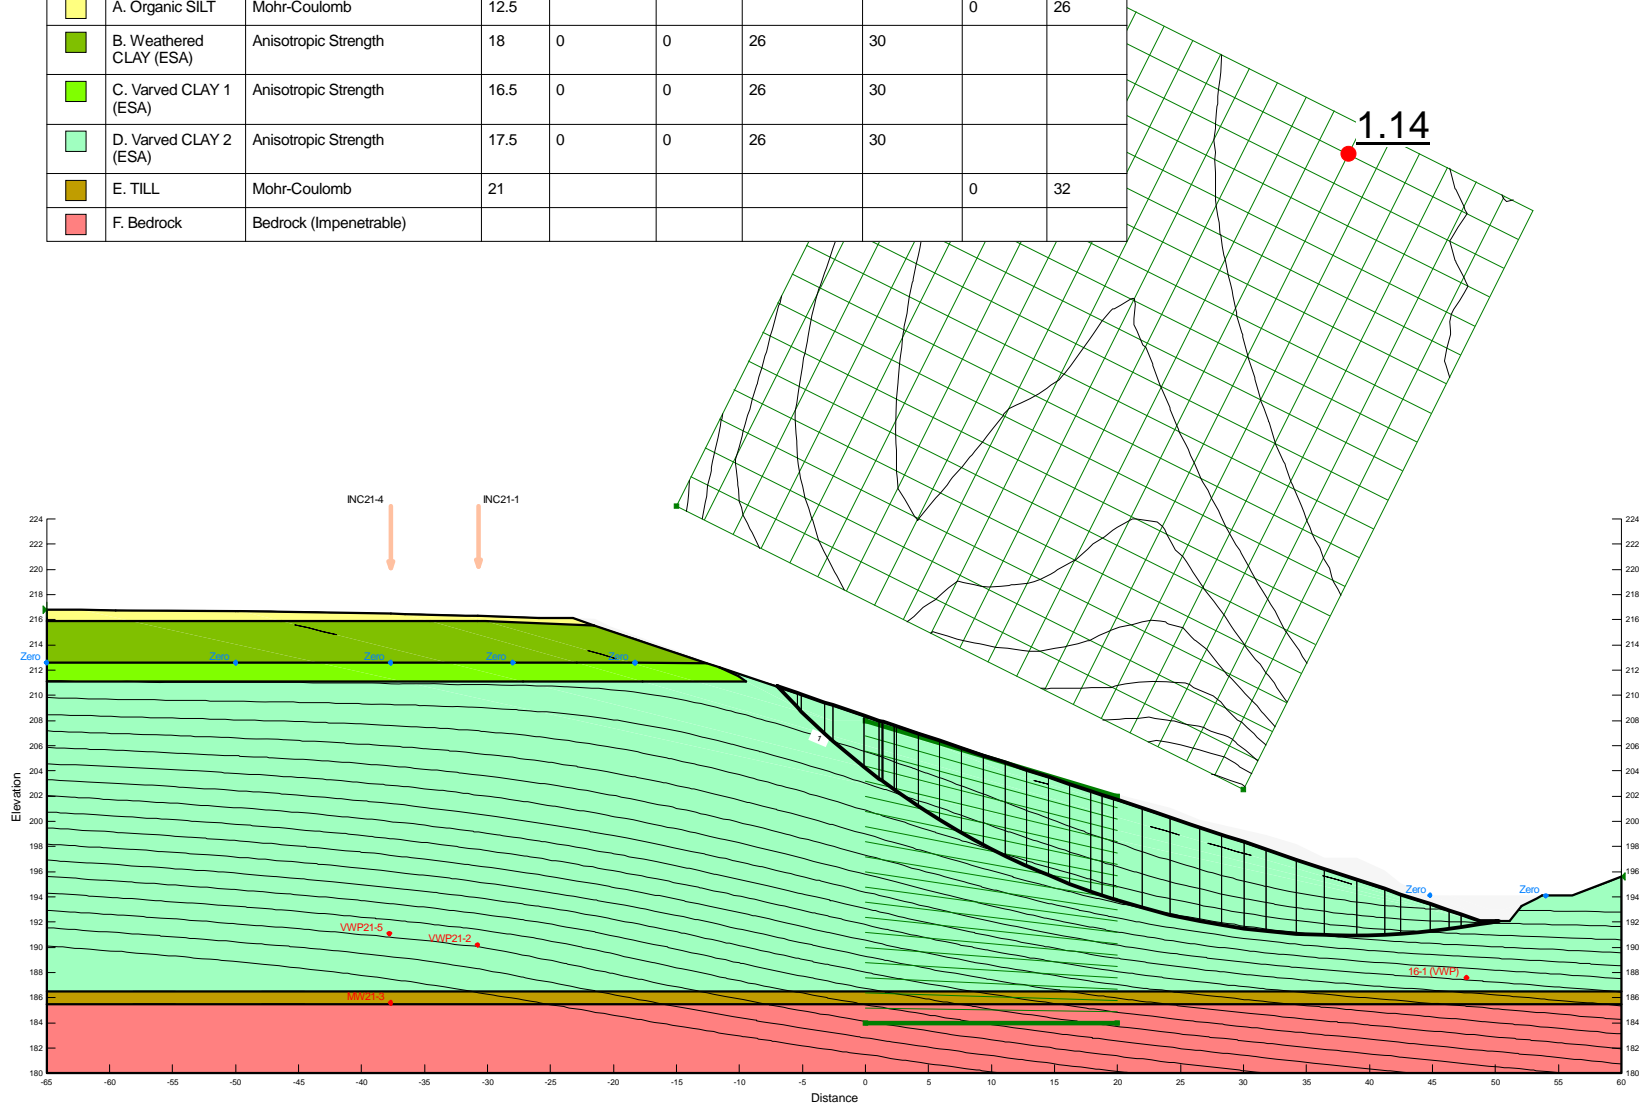
Figure J10

Project Calamity Creek		
Analysis 10) 3H:1V slope flattening		
Seismic Coefficient H: g, V: g	Last Run 01/27/2022, 11:37:41 AM	Scale 1:600

Additional Details
 Name: Section A-A
 Comments: Slope Stability Assessment
 Method: Morgenstern-Price, Half-Sine
 Minimum Slip Surface Depth: 1.52 m
 Entry: (-7.054381, 210.71813) m, Exit: (50.281744, 192.1) m
 Center: (38.35, 252.95) m, Radius: 62.008782 m

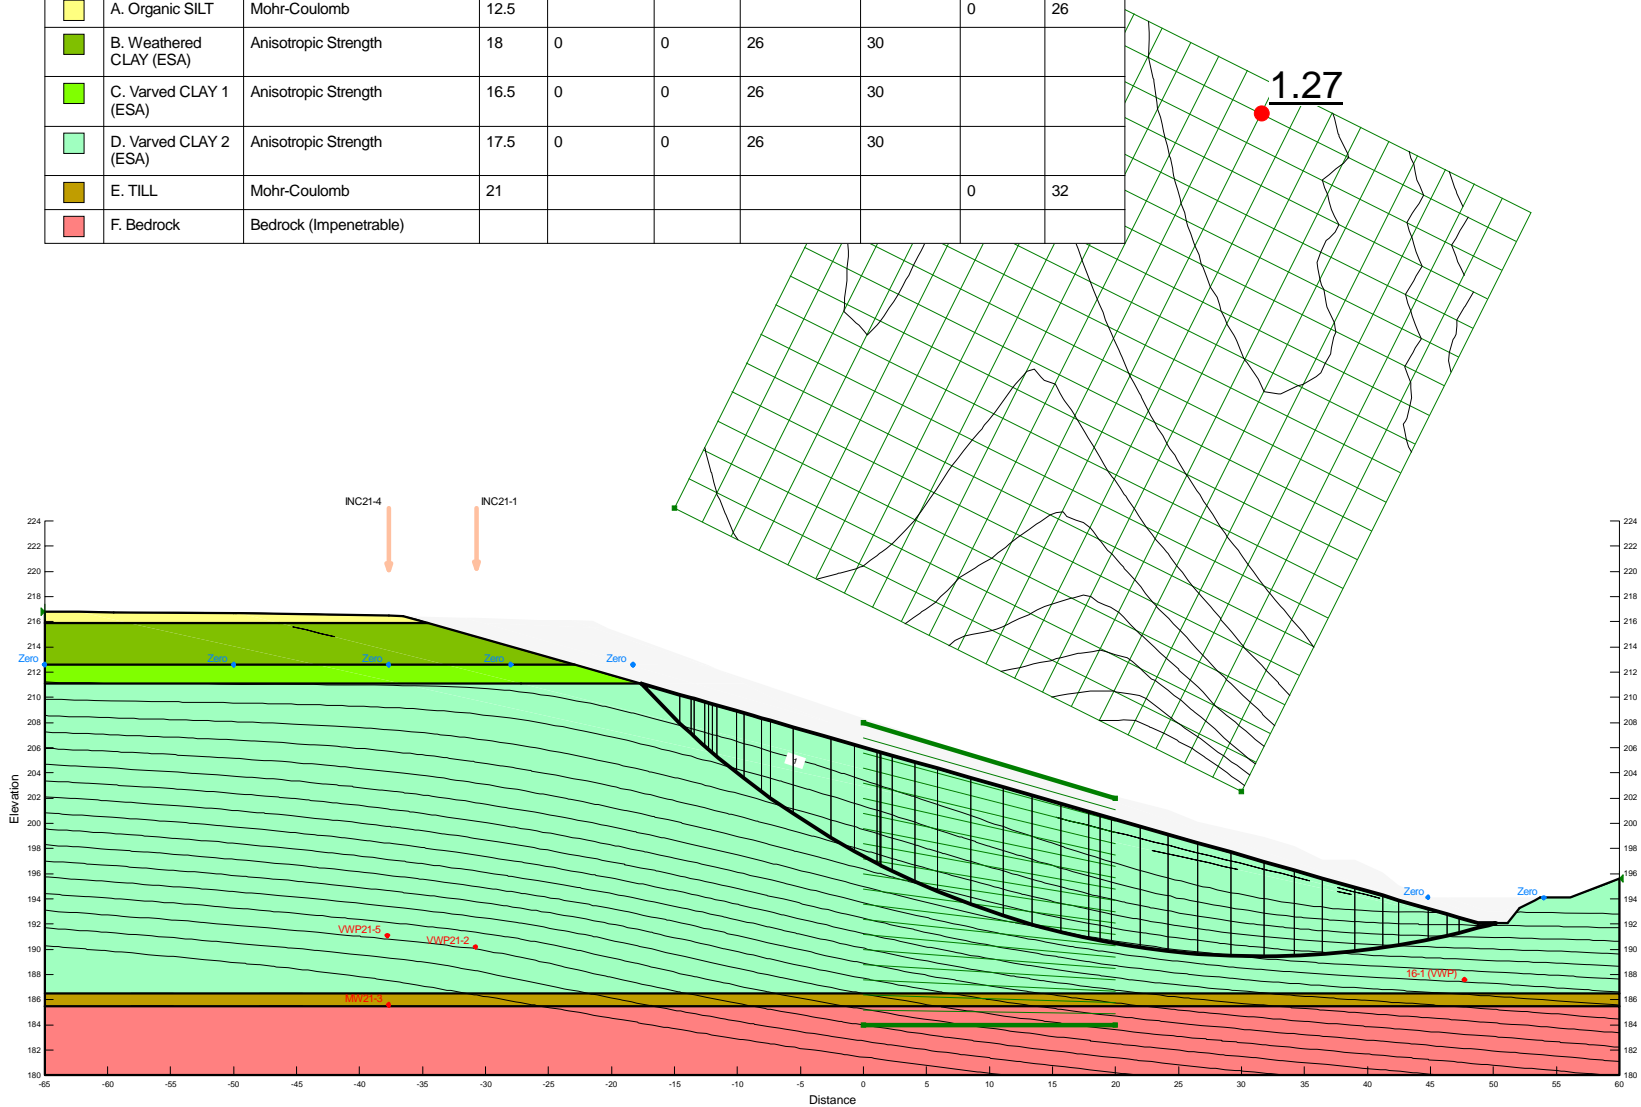
Project Calamity Creek		
Analysis 11) 3.5H:1V slope flattening		
Seismic Coefficient H: g, V: g	Last Run 01/27/2022, 11:37:30 AM	Scale 1:600

Additional Details
Name: Section A-A
Comments: Slope Stability Assessment
Method: Morgenstern-Price, Half-Sine
Minimum Slip Surface Depth: 1.52 m
Entry: (-17.640077, 211.07316) m, Exit: (50.240364, 192.1) m
Center: (31.6, 256.325) m, Radius: 66.87536 m
