**CALAMITY CREEK SLOPE FAILURE INVESTIGATION
HIGHWAY 11, 2.9 KM NORTH OF HWY 65 JUNCTION
NEW LISKEARD, ONTARIO
5018-E-0010, WORK ITEMS #7 AND #11**

G.W.P. NO. 5159-12-00

Geocres Number: 31M-133

March 2022

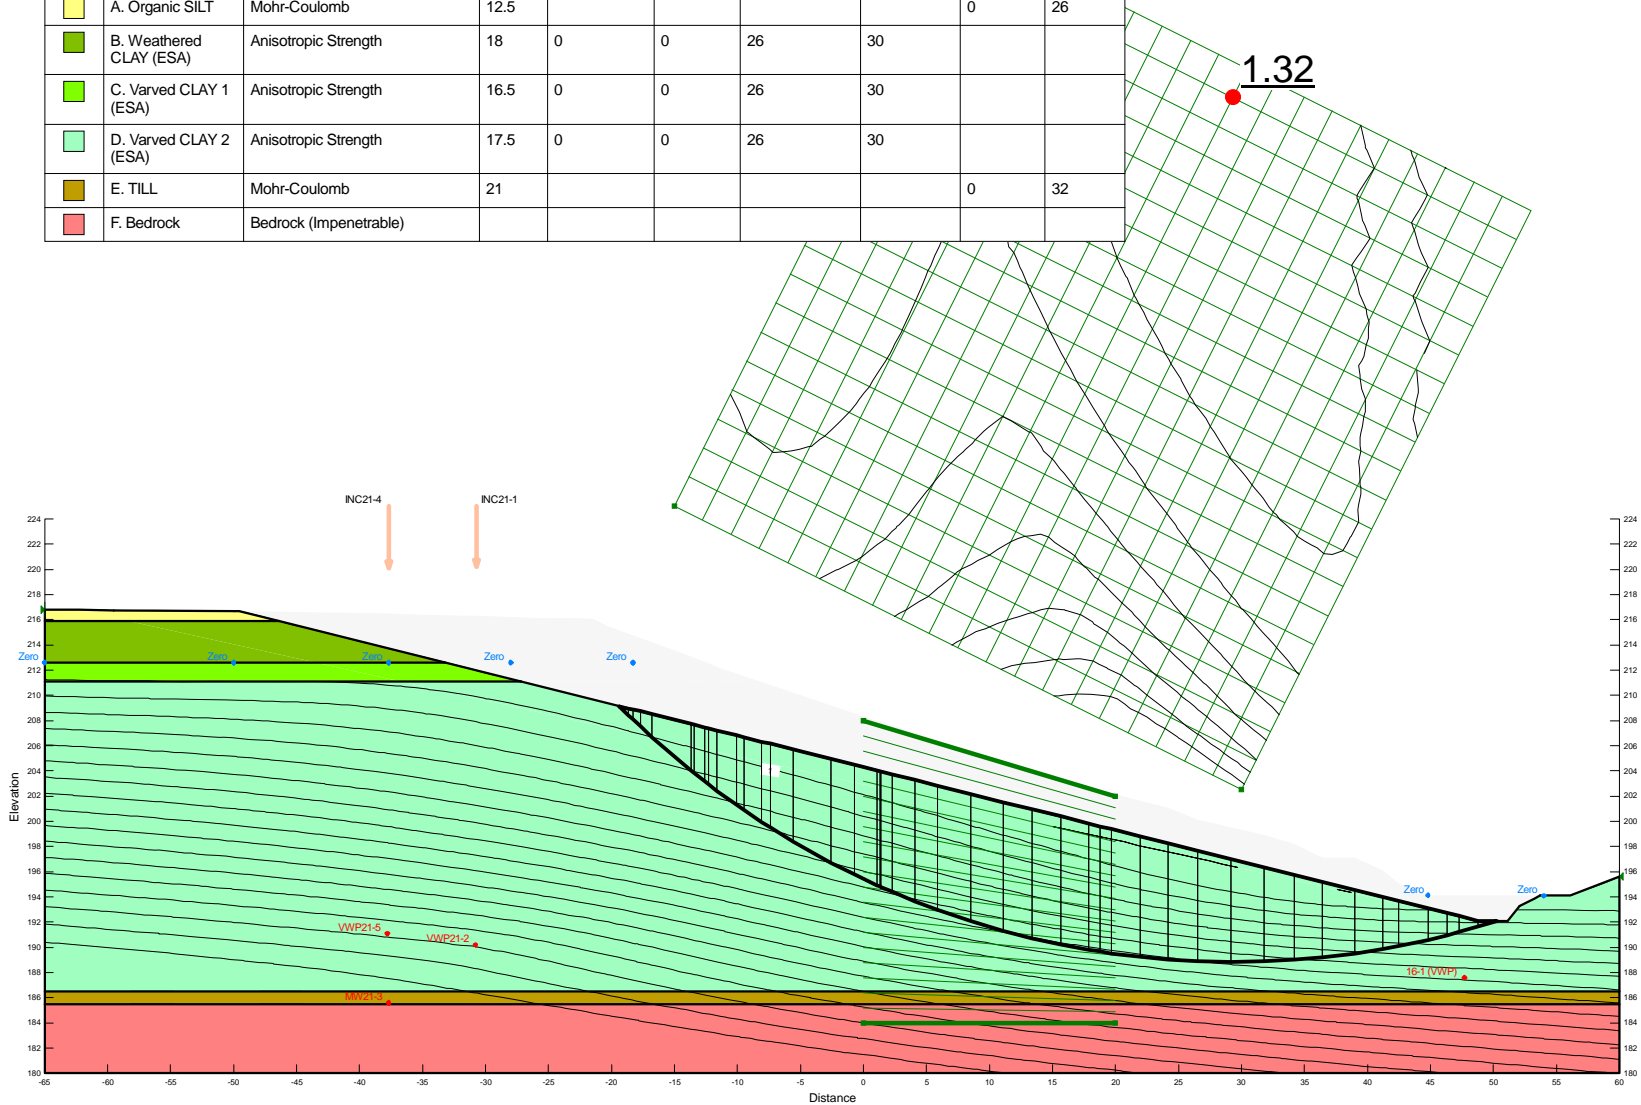
Project Calamity Creek		
Analysis 12) 4H:1V slope flattening		
Seismic Coefficient H: g, V: g	Last Run 01/27/2022, 11:37:46 AM	Scale 1:600

Additional Details
 Name: Section A-A
 Comments: Slope Stability Assessment
 Method: Morgenstern-Price, Half-Sine
 Minimum Slip Surface Depth: 1.52 m
 Entry: (-19.378893, 209.14472) m, Exit: (50.261295, 192.1) m
 Center: (29.35, 257.45) m, Radius: 68.614173 m

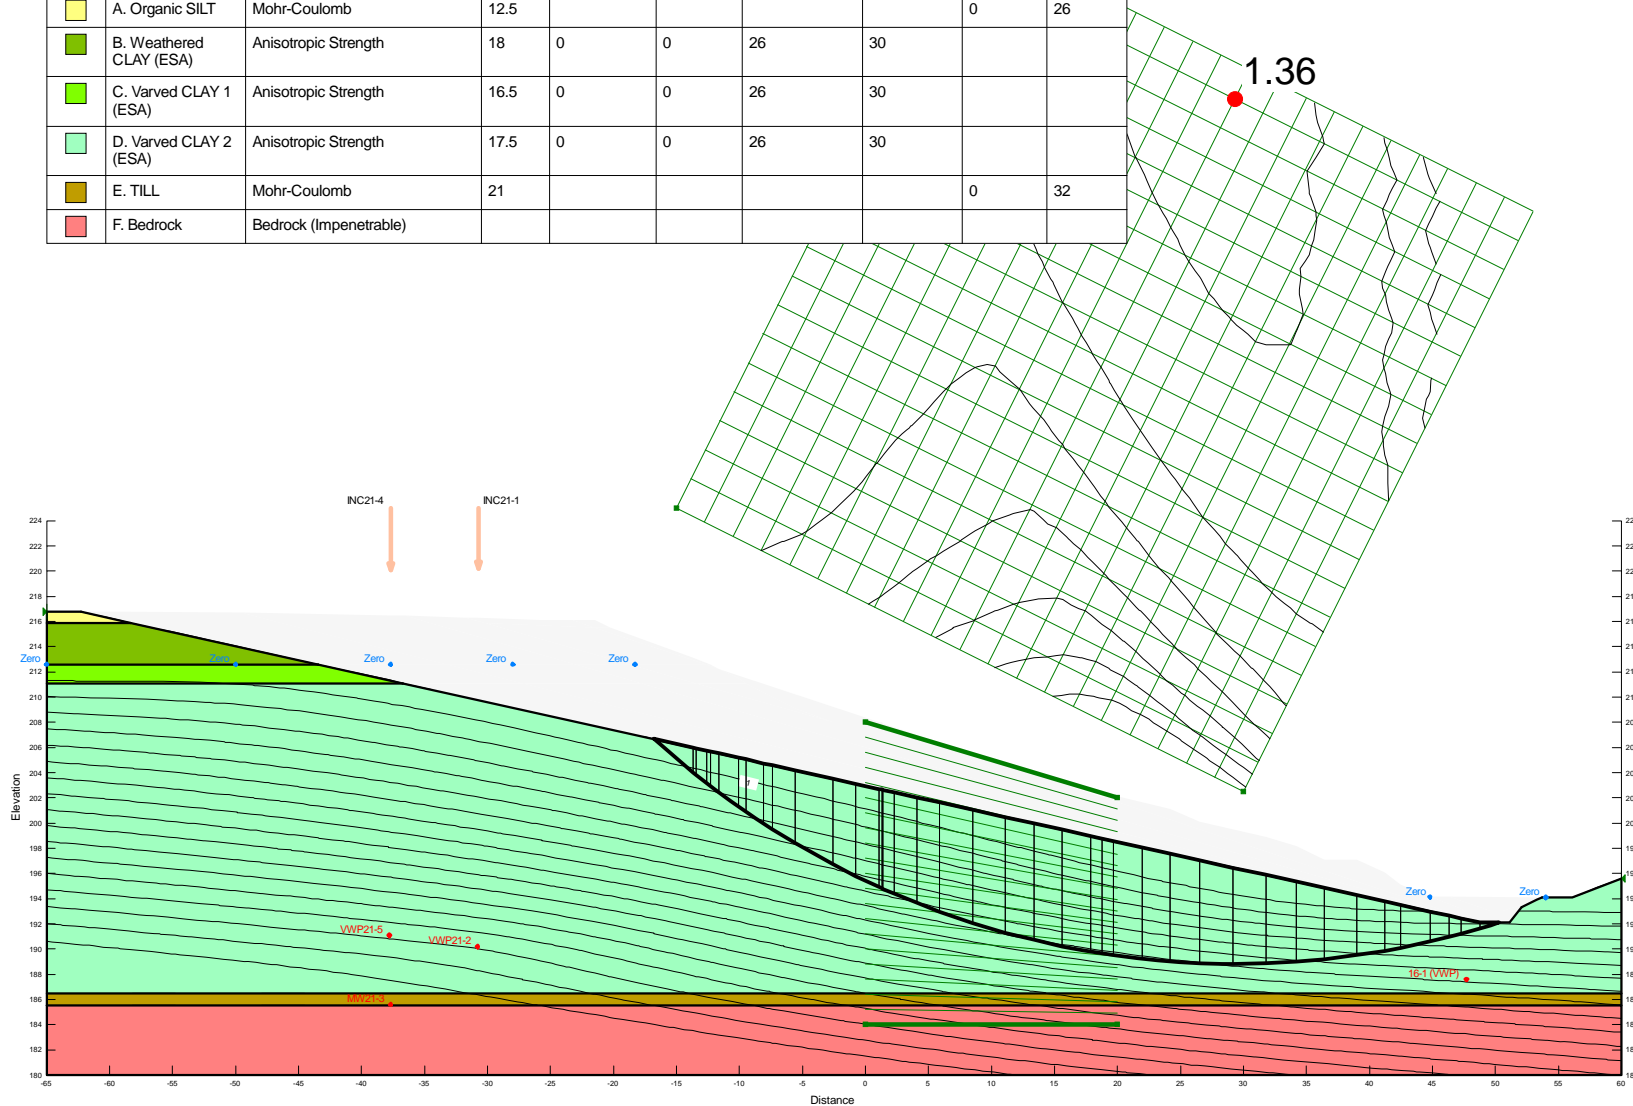
Project Calamity Creek		
Analysis 13) 4.5H:1V slope flattening		
Seismic Coefficient H: g, V: g	Last Run 01/27/2022, 11:37:49 AM	Scale 1:600

Additional Details
Name: Section A-A
Comments: Slope Stability Assessment
Method: Morgenstern-Price, Half-Sine
Minimum Slip Surface Depth: 1.52 m
Entry: (-16.803781, 206.67862) m, Exit: (50.261295, 192.1) m
Center: (29.35, 257.45) m, Radius: 68.614173 m

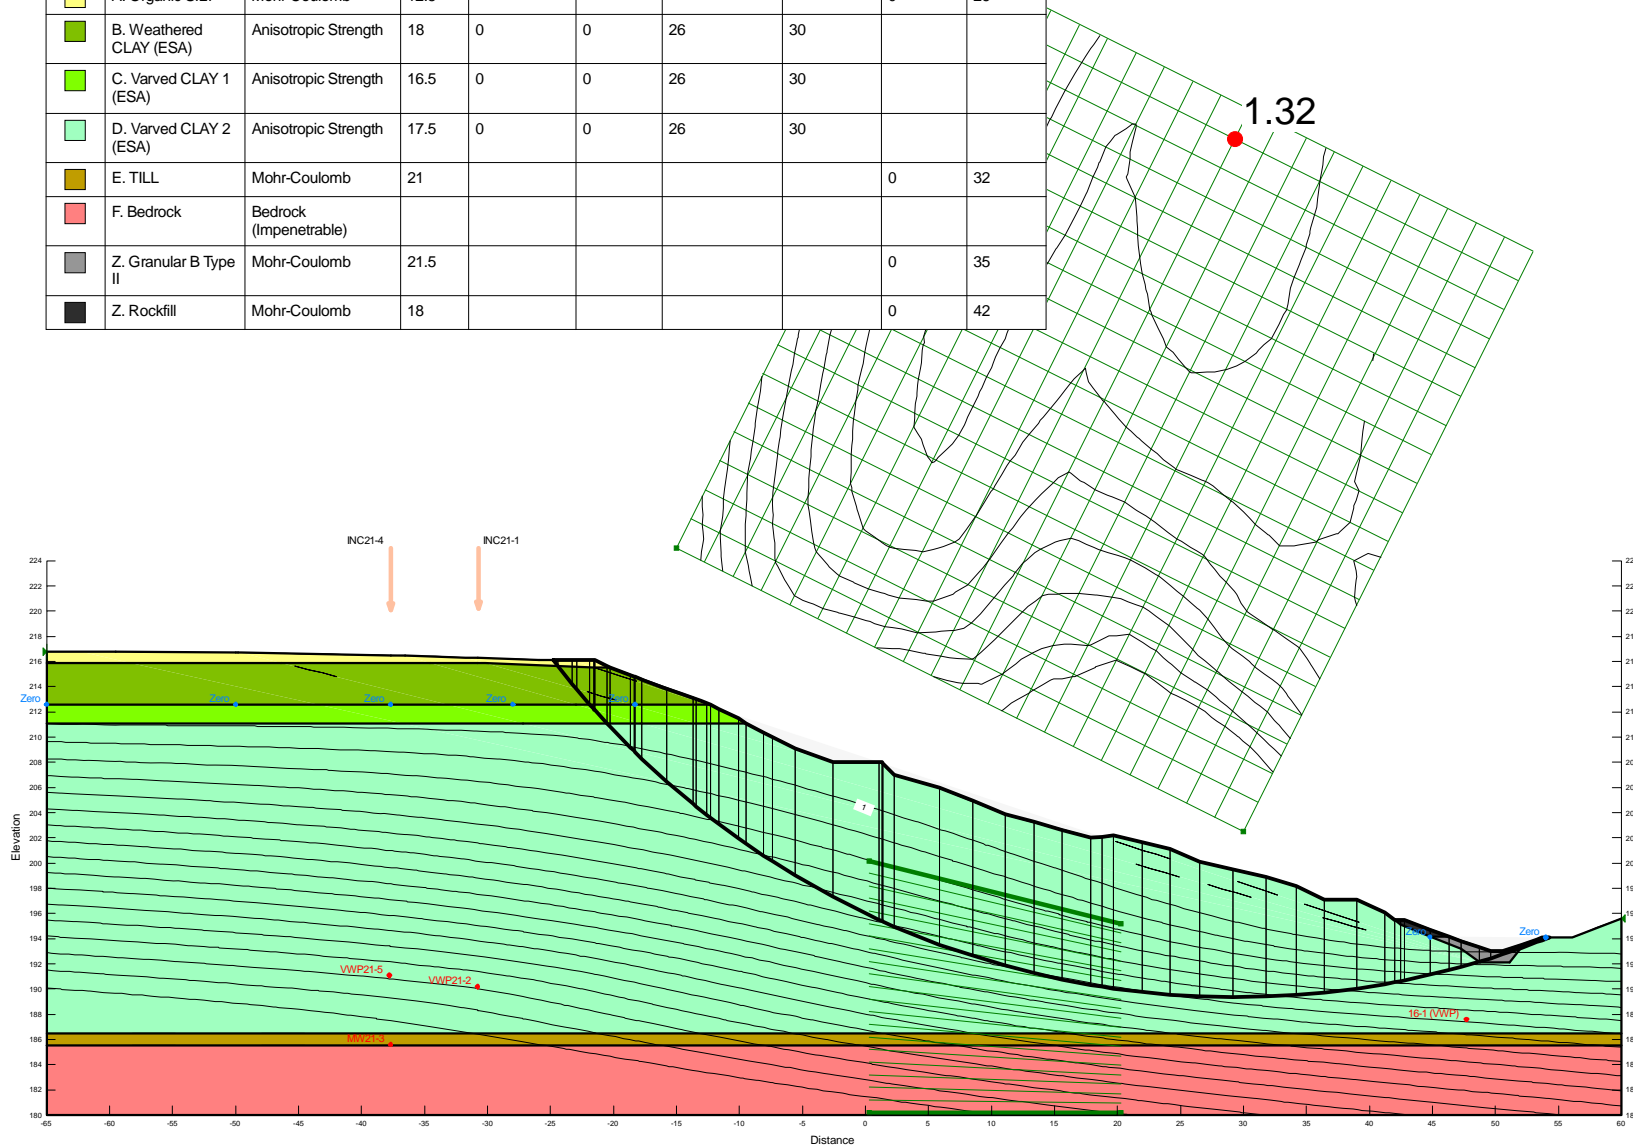
Project Calamity Creek		
Analysis 14) Butress (global slope)		
Seismic Coefficient H: g, V: g	Last Run 01/27/2022, 12:07:44 PM	Scale 1:600

Additional Details
 Name: Section A-A
 Comments: Slope Stability Assessment
 Method: Morgenstern-Price, Half-Sine
 Minimum Slip Surface Depth: 3.05 m
 Entry: (-24.76943, 216.1321) m, Exit: (54.307144, 194.1) m
 Center: (29.35, 257.45) m, Radius: 68.088777 m

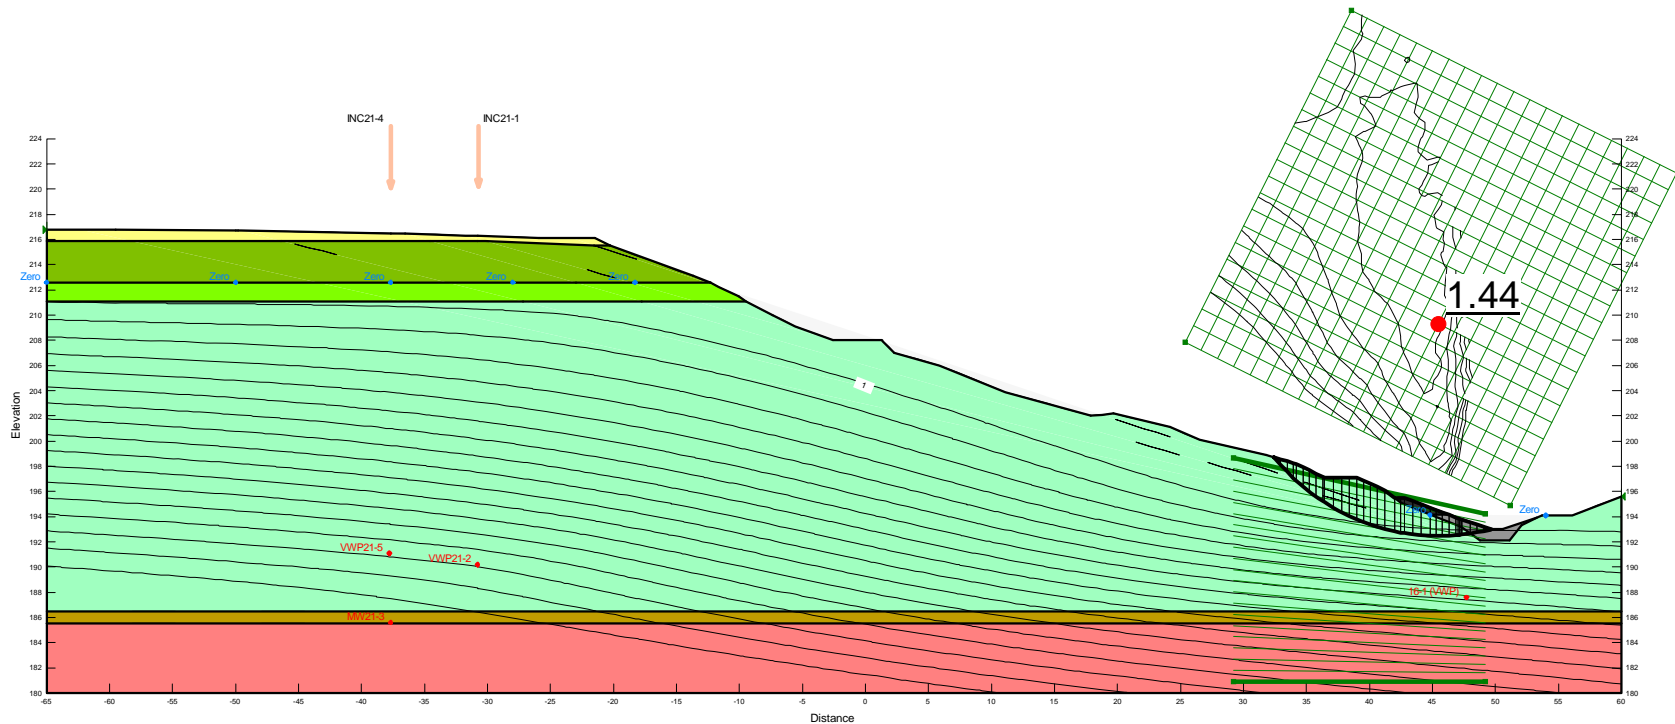
Project Calamity Creek		
Analysis 15) Butress (lower slope only)		
Seismic Coefficient H: g, V: g	Last Run 01/27/2022, 12:07:50 PM	Scale 1:600

Additional Details
 Name: Section A-A
 Comments: Slope Stability Assessment
 Method: Morgenstern-Price, Half-Sine
 Minimum Slip Surface Depth: 3.05 m
 Entry: (32.420695, 198.71896) m, Exit: (49.661853, 193) m
 Center: (45.50037, 209.30247) m, Radius: 16.825235 m

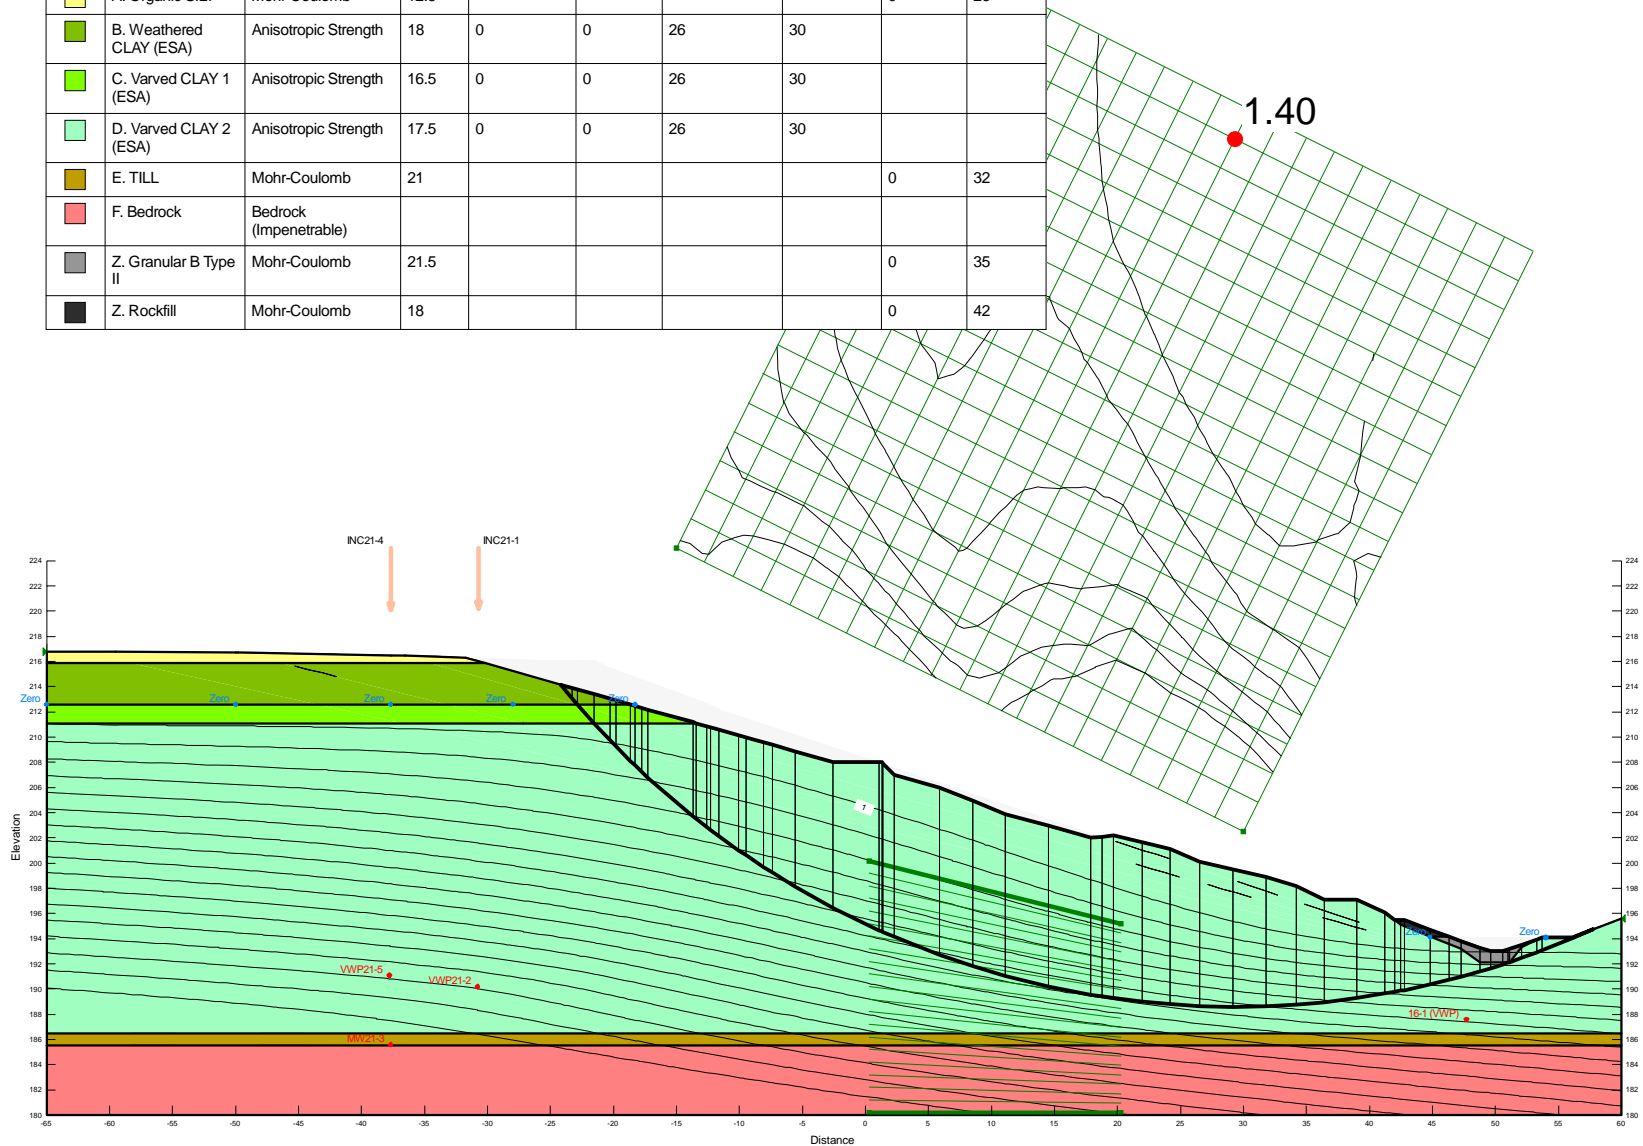
Figure J16

Project Calamity Creek		
Analysis 16) Butress & 3.5H:1V flattening at top (global slope)		
Seismic Coefficient H: g, V: g	Last Run 01/27/2022, 12:08:04 PM	Scale 1:600

Additional Details
 Name: Section A-A
 Comments: Slope Stability Assessment
 Method: Morgenstern-Price, Half-Sine
 Minimum Slip Surface Depth: 3.05 m
 Entry: (-24.19263, 214.16932) m, Exit: (57.779218, 194.74585) m
 Center: (29.35, 257.45) m, Radius: 68.847879 m

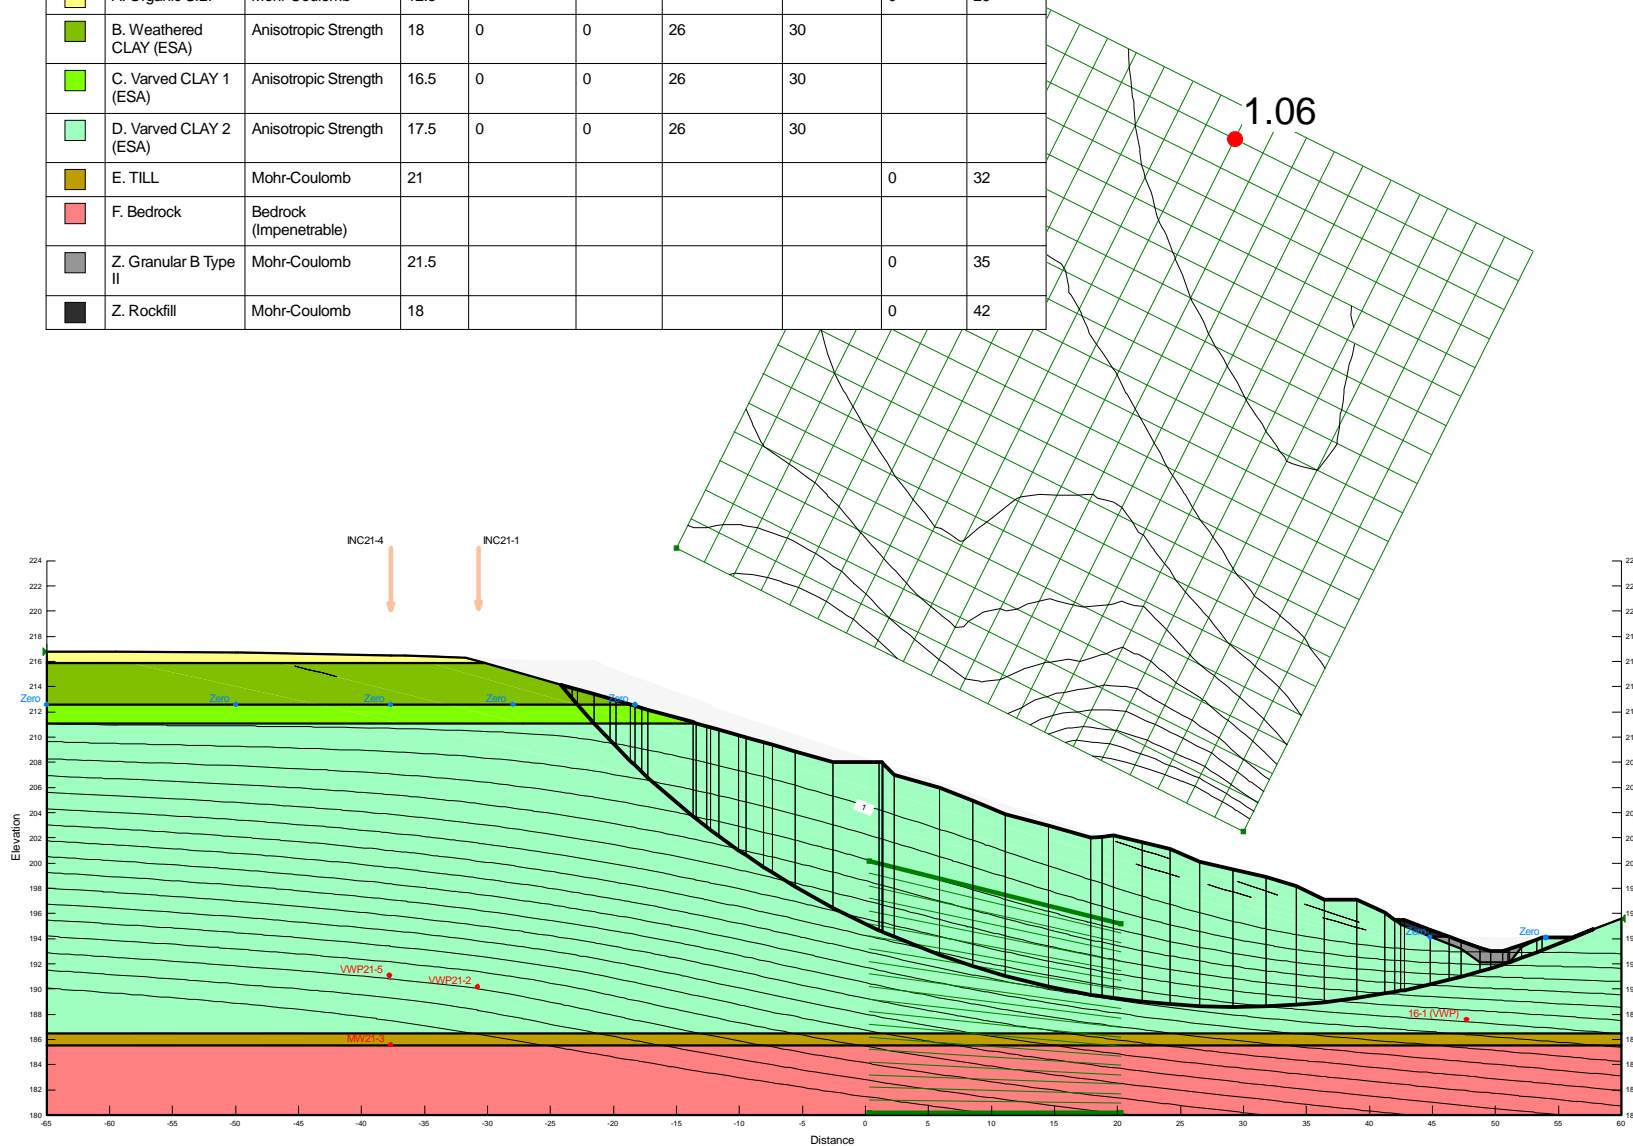
Project Calamity Creek		
Analysis 17) Butress & 3.5H:1V flattening at top with 475 yr earthquake		
Seismic Coefficient H: 0.081g, V: g	Last Run 01/27/2022, 12:08:20 PM	Scale 1:600

Additional Details
 Name: Section A-A
 Comments: Slope Stability Assessment
 Method: Morgenstern-Price, Half-Sine
 Minimum Slip Surface Depth: 3.05 m
 Entry: (-24.19263, 214.16932) m, Exit: (57.779218, 194.74585) m
 Center: (29.35, 257.45) m, Radius: 68.847879 m
