FOUNDATION INVESTIGATION REPORT
For

Failure of Approach Embankments
Overhead Structure at the Crossing of
Hwy. #140 and C.N.R.

Township of Humberstone, County of Welland
W.O. 72-11025 --- W.P. 60-60-02

FOUNDATION INVESTIGATION REPORT
For
Failure of Approach Embankments
Overhead Structure at the Crossing of
Hwy. #140 and C.N.R.
Township of Humberstone, County of Welland
W.O. 72-11025 -- W.P. 60-68-02

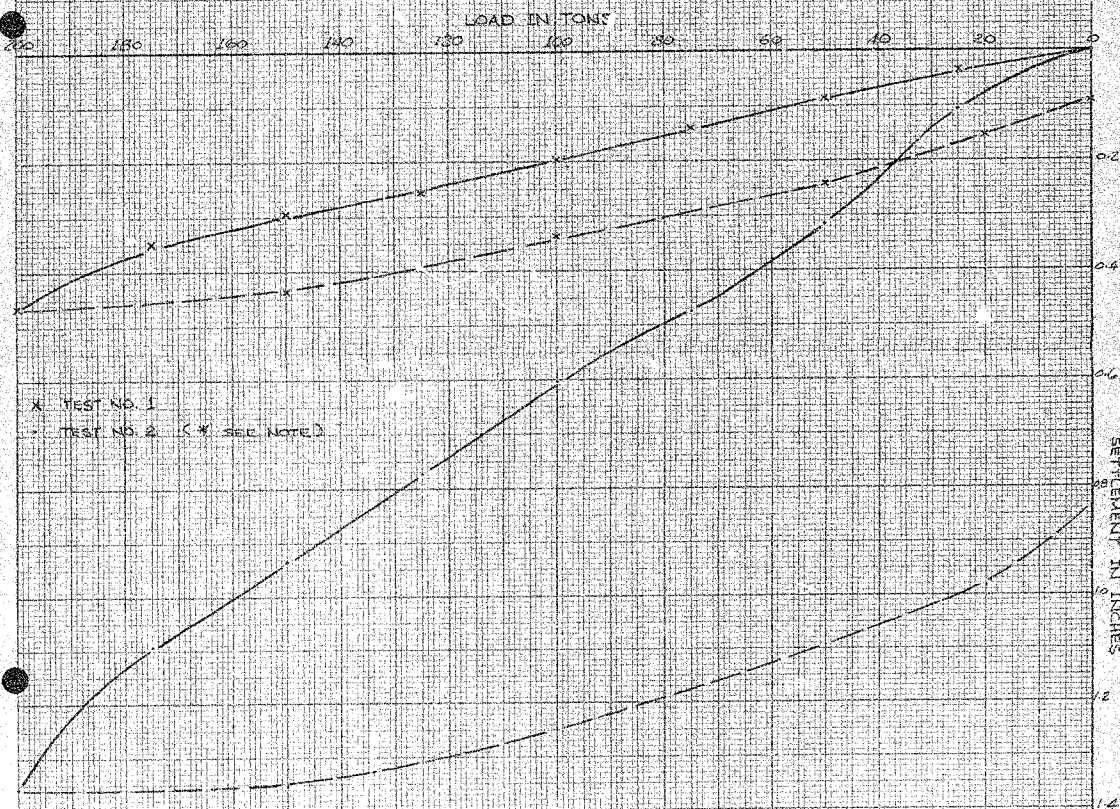
NOTE : DUE TO THE EXCESSIVE SETTLEMENT OF THE TEST PILE AT DESIGN LOAD, THE ST. LAWRENCE SEAWAY AUTHORITY PERSONNEL CONSIDERED THIS TEST UNSATISFACTORY. AFTER RE-DRIVING THE TEST PILE WITH VARIOUS DRIVING ENERGIES, THE FOLLOWING CRITERIA FOR REUSE WERE ESTABLISHED.

- i) 42 blows per inch for a minimum of 2 inches penetration using a driving energy of 9,500 ft-lbs (3 feet drop height)
- or ii) 52 blows per inch for a minimum of 2 inches penetration using a driving energy of 13,200 ft-lbs (2 feet drop height)

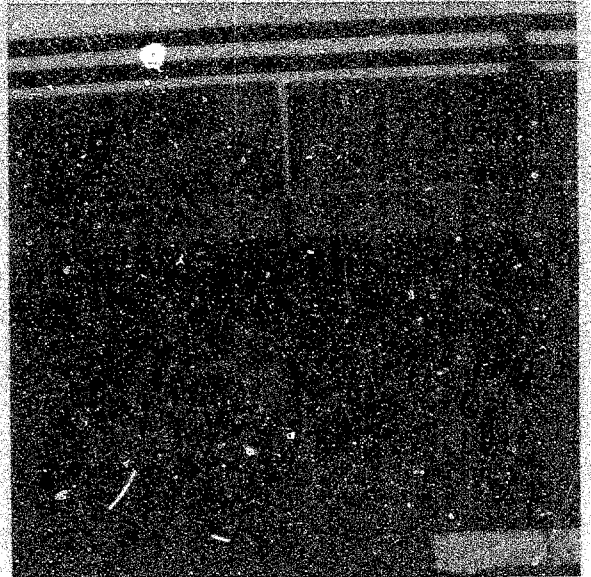
(2)

2. Tilting of the north abutment away from the bridge. (Photo #2 & 5)
3. The perforated drain in the north abutment granular backfill is likely plugged, water seeps below drain, washing material out and forming bad erosion. (Photo #3)
