FOUNDATION INVESTIGATION REPORT

For  
Embarkment Settlements at Hwy. #58 and  
Forkes Road  
District #4, Hamilton

W.P. 78-73-01

W.O. 73-11097

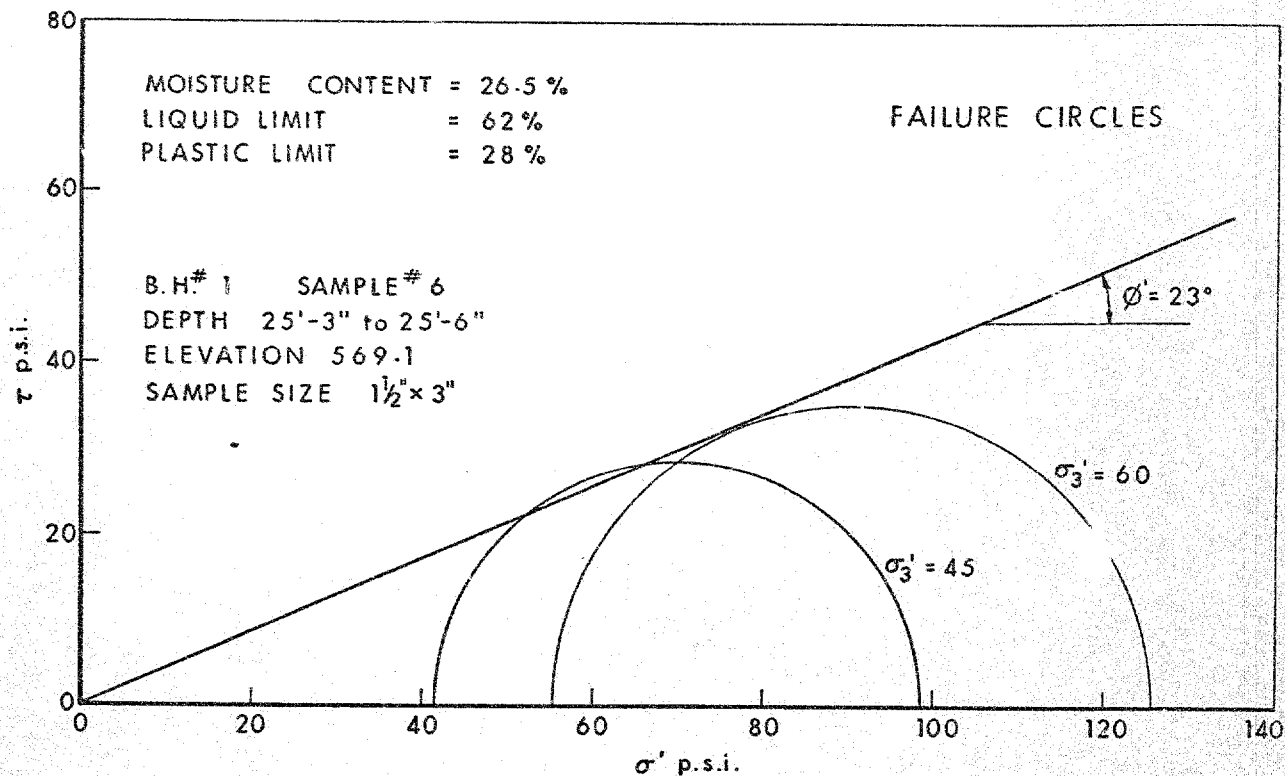
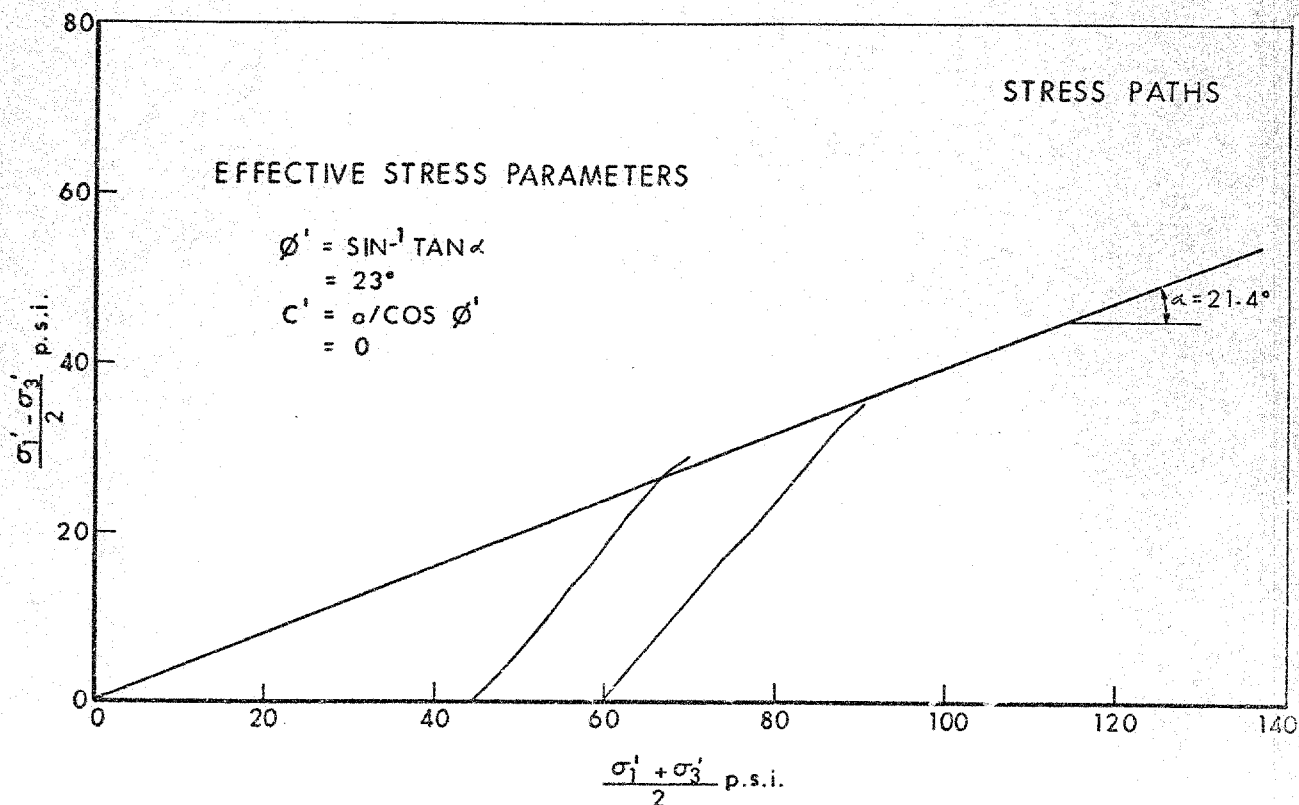
FIG. 2

The results of the consolidation tests conducted are presented in graphical form in figure 2. Interpretation of these results to obtain preconsolidation pressures was made using the Casagrande and Schmertmann construction if possible.

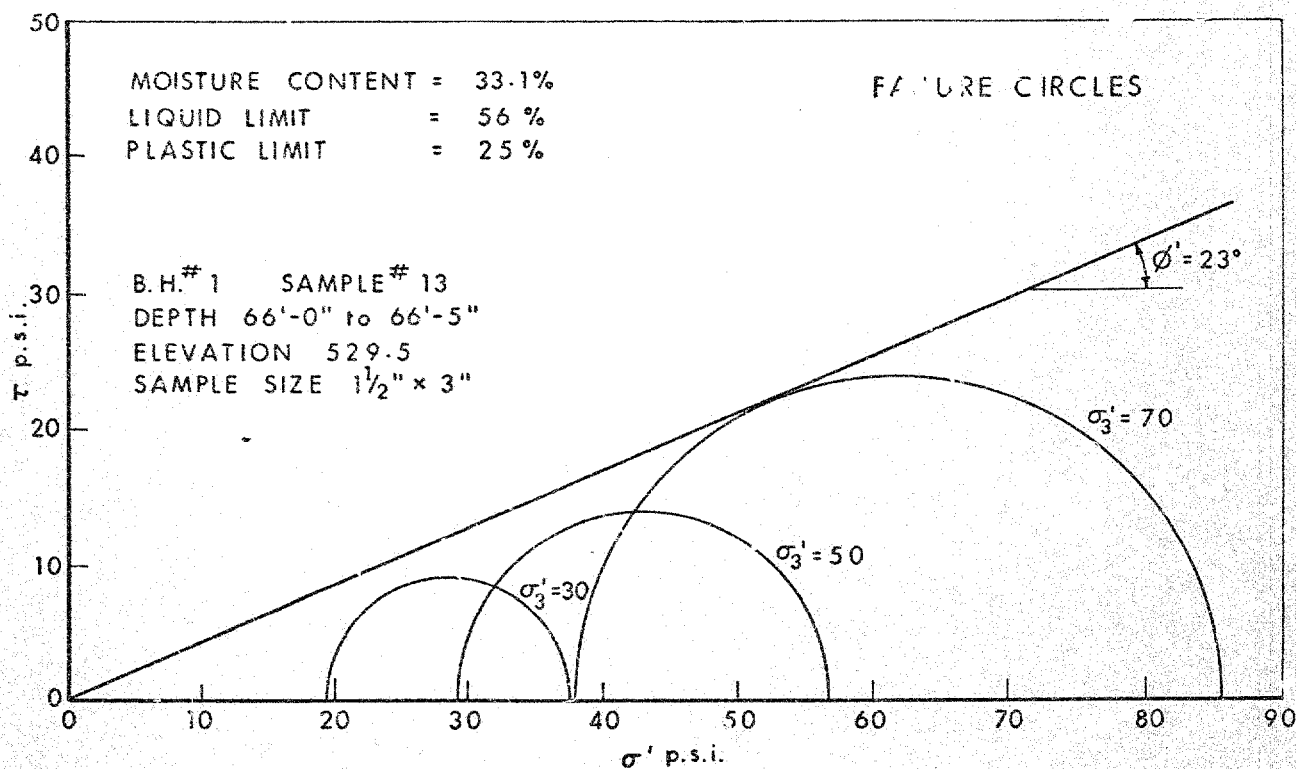
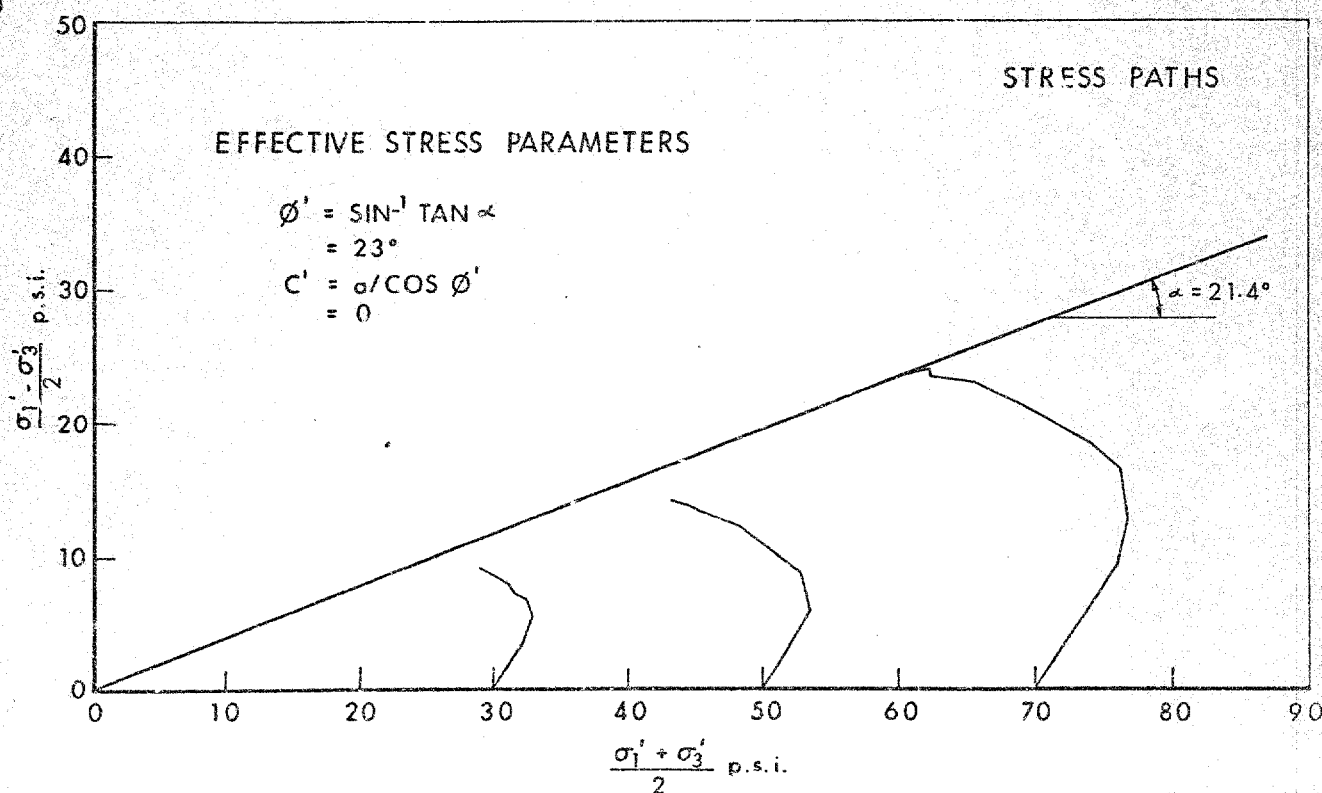
FIG. 3

The detailed test results for consolidated undrained tests (stage tests) with pore pressure measurements are presented in figures 3, 4 and 5.
