HWY. No. 140LOCATION CN Overpass  
Slope FailureNo of PAGES - 1

TYPICALS

# SLOPE FLATTENING & TREATMENT HWY 140 & CN OVERPASS SE QUADRANT

Re: Slope Instability  
Highway 140 and CN Overpass  
Central Region

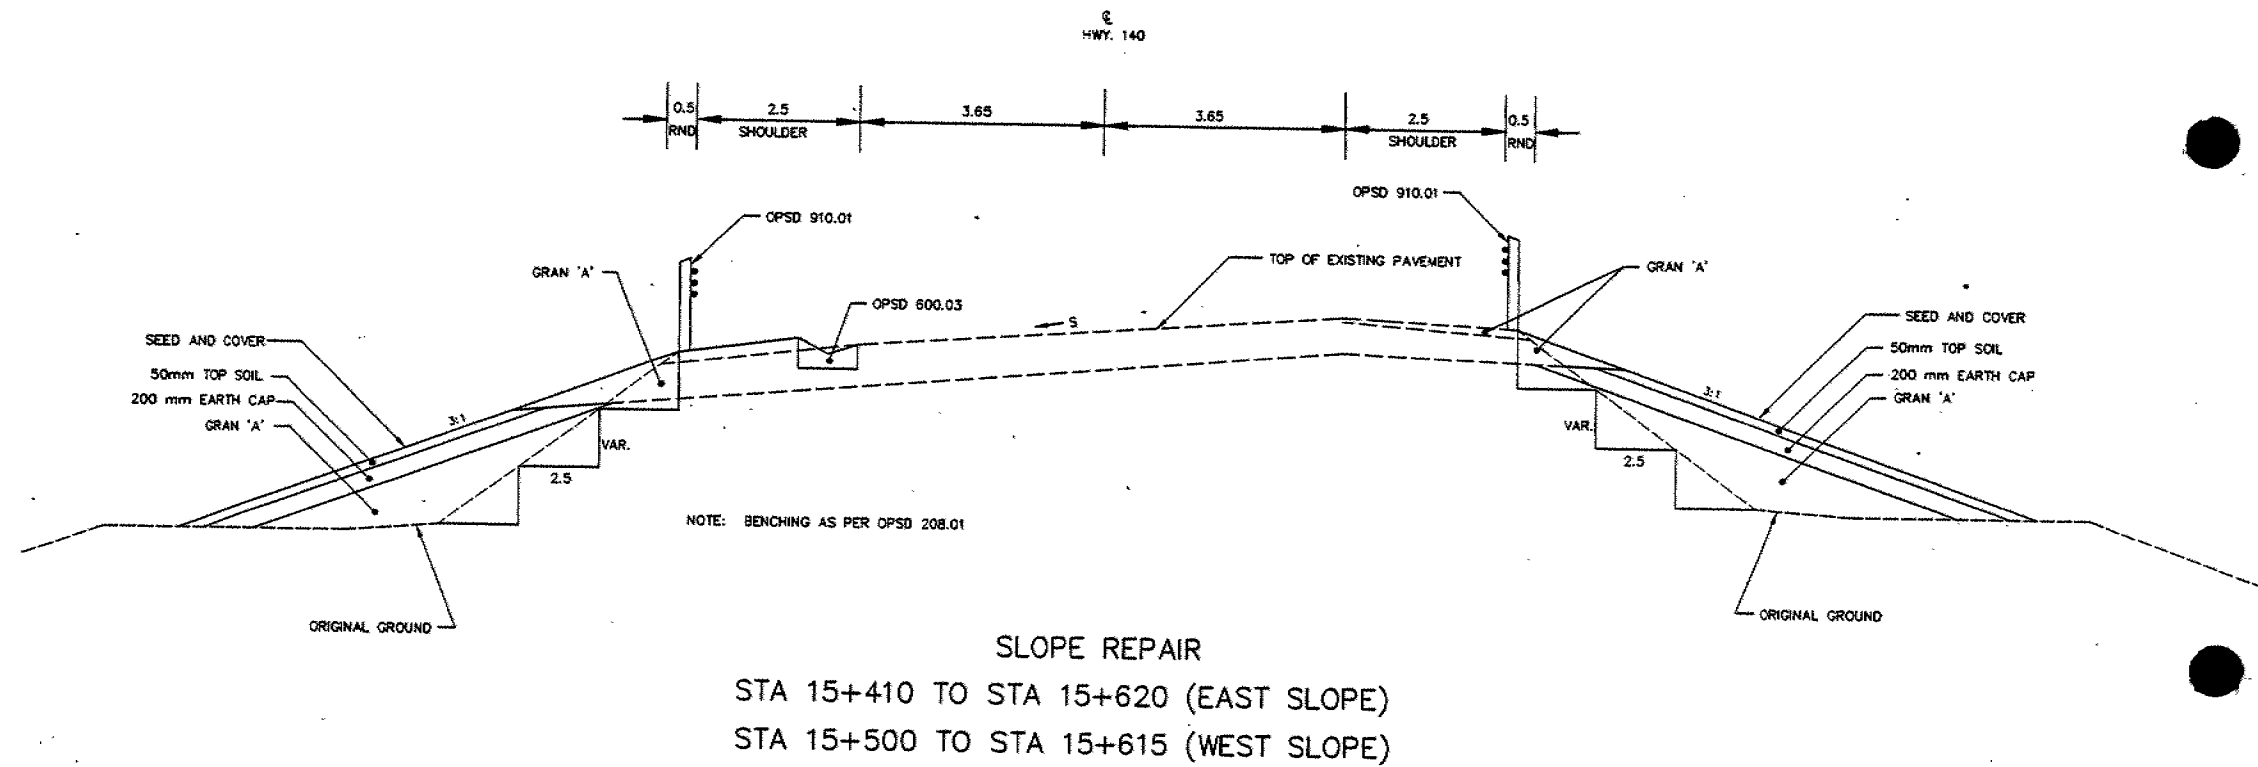
SHEET  
10

This memo is prepared in response to your request for recommendations regarding the slope instabilities at the approaches to the CN overpass on Highway 140. A site visit was made on August 9, 1997. As mentioned in your request, the crest of the slope in the south-east quadrant shows evidence of movement in the tension cracks in the shoulder of the roadway and the tilting guide rail. At various locations along the embankments, large crevices (150 mm wide and 300 mm deep) were observed.

- 1) REMOVE VEGETATION AND TOPSOIL
- 2) LEAVE IN PLACE EXISTING GRAVEL/CLEAR STONE
- 3) GRANULAR 'A' FILL TO BE USED FOR SLOPE FLATTENING

The request for foundation recommendations included examining the possibility of flattening the slopes at the south approach, east side. This would provide the most economical solution. A stability check was made using a slope of 3H:1V. There is no stability concern if the slopes are flattened. It would be sufficient to reduce the slope for the portions of the embankment above the berm only. However, this alone may not eliminate the surficial movements of the slope.

It is further recommended to incorporate french drains along the face of the upper slope. These would take the form of armoured channels excavated to the frost penetration depth (1.2 m). They should be spaced at 10 m intervals and filled with rip-rap. A shallow ditch or toe drain should be constructed along the base of the upper slope to control the surface runoff that the french drains may create. Where the berm is eliminated due to the flattening of the slope, the armoured channels should extend to the base of the embankment. During construction, it is recommended that all vegetation and topsoil be removed prior to regrading the slopes to 3H:1V. The slopes should be re-vegetated as soon as possible to minimize erosion.
