memorandum

Subject: South Approach Embankment, QEW SBL
Structure Over Welland River and N.Y.C. Railway
W.O. 93-11022
Site 34-65, District 6, Burlington

Date: 94 12 19

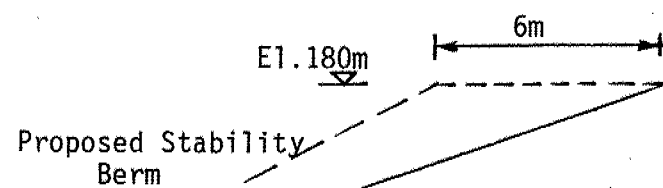
W.O. 93-11022
Figure 2

SECTION B-B
(AREA 2)

As discussed above, it is recommended to construct some mid-height berms at Areas 1 and 2 to ensure adequate factor of safety for overall stability. In addition, it is recommended to bench the existing slope for the full height and reconstruct the slope face above the berm level with compacted granular fill. This will ensure the new fill key in well with the existing cohesive fill to prevent shallow slips within the fill material. Geometry and extent of the proposed works are shown in Figures 1 & 2 and Drg. No. 9311022A respectively. Figure 3 shows a schematic design of the proposed works. The finished slope should be properly protected with vegetation cover.
