**Foundation Investigation and Design
Report - Slope Stability Analysis
Proposed Embankment Rehabilitation
N-E Ramp, Collier Road to
King's Highway 58, WP 312-97-00
City of Thorold, Region of Niagara**

BRGE0050774A

November 18, 1998

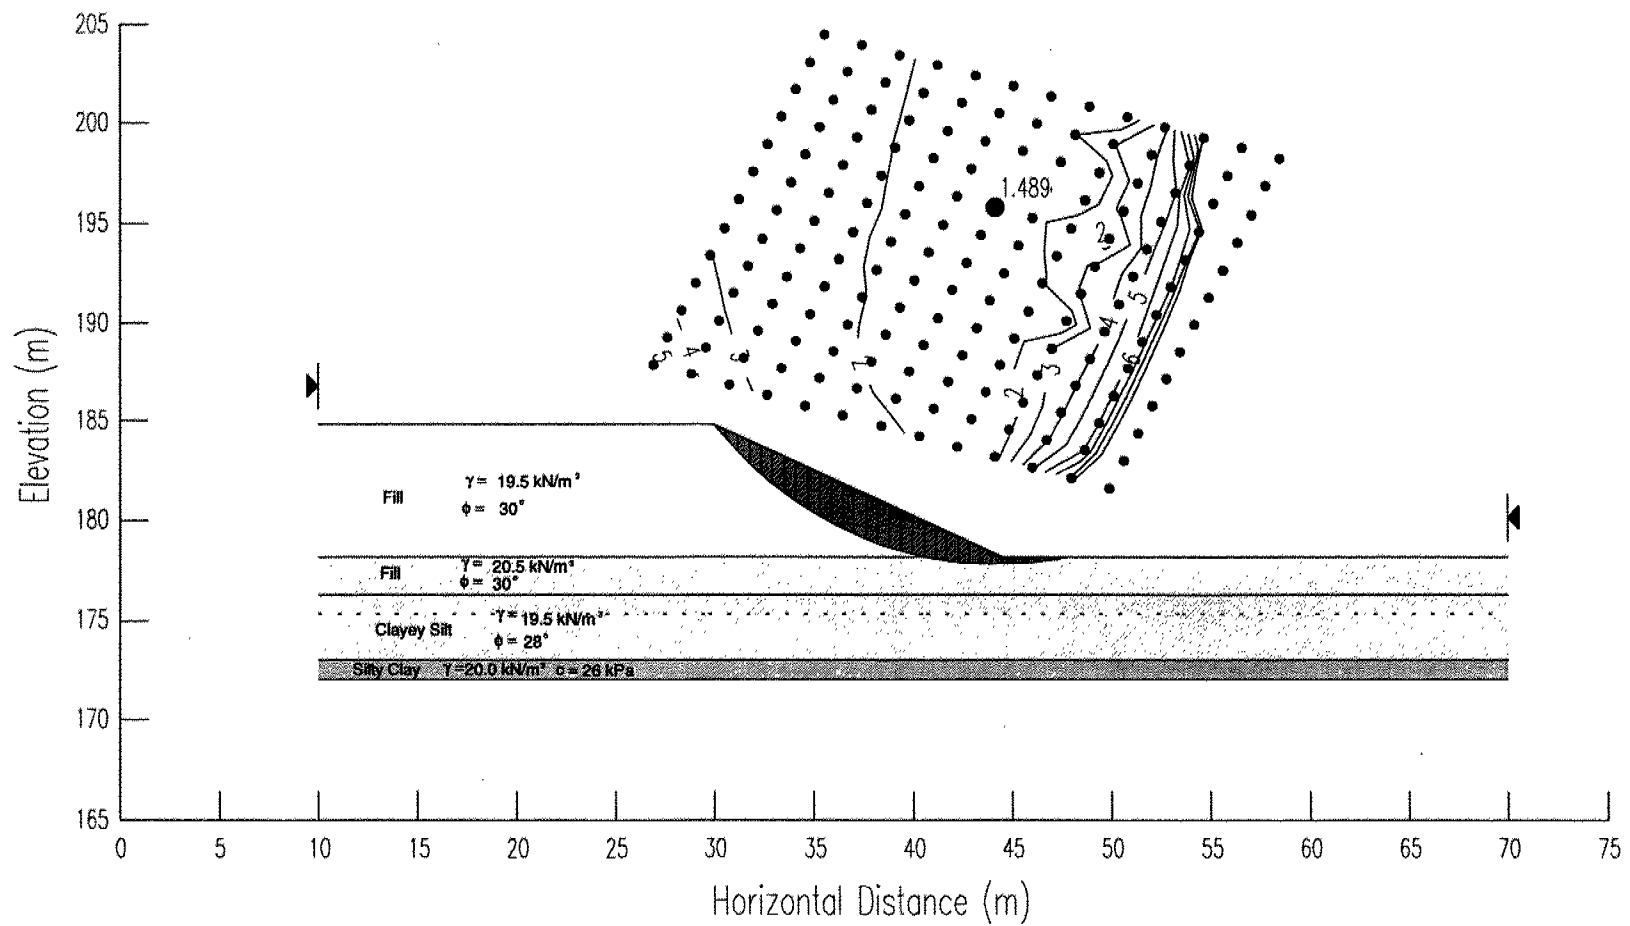
Highway 58 - Collier Road N-E Ramp
Figure 1

The results of the analysis are presented in Figures 1 to 3, in Appendix B, as summarized below.

a) Low Water Table Figure 1:

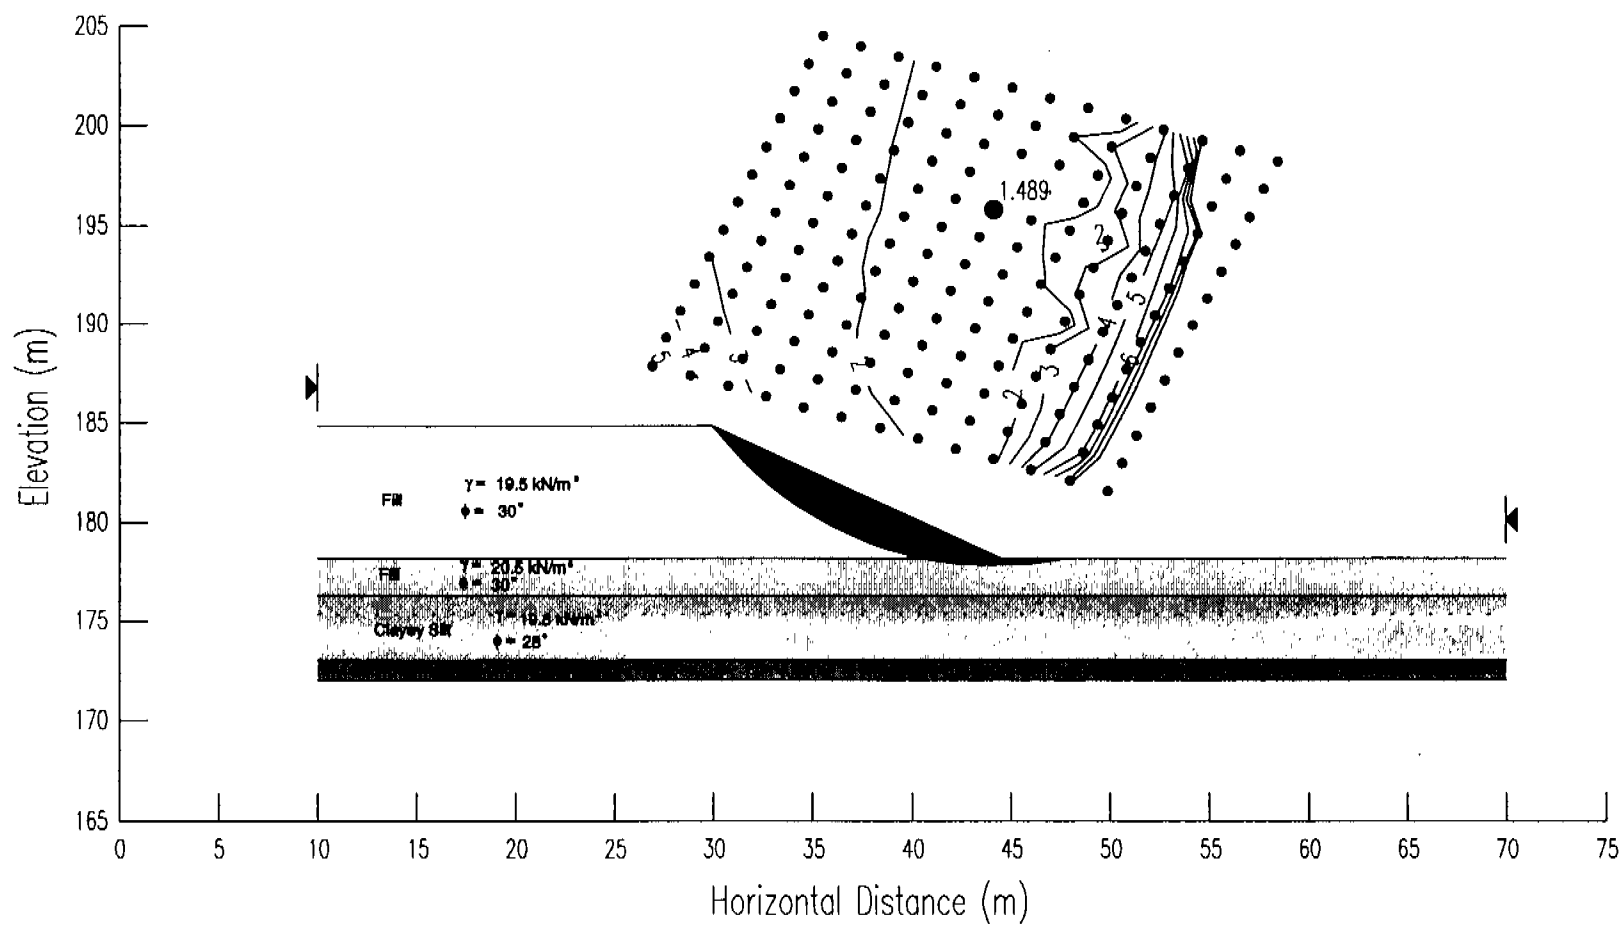
Highway 58 - Collier Road N-E Ramp
Figure 1

The results of the analysis are presented in Figures 1 to 3, in Appendix B, as summarized below.

a) Low Water Table Figure 1:
