FOUNDATION INVESTIGATION REPORT

Slope Failure - Hwy. 403, Culvert
Sta's. 105+10 - 106+70, District 4.

W.J. 64-F-39 - W.P. ~~231-58-3~~

Cont. 63-116 140-57-1

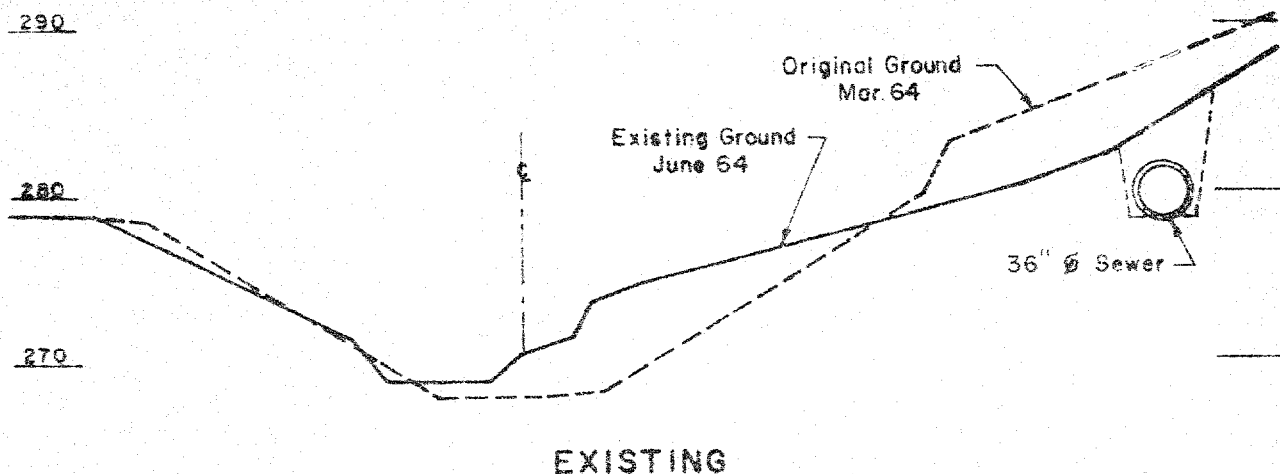
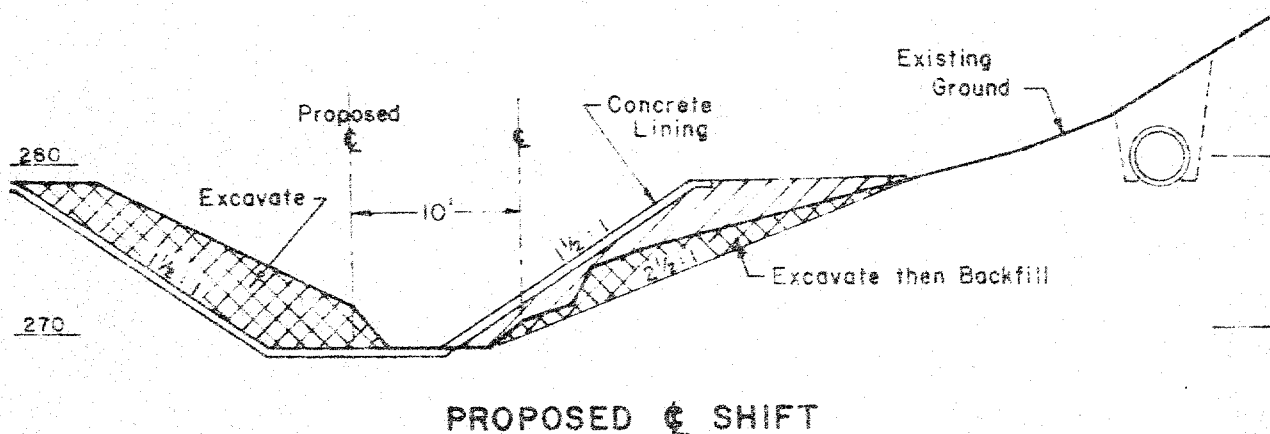
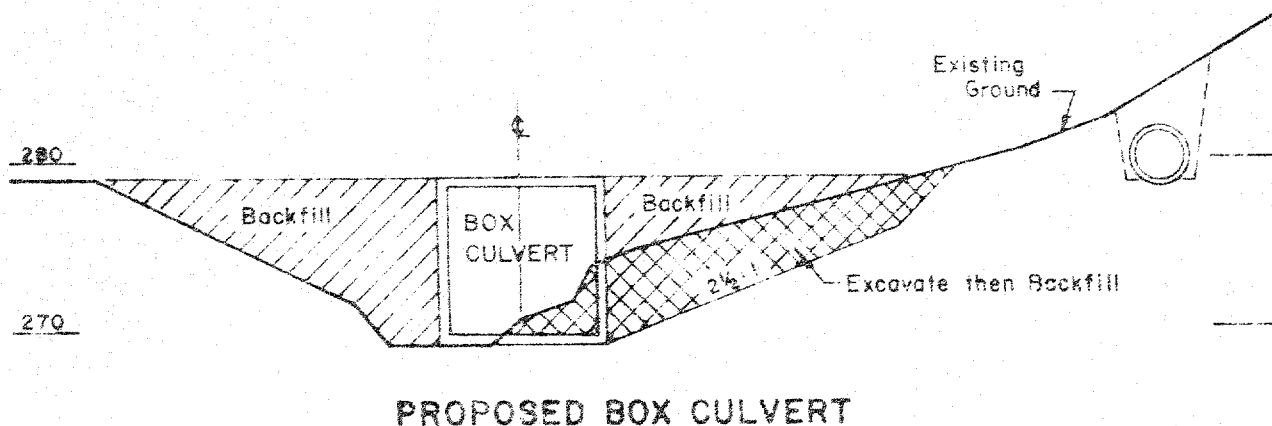
TYPICAL
CHANNEL CROSS - SECTIONS
STA. 105+00 \pm TO STA. 106+70 \pm
SCALE: 1" = 10'

The failure took place along the side of a drainage channel which was in a cut section through soft to medium stiff clayey silt. Preliminary analysis indicates the stability of the bank prior to failure was approx. unity.

- (1) In the vicinity of the failure area a new channel should be re-excavated with the existing centre line moved approx. 10 ft. to the south.

Since the failure slopes are now stable, this move will eliminate any instability caused by excavating the toe of the slide where it has partly filled in the existing channel.

- (2) If it is not desired to shift the centre line, the open channel should be replaced by a box culvert in the vicinity of the failure area. The culvert should be placed on spread footings with a contact pressure not to exceed 0.5 T.S.F.
