HWY. No. 25N

FOUNDATION INVESTIGATION REPORT
For
Proposed Realignment of Hwy. #25 (New)
Fill Stability
Station 120+00 to Station 124+00
Hwy. #5 Southerly to Q.E.W.
District No. 4 (Hamilton)
W.O. 70-11030 -- W.P. 131-65-01

To determine cause and propose counter measures for bin type retaining wall's movement on the west side of Highway 25 some 1500 feet north of Q.E.W. (Station 122+00+ to Station 123+50+ left of centre line Highway 25). Following at the site discussions, the meeting was moved to Bronte field office on South Service Road.

The results of an investigation carried out to determine the probable cause(s) of movement of an approximately 25 ft. high bin type retaining wall on Hwy 25 about 1/4 mile north of the Queen Elizabeth Way in Oakville, Ontario are reported and recommendations are provided for stabilizing the existing wall or replacing the wall with a new structure.

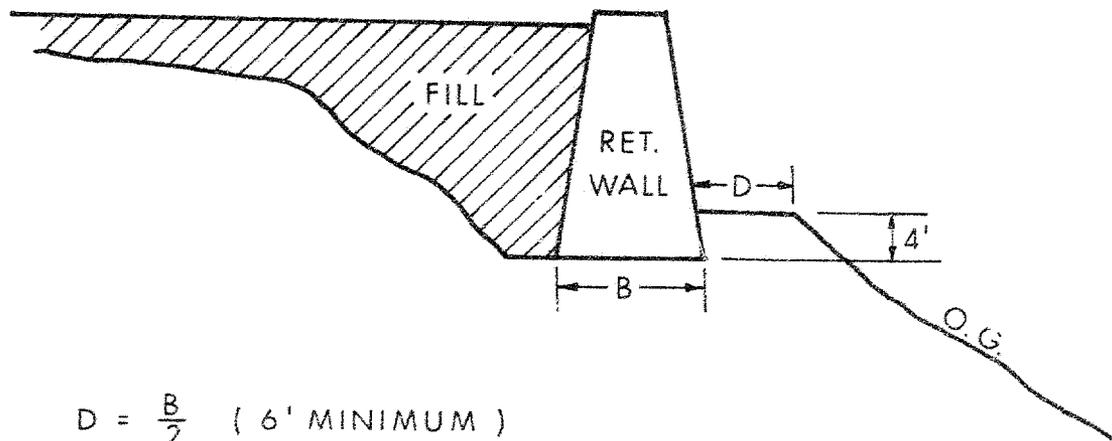
The proposed retaining walls may be founded on spread footing constructed within the shale bedrock or the overlying hard till deposits assuming a safe pressure of 5 t.s.f. A minimum of 4 ft. cover should be provided for frost protection. A horizontal bench in original ground of minimum width 6 ft. or half the footing width, whichever is greater, must be constructed in front of the wall as per the sketch below.

Backfilling of the walls should comply with D.H.O. Standard No. SD-4-58. The stability of the walls should be checked against sliding along the base of the wall caused by lateral earth pressure. In computing the resistance to lateral pressure an adhesion value of 3500 PSF may be assumed to apply along the footing bottoms.

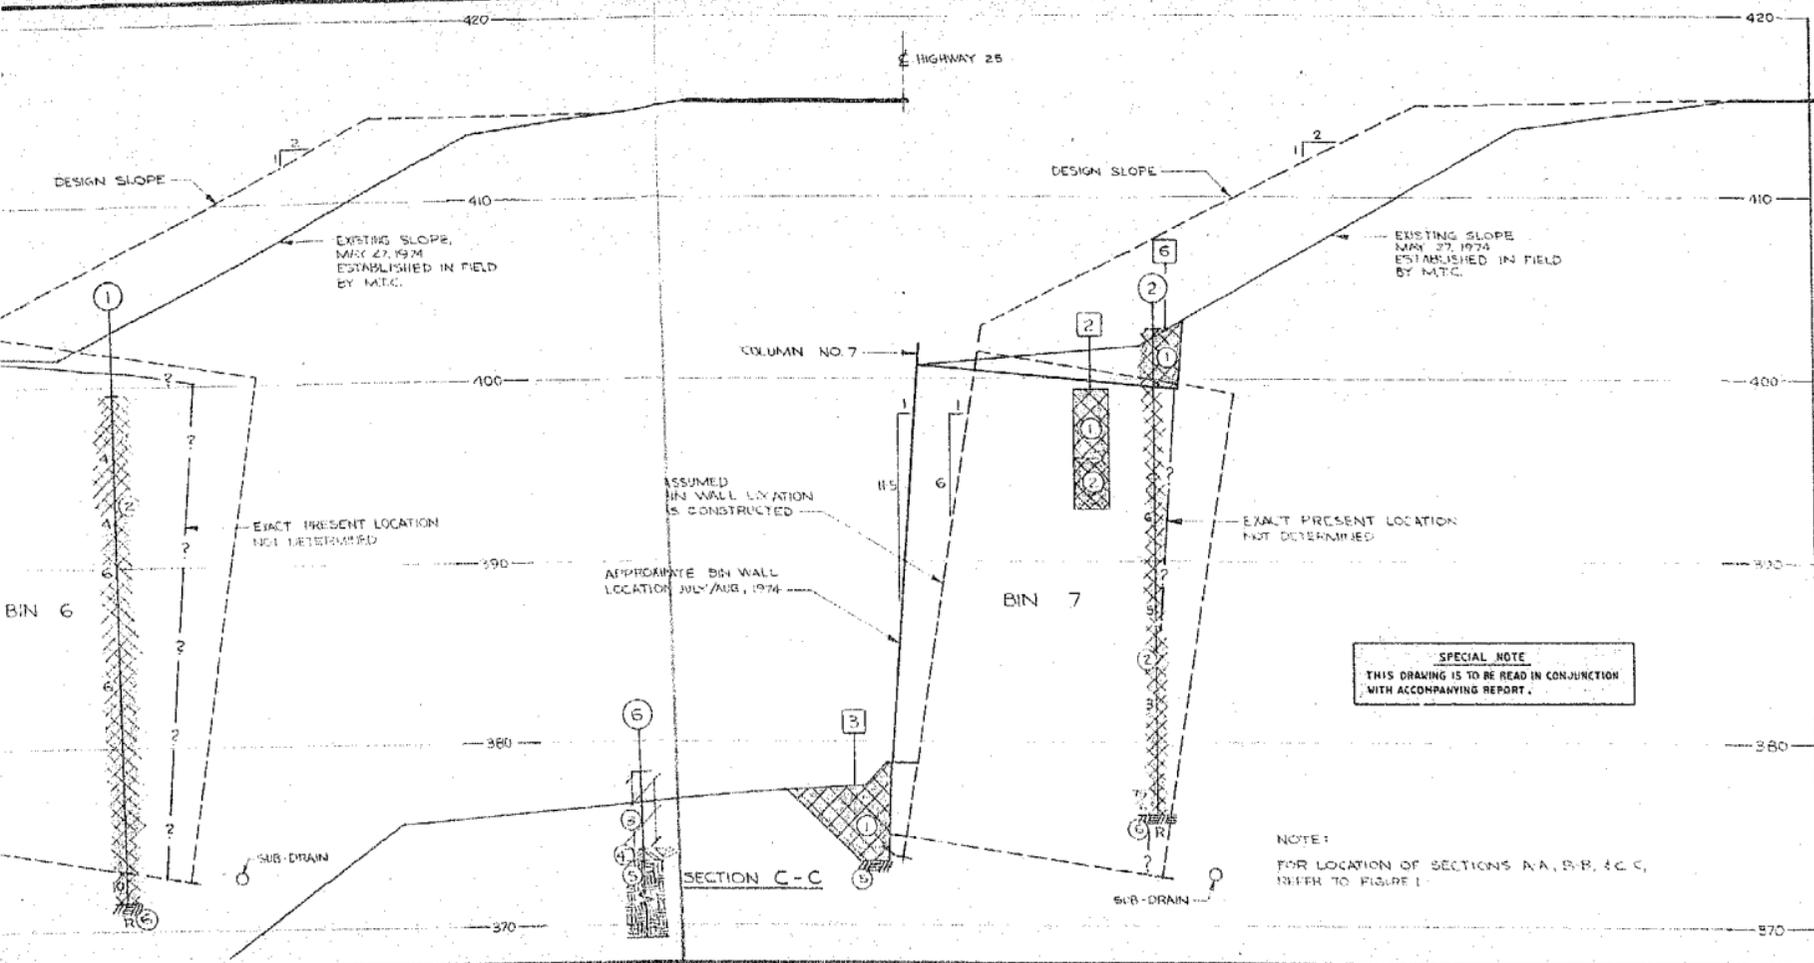
FIGURE 2

Figure 2 presents topographic sections through Bins 5, 6 and 7 and our estimate of the approximate existing configuration of the bins. It would appear that the corners of the bins are not square and have deflected and moved forward. The top of the rear bin at columns 5 and 7 has moved laterally and downward slightly from the "as-built" location.

SECTIONS SHOWING SOIL STRATIGRAPHY & RELATIVE MOVEMENT OF BIN RETAINING WALL

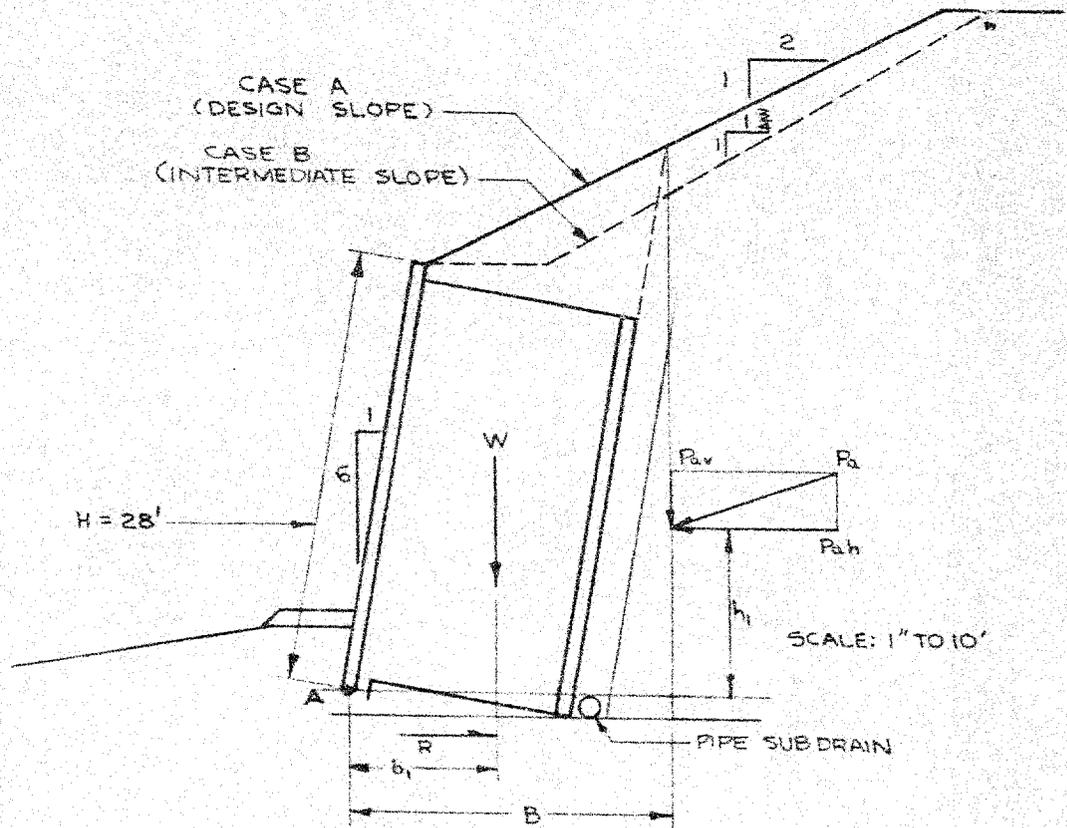
FIGURE 3

The bin type retaining wall must be stable when subjected to lateral earth pressures and superimposed surcharge loads. Figure 3 presents a force diagram of the bin wall retaining structure, equations for determination of factor of safety against overturning and against sliding, and soil parameters assumed for calculation purposes.

In summary, computations for the 28 foot high bin wall with 1 to 6 batter and surcharge loading (see Figure 3), indicate that the safety factor against overturning about the toe of the bin wall is slightly less than 2.0 and it is therefore considered adequate. However, the sliding resistance of the bin wall (assuming a high friction angle $\delta = 25$ degrees and full drainage behind the bin section) is only marginal at about 1.1. This value could approach unity if there is a small build-up of hydrostatic pressure (about 5 feet of head) above the base of the bins.

FORCE DIAGRAM OF BIN WALL RETAINING STRUCTURE

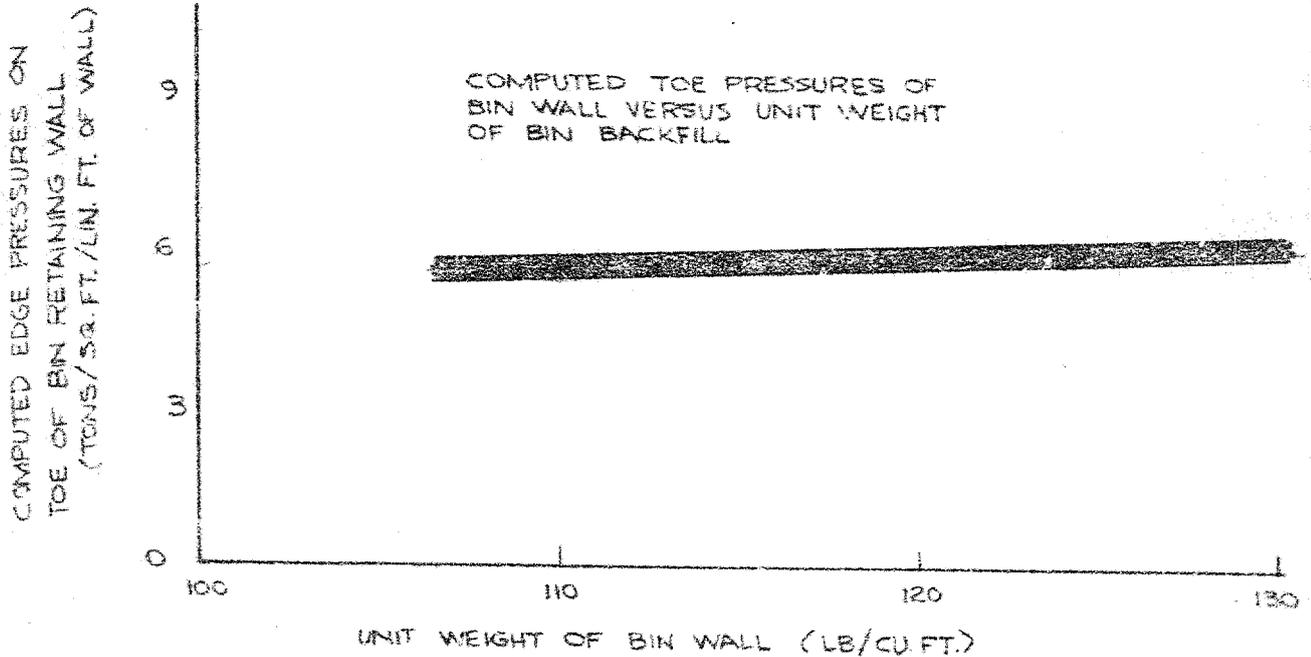
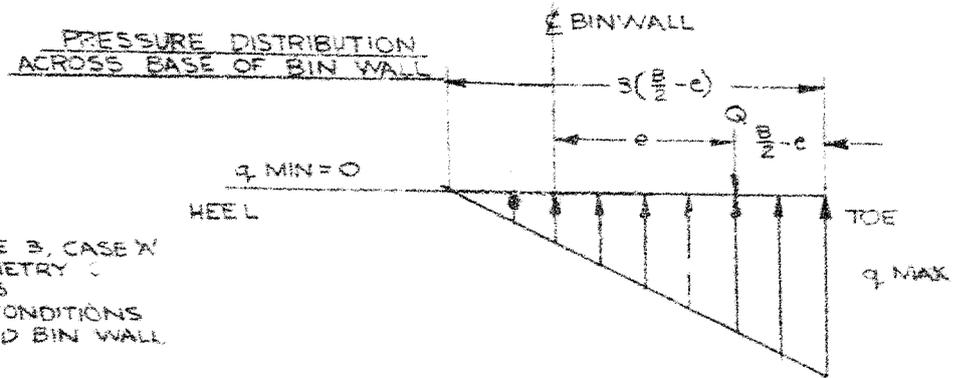
FIGURE 5

The effect of the unit weight for the bin backfill on the toe and heel pressures is given on Figure 5 and shows that the maximum toe pressures at the base of the bin wall could be as high as 6 tons per square foot.

EFFECT OF UNIT WEIGHT OF BACKFILL ON
TOE AND HEEL PRESSURES OF BIN WALL
(CASE A)

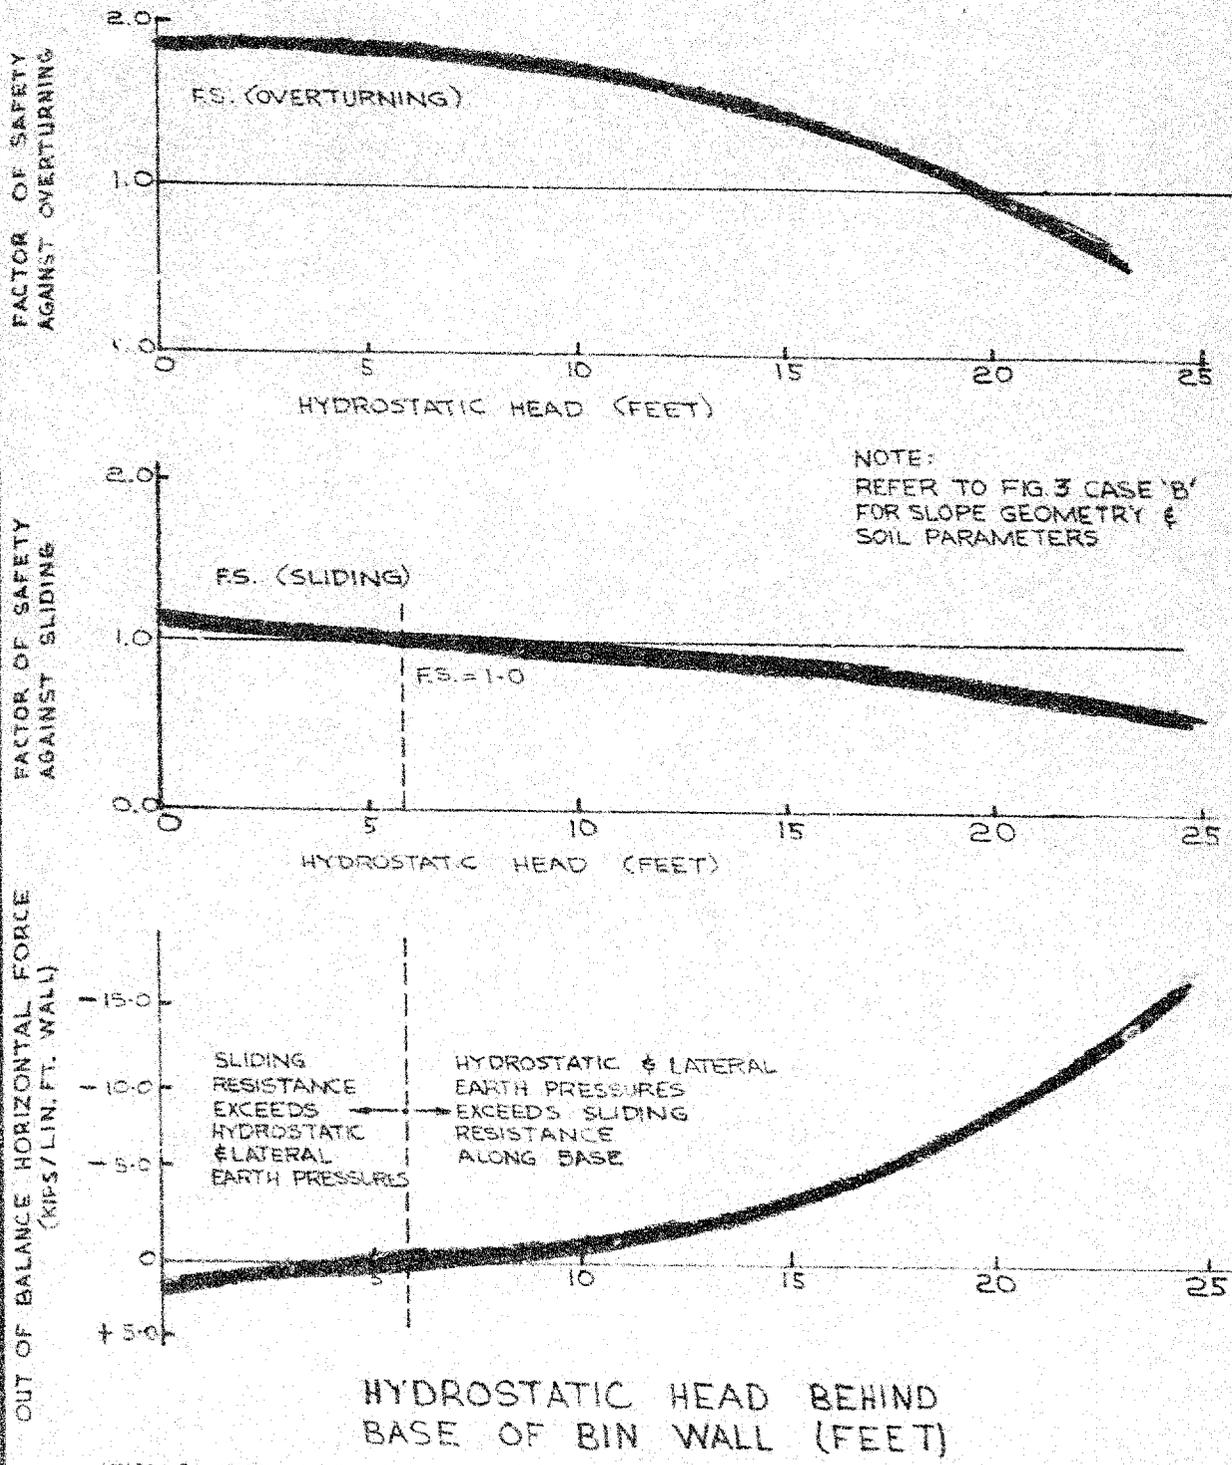
FIGURE 6

All stability analyses for the bin sections previously discussed in this report have assumed that there is NO hydrostatic pressure build-up behind the bin wall (sub-drains sufficient to maintain fully drained conditions at back of bins). The effect of hydrostatic build-up behind the bins on the stability is illustrated on Figure 6 (for Case B - intermediate slope corresponding to existing ground profile) and in the following table:

EFFECT OF HYDROSTATIC PRESSURES ON STABILITY OF BIN WALL (CASE B)

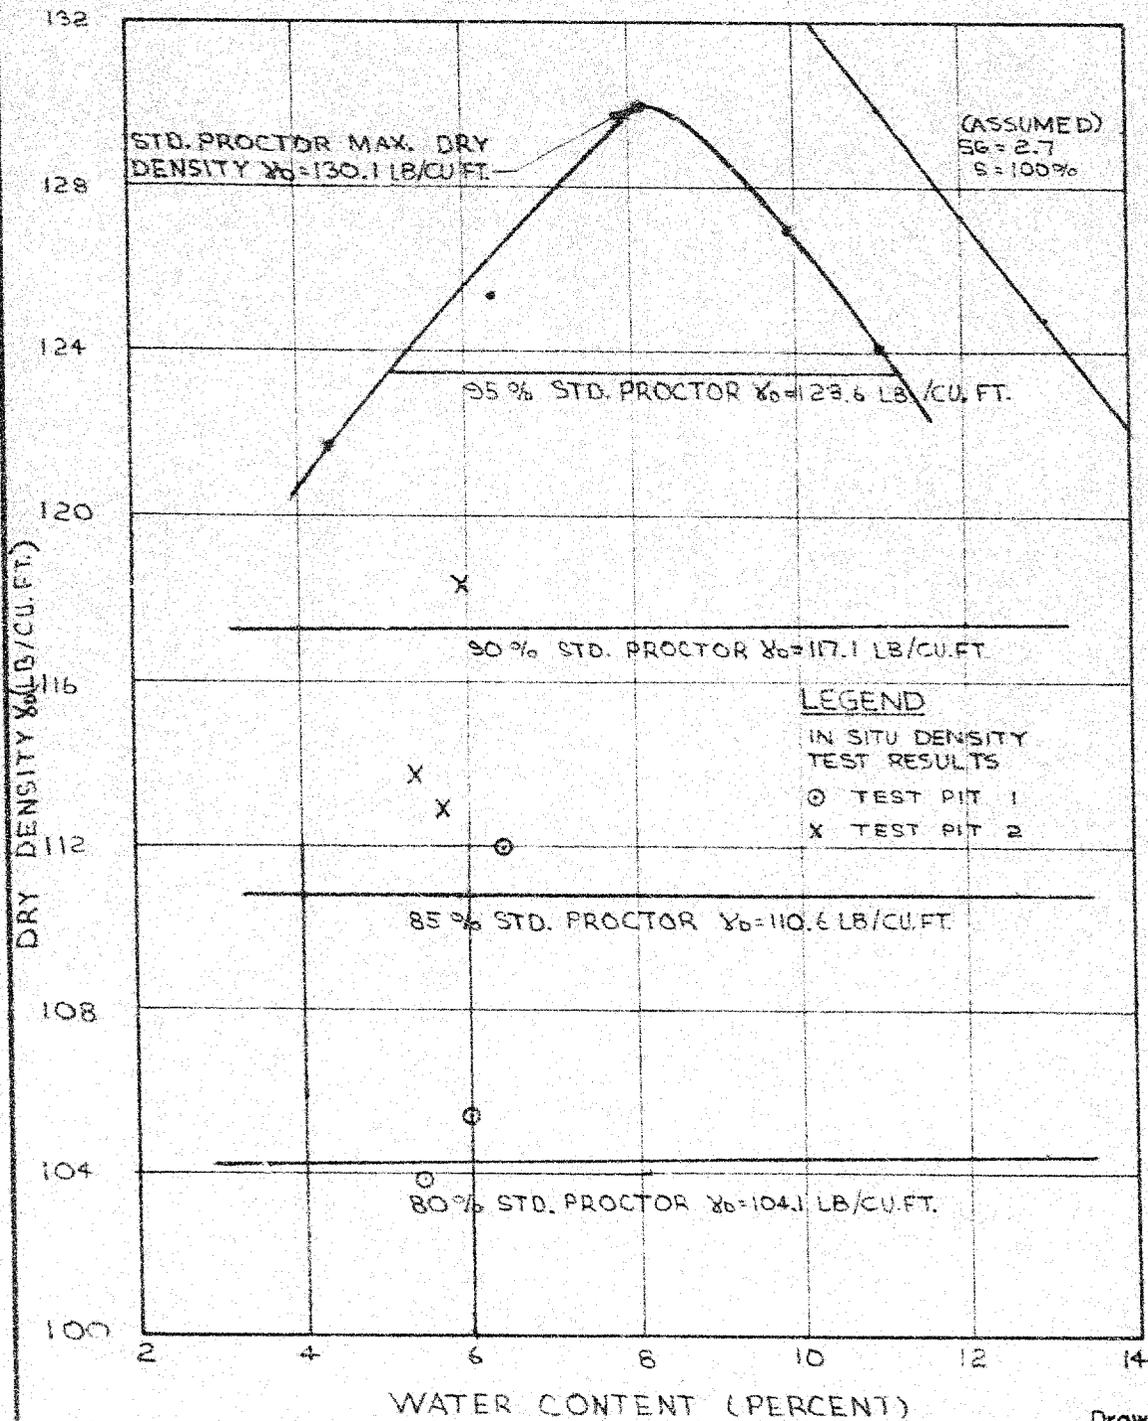
FIGURE 7

The results of a laboratory standard Proctor compaction test carried out on a bulk sample of the granular backfill (sand and gravel with some silt) are given on Figure 7, and indicate a maximum dry density of 130.1 pounds per cubic foot at an optimum water content of 8.1 per cent.

Reference to Figure 7 indicates that the in situ dry density of the upper 3 to 4.5 feet of the granular backfill in Bins 5 and 7 is typically only about 80 to 87 per cent standard Proctor density and it is therefore considered that the material is in only a loose state of packing. The results of standard penetration tests (M.T.C. Boreholes 1 and 2) in the granular backfill in Bins 5 and 6, gave 'N' values ranging from 3 to 6 blows per foot. There is an indication that the loose state of packing of the granular backfill could extend to the bottom of bin (maximum test depth of about 21 feet below ground level).

BIN WALL BACKFILL - GRANULAR 'A'
HIGHWAY 25, ONTARIO

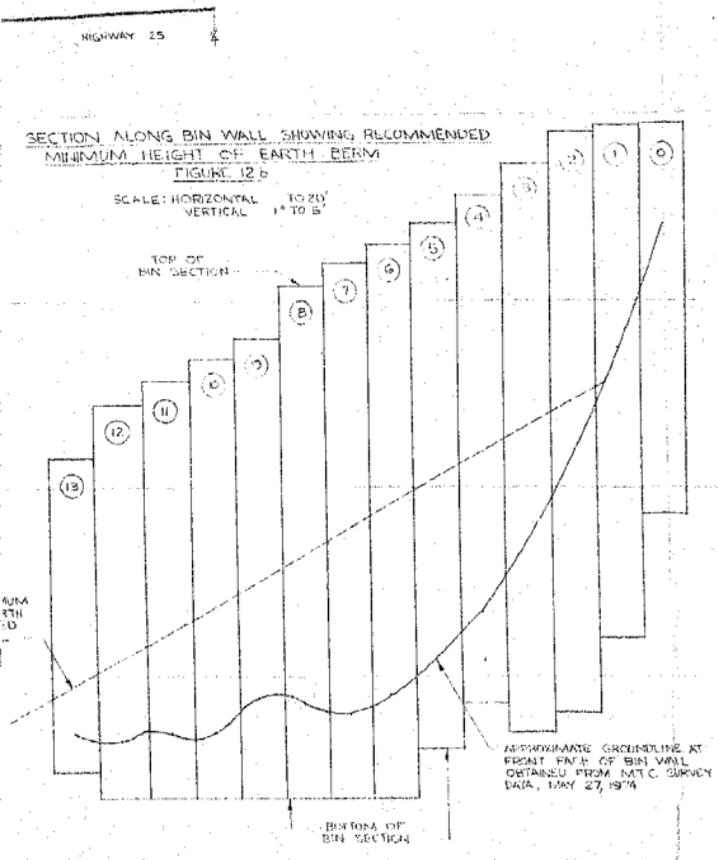
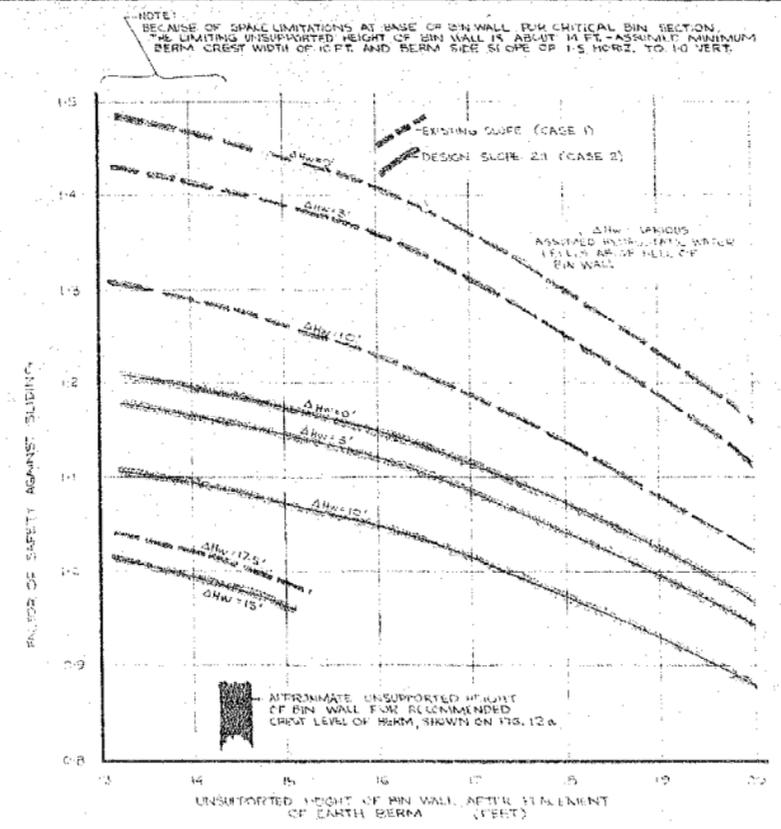
As shown on Figure 12C, the safety factor against sliding for the bins with the design fill slope 2

EFFECT OF HYDROSTATIC PRESSURES AND UNSUPPORTED HEIGHT OF BIN WALL ON FACTOR OF SAFETY AGAINST SLIDING
FIGURE 12c

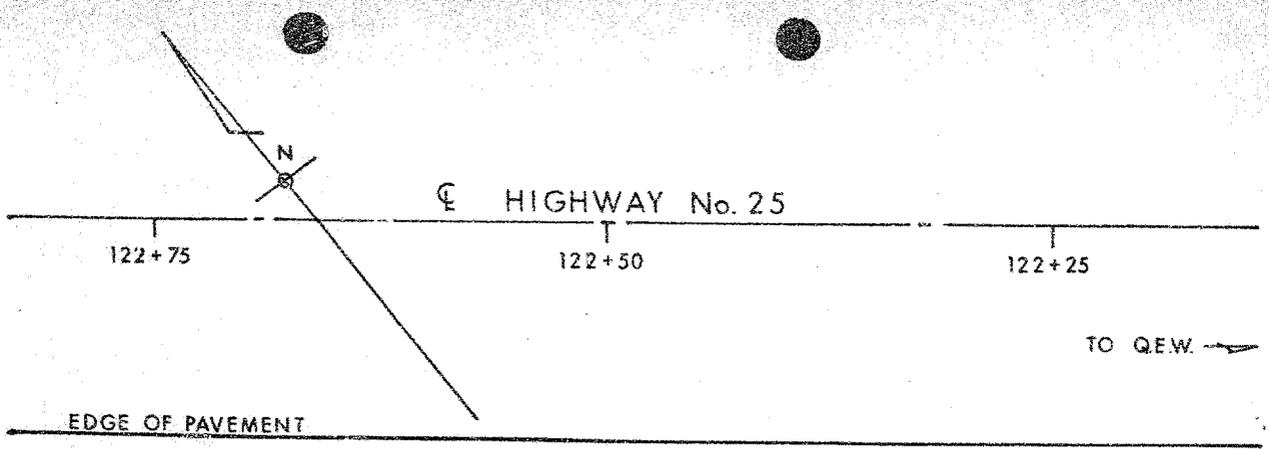
FIG. 1
 SHOWING POSITION OF BIN BEFORE (BROKEN LINES) AND AFTER FAILURE

Fig. # 3 shows the movements of the wall monitored by direct measurement at the top and at the base by District personnel. The movement versus time plot clearly indicates that from April 1974 onward, no further movement has occurred. By examining the present location and distorted shape of the bin (Fig. # 1) and taking into account the fact that the top of the wall has moved more than twice the distance than the base, an early rotational type of failure cannot be ruled out.

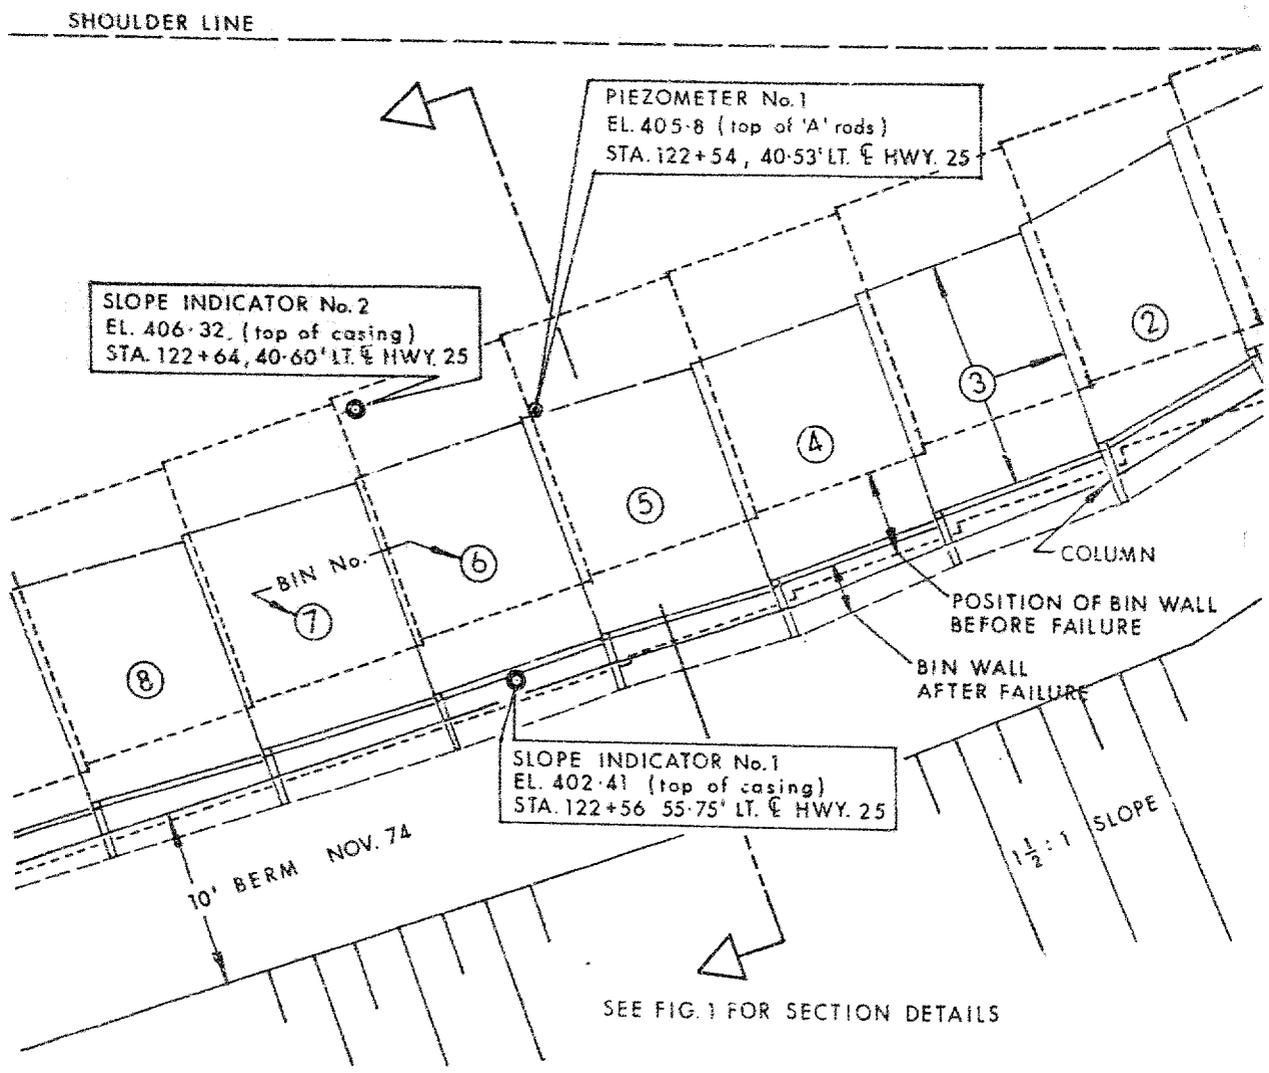
FIG. 2

Two slope indicators and one Geonor type brass piezometer were installed in February 1975 by the Geotechnical Office. The locations of the instruments are shown on Fig. # 2. Slope indicator casing # 1 has been attached to the face of bin # 6, the bottom of the casing being some five feet (1.5 m) below the top of the berm. Indicator casing # 2 rests on bedrock, and the top of the casing is about 2 ft. (0.61 m) outside the back of the bin. The length of the casing was supposed to be embedded in the granular backfill material, however, it was noticed during installation that the upper portion of the casing was in earth fill and only at the lower part of the casing was granular material encountered.

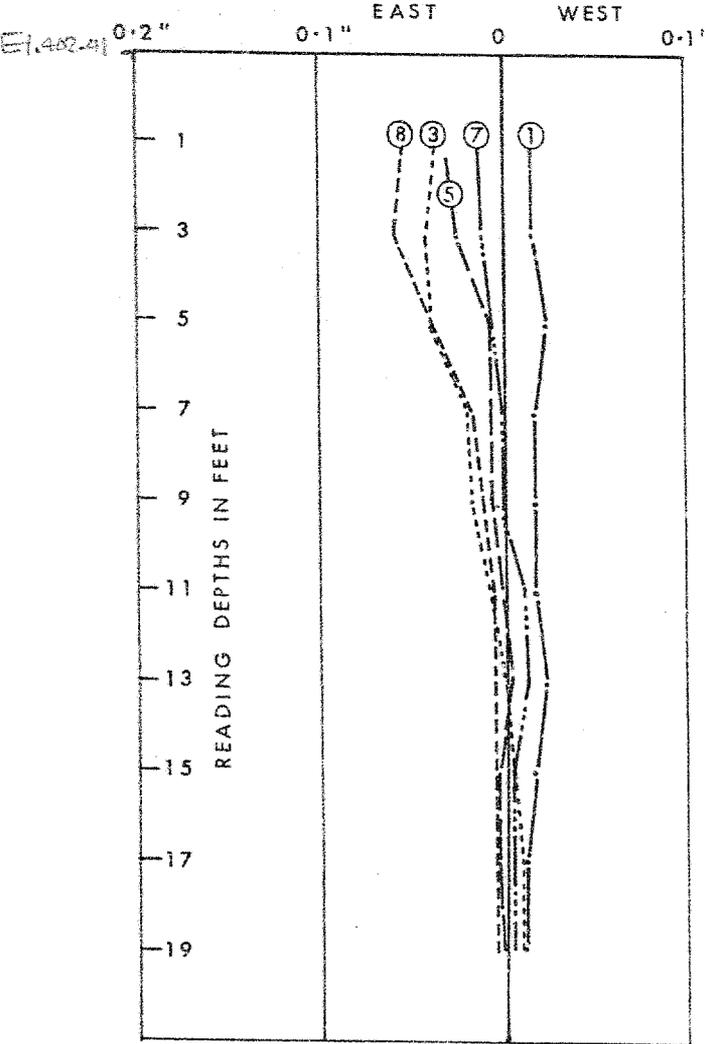
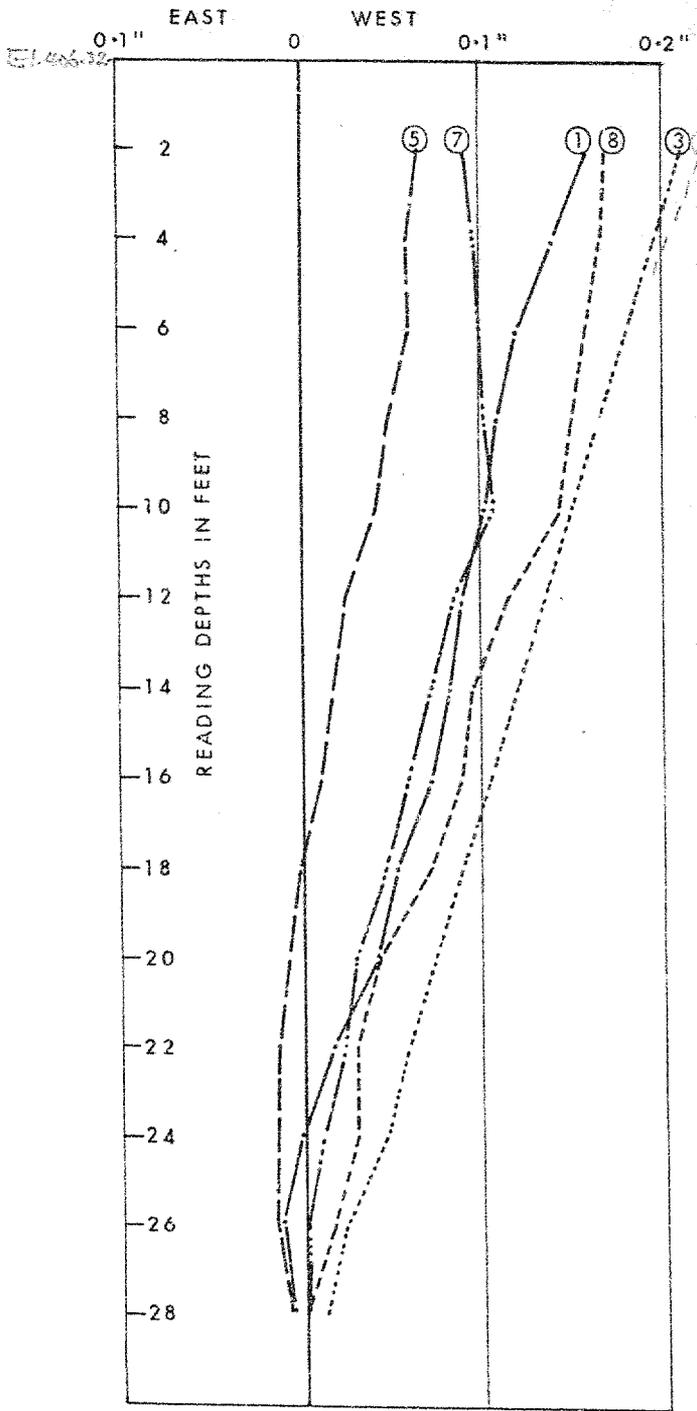
FIG. 3
SHOWING MOVEMENTS RECORDED BY THE DISTRICT

SLOPE INDICATOR No. 1
CASING STRAPPED TO FACE OF BIN #6
