**FOUNDATION INVESTIGATION AND DESIGN REPORT
for
LONGWOOD CHANNEL REHABILITATION, SECTION 3
HIGHWAY 403
GWP 2054-14-00
TASK NO. 2054-14-00-001
HAMILTON, ONTARIO**

PML Ref.: 16TF023A-1
Index No.: 027FIR and 028FDR
GEOCRES No.: 30M5-324
March 20, 2017

FOUNDATION INVESTIGATION REPORT
for
Longwood Channel Rehabilitation, Section 3
Highway 403, GWP 2054-14-00
Hamilton, Ontario

FOUNDATION DESIGN REPORT
for
Longwood Channel Rehabilitation, Section 3
Highway 403, GWP 2054-14-00
Hamilton, Ontario

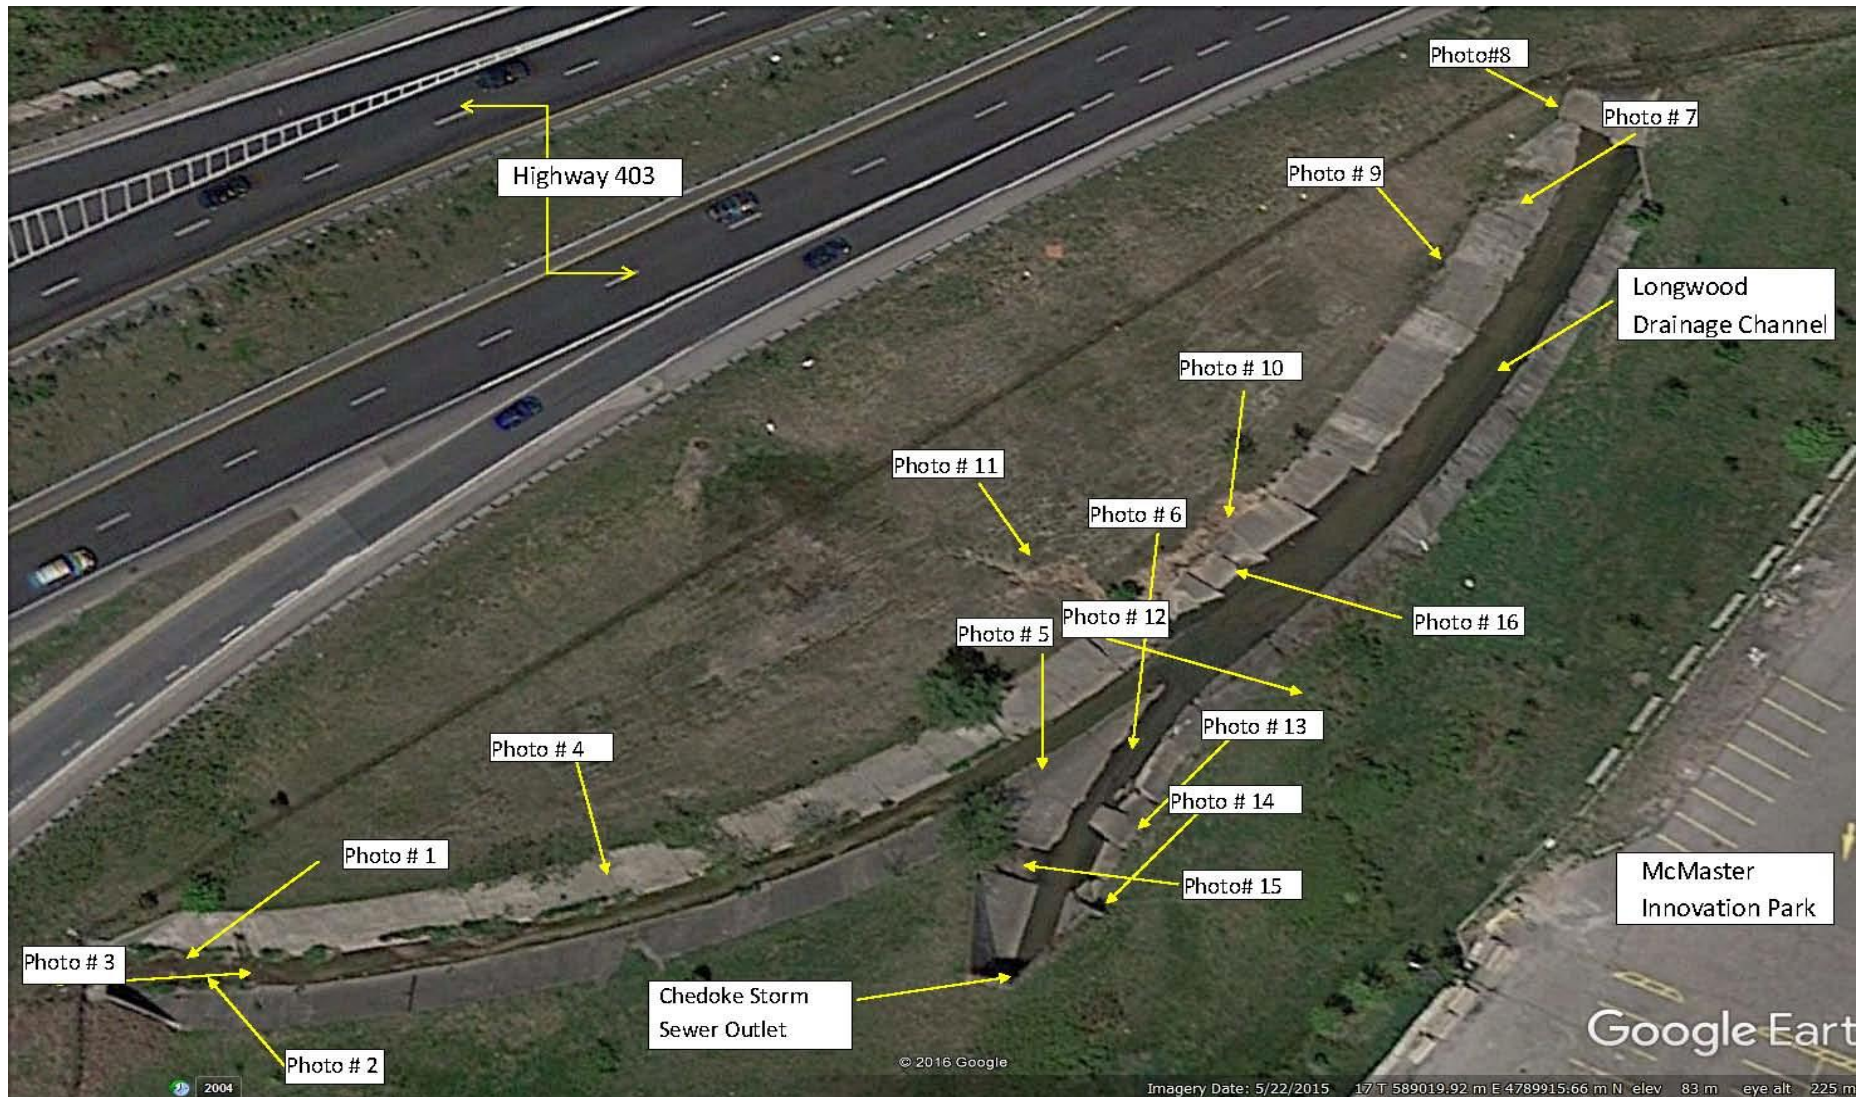
Locations and Directions of Photographs

Photograph No.1: Looking west to Longwood Channel Section 3 outlet. Grass grows on the side slope and base of channel. Cracks are observed on south channel wall (September 14, 2016).
