Rexdale, Ontario,
April 29th, 1963.

Re: Investigation of Slip Area,
Don Valley Parkway at Minton Place,
Toronto, Ontario.

SOIL CONDITIONS AND STABILITY STUDIES

DON VALLEY PARKWAY SLOPE AT MANTON PLACE

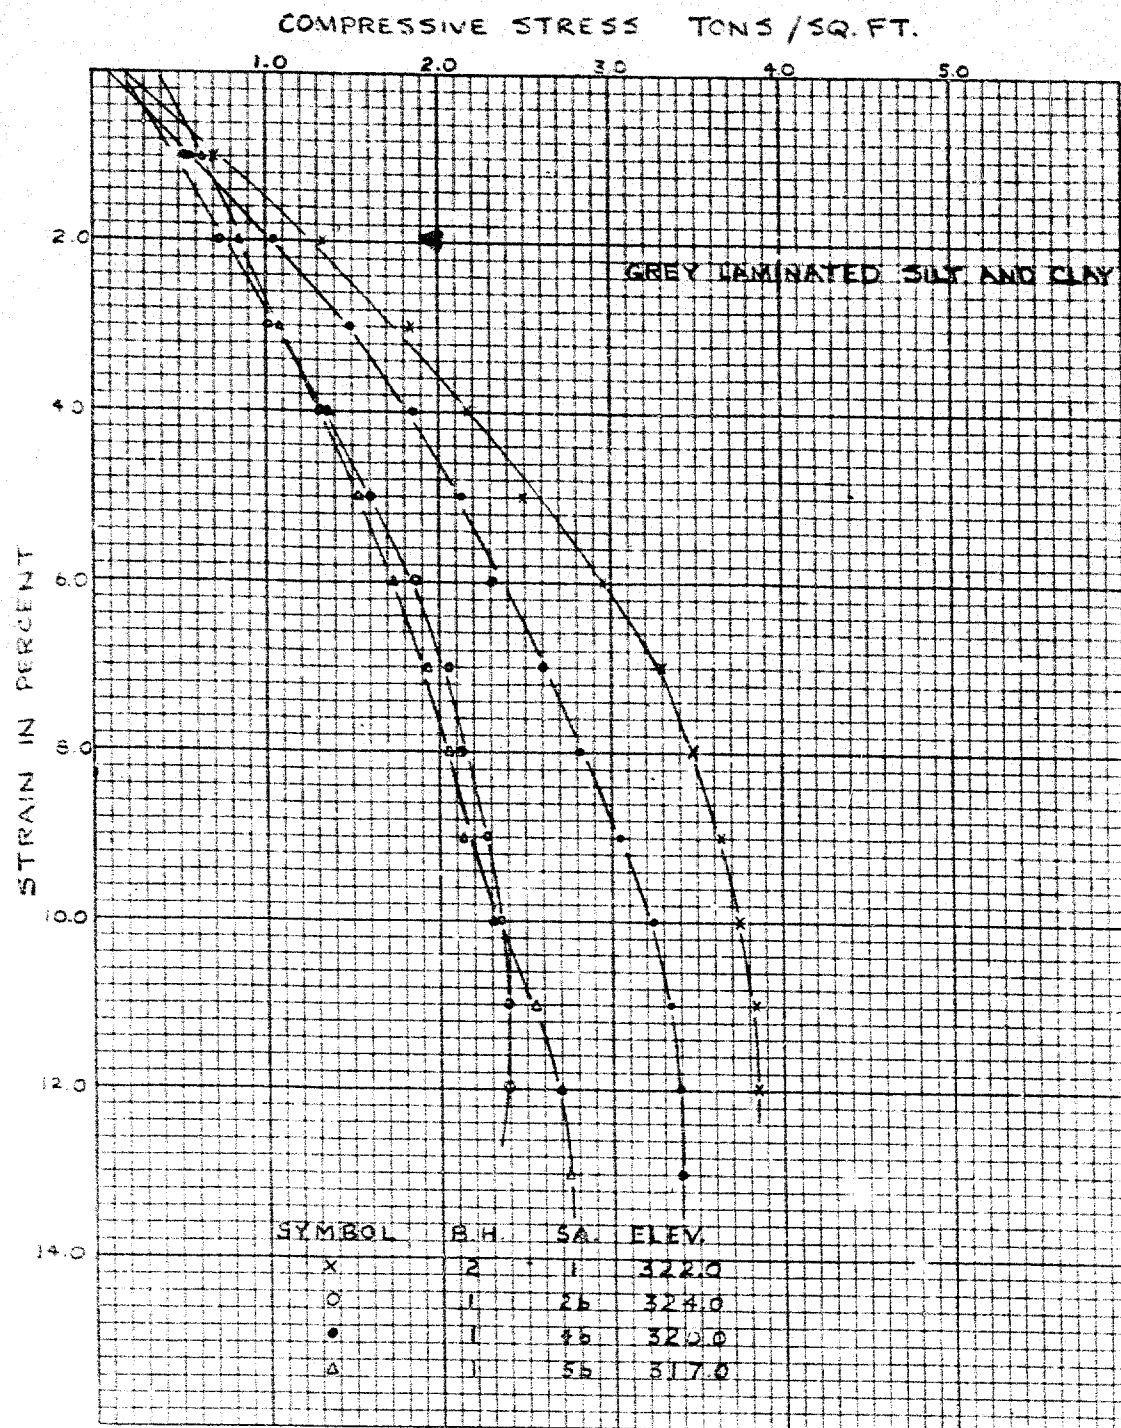
APPENDIX II
FIGURE 3
PROJECT T7489

Three effective stress circles obtained from consolidated undrained triaxial tests with pore pressure measurements are shown in Figure 3. On the basis of these test results, an effective friction angle, ϕ' , of 34 degrees and a cohesion intercept, c' , of zero have been used for design.

CONSOLIDATED UNDRAINED TRIAXIAL TESTS
WITH
PORE PRESSURE MEASUREMENTS
