ROBERT DODDS LIMITED
CONSULTING GEOTECHNICAL ENGINEERS

FOUNDATION INSPECTION
CONSTRUCTION OF HIGHWAY 406 BRIDGE
TWELVE MILE CREEK
CITY OF ST. CATHERINES
REGIONAL MUNICIPALITY OF NIAGARA

Our Reference No. R80168
MTC Contract No. 80-44
August, 1980

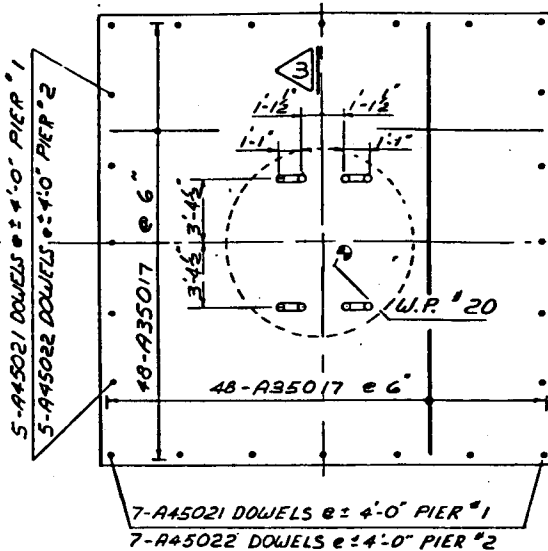
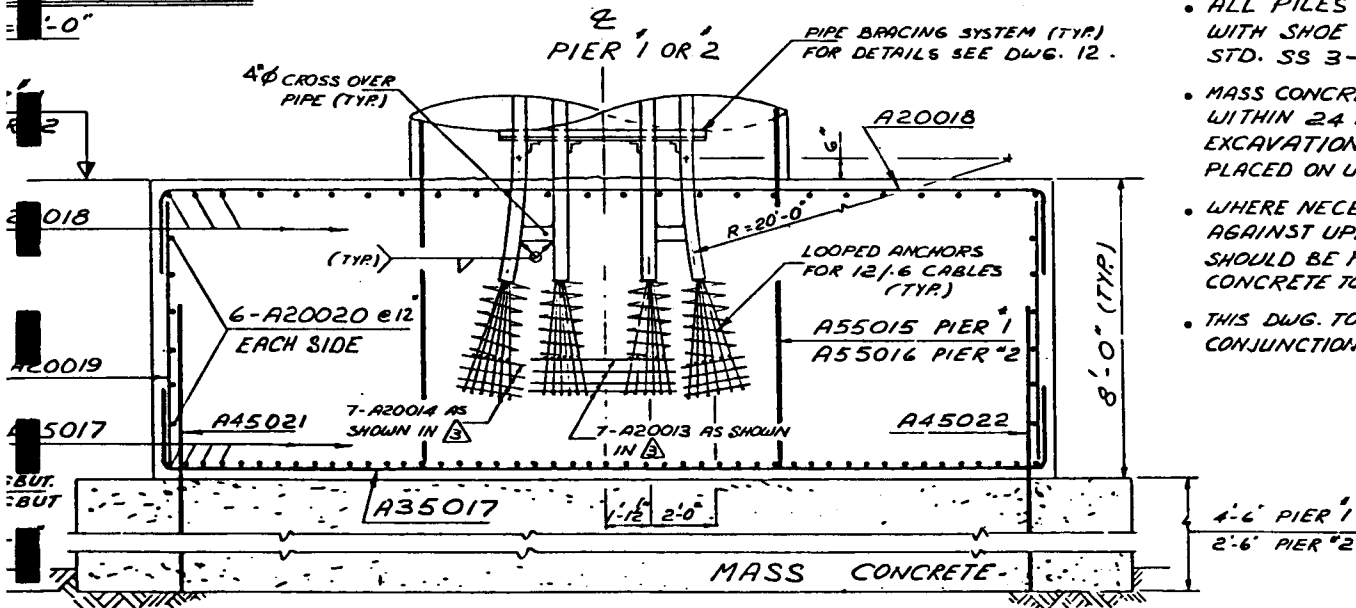
PIER 1 & 2 FTGS

Pier No. 2 in the northbound lane was excavated to approximately elevation 243 ft. without encountering sound Queenston shale. The rock encountered is shale. However, it is relatively soft and easily broken. In addition, the flow of water from the borehole collar would indicate that there are open joints or fractures in the rock.

It is our opinion that footings of piers founded in this material rather than sound Queenston shale may experience detrimental settlements. Construction has indicated that the rock is easily broken up and weathers very quickly when exposed to air. The rock mass has open fractures to allow passage of water and could compress under loading.

Alternate design could be considered, such as steel H piles augered and then driven to refusal at greater depth or cast-in-place concrete piles that obtain their capacity from socketing in underlying sound rock.
