## THOROLD TUNNEL

Investigations to Determine the  
Cause of Cracking in the Structure

March 1972

Thorold Tunnel  
Investigations to Determine  
the Cause of Cracking

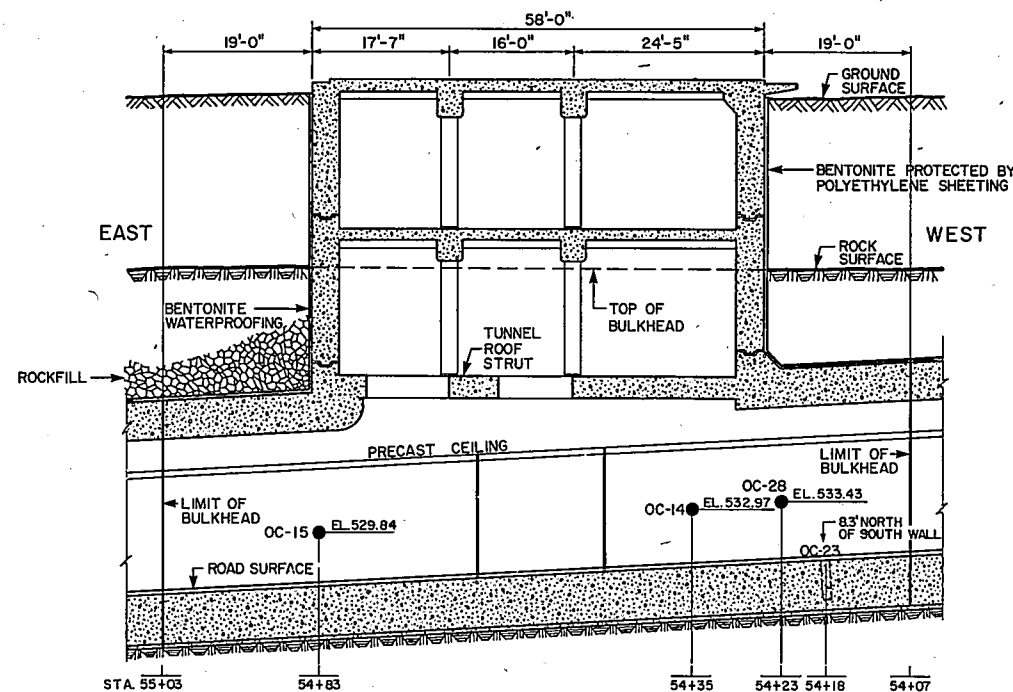
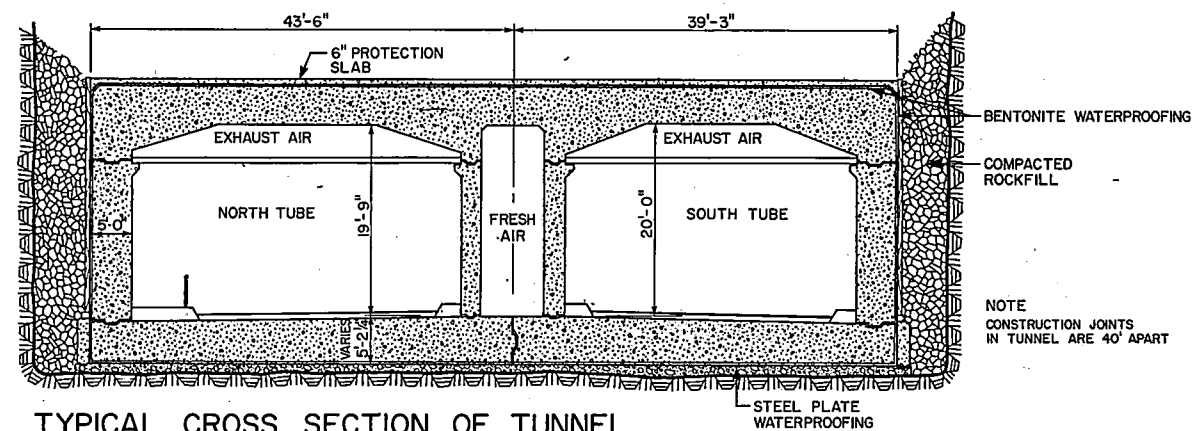
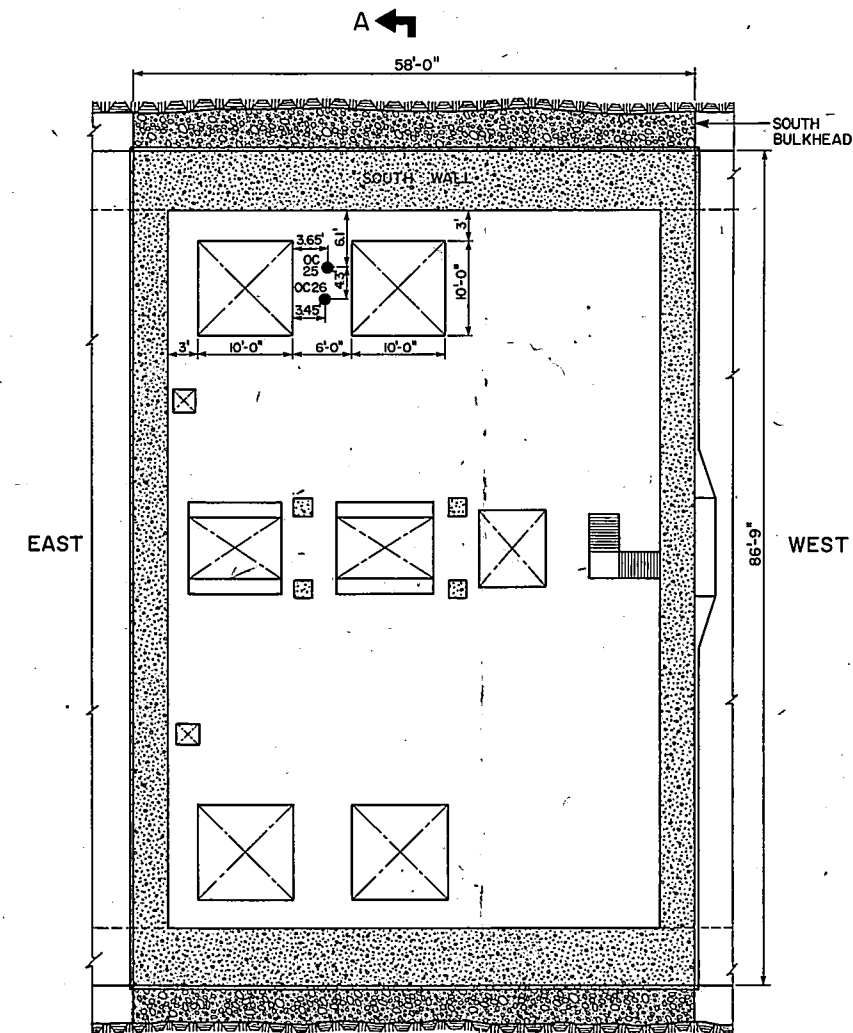
DEPARTMENT OF TRANSPORTATION AND COMMUNICATIONS THOROLD TUNNEL STRUCTURAL INVESTIGATIONS	
	WEST SERVICE BUILDING PATTERN OF CRACKING SOUTH WALL	
	FEBRUARY 1972	PLATE 5

The cracks mapped in the south wall of the tunnel under the west service building are shown in elevation on Plate 5. The trend of the cracking is essentially horizontal rather than parallel to the road surface and is confined to a relatively narrow band. Although attempts were made in the drilling program to follow individual cracks through the wall, they were unsuccessful. However, in a number of drill holes, cracks were intersected at depths up to 3 feet 6 inches from the face of the tunnel wall, and from these it was concluded that the cracked planes were within plus or minus 5 degrees of the horizontal.

SECTION A-A AT STATION 54+55

SOUTH TUNNEL WALL - ELEVATION

TYPICAL CROSS SECTION OF TUNNEL

PLAN AT EL.549.83

1. CRACKING BELOW PRECAST CEILING  
MAPPED MAY 1971, NOT SIGNIFICANTLY CHANGED FEB 1972
2. ABOVE PRECAST CEILING  
FIRST OBSERVED FEB 1972

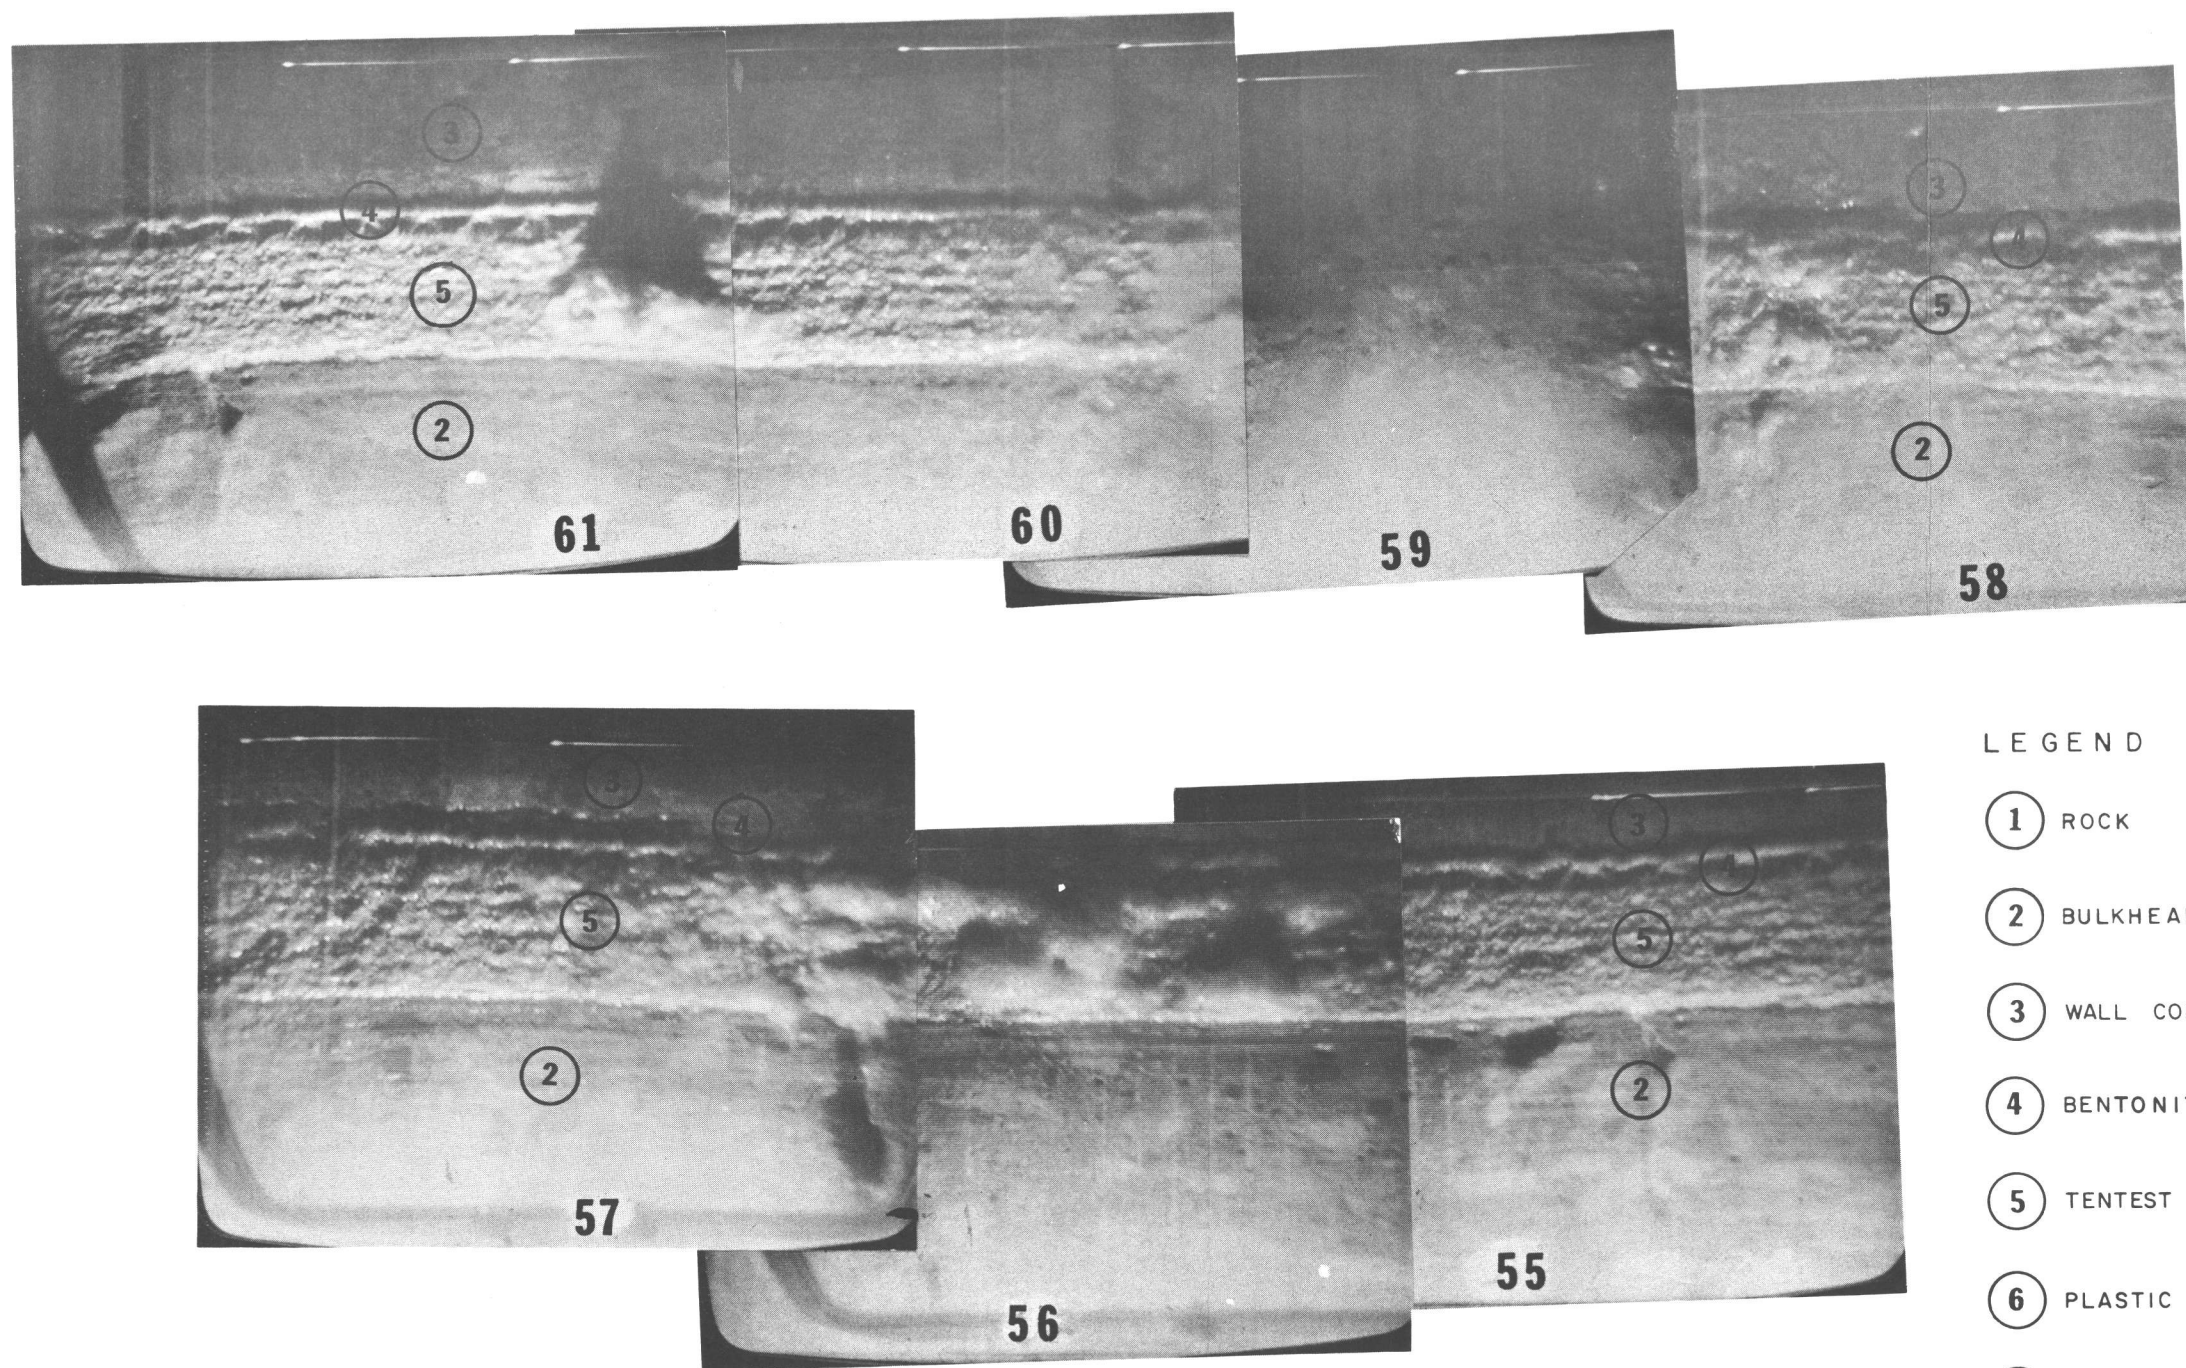
OBSERVED CRACKS IN OC 14
